**REPORT NUMBER: TWG-MGA-2013-008B**

**SIDE AIRBAG OUT-OF-POSITION INJURY  
TECHNICAL WORKING GROUP**

**MERCEDES-BENZ U.S. INTL., INC  
2013 Mercedes-Benz ML350 AWD SUV  
NHTSA No.: MD0509TWG3**

**FINAL REPORT**

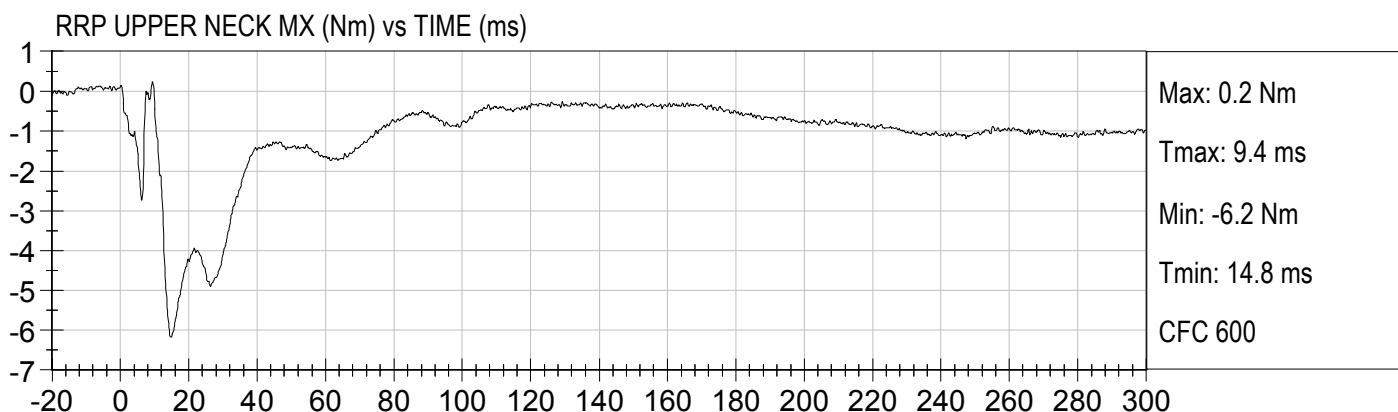
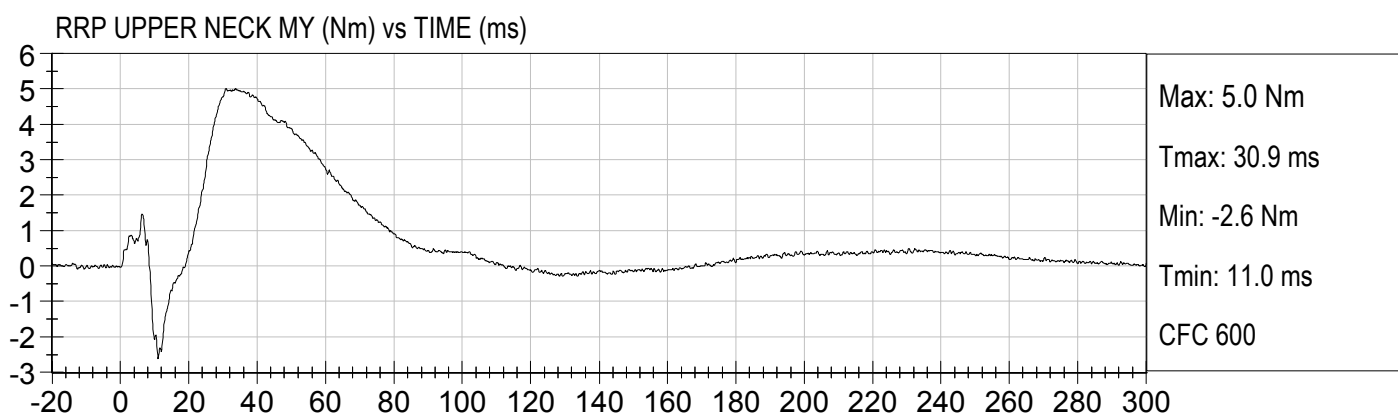
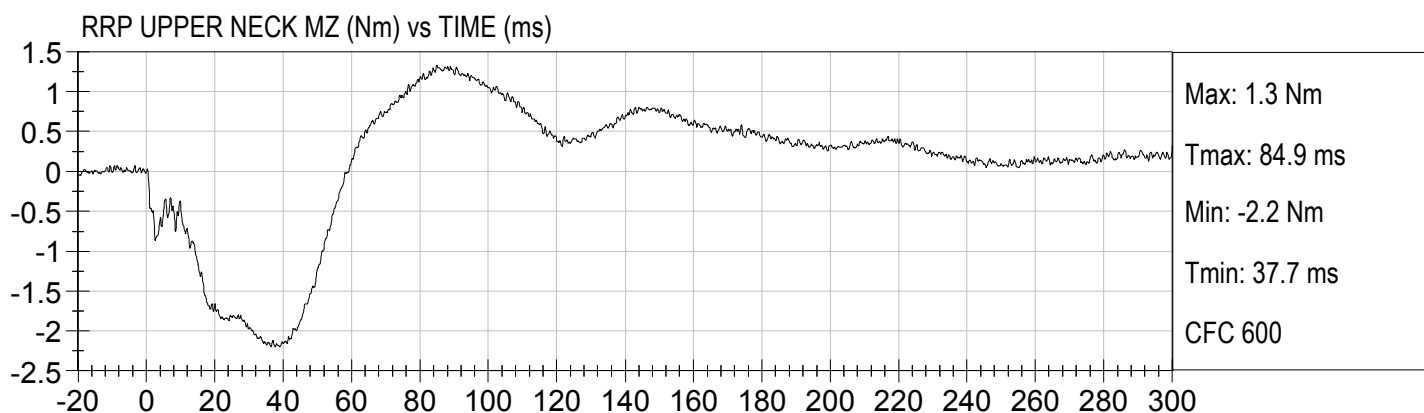
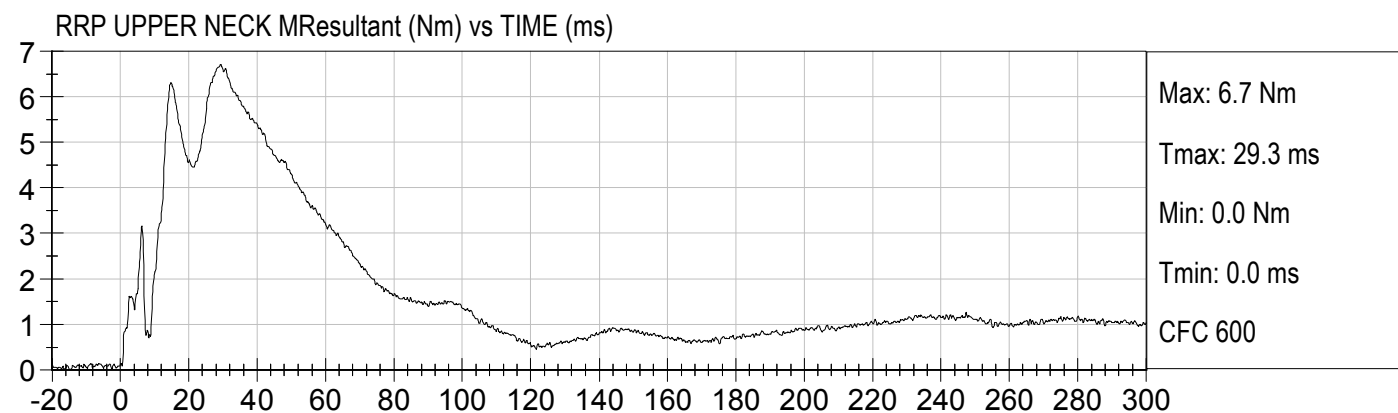
| | <u>Page No.</u> |
|---|---|
| Figure No. 9. RRP Upper Neck X Moment vs. Time | 22 |
| Figure No. 10. RRP Upper Neck Y Moment vs. Time | 22 |
| Figure No. 11. RRP Upper Neck Z Moment vs. Time | 22 |
| Figure No. 12. RRP Upper Neck Resultant Moment vs. Time | 22 |

| | | MAXIMUM VALUE | | | |
|---|---|---|---|---|---|
| Upper Neck Mx | Nm | 0.2 | 9.4 | -6.2 | 14.8 |
| Upper Neck My | Nm | 5.0 | 30.9 | -2.6 | 11.0 |
| Upper Neck Mz | Nm | 1.3 | 84.9 | -2.2 | 37.7 |
| Upper Neck M Resultant | Nm | 6.7 | 29.3 | | |

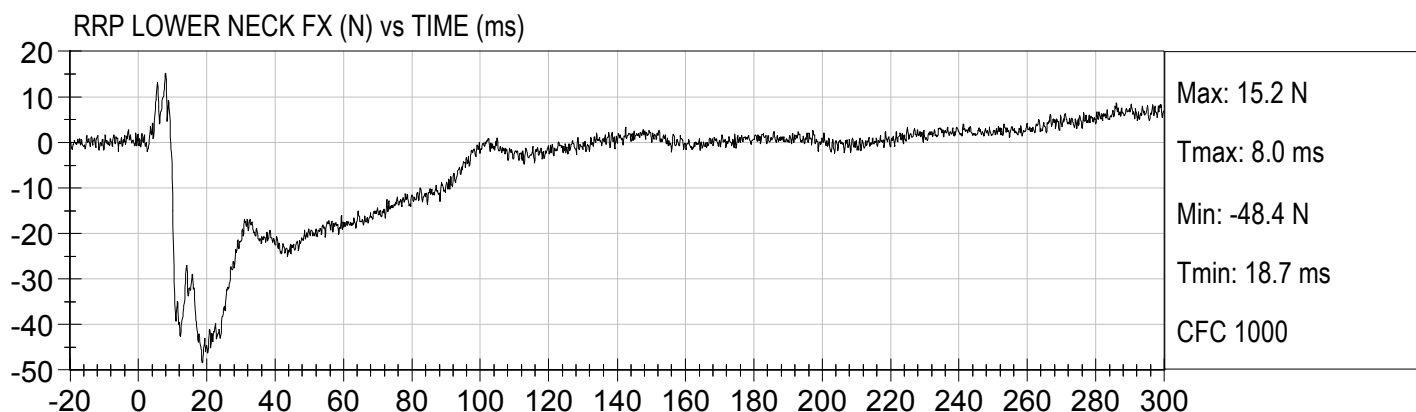
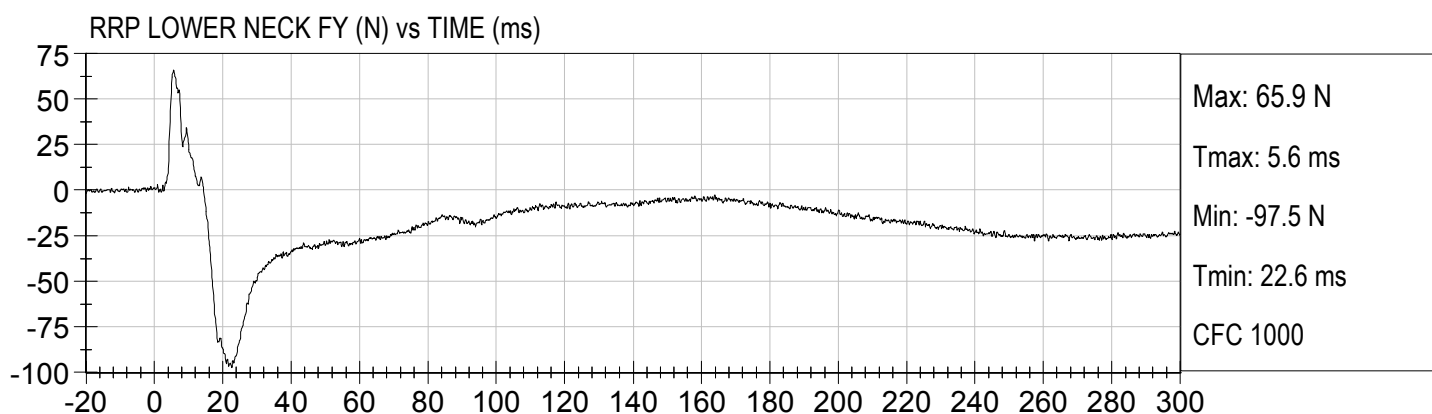
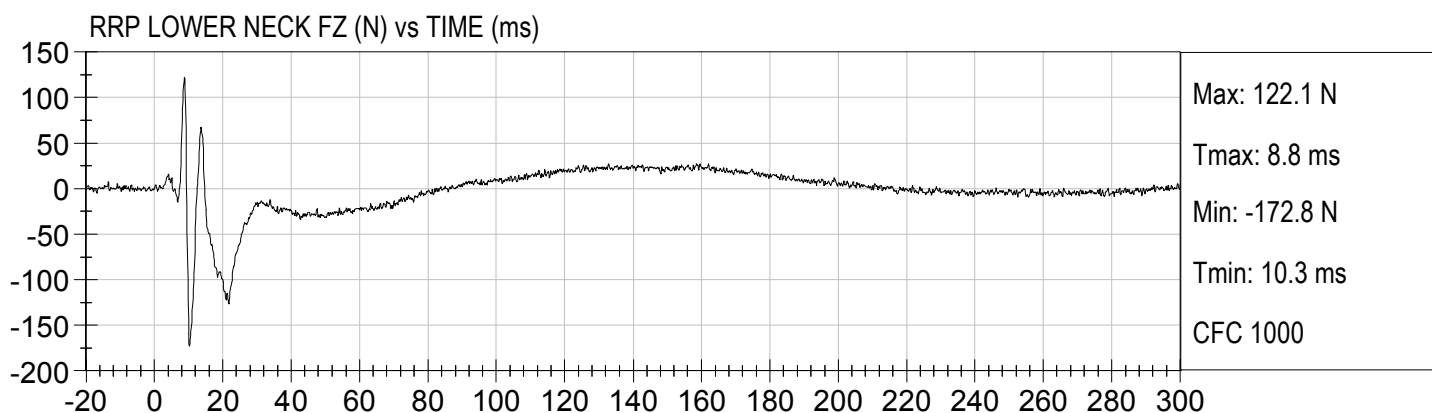
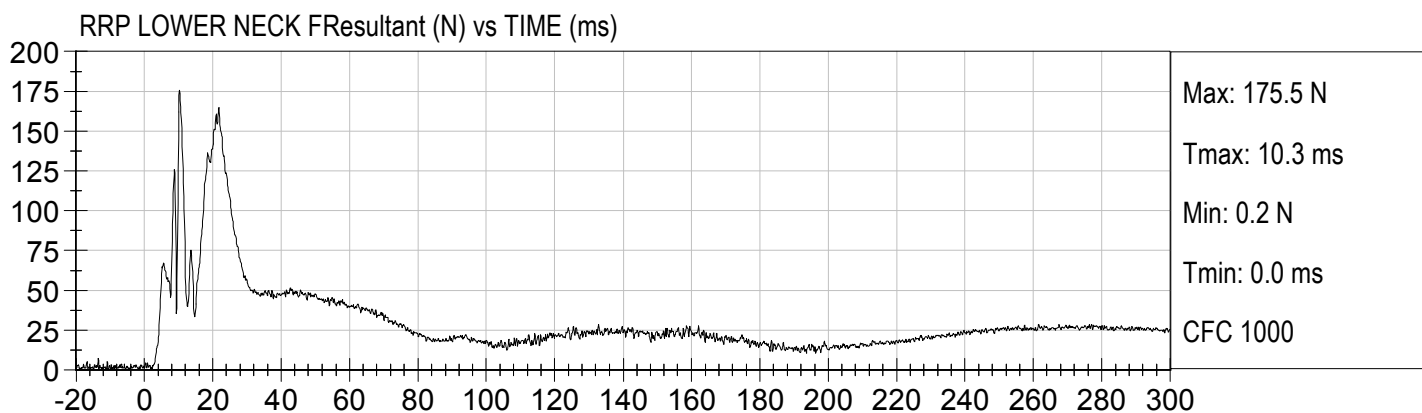
| | <u>Page No.</u> |
|---|---|
| Figure No. 13. RRP Lower Neck X Force vs. Time | 23 |
| Figure No. 14. RRP Lower Neck Y Force vs. Time | 23 |
| Figure No. 15. RRP Lower Neck Z Force vs. Time | 23 |
| Figure No. 16. RRP Lower Neck Resultant Force vs. Time | 23 |

| | | MAXIMUM VALUE | | | |
|---|---|---|---|---|---|
| Lower Neck Fx | N | 15.2 | 8.0 | -48.4 | 18.7 |
| Lower Neck Fy | N | 65.9 | 5.6 | -97.5 | 22.6 |
| Lower Neck Fz | N | 122.1 | 8.8 | -172.8 | 10.3 |
| Lower Neck F Resultant | N | 175.5 | 10.3 | | |

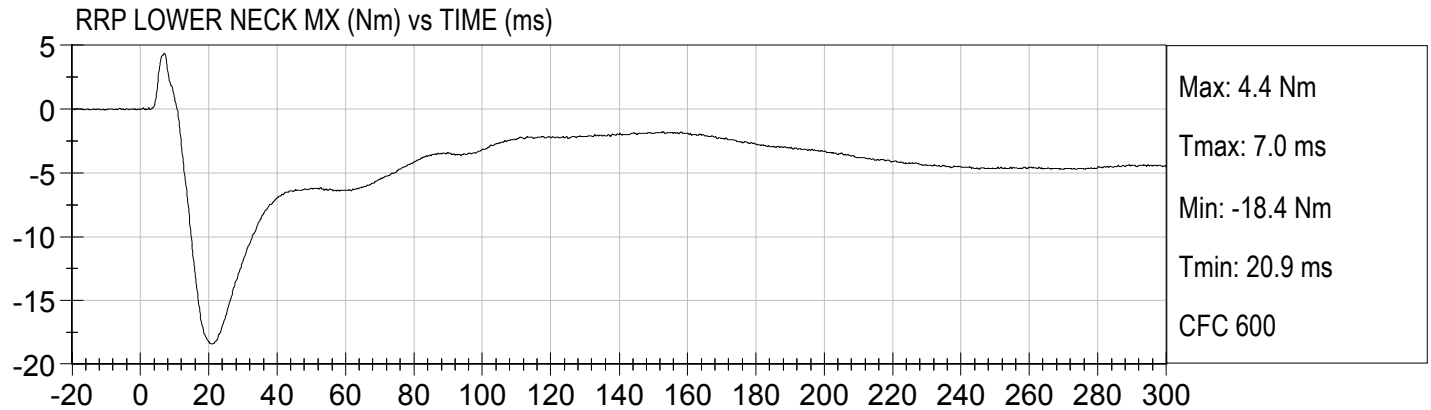
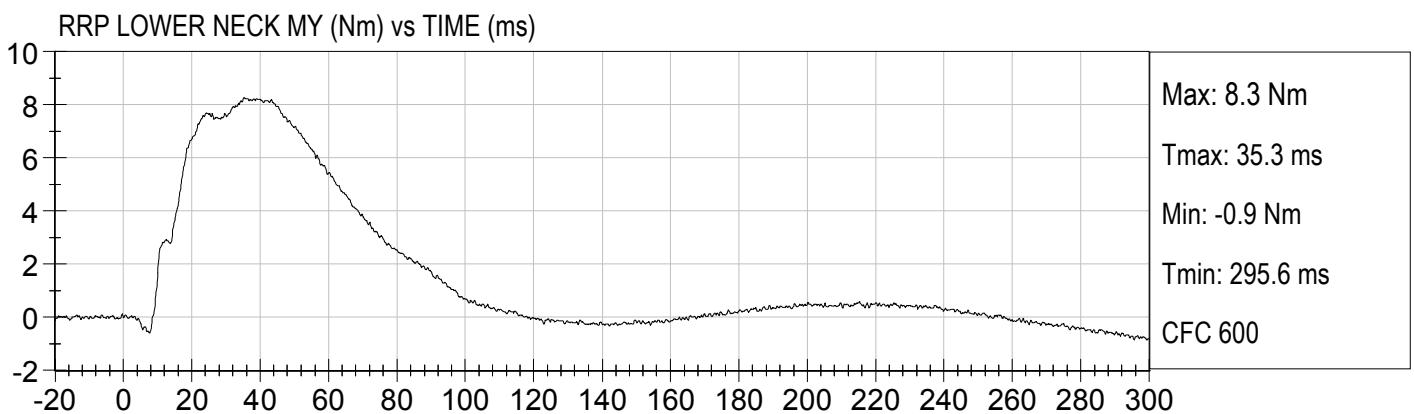
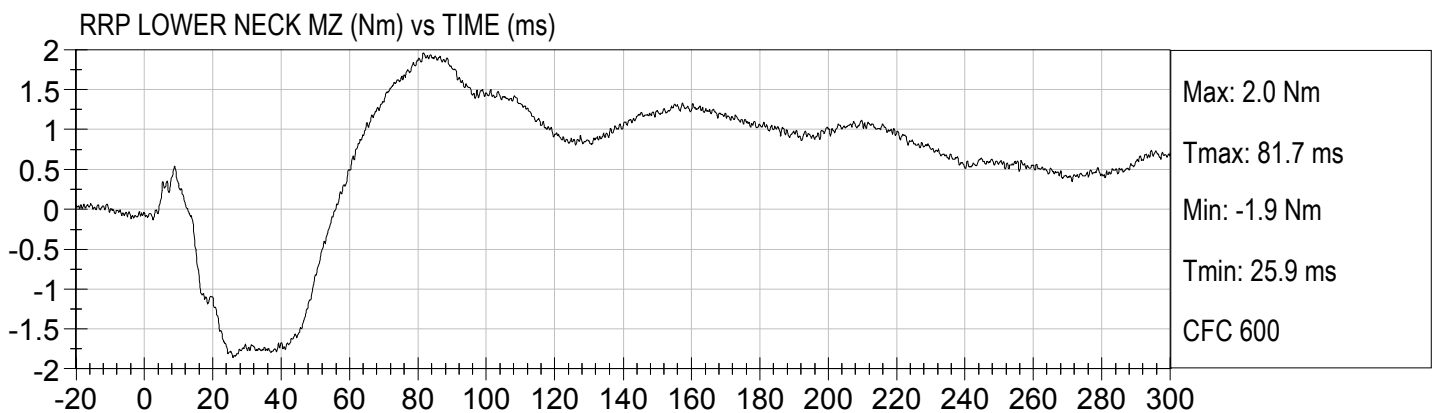
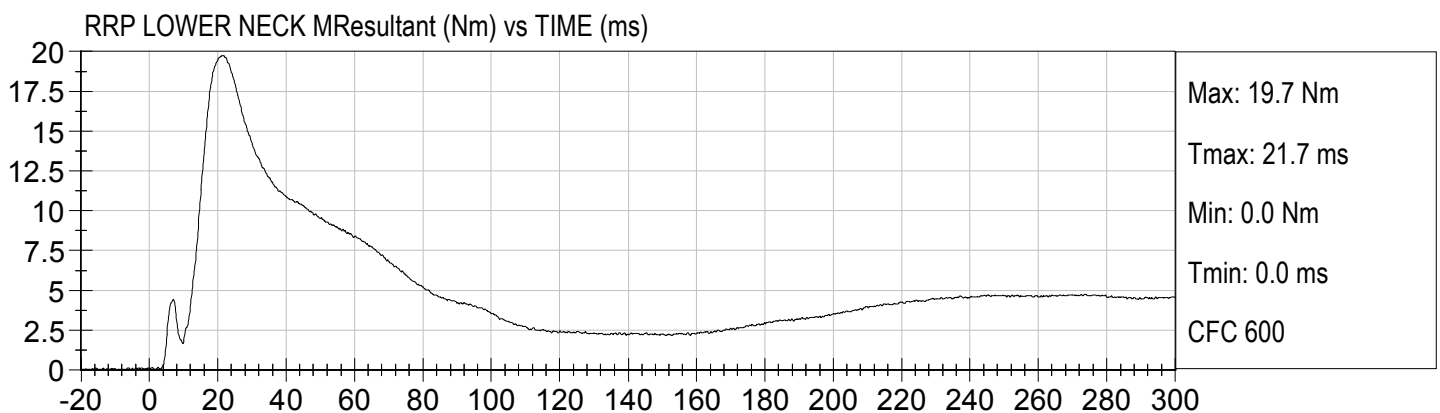
| | <u>Page No.</u> |
|---|---|
| Figure No. 17. RRP Lower Neck X Moment vs. Time | 24 |
| Figure No. 18. RRP Lower Neck Y Moment vs. Time | 24 |
| Figure No. 19. RRP Lower Neck Z Moment vs. Time | 24 |
| Figure No. 20. RRP Lower Neck Resultant Moment vs. Time | 24 |

| | | MAXIMUM VALUE | | | |
|---|---|---|---|---|---|
| Lower Neck Mx | Nm | 4.4 | 7.0 | -18.4 | 20.9 |
| Lower Neck My | Nm | 8.3 | 35.3 | -0.9 | 295.6 |
| Lower Neck Mz | Nm | 2.0 | 81.7 | -1.9 | 25.9 |
| Lower Neck M Resultant | Nm | 19.7 | 21.7 | | |

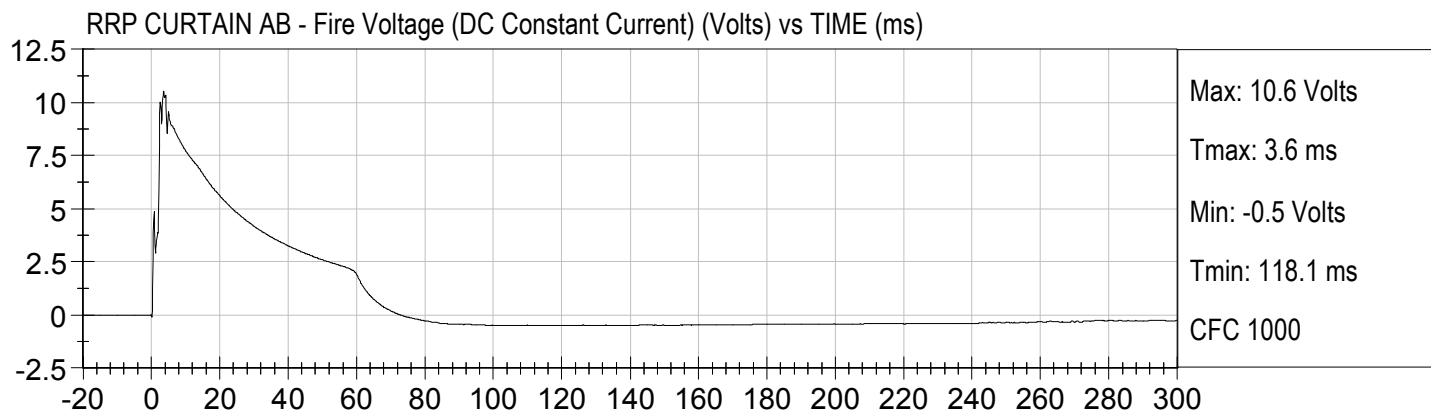
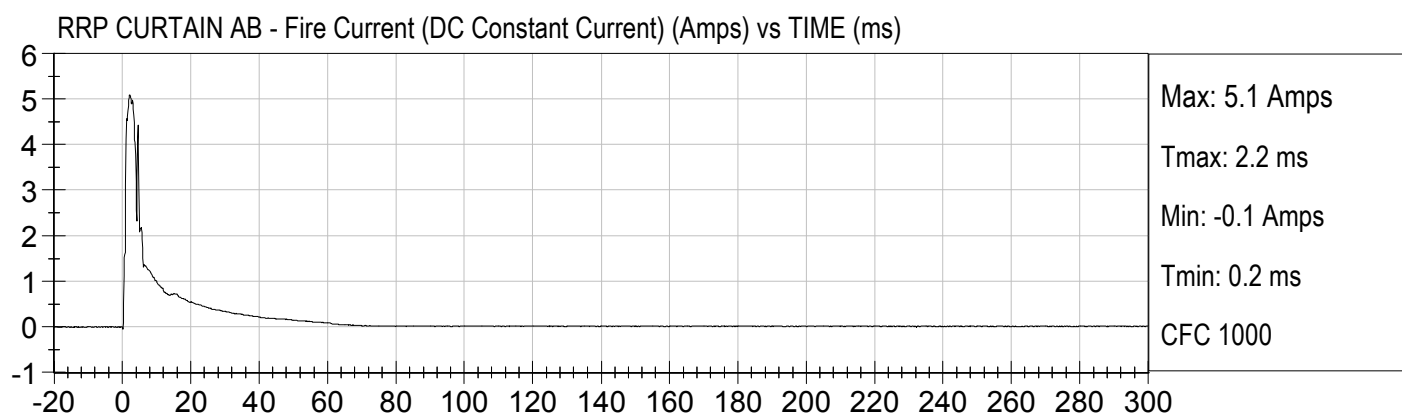
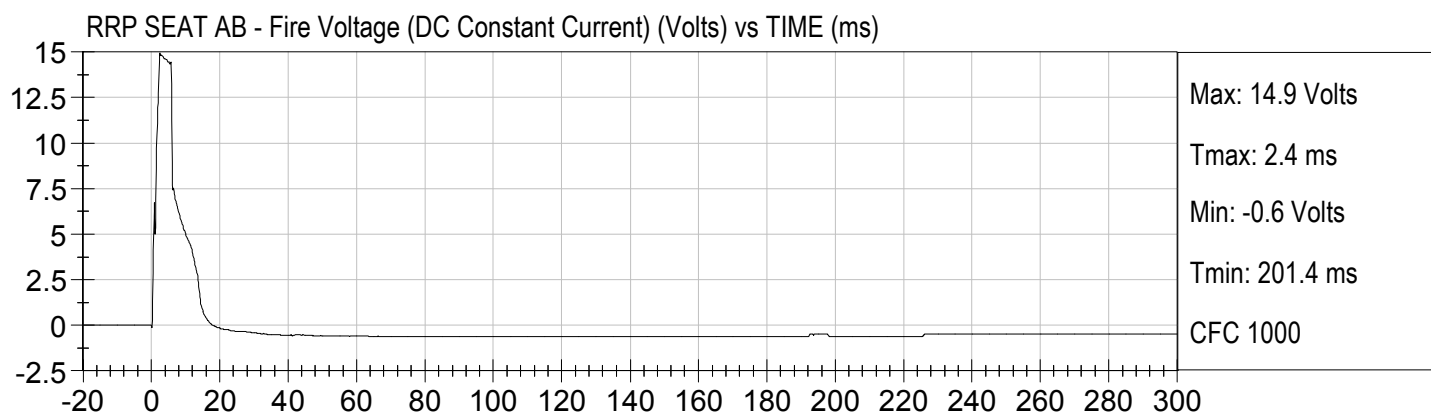
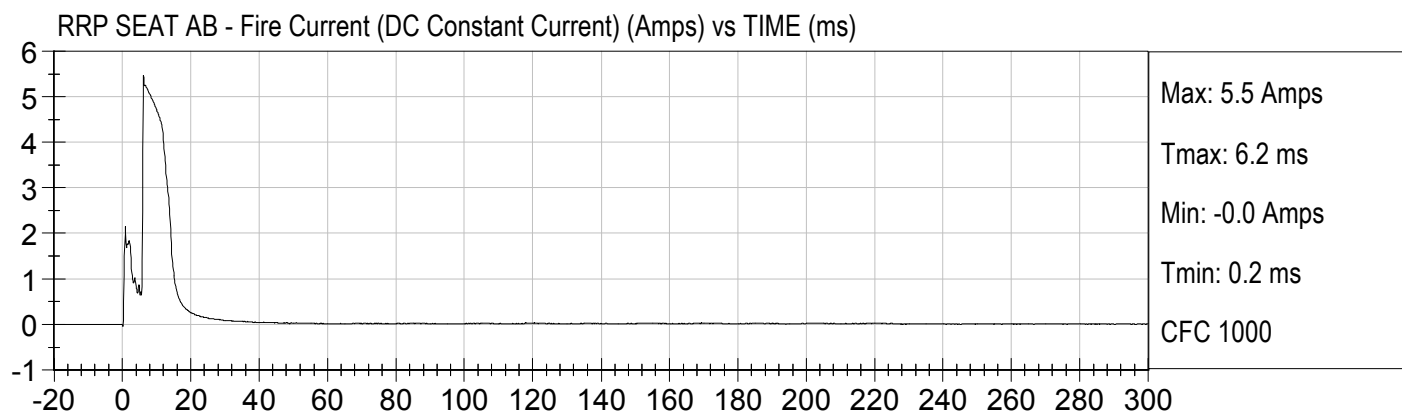
| | <u>Page No.</u> |
|---|---|
| Figure No. 21. RRP Curtain Airbag – Fire Voltage vs. Time | 25 |
| Figure No. 22. RRP Curtain Airbag – Fire Current vs. Time | 25 |
| Figure No. 23. RRP Seat Airbag – Fire Voltage vs. Time | 25 |
| Figure No. 24. RRP Seat Airbag – Fire Current vs. Time | 25 |
