**REPORT NUMBER: TWG-MGA-2013-009**

**SIDE AIRBAG OUT-OF-POSITION INJURY  
TECHNICAL WORKING GROUP**

**CHRYSLER GROUP LLC  
2013 Dodge Challenger SXT 2-Dr Coupe  
NHTSA No.: MD0300TWG2**

**FINAL REPORT**

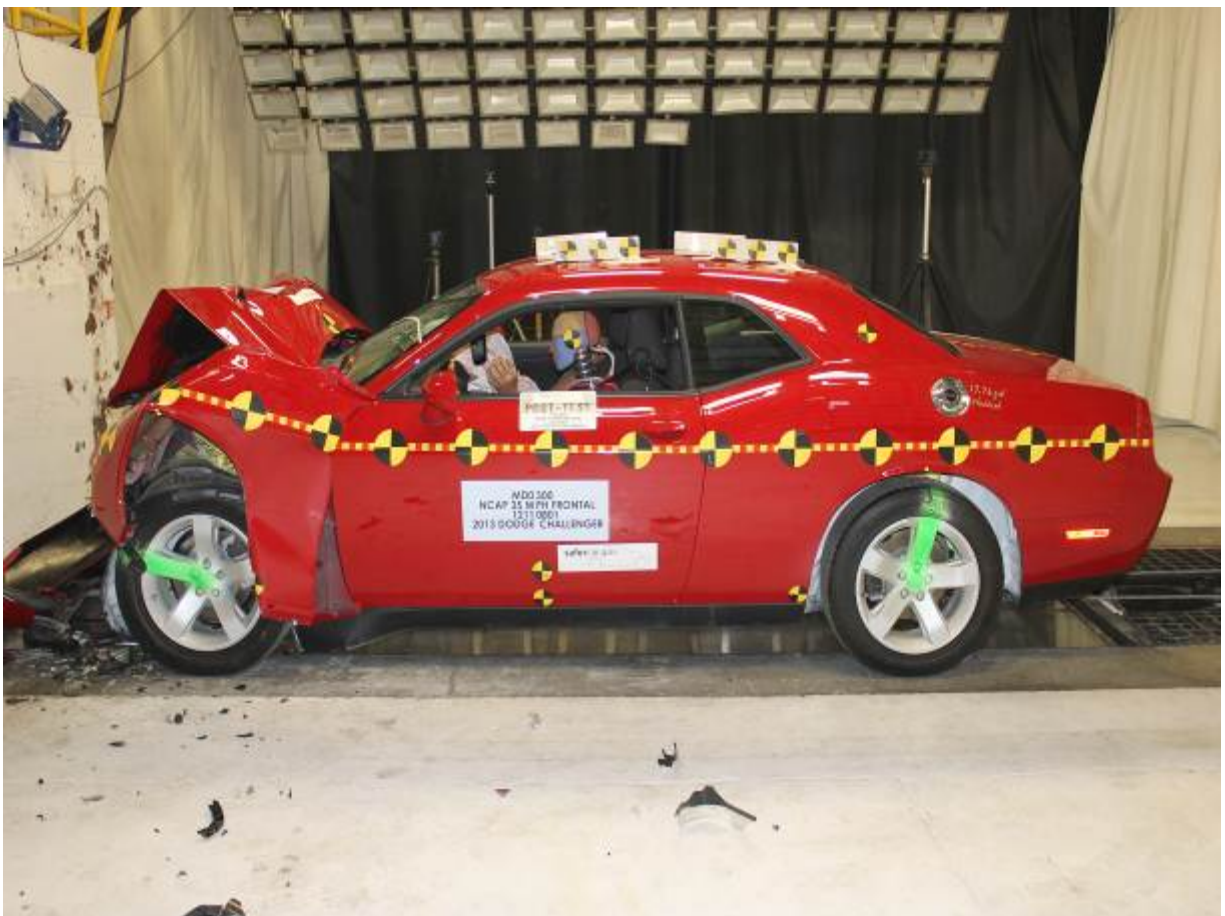
Post-Test Vehicle Left Side View

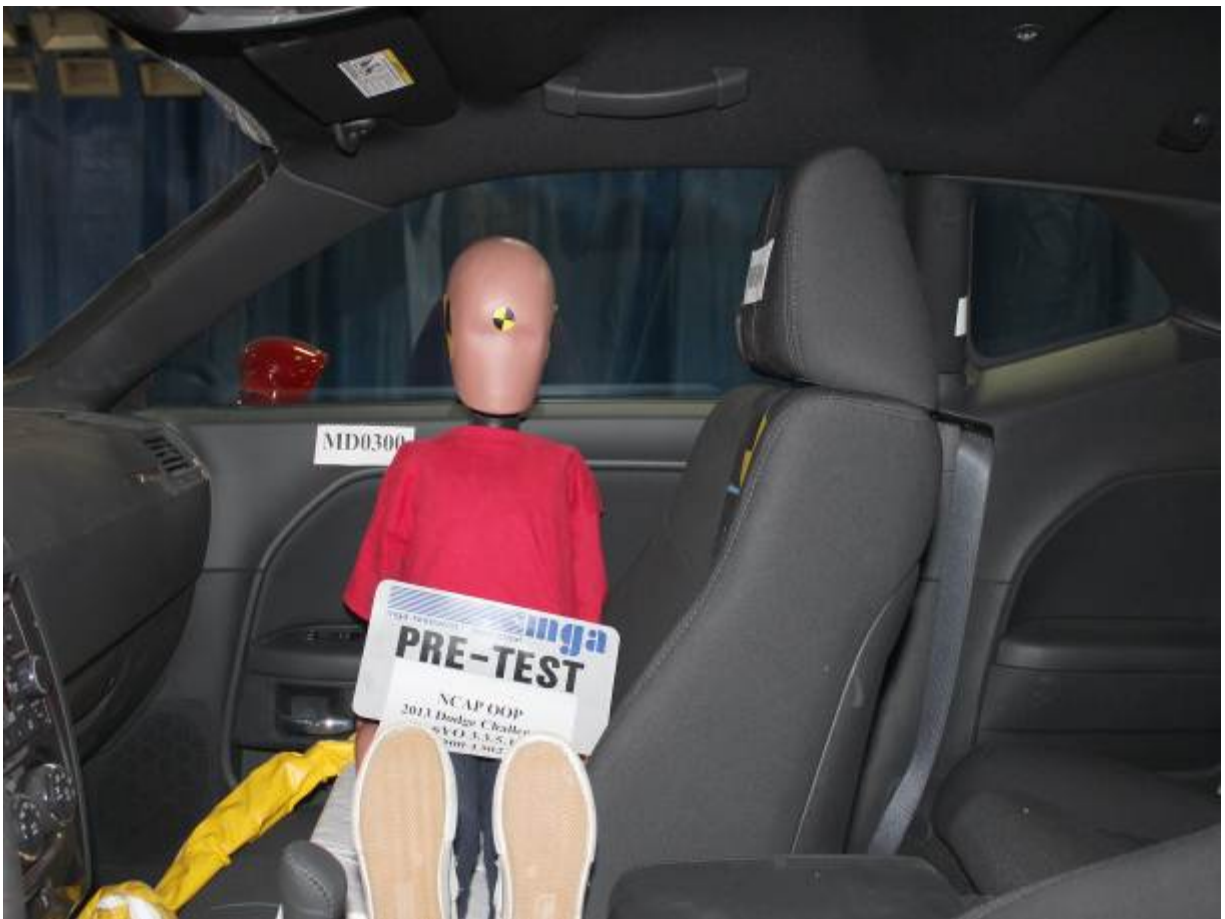
Pre-Test 6-Year-Old Child Dummy Left Side View

The Hybrid III 6-Year-Old child dummy was placed in the right front passenger seat along the outboard edge of the foam block, facing inboard with its legs extended and arms hanging at its sides. The seat track was positioned forward to maximize the cushion to head interaction. The dummy's pelvis was slid outboard until the dummy's back contacted the door trim panel or armrest and the center of gravity of the head was centered in the deployment trajectory of the airbag. The head remained in its neutral orientation. A vertical plane through the centerline of the dummy's shoulder bolts was parallel to the vehicle centerline. The dummy's arms were bent at the elbow until the fingertips contacted the foam block.

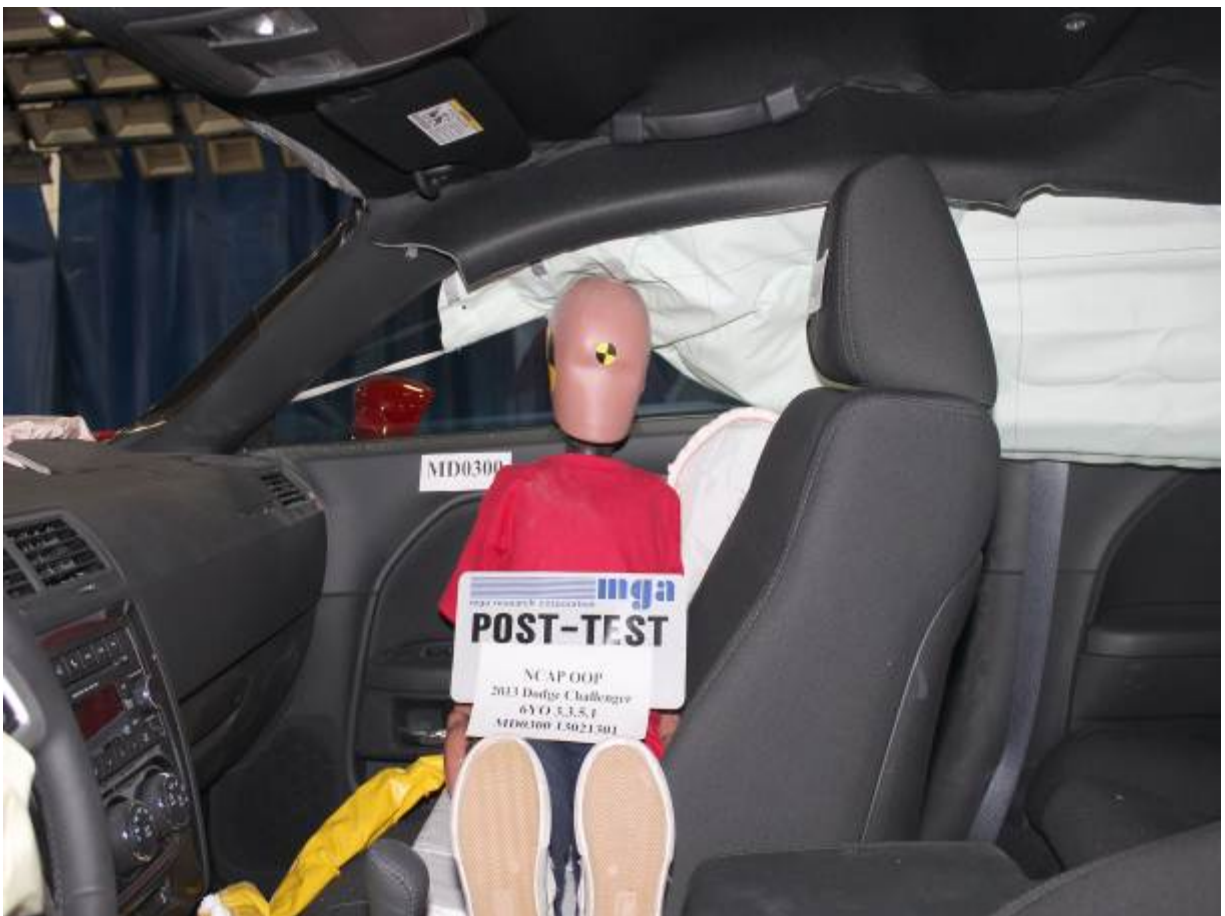
Post-Test 6-Year-Old Child Dummy Left Side View

- Curtain airbag to top and back of head
- Torso/pelvis bag to left shoulder, left torso, and pelvis

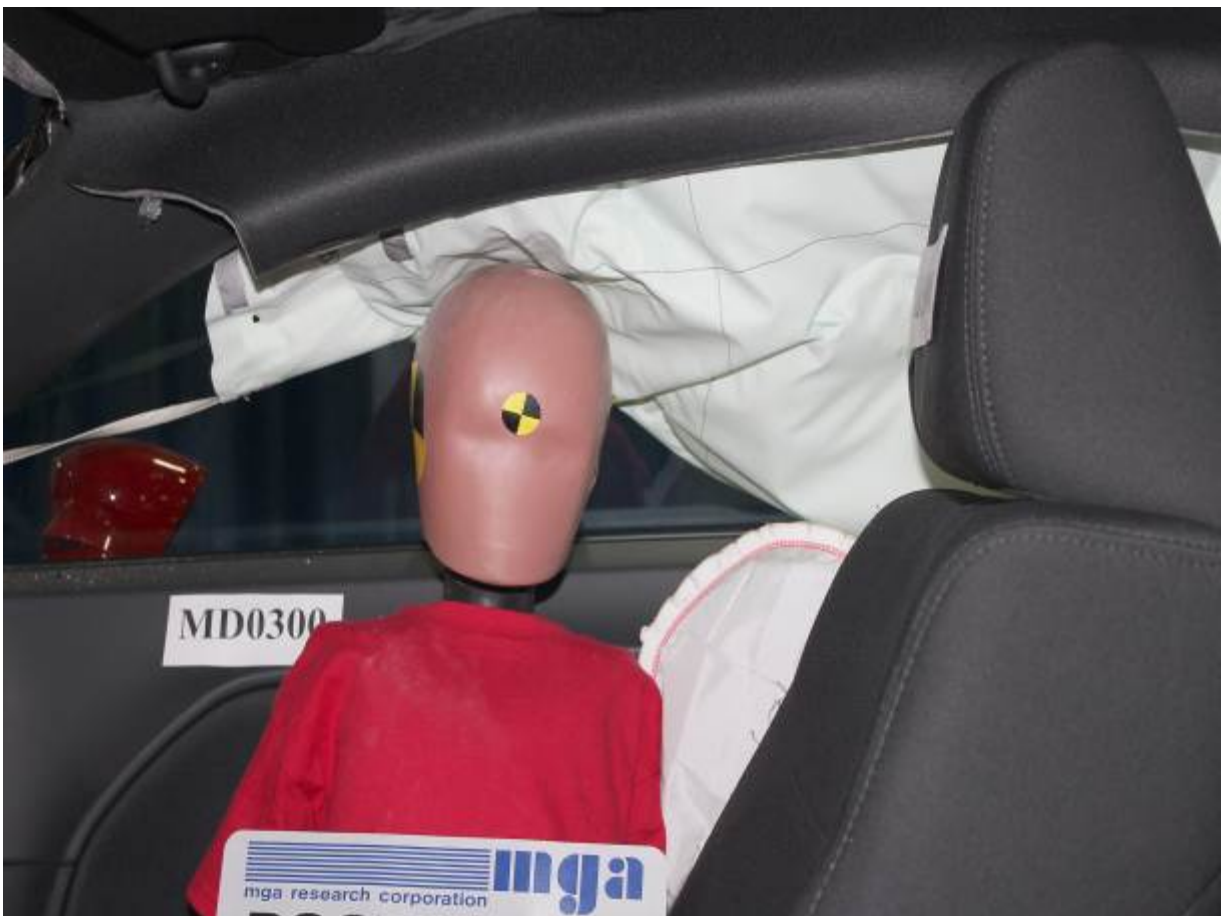
Post-Test 6-Year-Old Child Dummy Left Side Closeup View

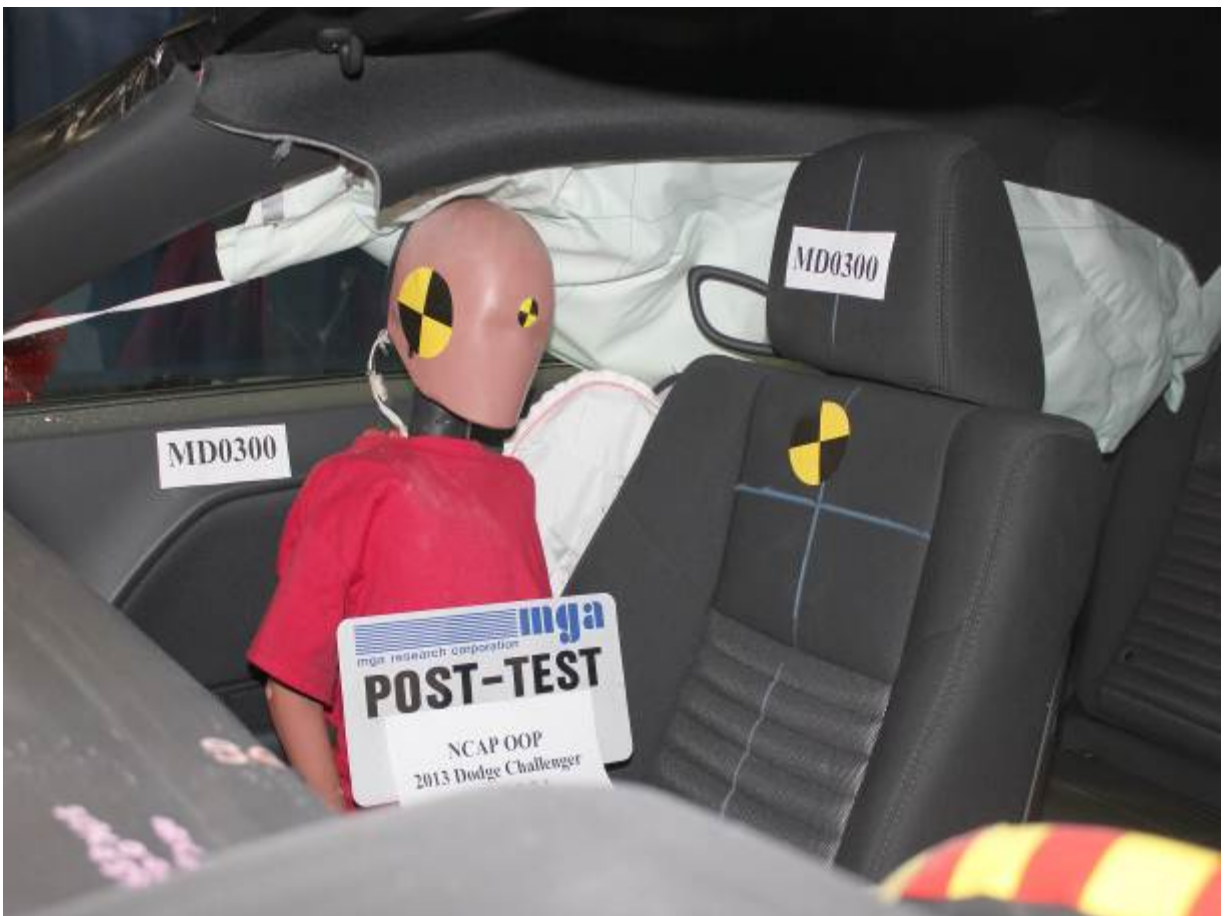
Post-Test 6-Year-Old Child Dummy Left ¾ Front View

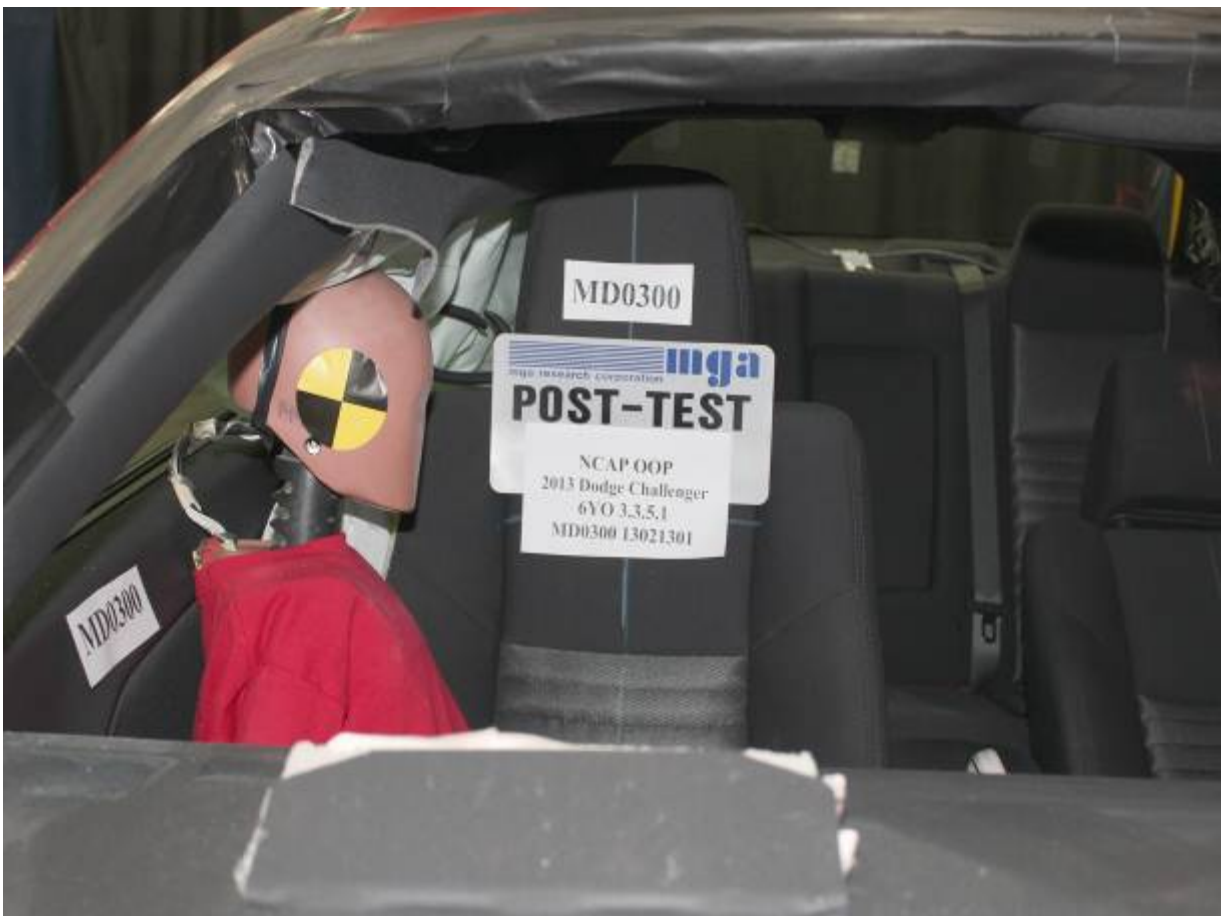
Post-Test 6-Year-Old Child Dummy Front View

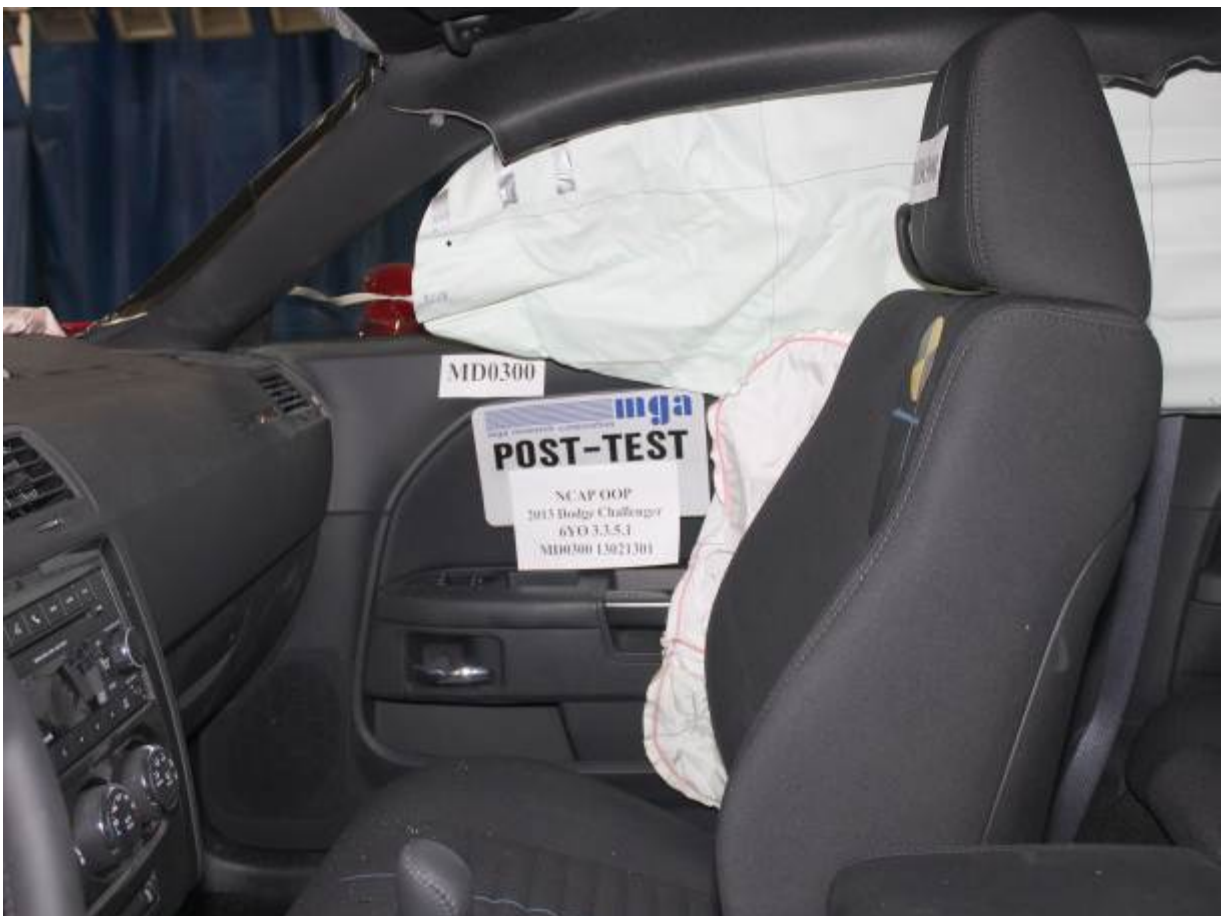
Post-Test Curtain Airbag Left Side View

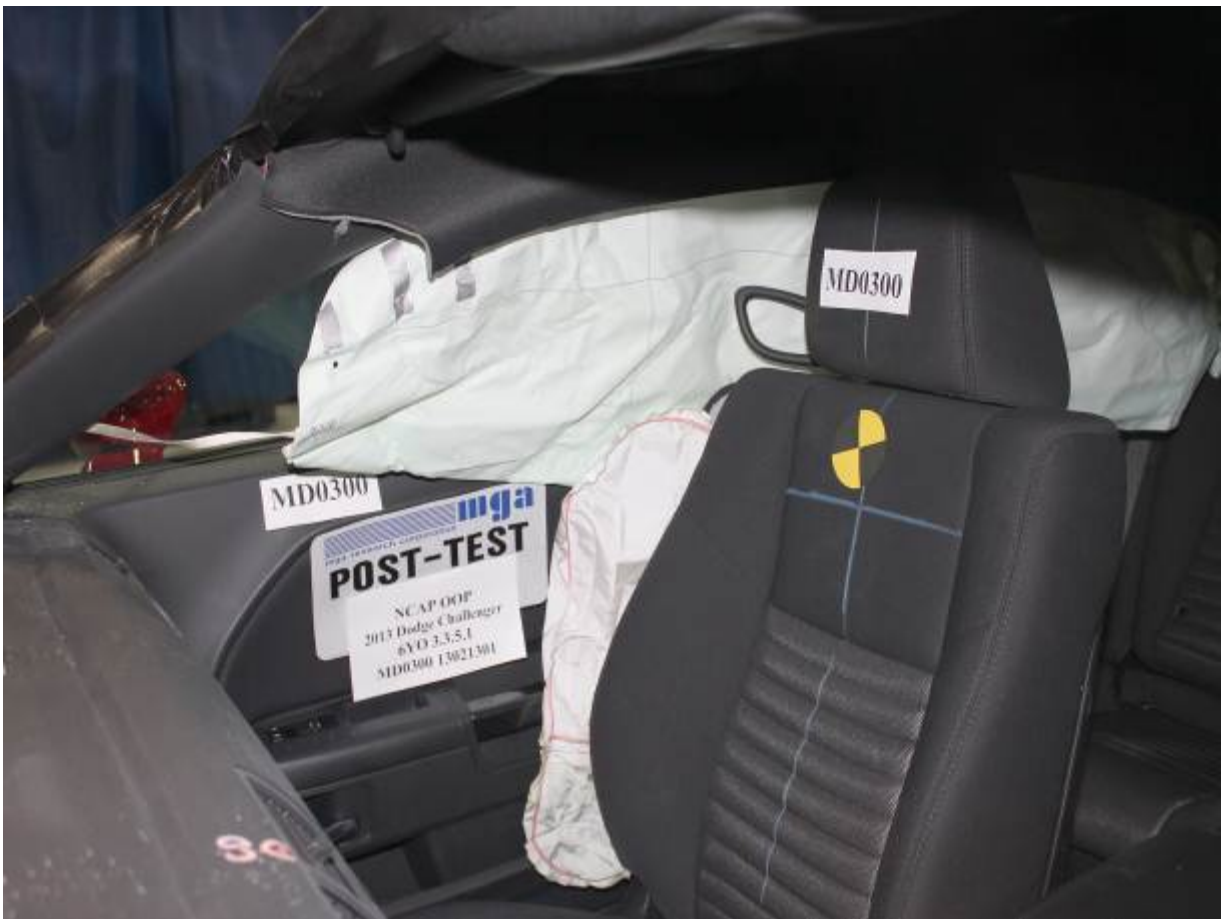
Post-Test Curtain Airbag Left 3/4 Front View

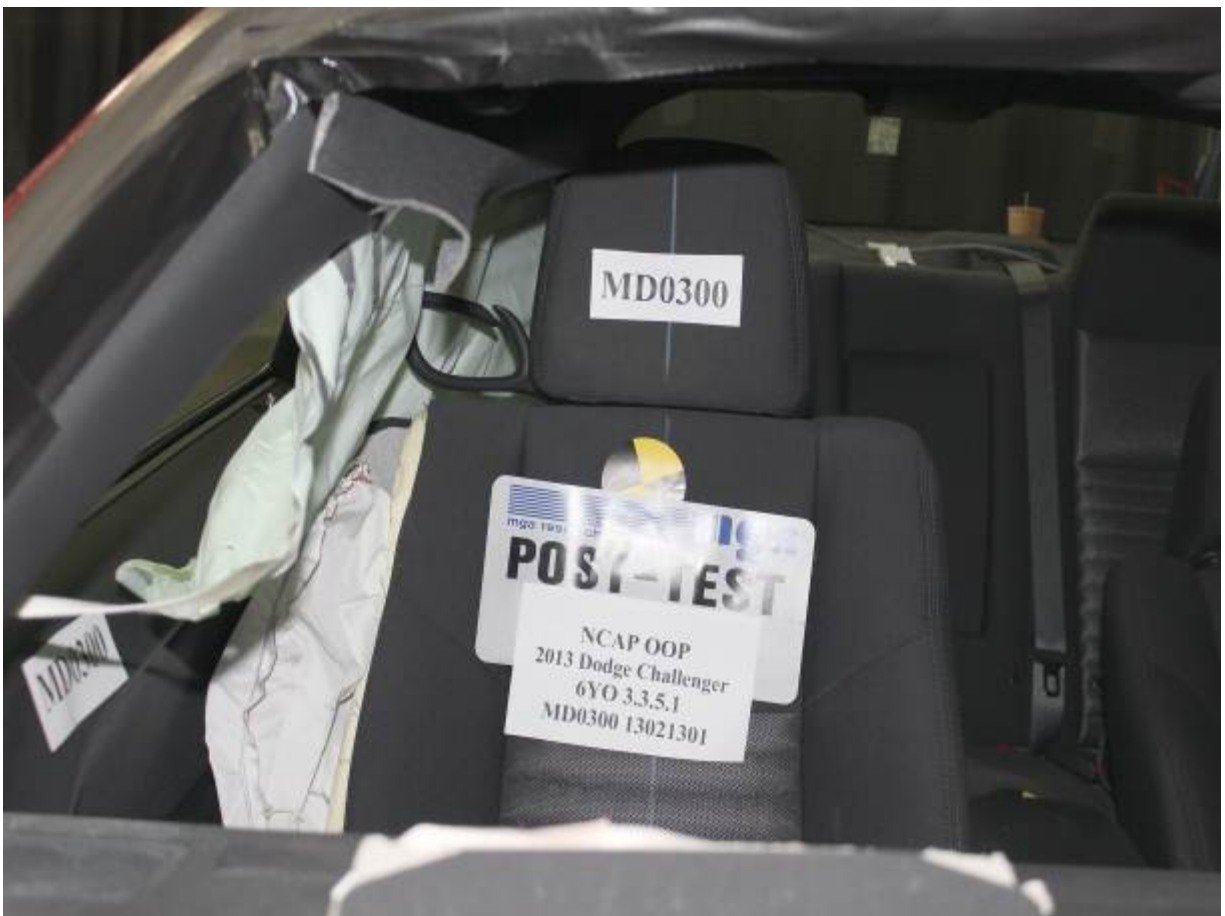
Post-Test Curtain Airbag Front View

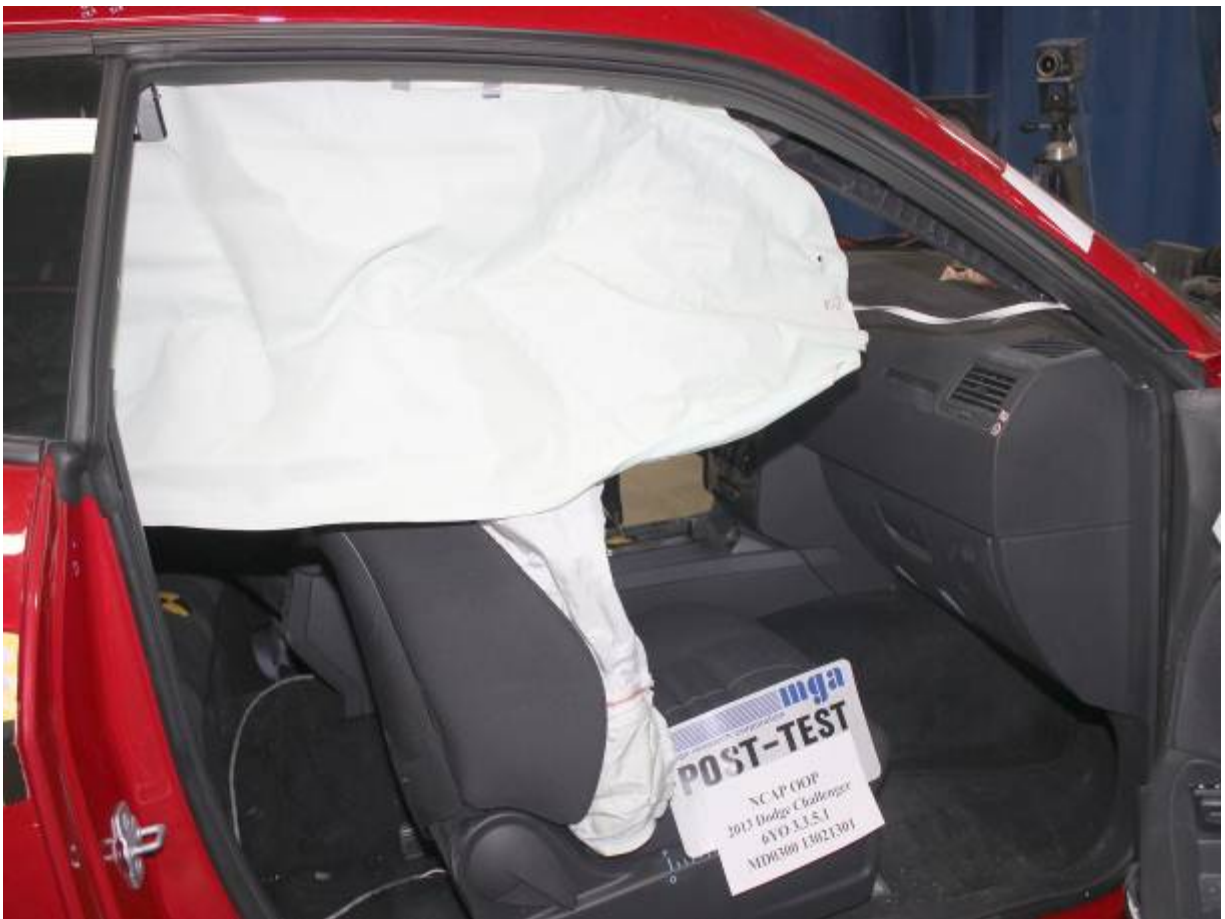
Post-Test Curtain Airbag Right Side View (Door Open)

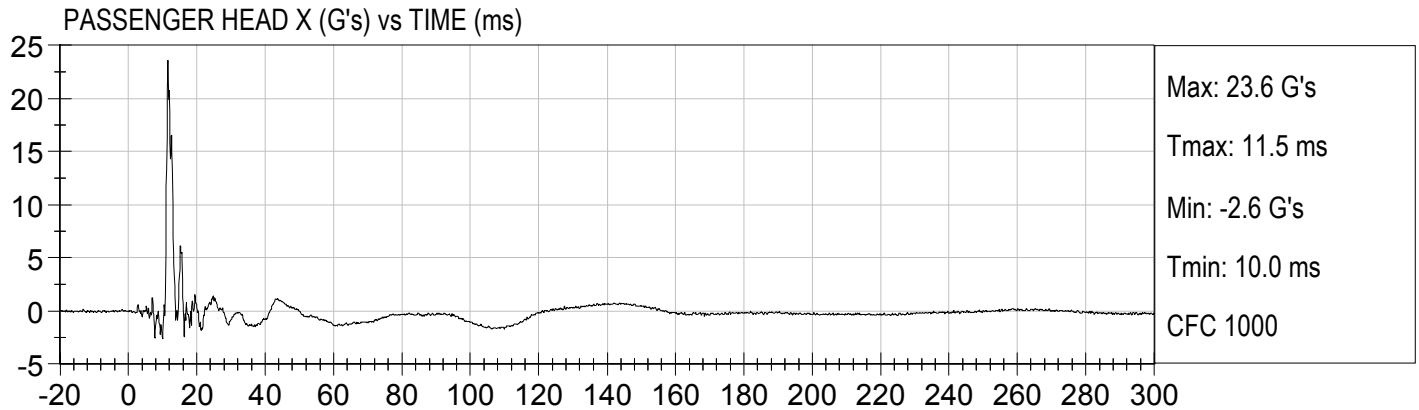
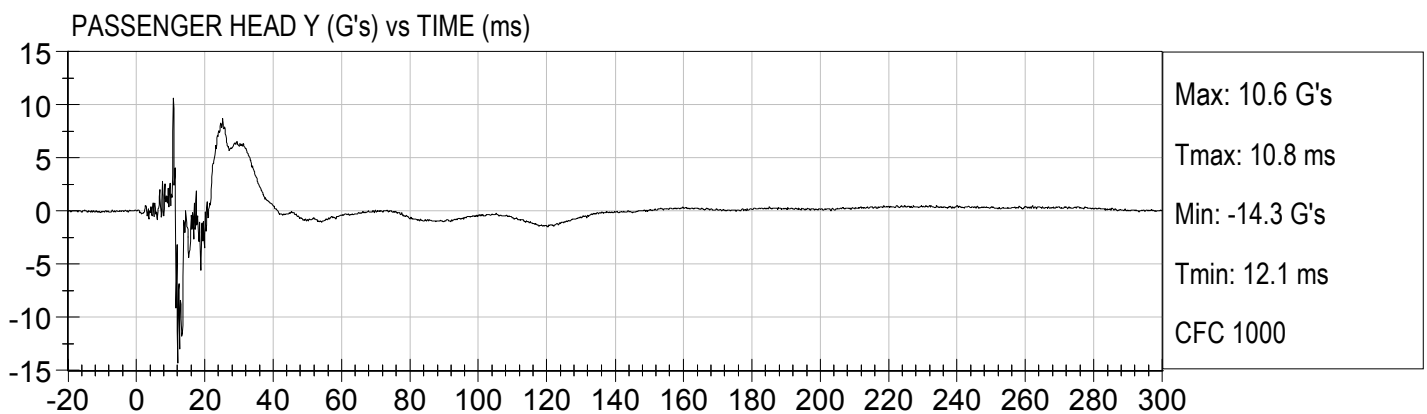
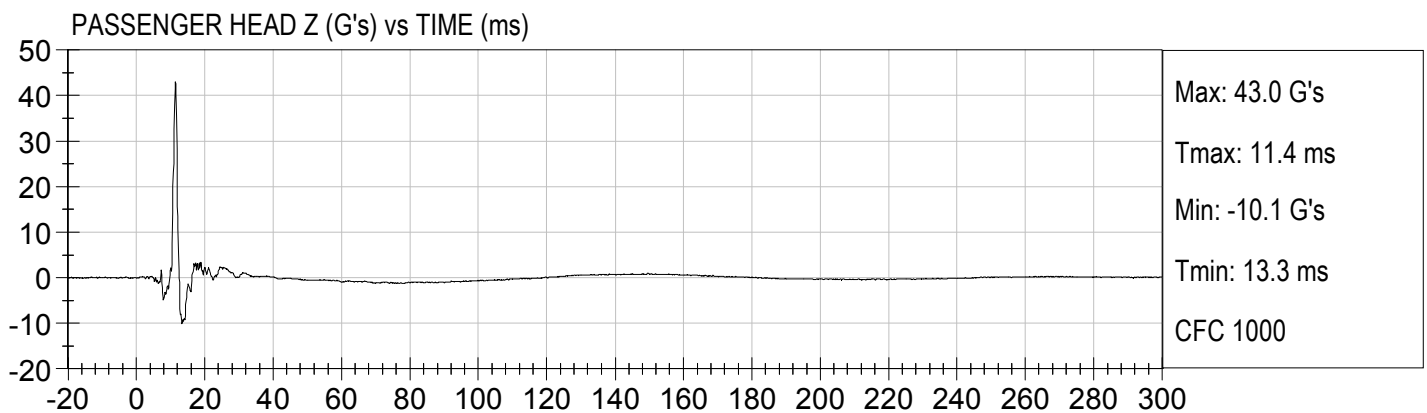
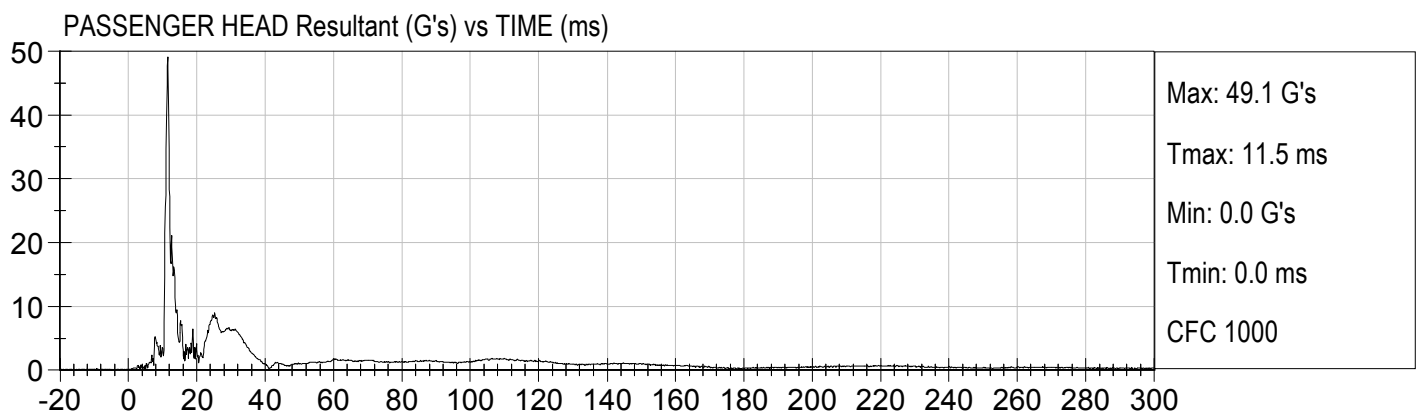
| | <u>Page No.</u> |
|---|---|
| Figure No. 1. Passenger Head X Acceleration vs. Time | 23 |
| Figure No. 2. Passenger Head Y Acceleration vs. Time | 23 |
| Figure No. 3. Passenger Head Z Acceleration vs. Time | 23 |
| Figure No. 4. Passenger Head Resultant Acceleration vs. Time | 23 |

| | | MAXIMUM VALUE | | | |
|---|---|---|---|---|---|
| Head X | g | 23.6 | 11.5 | -2.6 | 10.0 |
| Head Y | g | 10.6 | 10.8 | -14.3 | 12.1 |
| Head Z | g | 43.0 | 11.4 | -10.1 | 13.3 |
| Head Resultant | g | 49.1 | 11.5 | | |

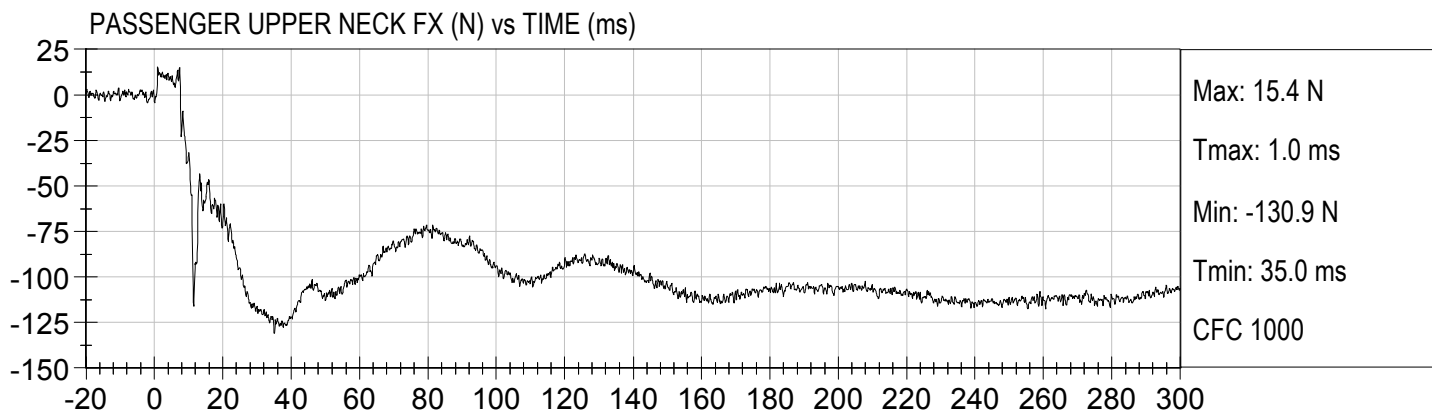
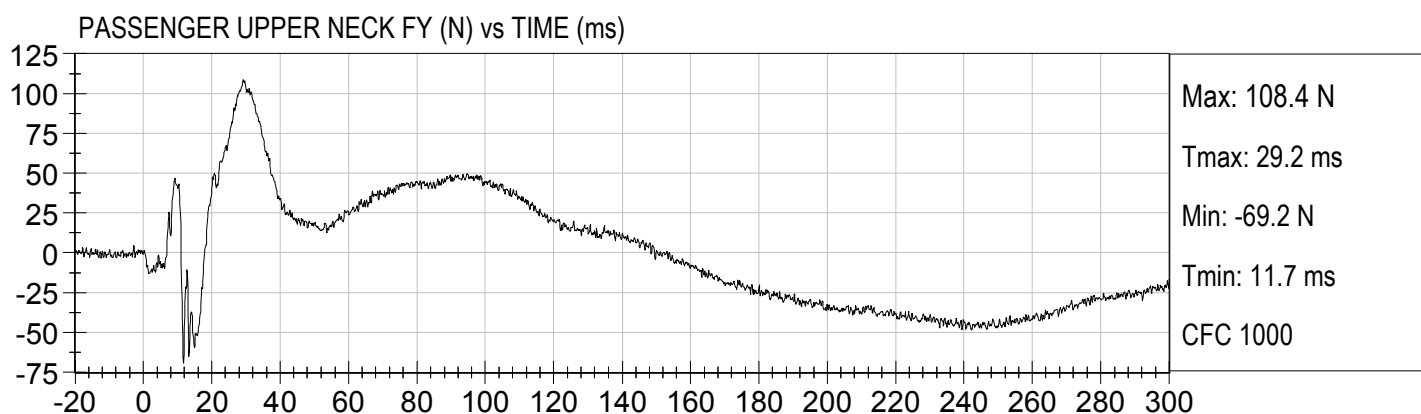
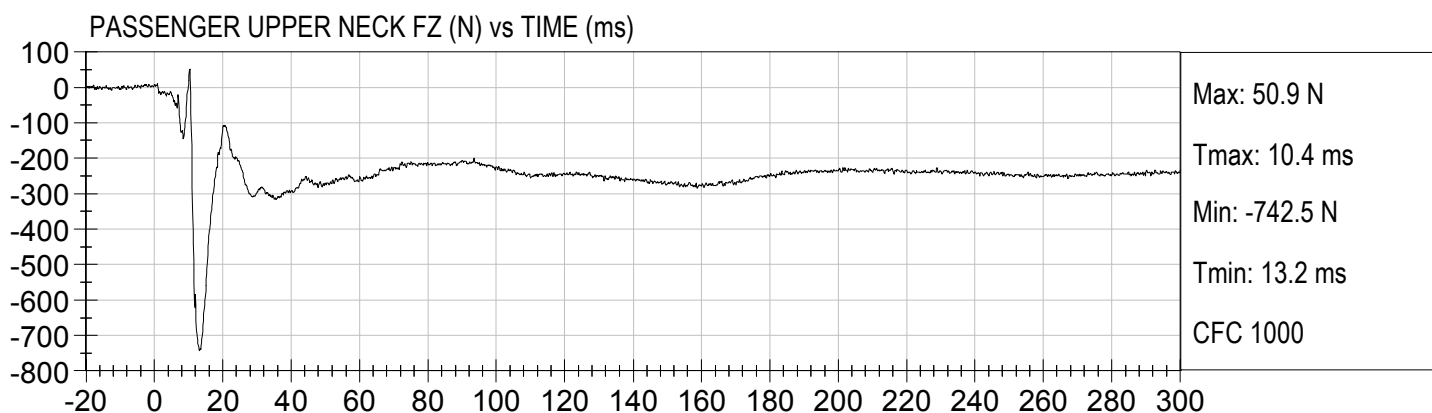
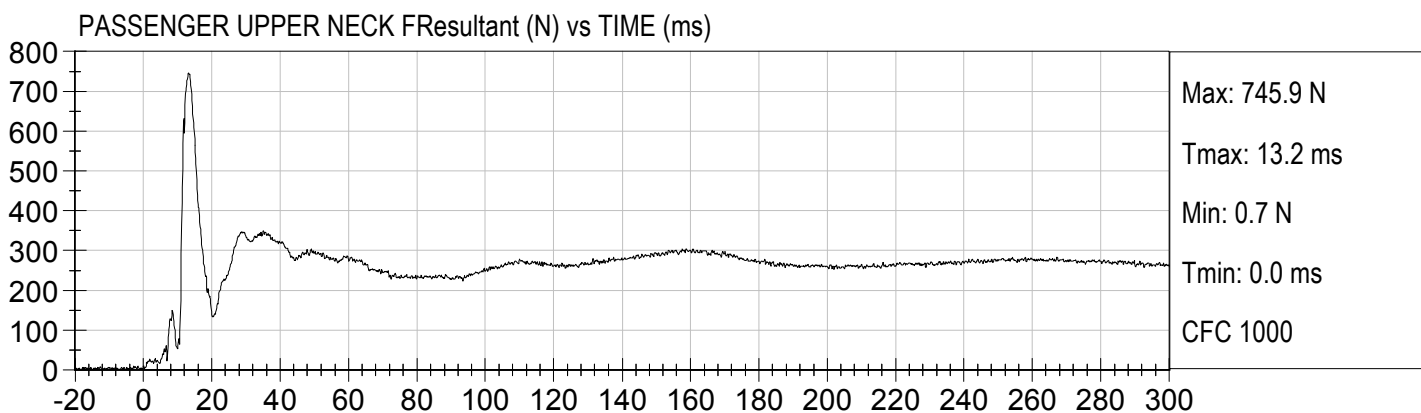
| | <u>Page No.</u> |
|---|---|
| Figure No. 5. Passenger Upper Neck X Force vs. Time | 24 |
| Figure No. 6. Passenger Upper Neck Y Force vs. Time | 24 |
| Figure No. 7. Passenger Upper Neck Z Force vs. Time | 24 |
| Figure No. 8. Passenger Upper Neck Resultant Force vs. Time | 24 |

| | | MAXIMUM VALUE | | | |
|---|---|---|---|---|---|
| Upper Neck Fx | N | 15.4 | 1.0 | -130.9 | 35.0 |
| Upper Neck Fy | N | 108.4 | 29.2 | -69.2 | 11.7 |
| Upper Neck Fz | N | 50.9 | 10.4 | -742.5 | 13.2 |
| Upper Neck F Resultant | N | 745.9 | 13.2 | | |

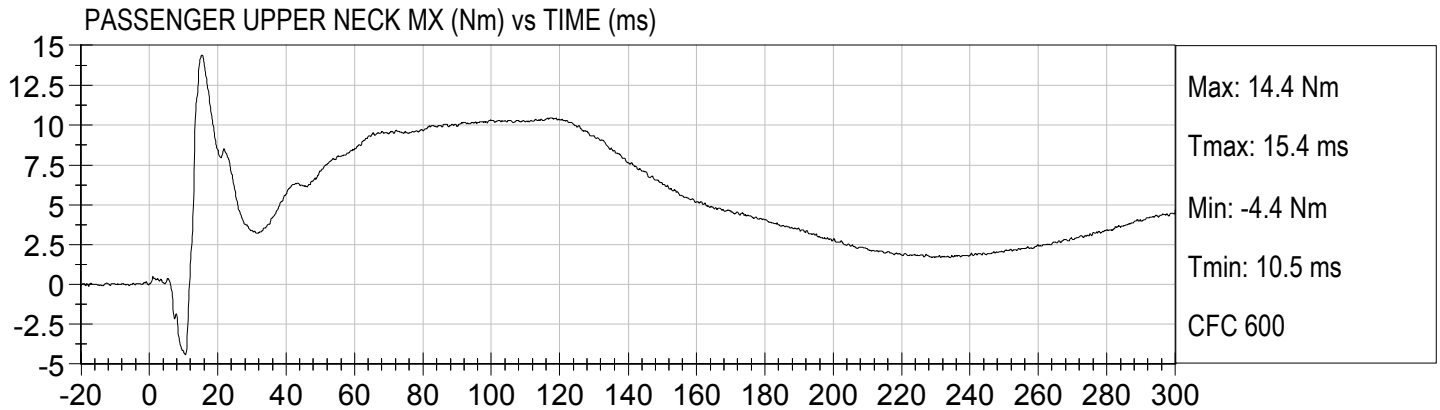
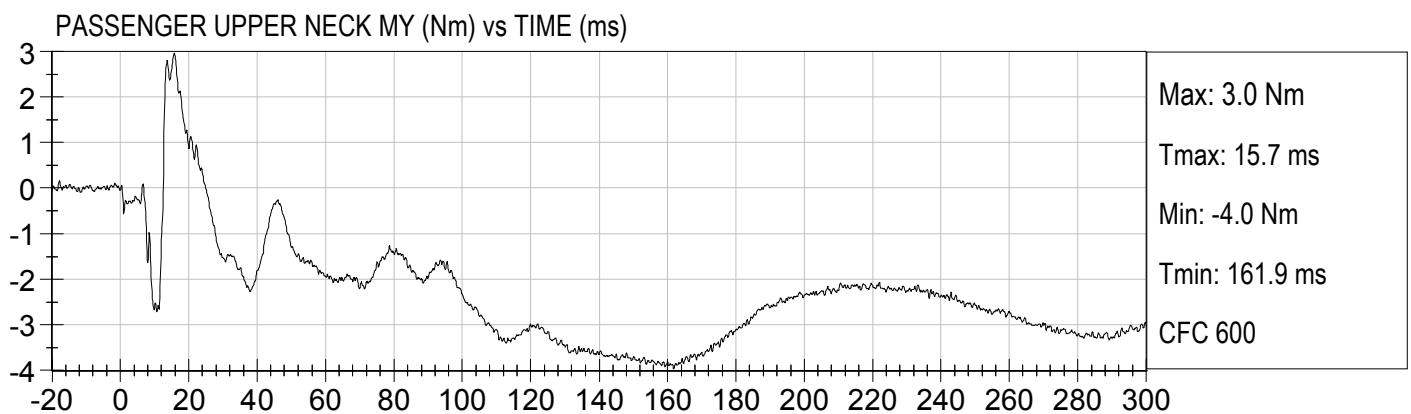
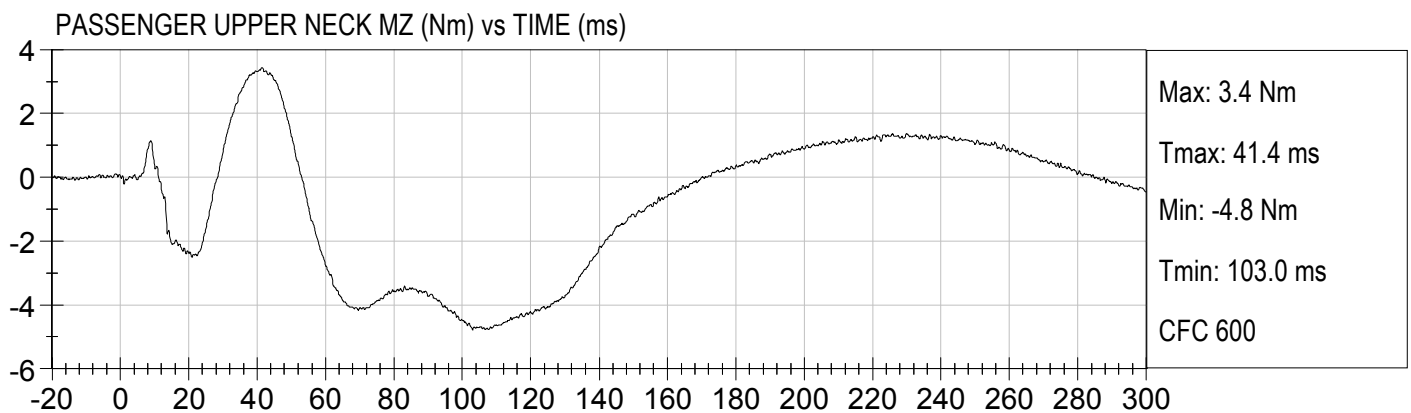
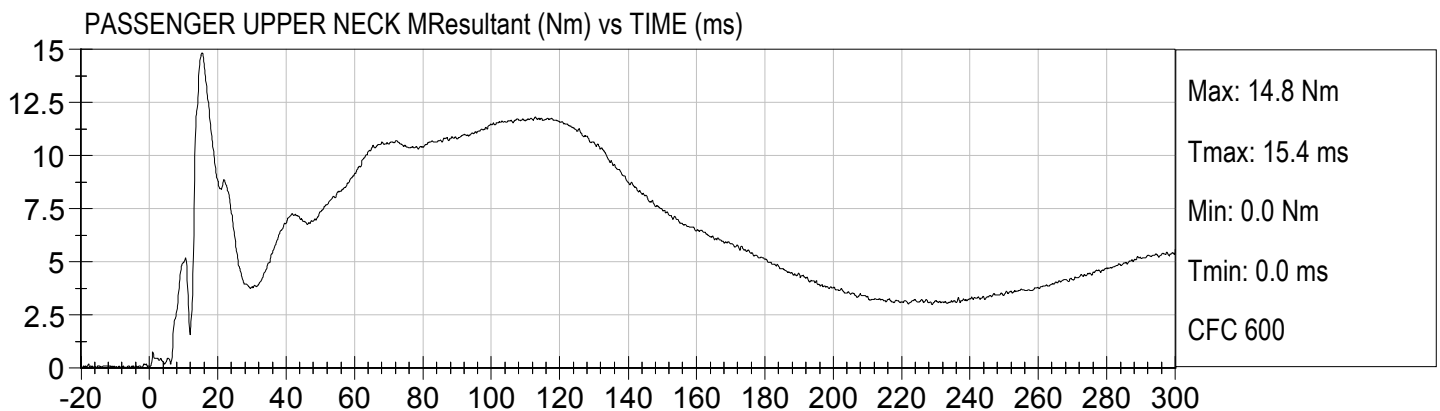
| | <u>Page No.</u> |
|---|---|
| Figure No. 9. Passenger Upper Neck X Moment vs. Time | 25 |
| Figure No. 10. Passenger Upper Neck Y Moment vs. Time | 25 |
| Figure No. 11. Passenger Upper Neck Z Moment vs. Time | 25 |
| Figure No. 12. Passenger Upper Neck Resultant Moment vs. Time | 25 |

| | | MAXIMUM VALUE | | | |
|---|---|---|---|---|---|
| Upper Neck Mx | Nm | 14.4 | 15.4 | -4.4 | 10.5 |
| Upper Neck My | Nm | 3.0 | 15.7 | -4.0 | 161.9 |
| Upper Neck Mz | Nm | 3.4 | 41.4 | -4.8 | 103.0 |
| Upper Neck M Resultant | Nm | 14.8 | 15.4 | | |

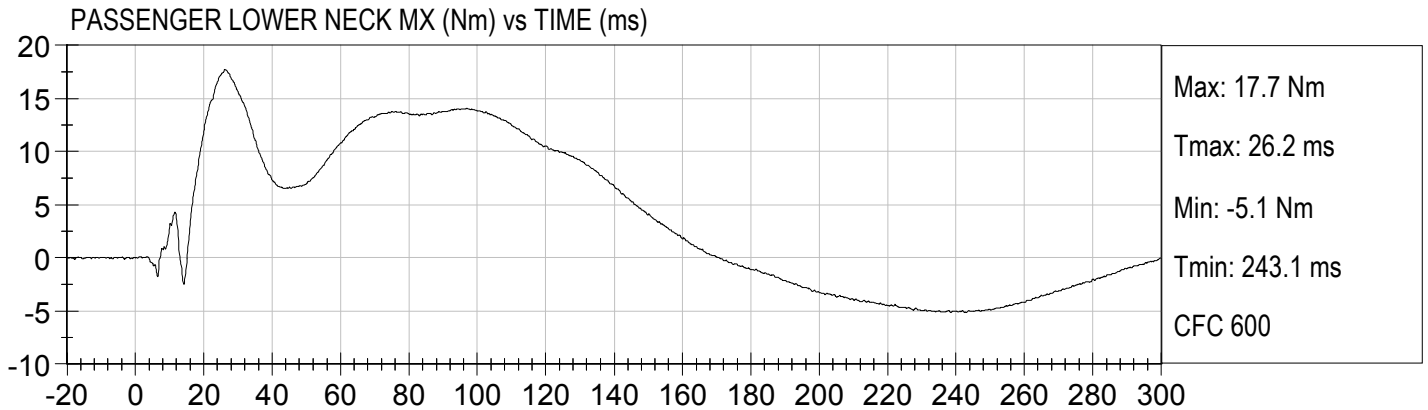
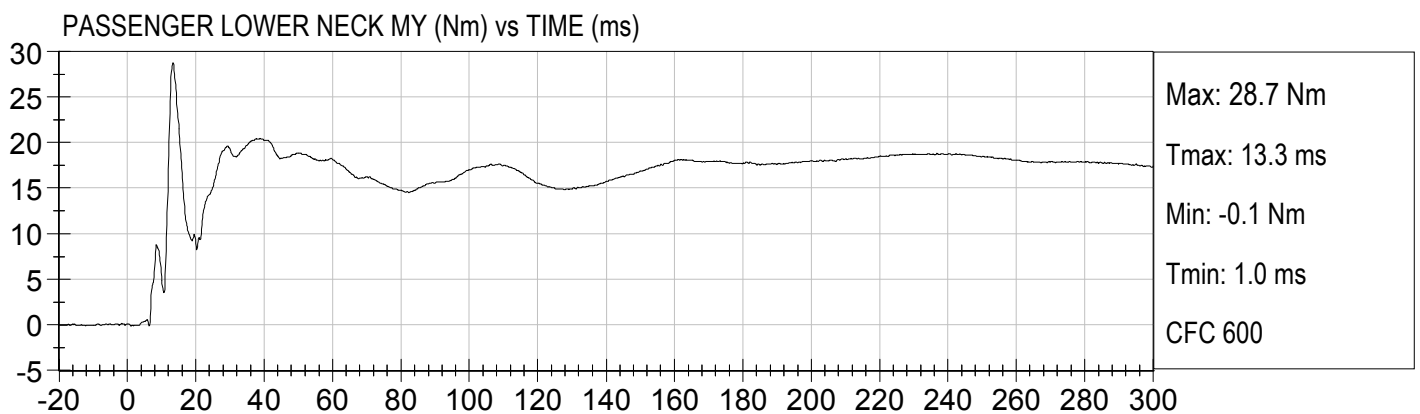
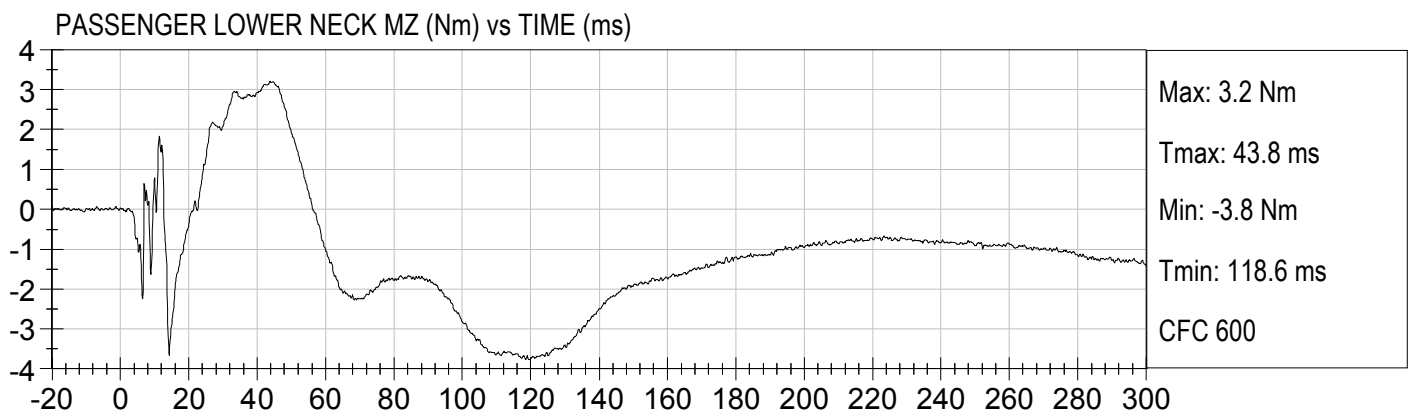
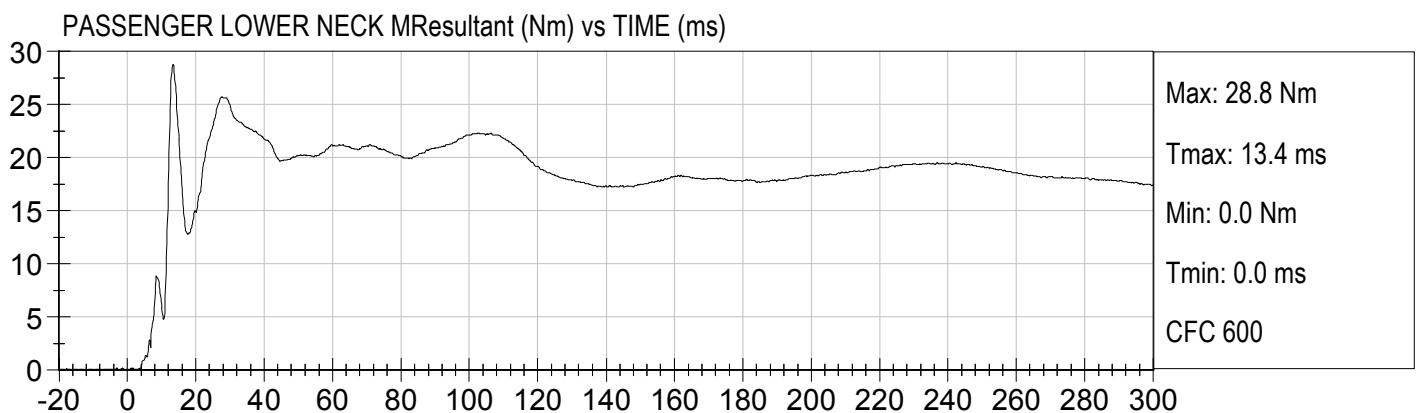
| | <u>Page No.</u> |
|---|---|
| Figure No. 17. Passenger Lower Neck X Moment vs. Time | 27 |
| Figure No. 18. Passenger Lower Neck Y Moment vs. Time | 27 |
| Figure No. 19. Passenger Lower Neck Z Moment vs. Time | 27 |
| Figure No. 20. Passenger Lower Neck Resultant Moment vs. Time | 27 |
