**REPORT NUMBER: TWG-MGA-2013-009**

**SIDE AIRBAG OUT-OF-POSITION INJURY  
TECHNICAL WORKING GROUP**

**CHRYSLER GROUP LLC  
2013 Dodge Challenger SXT 2-Dr Coupe  
NHTSA No.: MD0300TWG2**

**FINAL REPORT**

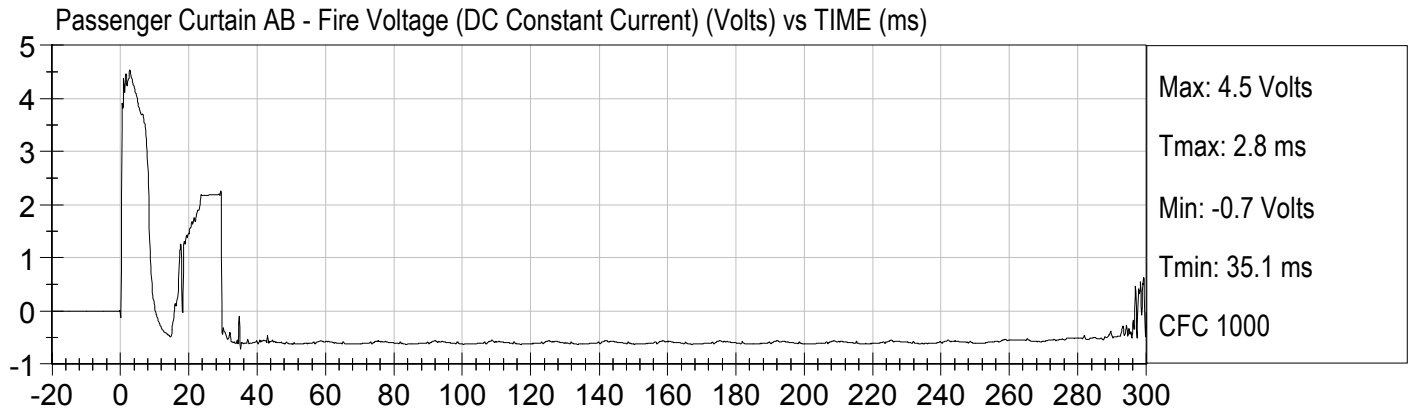
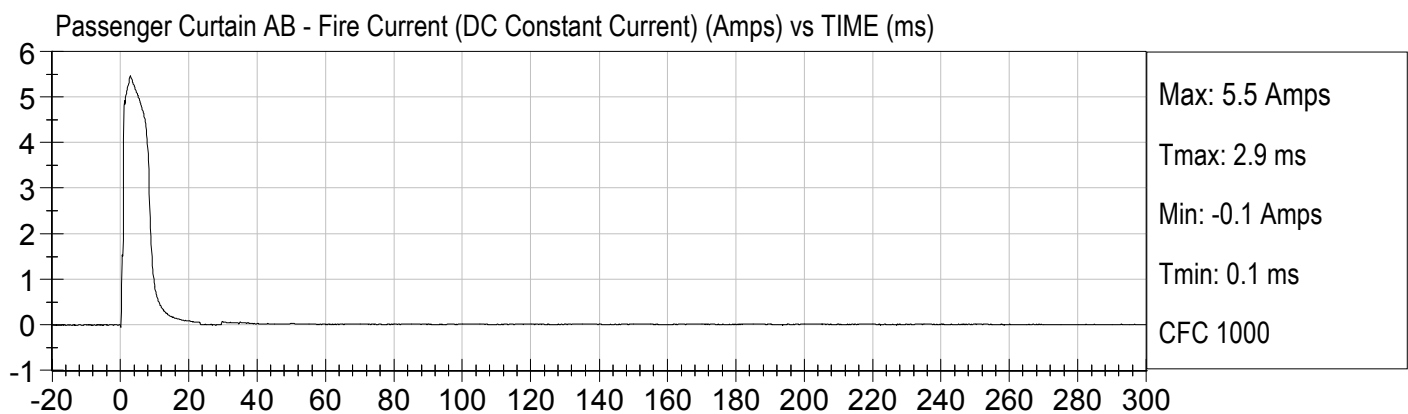
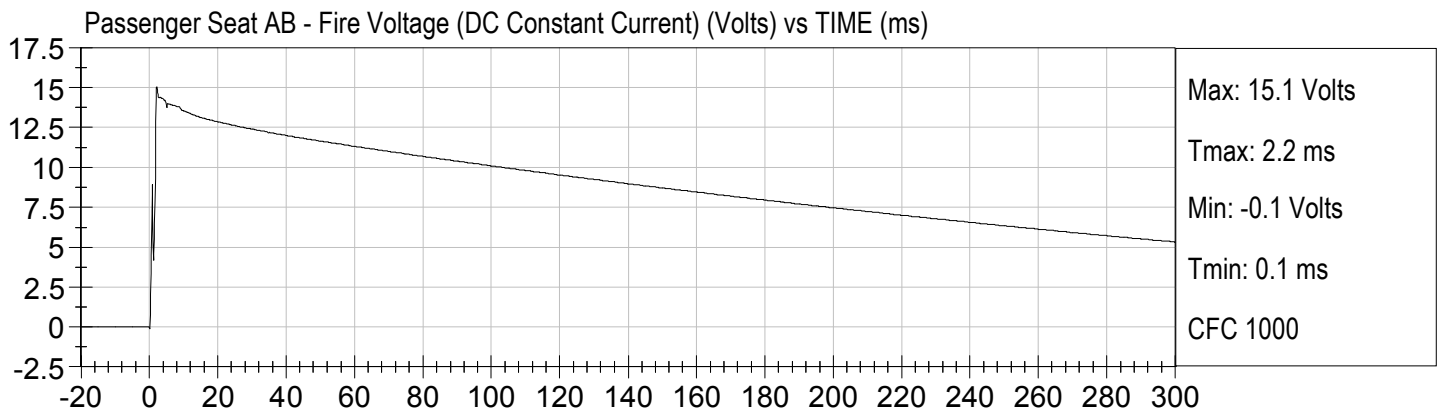
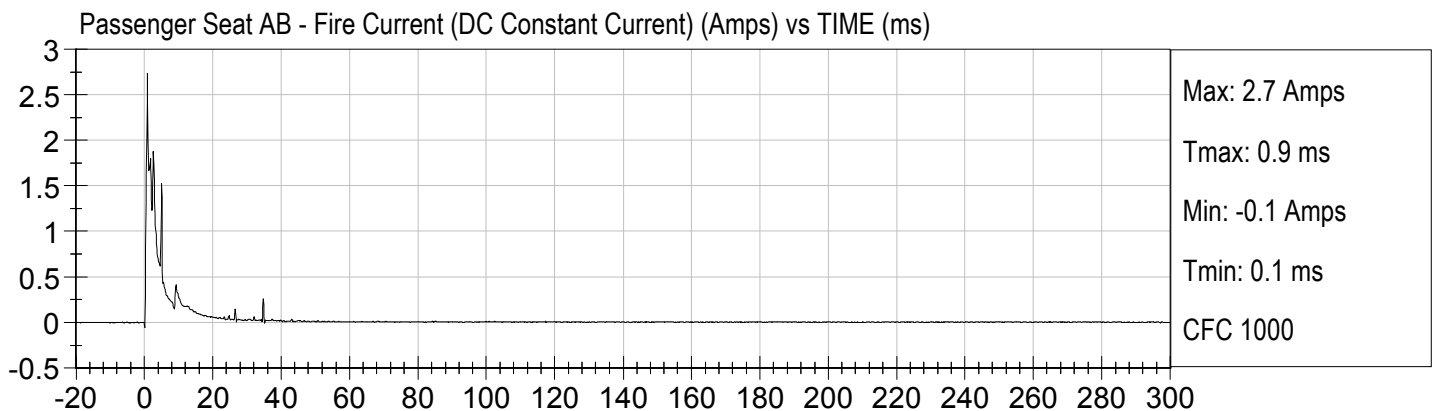
| | <u>Page No.</u> |
|---|---|
| Figure No. 21. Passenger Curtain Airbag – Fire Voltage vs. Time | 28 |
| Figure No. 22. Passenger Curtain Airbag – Fire Current vs. Time | 28 |
| Figure No. 23. Passenger Seat Airbag – Fire Voltage vs. Time | 28 |
| Figure No. 24. Passenger Seat Airbag – Fire Current vs. Time | 28 |
