**REPORT NUMBER: NCAP-MGA-2013-050**

**NEW CAR ASSESSMENT PROGRAM (NCAP)  
Frontal Barrier Impact Test**

**FORD MOTOR CO.  
2013 Ford C-MAX Energi SEL 5-Dr Hatchback  
NHTSA No.: MD0208**

**MGA RESEARCH CORPORATION  
5000 Warren Road  
Burlington, WI 53105**

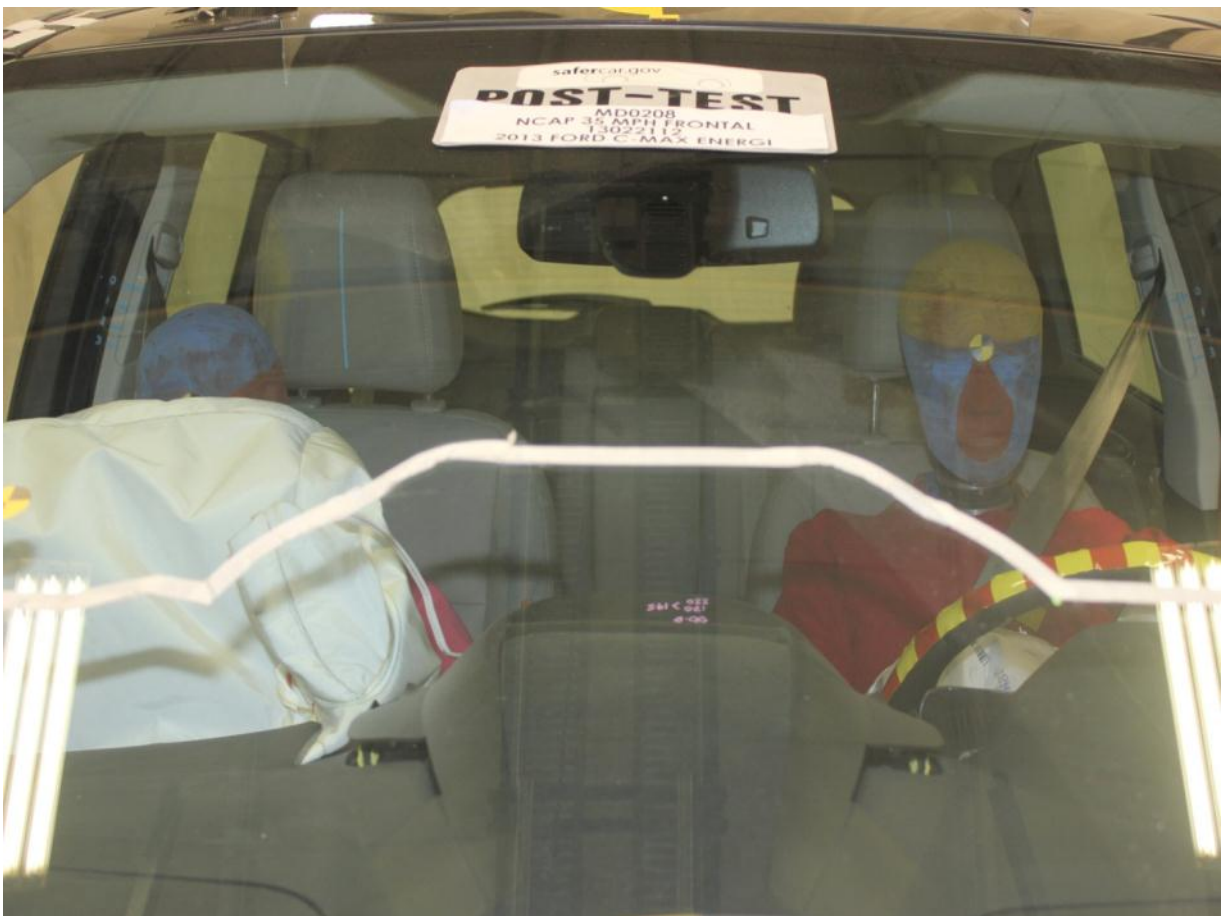
Post-Test Windshield View

There was 100 percent windshield retention and no intrusion into the protected zone of the windshield during the event. There was no Stoddard Solvent leakage after the event or during any phase of the static rollover.
