REPORT NUMBER: NCAP-KAR-13-046

**NEW CAR ASSESSMENT PROGRAM (NCAP)
FRONTAL BARRIER IMPACT TEST**

**HONDA OF CANADA MFG.
2013 HONDA CIVIC LX 2-DOOR COUPE**

NHTSA NUMBER: MD5306

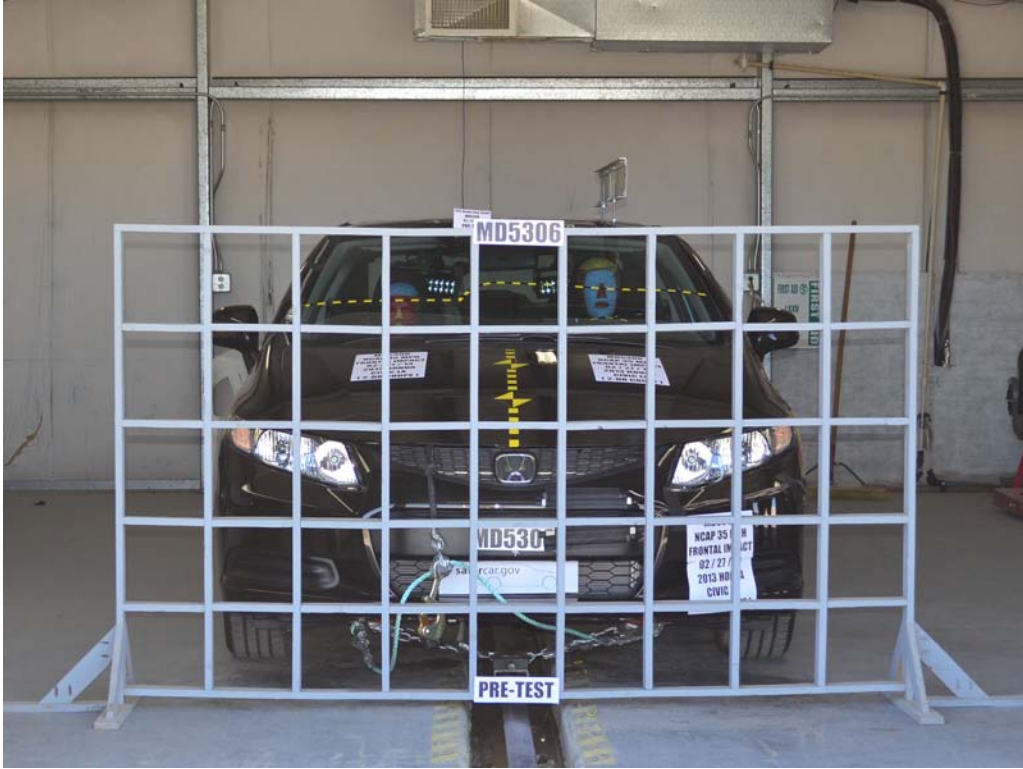
FIGURE 1. Load Cell Location

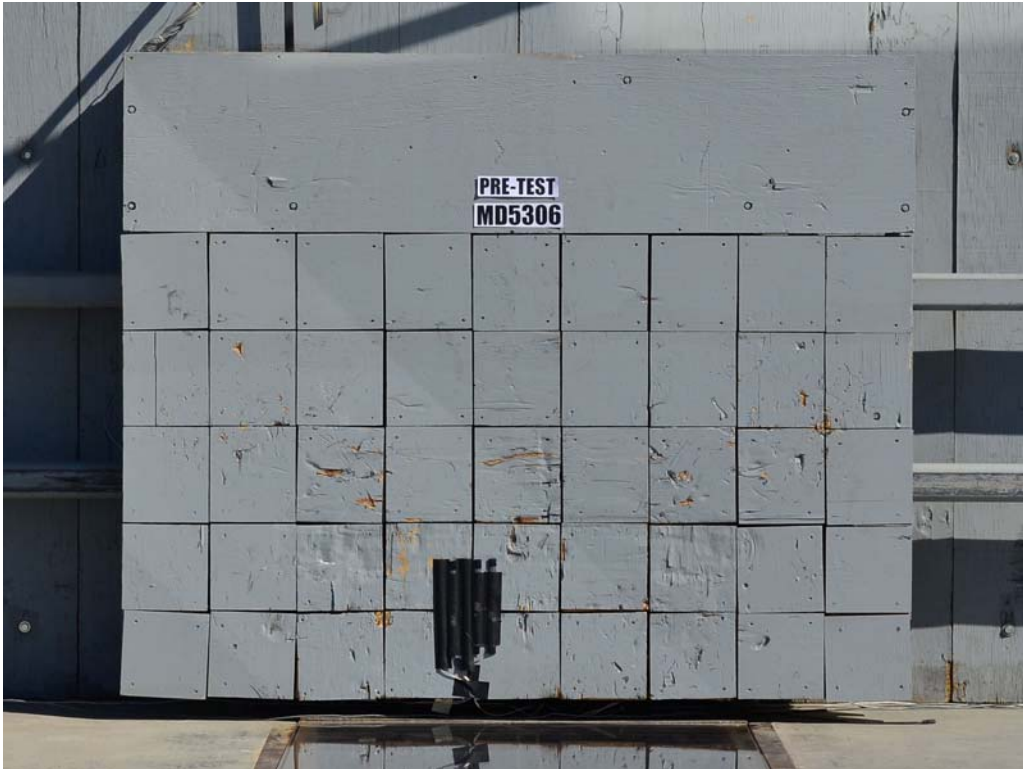
FIGURE 2. Load Cell Wall

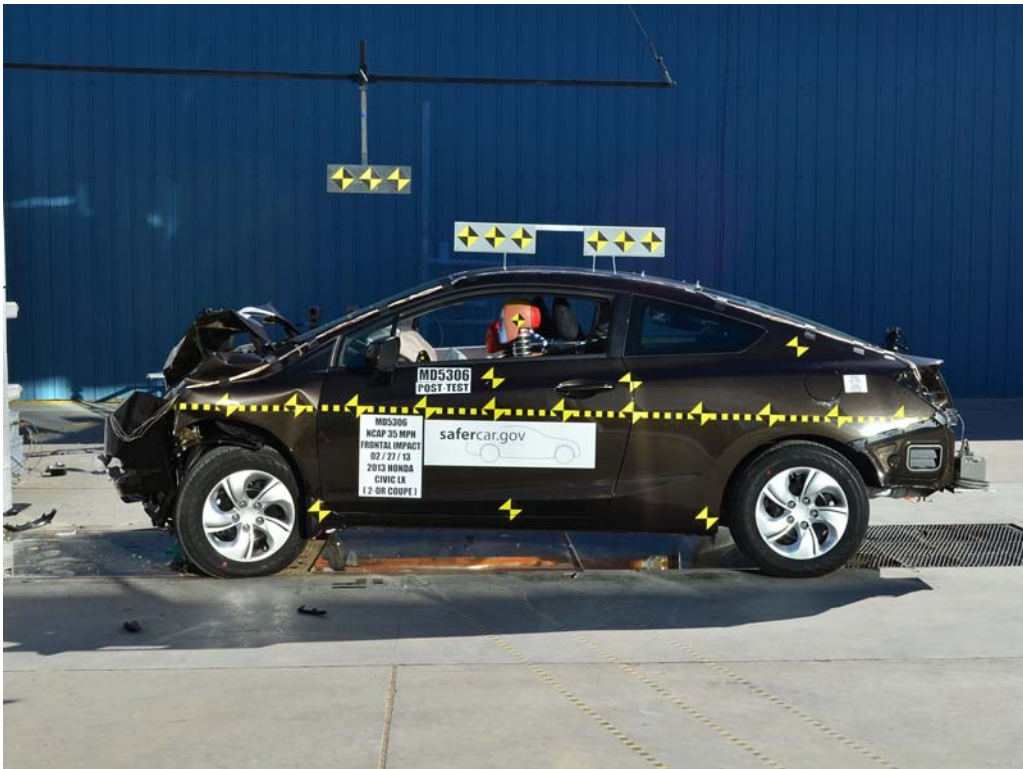
FIGURE 10. Post-Test Left View of Test Vehicle

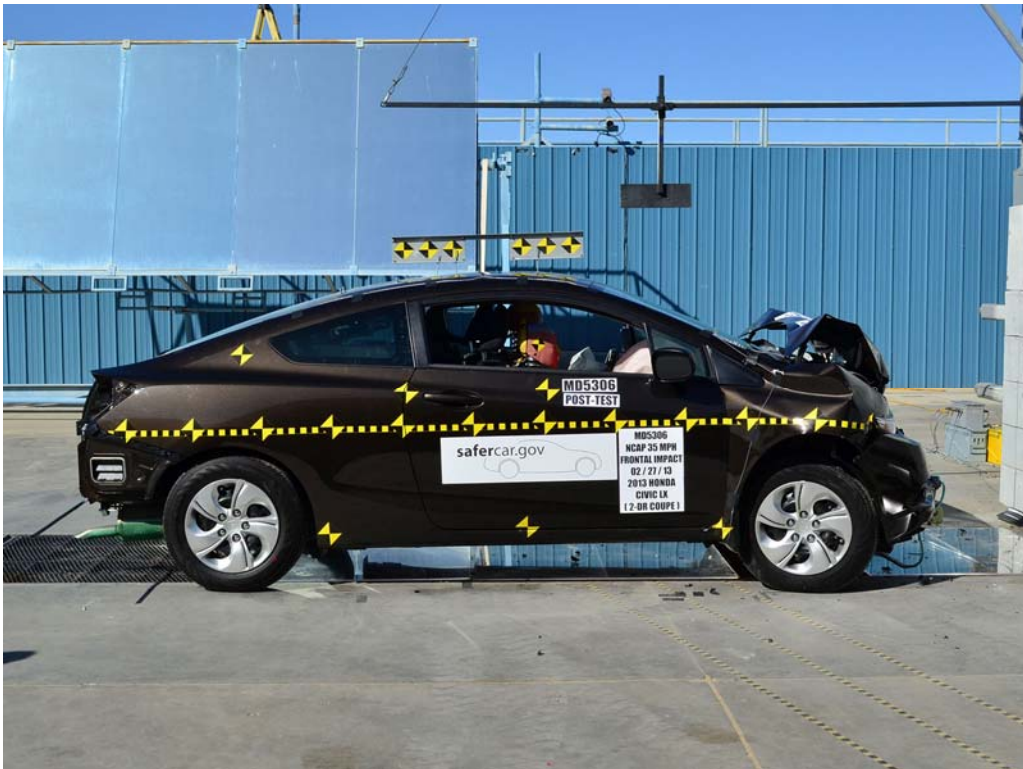
FIGURE 12. Post-Test Right View of Test Vehicle

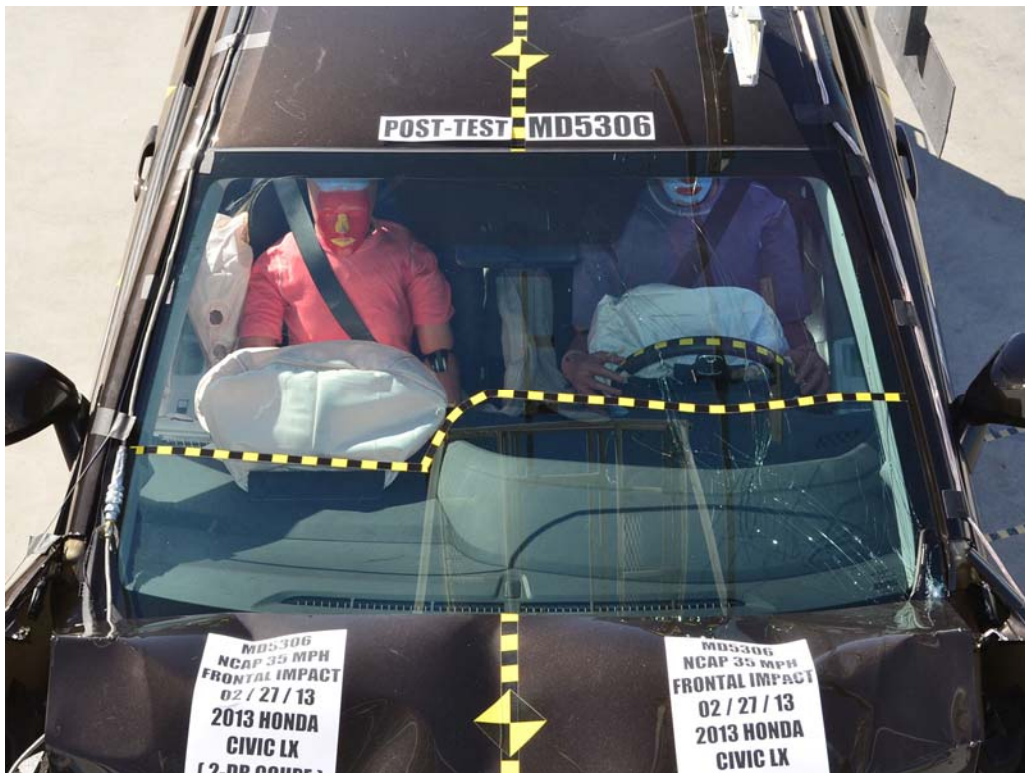
FIGURE 18. Post-Test Windshield View

There was 100% windshield retention and no intrusion into the protected zone of the windshield during the event. There was no Stoddard solvent leakage after the event or during any phase of the static rollover.

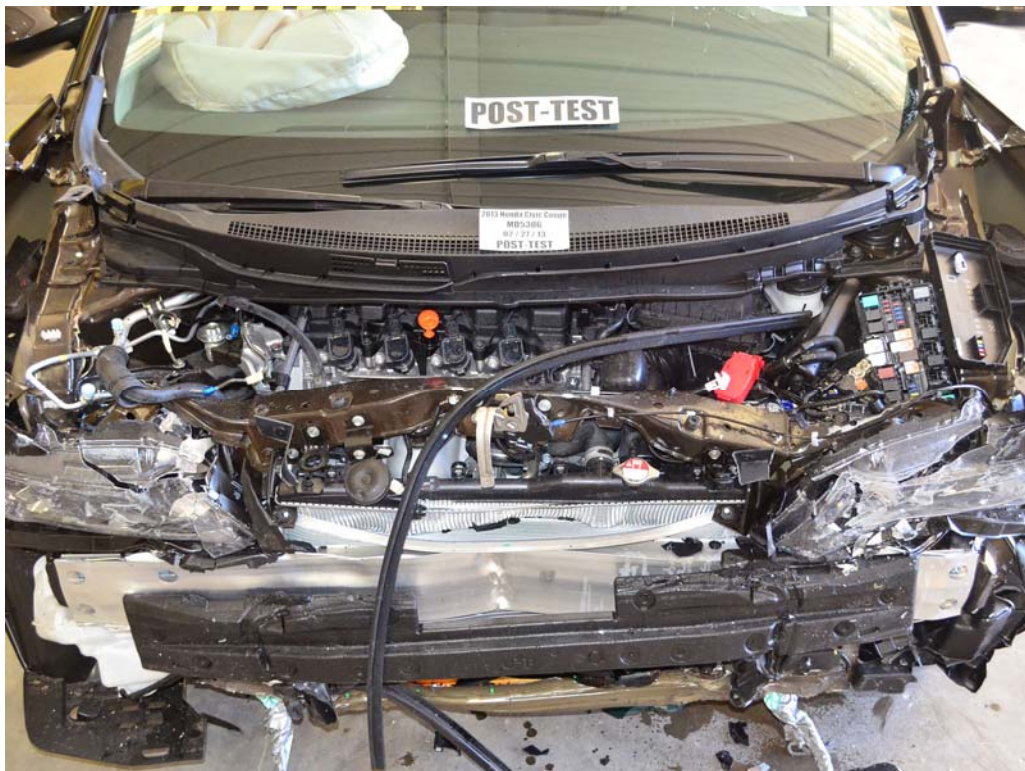
FIGURE 20. Post-Test Engine Compartment View

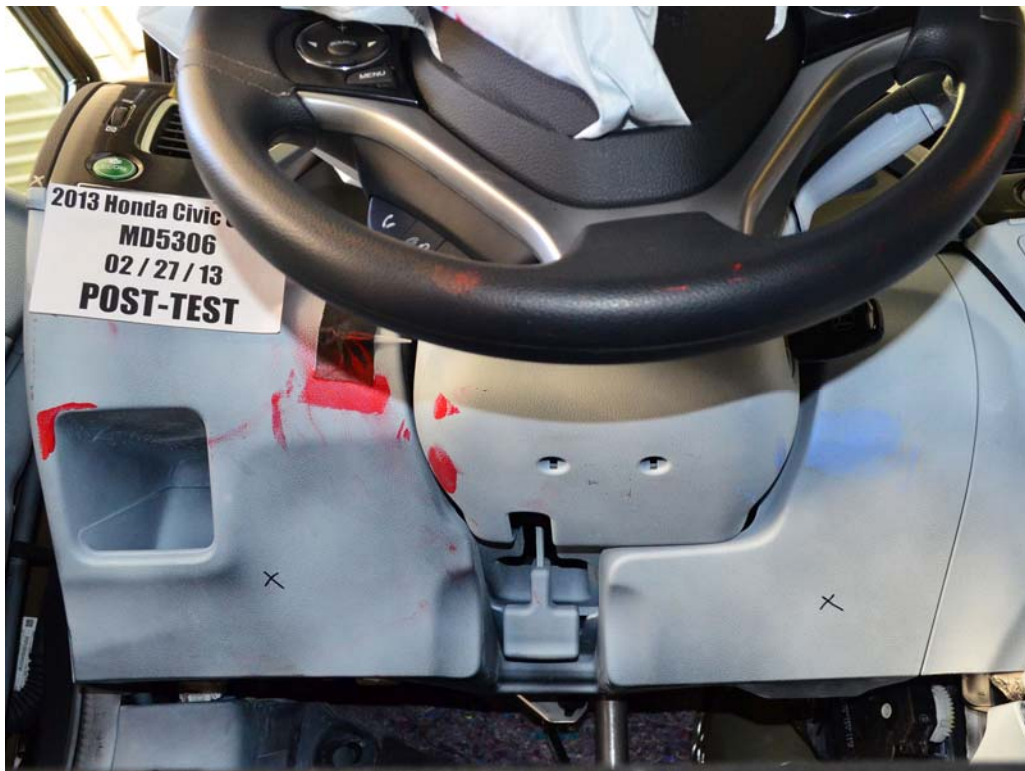
FIGURE 47a. Post-Test Driver Dummy Contact with Knee Bolster

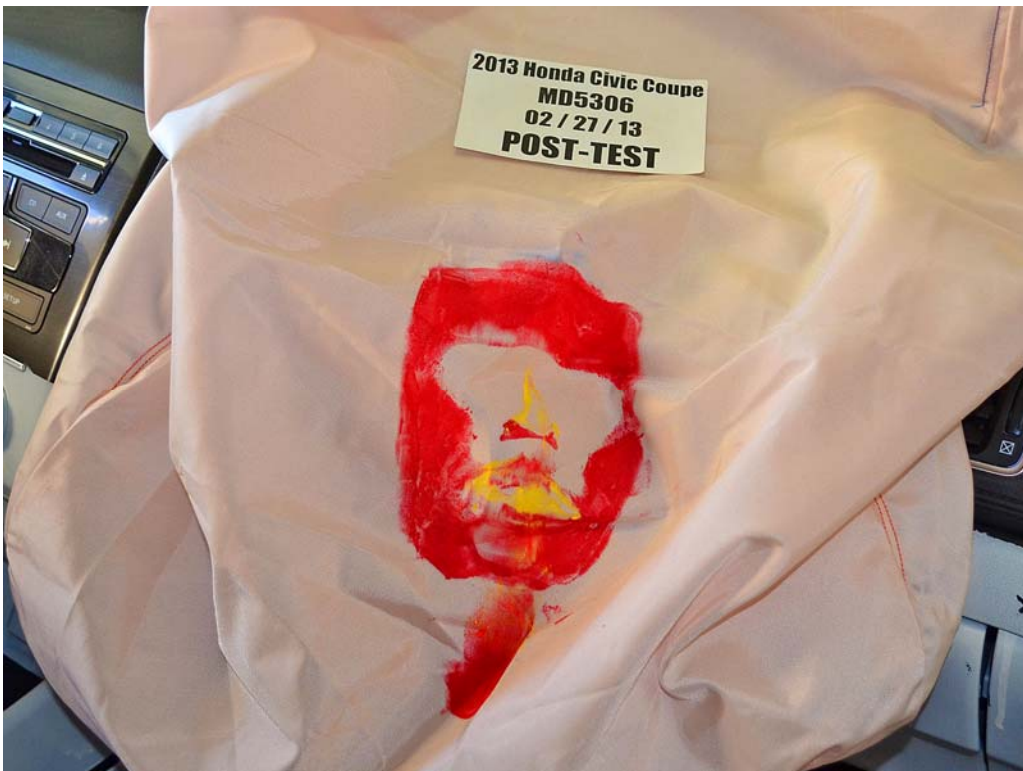
FIGURE 66. Post-Test Passenger Dummy Contact with Airbag

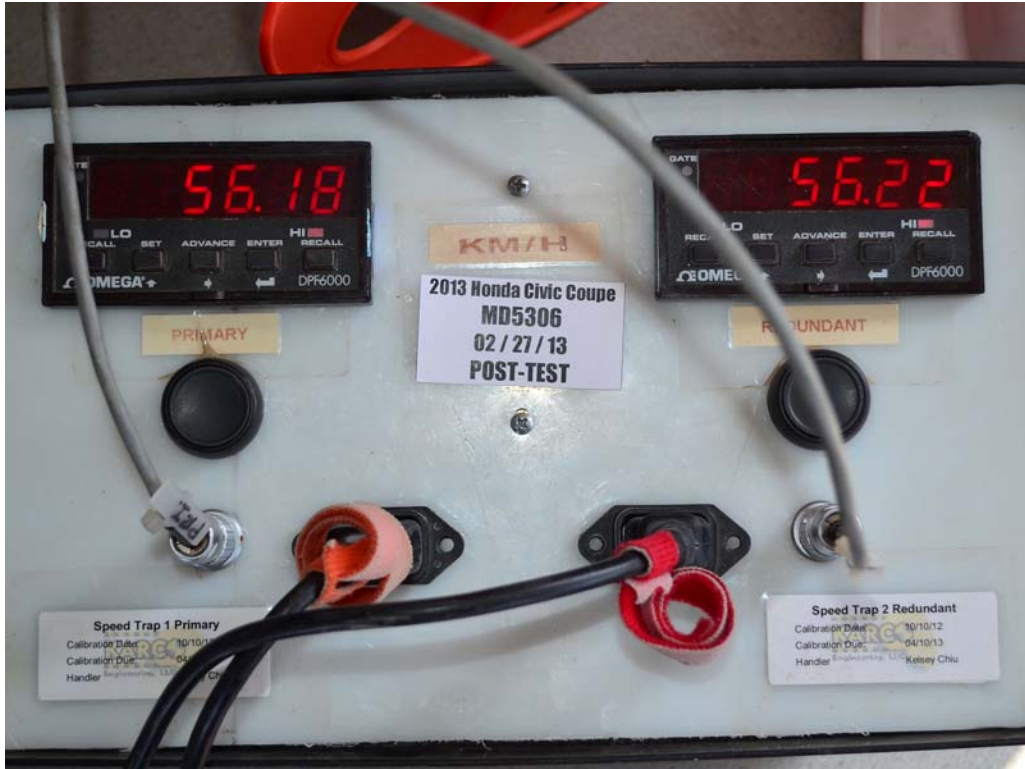
FIGURE 69. Post-Test Speed Trap Read-Out

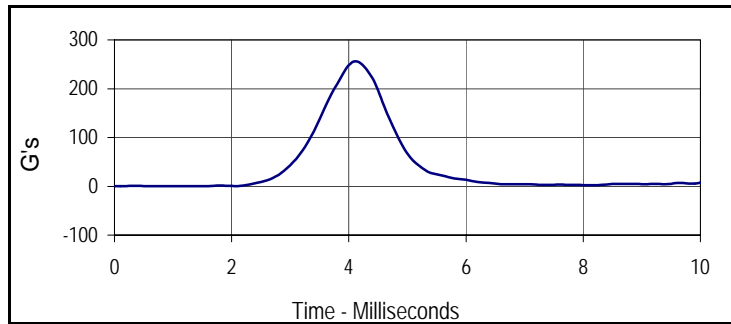
Curve Description			
Head Resultant			
Plot No.	Type	SAE Class	Units
001	RES	1000	G's
Max	Time	Min	Time
256.1	4.1	0.2	1.0
