REPORT NUMBER: SINCAP-KAR-13-047

**NEW CAR ASSESSMENT PROGRAM (NCAP)
MOVING DEFORMABLE BARRIER SIDE IMPACT TEST**

**HONDA OF CANADA MFG.
2013 HONDA CIVIC LX 2-DOOR COUPE**

NHTSA No: MD5308

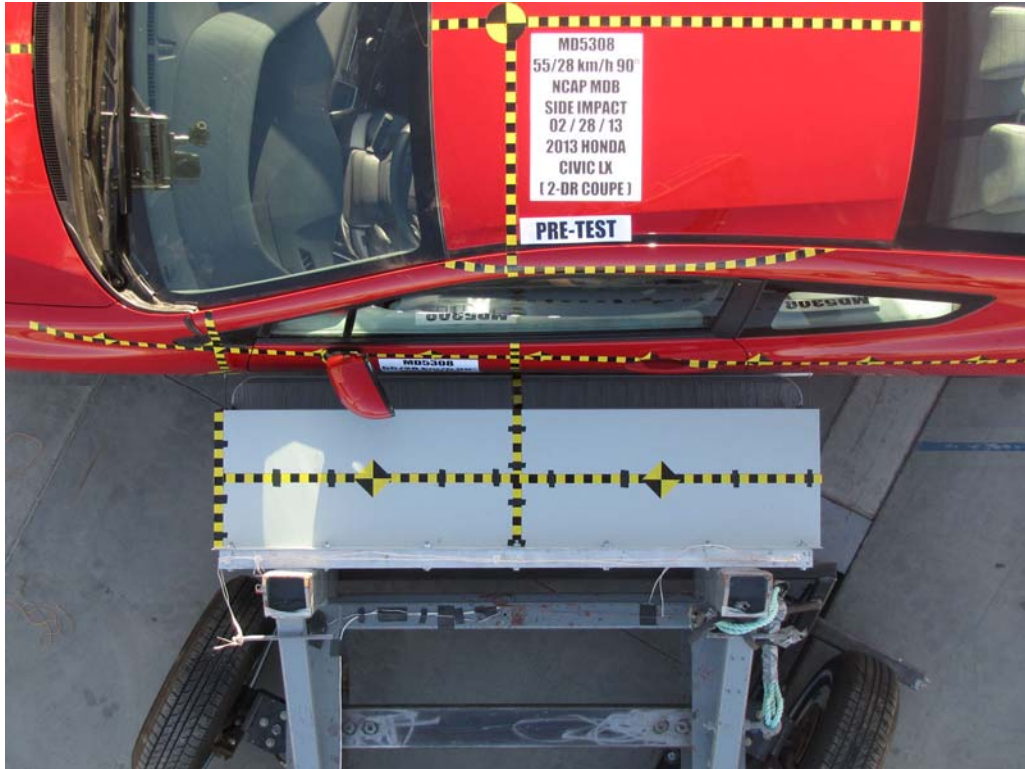
FIGURE 15. Pre-Test Overhead View of Test Area

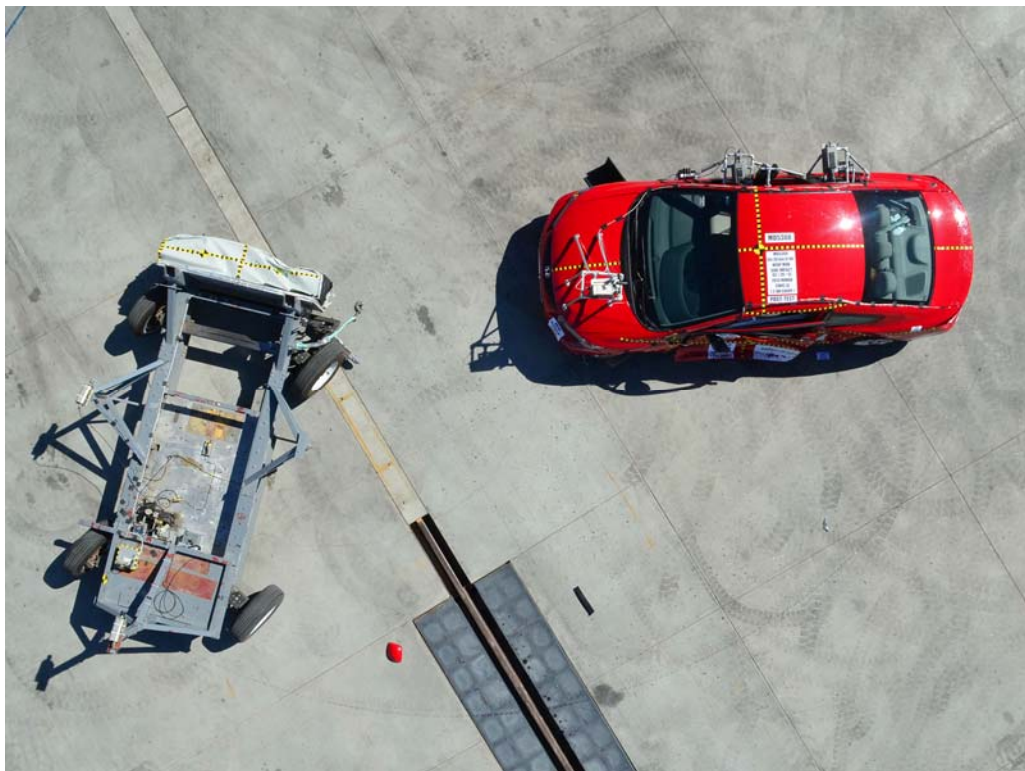
FIGURE 16. Post-Test Overhead View of Test Area

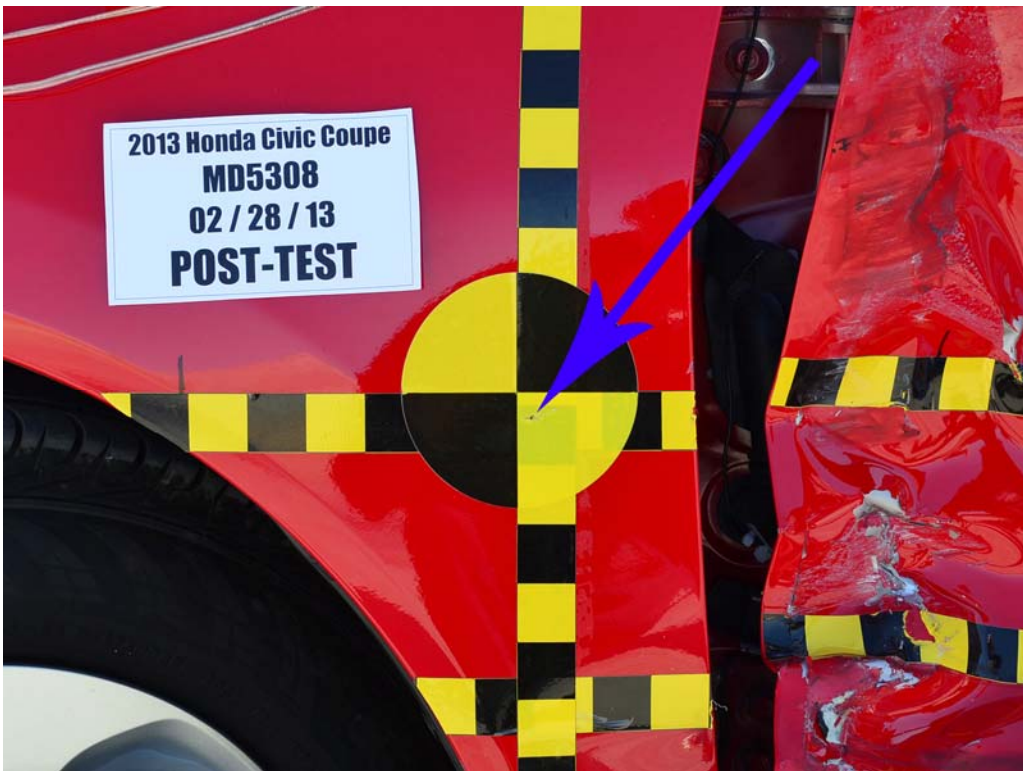
FIGURE 20. Post-Test Close-Up View of Impact Point Target

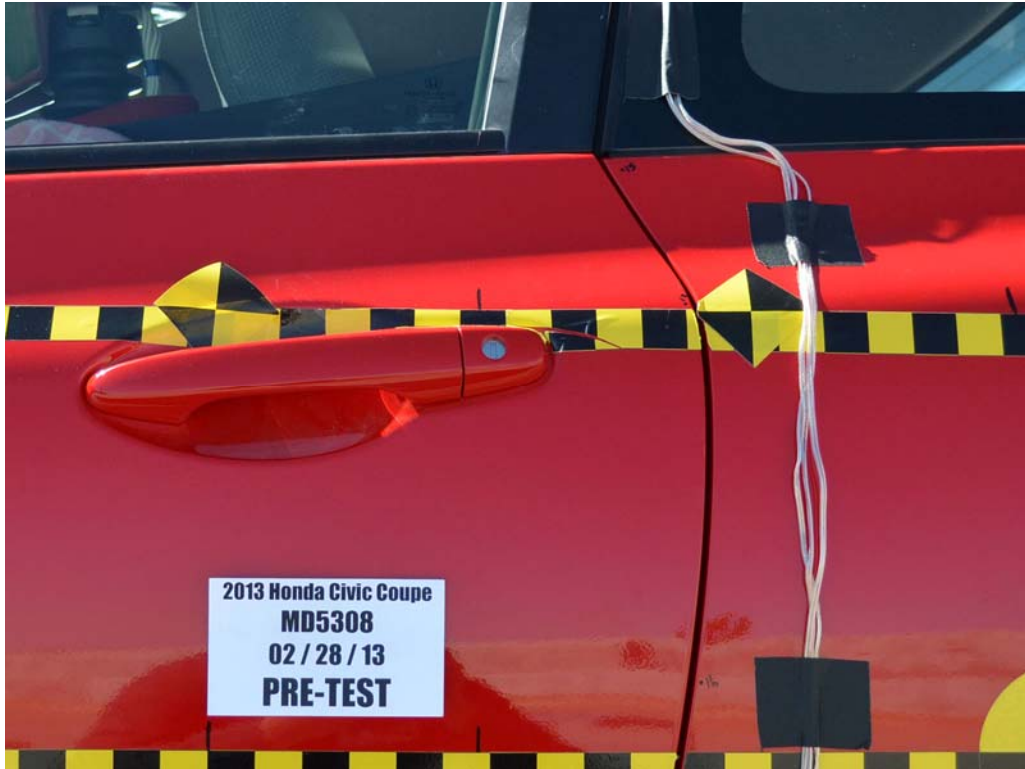
FIGURE 21. Pre-Test Left Front Door Latch Close-Up

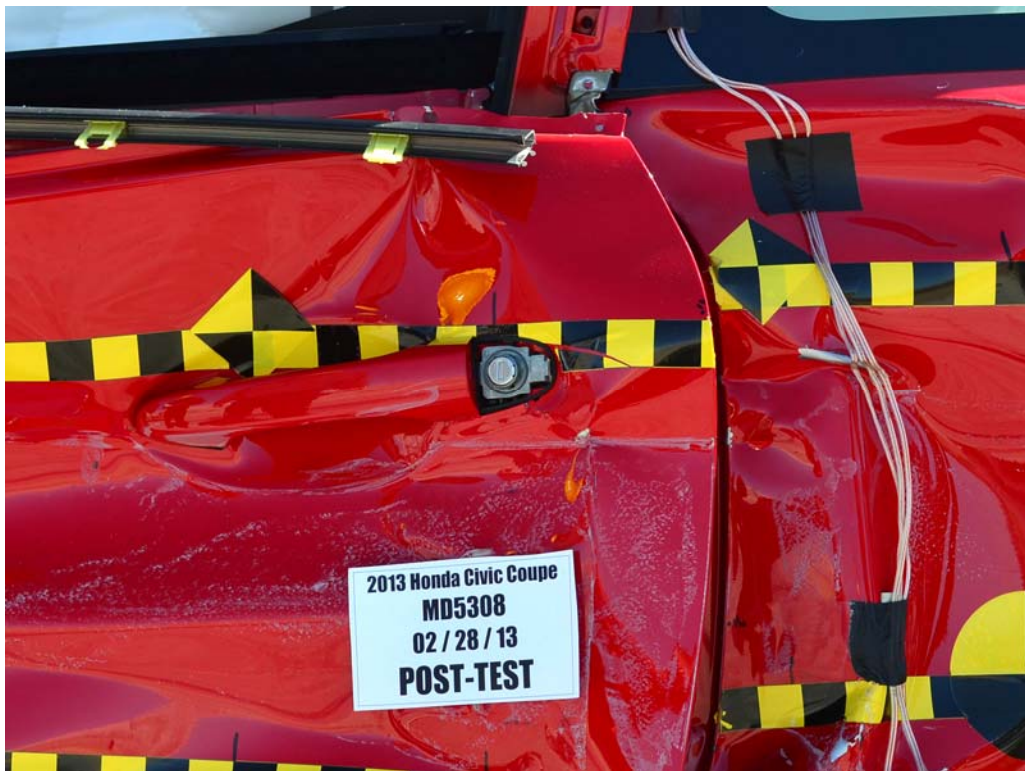
FIGURE 22. Post-Test Left Front Door Latch Close-Up

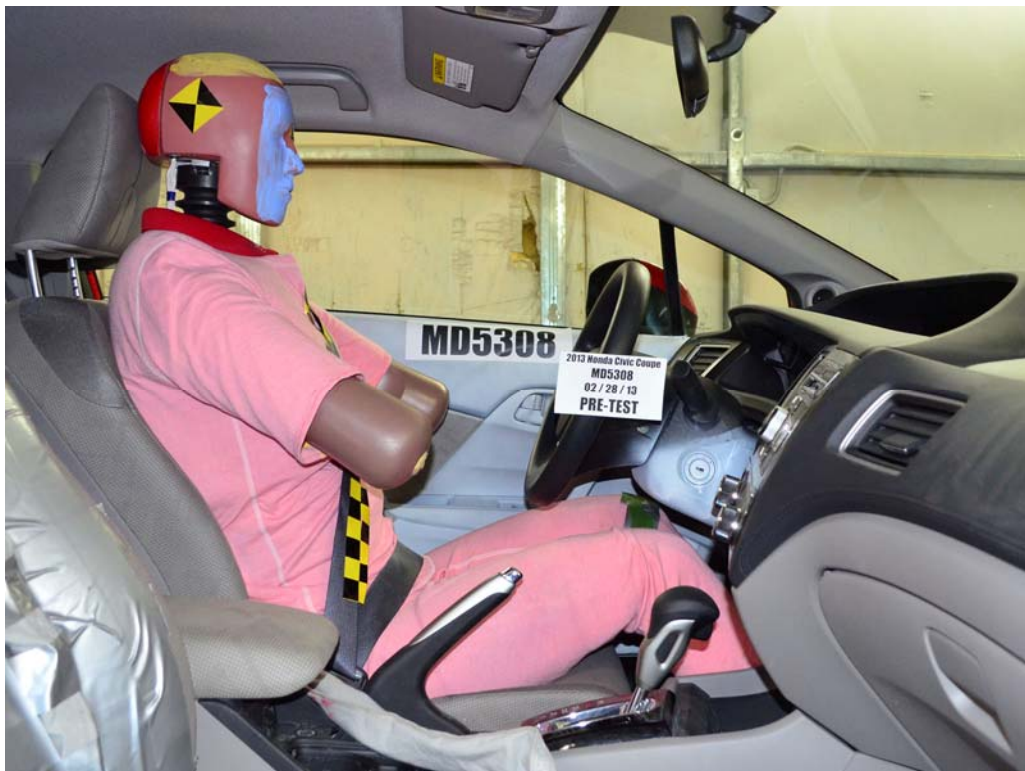
FIGURE 44. Pre-Test Right Side View of Driver Dummy and Front Seat of Occupant Compartment

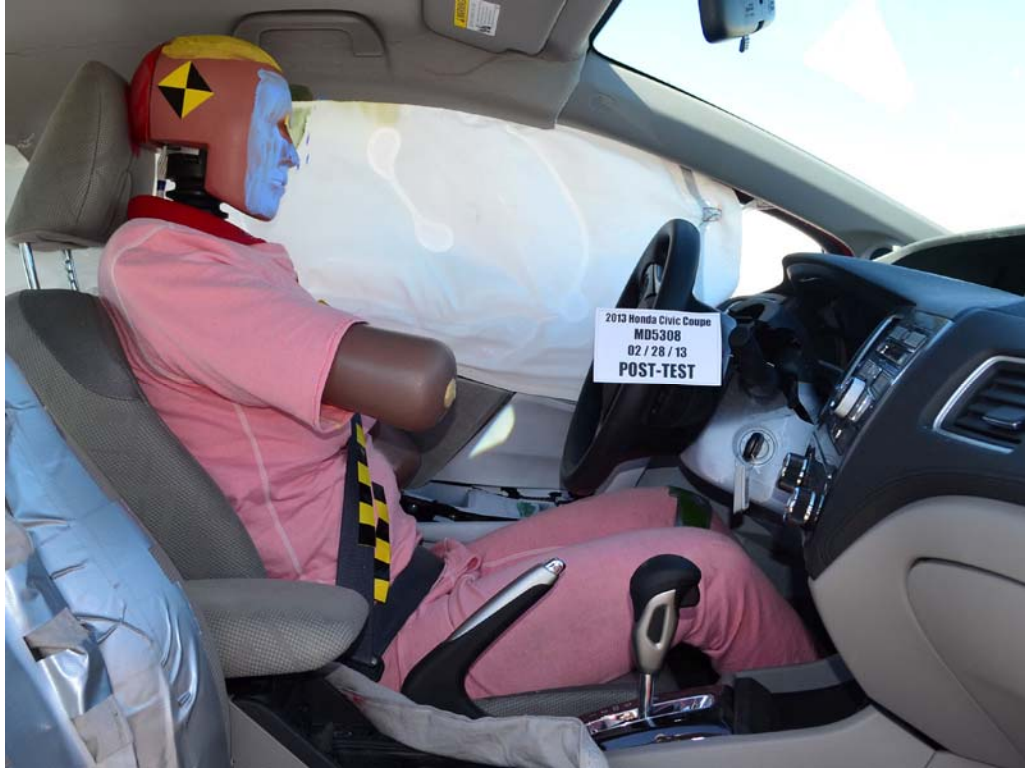
FIGURE 45. Post-Test Right Side View of Driver Dummy and Front Seat of Occupant Compartment

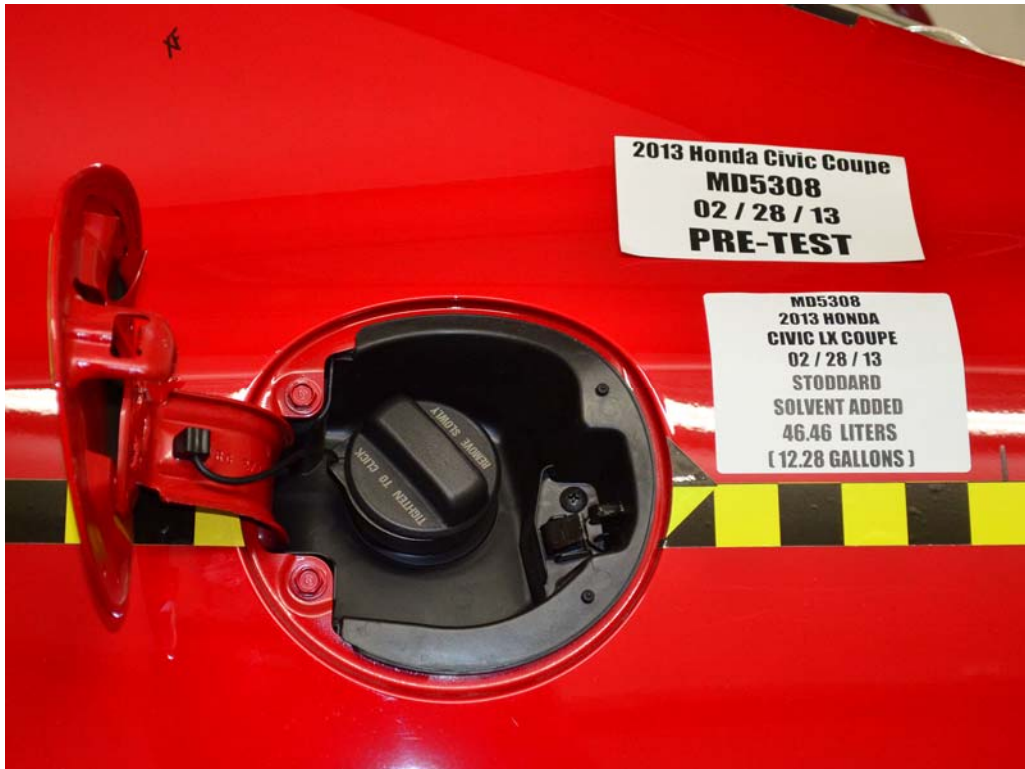
FIGURE 82. Pre-Test View of Fuel Filler Cap or Fuel Filler Neck

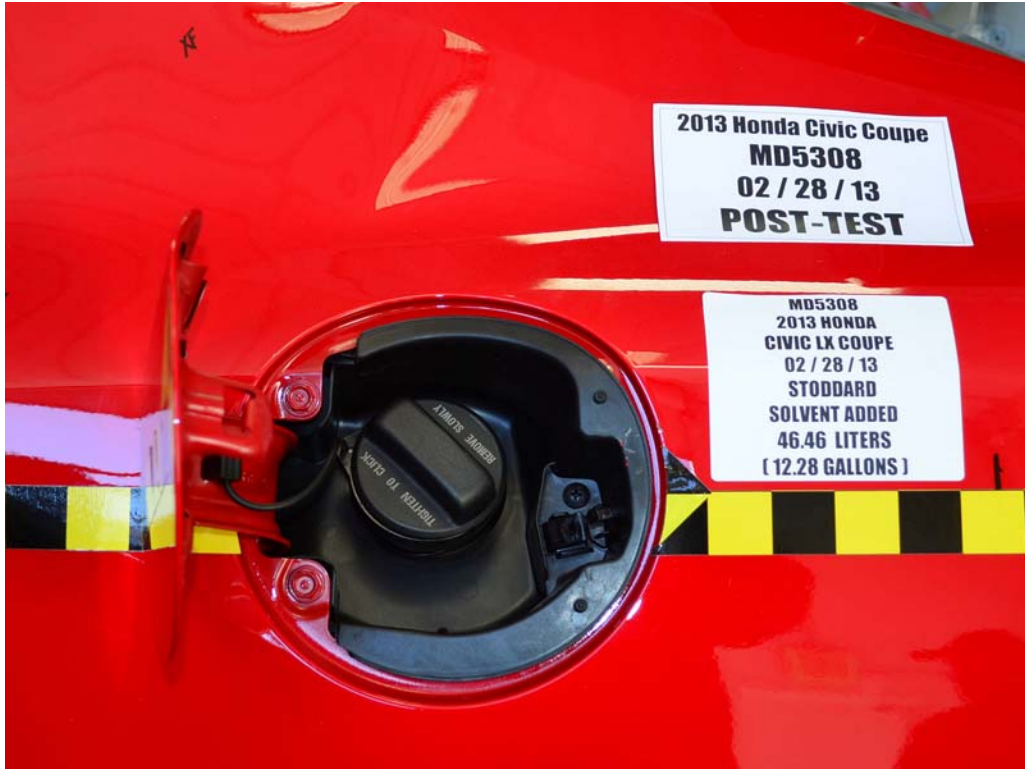
FIGURE 83. Post-Test View of Fuel Filler Cap or Fuel Filler Neck

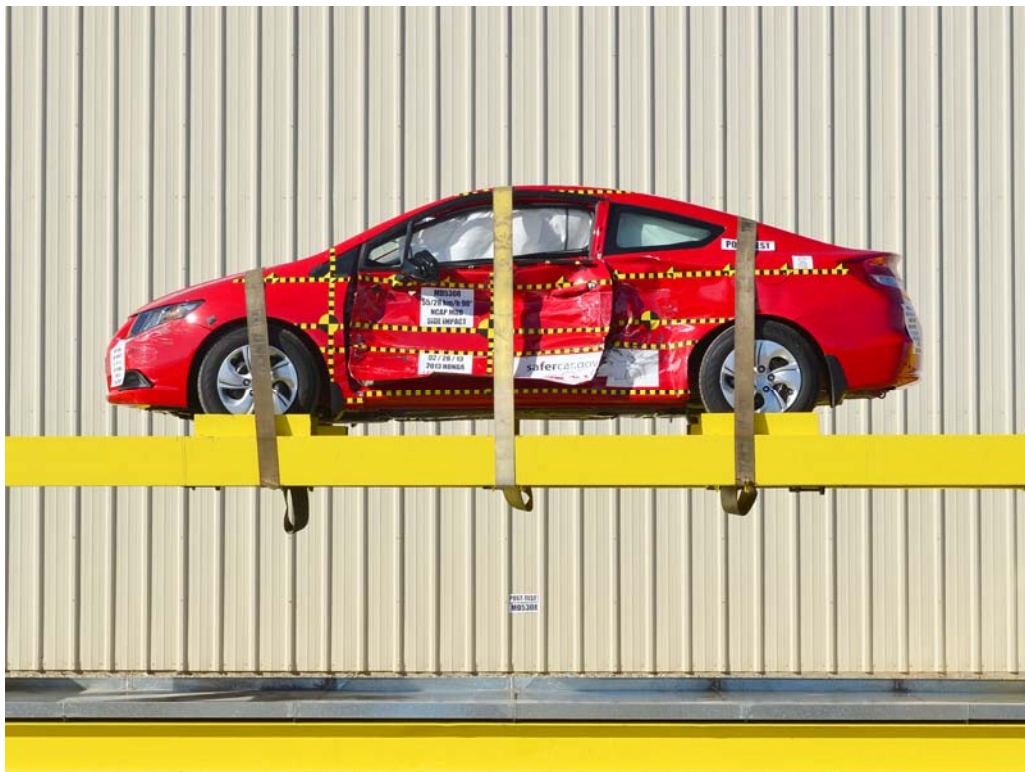
FIGURE 96. FMVSS No. 301 Static Rollover 0 Degrees

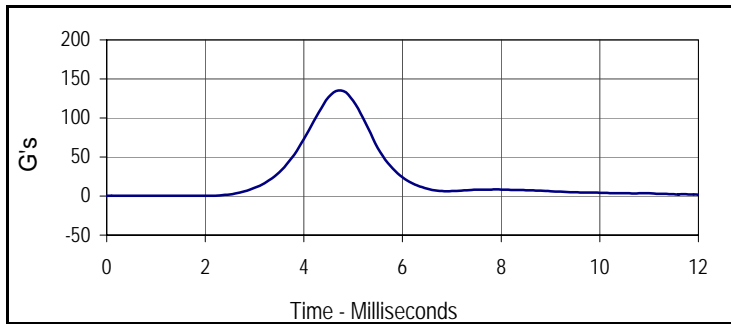
Tested Parameter	Units	Specification	Result	Pass/Fail
Head Assembly Soak Time	Minutes	≥240	325	Pass
Temperature During Soak	Max	20.6 to 22.2	21.8	Pass
	Min		20.8	Pass
Humidity During Soak	Max	10.0 to 70.0	30.5	Pass
	Min		28.6	Pass
Laboratory Temperature During Test	°C	20.6 to 22.2	21.6	Pass
Laboratory Humidity During Test	%	10.0 to 70.0	29.7	Pass
Peak Head Resultant Acceleration	G's	125 to 155	135.4	Pass
Peak Head X Acceleration	G's	≤15	5.8	Pass
Is Acceleration Unimodal?	Yes/No	Yes	Yes	Pass
Oscillations After Main Pulse	%	<15	6.2	Pass
Overall Test Results				Pass

Curve Description			
Head Resultant			
Plot No.	Type	SAE Class	Units
001	RES	1000	G's
Max	Time	Min	Time
135.4	4.7	0.2	1.7

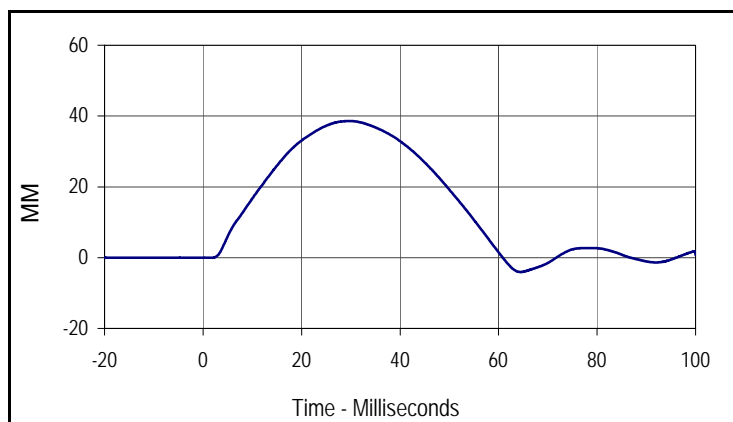
Tested Parameter	Units	Specification	Result	Pass/Fail
Rib Module Soak Time	Minutes	≥240	425	Pass
Temperature During Soak	Max	20.6 to 22.2	21.8	Pass
	Min		20.8	Pass
Humidity During Soak	Max	10.0 to 70.0	30.5	Pass
	Min		28.6	Pass
Laboratory Temperature During Test	°C	20.6 to 22.2	21.5	Pass
Laboratory Humidity During Test	%	10.0 to 70.0	29.7	Pass
Peak Rib Deflection at 459 +/- 5 mm Drop Height	mm	36 to 40	38.6	Pass
Peak Rib Deflection at 815 +/- 8 mm Drop Height	mm	46 to 51	48.9	Pass
Overall Test Results				Pass

Curve Description			
Upper Rib Deflection (459 mm Drop Height)			
Plot No.	Type	SAE Class	Units
001	FIL	180	MM
Max	Time	Min	Time
38.6	29.7	-4.1	64.4

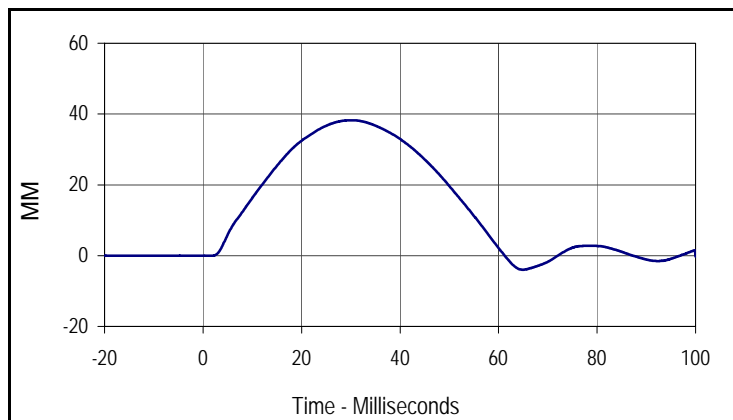
Tested Parameter	Units	Specification	Result	Pass/Fail
Rib Module Soak Time	Minutes	≥240	440	Pass
Temperature During Soak	Max	20.6 to 22.2	21.8	Pass
	Min		20.8	Pass
Humidity During Soak	Max	10.0 to 70.0	30.5	Pass
	Min		28.6	Pass
Laboratory Temperature During Test	°C	20.6 to 22.2	21.6	Pass
Laboratory Humidity During Test	%	10.0 to 70.0	29.6	Pass
Peak Rib Deflection at 459 +/- 5 mm Drop Height	mm	36 to 40	38.2	Pass
Peak Rib Deflection at 815 +/- 8 mm Drop Height	mm	46 to 51	49.3	Pass
Overall Test Results				Pass

Curve Description			
Middle Rib Deflection (459 mm Drop Height)			
Plot No.	Type	SAE Class	Units
001	FIL	180	MM
Max	Time	Min	Time
38.2	30.2	-4.0	64.9

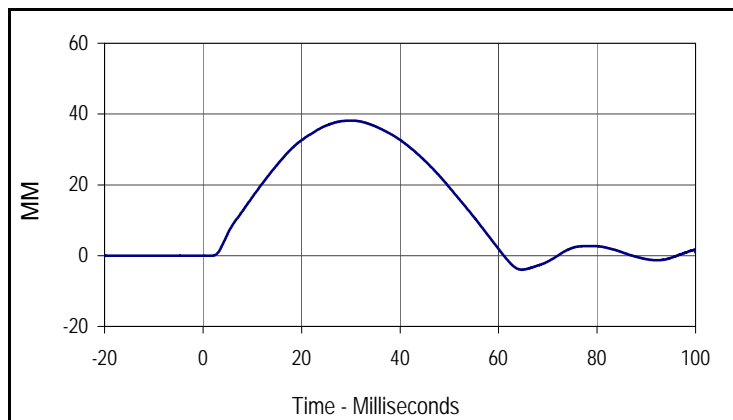
Tested Parameter	Units	Specification	Result	Pass/Fail
Rib Module Soak Time	Minutes	≥240	455	Pass
Temperature During Soak	Max	20.6 to 22.2	21.8	Pass
	Min		20.8	Pass
Humidity During Soak	Max	10.0 to 70.0	30.5	Pass
	Min		28.6	Pass
Laboratory Temperature During Test	°C	20.6 to 22.2	21.6	Pass
Laboratory Humidity During Test	%	10.0 to 70.0	29.6	Pass
Peak Rib Deflection at 459 +/- 5 mm Drop Height	mm	36 to 40	38.1	Pass
Peak Rib Deflection at 815 +/- 8 mm Drop Height	mm	46 to 51	49.6	Pass
Overall Test Results				Pass

Curve Description			
Lower Rib Deflection (459 mm Drop Height)			
Plot No.	Type	SAE Class	Units
001	FIL	180	MM
Max	Time	Min	Time
38.1	30.1	-4.0	64.7

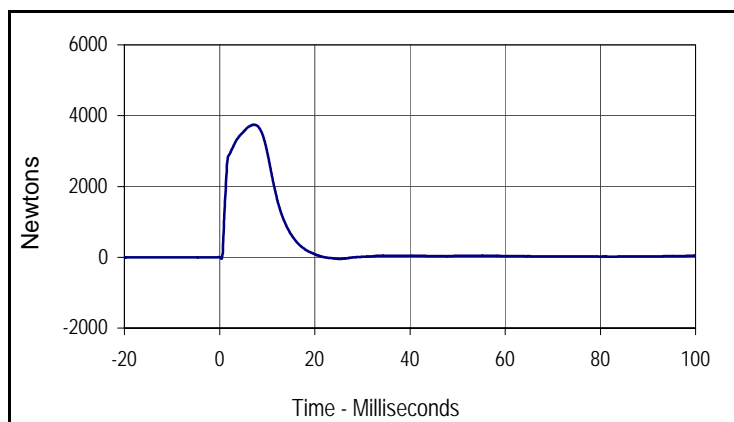
Tested Parameter	Units	Specification	Result	Pass/Fail
Dummy Soak Time	Minutes	≥180	555	Pass
Temperature During Soak	Max	20.6 to 22.2	21.8	Pass
	Min		20.8	Pass
Humidity During Soak	Max	10.0 to 70.0	30.6	Pass
	Min		28.6	Pass
Laboratory Temperature During Test	°C	18.9 to 25.6	21.5	Pass
Laboratory Humidity During Test	%	10.0 to 70.0	29.6	Pass
Impactor Velocity	m/s	6.6 to 6.8	6.64	Pass
Peak Acetabulum Force Y	Newtons	3600 to 4300	3744.8	Pass
Peak Pelvis Y Acceleration After 6 msec.	G's	34 to 42	38.6	Pass
Peak Impactor Acceleration	G's	38 to 47	45.8	Pass
Overall Test Results				Pass

Curve Description			
Pelvis Acetabulum Force			
Plot No.	Type	SAE Class	Units
001	FIL	600	Newtons
Max	Time	Min	Time
3744.8	7.2	-45.4	25.2

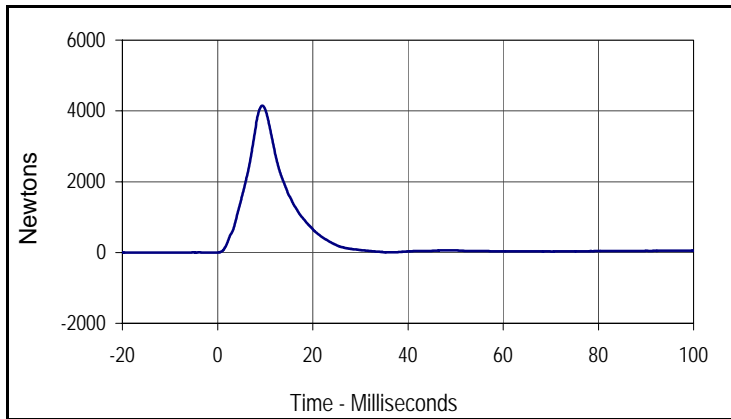
Tested Parameter	Units	Specification	Result	Pass/Fail
Dummy Soak Time	Minutes	≥180	610	Pass
Temperature During Soak	Max	20.6 to 22.2	21.8	Pass
	Min		20.8	Pass
Humidity During Soak	Max	10.0 to 70.0	30.6	Pass
	Min		28.6	Pass
Laboratory Temperature During Test	°C	18.9 to 25.6	21.5	Pass
Laboratory Humidity During Test	%	10.0 to 70.0	29.7	Pass
Impactor Velocity	m/s	4.2 to 4.4	4.27	Pass
Peak Iliac Force	Newtons	4100 to 5100	4150.1	Pass
Peak Pelvis Y Acceleration	G's	28 to 39	30.6	Pass
Peak Impactor Acceleration	G's	36 to 45	39.4	Pass
Overall Test Results				Pass

Curve Description			
Pelvis Iliac Force			
Plot No.	Type	SAE Class	Units
001	FIL	600	Newtons
Max	Time	Min	Time
4150.1	9.4	-2.3	-16.6
