**REPORT NUMBER: SPNCAP-KAR-13-048**

**NEW CAR ASSESSMENT PROGRAM (NCAP)  
SIDE IMPACT POLE TEST**

**HONDA OF CANADA MFG.  
2013 HONDA CIVIC LX 2-DOOR COUPE**

**FINAL REPORT**

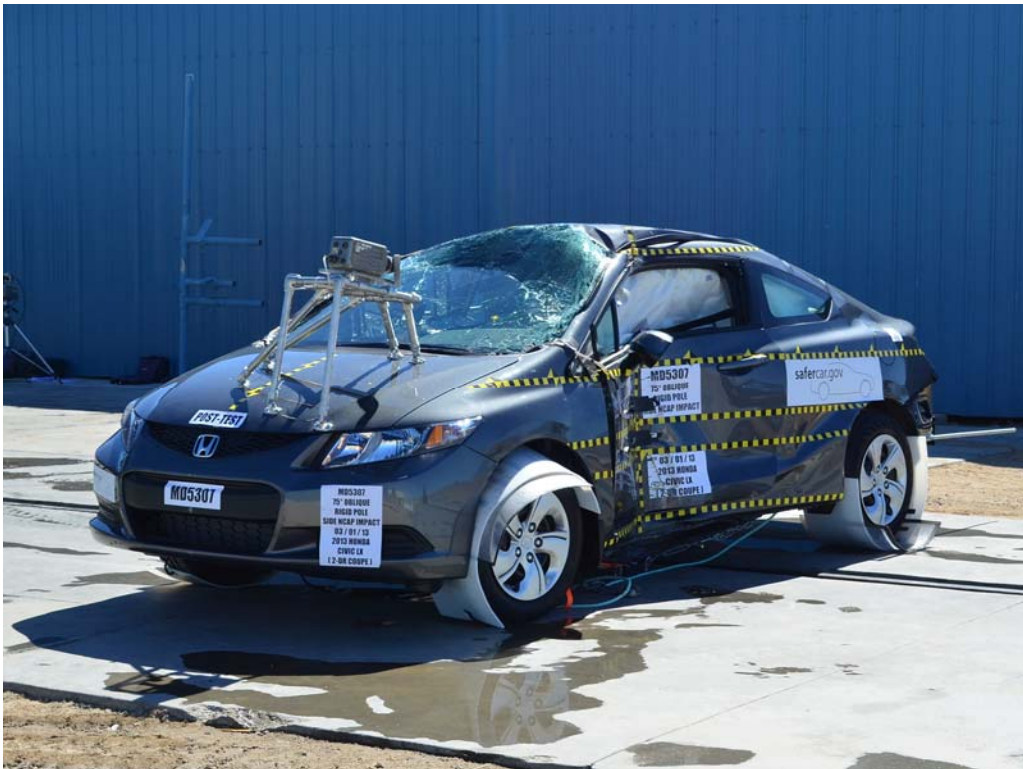
FIGURE 6. Post-Test Left Front  $\frac{3}{4}$  View of Test Vehicle

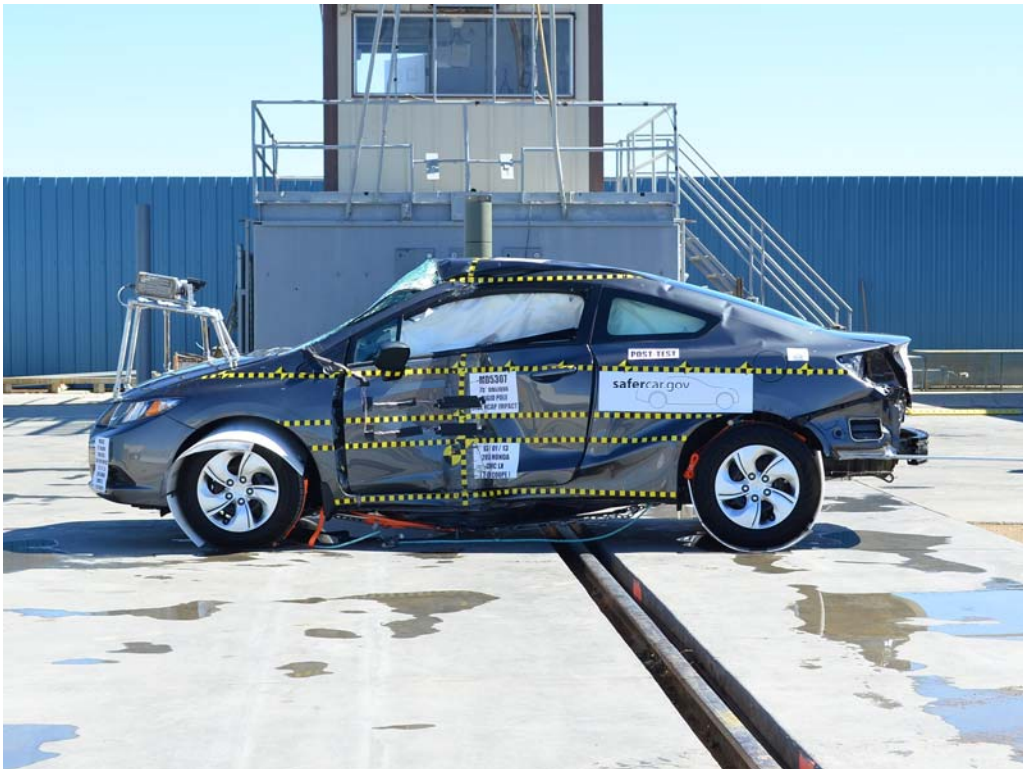
FIGURE 8. Post-Test Left Side View of Test Vehicle

The front door on the struck side of the vehicle remained closed and latched. There was no separation at the hinges or latches. The front door on the non-struck side remained closed and latched. There were no ATD values that exceeded limits.

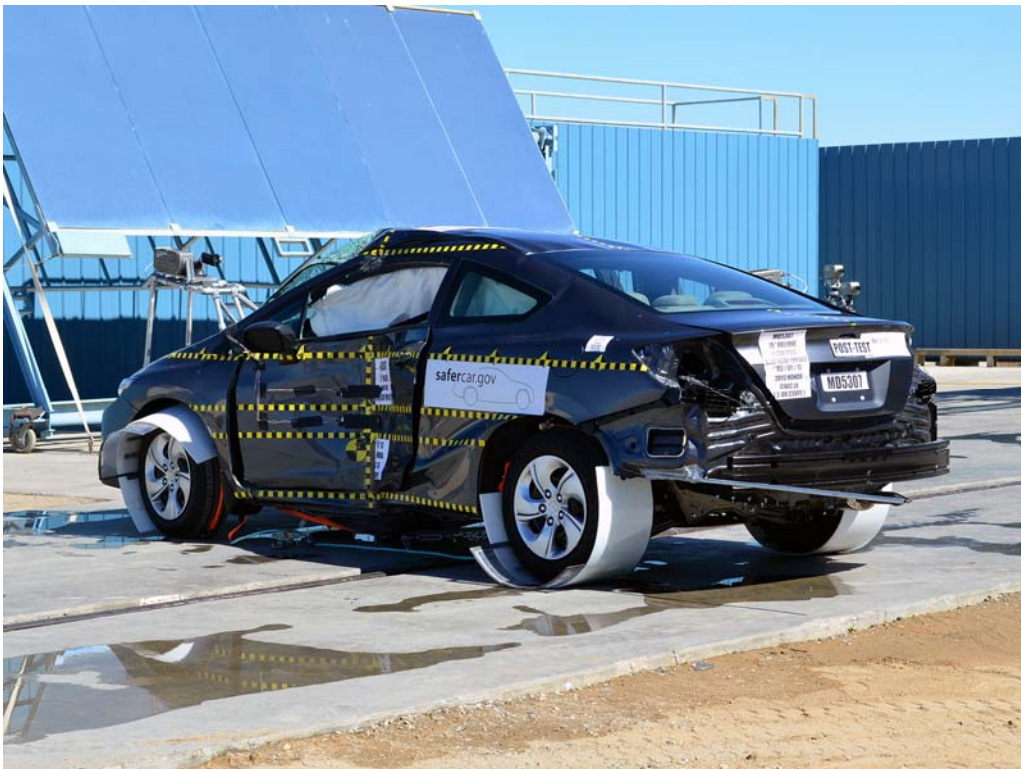
FIGURE 10. Post-Test Left Rear  $\frac{3}{4}$  View of Test Vehicle

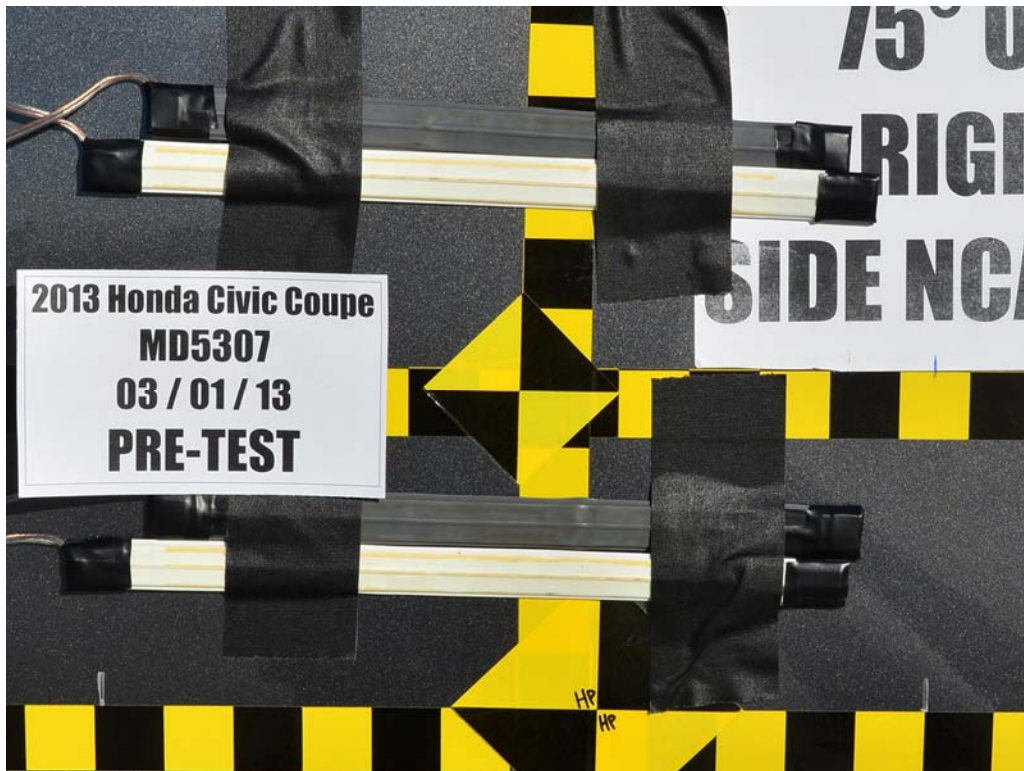
FIGURE 19. Pre-Test Close-Up View of Impact Point Target

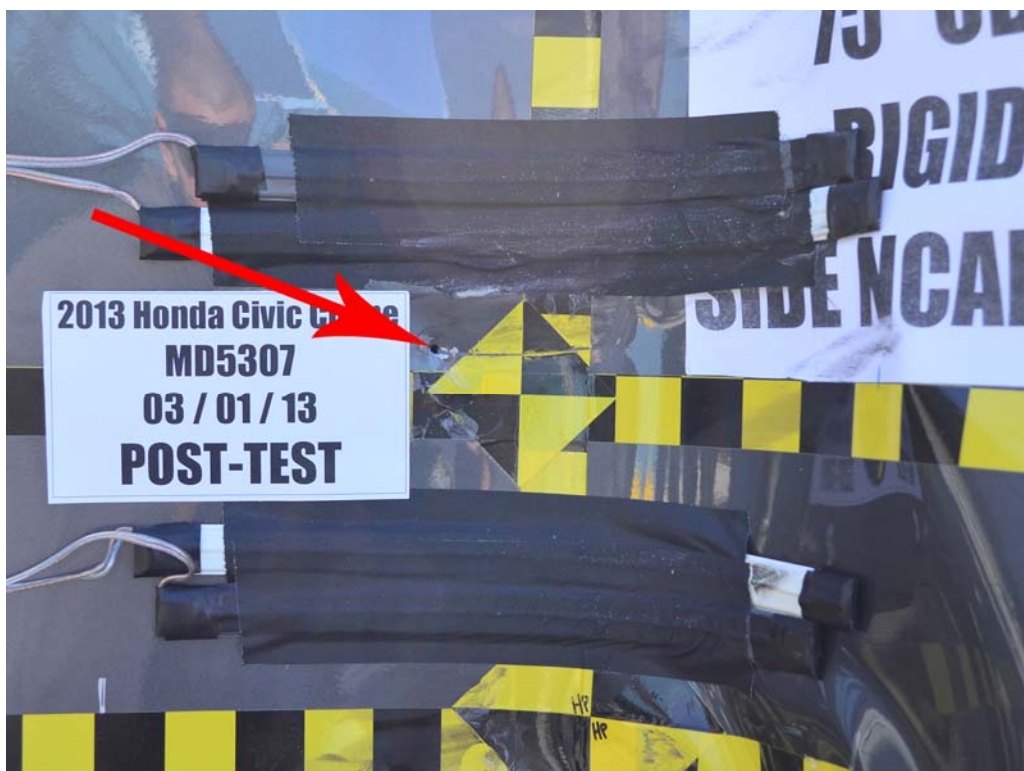
FIGURE 20. Post-Test Close-Up View of Impact Point Target

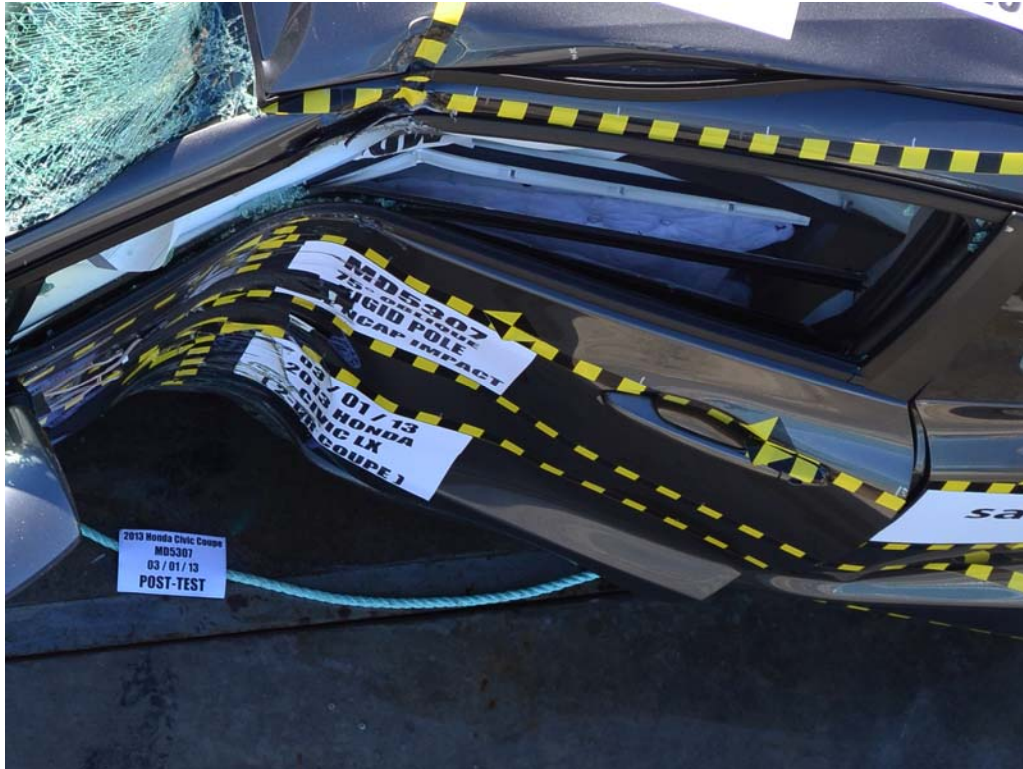
FIGURE 41. Post-Test Dummy and Door Clearance

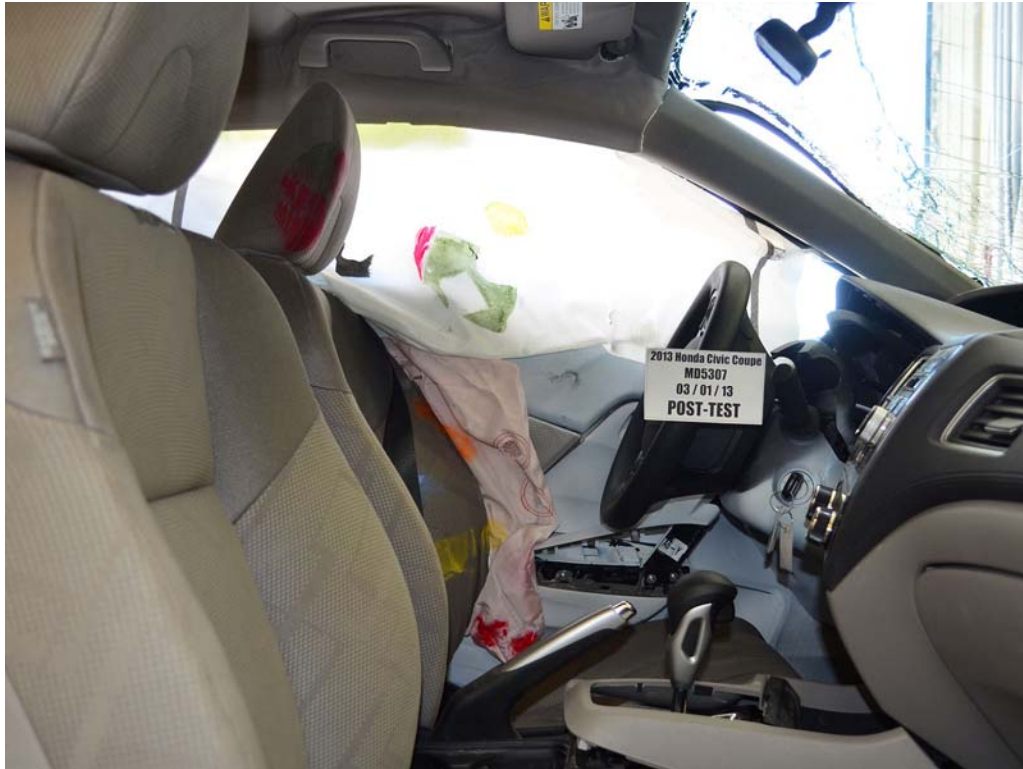
FIGURE 45. Post-Test Inner Door Panel View  
Showing Dummy Contact Location

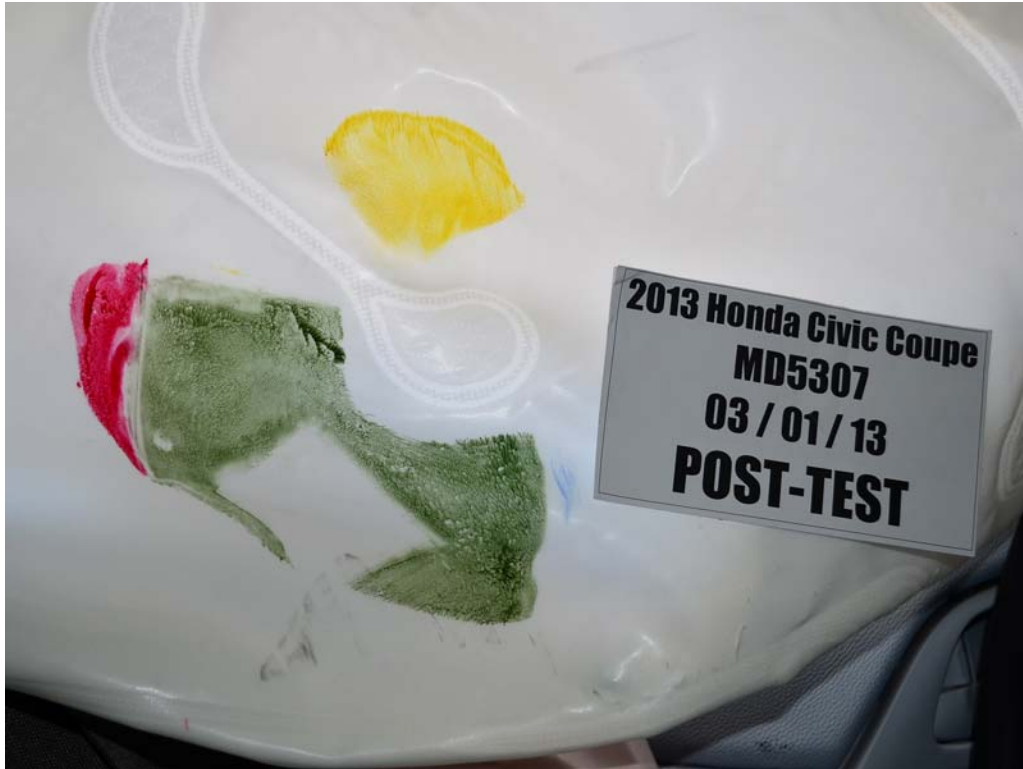
FIGURE 47. Post-Test Dummy Close-Up Head Contact with Side Airbag View

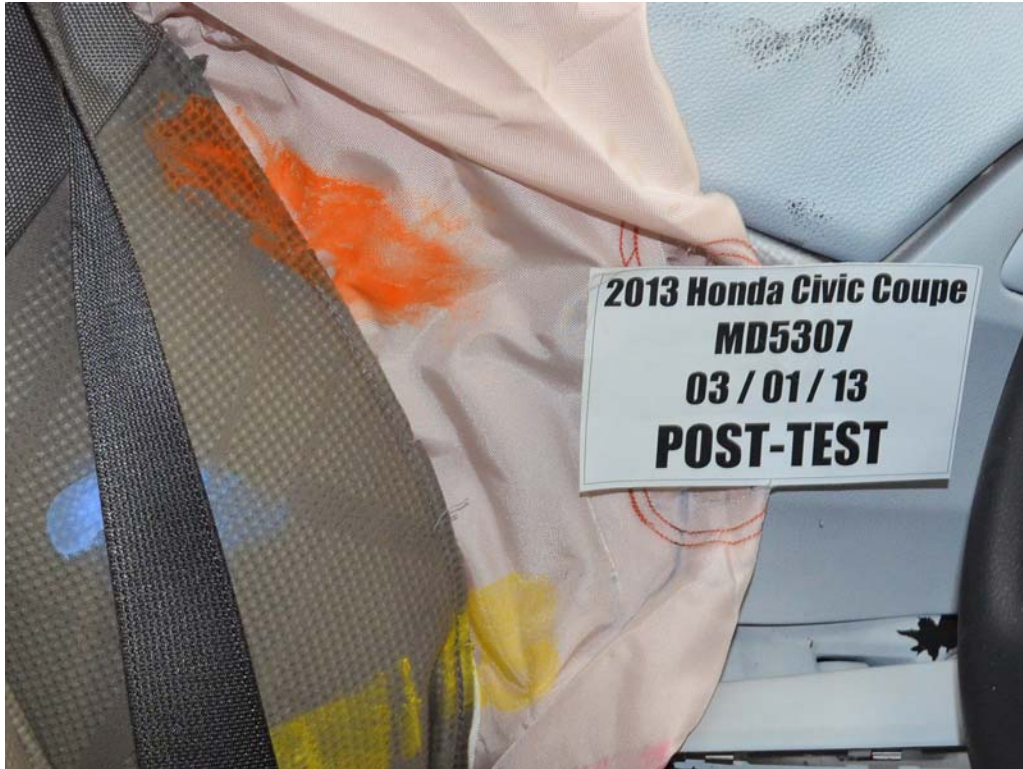
FIGURE 49. Post-Test Dummy Close-Up Torso Contact with Side Airbag View

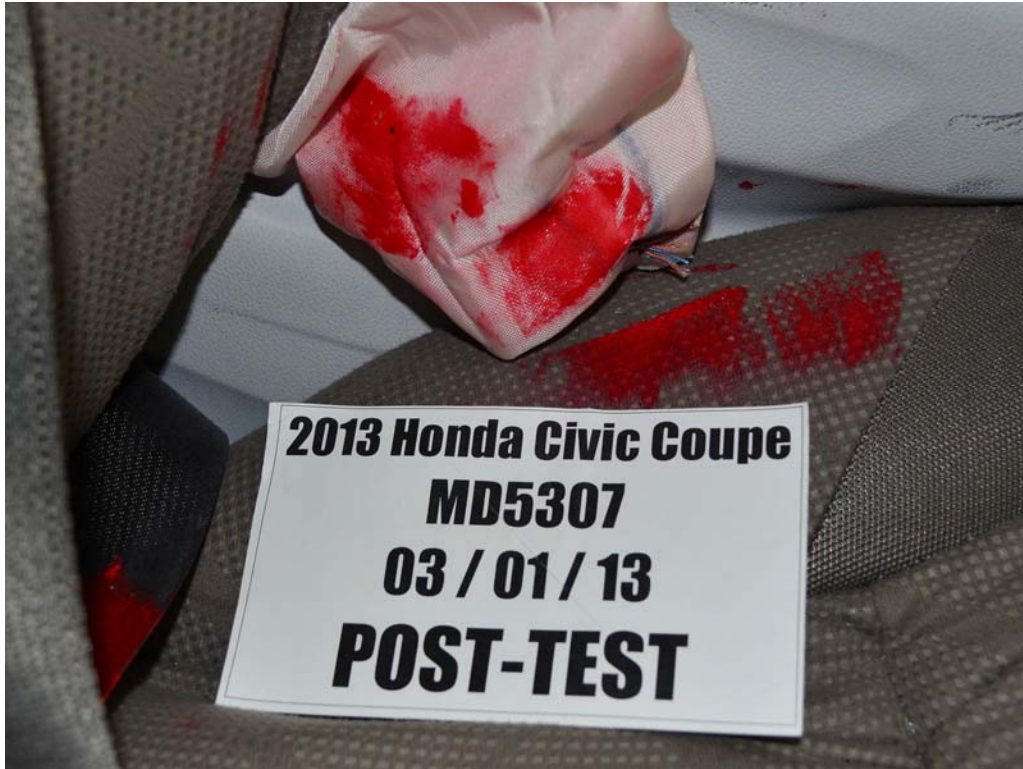
FIGURE 51. Post-Test Dummy Close-Up Pelvis Contact with Side Airbag View

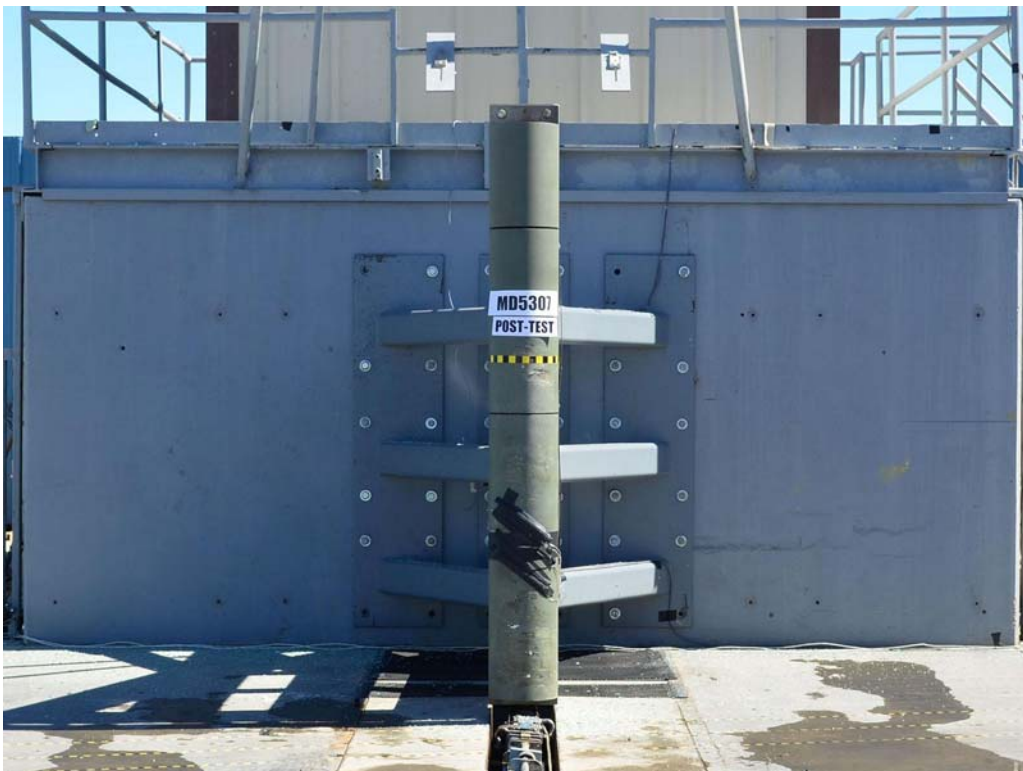
FIGURE 58. Post-Test Pole Barrier Front View

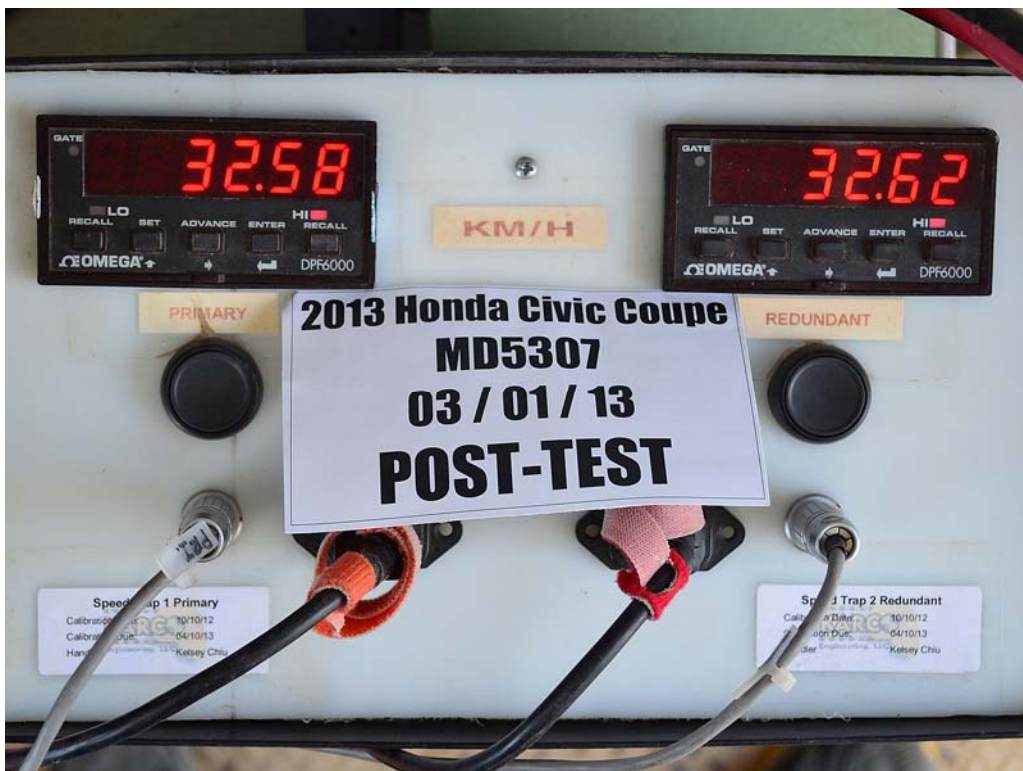
FIGURE 62. Post-Test Primary and Redundant Speed Trap Read-Out

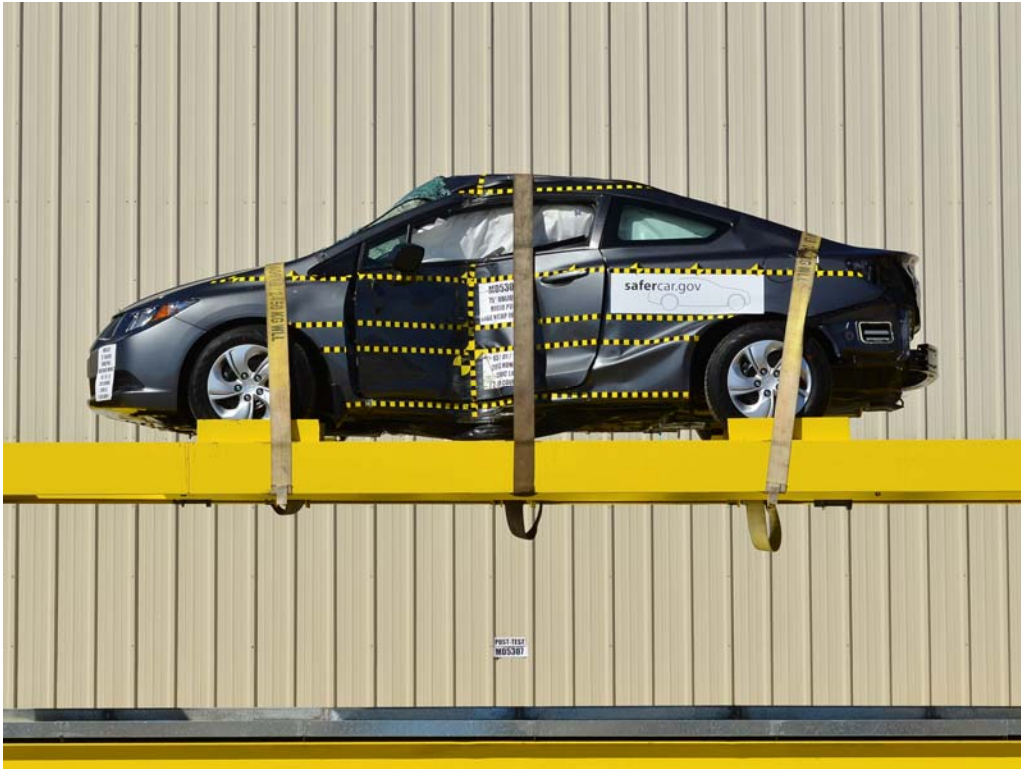
FIGURE 63. FMVSS No. 301 Static Rollover 0 Degrees

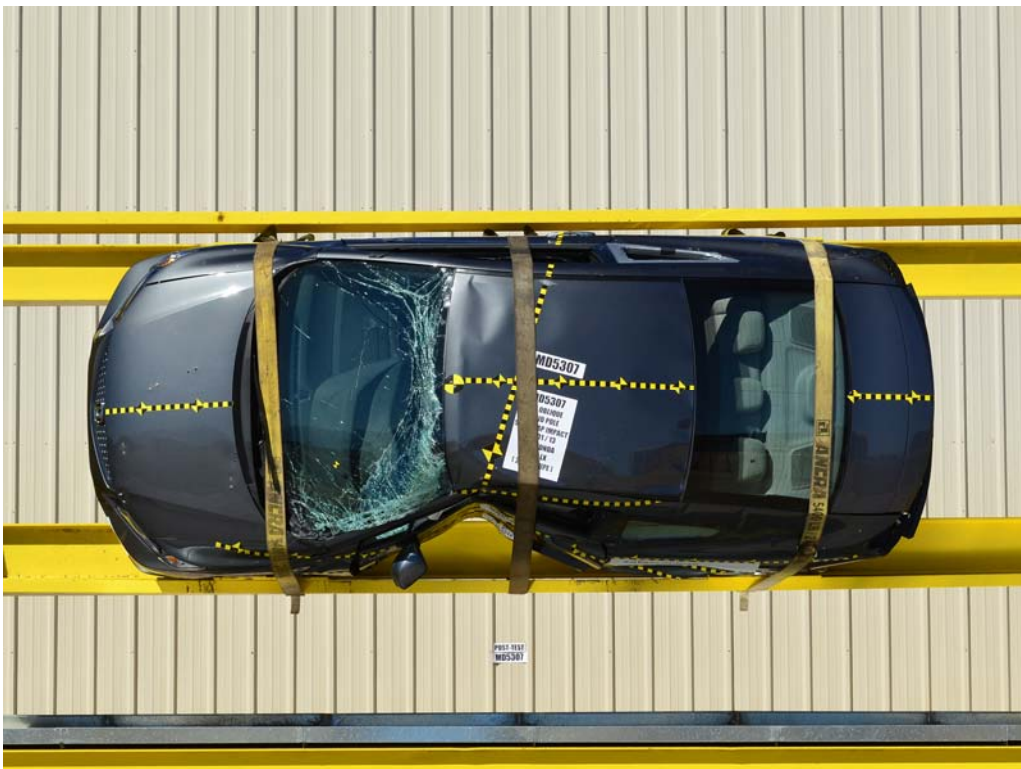
FIGURE 64. FMVSS No. 301 Static Rollover 90 Degrees

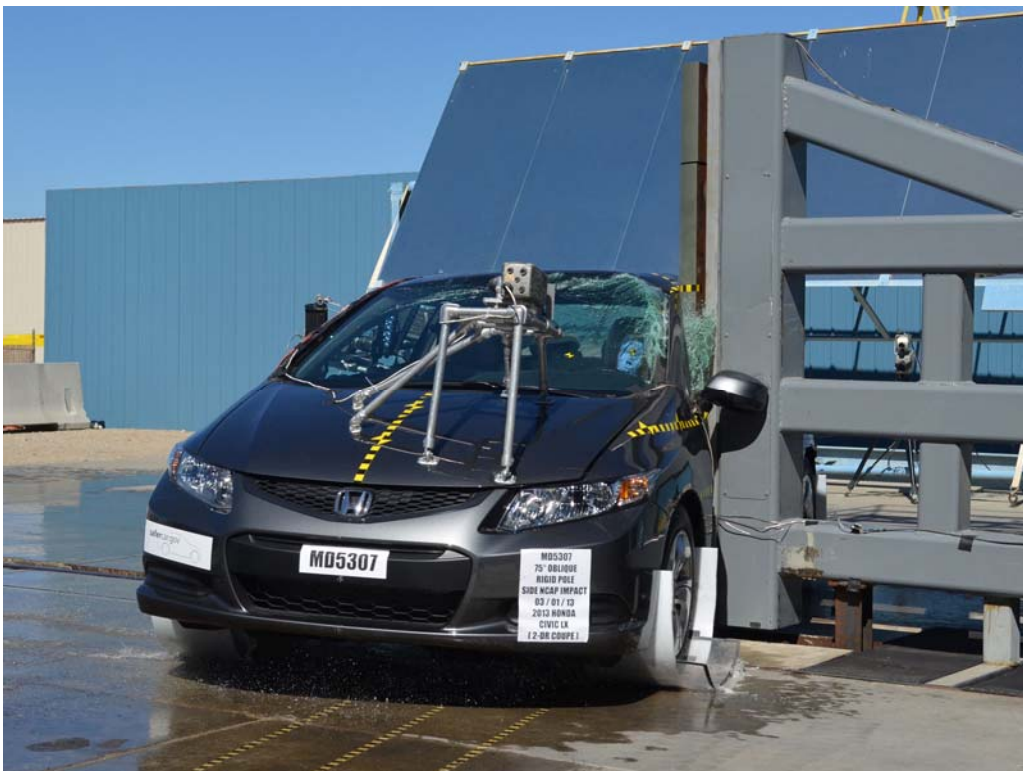
FIGURE 68. Impact Event

A rigid pole side impact test was conducted on a 2013 Honda Civic LX 2-door coupe. The subject vehicle was towed into the rigid pole at an angle of 75.2° and a velocity of 32.6 km/h. The test was conducted by KARCO Engineering, LLC. in Adelanto, California on March 1, 2013. Pre- and post-test photographs of the test vehicle and side impact dummy (SID-IIs) are included in Appendix A of this report.
