**REPORT NUMBER: SINCAP-MGA-2013-053**

**NEW CAR ASSESSMENT PROGRAM (NCAP)  
Moving Deformable Barrier Side Impact Test**

**TOYOTA MOTOR MANUFACTURING CANADA INC.  
2013 Toyota RAV4 LE SUV  
NHTSA No.: YD5111**

**FINAL REPORT**

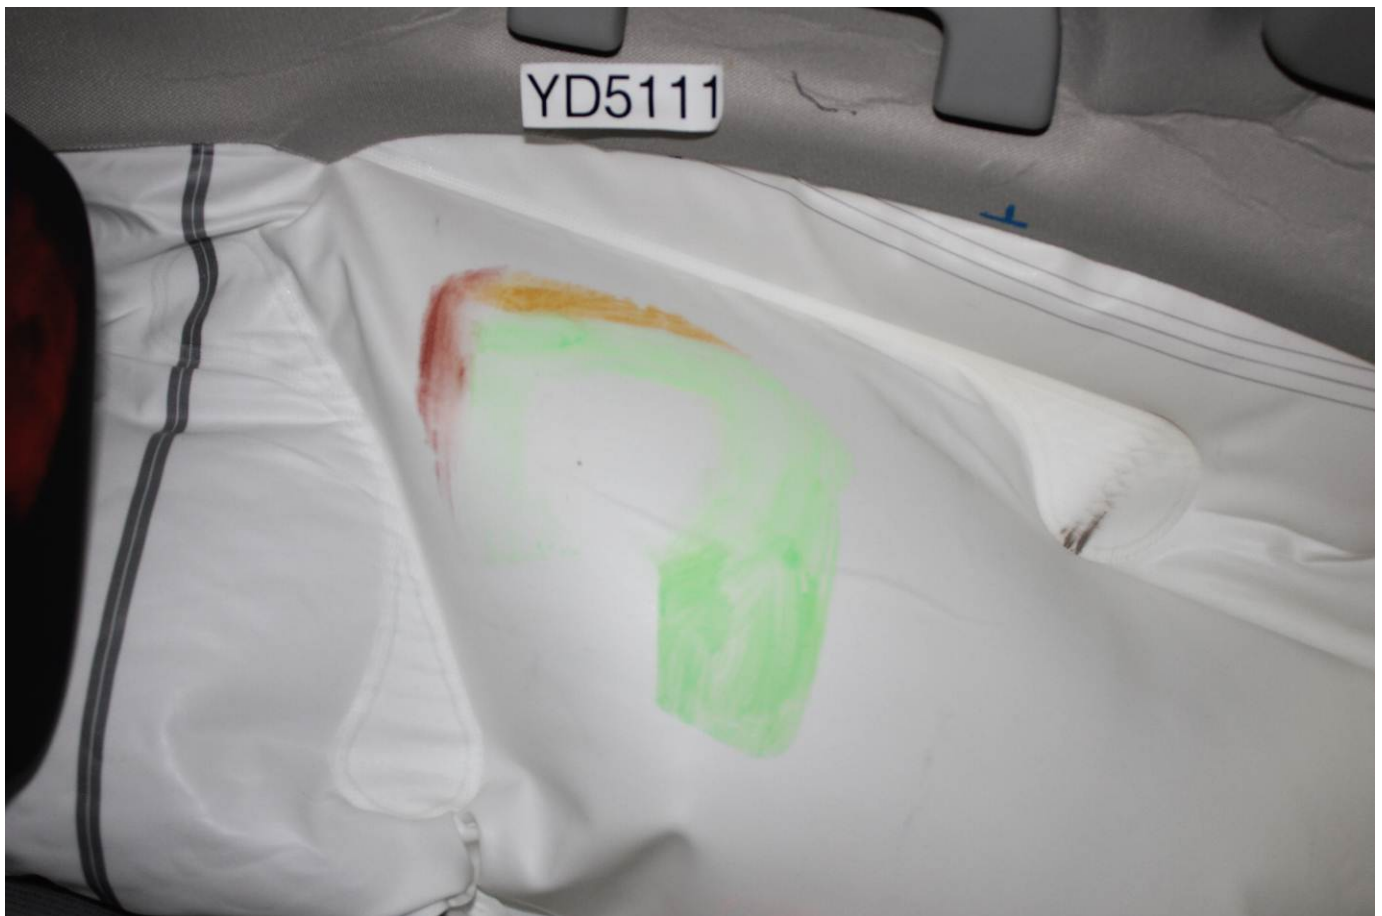
Post-Test Driver Dummy Close-up Head Contact with Vehicle Interior View

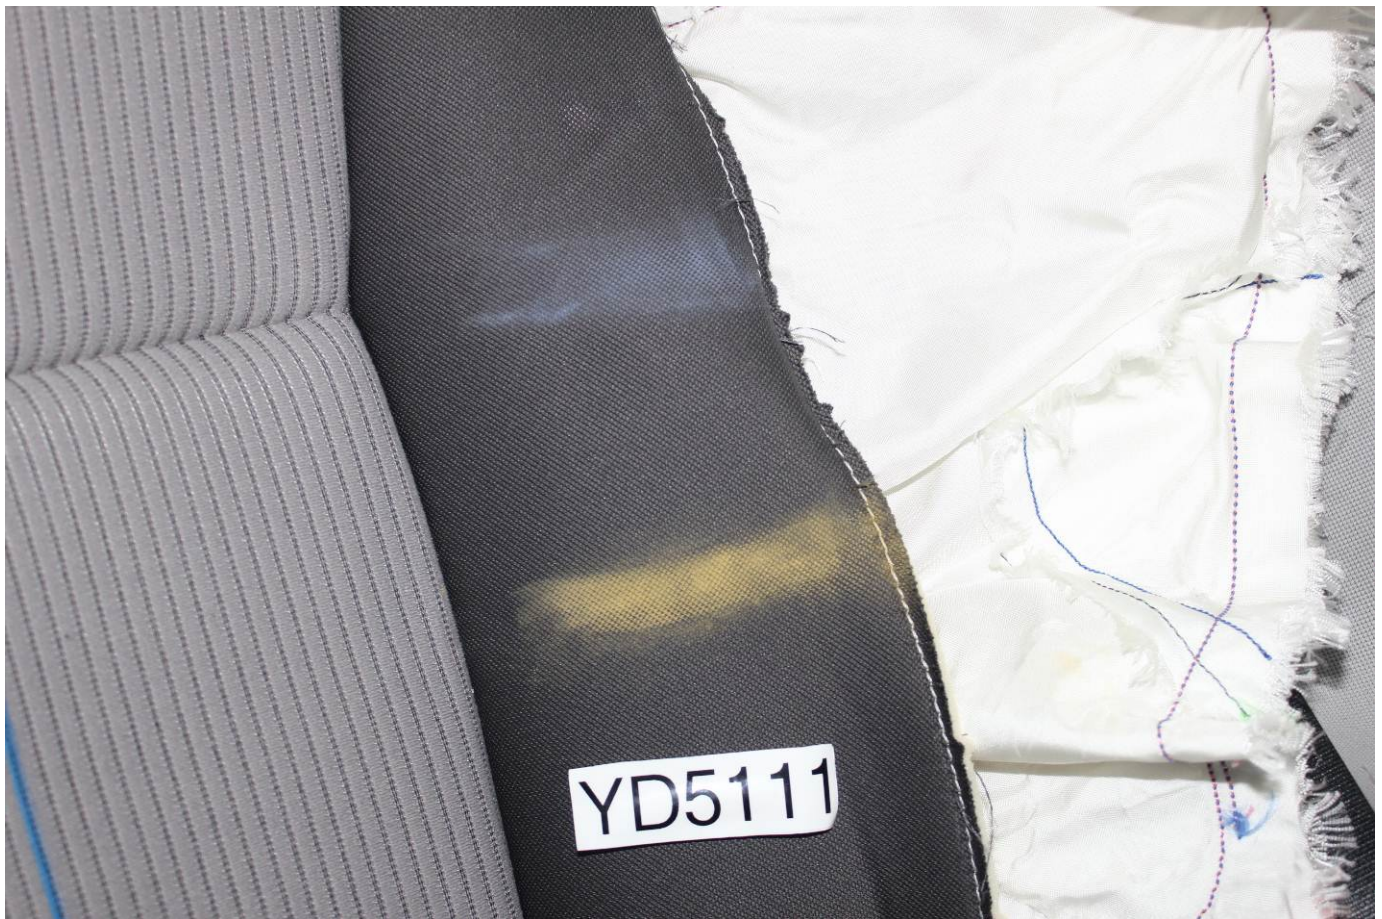
Post-Test Driver Dummy Close-up Head Contact with Side Airbag View

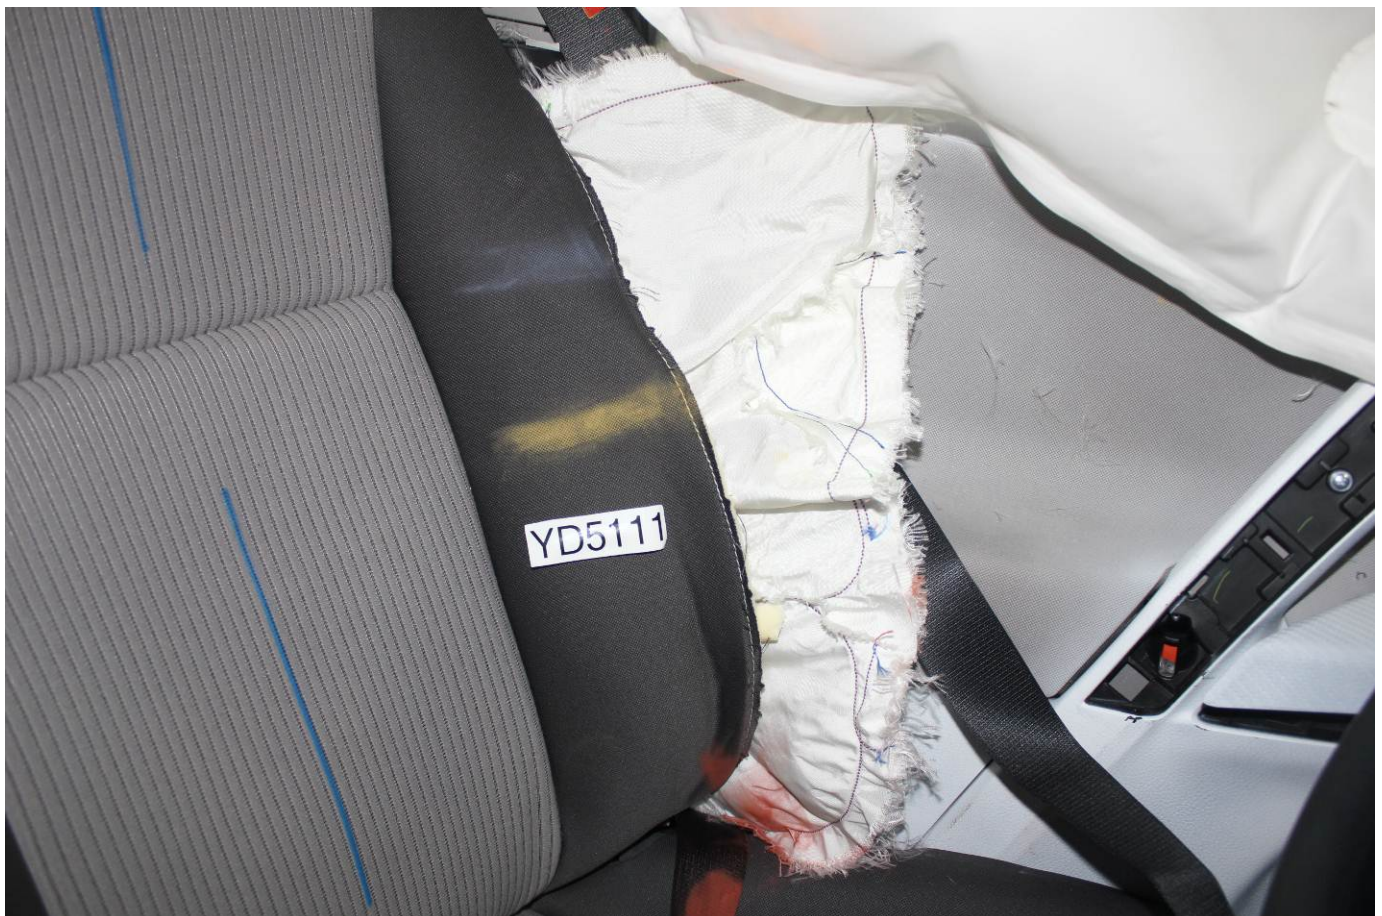
Post-Test Driver Dummy Close-up Torso Contact with Vehicle Interior View

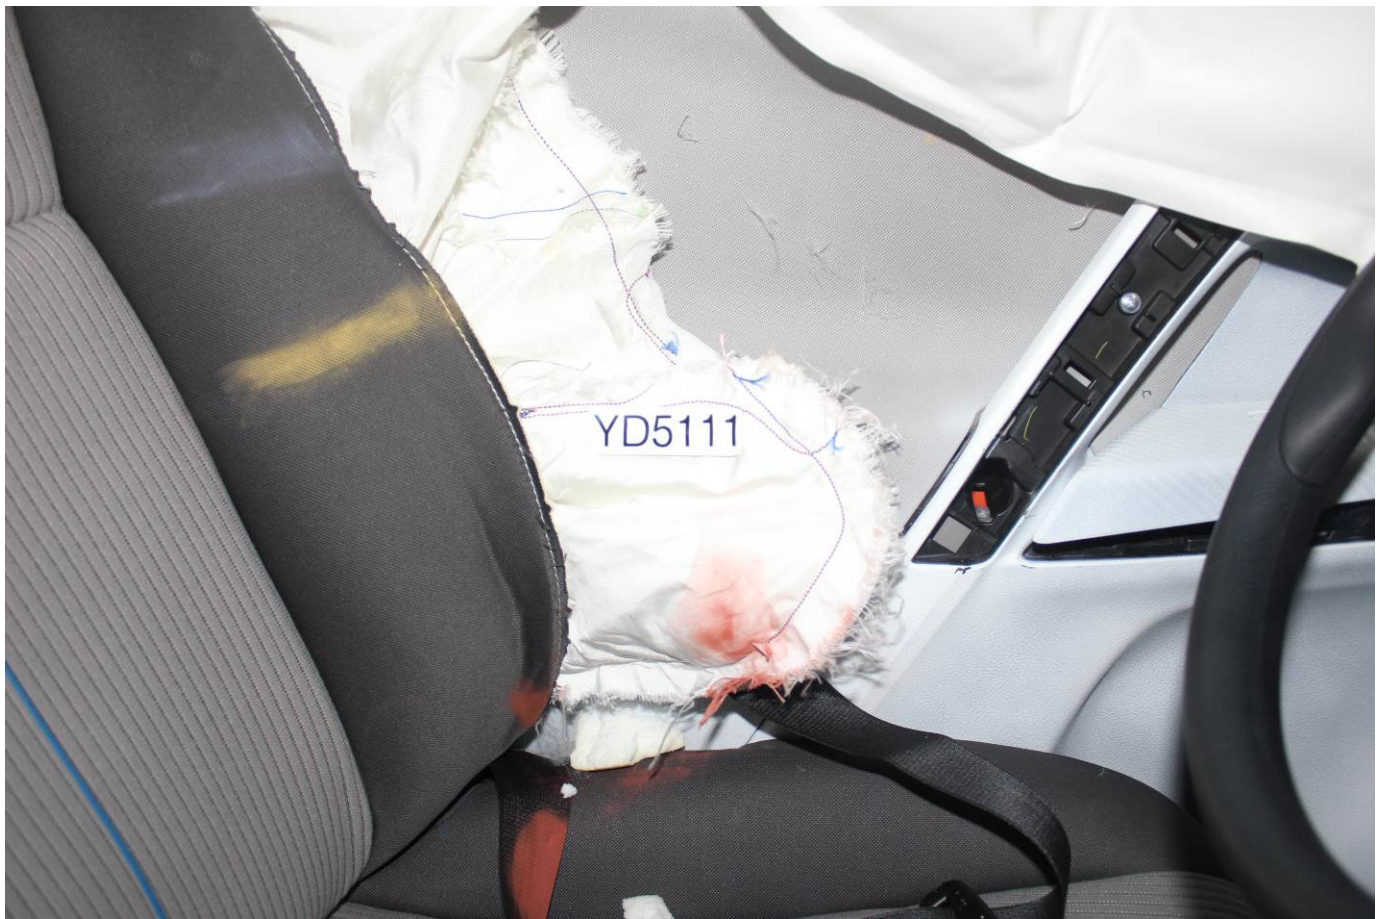
Post-Test Driver Dummy Close-up Torso Contact with Side Airbag View

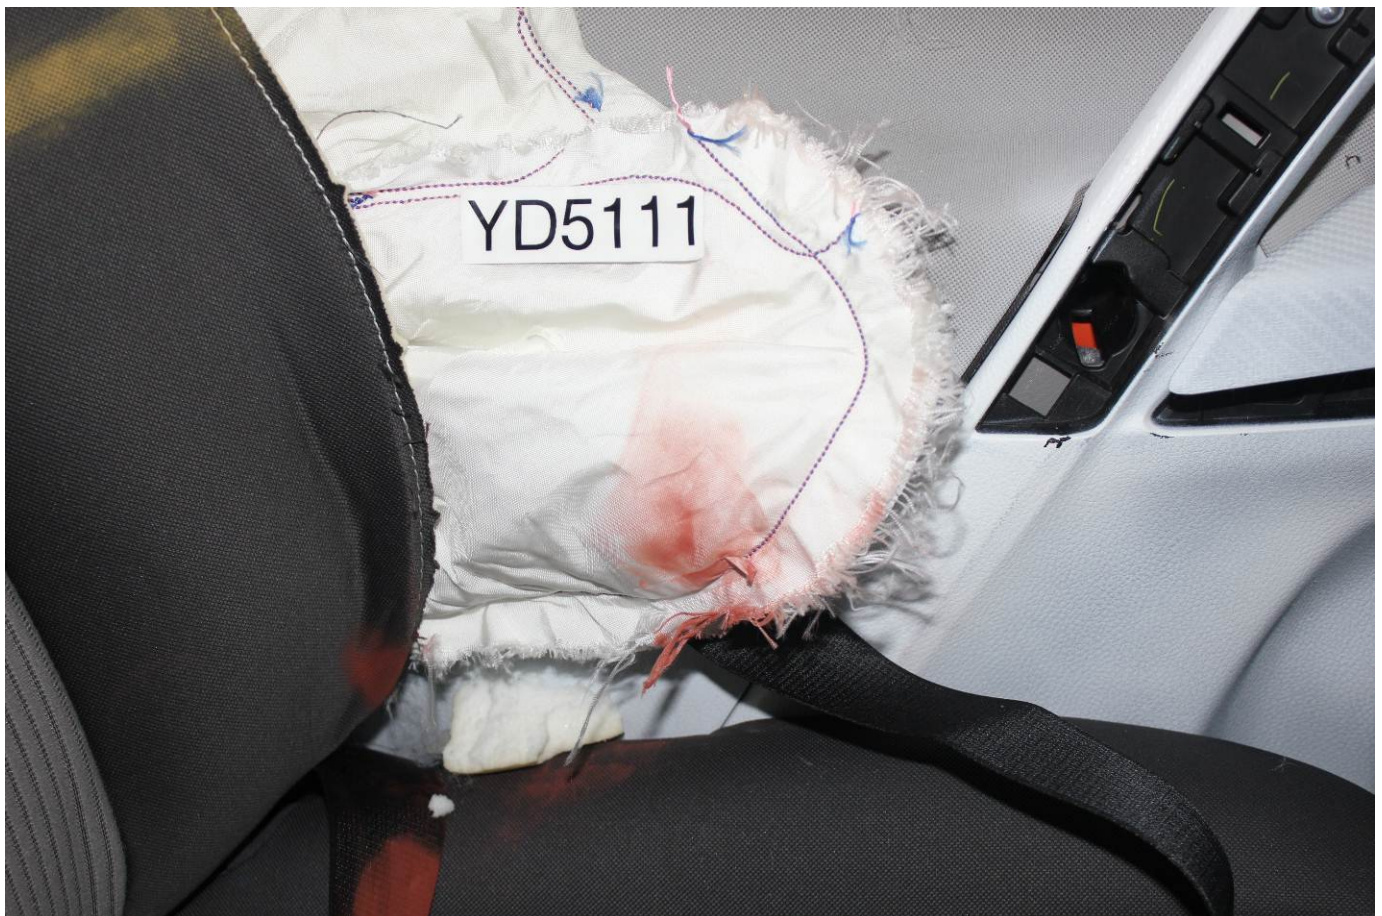
Post-Test Driver Dummy Close-up Pelvis Contact with Vehicle Interior View

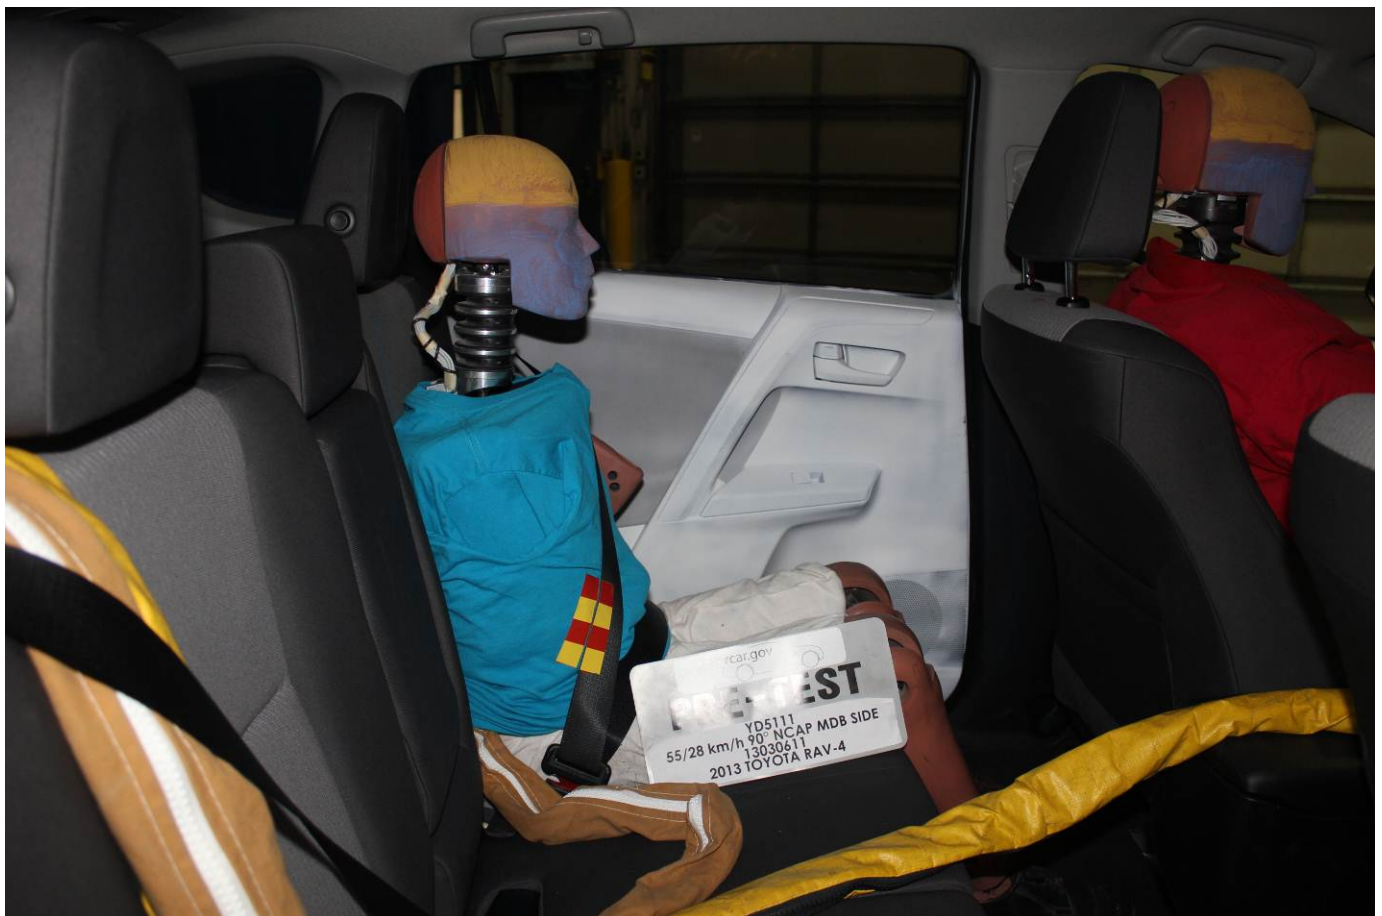
Post-Test Rear Passenger Dummy and Door Clearance View

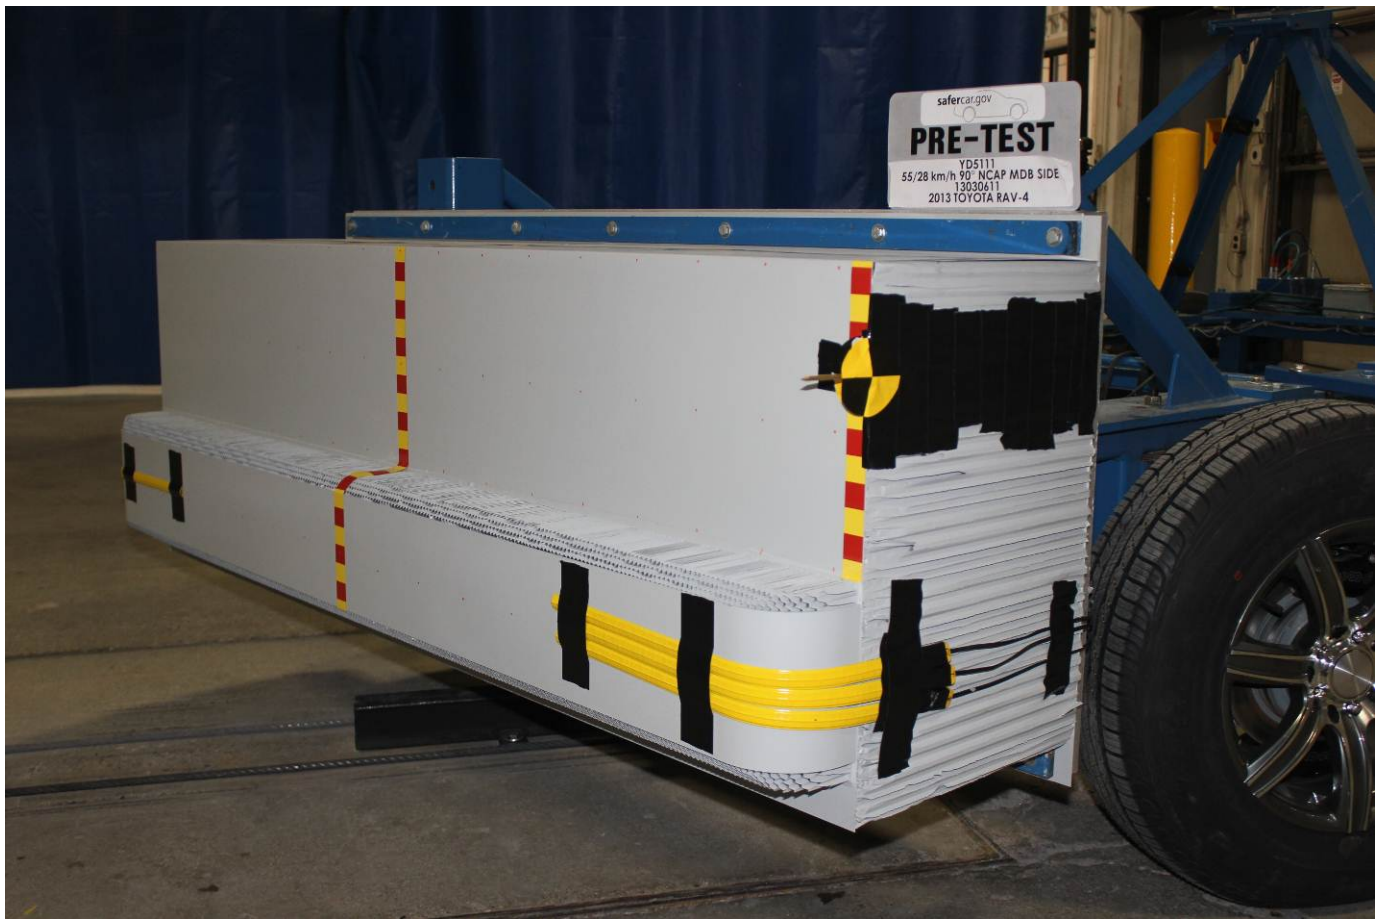
Post-Test Top View of MDB Impactor Face

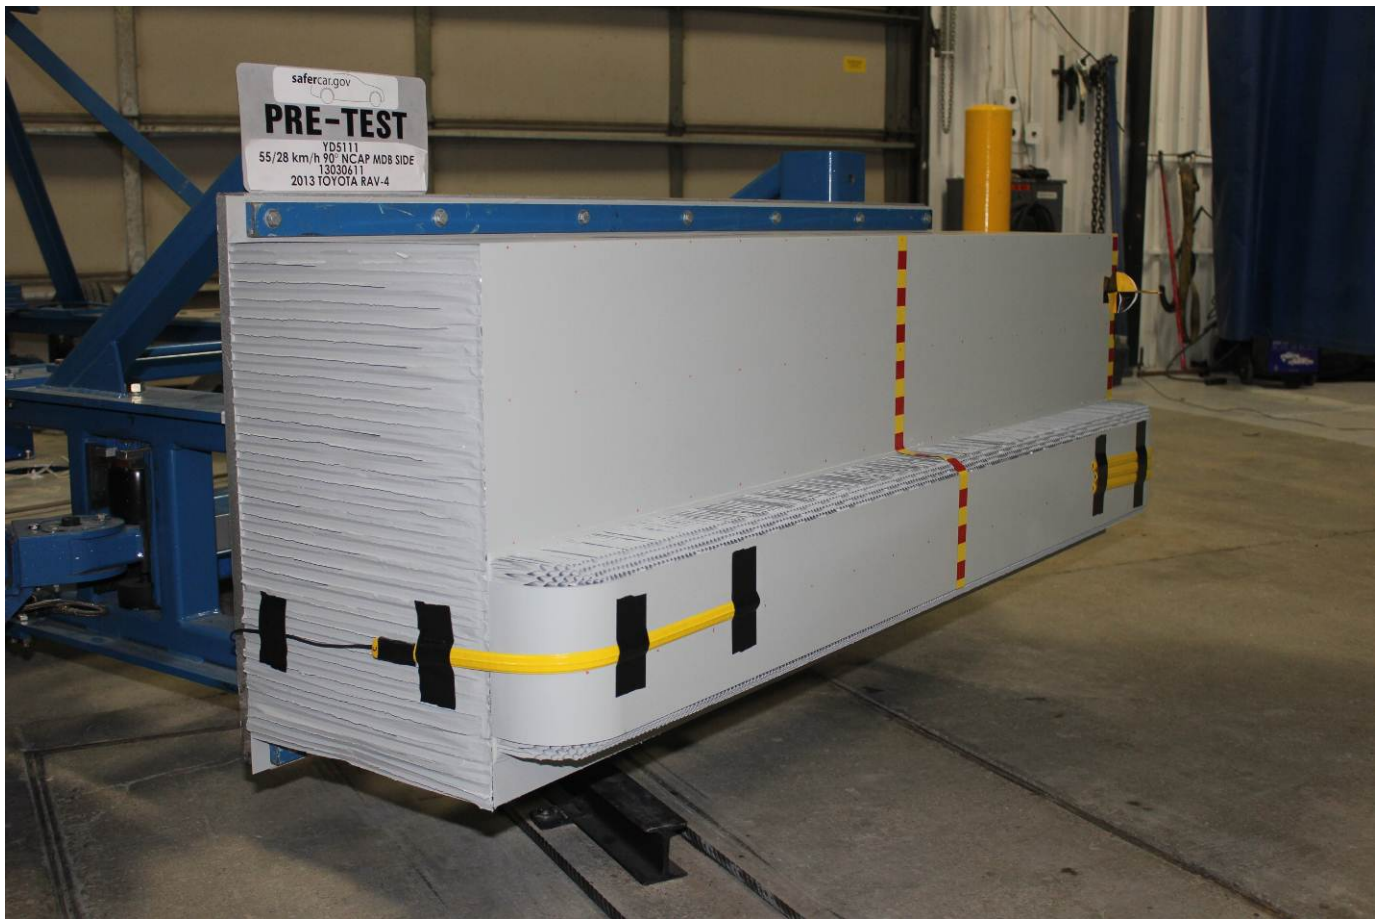
Post-Test Left Side View of MDB Impactor Face
