**REPORT NUMBER: SPNCAP-MGA-2013-054**

**NEW CAR ASSESSMENT PROGRAM (NCAP)  
Side Impact Pole Test**

**TOYOTA MOTOR MANUFACTURING CANADA INC.  
2013 Toyota RAV4 LE SUV  
NHTSA No.: YD5110**

**FINAL REPORT**

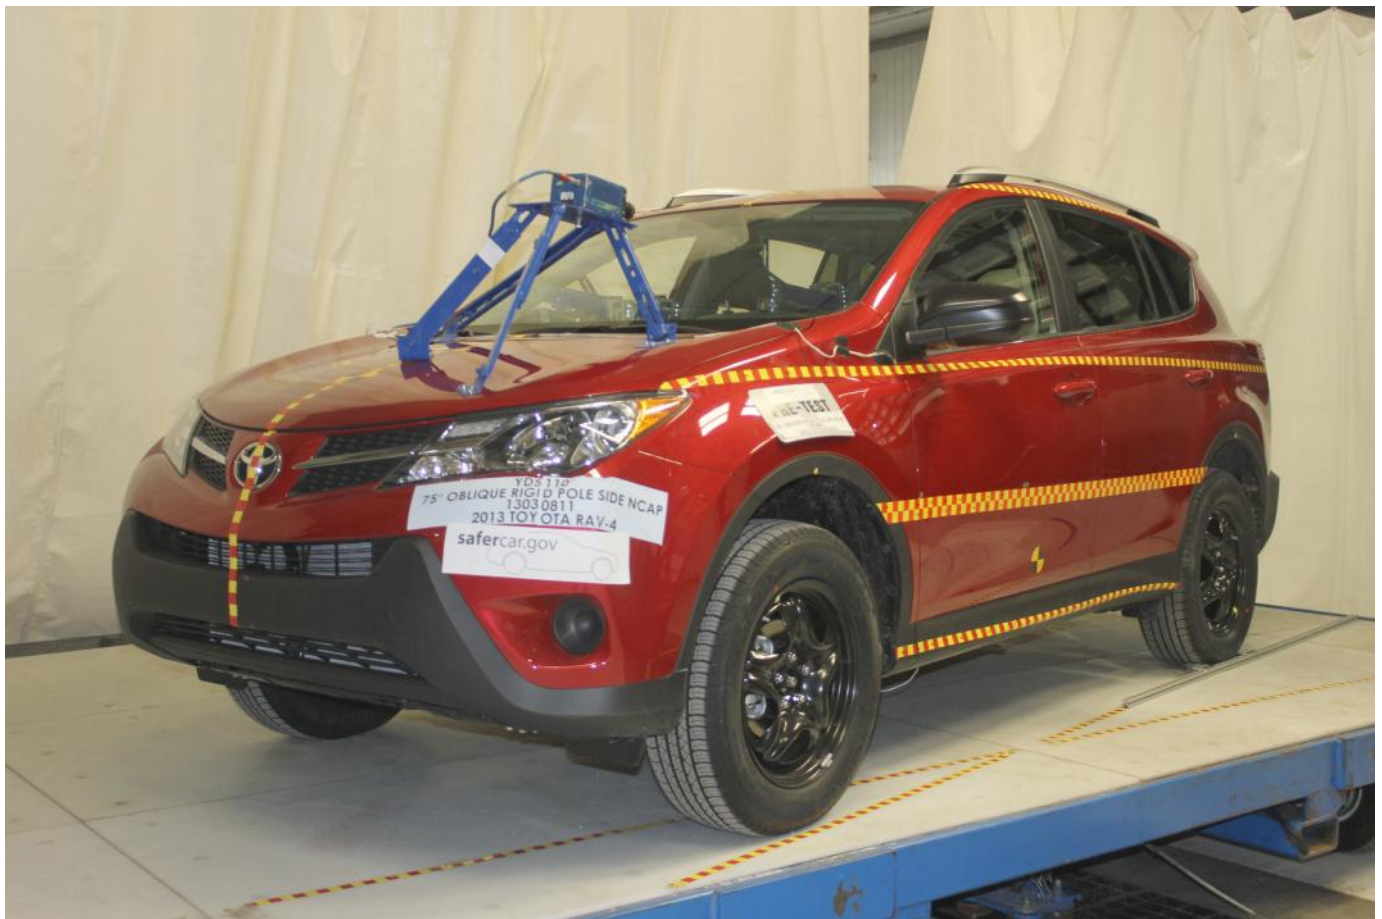
Post-Test Frontal View of Test Vehicle

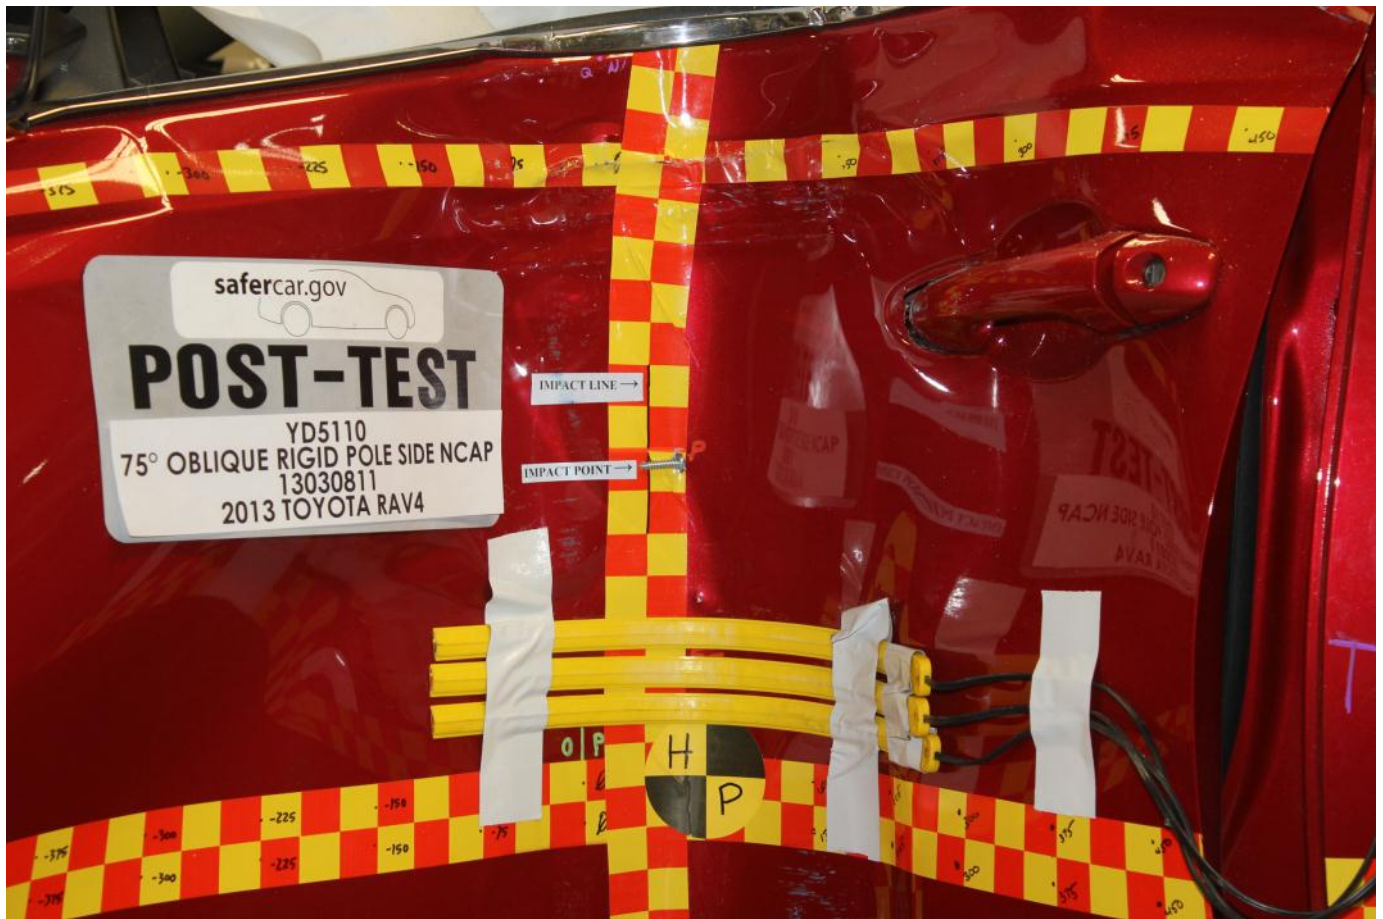
Post-Test Close-Up View of Impact Point Target Showing Impact Location

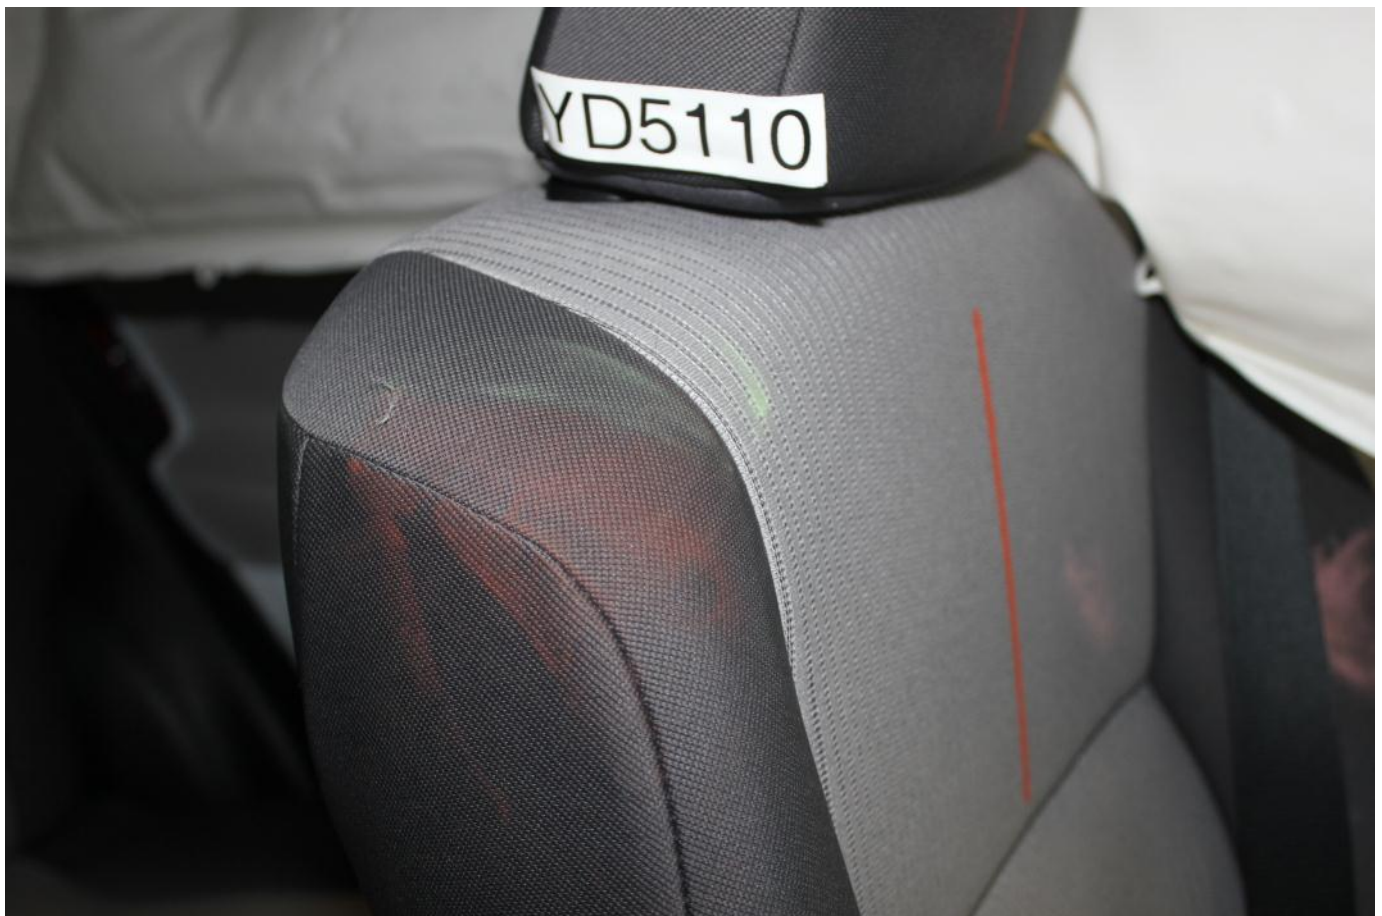
Post-Test Dummy Close-Up Head Contact with Vehicle Interior View

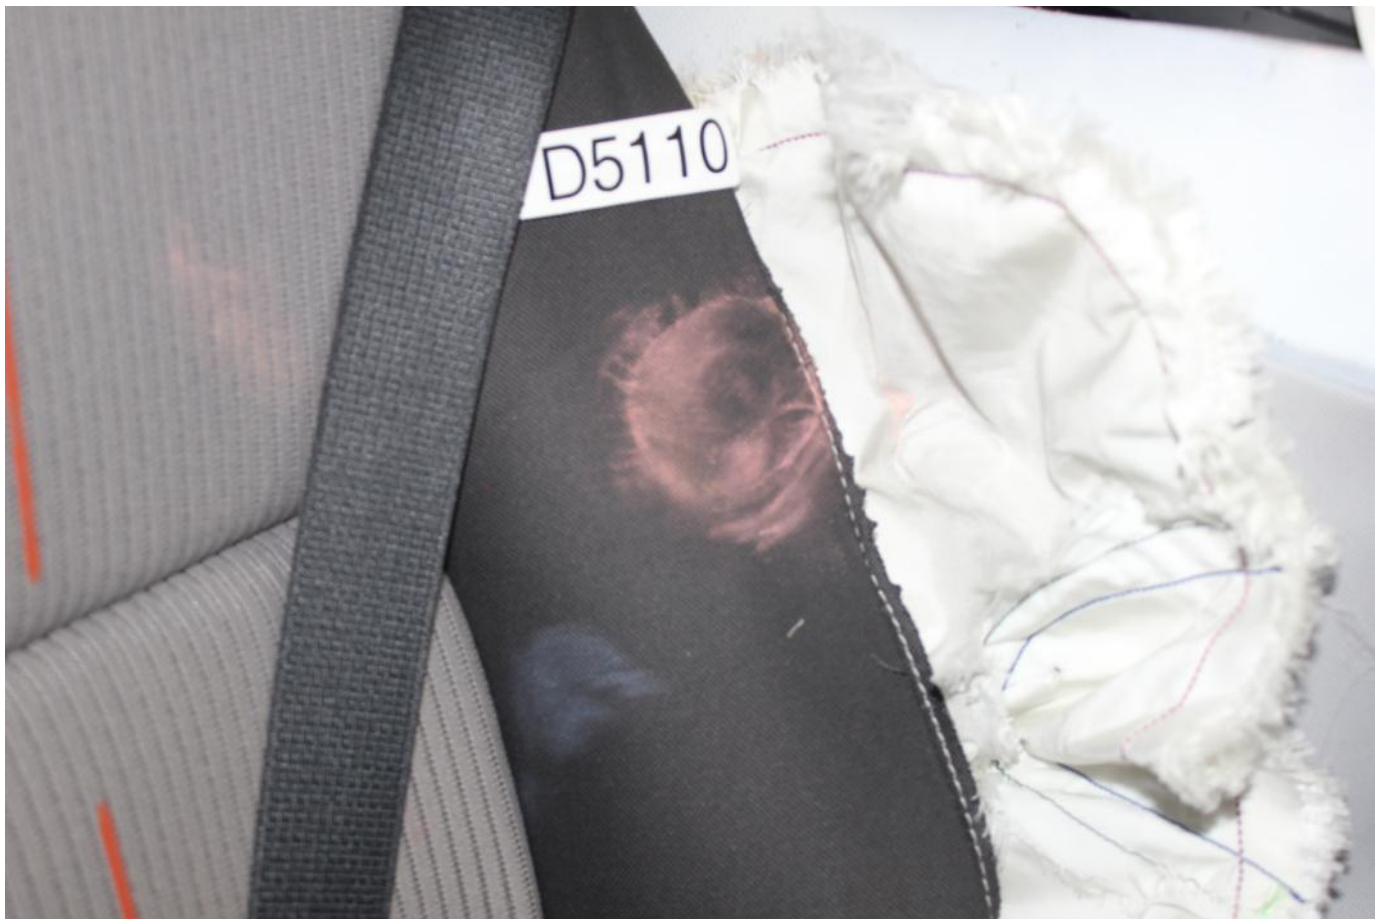
Post-Test Dummy Close-Up Torso Contact with Vehicle Interior View

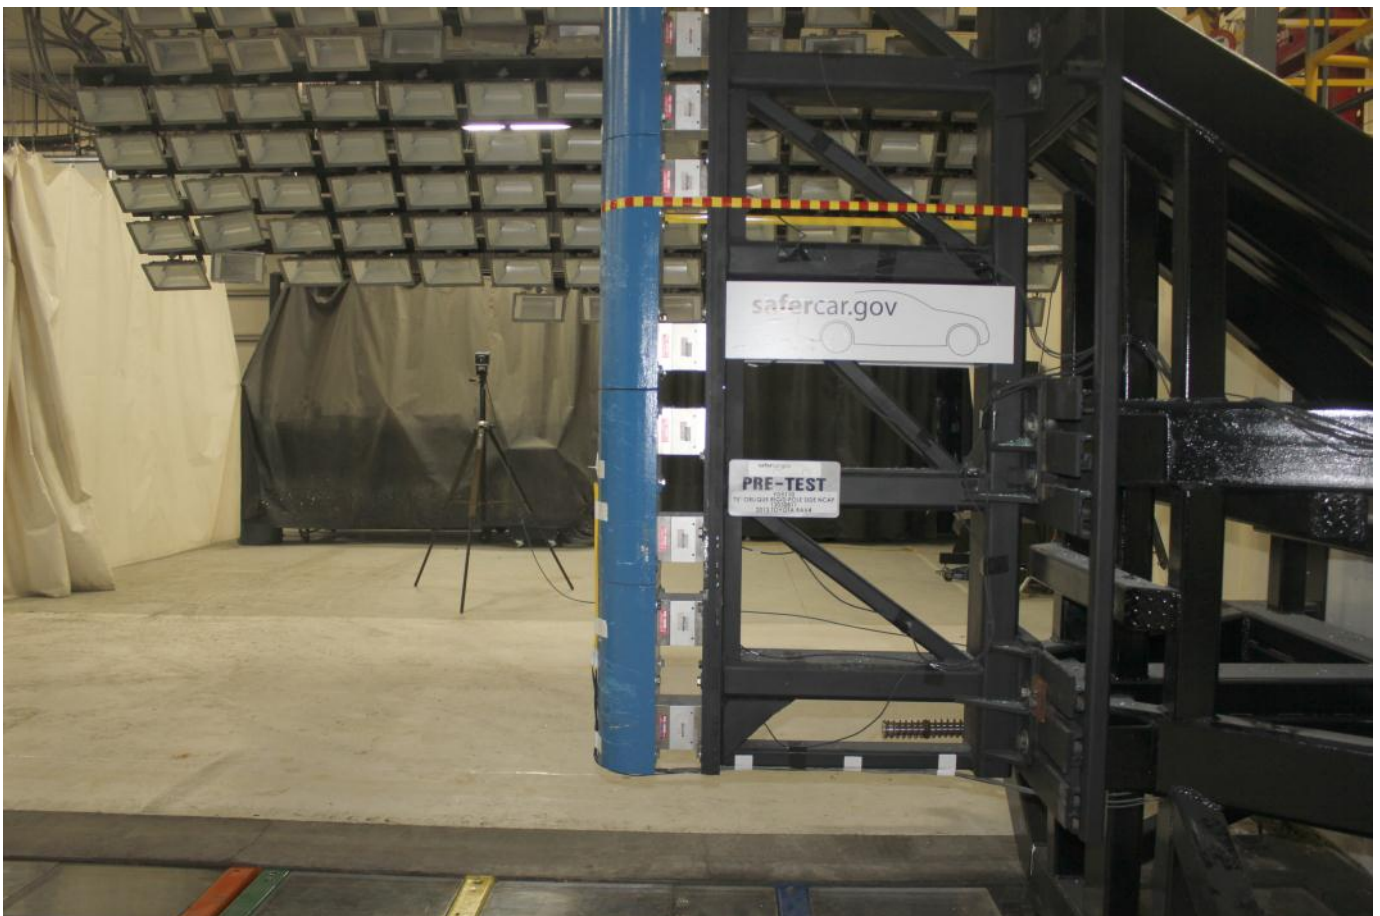
Post-Test Pole Barrier Front View

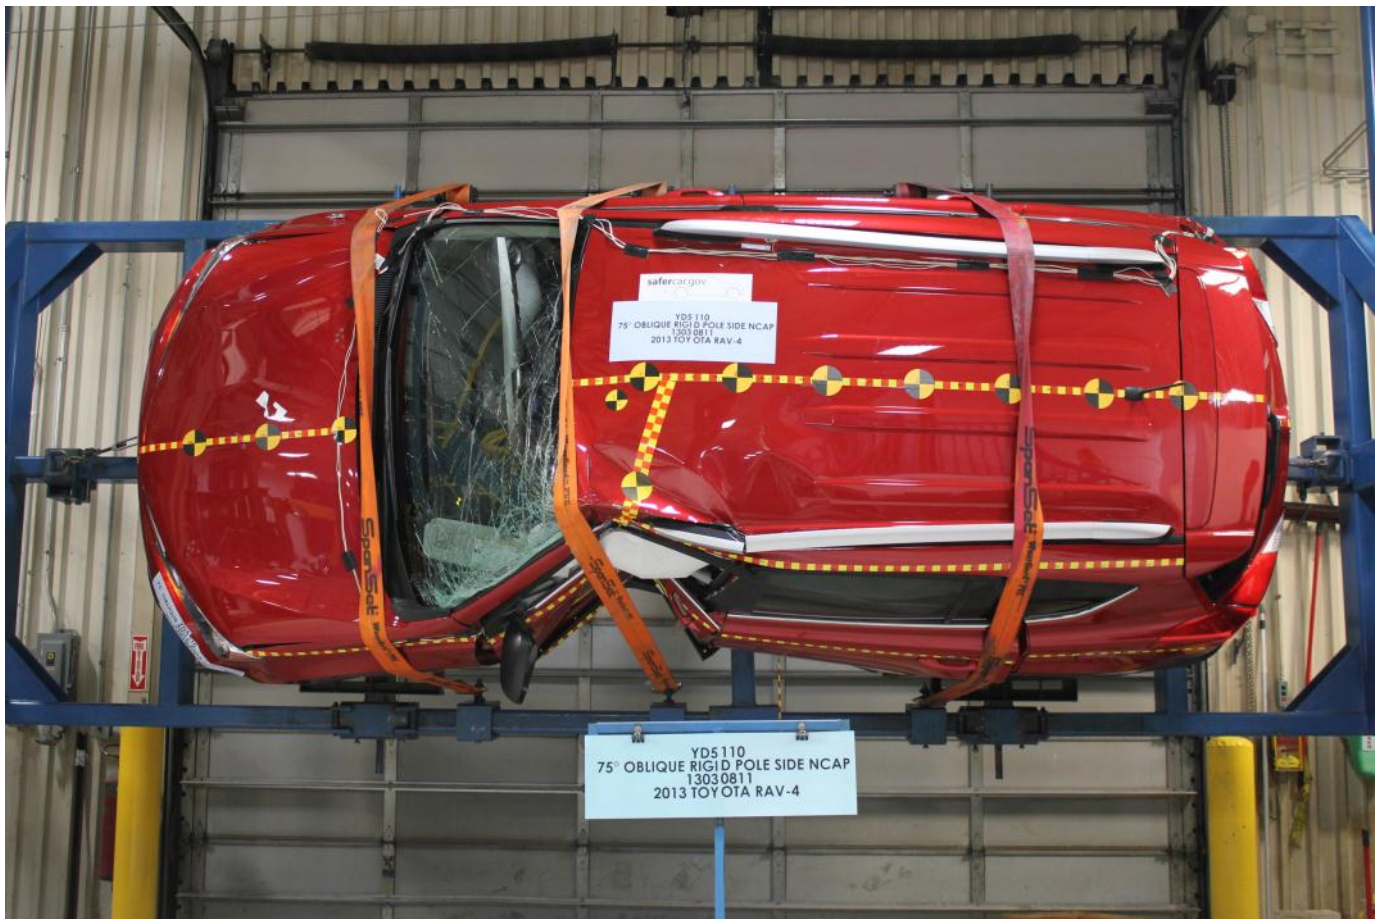
FMVSS No. 301 Static Rollover 90 Degrees

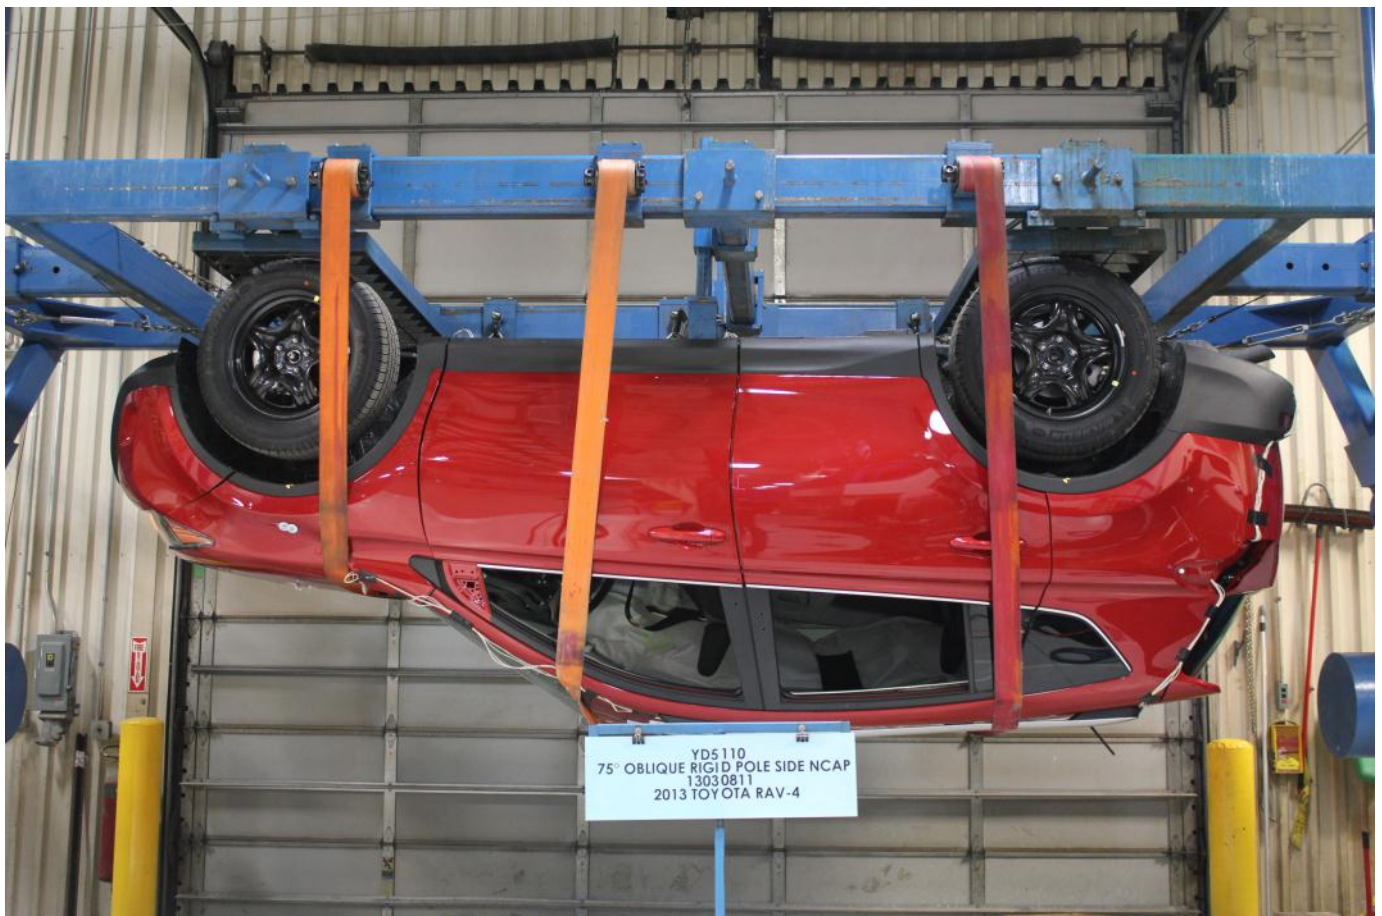
FMVSS No. 301 Static Rollover 180 Degrees
