**REPORT NUMBER: NCAP-KAR-13-049**

**NEW CAR ASSESSMENT PROGRAM (NCAP)  
FRONTAL BARRIER IMPACT TEST**

**HONDA MFG. OF INDIANA, LLC  
2013 HONDA CIVIC HYBRID 4-DOOR SEDAN**

**FINAL REPORT**

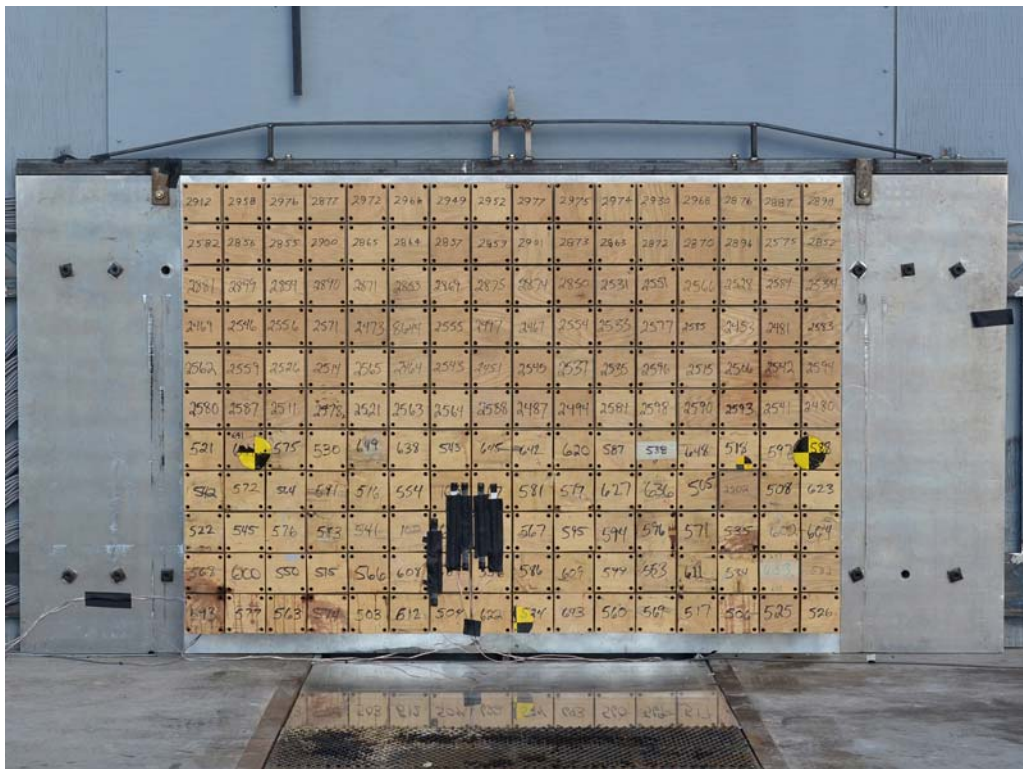
FIGURE 2. Load Cell Wall

A load cell barrier consisting of 176 load cells was impacted by a 2013 Honda Civic Hybrid 4-door sedan at a velocity of 56.20 km/h. The test was performed at KARCO Engineering, LLC, on March 27, 2013. Pre- and post-test photographs of the vehicle and dummies can be found in Appendix A of this report.

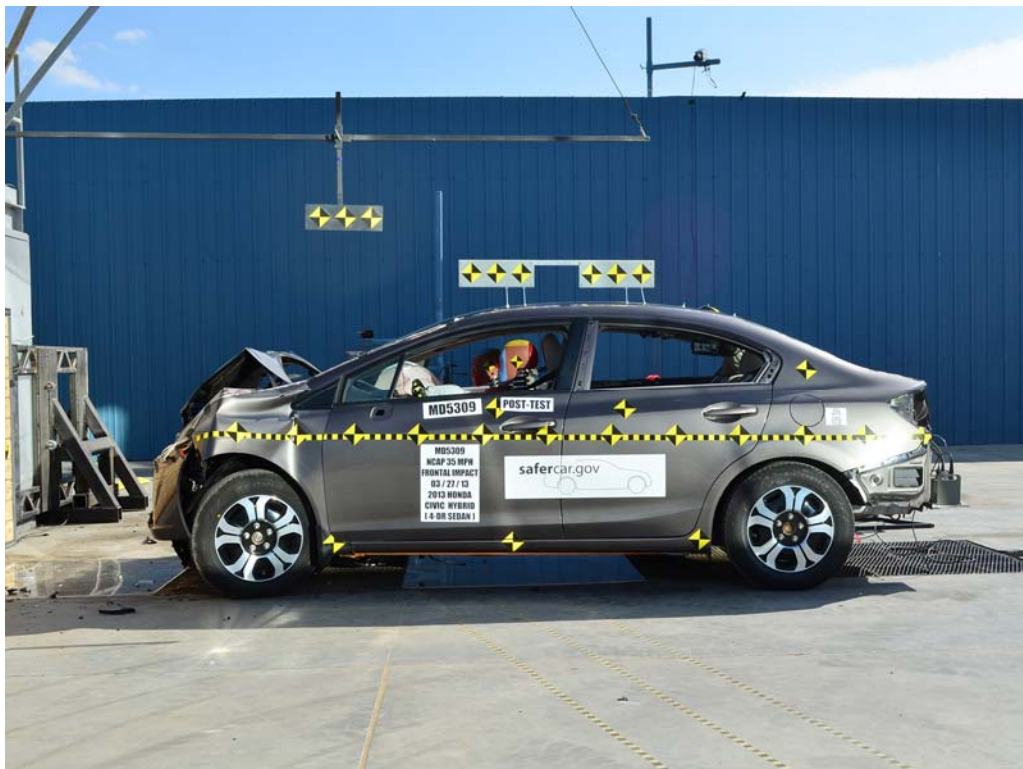
FIGURE 10. Post-Test Left View of Test Vehicle

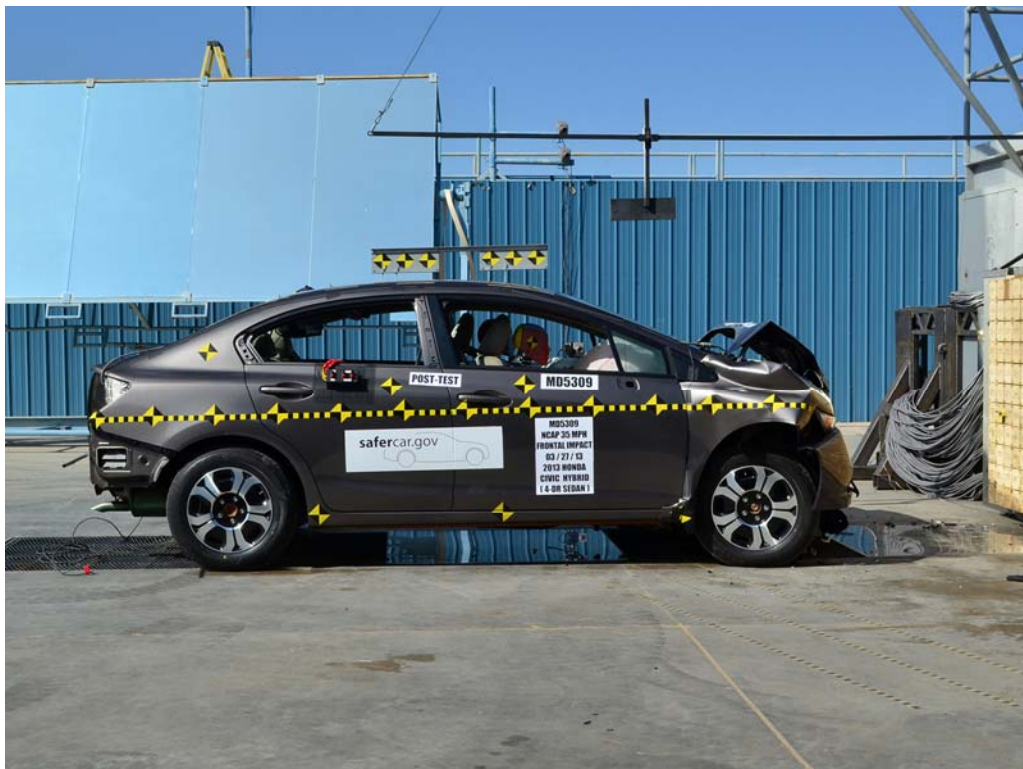
FIGURE 12. Post-Test Right View of Test Vehicle

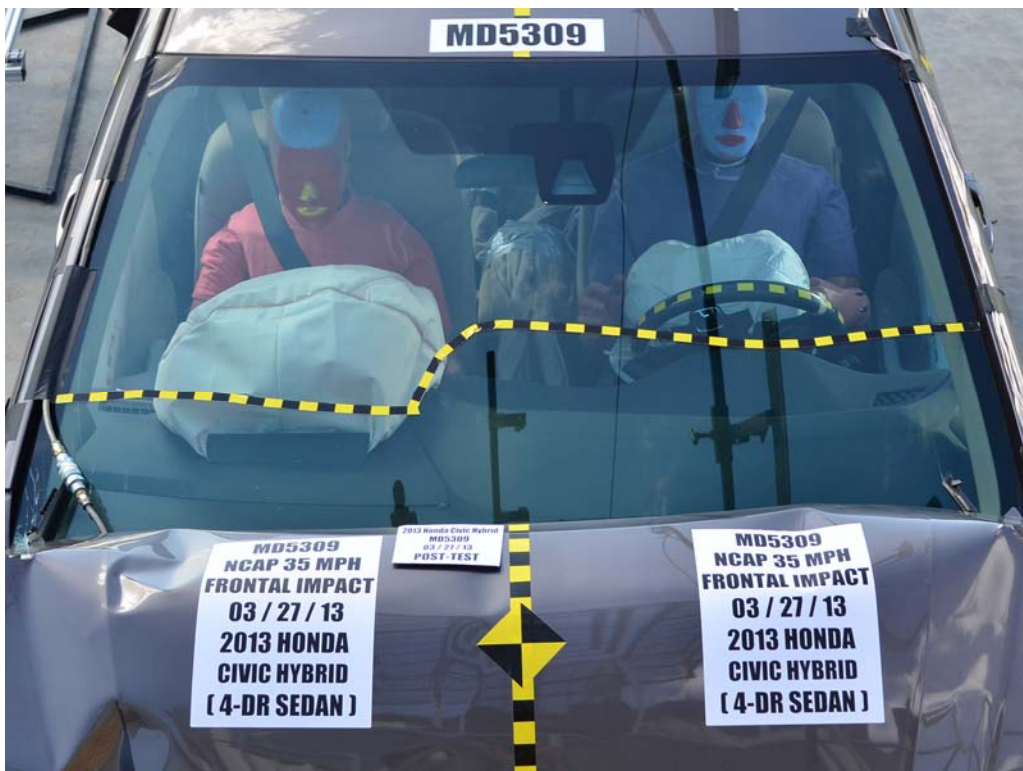
FIGURE 18. Post-Test Windshield View

There was 100% windshield retention and no intrusion into the protected zone of the windshield during the event. There was no Stoddard solvent leakage after the event or during any phase of the static rollover.

| Critical Areas of Performance | Observations and Conclusions |
|---|---|
| Windshield Damage | Cracked |

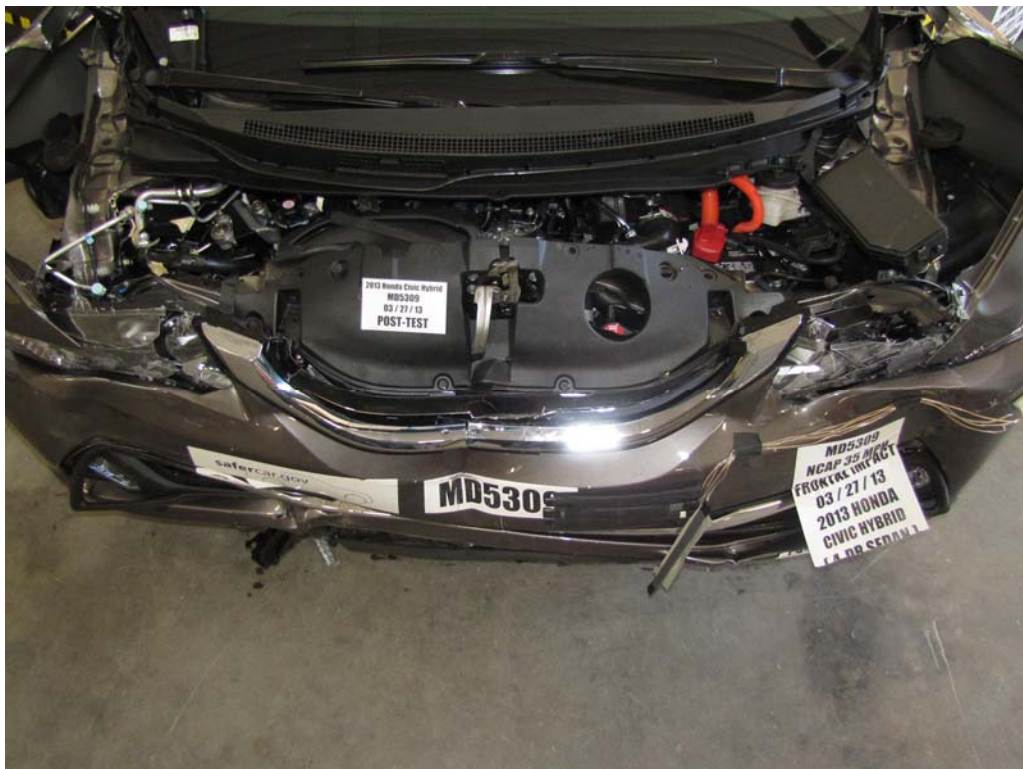
FIGURE 20. Post-Test Engine Compartment View

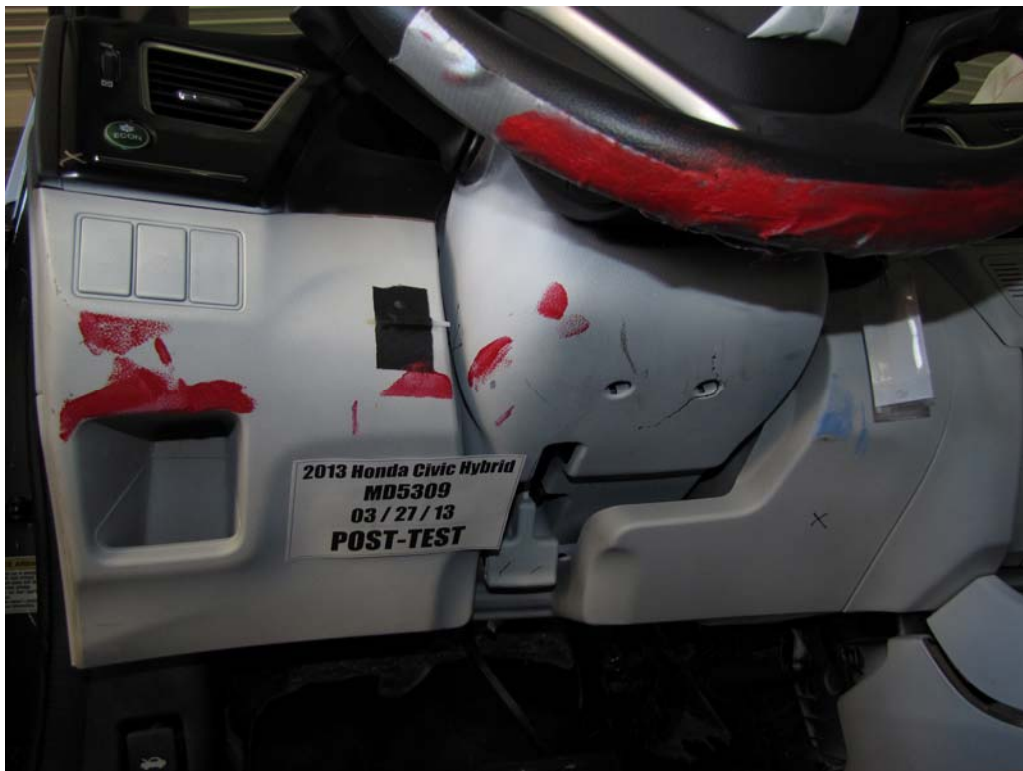
FIGURE 47a. Post-Test Driver Dummy Contact with Knee Bolster

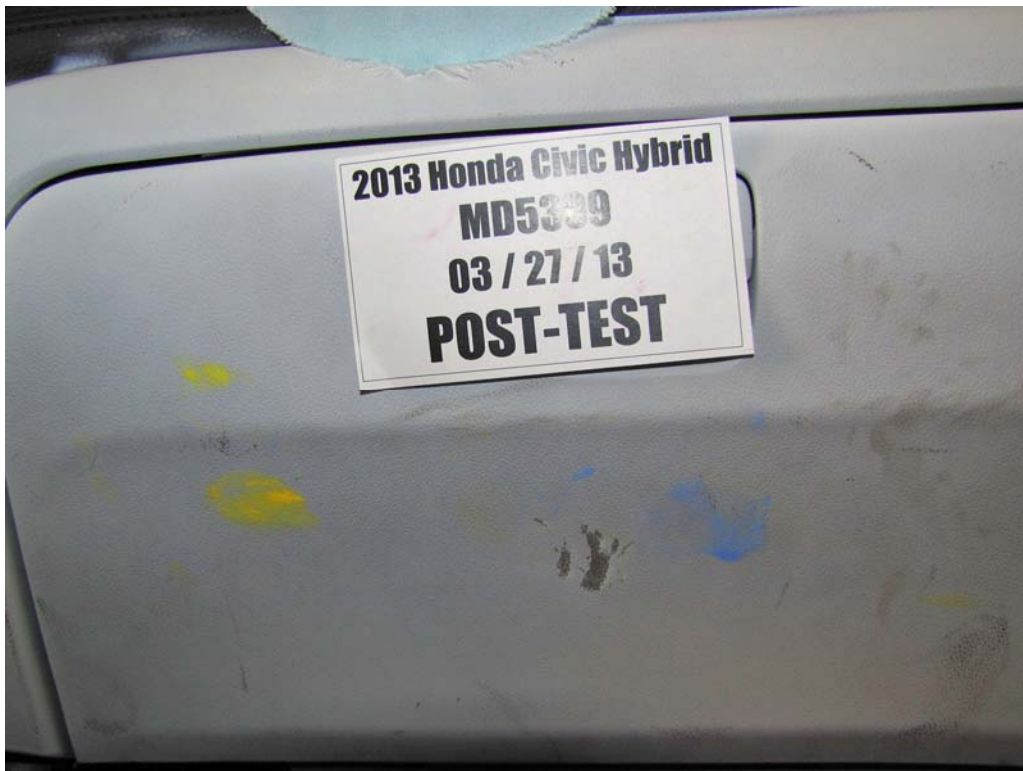
FIGURE 66b. Post-Test Passenger Dummy Contact with Glovebox

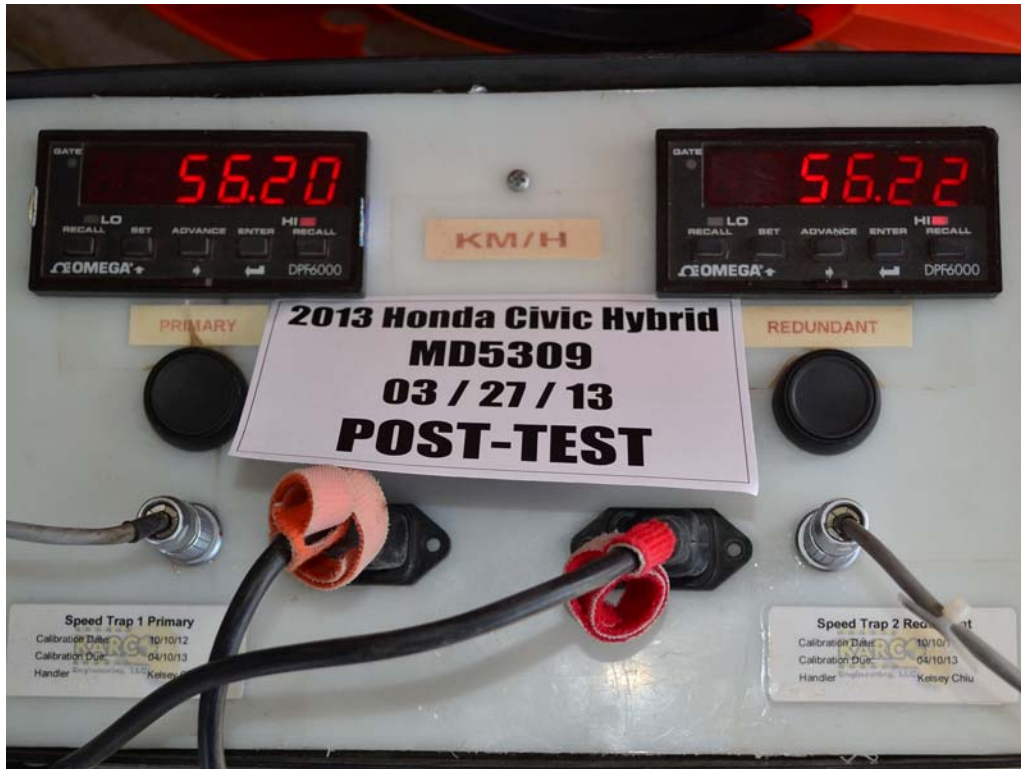
FIGURE 69. Post-Test Speed Trap Read-Out
