**REPORT NUMBER: SPNCAP-KAR-13-051**

**NEW CAR ASSESSMENT PROGRAM (NCAP)  
SIDE IMPACT POLE TEST**

**HONDA MFG. OF INDIANA, LLC  
2013 HONDA CIVIC HYBRID 4-DOOR SEDAN**

**NHTSA No: MD5310**

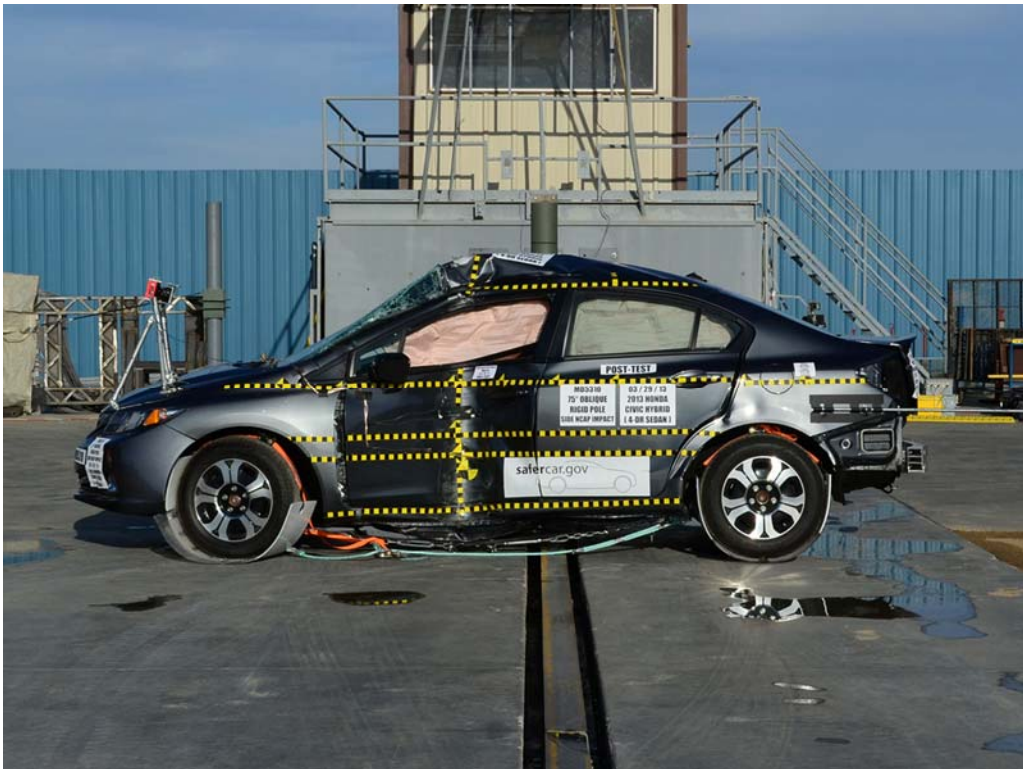
FIGURE 8. Post-Test Left Side View of Test Vehicle

Both the front and rear doors on the struck side of the vehicle remained closed and latched. There was no separation at the hinges or latches. Both doors on the non-struck side remained closed and latched. There were no ATD values that exceeded limits.

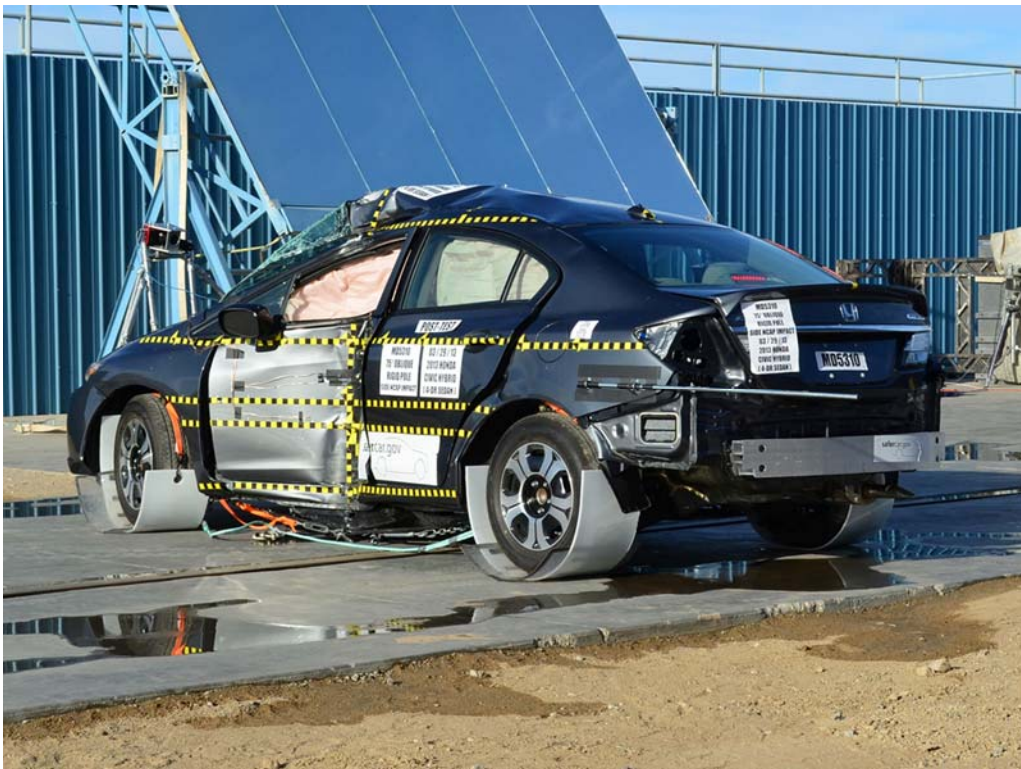
FIGURE 10. Post-Test Left Rear  $\frac{3}{4}$  View of Test Vehicle

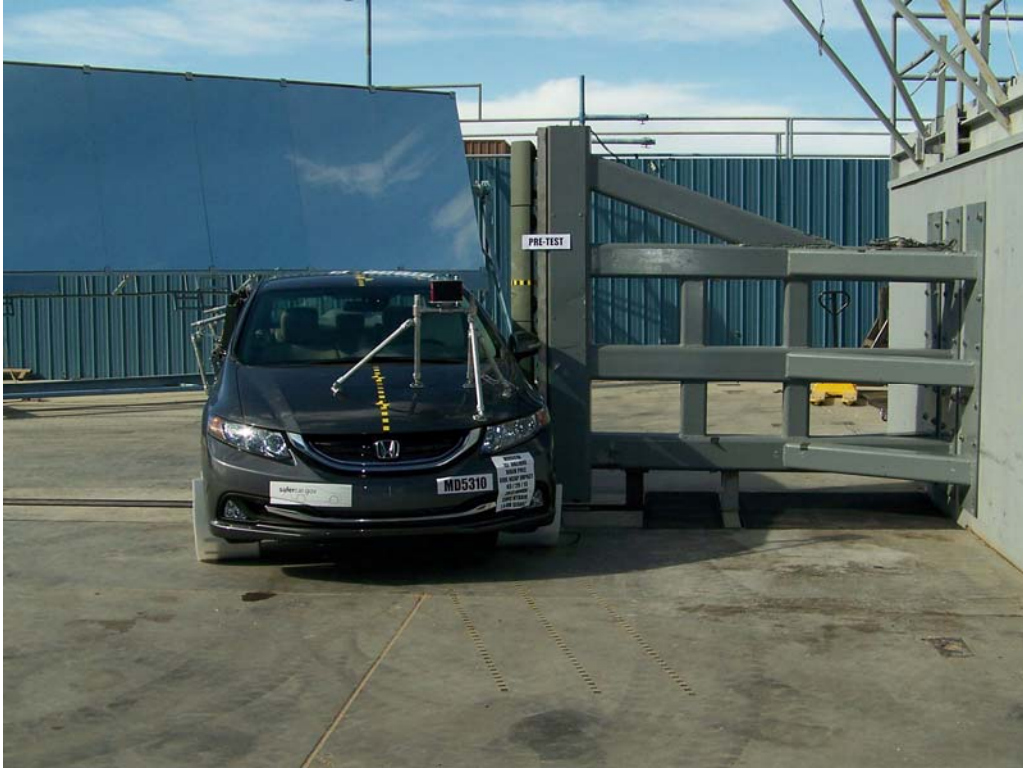
FIGURE 17. Pre-Test Left Side View of Pole  
Positioned Against Side of Test Vehicle

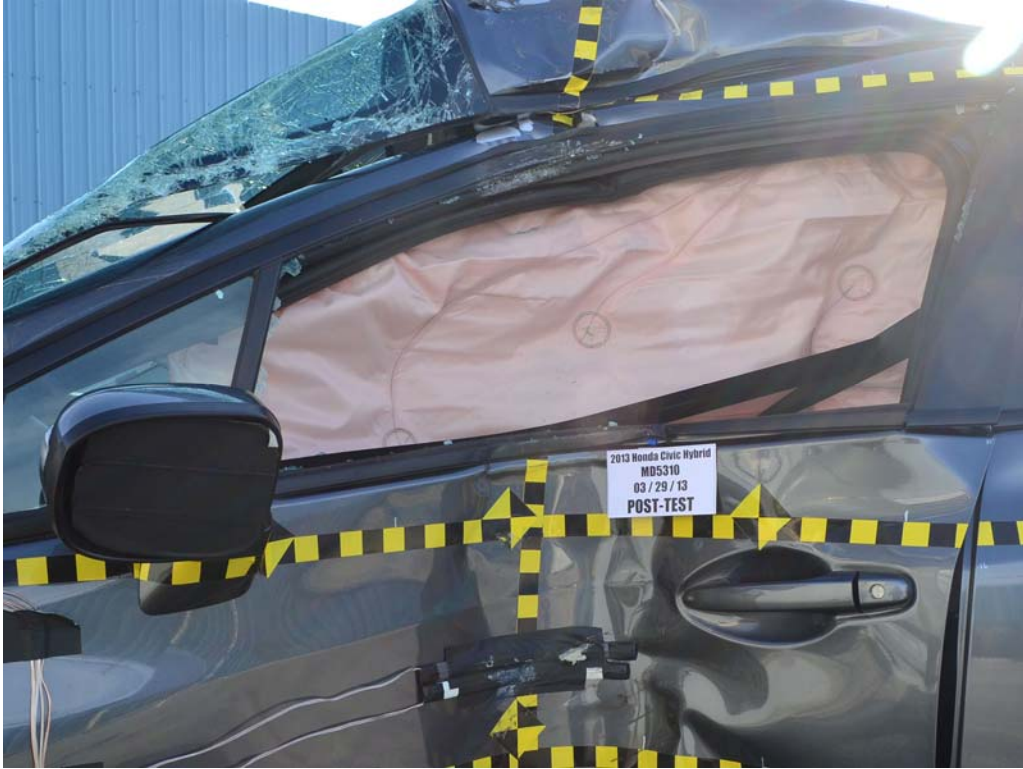
FIGURE 25. Post-Test Left Side View of Dummy Shoulder and Door Top View

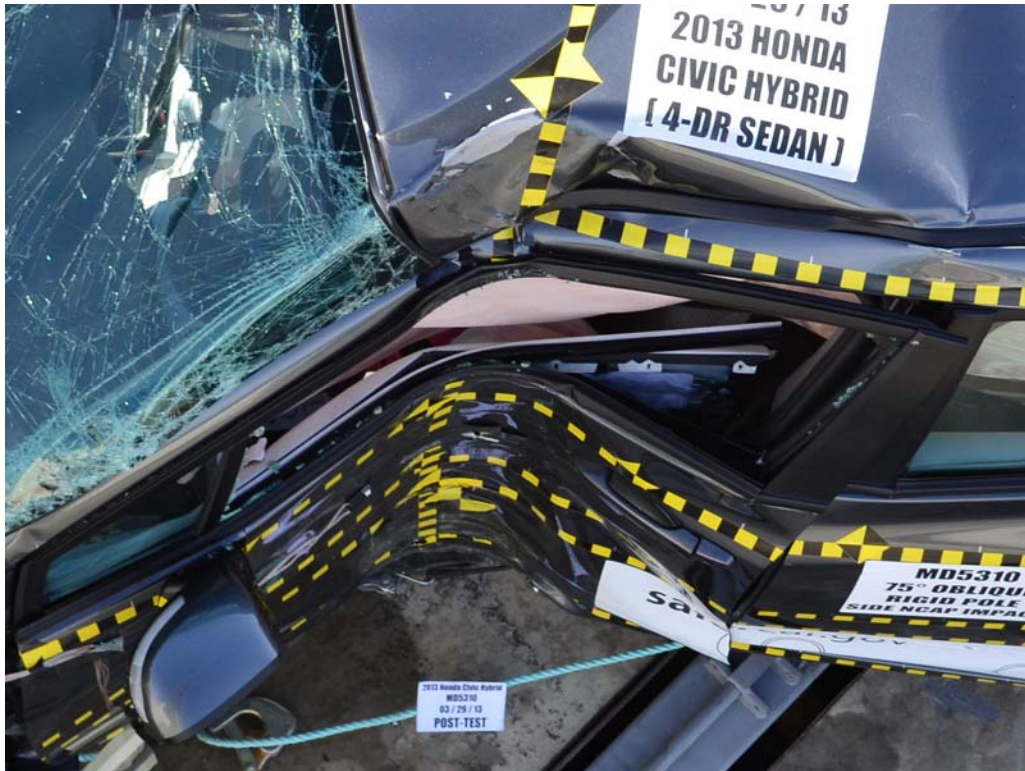
FIGURE 41. Post-Test Dummy and Door Clearance

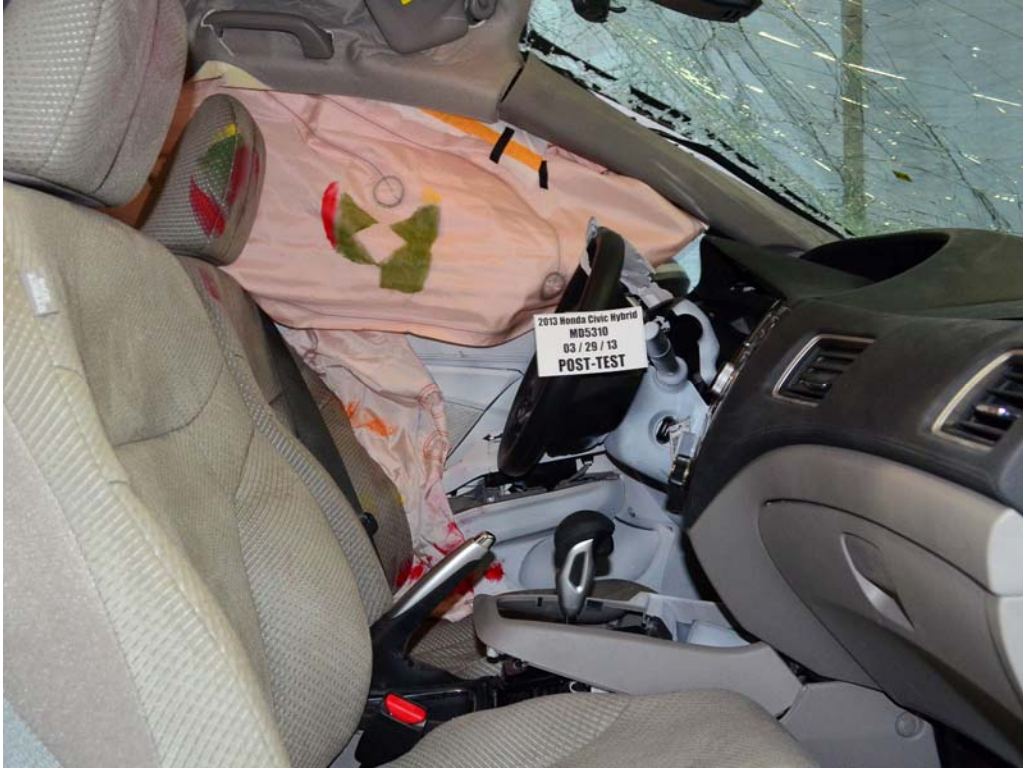
FIGURE 45. Post-Test Inner Door Panel View  
Showing Dummy Contact Location

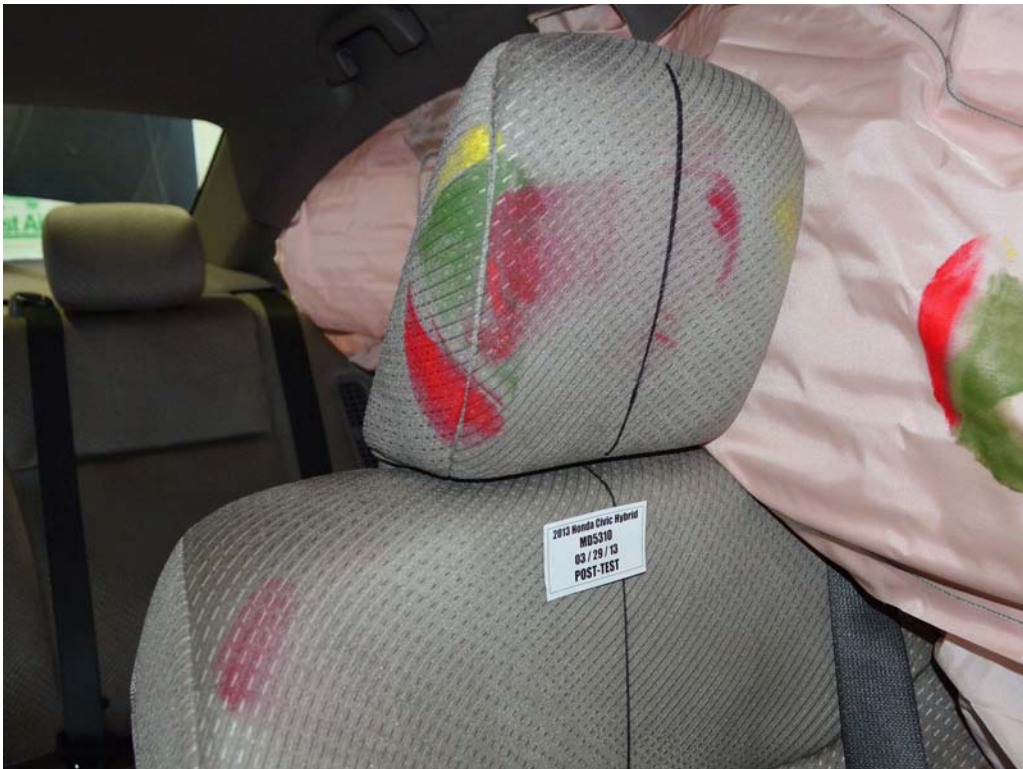
FIGURE 46. Post-Test Dummy Close-Up Head Contact with Vehicle Interior View

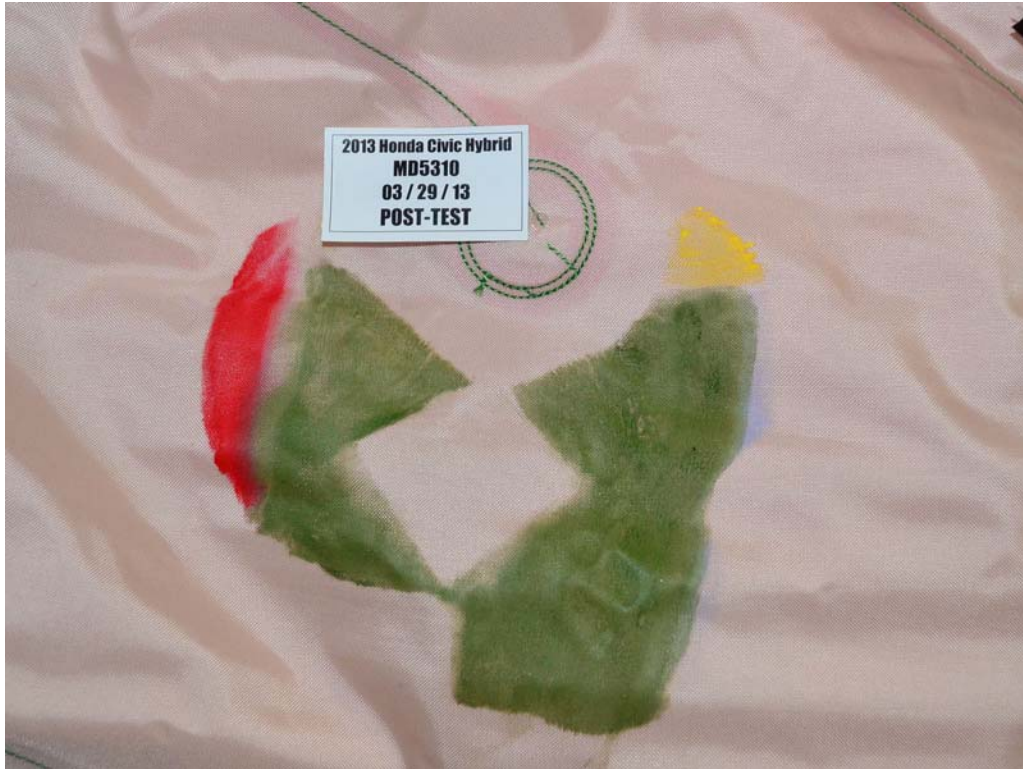
FIGURE 47. Post-Test Dummy Close-Up Head Contact with Side Airbag View

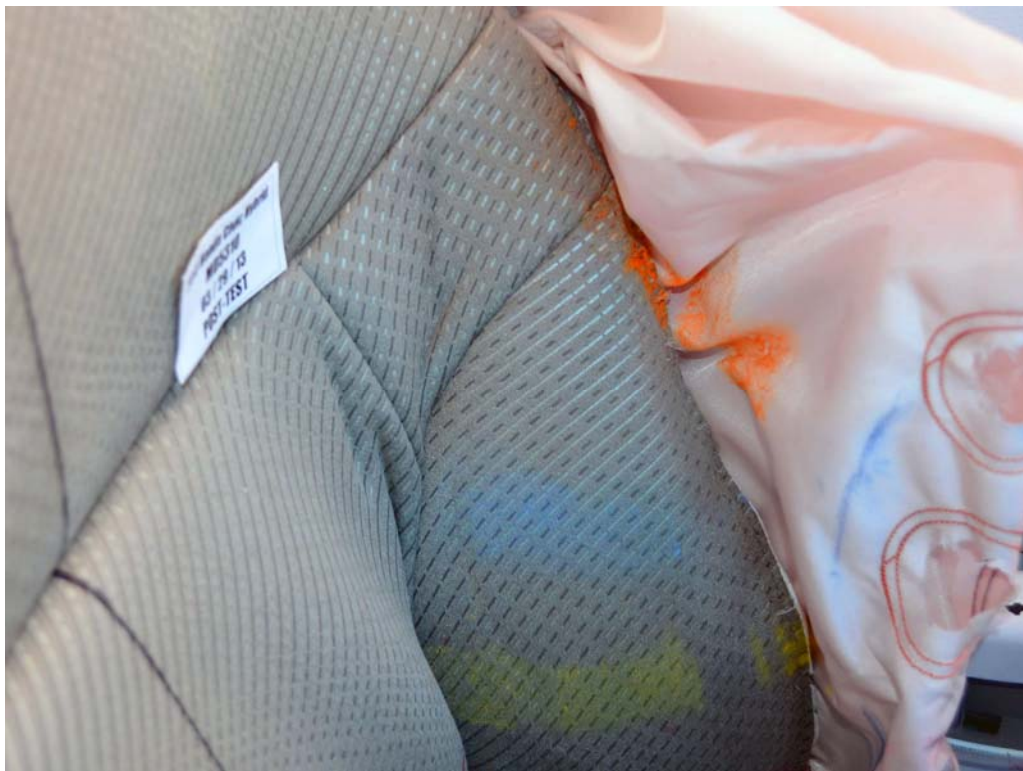
FIGURE 48. Post-Test Dummy Close-Up Torso Contact with Vehicle Interior View

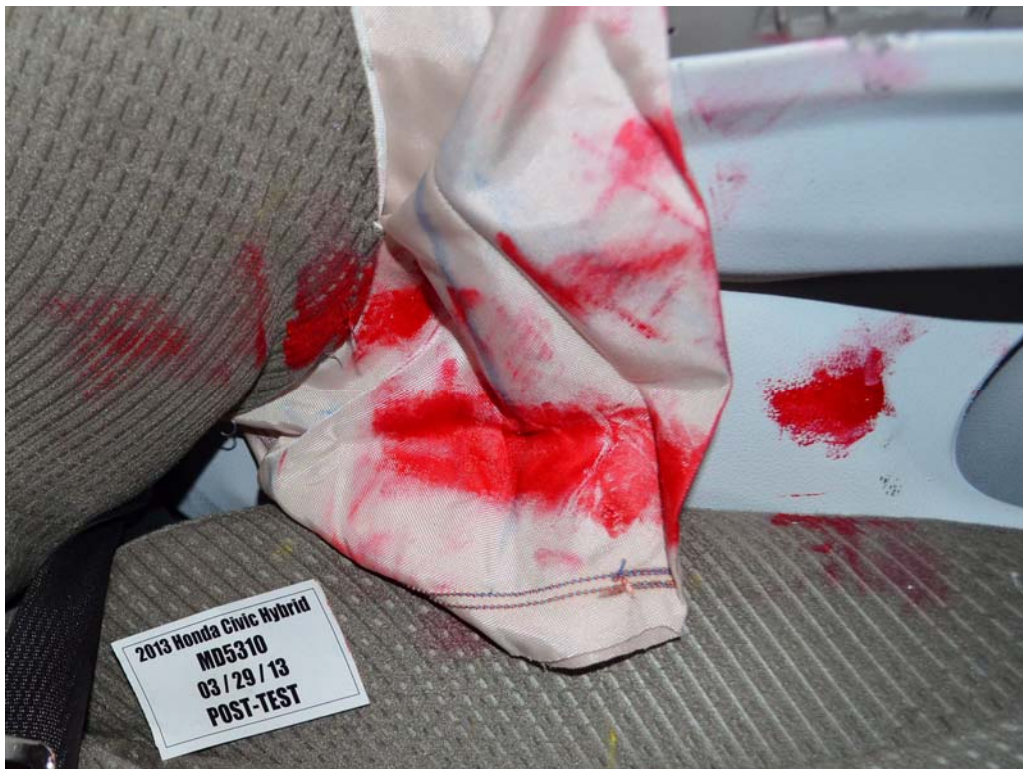
FIGURE 50. Post-Test Dummy Close-Up Pelvis Contact with Vehicle Interior View

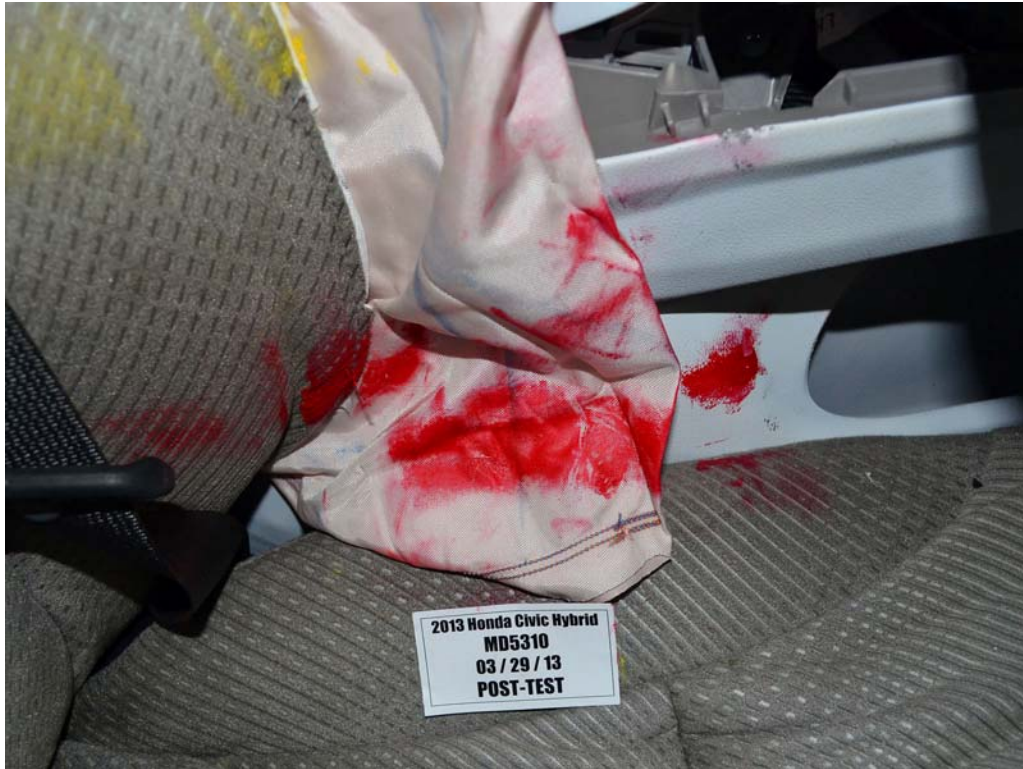
FIGURE 51. Post-Test Dummy Close-Up Pelvis Contact with Side Airbag View

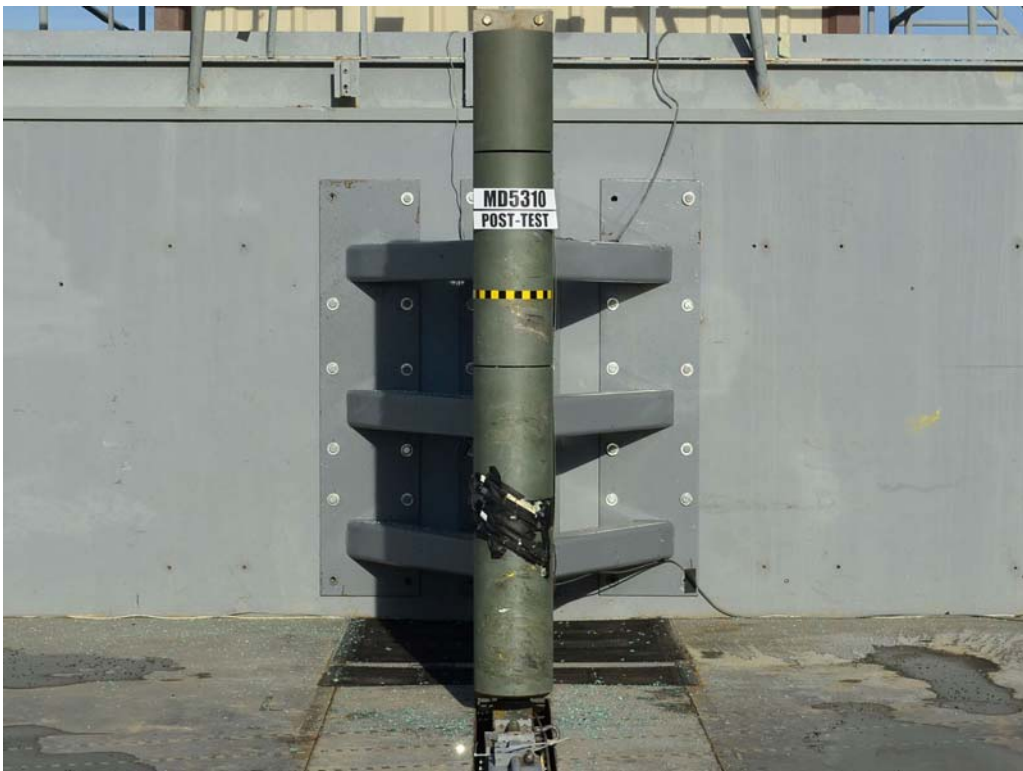
FIGURE 58. Post-Test Pole Barrier Front View

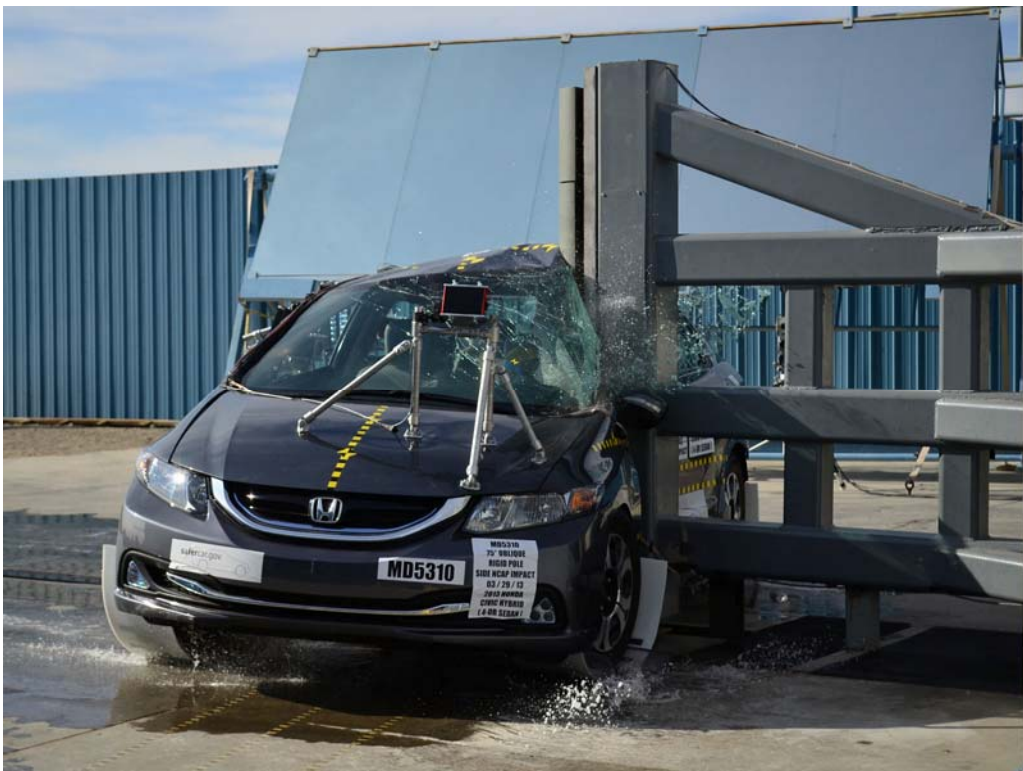
FIGURE 68. Impact Event

A rigid pole side impact test was conducted on a 2013 Honda Civic Hybrid 4-door sedan. The subject vehicle was towed into the rigid pole at an angle of 74.7° and a velocity of 32.41 km/h. The test was conducted by KARCO Engineering, LLC. in Adelanto, California on March 29, 2013. Pre- and post-test photographs of the test vehicle and side impact dummy (SID-IIs) are included in Appendix A of this report.
