**REPORT NUMBER: NCAP-MGA-2013-056**

**NEW CAR ASSESSMENT PROGRAM (NCAP)  
Frontal Barrier Impact Test**

**MAZDA MOTOR CORPORATION  
2014 Mazda CX-5 Sport AWD 5-Dr SUV  
NHTSA No.: O20145400**

**FINAL REPORT**

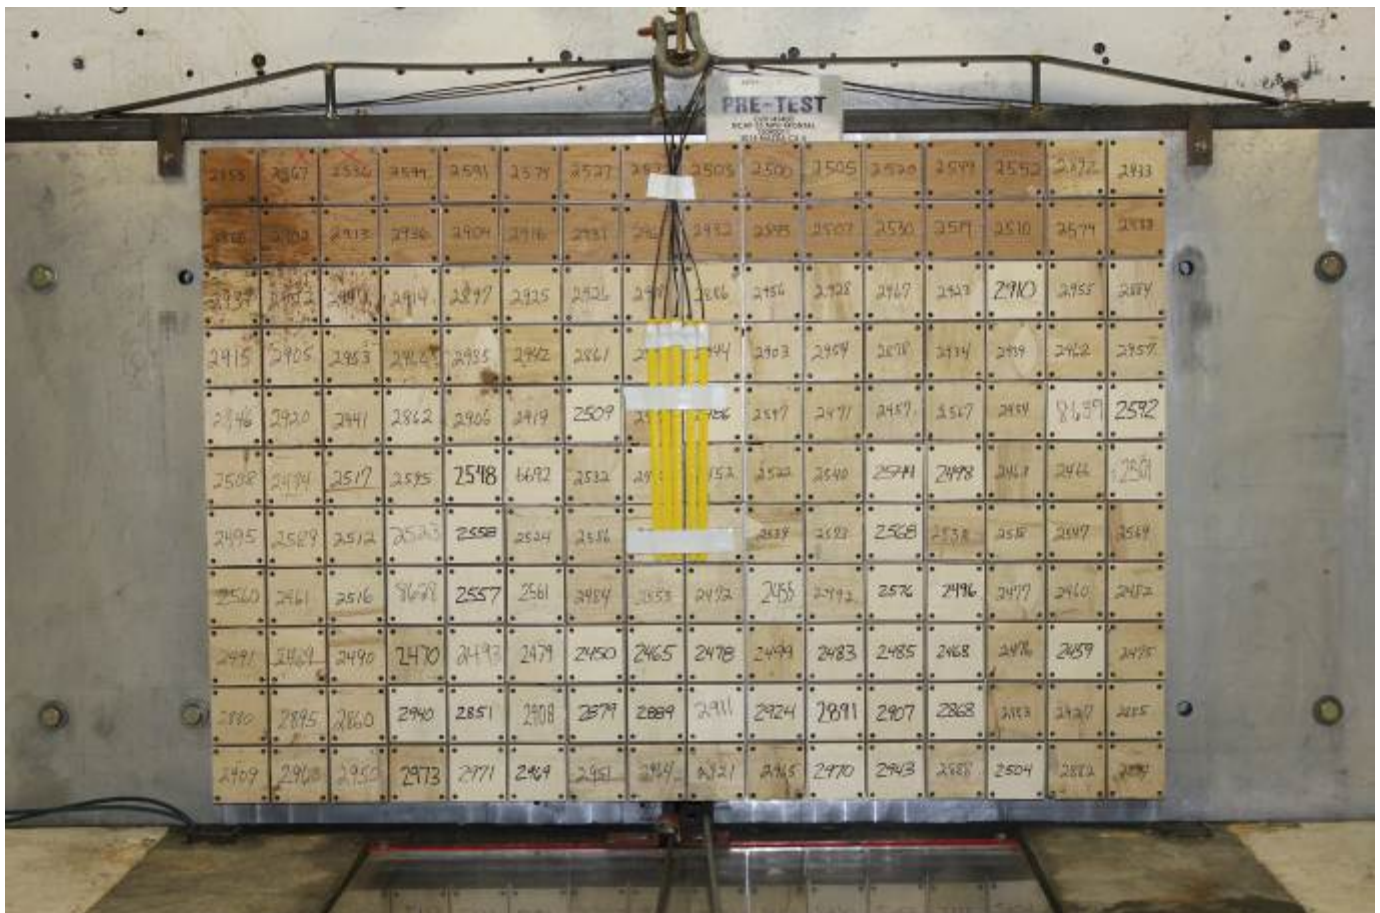
Load Cell Wall

A load cell barrier consisting of 176 load cells was impacted by a 2014 Mazda CX-5 Sport AWD 5-Dr SUV at a velocity of 56.4 km/h. The test was performed at MGA Research Corporation on April 2, 2013. Pre-test and post-test photographs of the vehicle and dummies can be found in Appendix A.

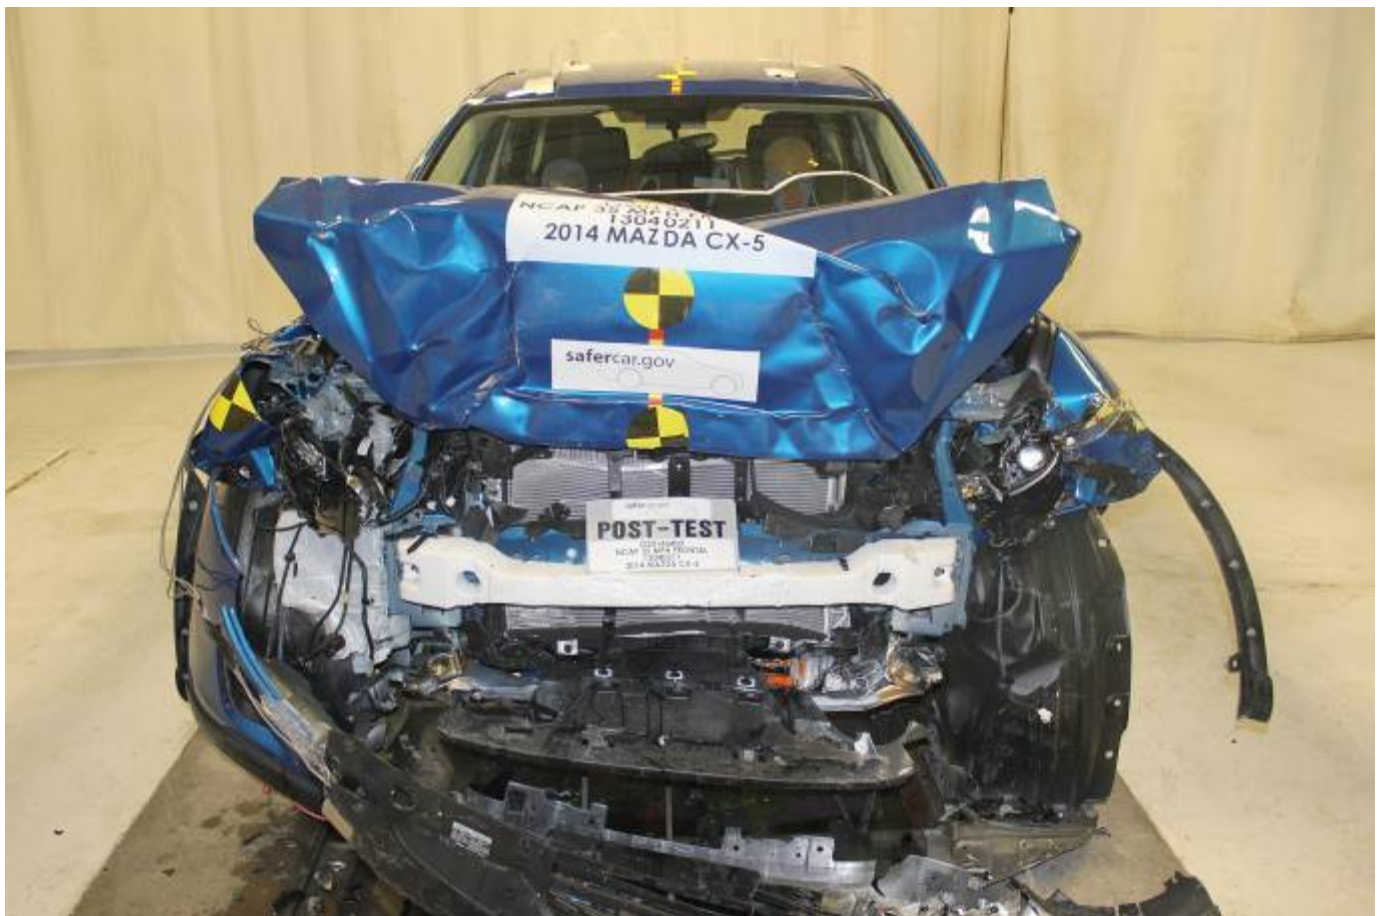
Post-Test Front View of Test Vehicle

The maximum static crush of the vehicle was 598 mm and both the driver and passenger side doors remained closed during the impact event and were operable after the impact.

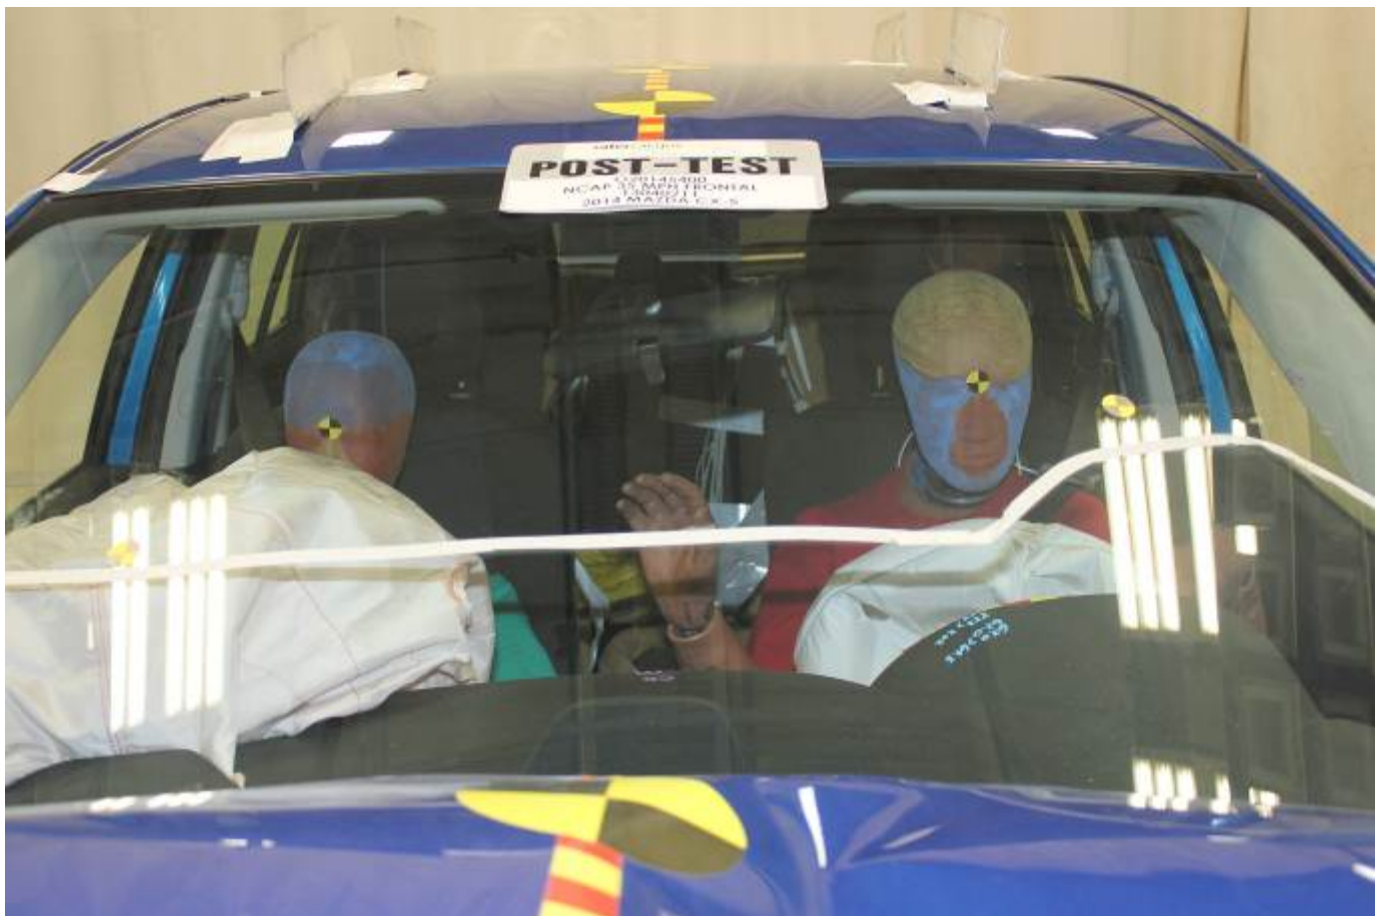
Post-Test Windshield View

There was 100 percent windshield retention and no intrusion into the protected zone of the windshield during the event. There was no Stoddard Solvent leakage after the event or during any phase of the static rollover.

| Critical Areas of Performance | Observations and Conclusions |
|---|---|
| Windshield Damage | Cracked |

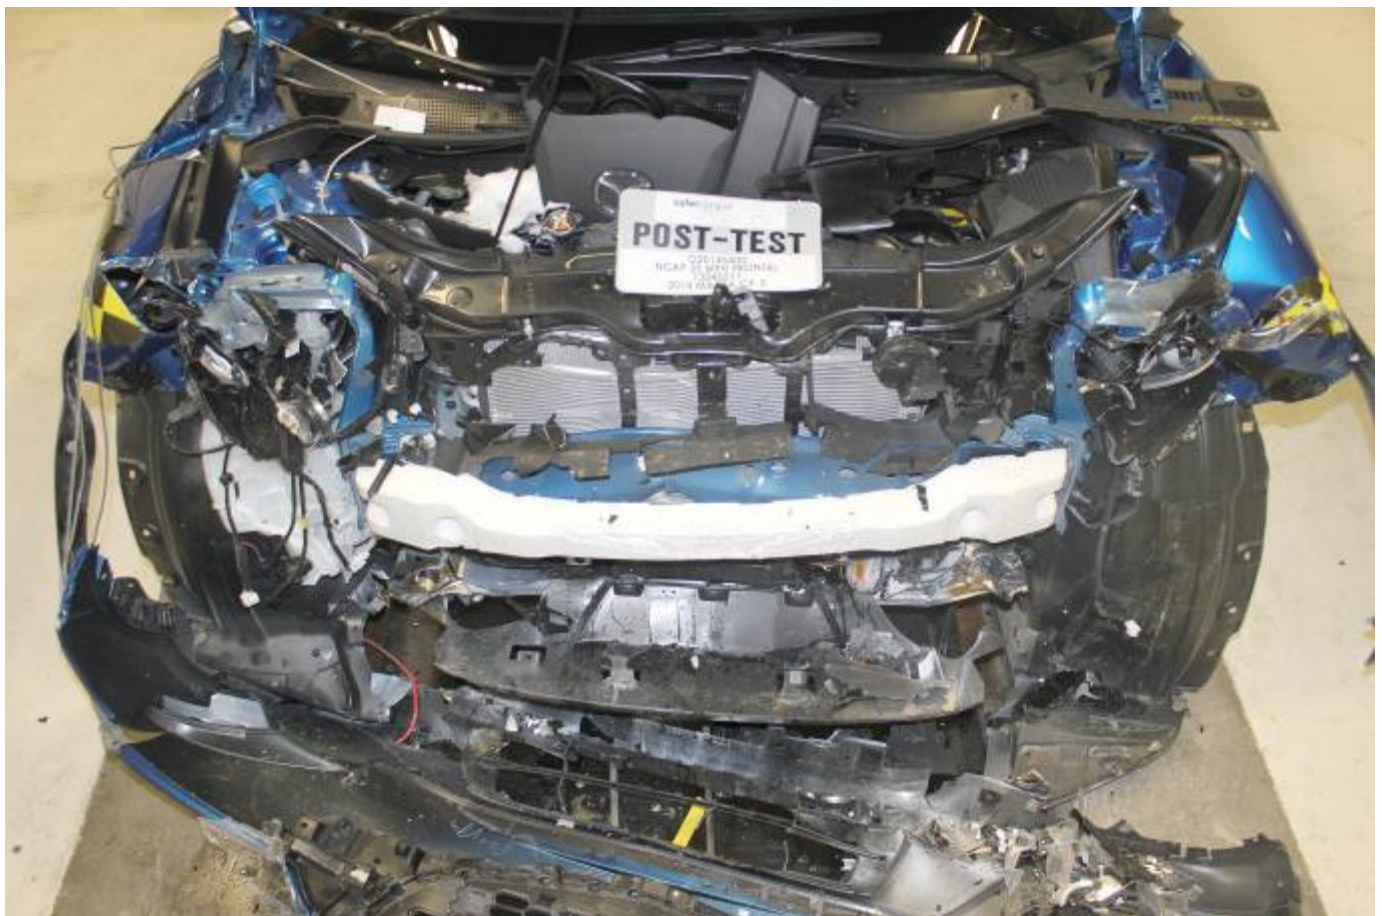
Post-Test Engine Compartment View

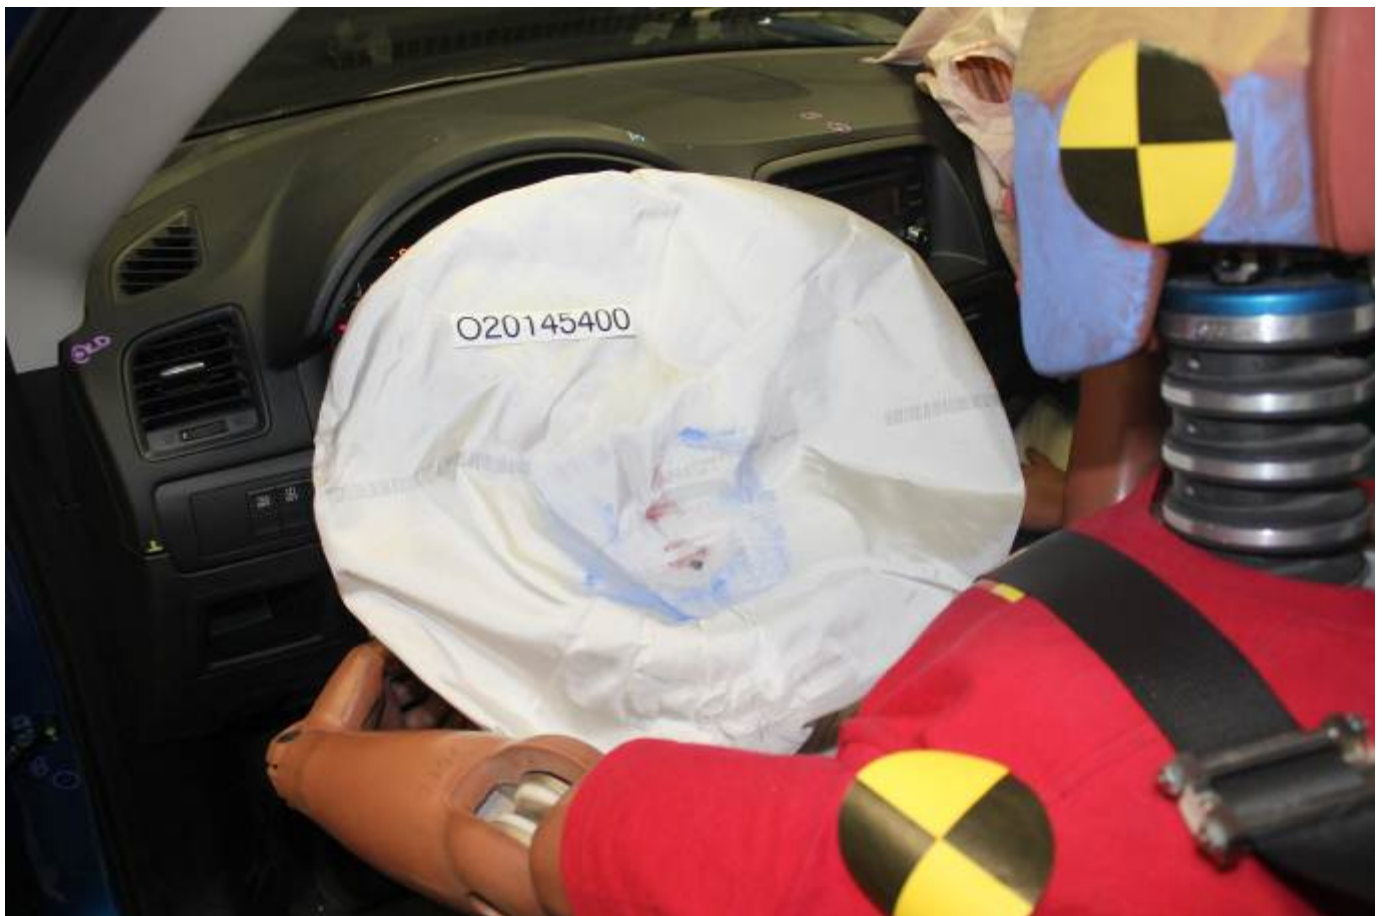
Post-Test Driver Dummy Contact with Airbag

The driver's visible contact points were as follows: The driver's head and chest contacted the airbag. The driver's head also contacted the headrest. The driver's knees contacted the knee bolster and steering column. The passenger's visible contact points were as follows: The passenger's head and chest contacted the airbag. The passenger's head also contacted the headrest. The passenger's knees contacted the glove box.

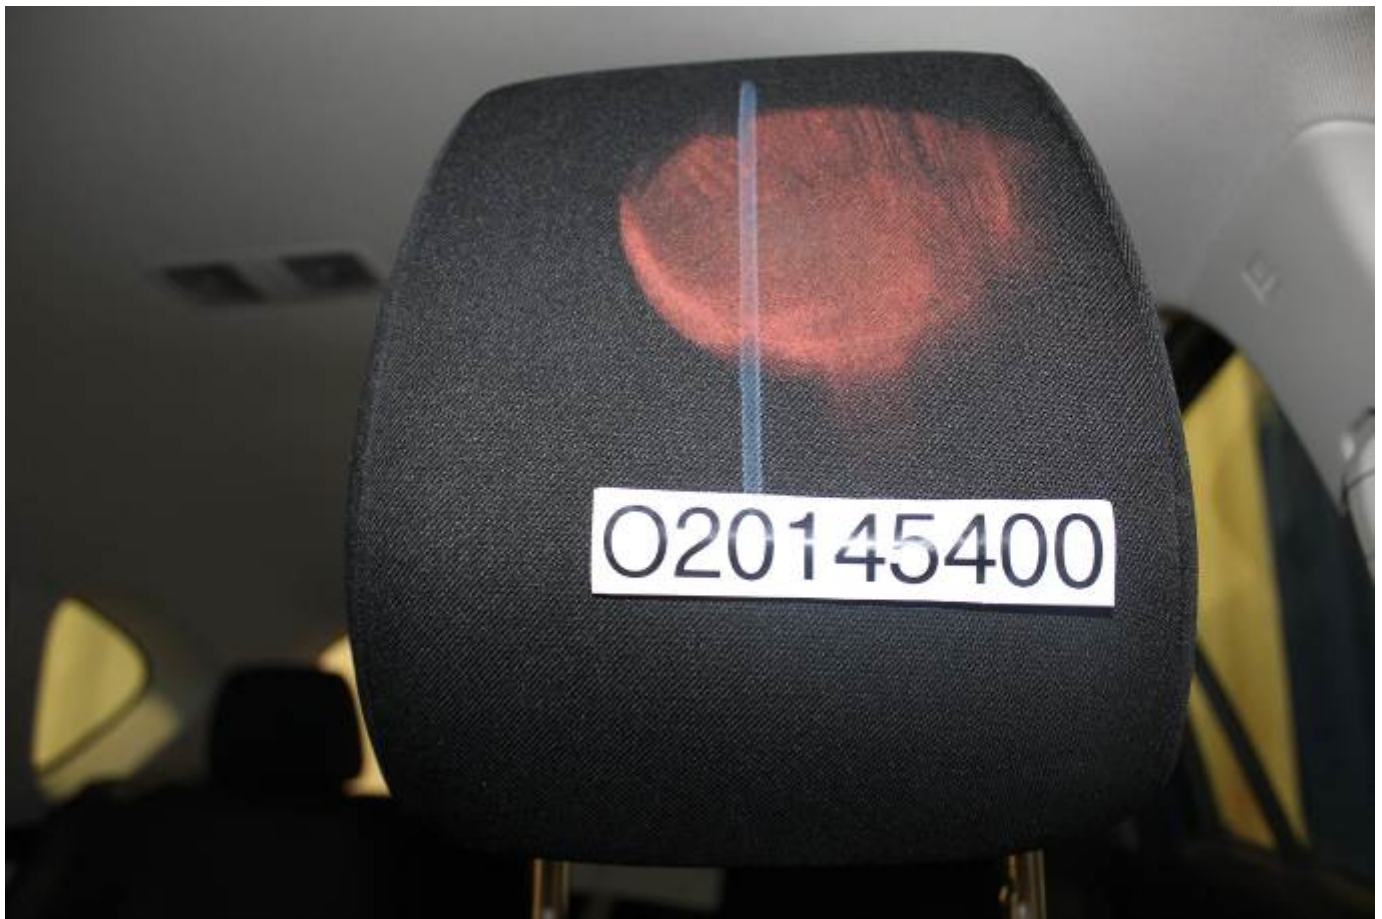
Post-Test Driver Dummy Contact with Headrest

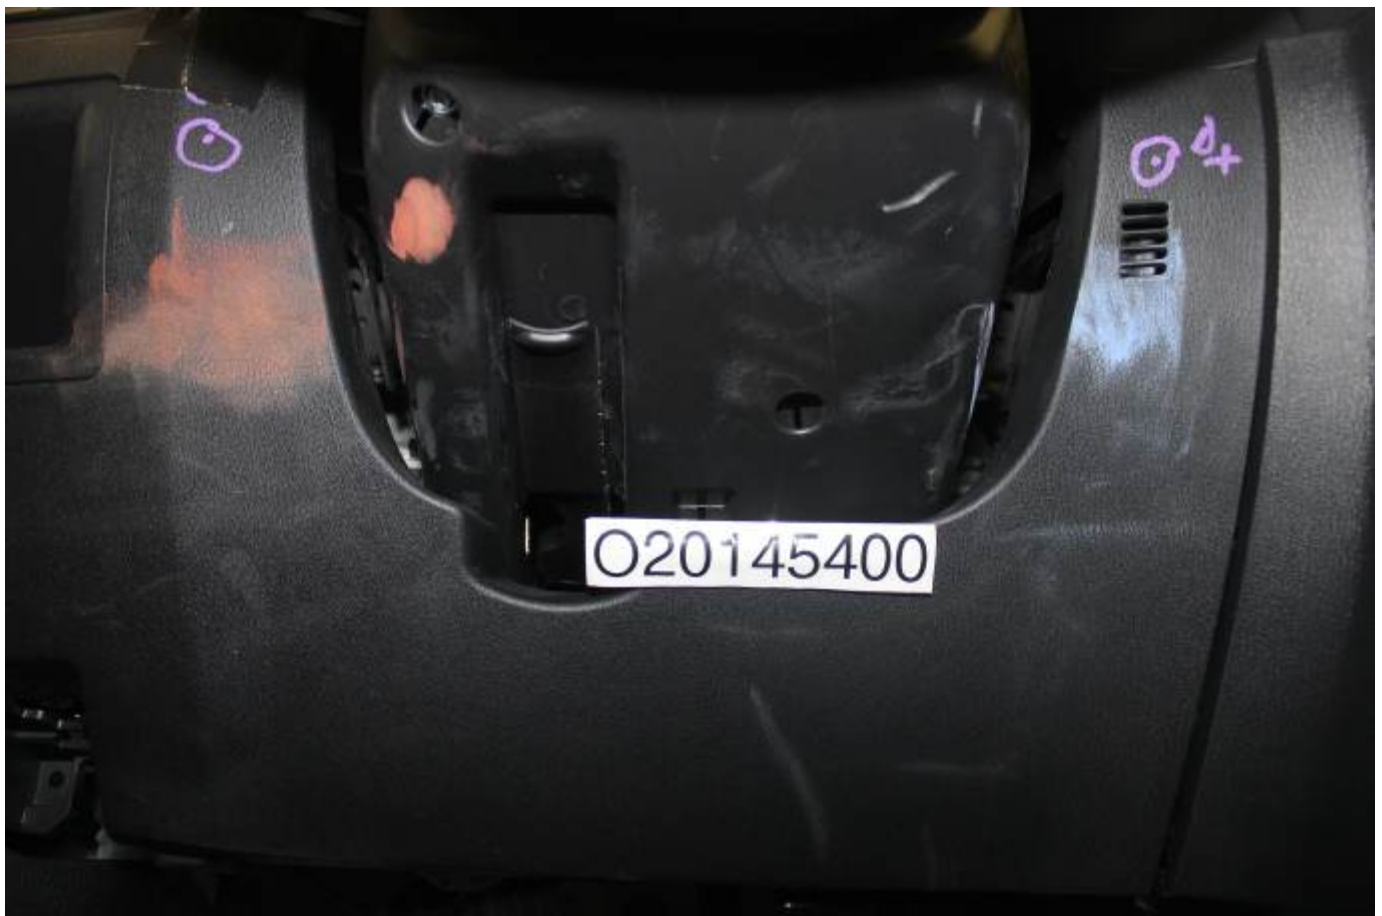
Post-Test Driver Dummy Contact with Knee Bolster

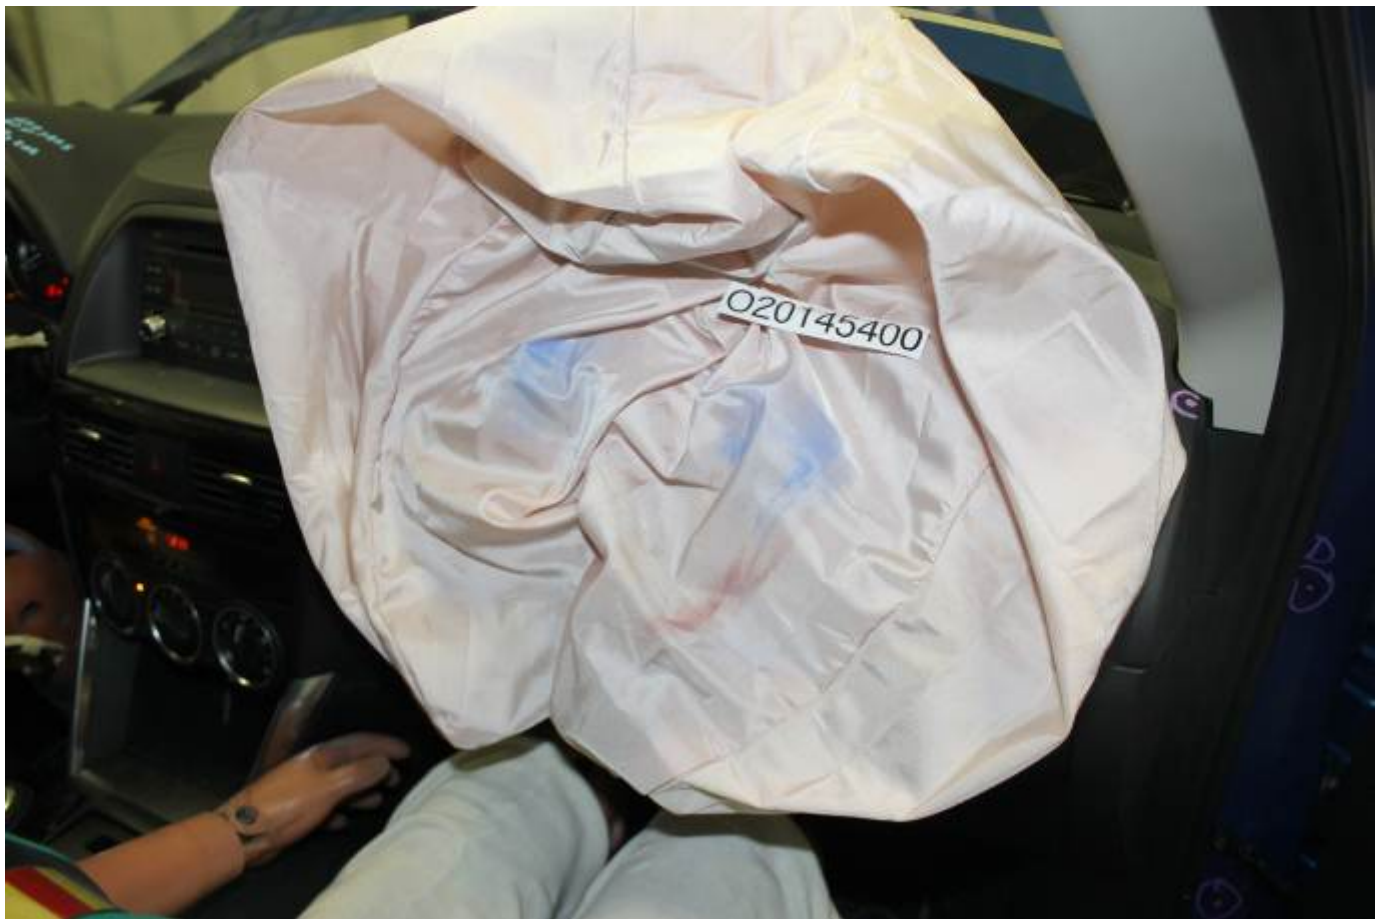
Post-Test Passenger Dummy Contact with Airbag

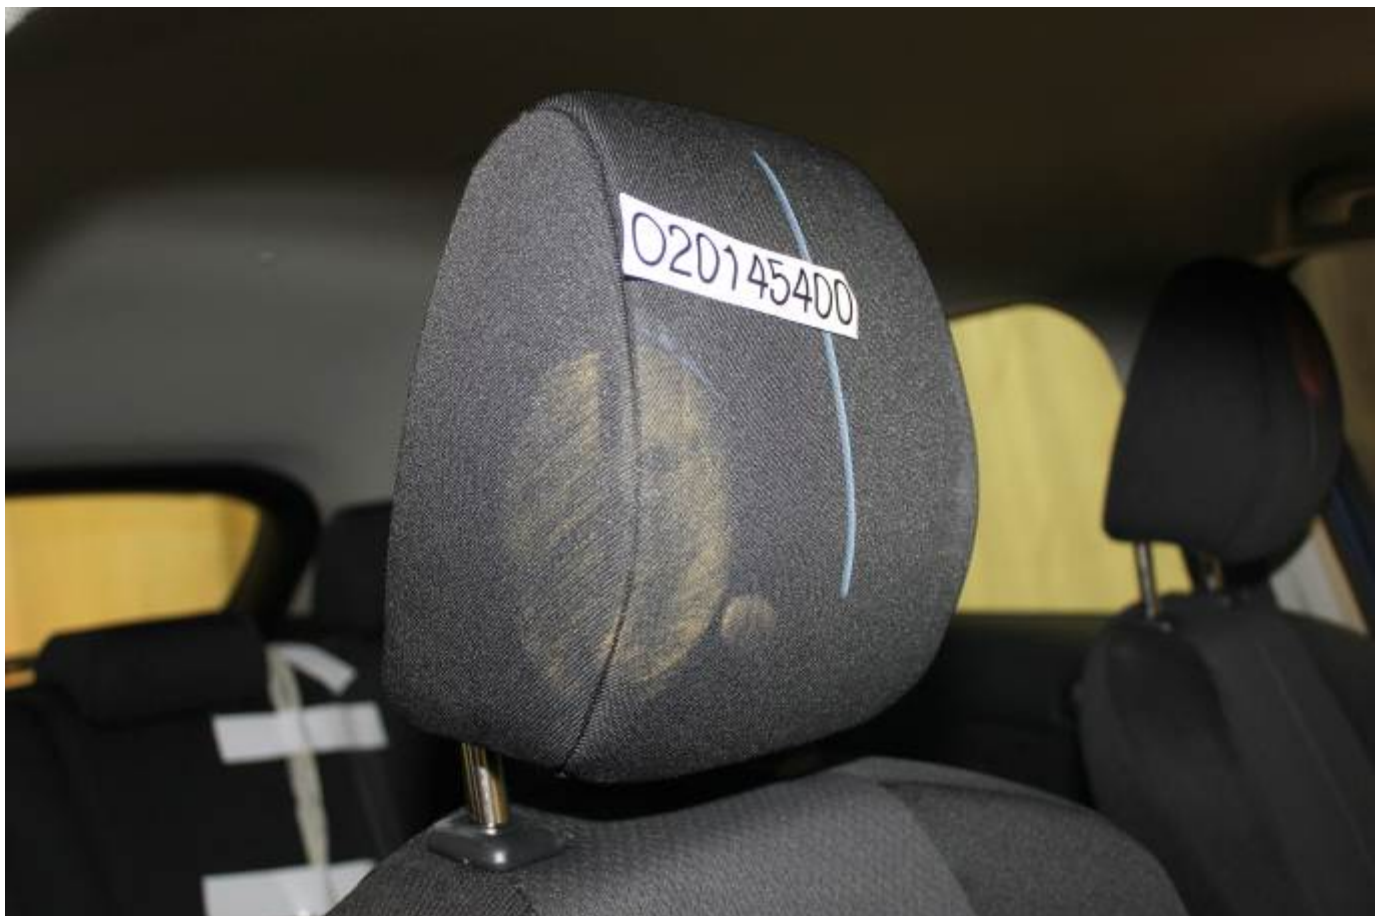
Post-Test Passenger Dummy Contact with Headrest

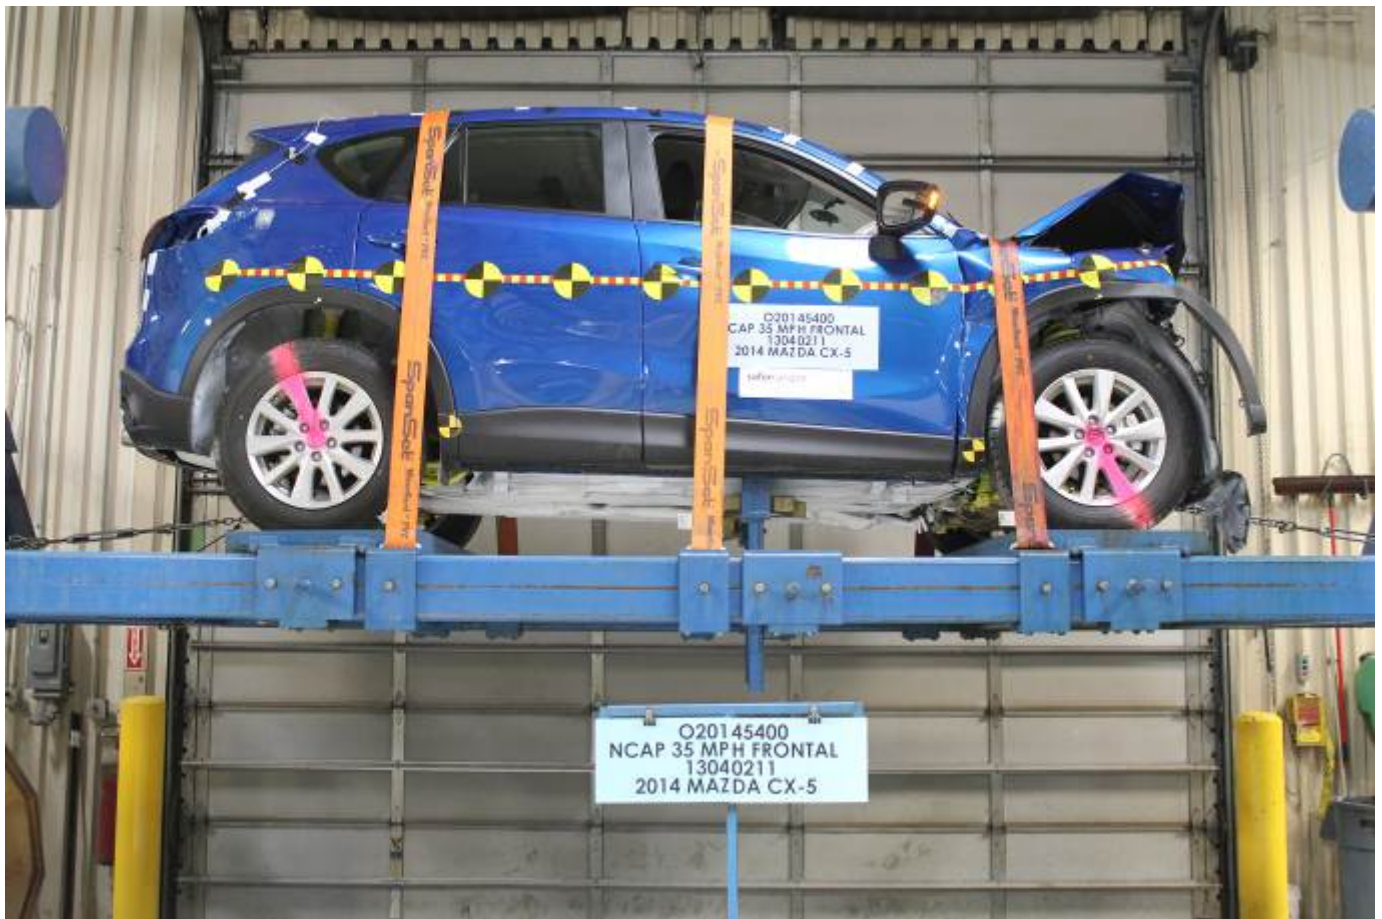
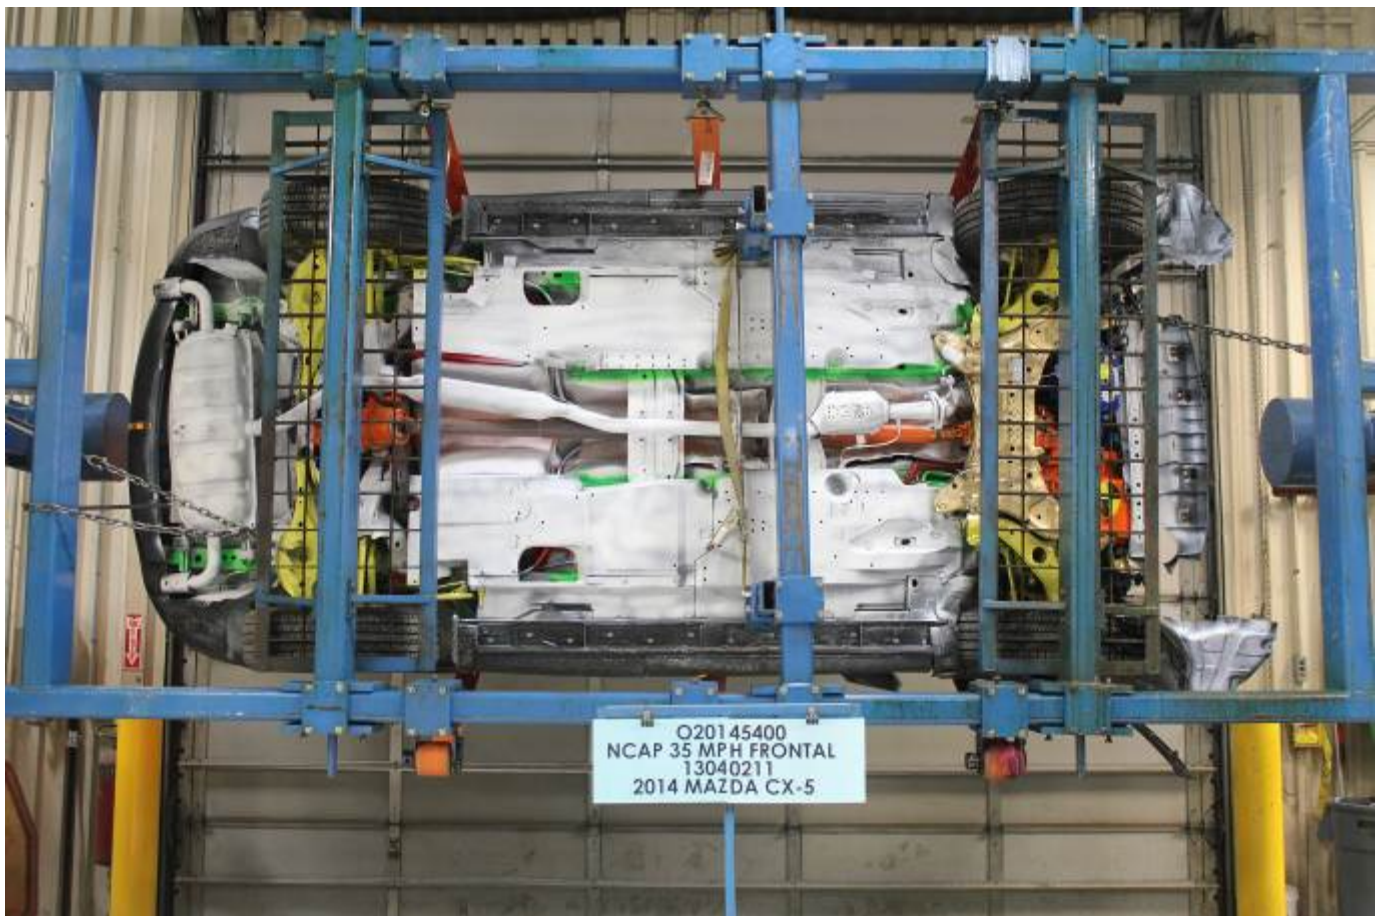
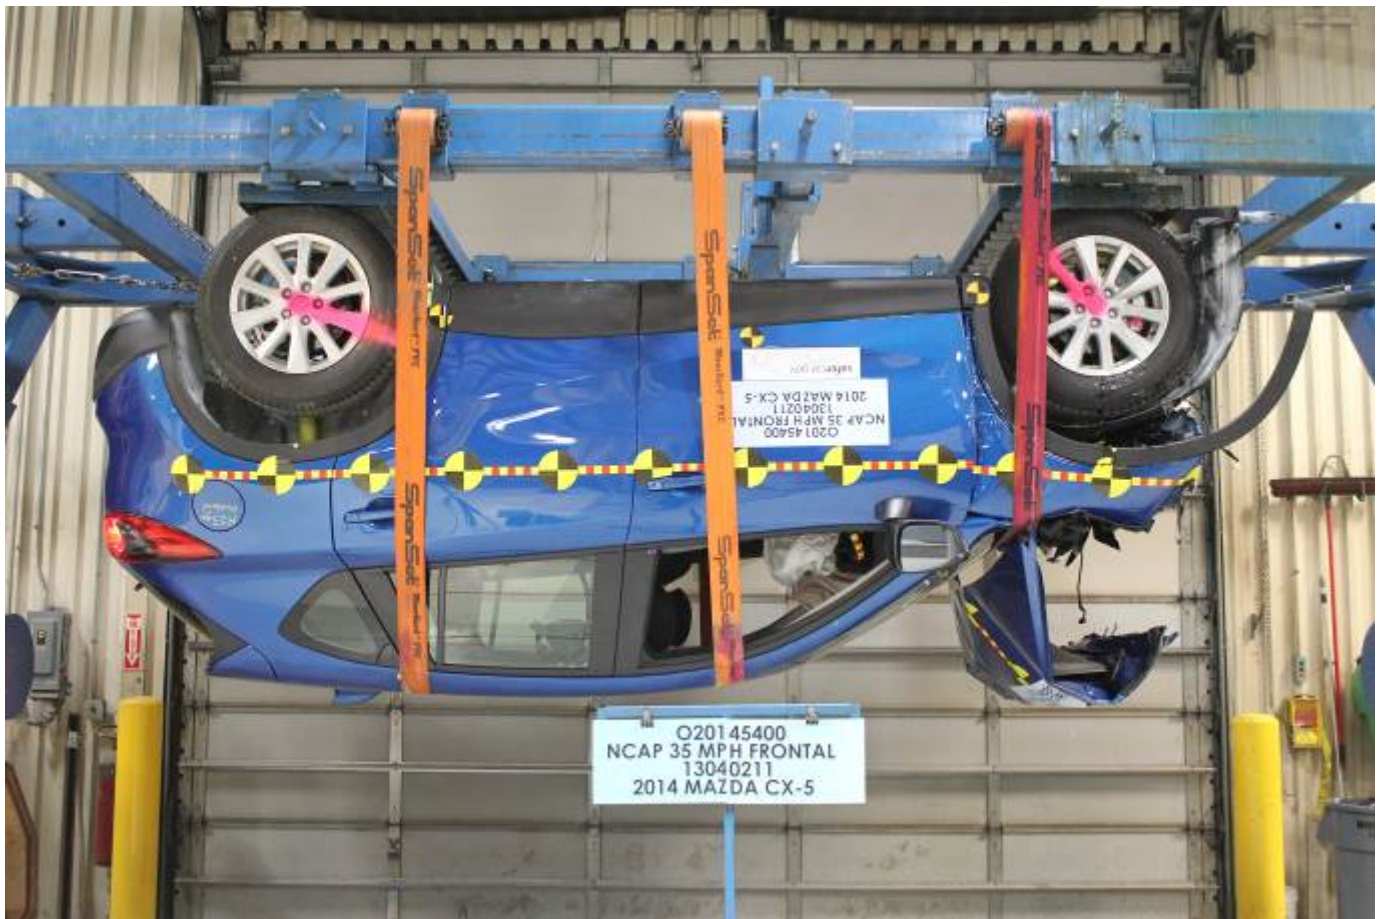
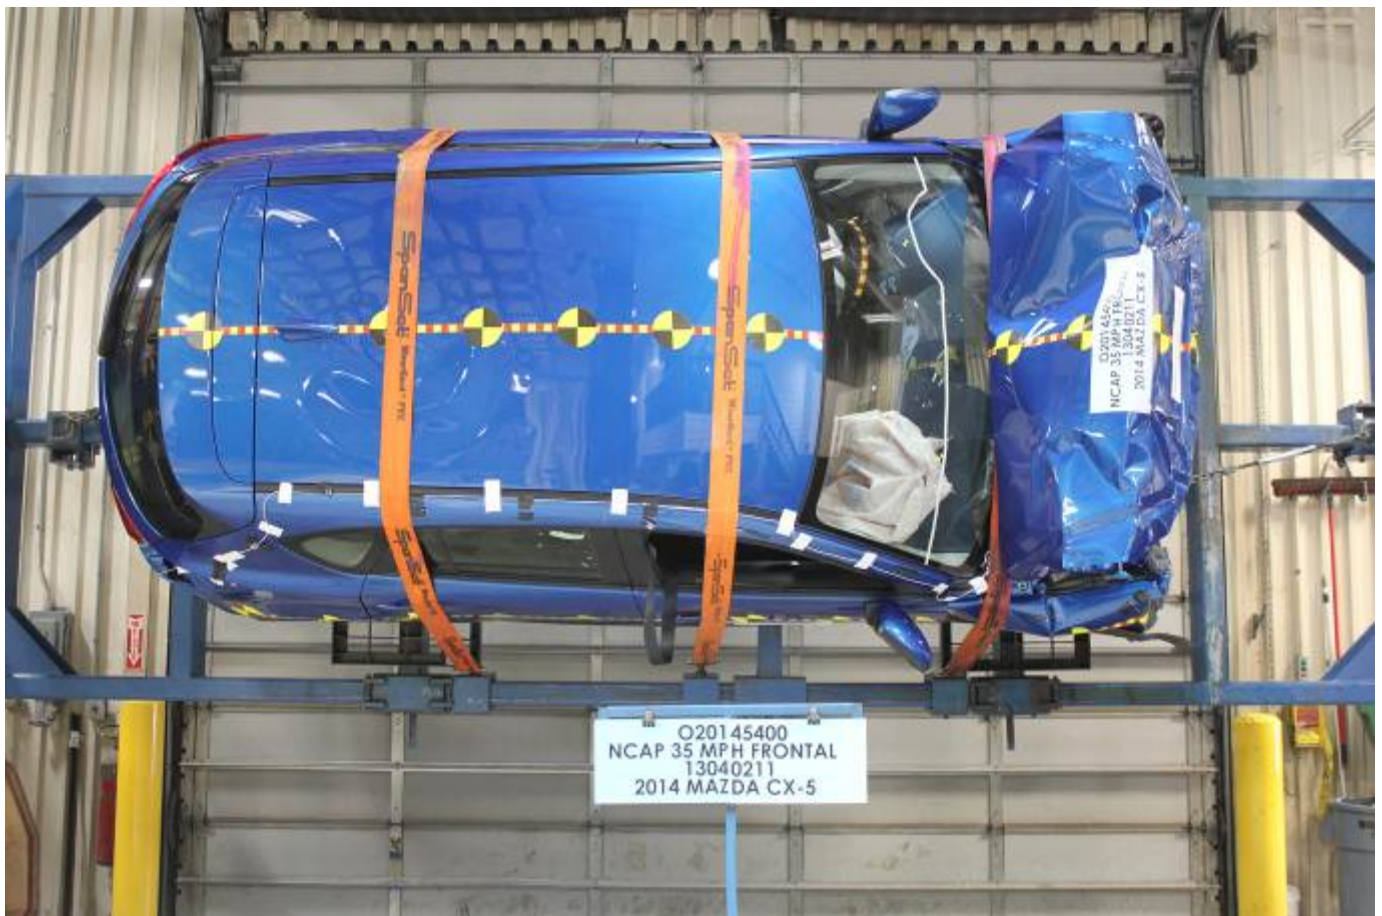
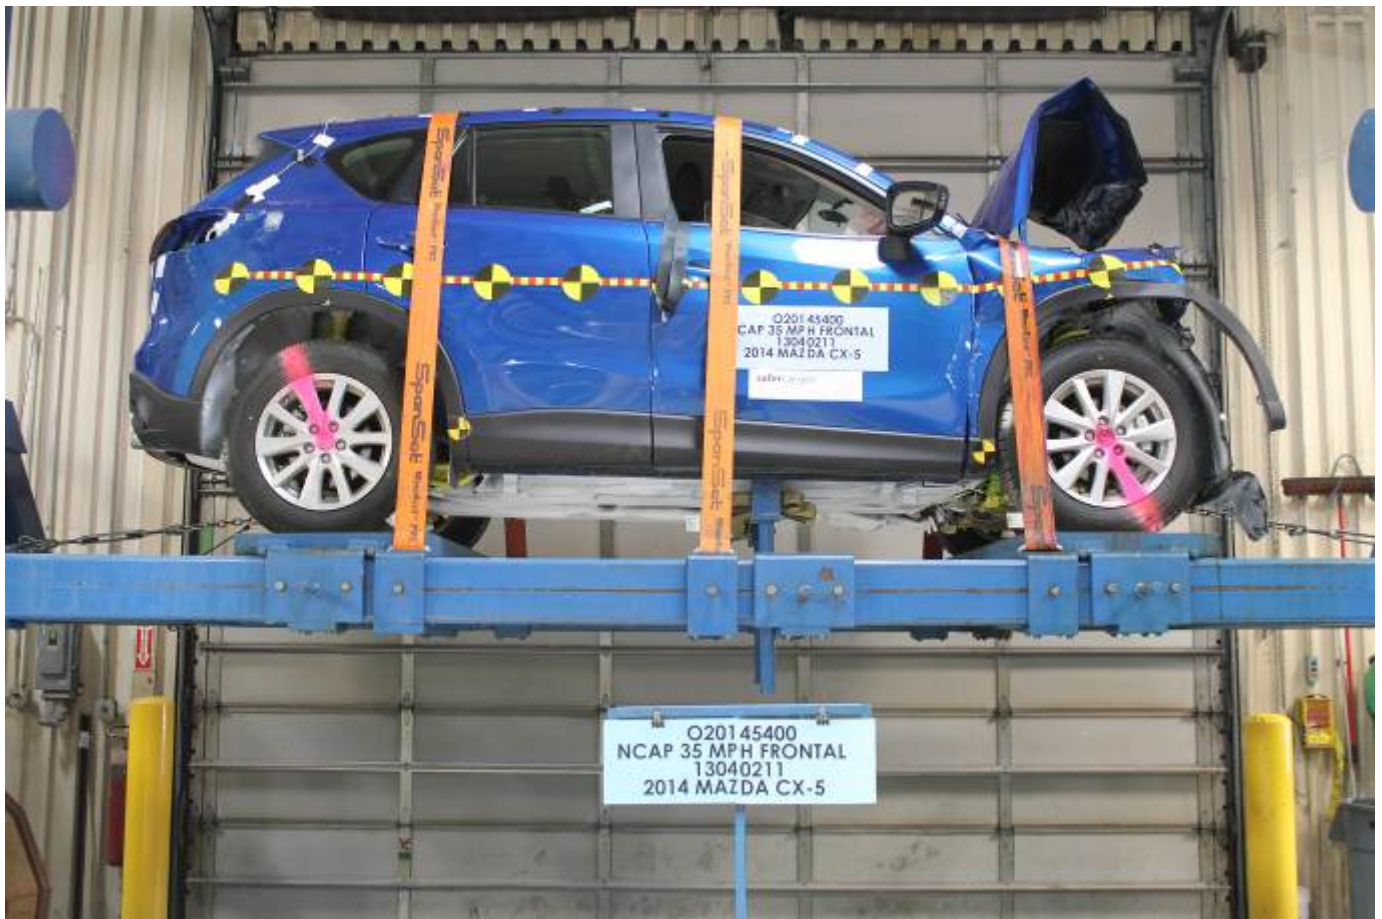
Vehicle at 0° on Static Rollover Device

Vehicle at 90° on Static Rollover Device

Vehicle at 180° on Static Rollover Device

Vehicle at 270° on Static Rollover Device

Vehicle at 360° on Static Rollover Device
