**REPORT NUMBER: SINCAP-MGA-2013-059**

**NEW CAR ASSESSMENT PROGRAM (NCAP)  
Moving Deformable Barrier Side Impact Test**

**GM KOREA COMPANY  
2013 Buick Encore SUV  
NHTSA No.: GD0103**

**FINAL REPORT**

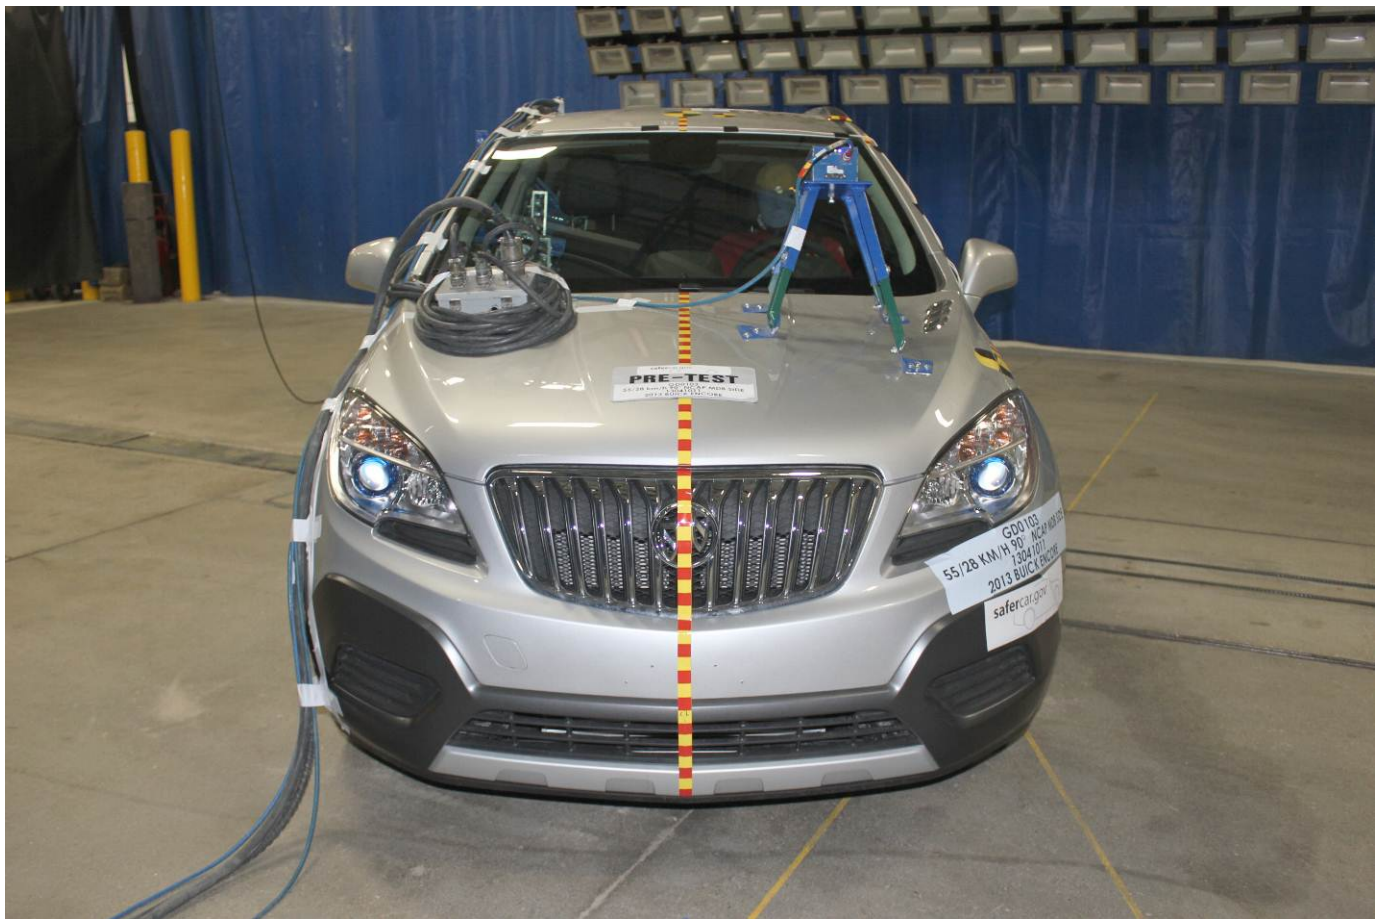
Pre-Test Frontal View of Test Vehicle

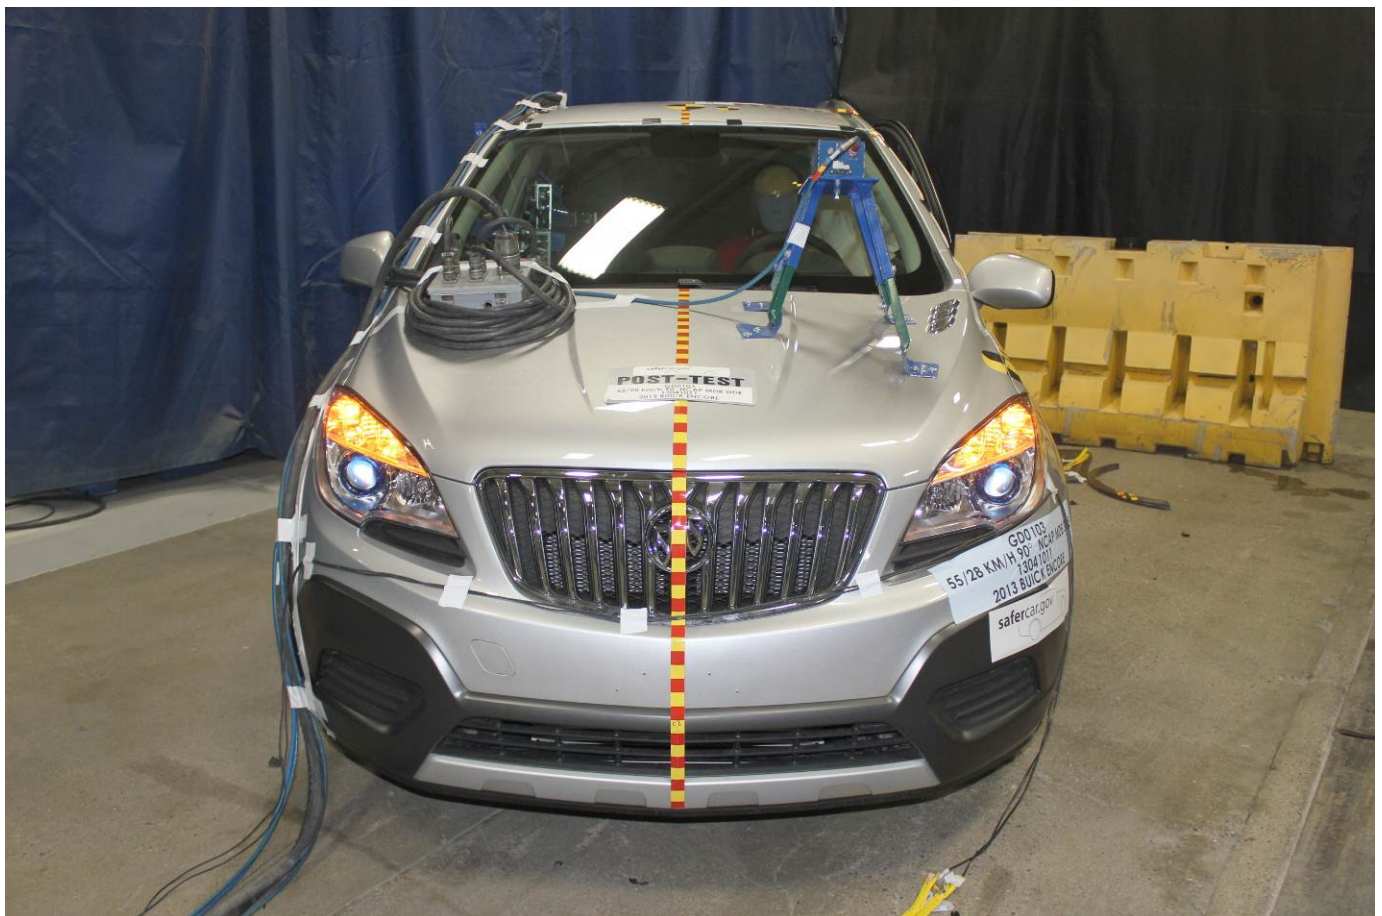
Post-Test Frontal View of Test Vehicle

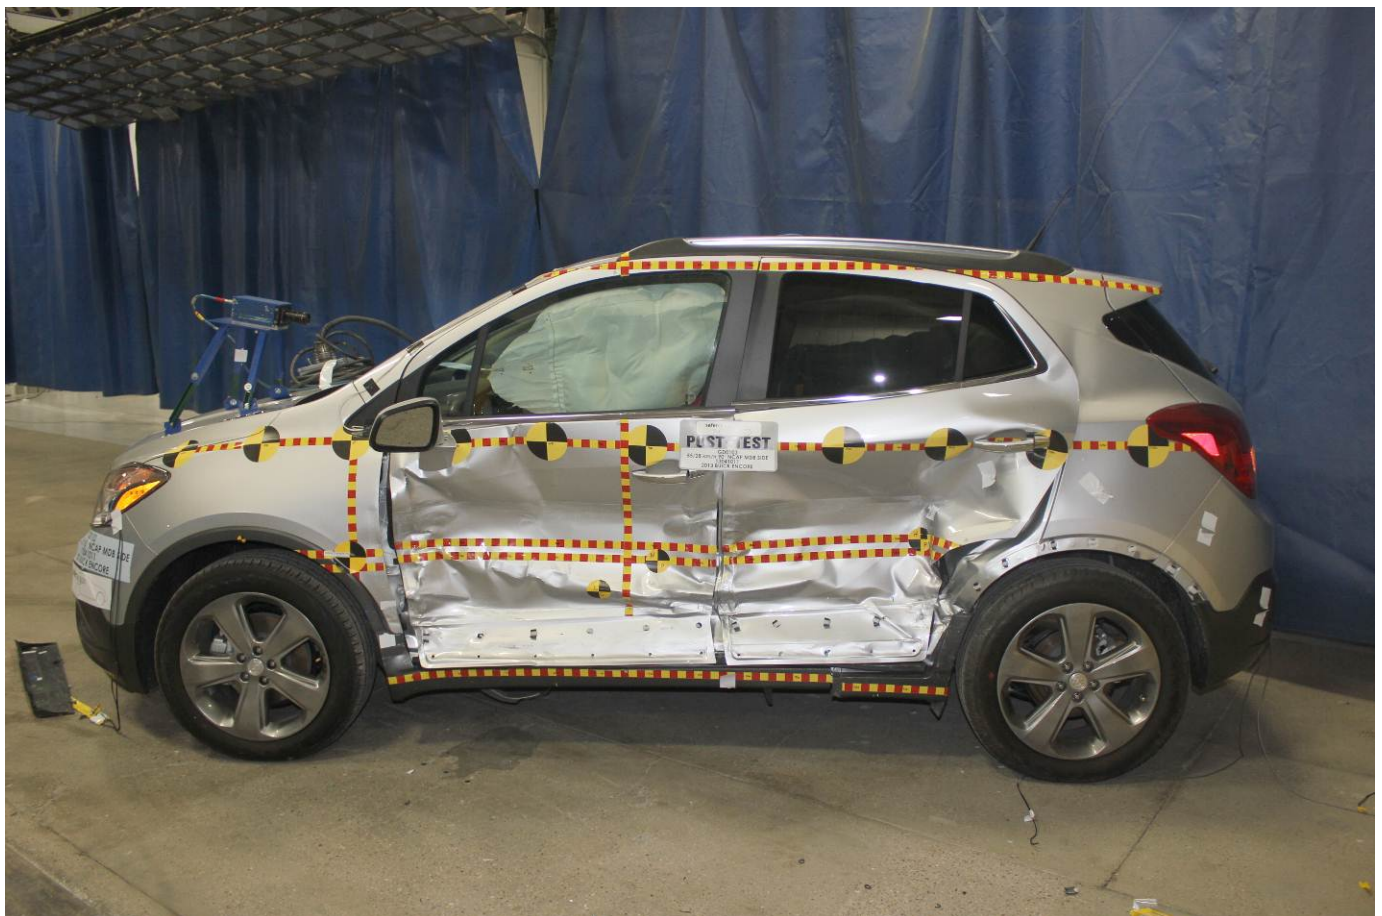
Post-Test Left Side View of Test Vehicle

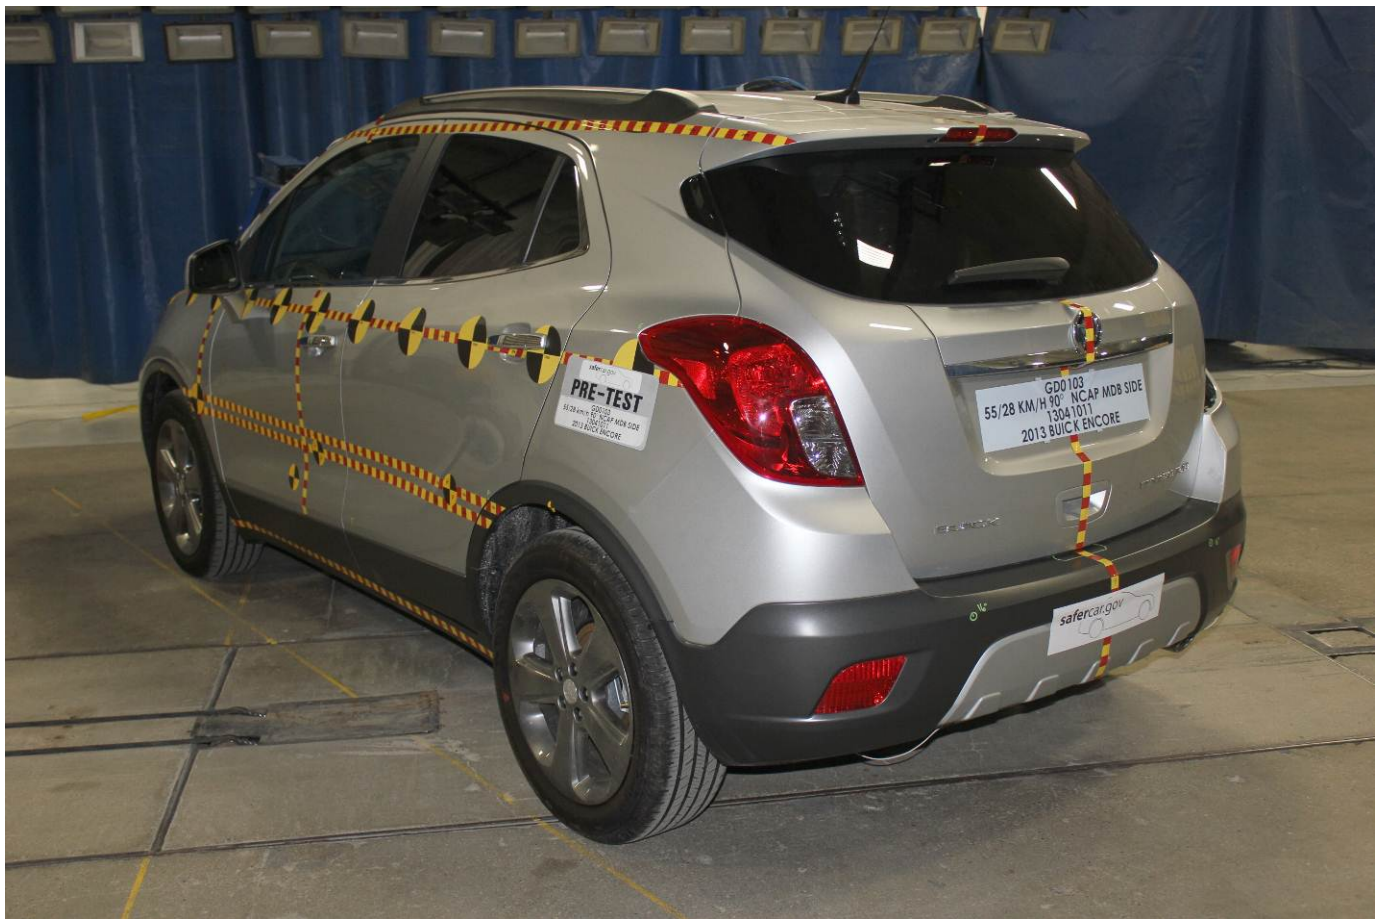
Pre-Test Left Three-Quarter Rear View of Test Vehicle

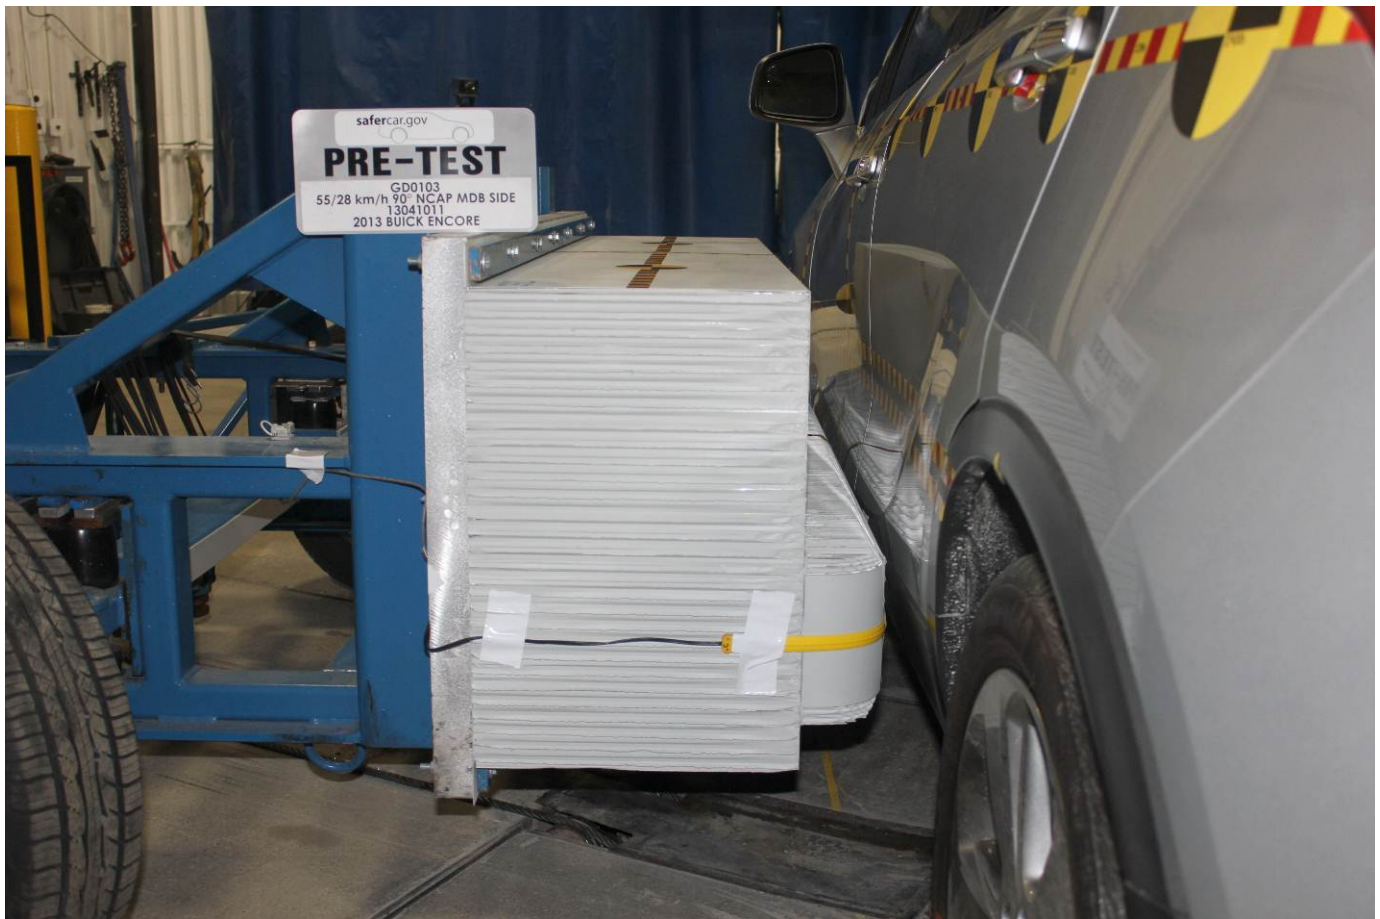
Pre-Test Left Side View of MDB Positioned Against Side of Test Vehicle

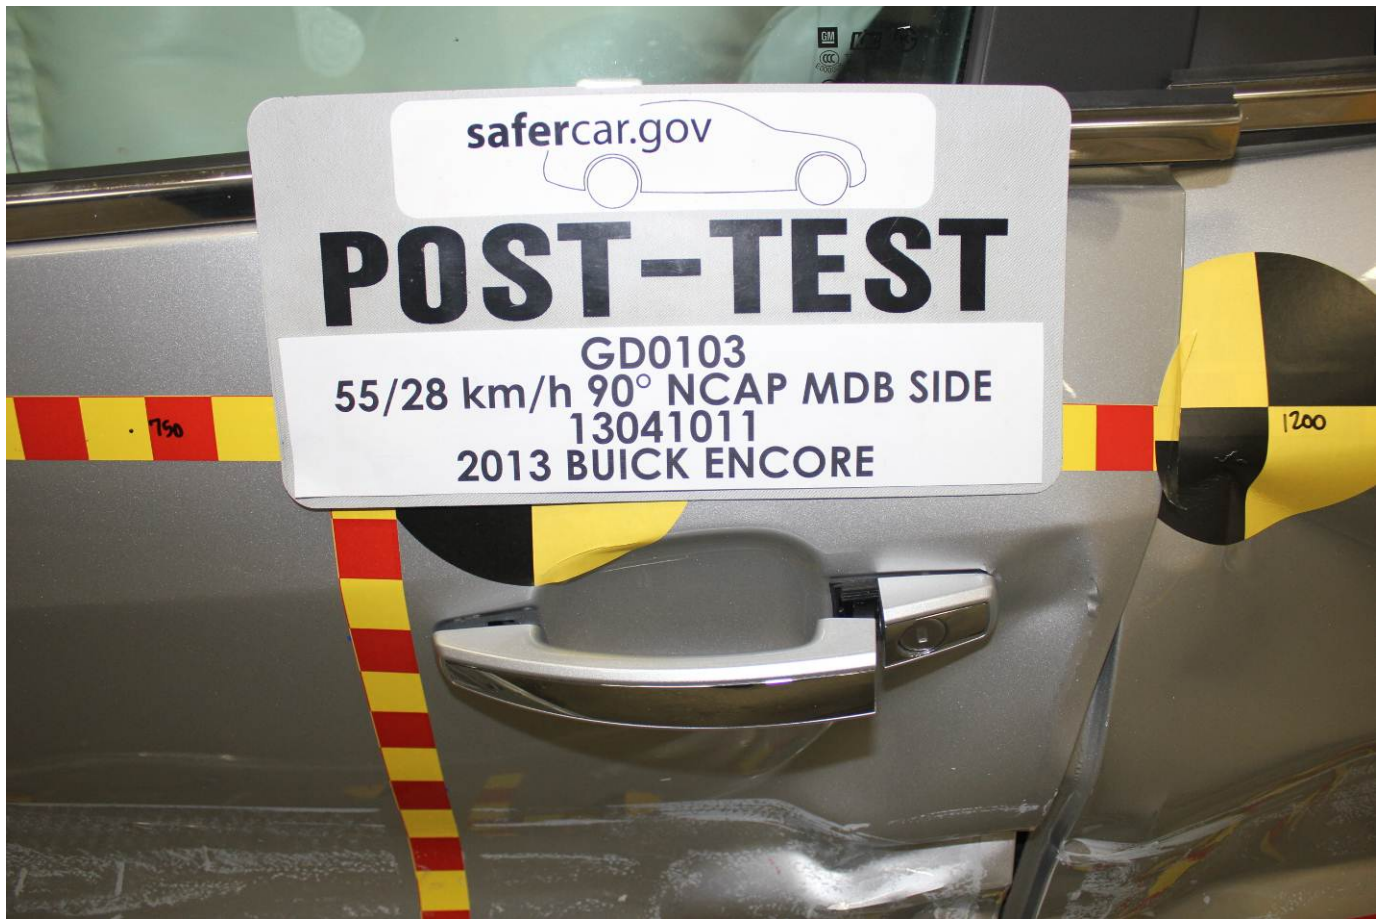
Post-Test Left Front Door Latch Close-Up

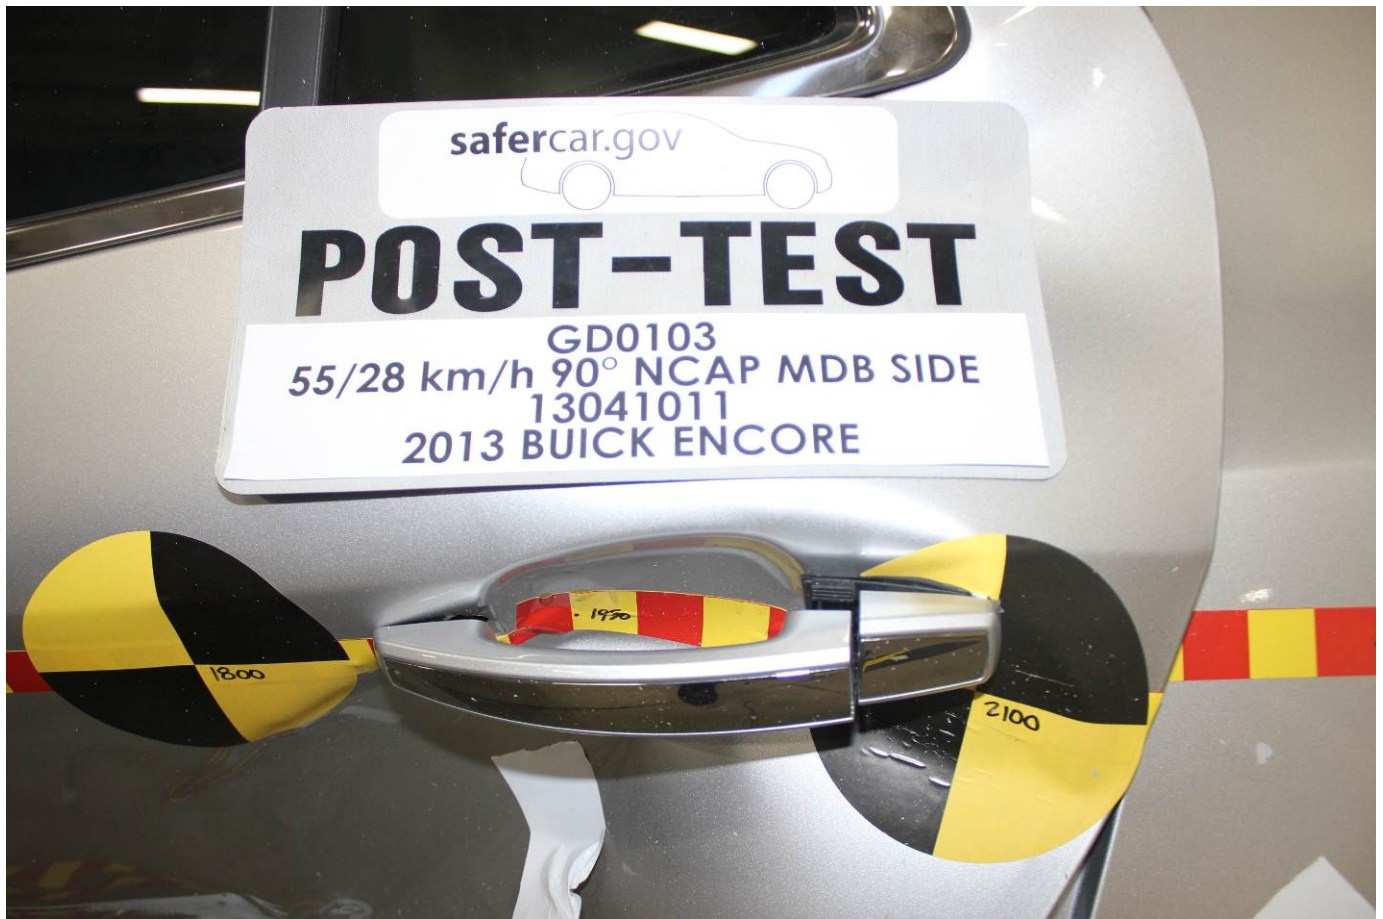
Post-Test Left Rear Door Latch Close-Up

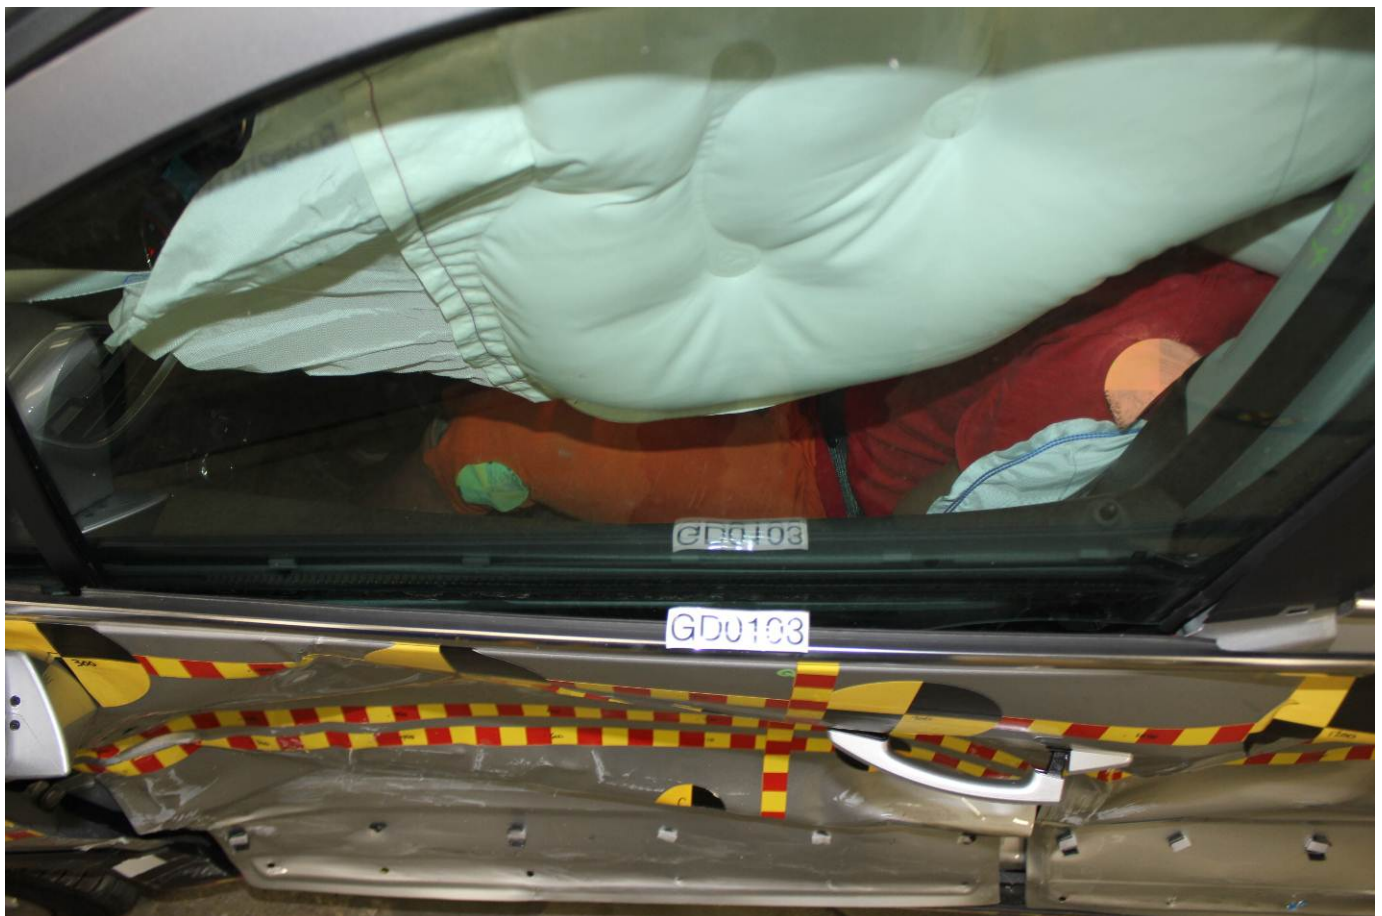
Post-Test Driver Dummy and Door Clearance View

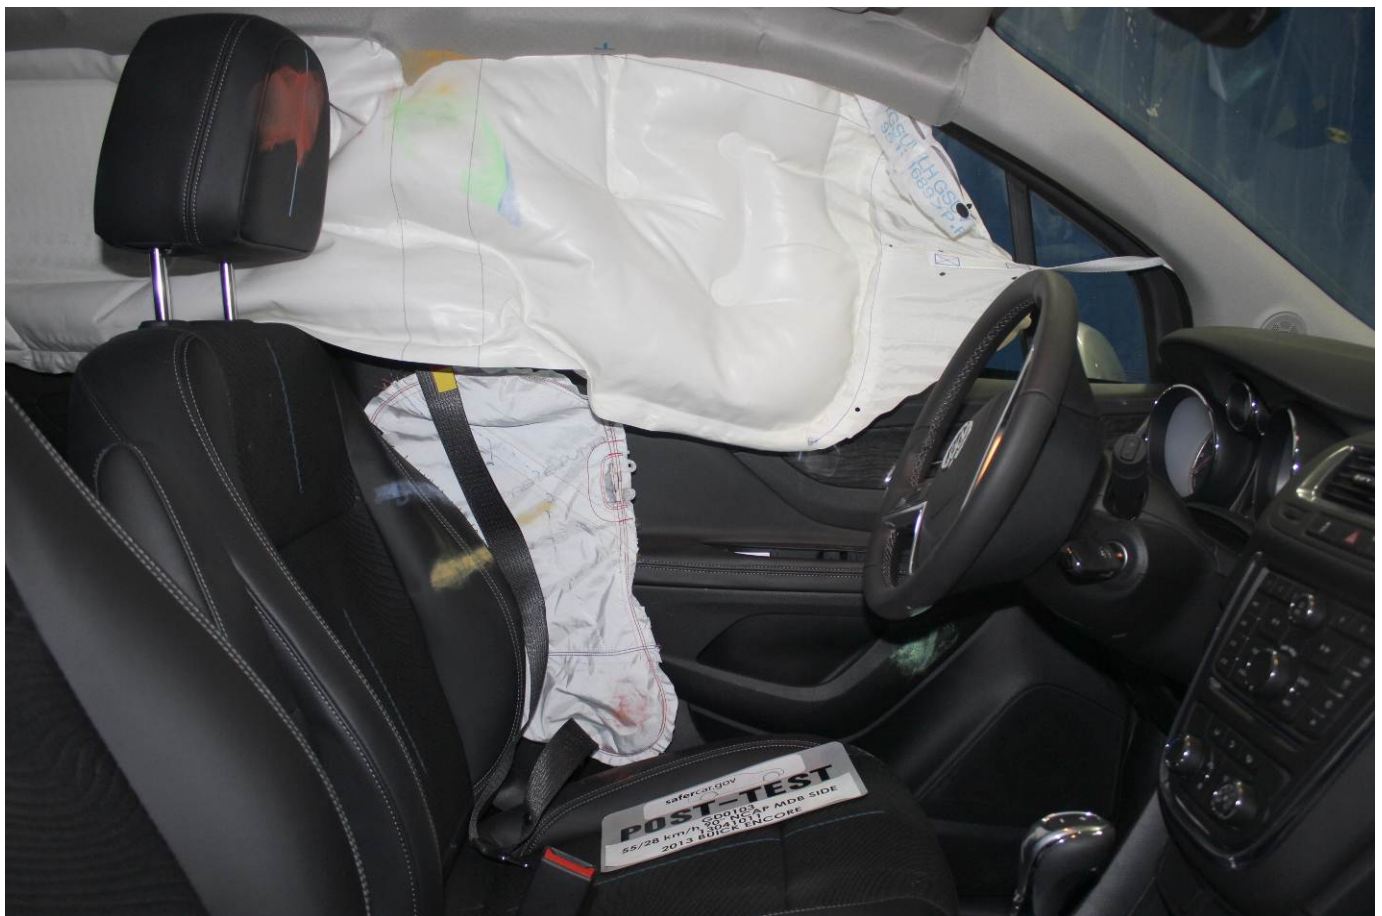
Post-Test Driver Inner Door Panel View

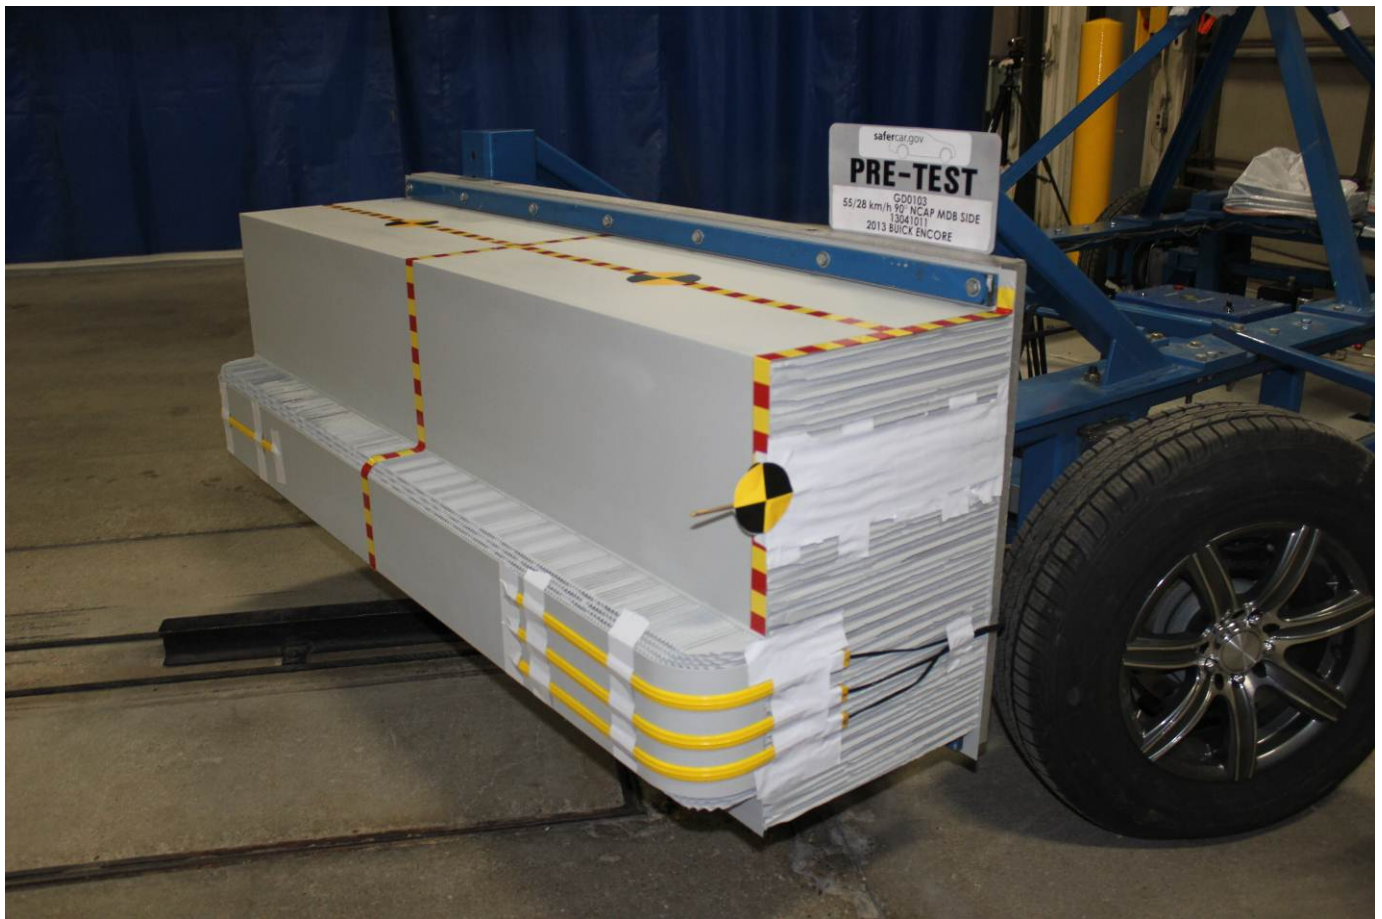
Post-Test Top View of MDB Impactor Face
