**REPORT NUMBER: NCAP305I-MGA-2013-013**

**NEW CAR ASSESSMENT PROGRAM (NCAP)  
FMVSS No. 305 Indicant Test**

**NISSAN MOTOR CO., LTD.  
2013 Nissan Leaf S 5-Dr Hatchback  
NHTSA NUMBER: MD5211**

**FINAL REPORT**

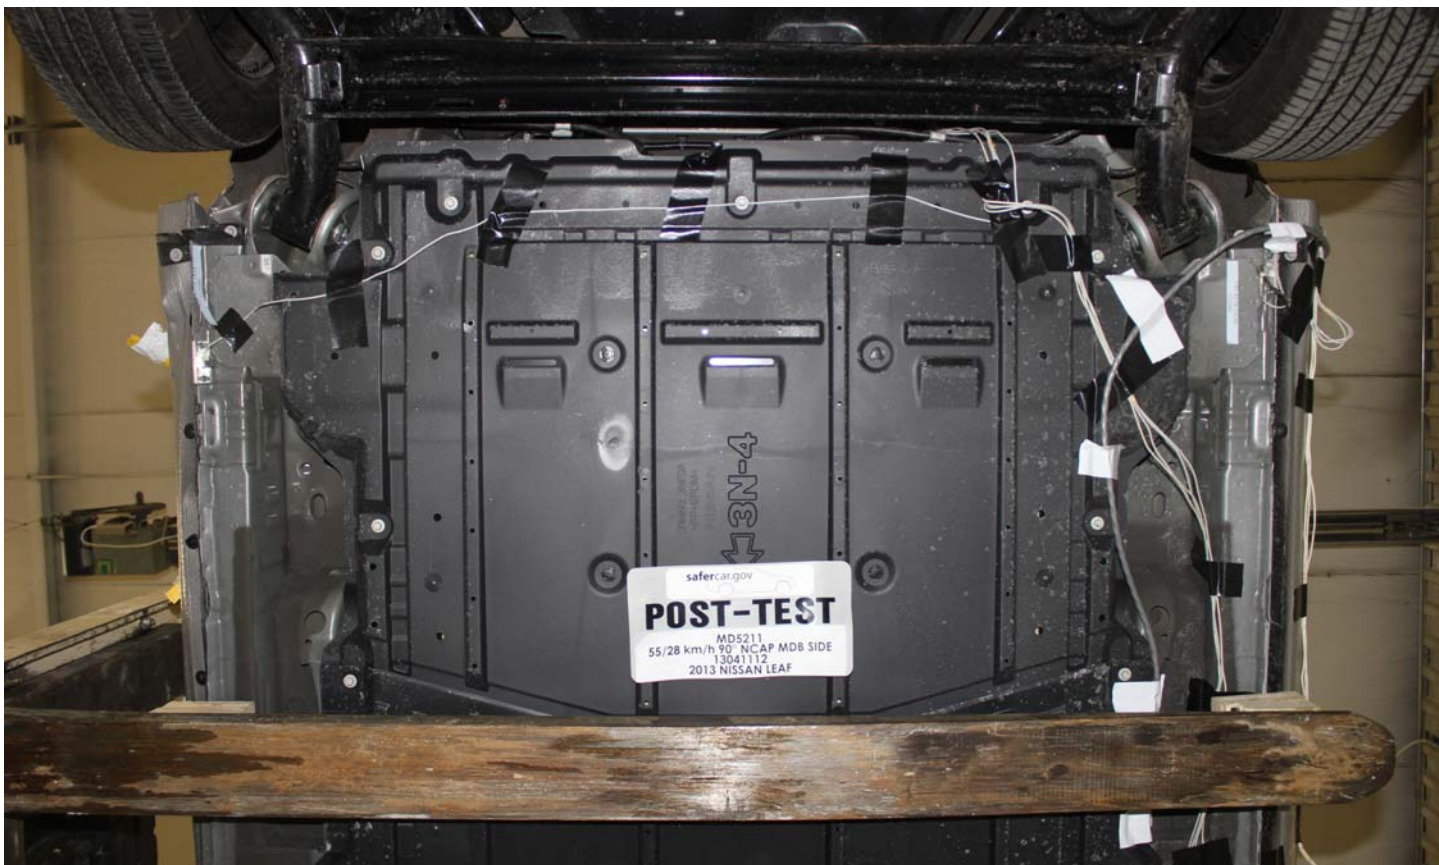
No. 010 Post-Impact Front View of Propulsion Battery

| | Yes, Pass | No, Fail |
|---|---|---|
| All Components of Electrical Energy Storage/Conversion Device remained attached to the vehicle with at least one mounting location. | X | |

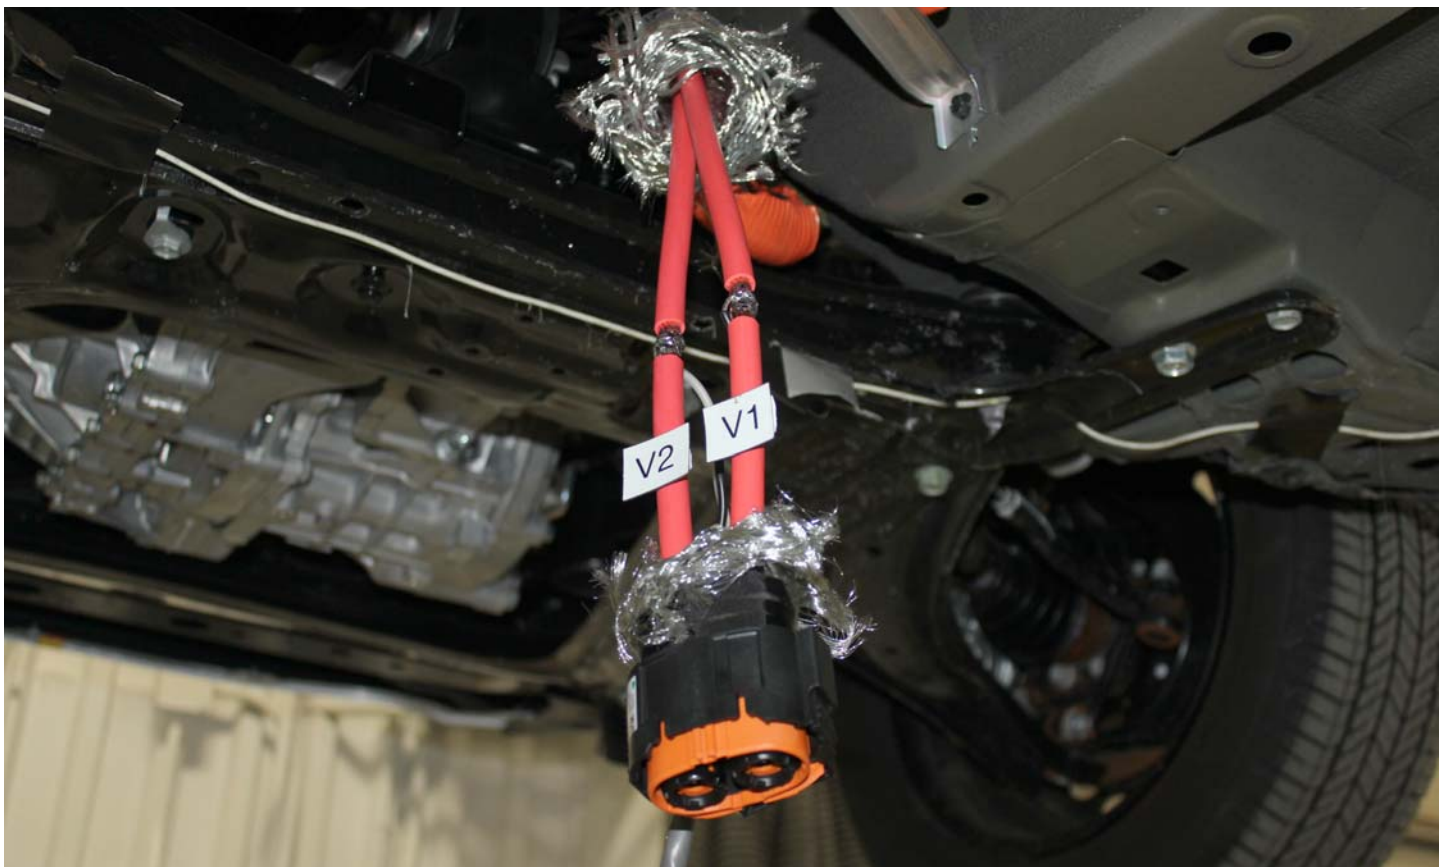
No. 022 Pre-Impact View of High Voltage Leads Attached

| Details of Electric Energy Storage/Conversion System Test Points: | + and – attached to the primary HV cable between the battery pack and inverter |

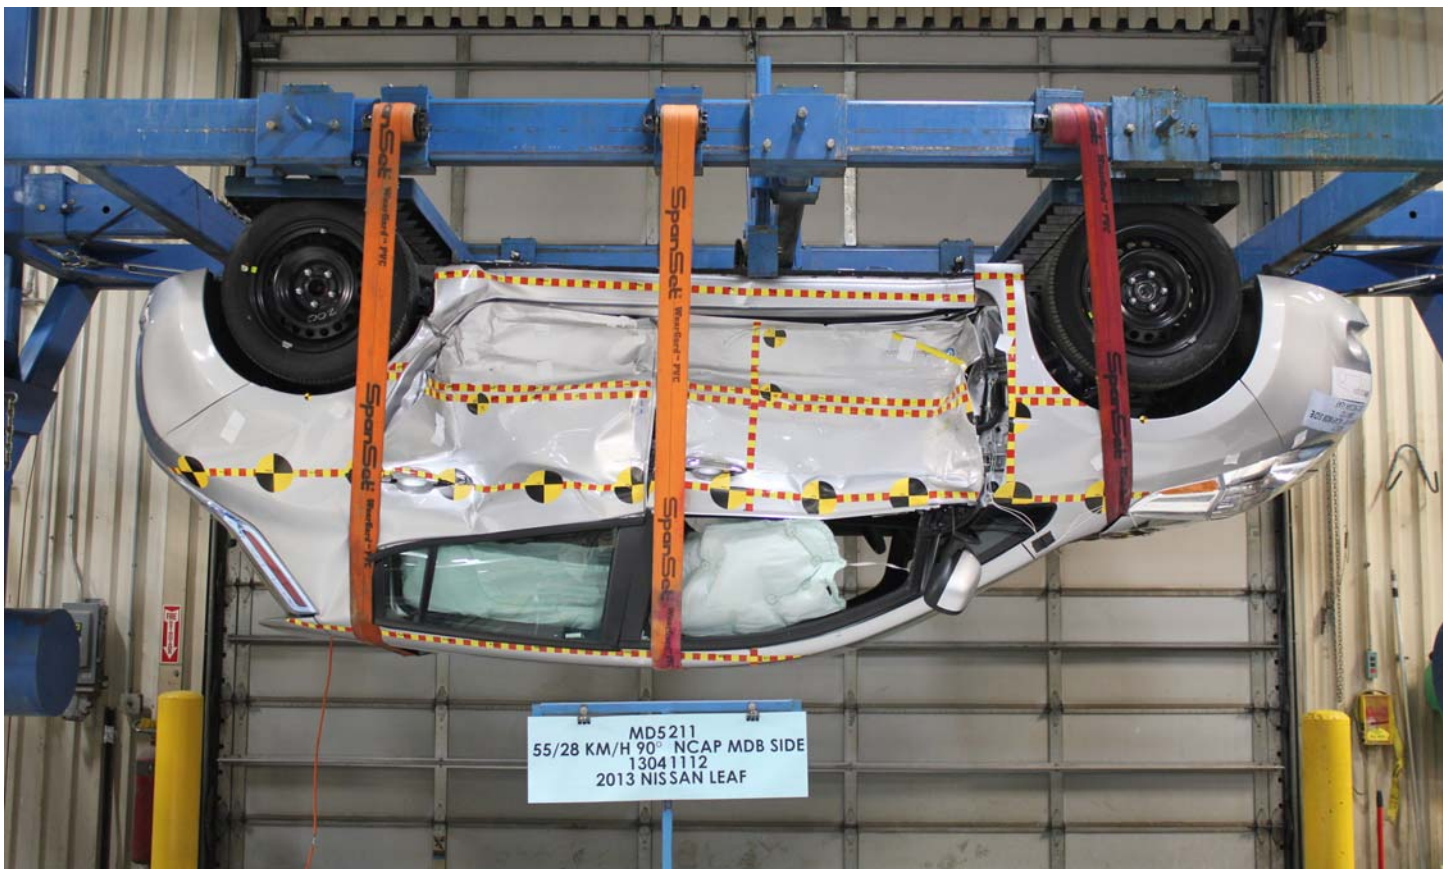
No. 028 FMVSS No. 305 Static Rollover at 90°

| Rollover Stage | Electric Energy Storage/Conversion<br>Device Electrolyte Spillage (L) | Spillage Location |
|---|---|---|
| 0° to 90° | 0 | Not Applicable |

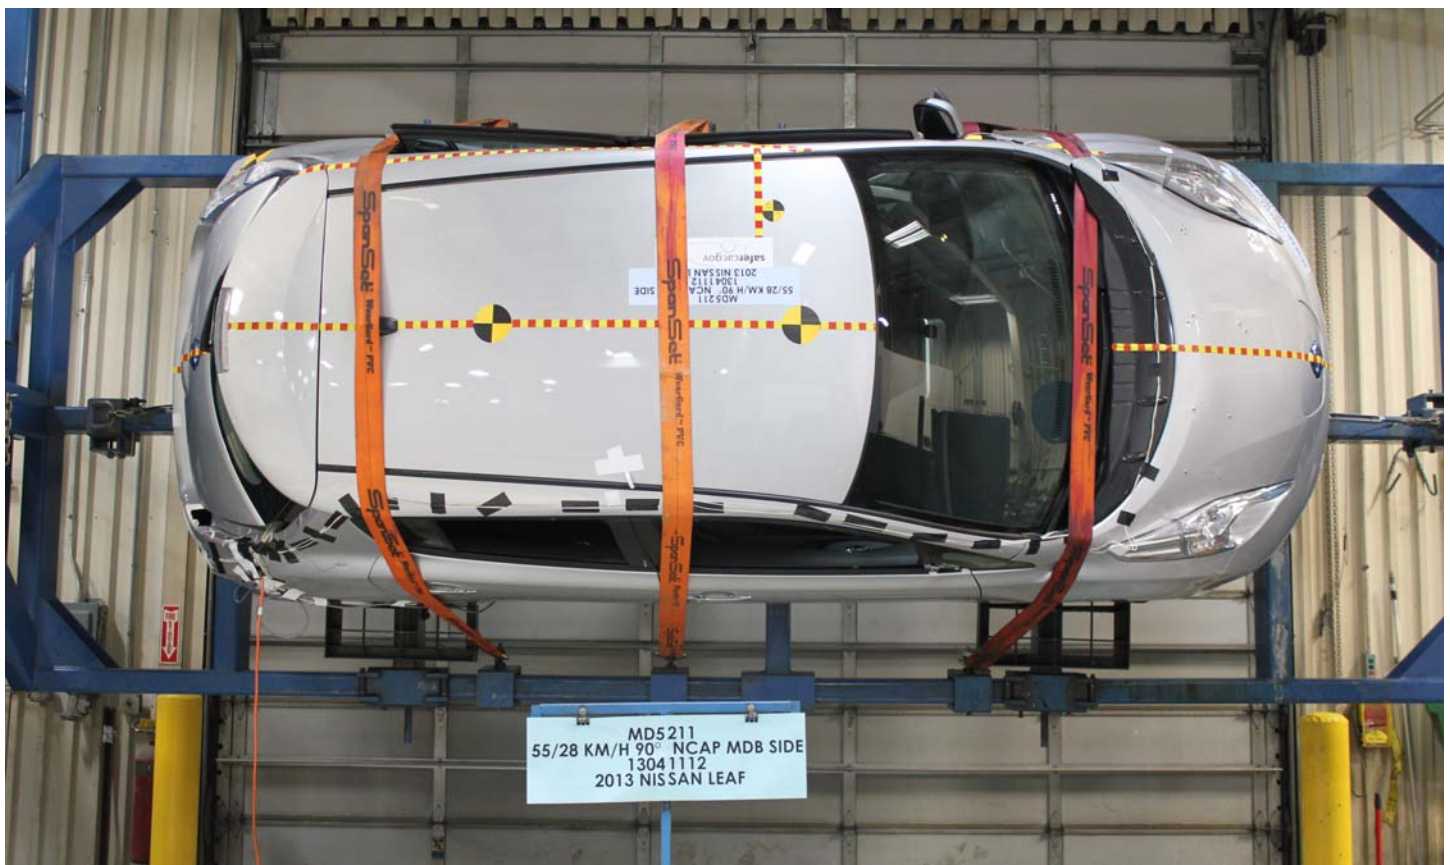
No. 029 FMVSS No. 305 Static Rollover at 180°

| Rollover Stage | Electric Energy Storage/Conversion<br>Device Electrolyte Spillage (L) | Spillage Location |
|---|---|---|
| 90° to 180° | 0 | Not Applicable |

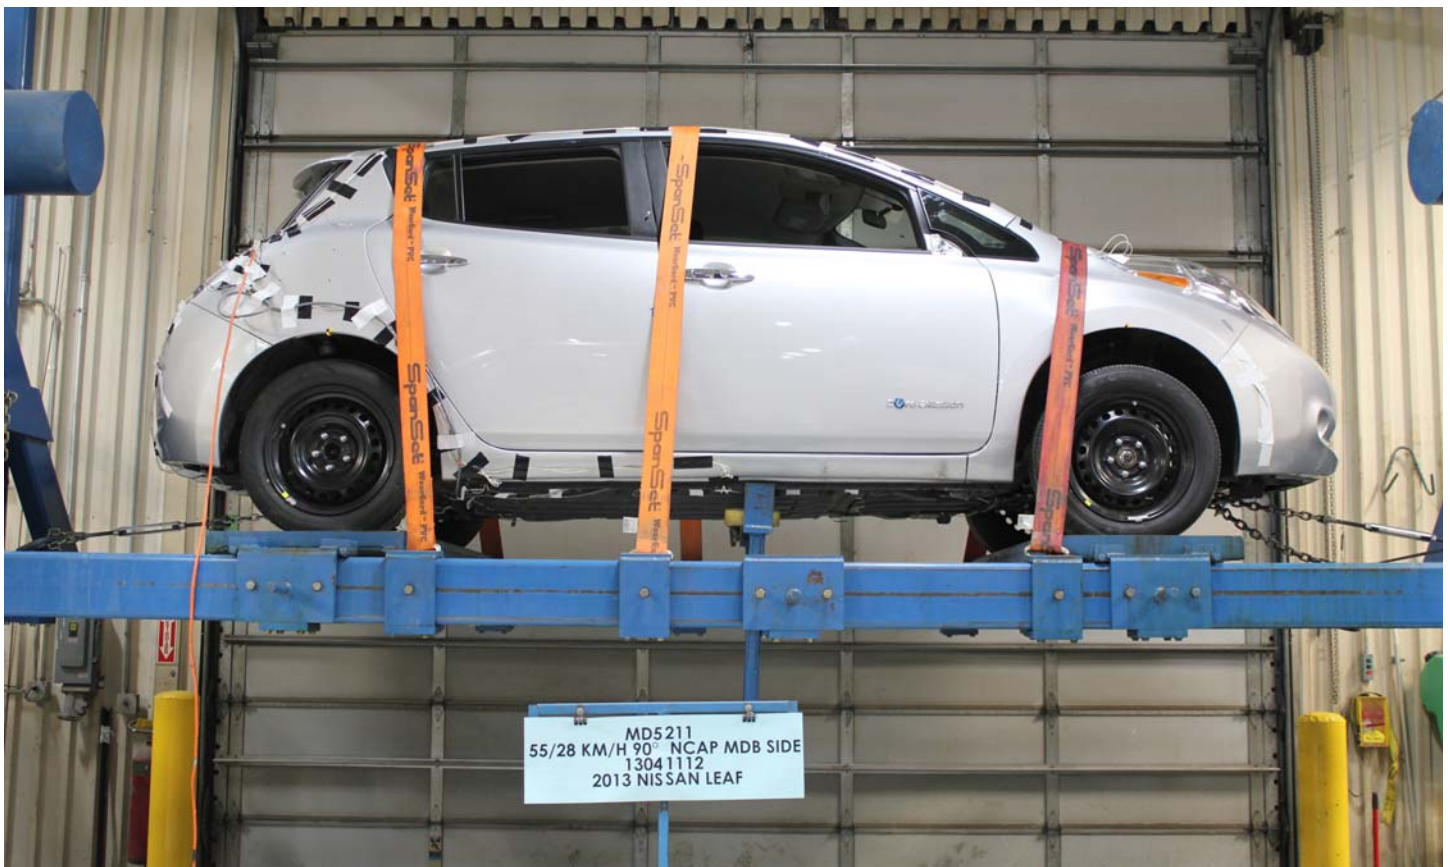
No. 030 FMVSS No. 305 Static Rollover at 270°

| Rollover Stage | Electric Energy Storage/Conversion<br>Device Electrolyte Spillage (L) | Spillage Location |
|---|---|---|
| 180° to 270° | 0 | Not Applicable |
