**REPORT NUMBER: SINCAP-MGA-2013-065**

**NEW CAR ASSESSMENT PROGRAM (NCAP)  
Moving Deformable Barrier Side Impact Test**

**FORD MOTOR COMPANY  
2013 Ford Fusion Energi SE 4-Dr Sedan  
NHTSA No.: MD0222**

**FINAL REPORT**

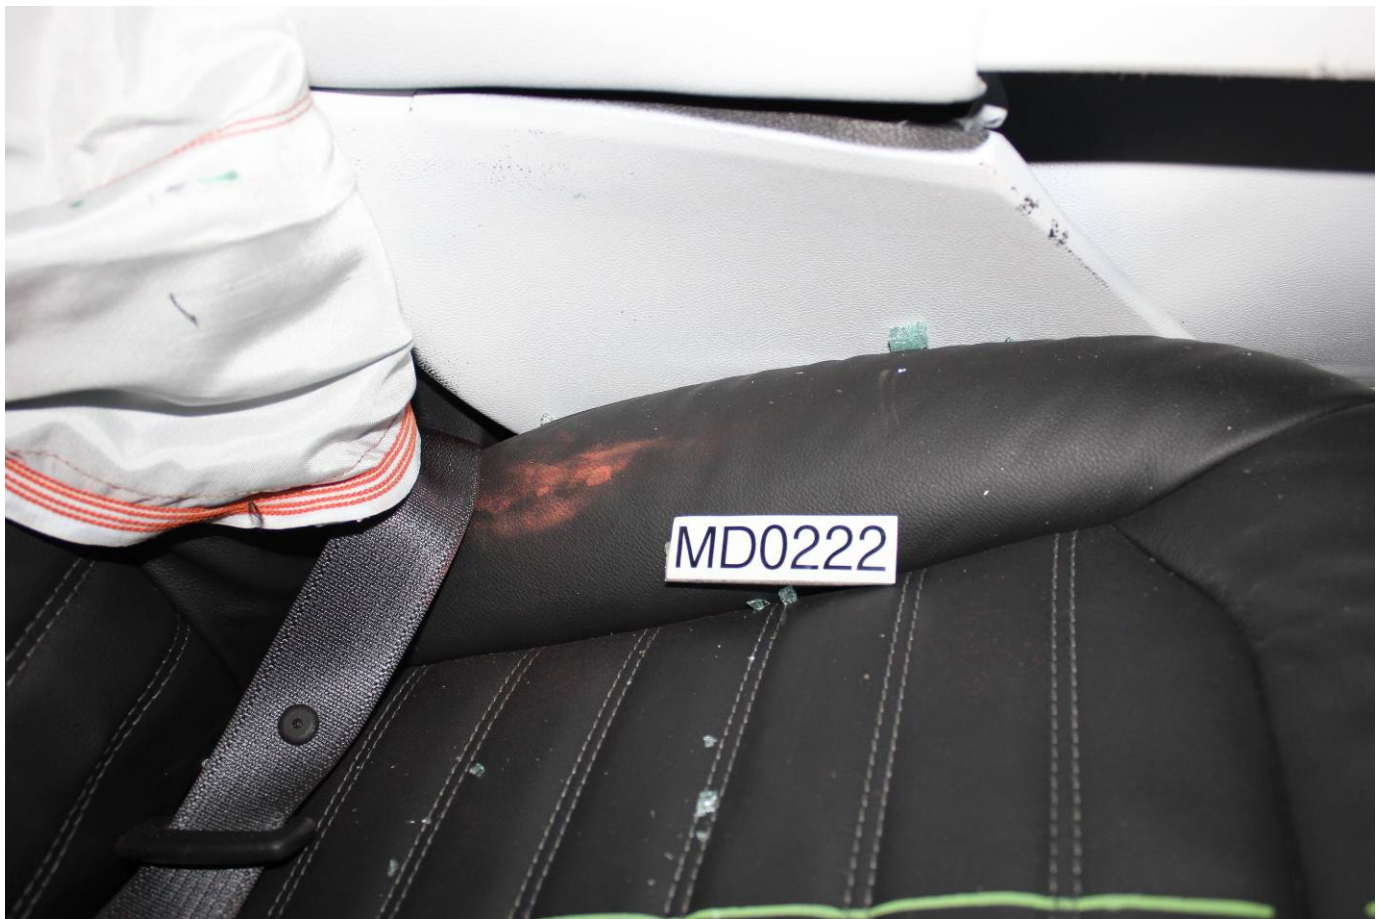
Post-Test Driver Dummy Close-up Torso Contact with Side Airbag View

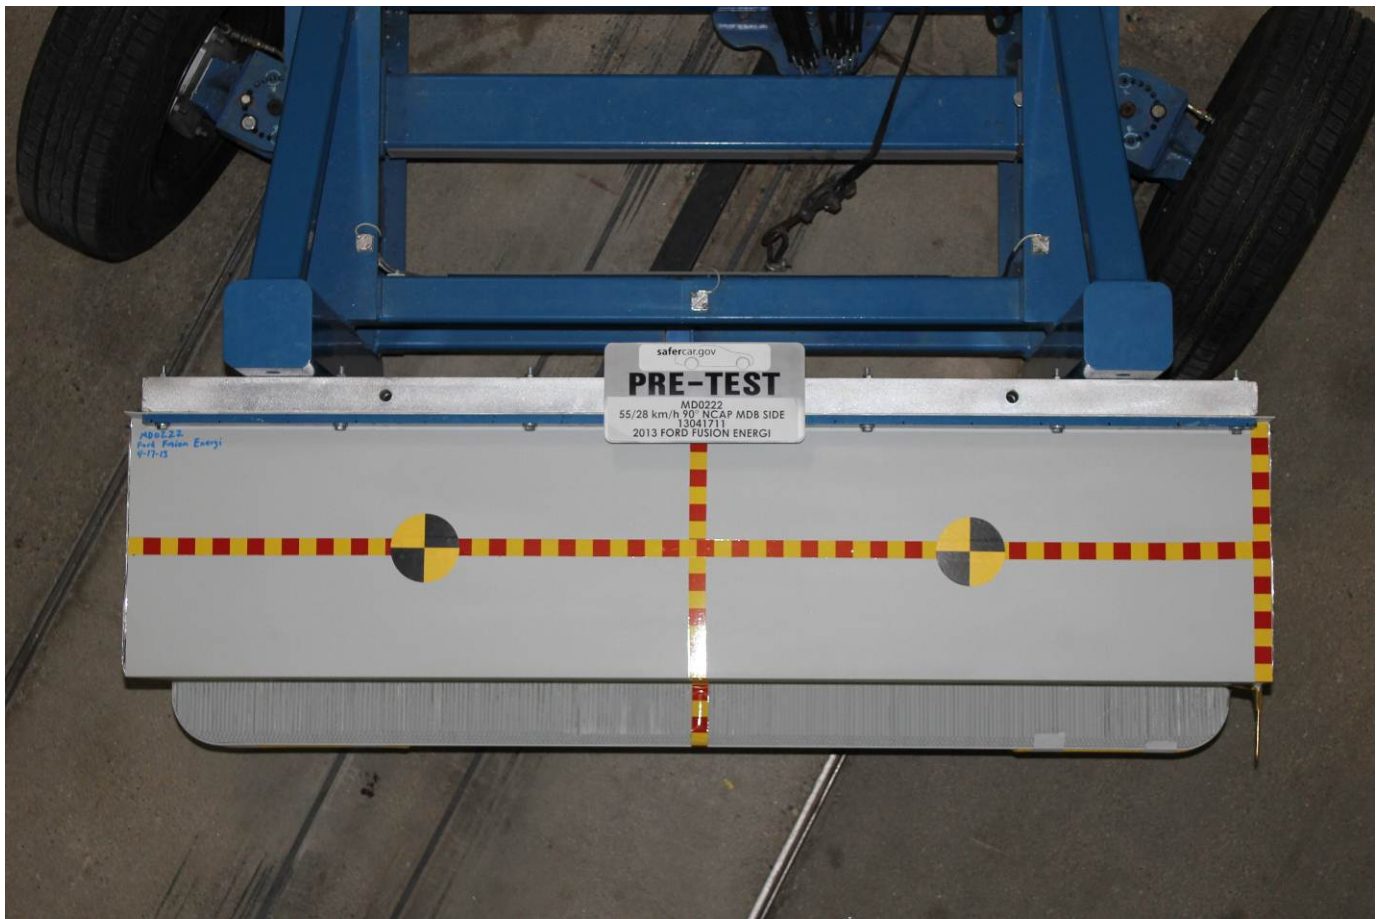
Post-Test Front View of MDB Impactor Face

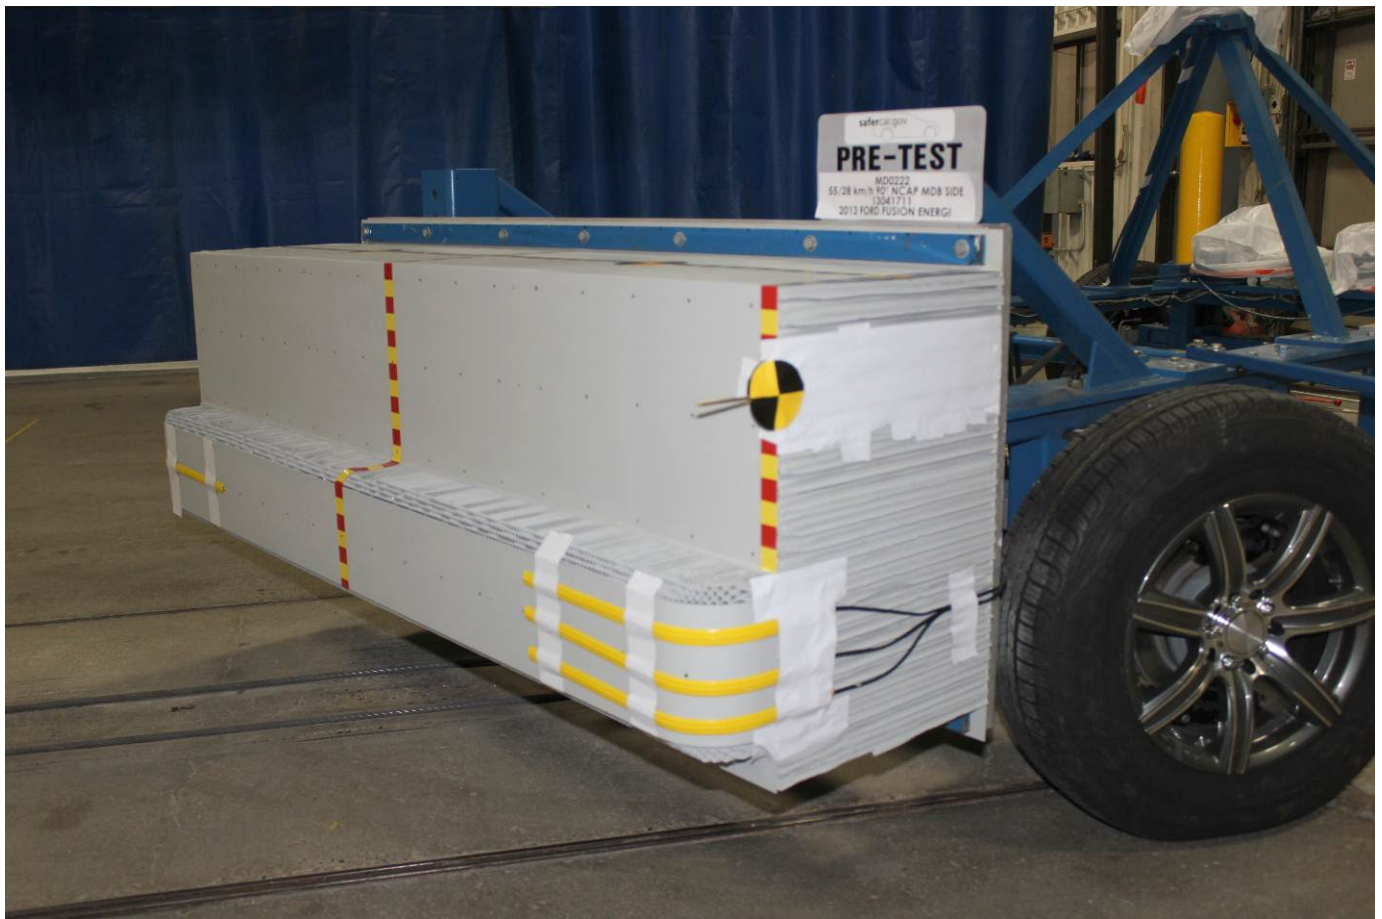
Post-Test Top View of MDB Impactor Face

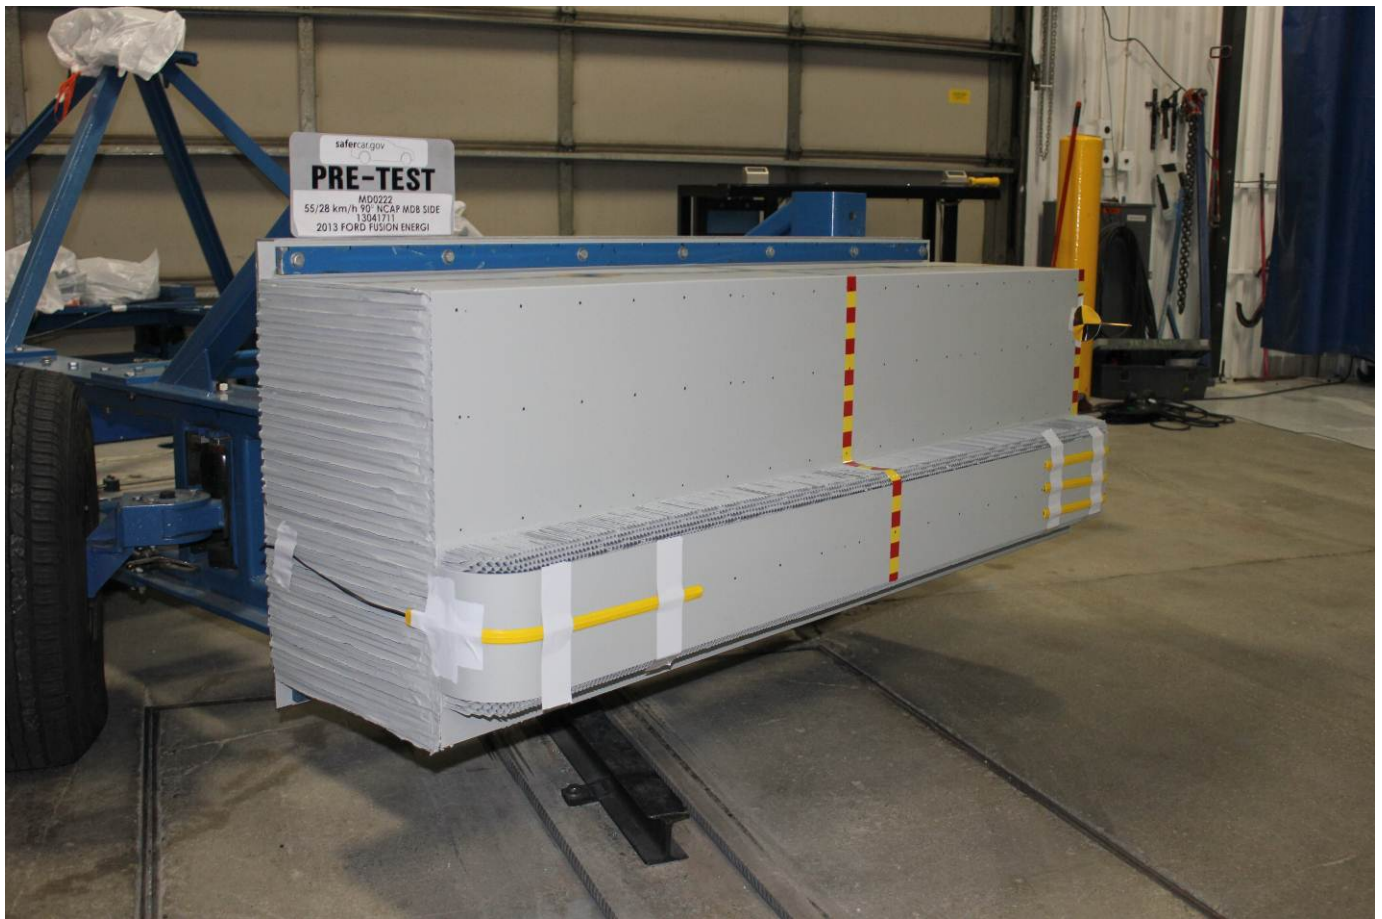
Post-Test Left Side View of MDB Impactor Face
