**NEW CAR ASSESSMENT PROGRAM (NCAP)**  
SIDE AIRBAG OUT-OF-POSITION INJURY TESTING

CHRYSLER GROUP LLC  
2013 JEEP COMPASS  
SPORT 4X4 4-DOOR

NHTSA NUMBER: MD0307TWG2  
TRC TEST NUMBER: S130408

FINAL REPORT

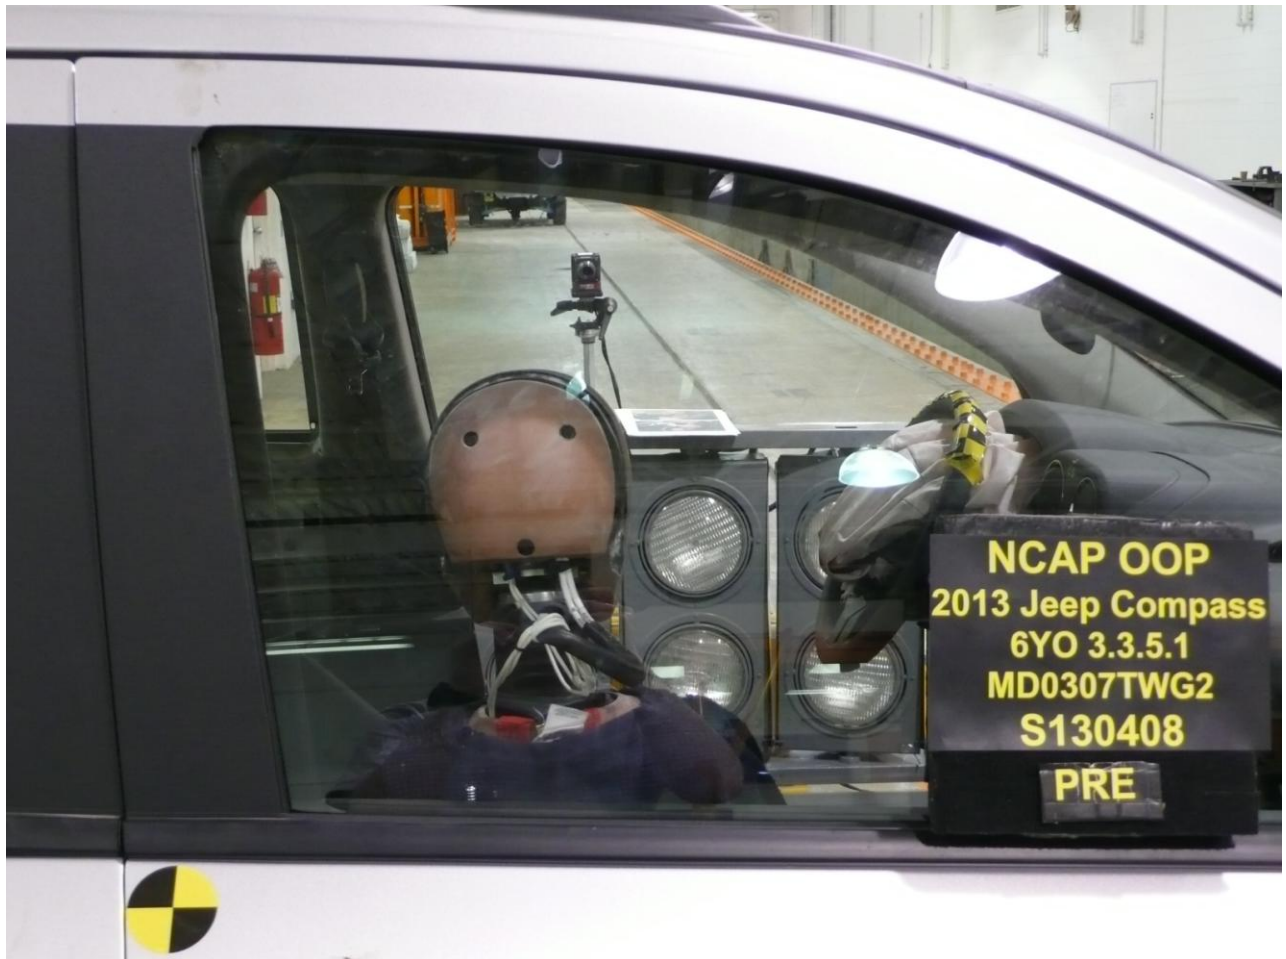
**Figure A-5 Pre-Test Right Front Dummy Position – Right Side View**

The Hybrid III 6-year-old ATD was positioned in the seat on a foam block facing inboard with its arms hanging at its sides and its legs extended. The seat track was positioned forward to minimize the vertical distance between the dummy's head and the roof-rail module and to maximize the cushion to head interaction. The head was kept in its neutral orientation while the dummy's pelvis was slid outboard until the dummy's back contacted the door and the center of gravity of the head was centered in the deployment trajectory of the airbag. A vertical plane through the centerline of the dummy's shoulder bolts was parallel to the vehicle centerline. The dummy's arms were bent at the elbow until the fingers just touched the foam block. This orientation complies with section 3.3.5.1 of the TWG Recommended Procedures for Evaluating Occupant Injury Risk from Deploying Side Airbags, First Revision dated July, 2003.

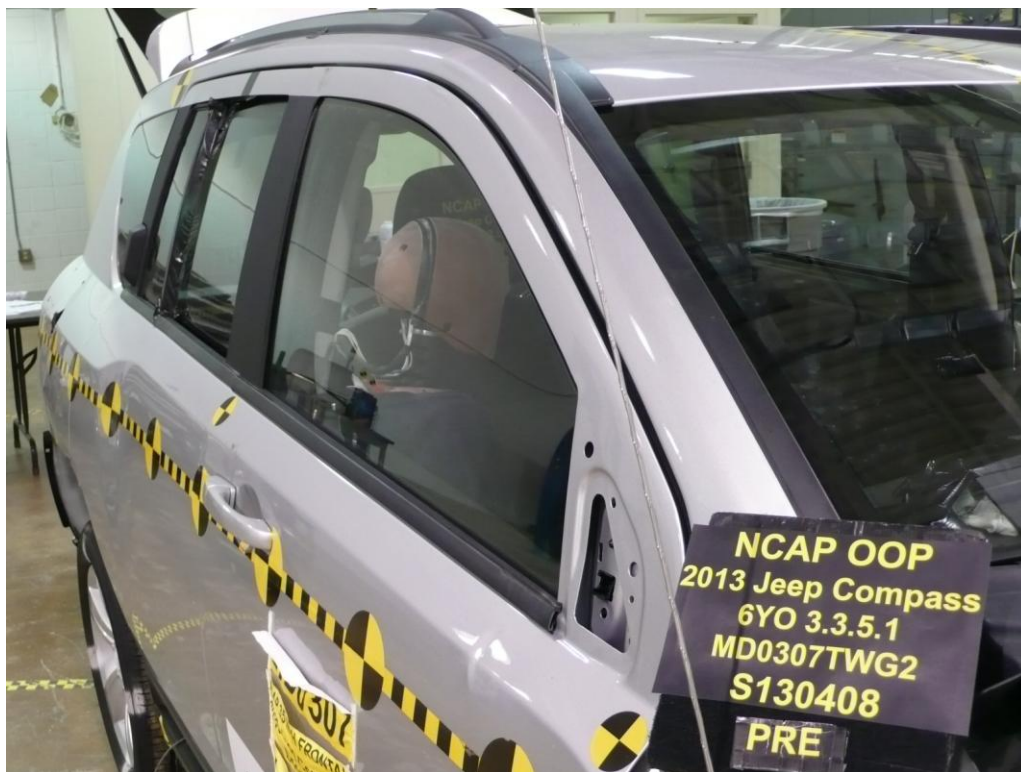
**Figure A-6 Pre-Test Right Front Dummy Position – 3/4 View**

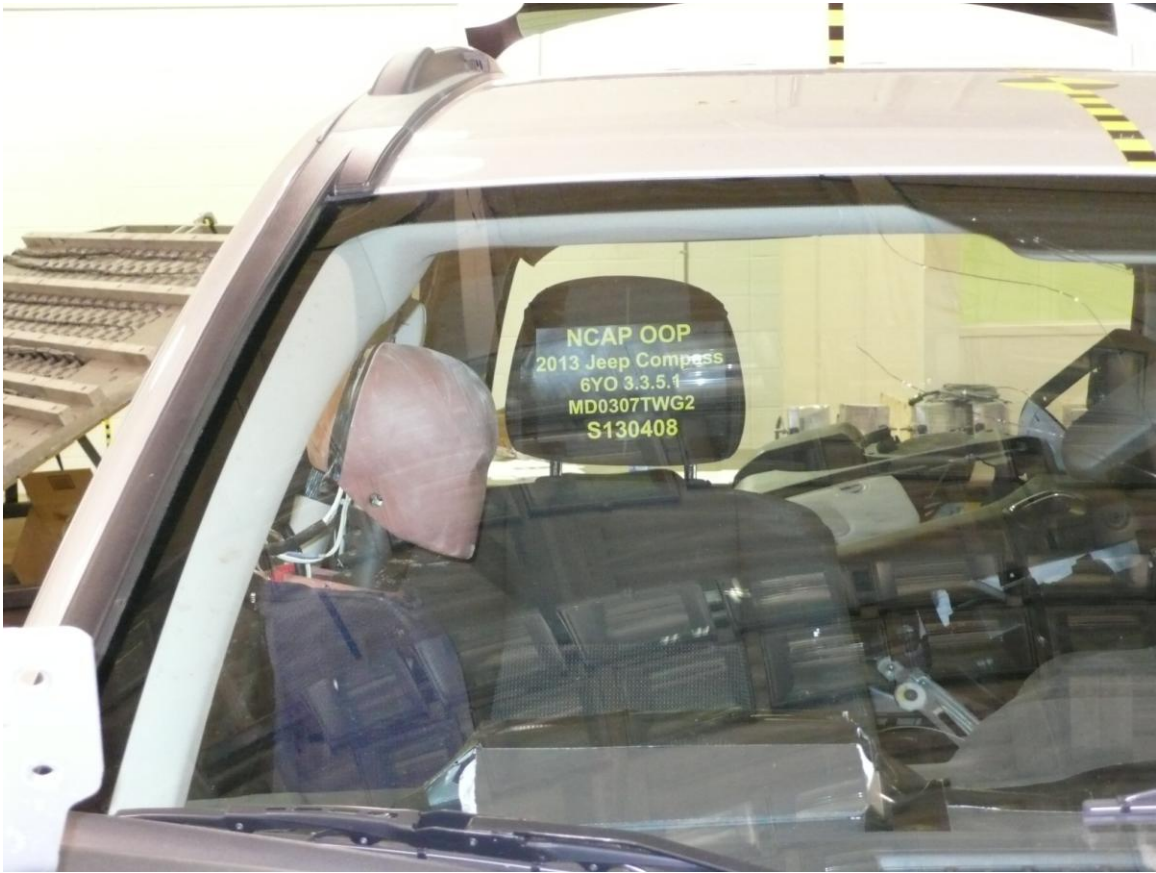
Figure A-7 Pre-Test Right Front Dummy Position – Front View

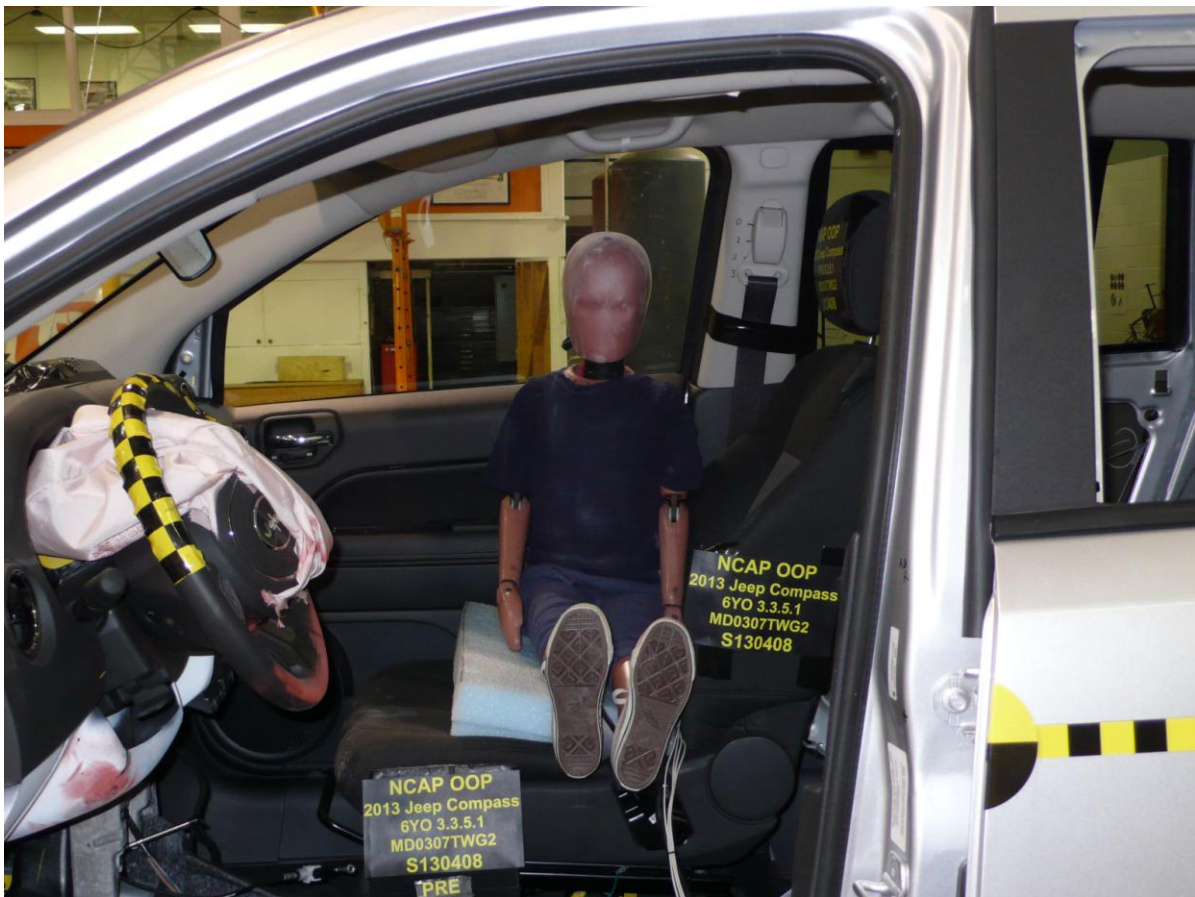
Figure A-8 Pre-Test Right Front Dummy Position – Left Side View

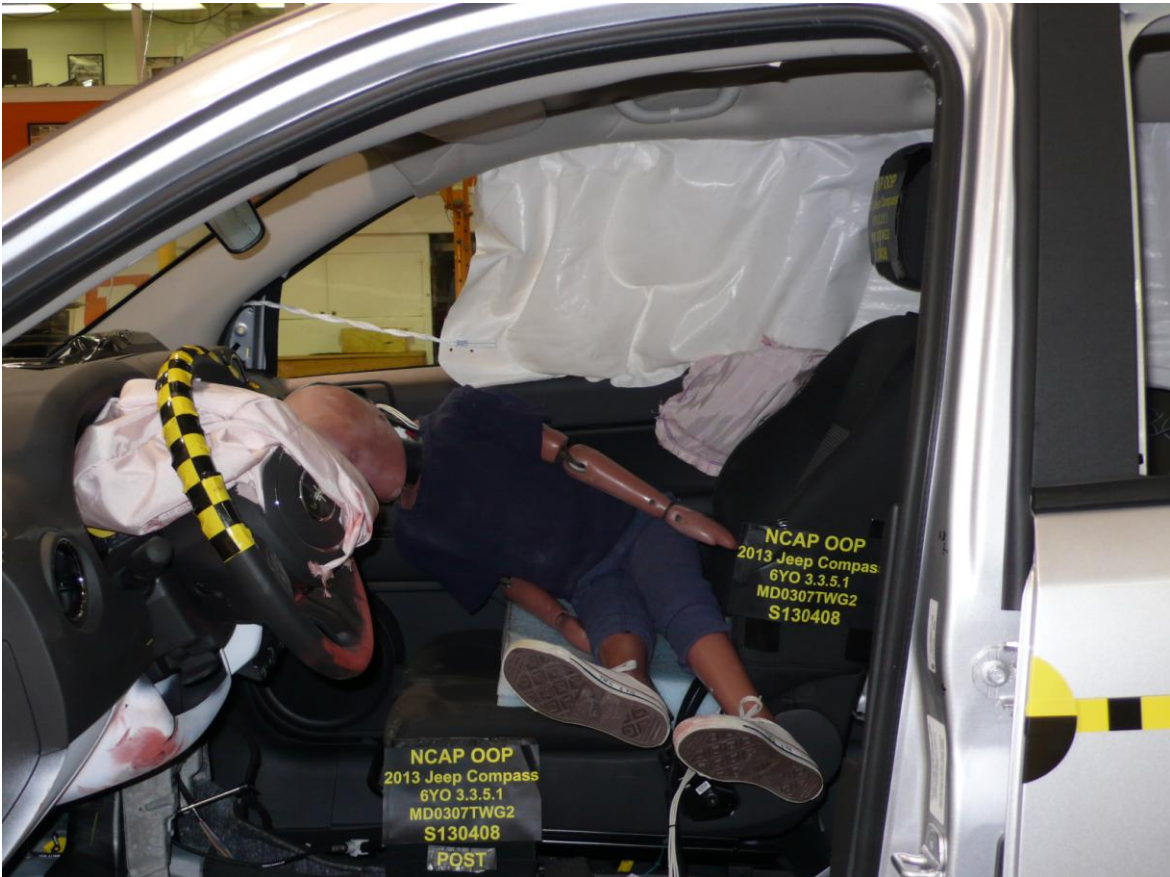
**Figure A-9 Post-Test Right Front Dummy Position – Left Side View**

<b>Head Contact:</b>	Curtain Airbag, I/P
<b>Upper Torso Contact:</b>	Torso Airbag
<b>Lower Torso Contact:</b>	None
<b>Left Knee Contact:</b>	None
<b>Right Knee Contact:</b>	None

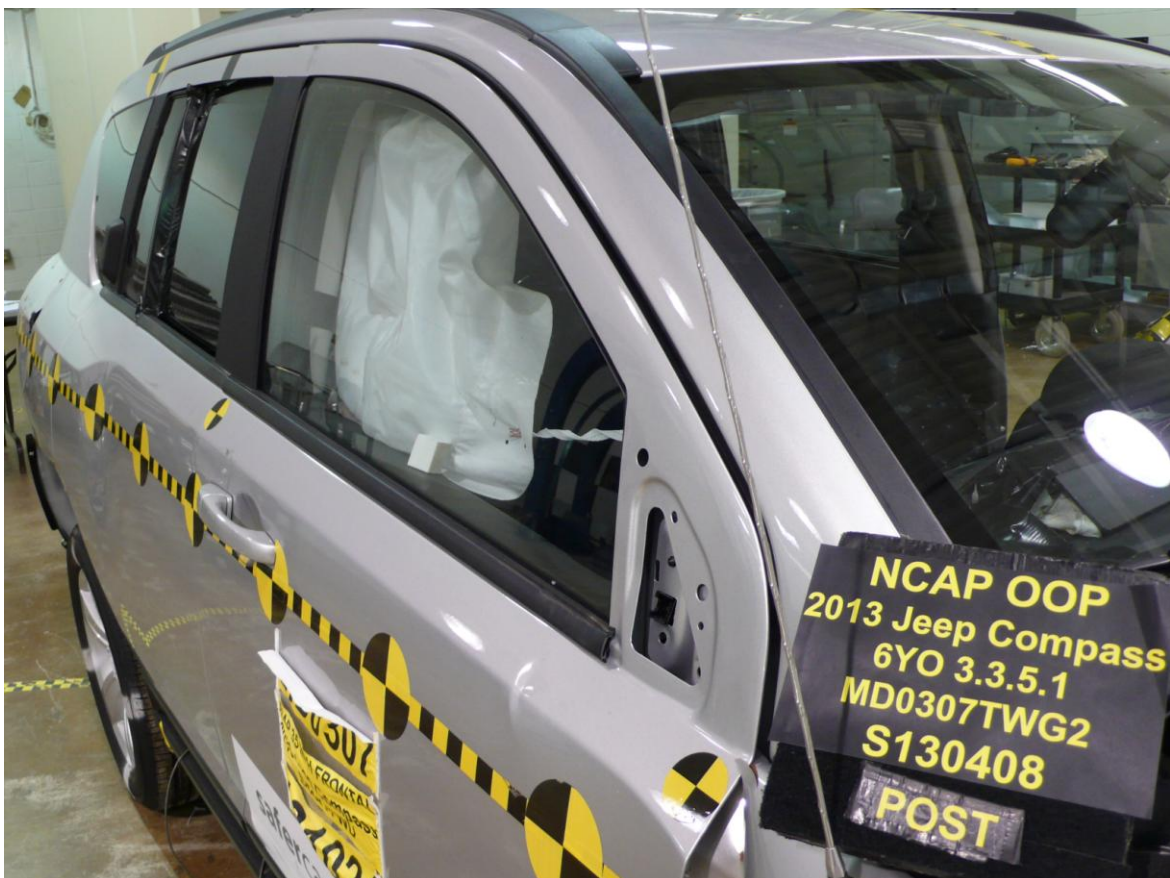
**Figure A-10 Post-Test Right Front Dummy Position – 3/4 View**

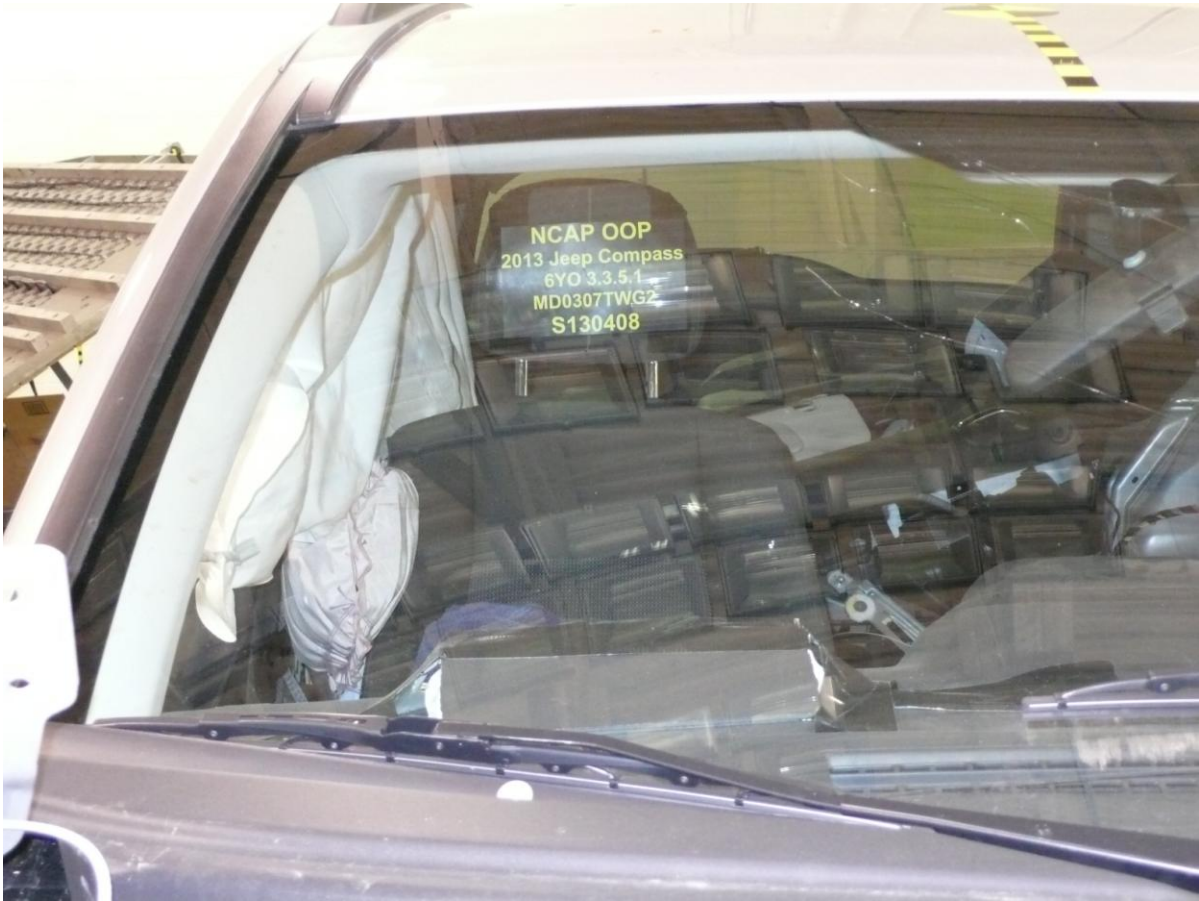
**Figure A-11 Post-Test Right Front Dummy Position – Front View**

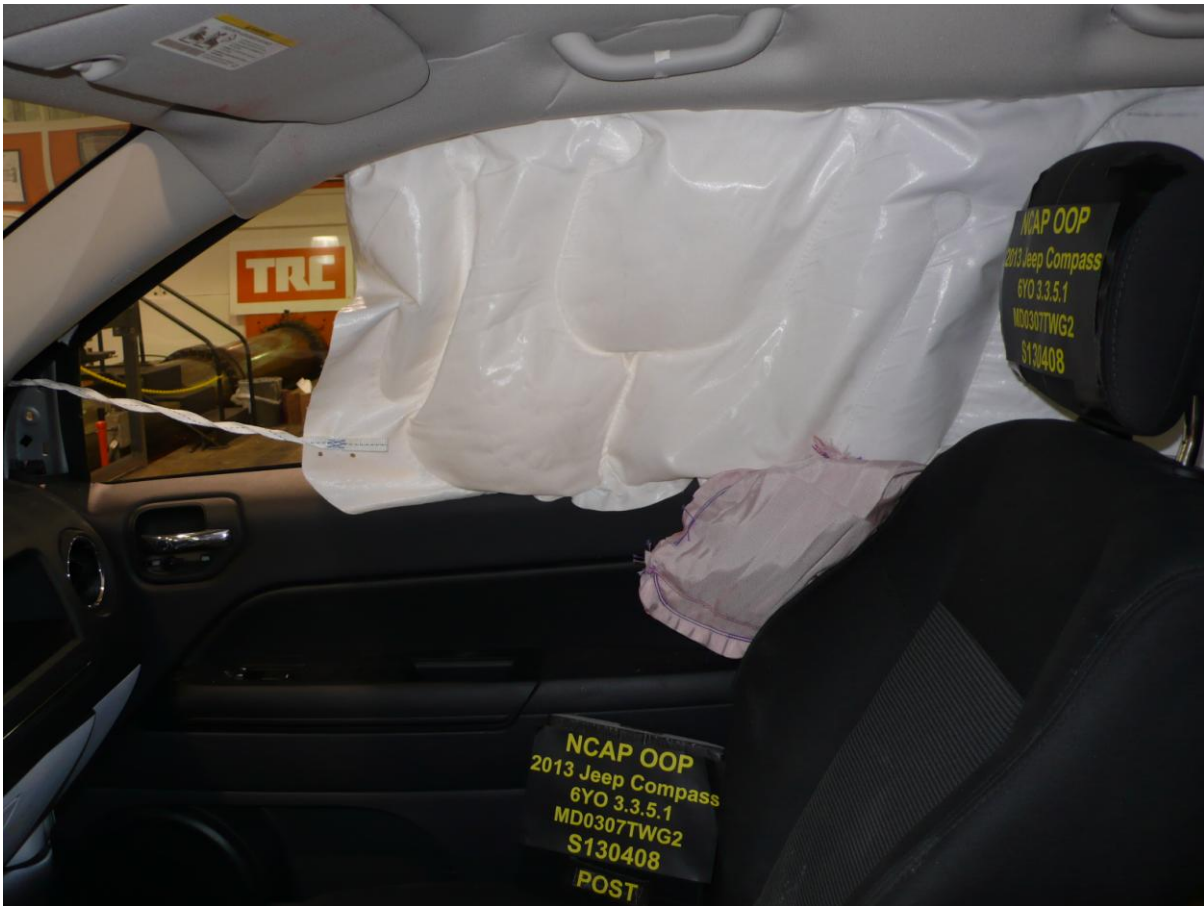
**Figure A-12 Post-Test Front Passenger Airbags – Left Side View**

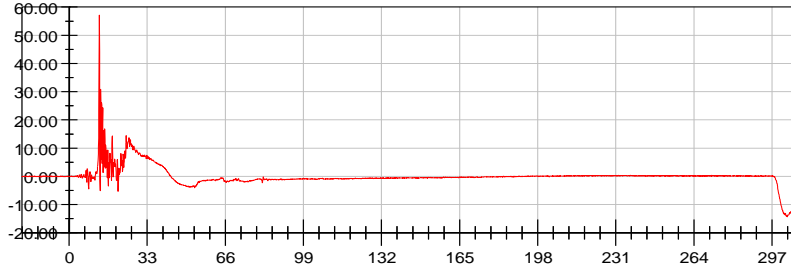
Head Accel X (g) vs. Time [ms]

57.12 g at 12.80 ms

-14.33 g at 303.44 ms

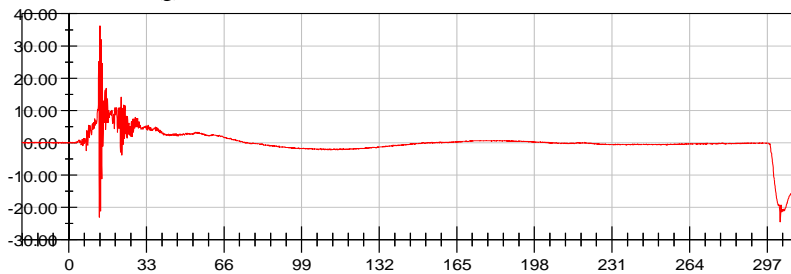
Head Accel Y (g) vs. Time [ms]

36.21 g at 13.20 ms

-24.56 g at 302.56 ms

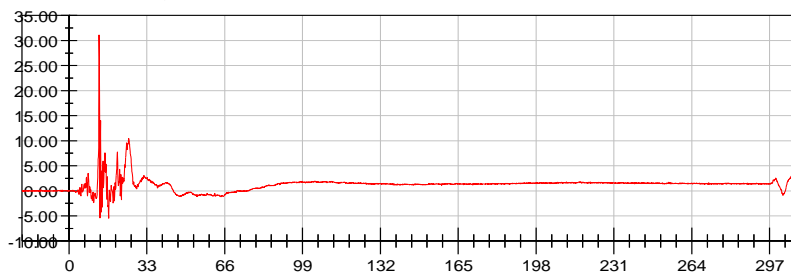
Head Accel Z (g) vs. Time [ms]

31.12 g at 12.80 ms

-5.47 g at 16.80 ms

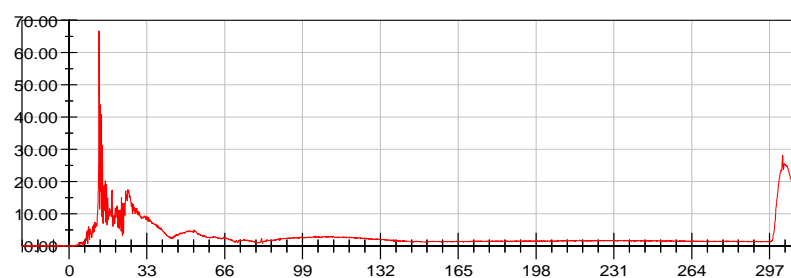
Head Accel Resultant (g) vs. Time [ms]

66.72 g at 12.72 ms

0.04 g at -17.84 ms

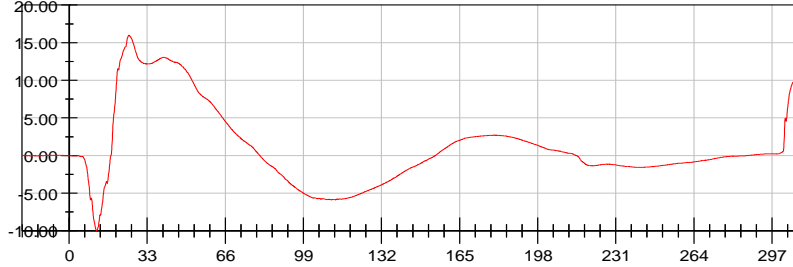
Upper Neck Moment X (Nm) vs. Time [ms]

15.99 Nm at 25.28 ms

-9.99 Nm at 11.60 ms

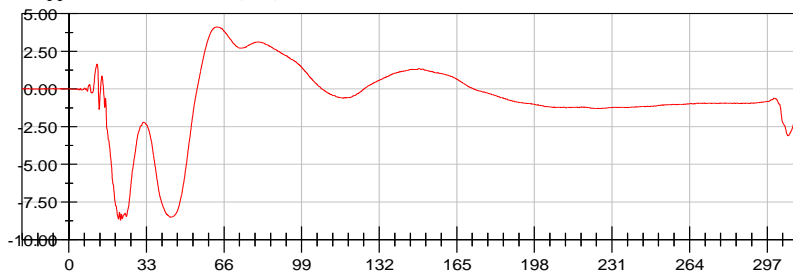
Upper Neck Moment Y (Nm) vs. Time [ms]

4.11 Nm at 63.04 ms

-8.72 Nm at 22.00 ms

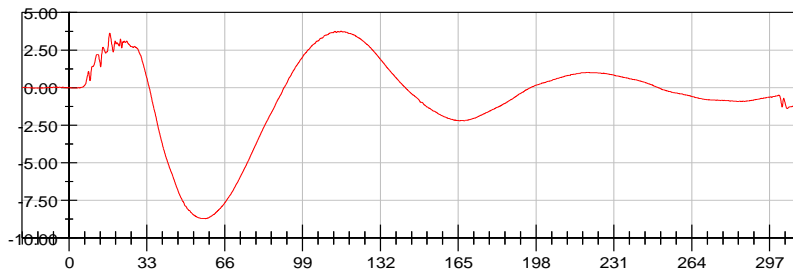
Upper Neck Moment Z (Nm) vs. Time [ms]

3.76 Nm at 115.36 ms

-8.71 Nm at 57.92 ms

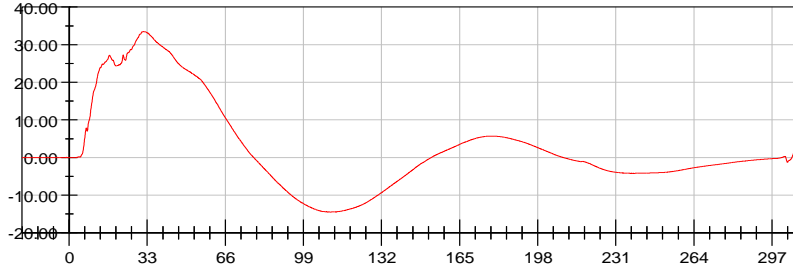
Lower Neck Moment X (Nm) vs. Time [ms]

33.49 Nm at 31.52 ms

-14.50 Nm at 110.40 ms

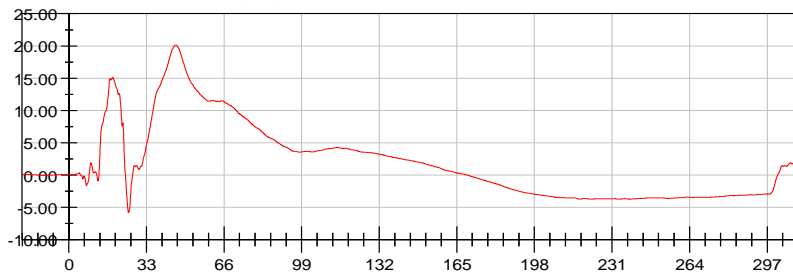
Lower Neck Moment Y (Nm) vs. Time [ms]

20.11 Nm at 45.60 ms

-5.85 Nm at 25.36 ms

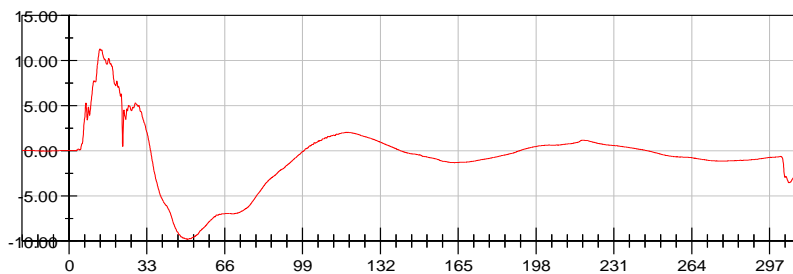
Lower Neck Moment Z (Nm) vs. Time [ms]

11.29 Nm at 13.12 ms

-9.82 Nm at 50.16 ms
