REPORT NUMBER: TWG-CAL-13-03

NEW CAR ASSESSMENT PROGRAM (NCAP)
SIDE AIRBAG OUT-OF-POSITION INJURY TESTING

Chrysler Group LLC
2013 Dodge Dart
Four Door Sedan

NHTSA NUMBER: MD0303TWG3
CALSPAN TEST NUMBER: CT2013-03

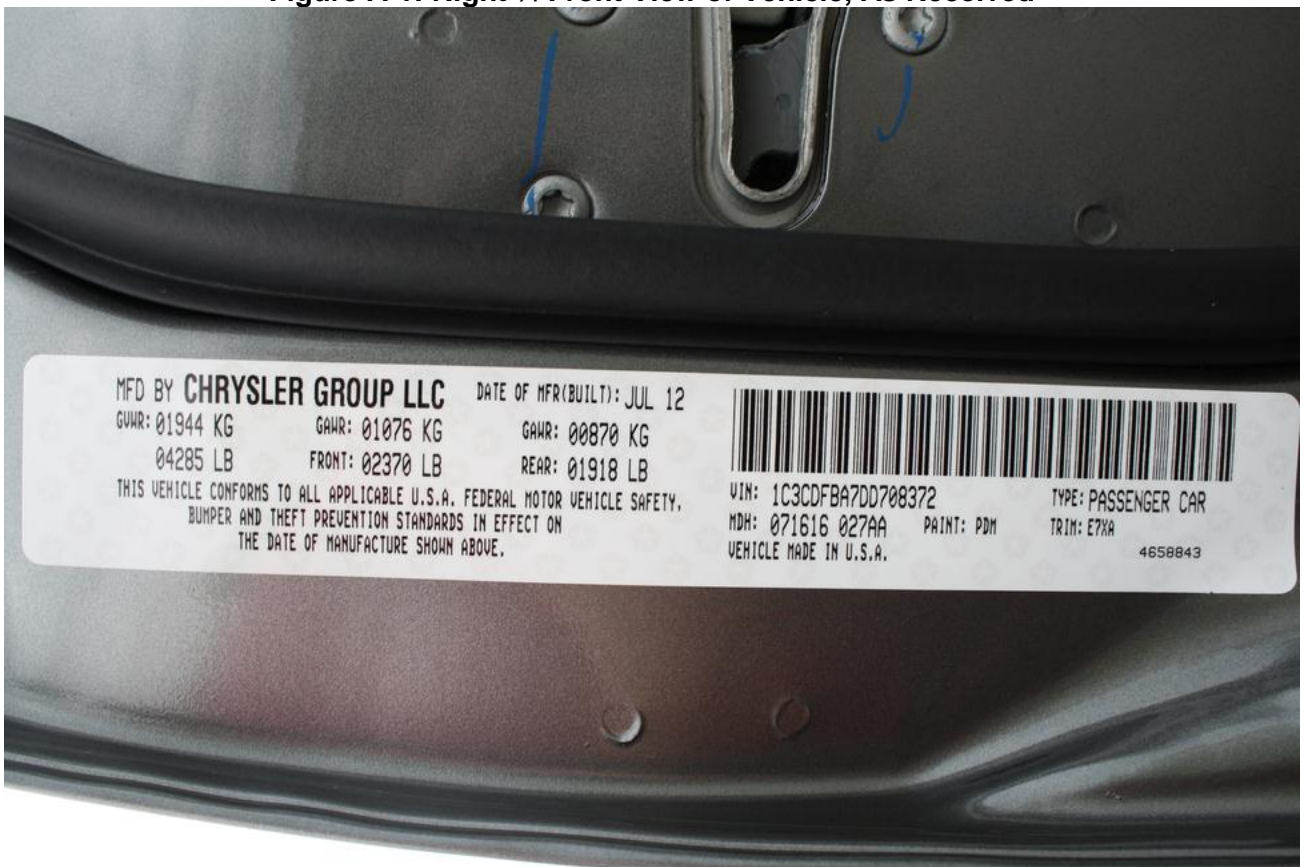
Figure A-2: Vehicle Certification Placard

Vehicle Manufactured by: Chrysler Group LLC
Date of Manufacture 07/12
GVWR: 1944 kg; GAWR: 1076 kg FRONT; 870 kg REAR

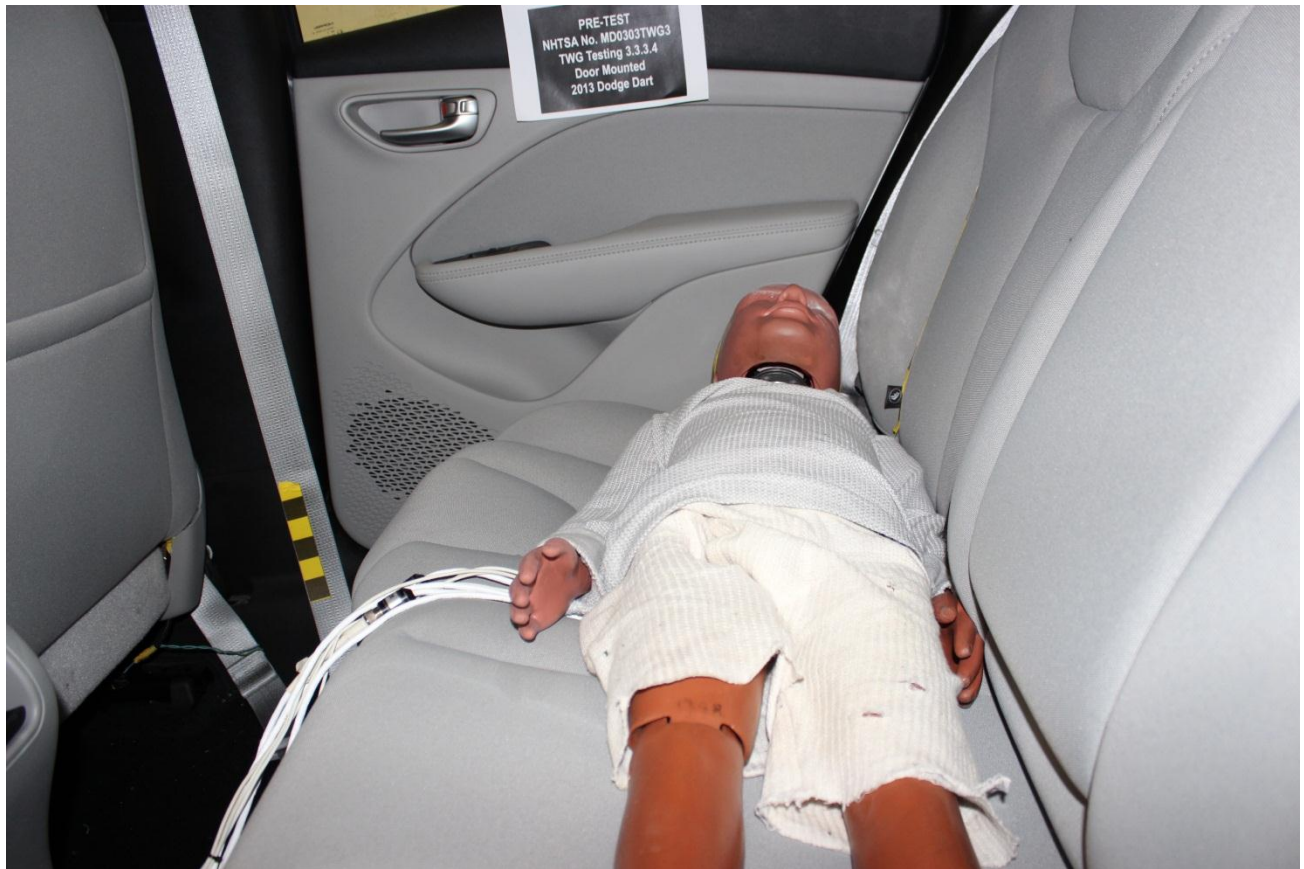
Figure A-5: Pre-Test 3YO Dummy Left Side View

The HIII-3YO ATD was positioned facing upwards on the right rear (passenger) seat lying cross car with its head against the right rear door. The seat track was adjusted to locate the head c.g. on top of the expected deployment location of a head curtain chamber to maximize the airbag to head interaction. The location was determined by observing test data from the previous left side impact test on this vehicle. While keeping the head in neutral orientation, the ATD's body was moved outboard until the dummy's head contacted the door trim panel armrest. The center of gravity of the head was centered in the deployment trajectory of the airbag. The ATD's arms were straight at its side. This orientation complies with section 3.3.3.4 of the TWG Recommended Procedures for Evaluating Occupant Injury Risk from Deploying Side Airbags as defined by Lund, et al and the Technical Working Group First Revision dated July, 2003.

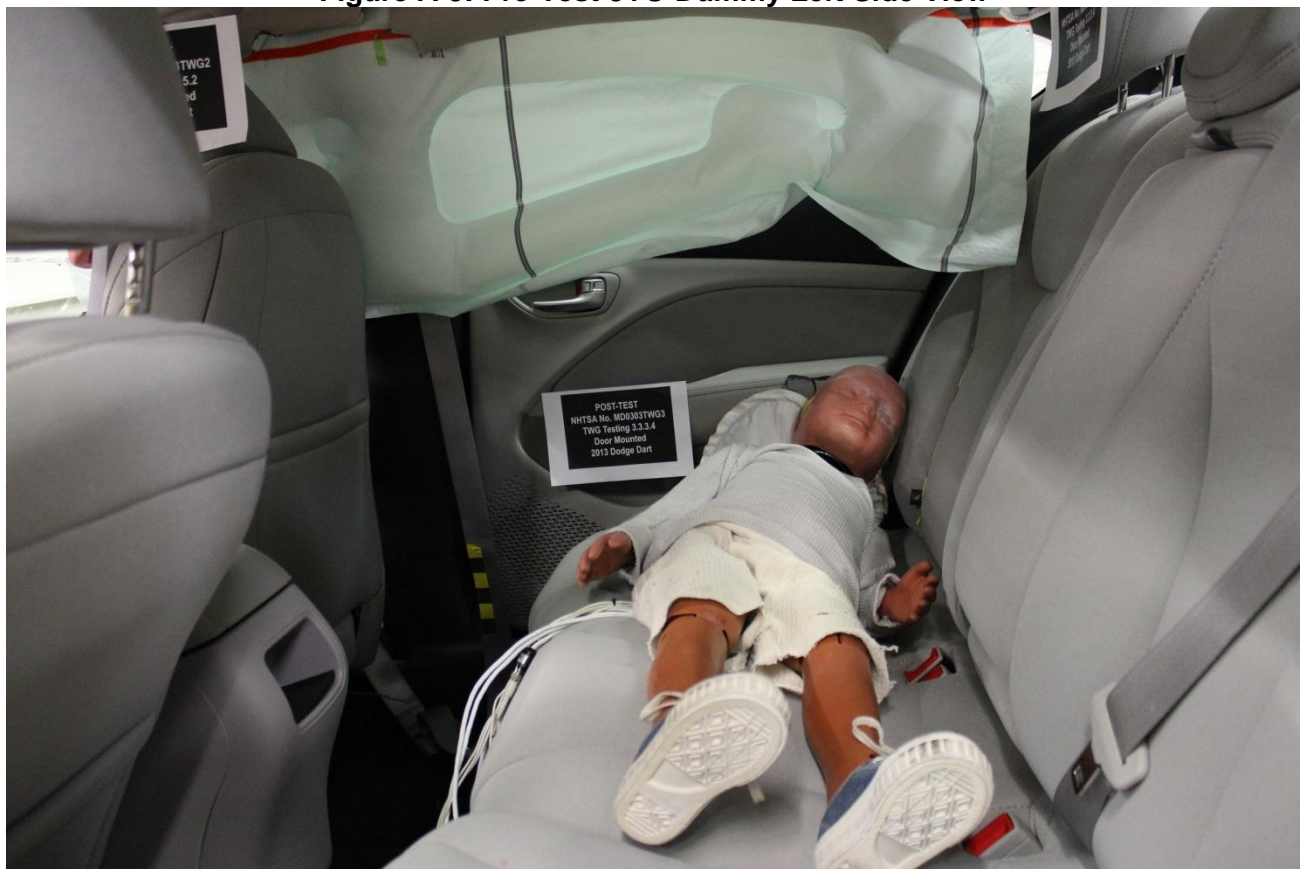
Figure A-6: Post-Test 3YO Dummy Left Side View

Head Contact:	Pelvis Airbag & Seat Back
Upper Torso Contact:	Seat Bottom & Seat Back
Lower Torso Contact:	Seat Bottom
Left Knee Contact:	None
Right Knee Contact:	None

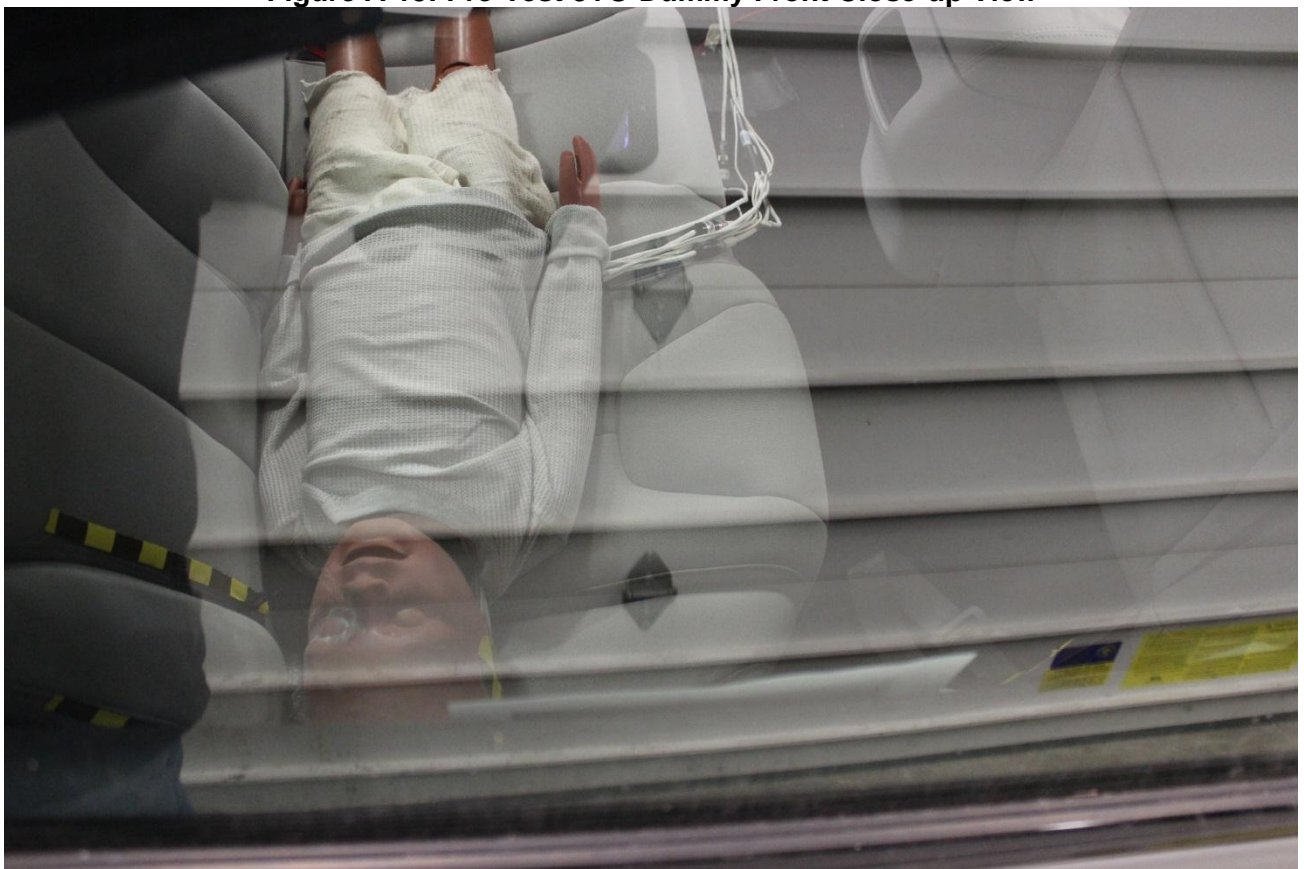
Figure A-16: Pre-Test 3YO Dummy Right Side View

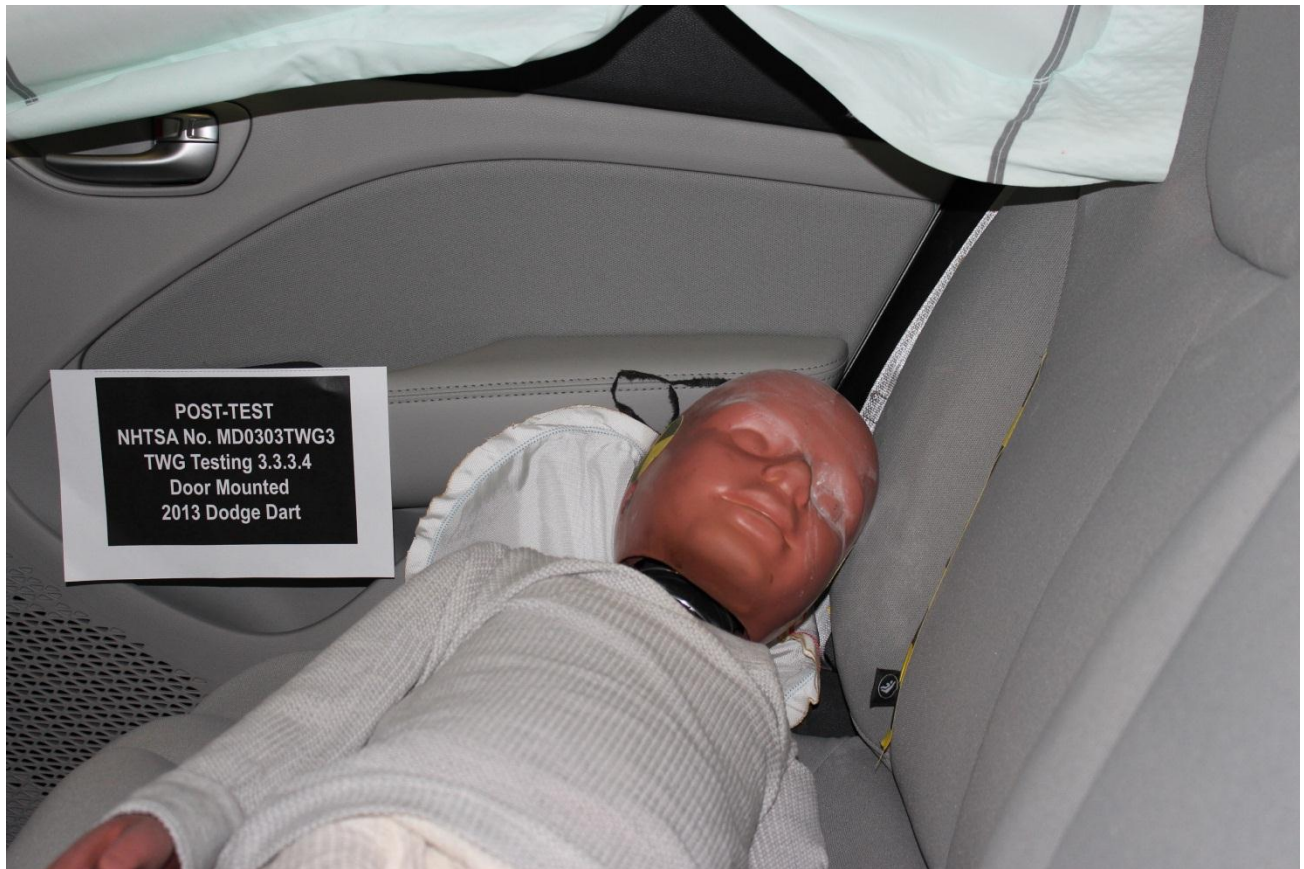
Figure A-17: Post-Test Curtain Airbag Left Side View

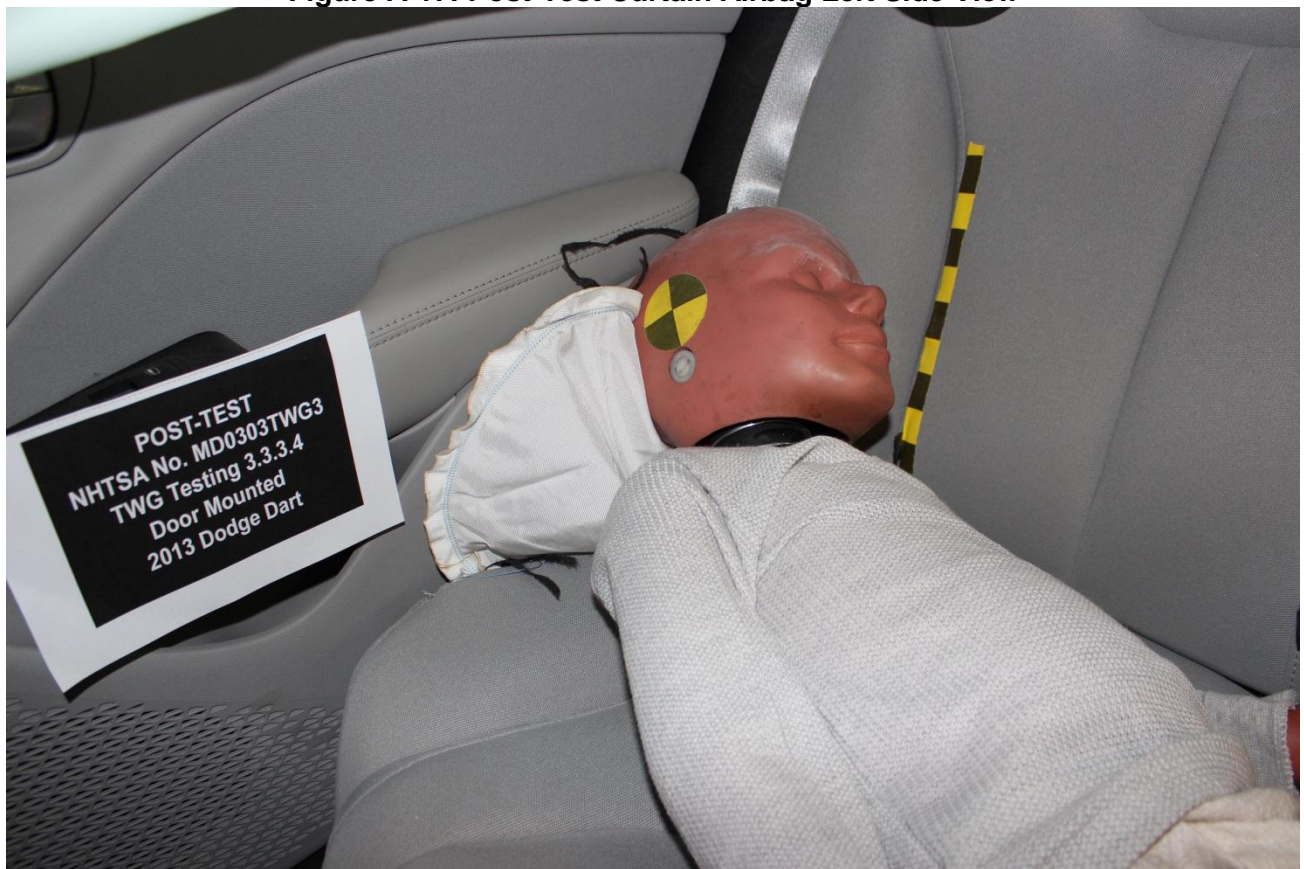
Figure A-18: Post-Test Curtain Airbag Left $\frac{3}{4}$ Front View

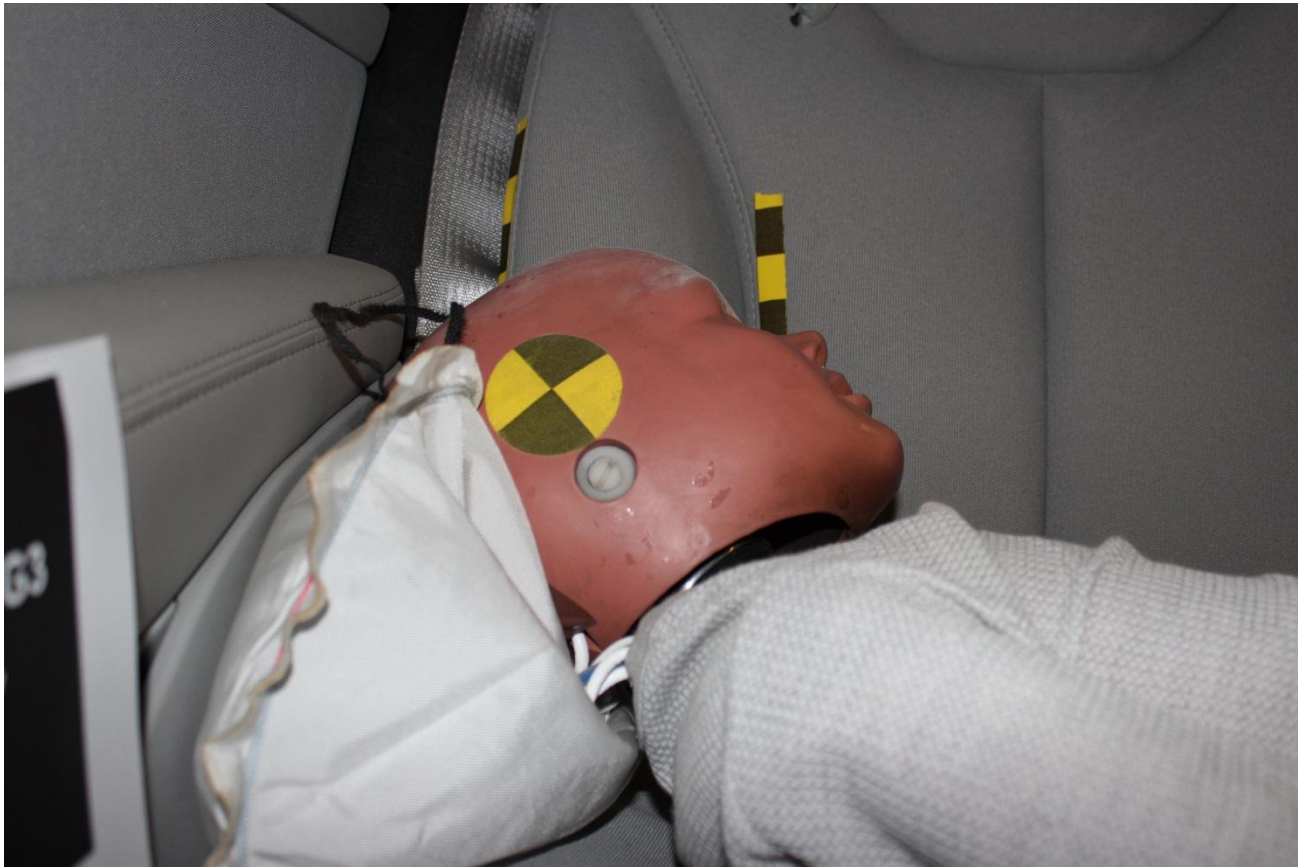
Figure A-19: Post-Test Curtain Airbag Front View

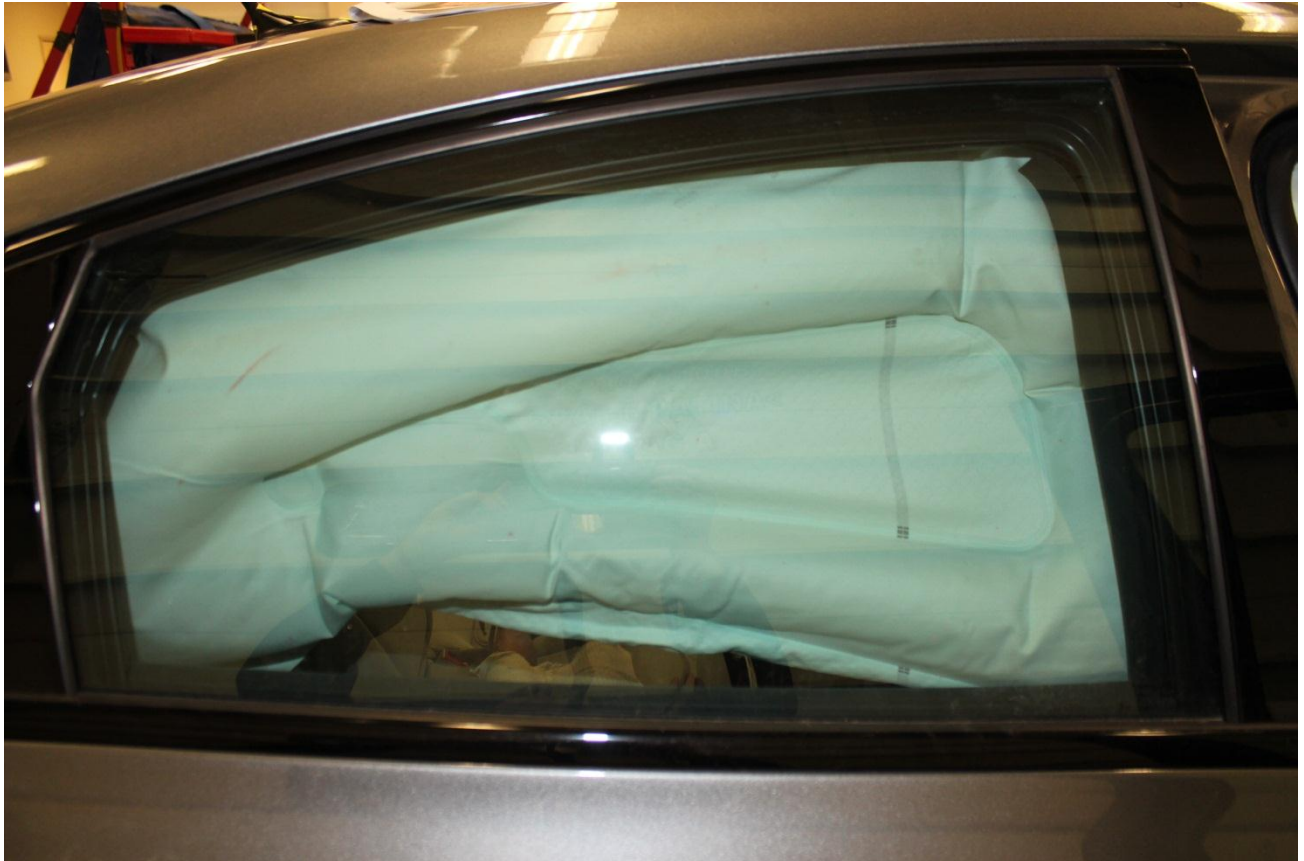
Figure A-20: Post-Test Curtain Airbag Right Side View
