REPORT NUMBER: TWG-CAL-13-07

**NEW CAR ASSESSMENT PROGRAM (NCAP)**  
SIDE AIRBAG OUT-OF-POSITION INJURY TESTING

**Toyota Motor Manufacturing, Texas, Inc**  
**2013 Toyota Tacoma 4x2**  
**Access Cab Pickup**

NHTSA NUMBER: MD5120TWG2  
CALSPAN TEST NUMBER: CT2013-07

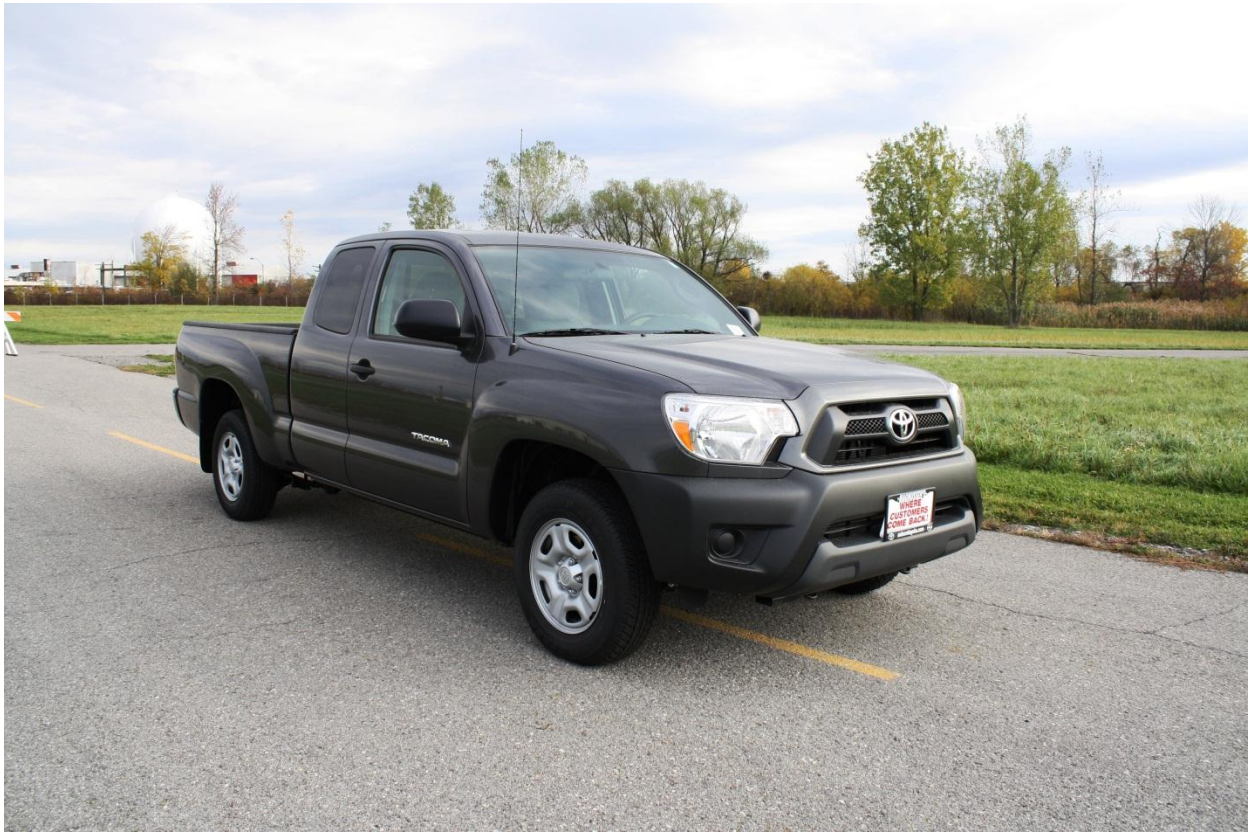
**Figure A-1: Right ¾ Front View of Vehicle, As Received**

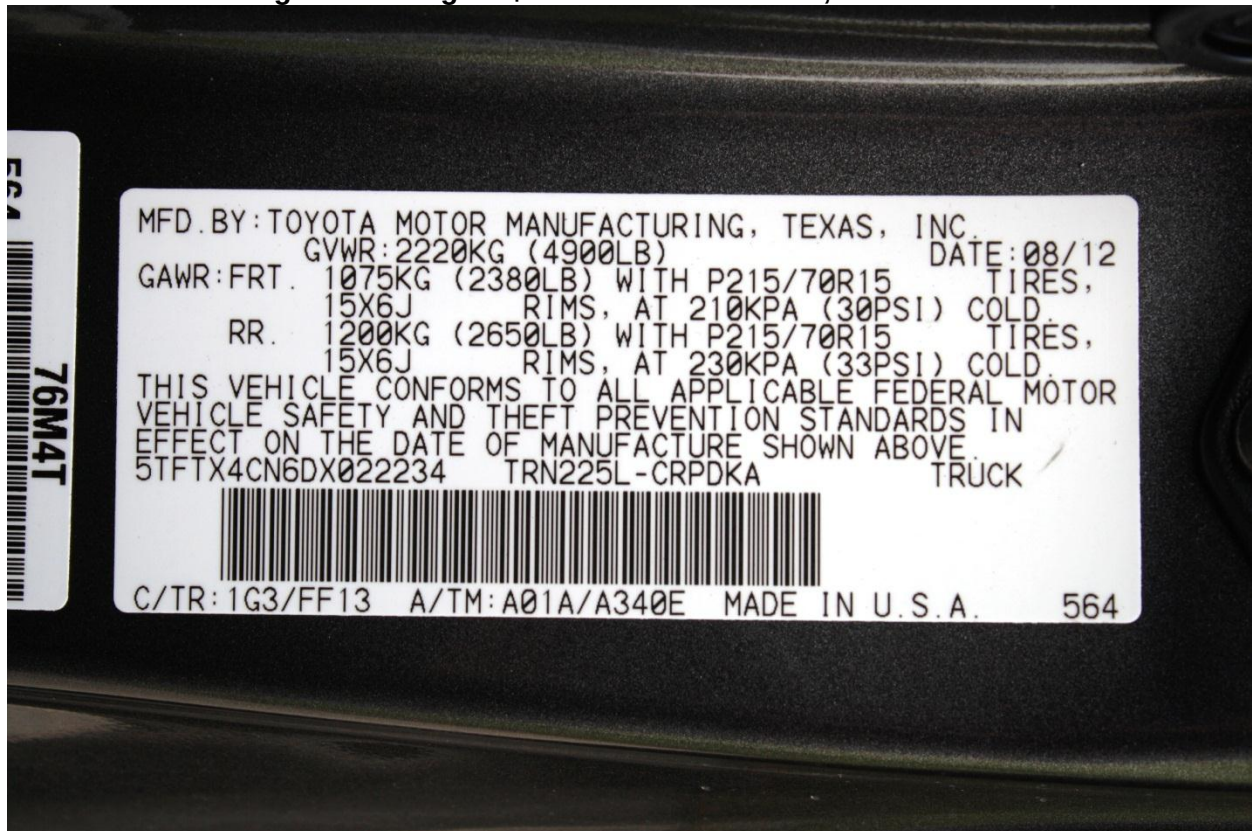
**Figure A-2: Vehicle Certification Placard**

Vehicle Manufactured by: Toyota Motor Manufacturing Texas INC

Date of Manufacture 08/12

GVWR: 2,220 kg; GAWR: 1,075 kg FRONT; 1,200 kg REAR

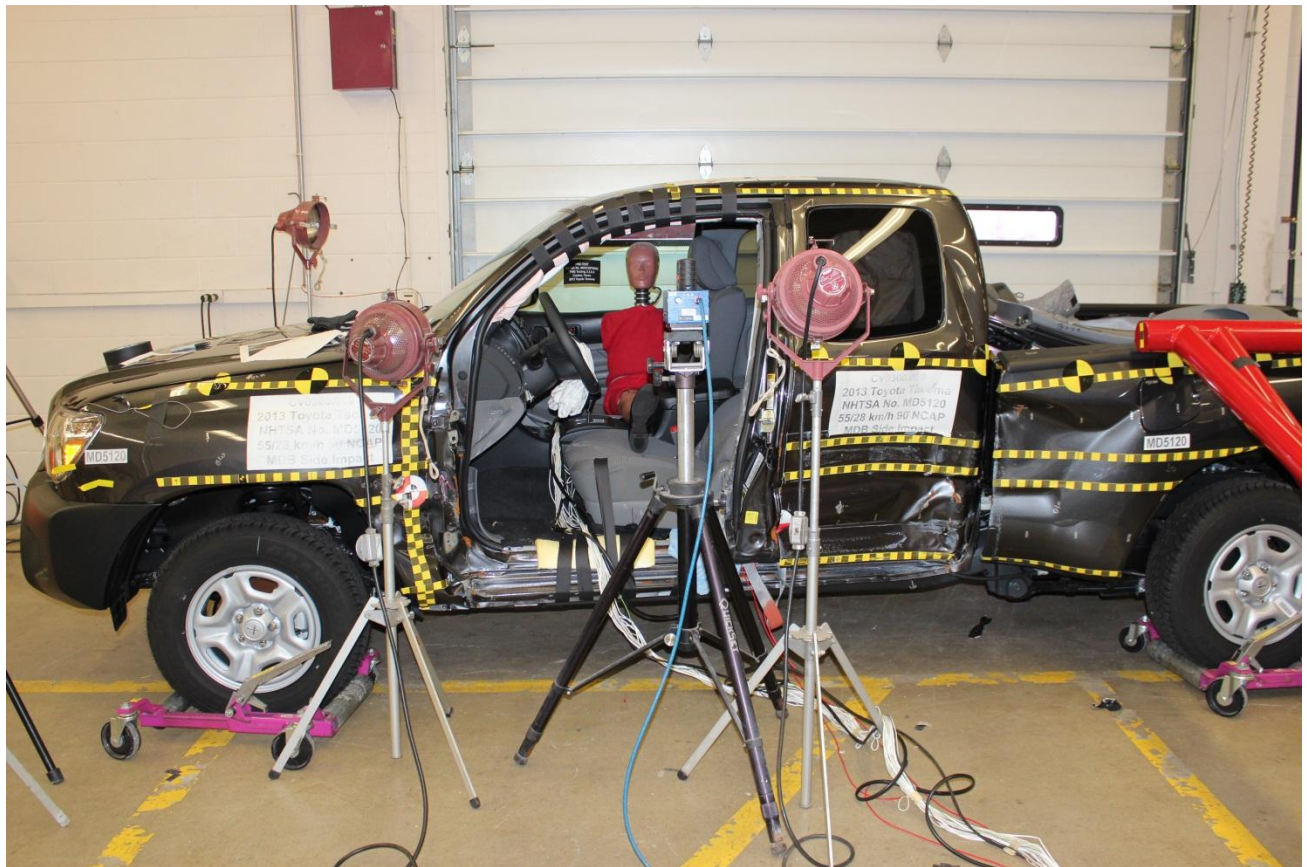
**Figure A-3: Pre-Test Vehicle Left Side View**

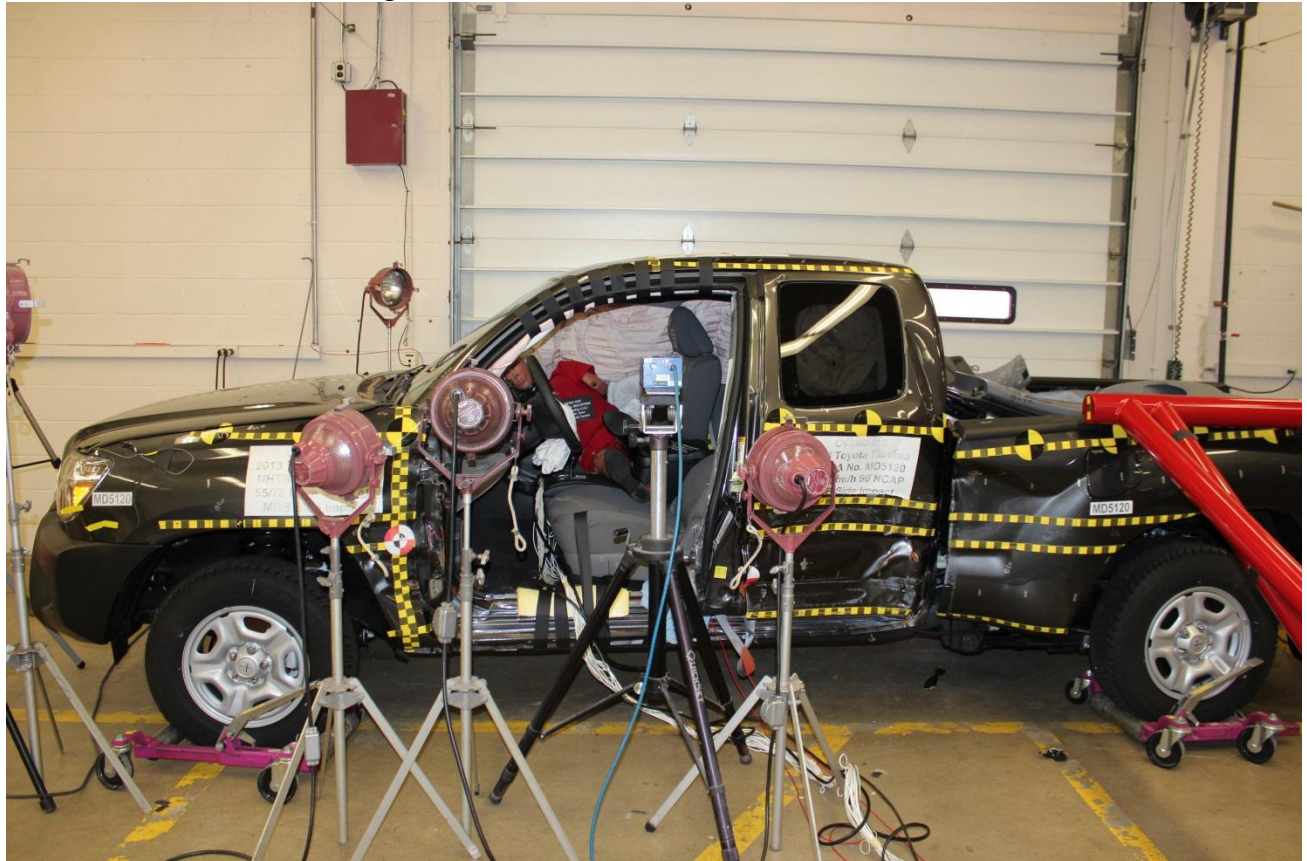
**Figure A-4: Post-Test Vehicle Left Side View**

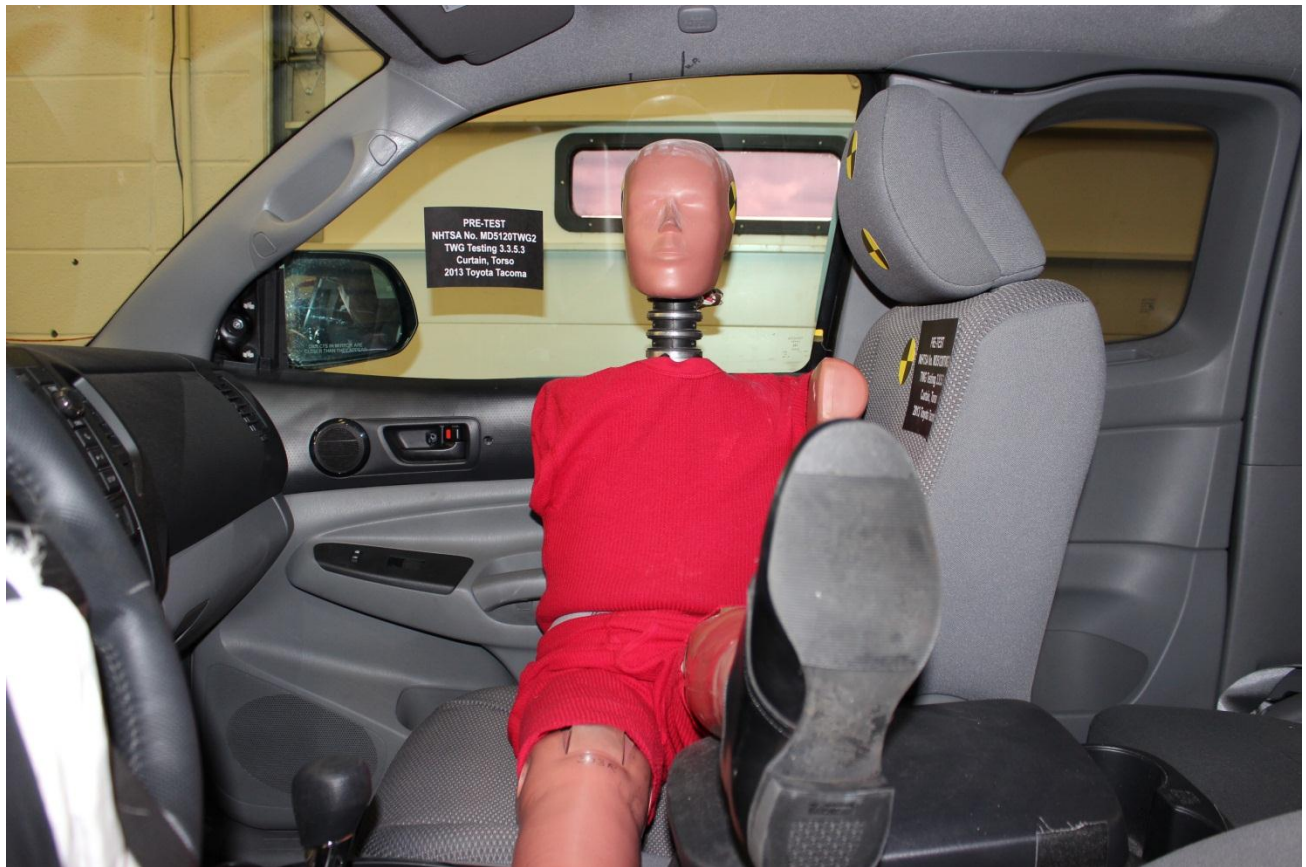
**Figure A-5: Pre-Test 5th female SID-II's Dummy Left Side View**

The 5<sup>th</sup> female ATD was placed with its left arm outstretched against the back of the right front (passenger) seat facing inboard cross car with its legs extended. After consultation with the program sponsor, the seat track was adjusted to locate the head C.G. under the expected deployment location of a head curtain chamber to maximize the airbag to head interaction. The location was determined by observing test data from the previous left side impact test on this vehicle. While keeping the head in neutral orientation, the ATD's pelvis was moved outboard until the dummy's back contacted the door trim panel armrest. The center of gravity of the head was centered in the deployment trajectory of the airbag. The dummy was then moved to maintain the vertical plane through the centerline of the ATD's shoulder bolts parallel to the vehicle centerline. The ATD's arm was bent straight across the back seat cushion. This orientation complies with section 3.3.5.3 of the TWG Recommended Procedures for Evaluating Occupant Injury Risk from Deploying Side Airbags as defined by Lund, et al and the Technical Working Group First Revision dated July, 2003.

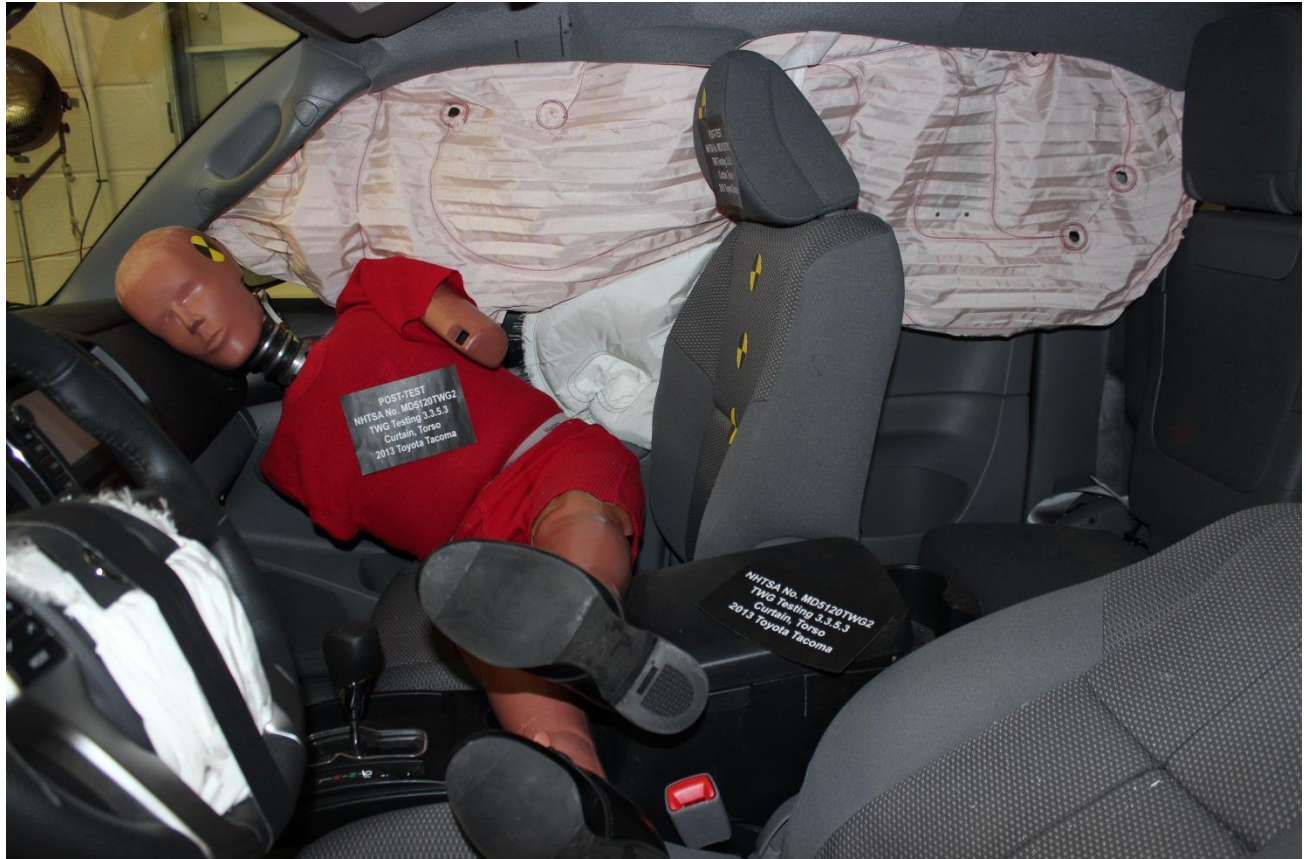
**Figure A-6: Post-Test 5th female SID-II's Dummy Left Side View**

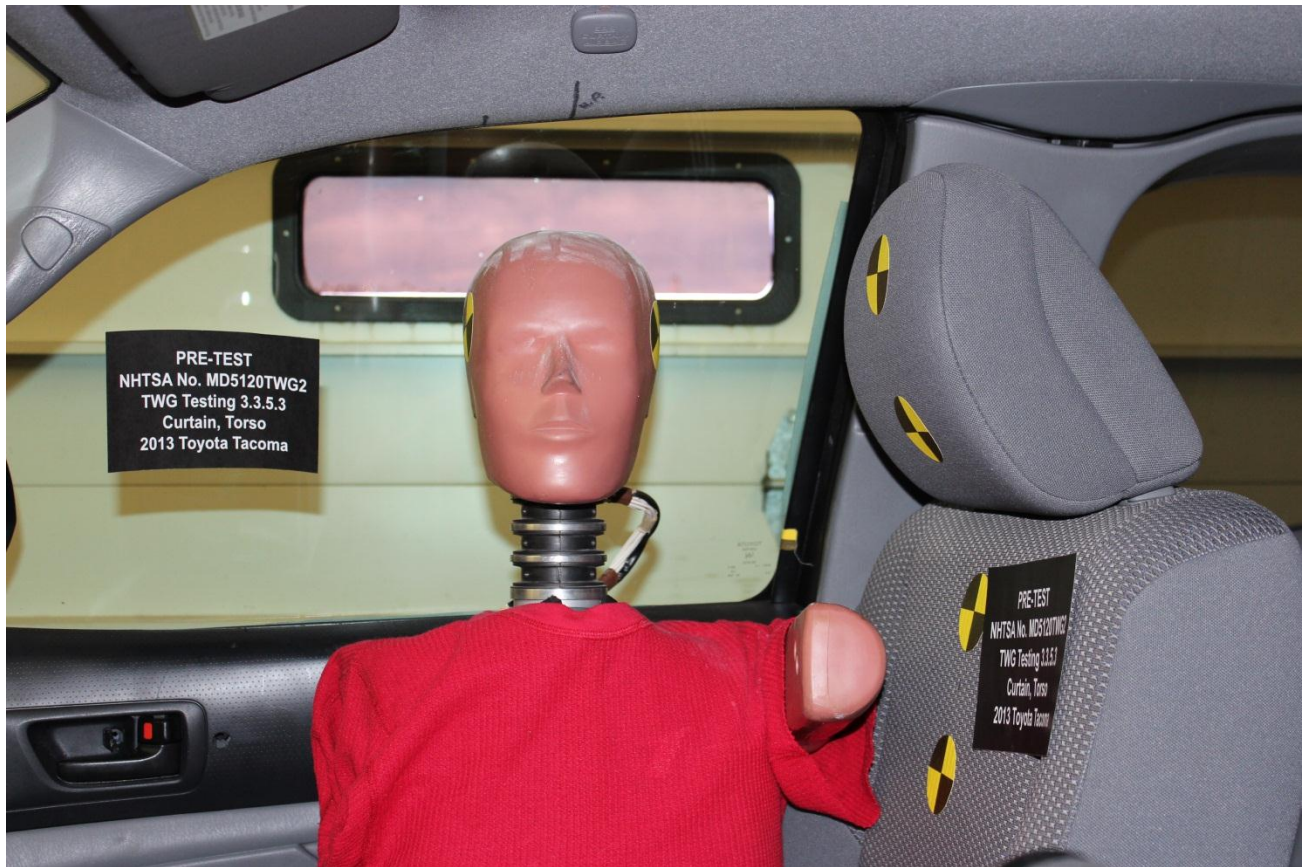
**Figure A-7: Pre-Test 5th female SID-III's Dummy Left Side Close-up View**

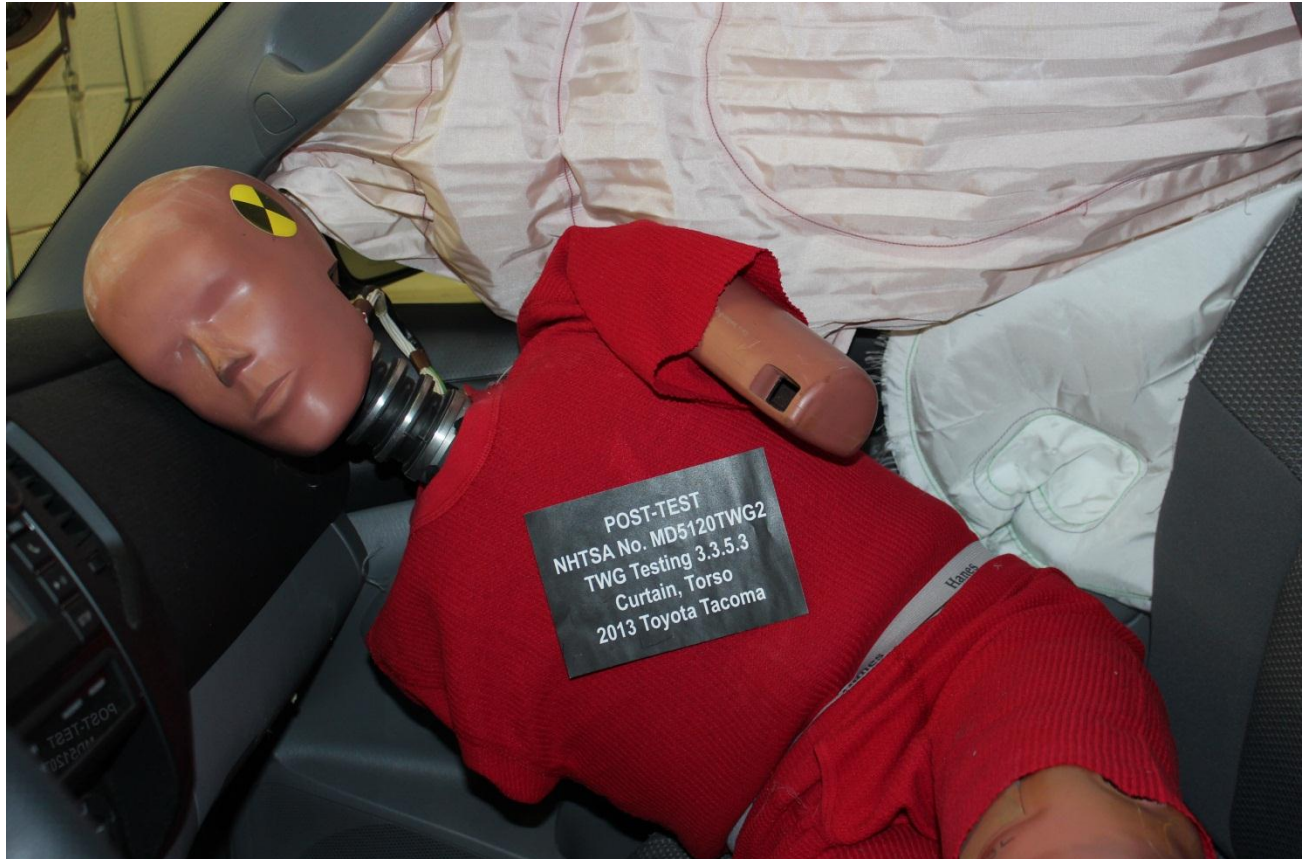
**Figure A-8: Post-Test 5th female SID-III's Dummy Left Side Close-up View**

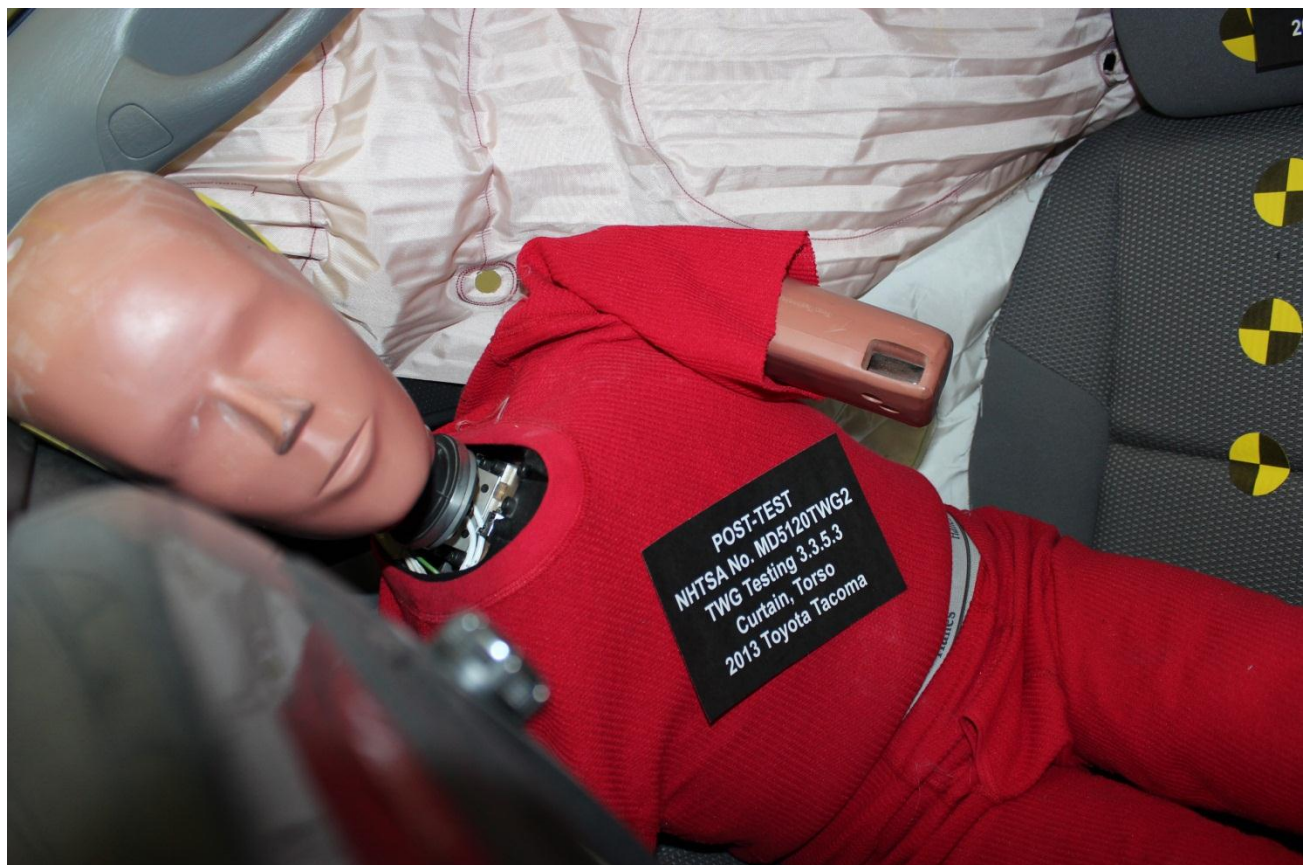
**Figure A-12: Post-Test 5th female SID-III Dummy Left  $\frac{3}{4}$  Front Close-up View**

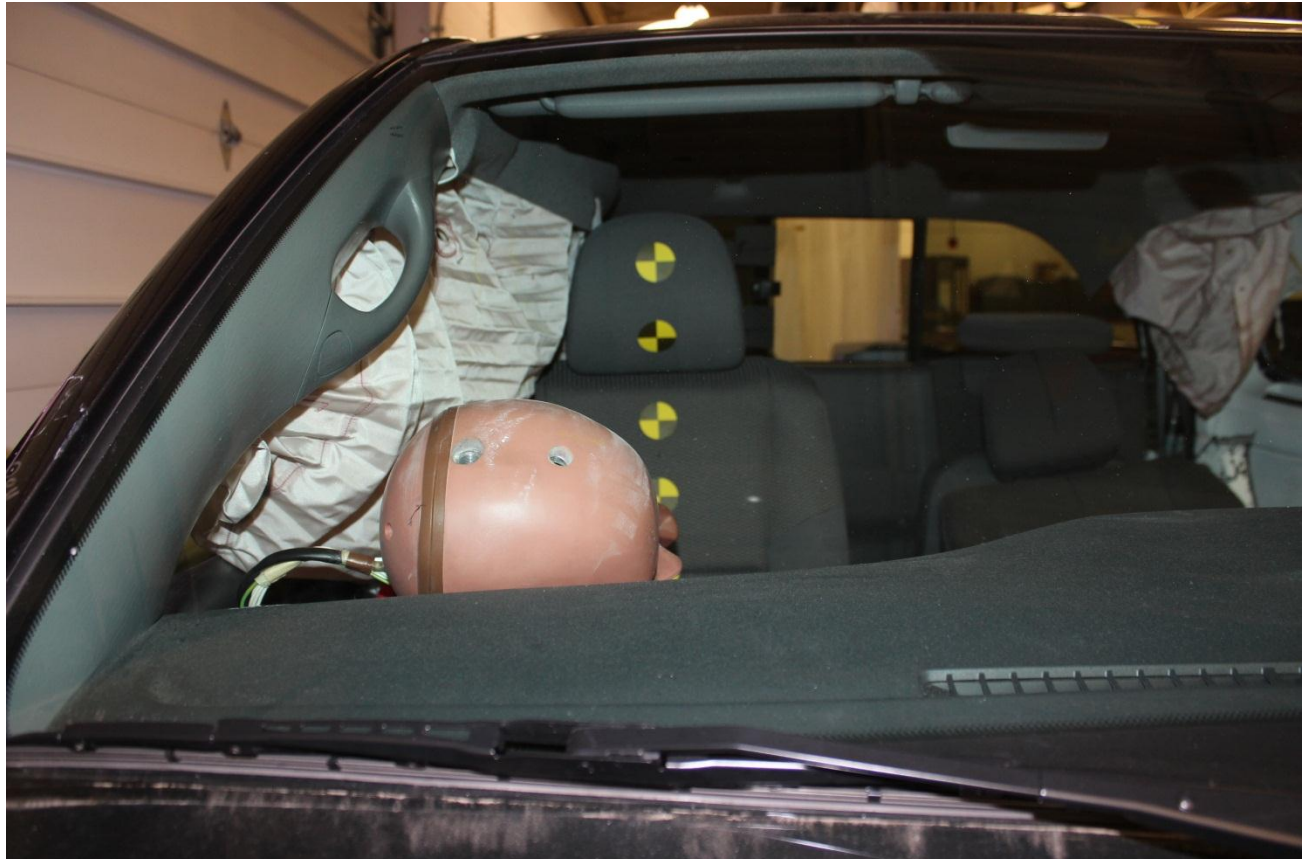
**Figure A-14: Post-Test 5th female SID-IIs Dummy Front View**

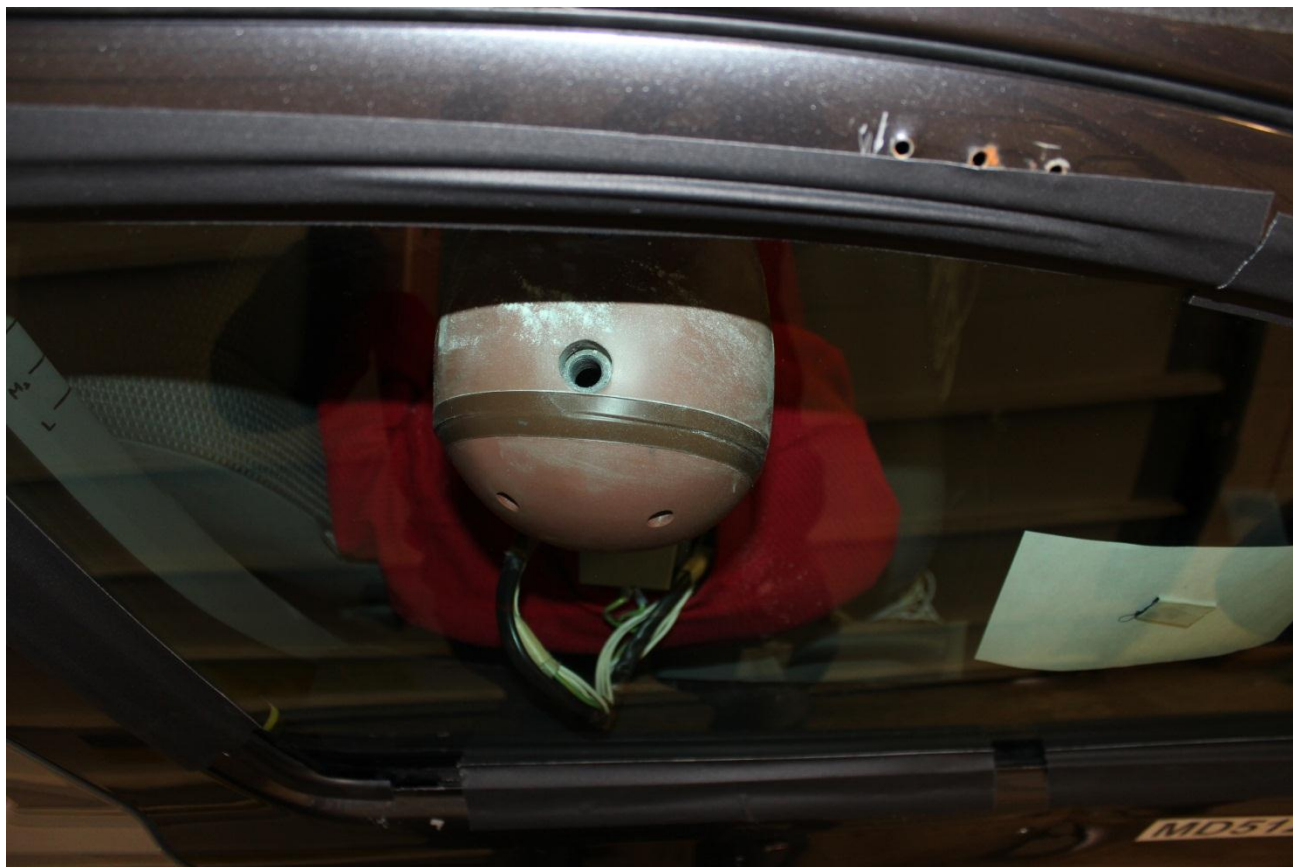
**Figure A-17: Pre-Test 5th female SID-IIs Dummy Right Side Clearance View**

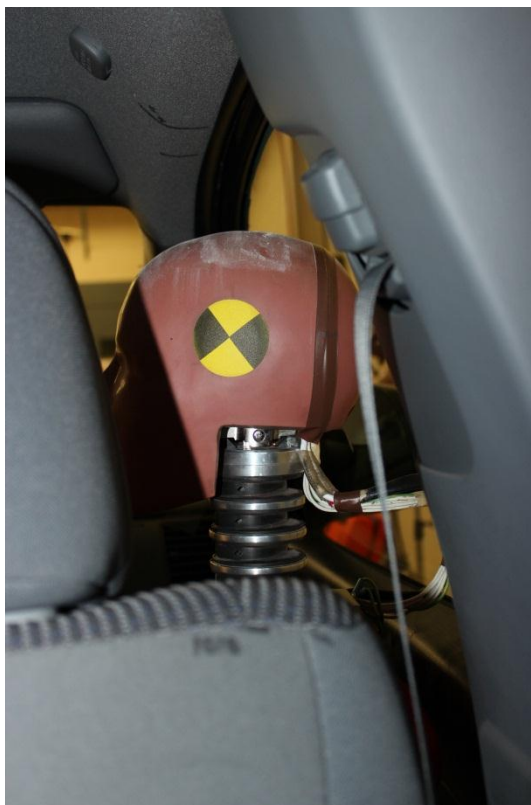
**Figure A-18: Pre-Test 5th female SID-IIs Dummy Rear Right Side Clearance View**

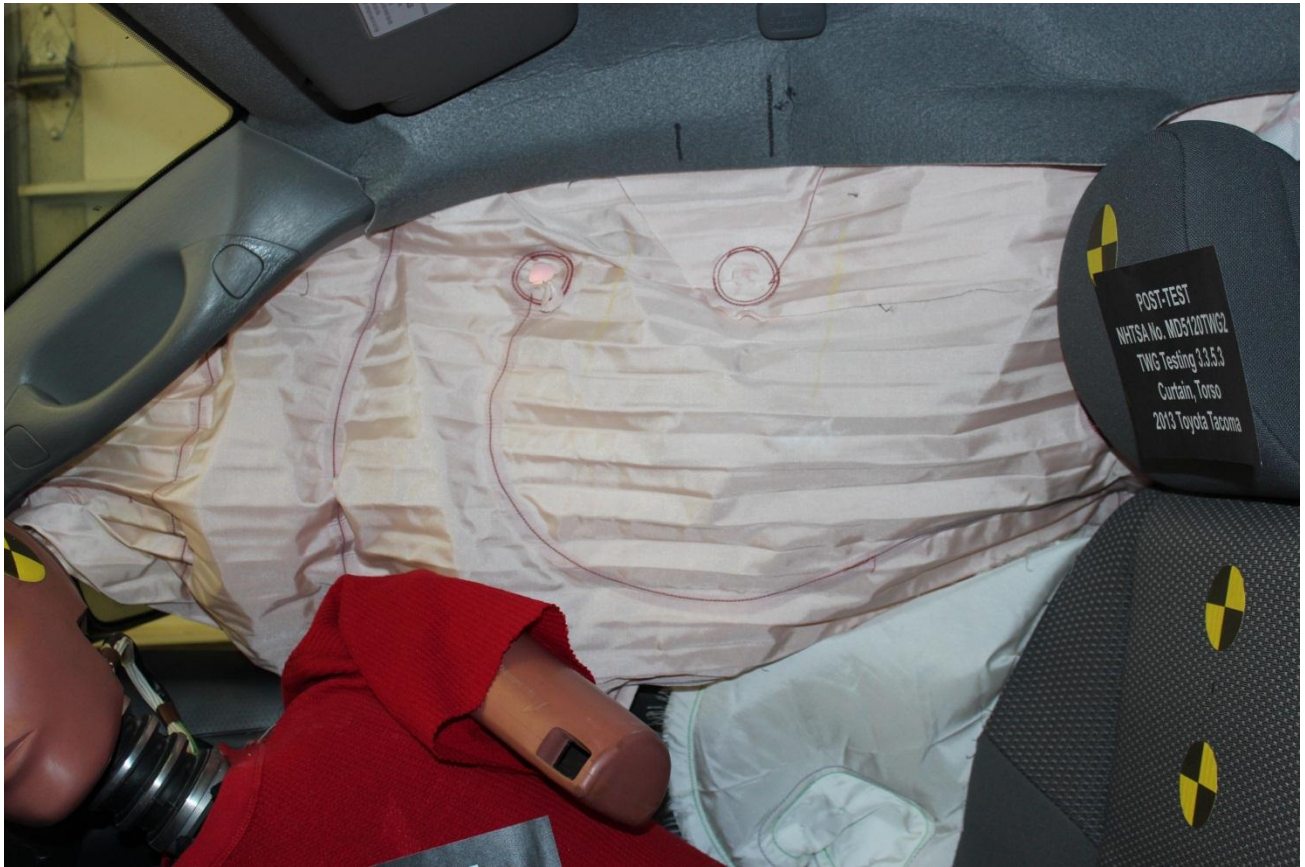
**Figure A-19: Post-Test Curtain Airbag Left Side View**

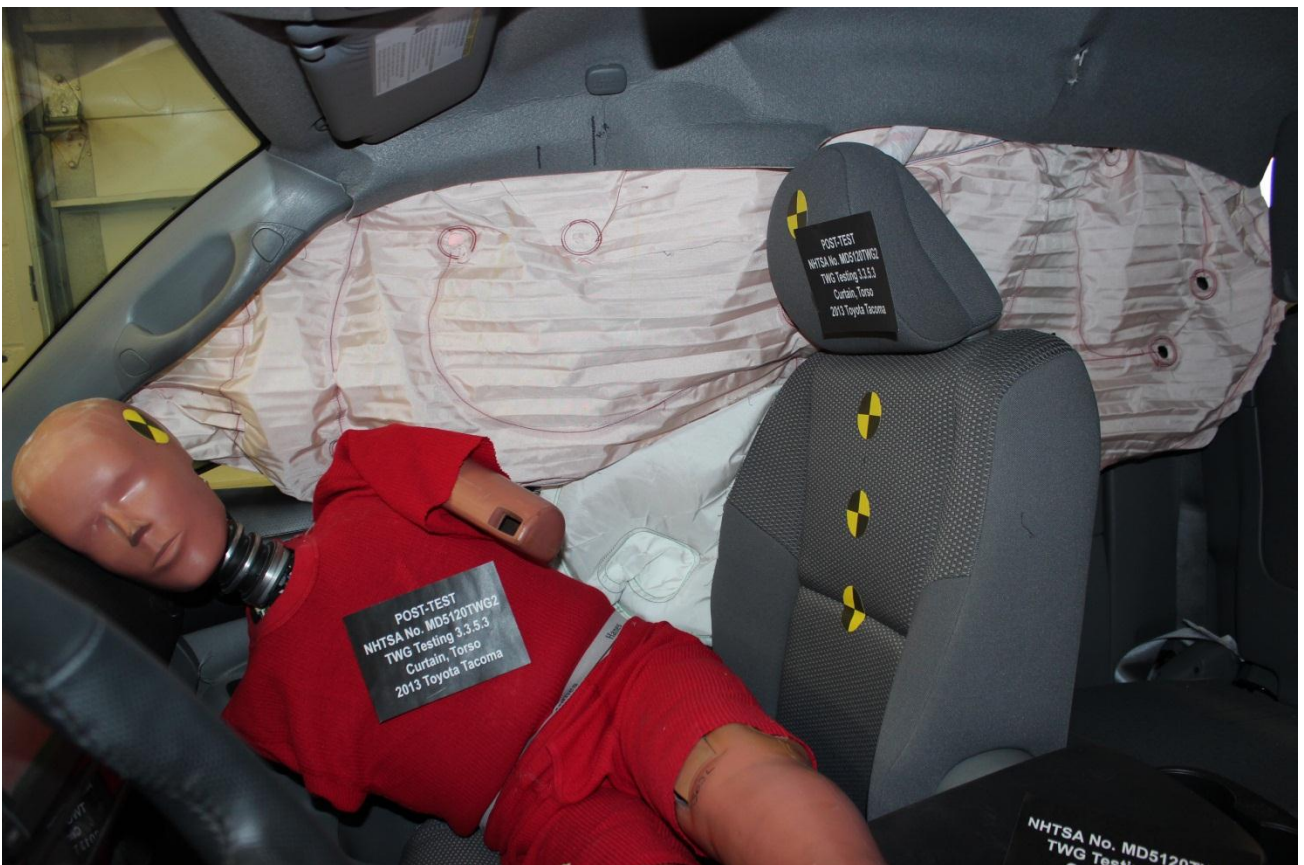
**Figure A-20: Post-Test Curtain Airbag Left  $\frac{3}{4}$  Front View**

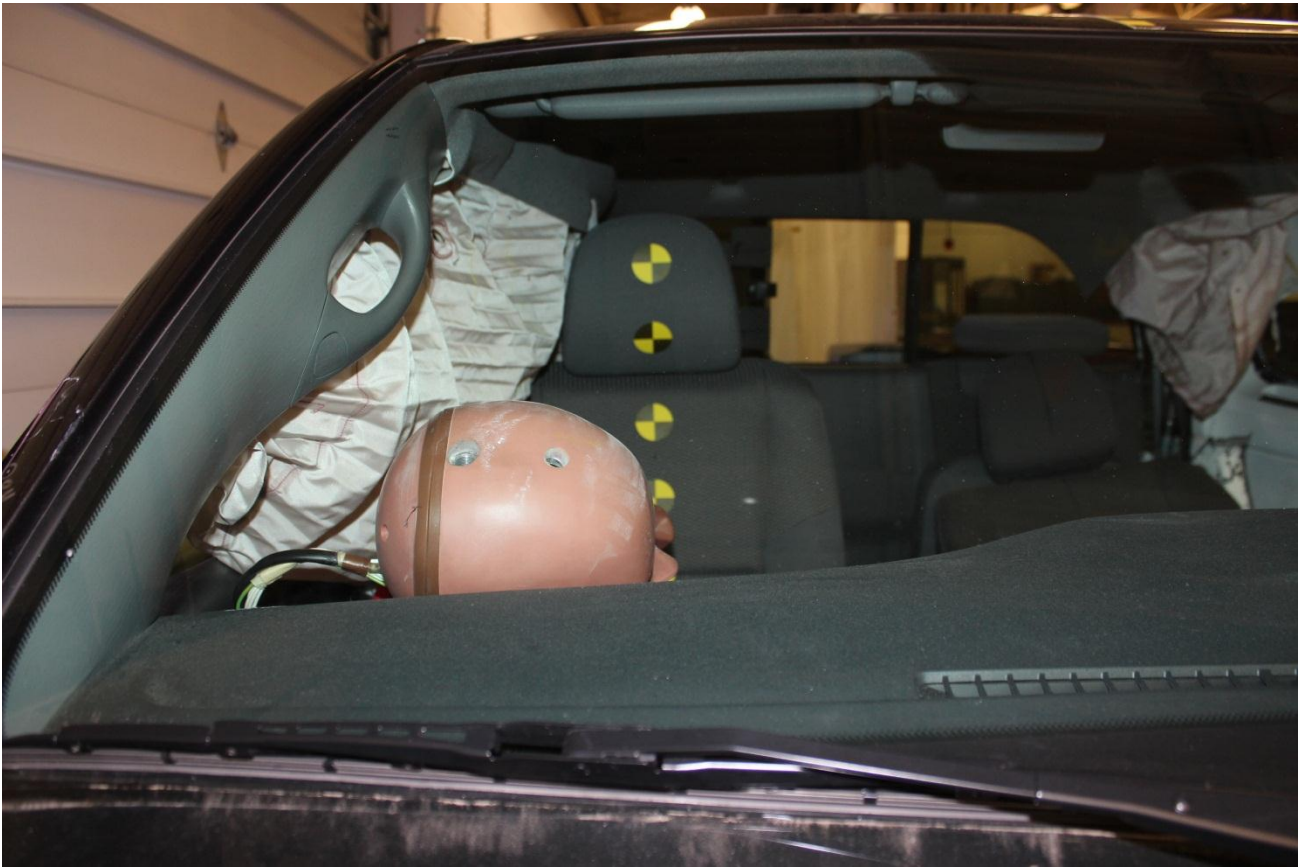
**Figure A-21: Post-Test Curtain Airbag Front View**

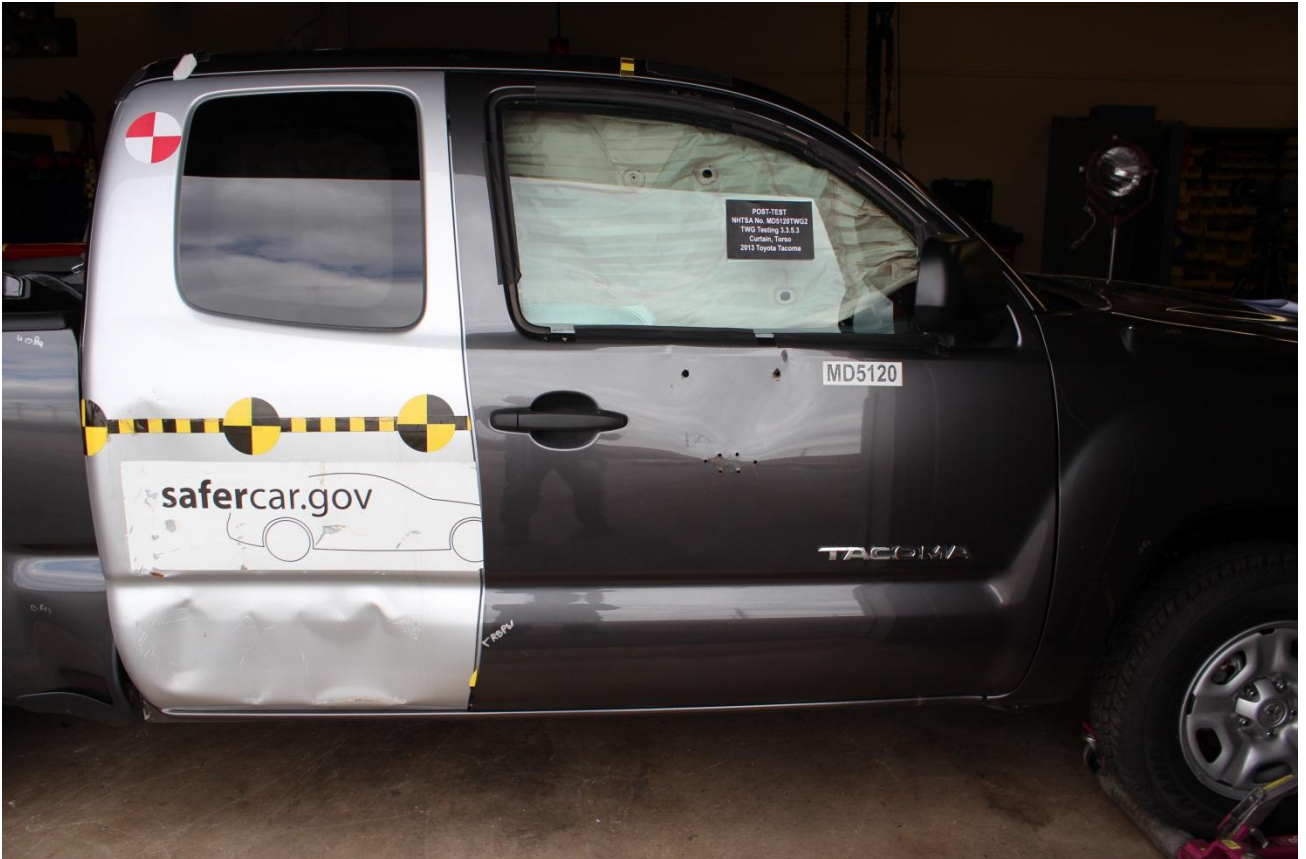
**Figure A-22: Post-Test Curtain Airbag Right Side View**

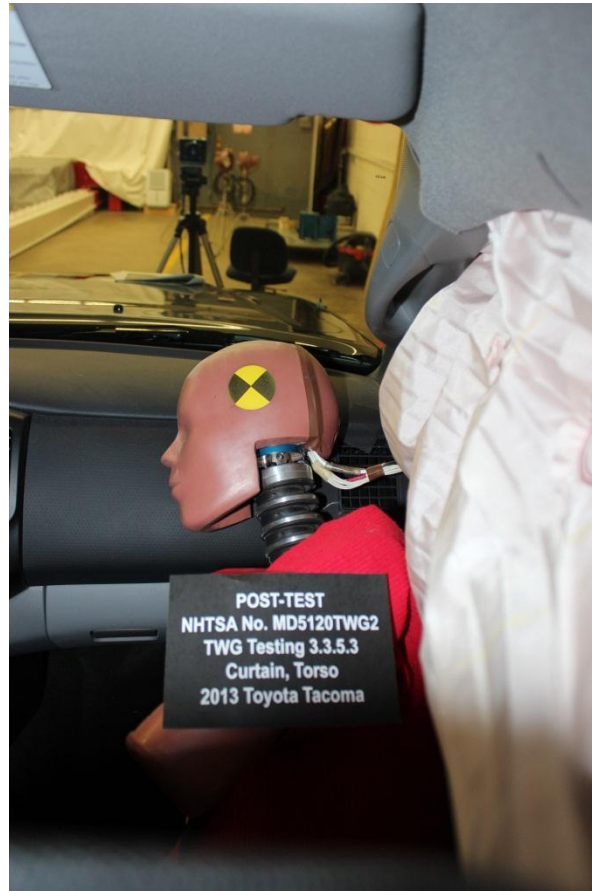
**Figure A-23: Post-Test Curtain Airbag Rear Right Side View**

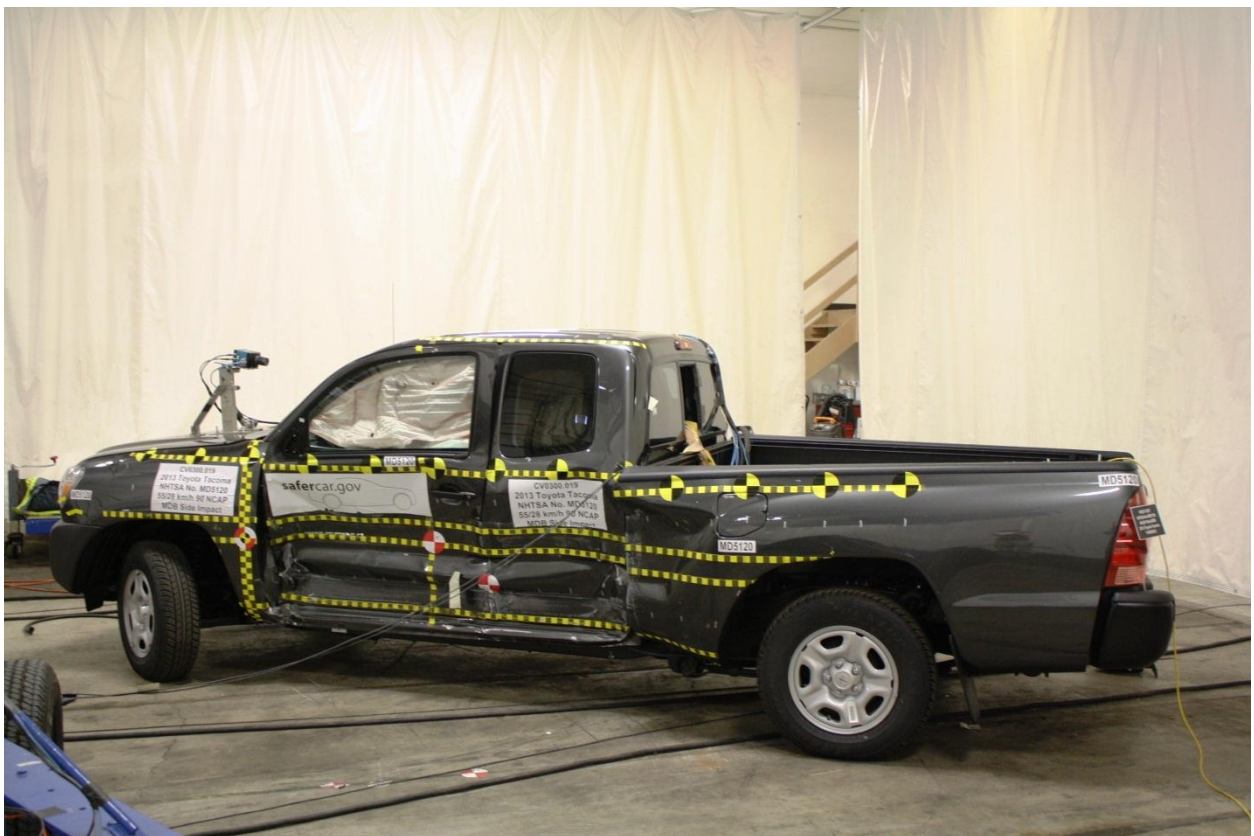
**Figure A-24: Post NCAP Left Side View**

‡Vehicle had previously undergone a New Car Assessment Program Side NCAP MDB Test.
