REPORT NUMBER: TWG-CAL-13-08

**NEW CAR ASSESSMENT PROGRAM (NCAP)**  
SIDE AIRBAG OUT-OF-POSITION INJURY TESTING

**General Motors LLC**  
**2013 Chevrolet Traverse**  
**Four Door SUV**

NHTSA NUMBER: MD0117TWG2  
CALSPAN TEST NUMBER: CT2013-08

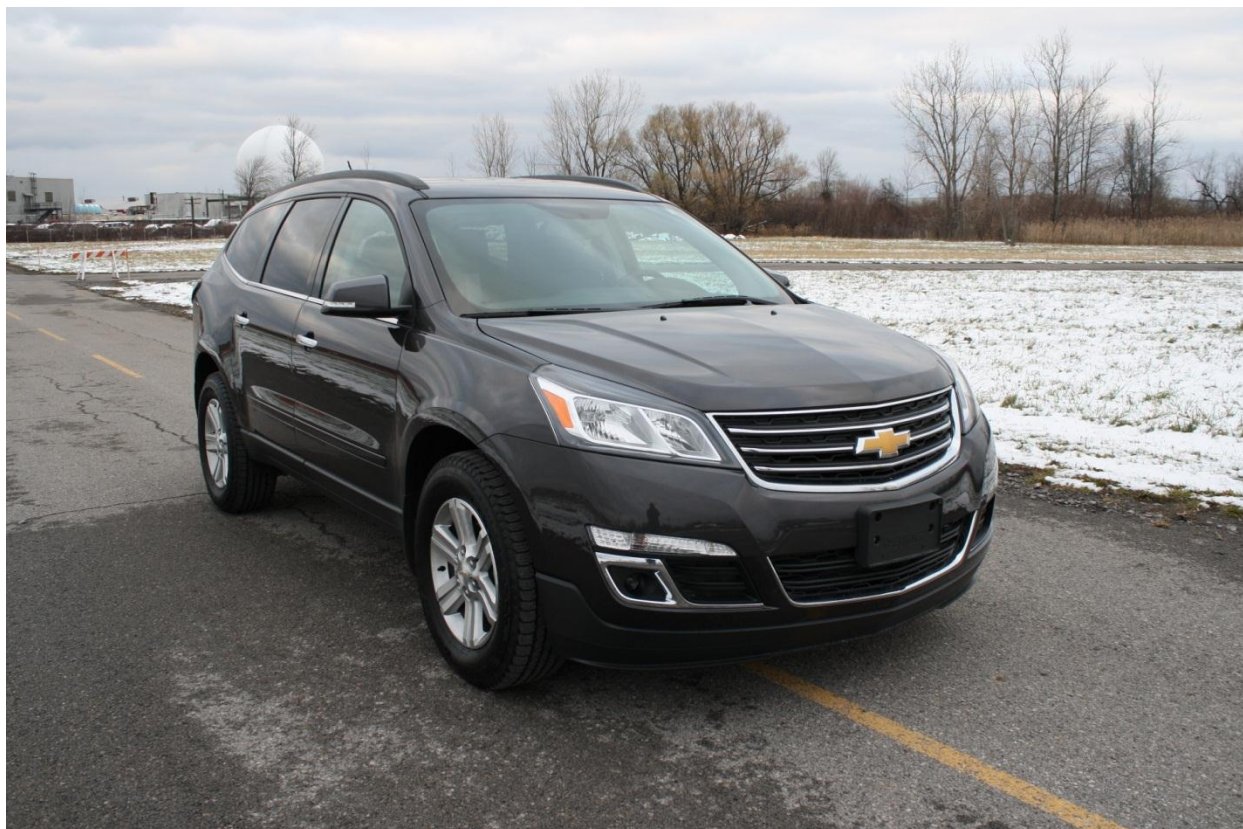
**Figure A-1: Right ¾ Front View of Vehicle, As Received**

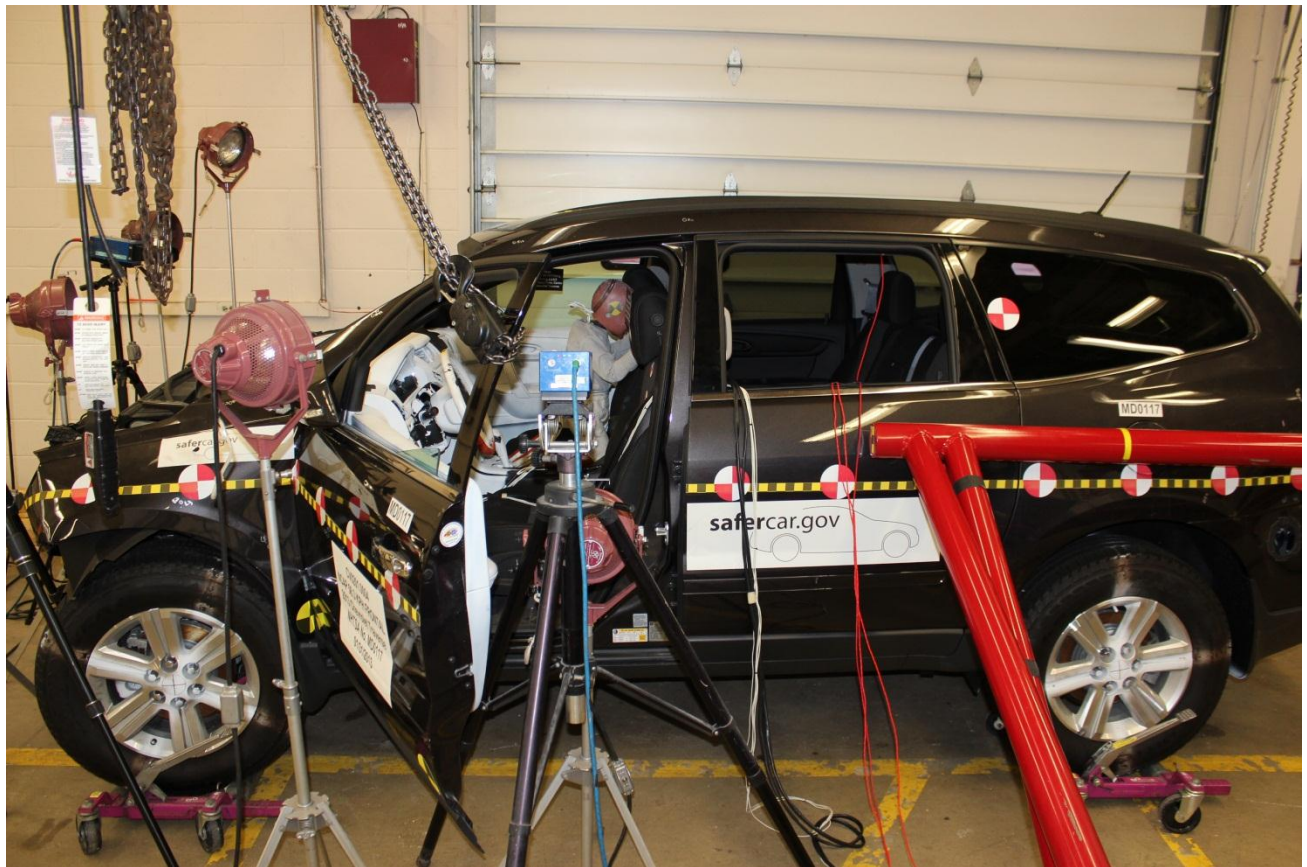
**Figure A-3: Pre-Test Vehicle Left Side View**

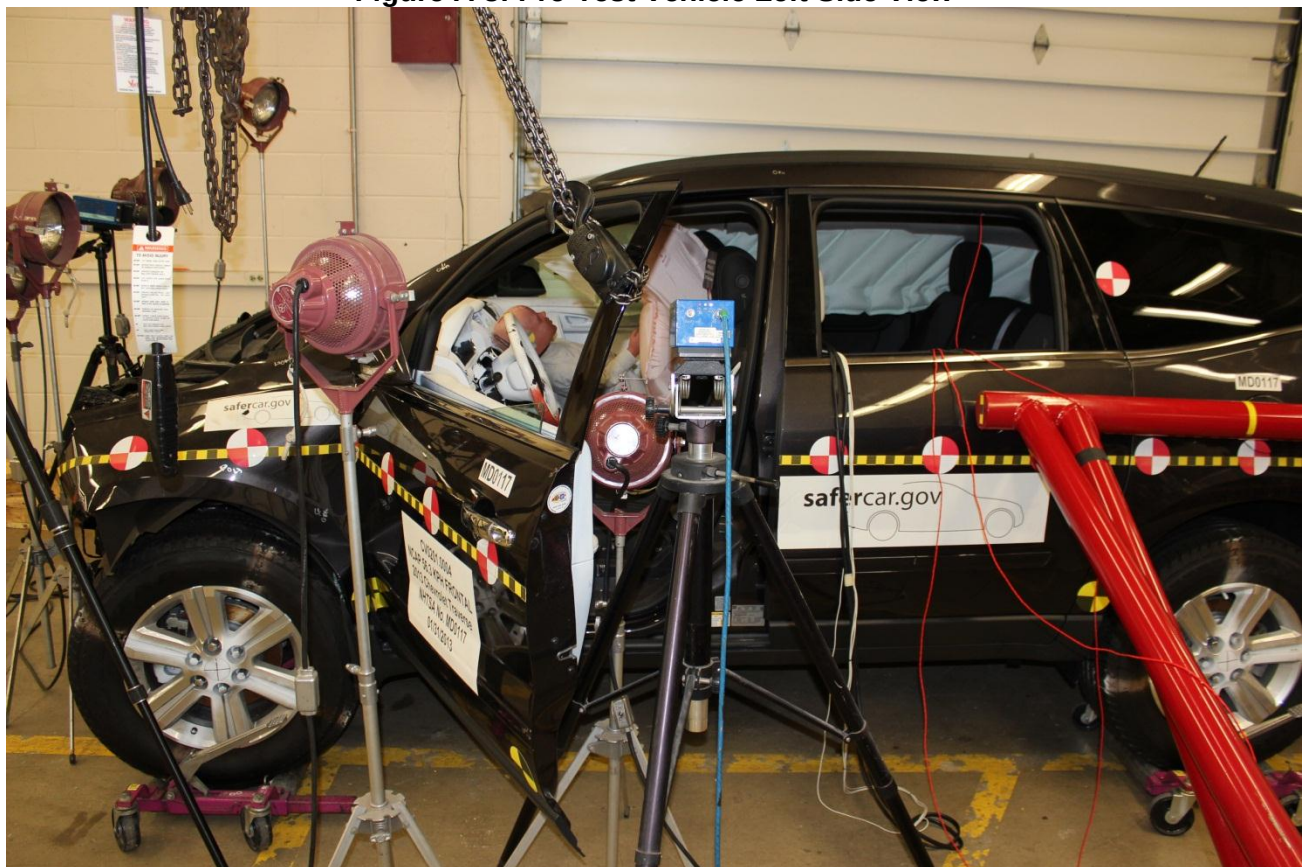
**Figure A-4: Post-Test Vehicle Left Side View**

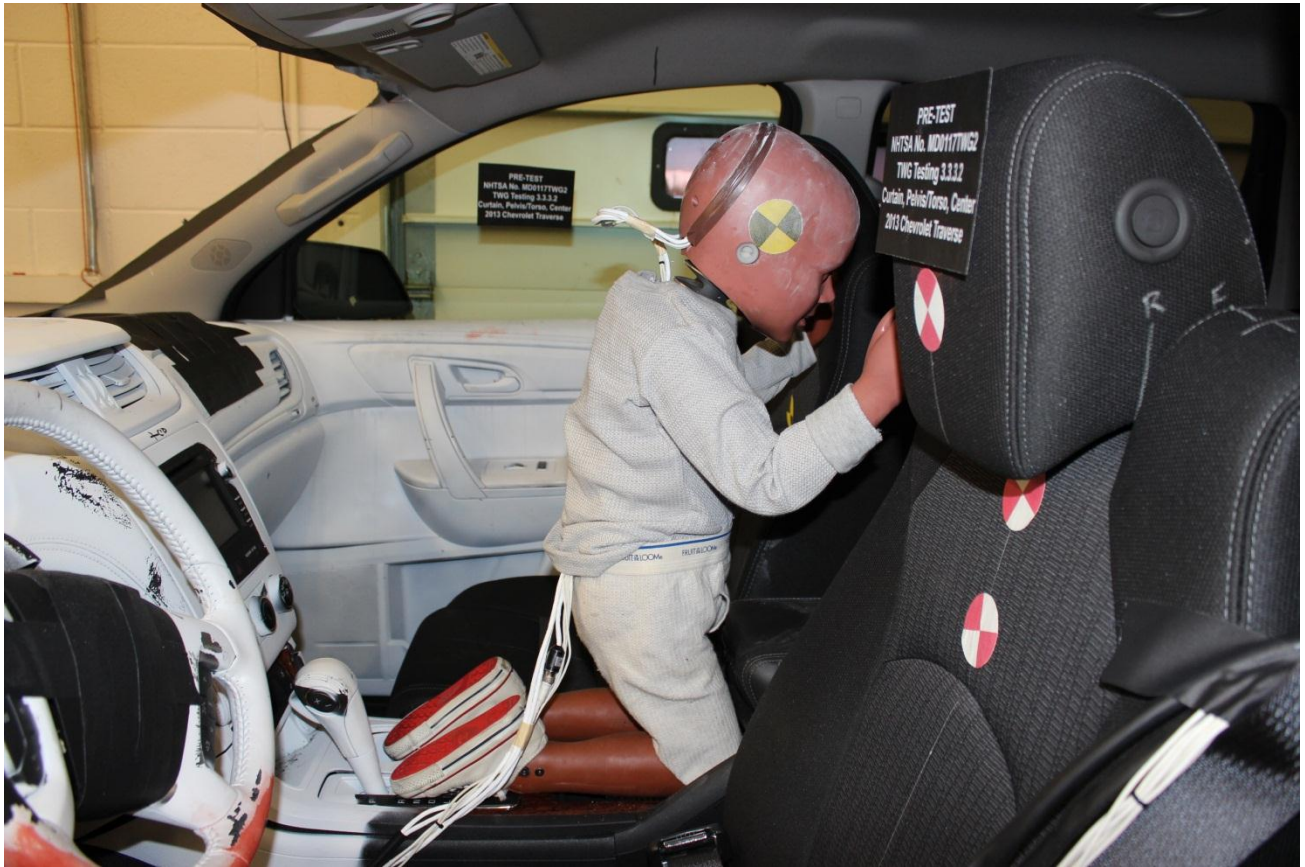
**Figure A-5: Pre-Test HIII 3 Year Old Dummy Left Side View**

The Hybrid III 3-Year-Old ATD was placed on the center console of the vehicle between the driver and passenger seats, kneeling and facing rearward. The ATD's legs were positioned parallel to the seats centerlines. The ATD's left arm was placed on the passenger seat and its right arm on the driver's seat in a position attempting to simulate a child talking to persons in the rear of the vehicle. The Driver and Passenger seat backs were adjusted to the manufacturers design angle with the ATD positioned in a natural upright position whilst remaining as close as possible to the driver seat to maximize contact between ATD and the airbag. This orientation is a modified version of section 3.3.3.2 of the TWG Recommended Procedures for Evaluating Occupant Injury Risk from Deploying Side Airbags as defined by Lund, et al and the Technical Working Group First Revision dated July, 2003.

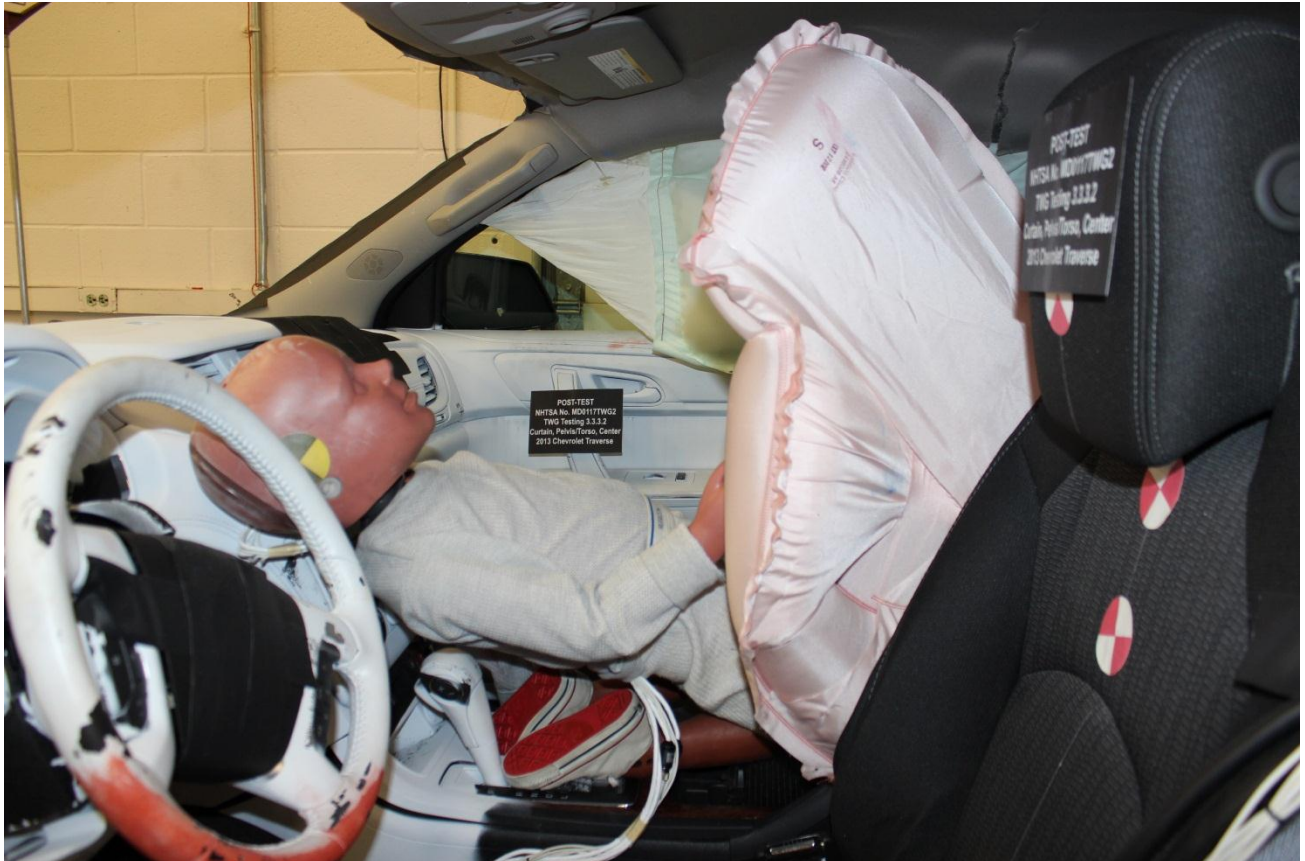
**Figure A-6: Post-Test HIII 3 Year Old Dummy Left Side View**

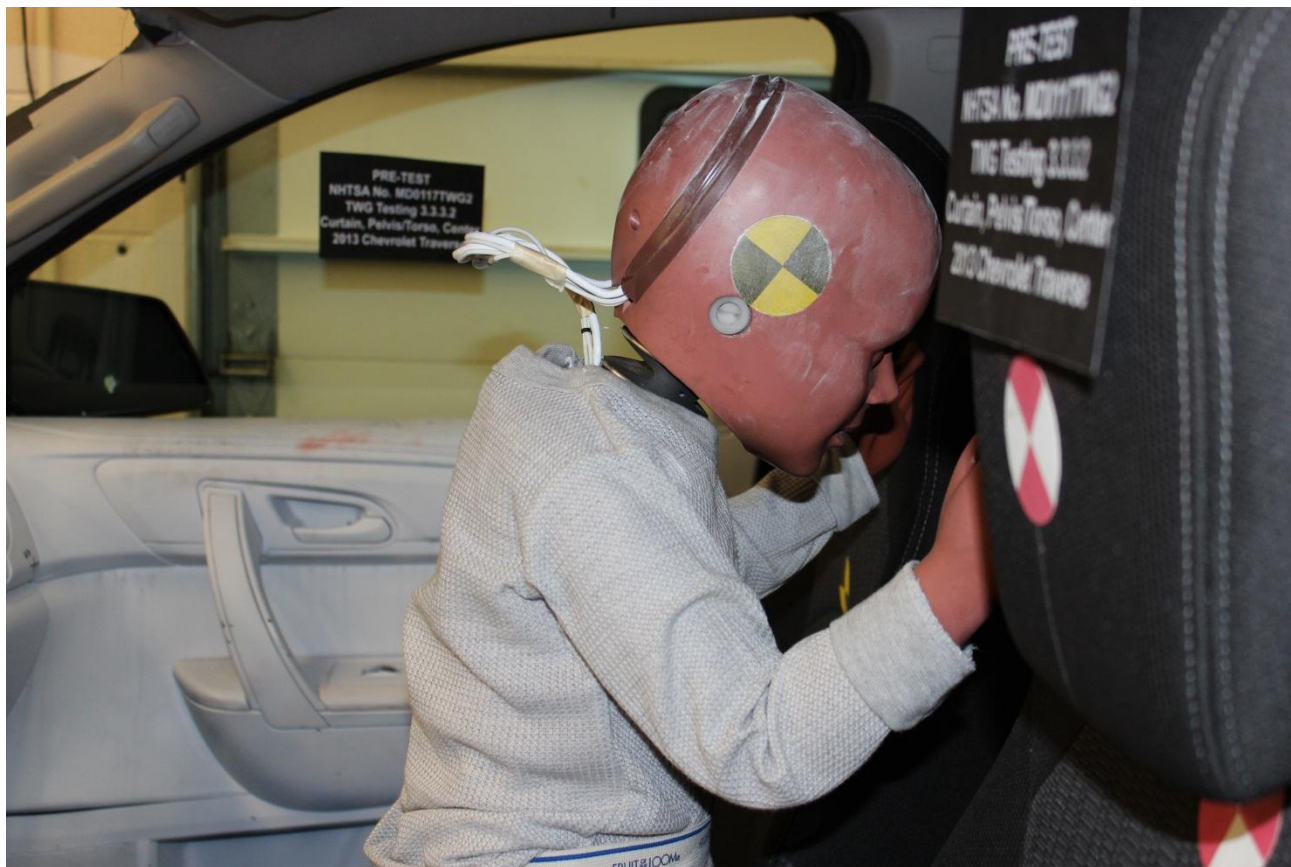
**Figure A-7: Pre-Test HIII 3 Year Old Dummy Left Side Close-up View**

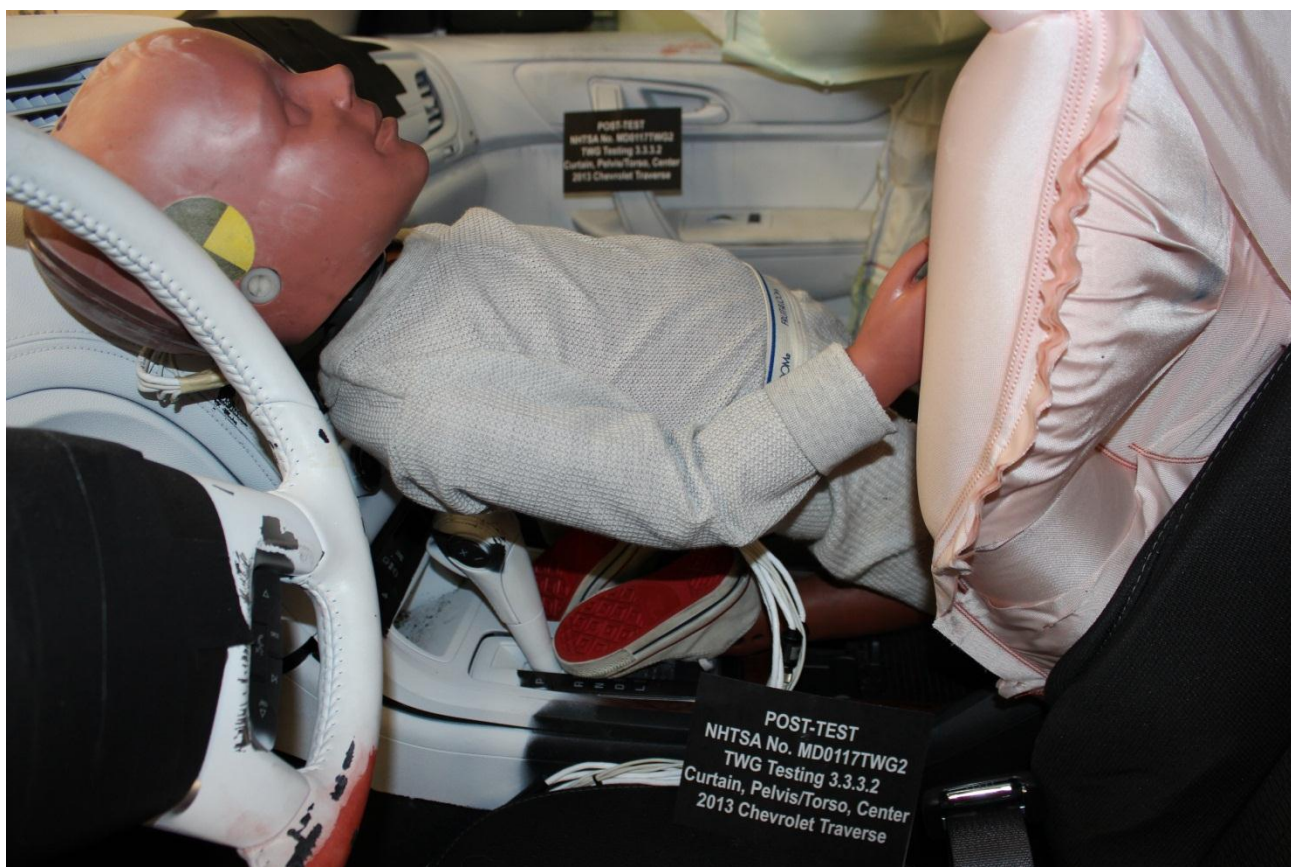
**Figure A-8: Post-Test HIII 3 Year Old Dummy Left Side Close-up View**

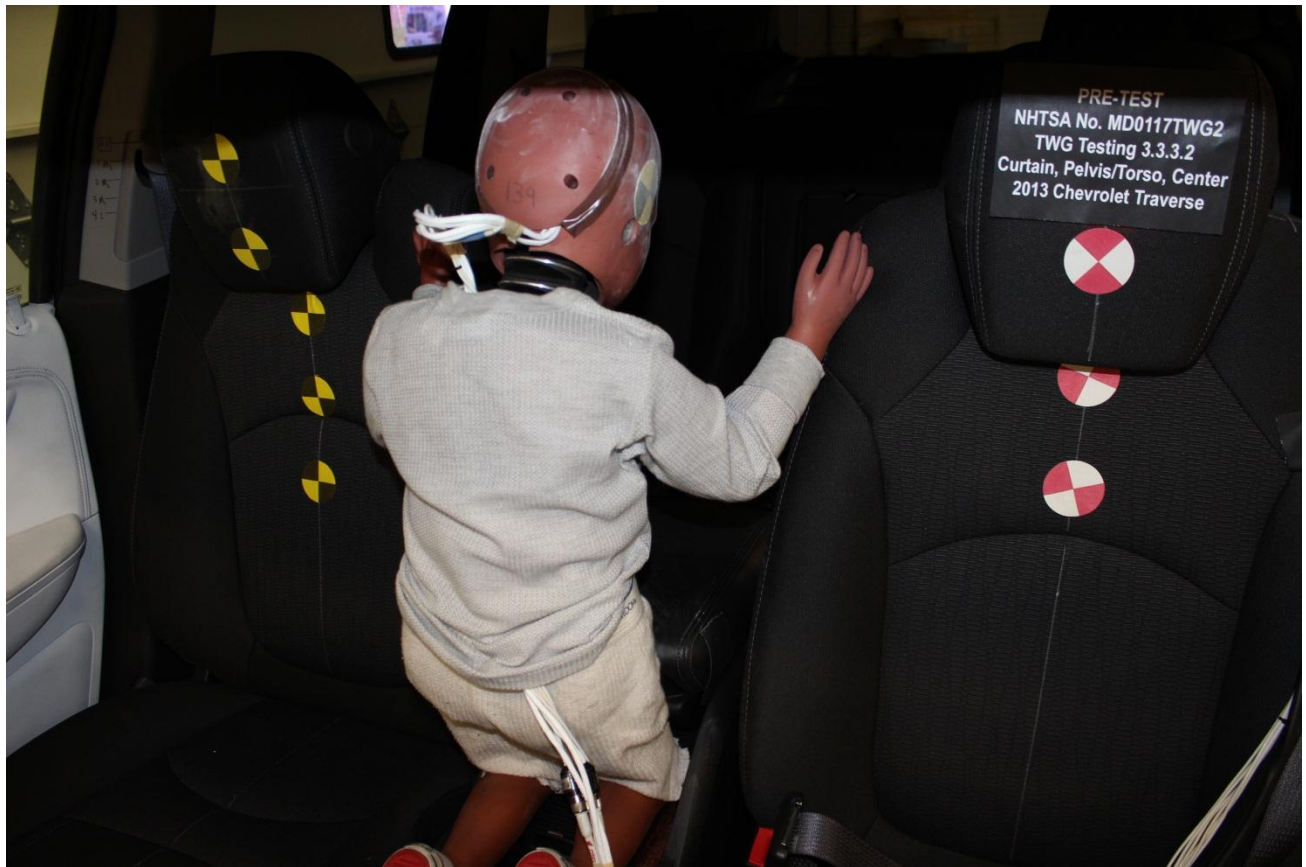
**Figure A-9: Pre-Test HIII 3 Year Old Dummy Left  $\frac{3}{4}$  Front View**

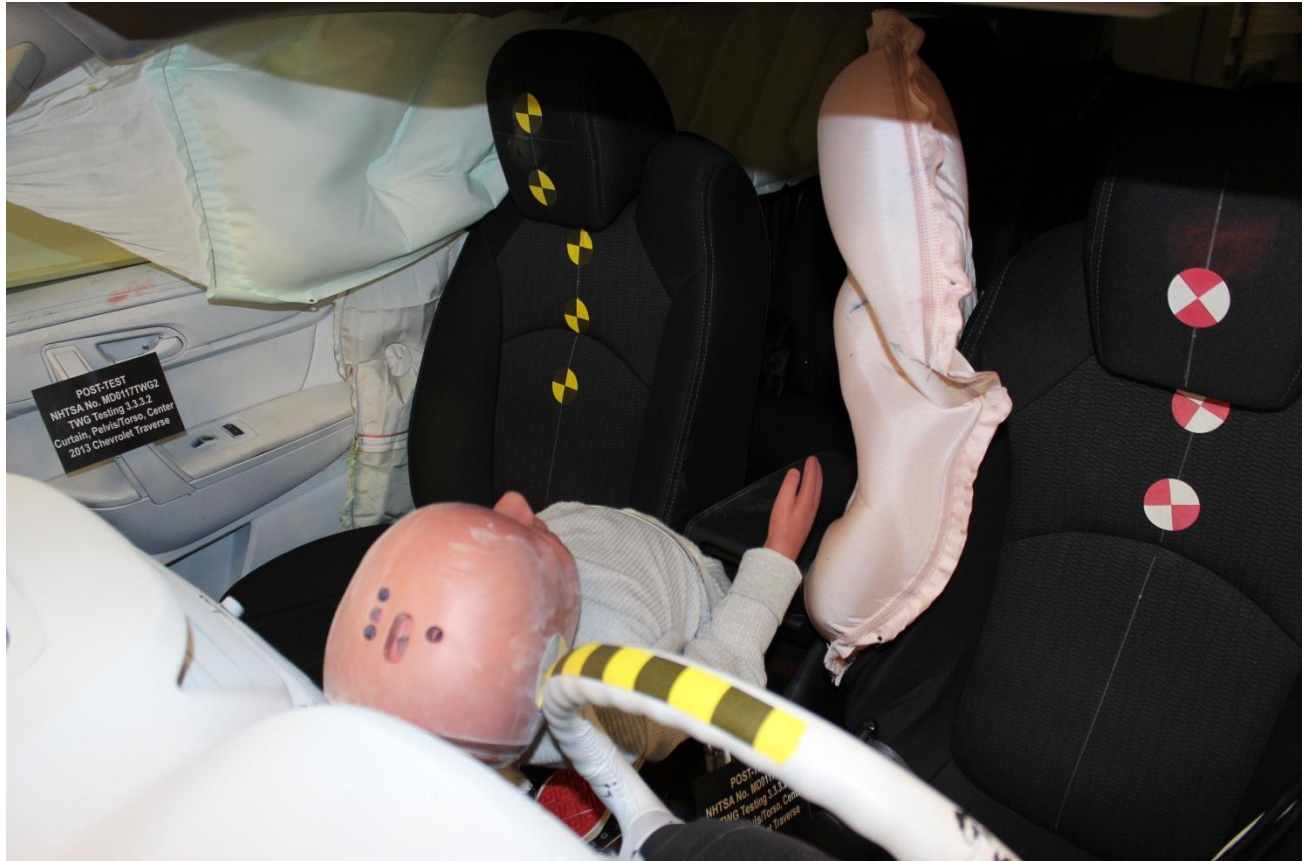
**Figure A-10: Post-Test HIII 3 Year Old Dummy Left  $\frac{3}{4}$  Front View**

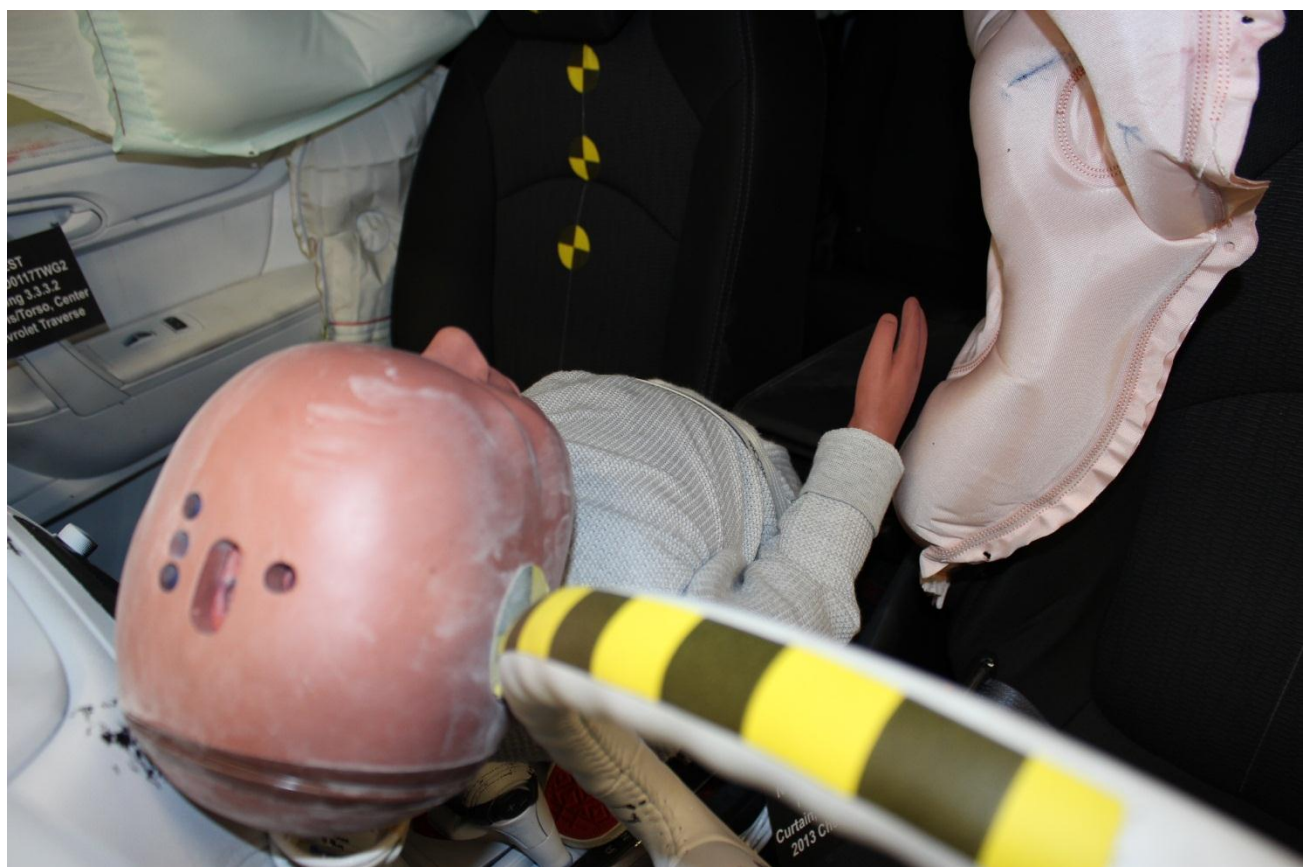
**Figure A-12: Post-Test HIII 3 Year Old Dummy Left  $\frac{3}{4}$  Front Close-up View**

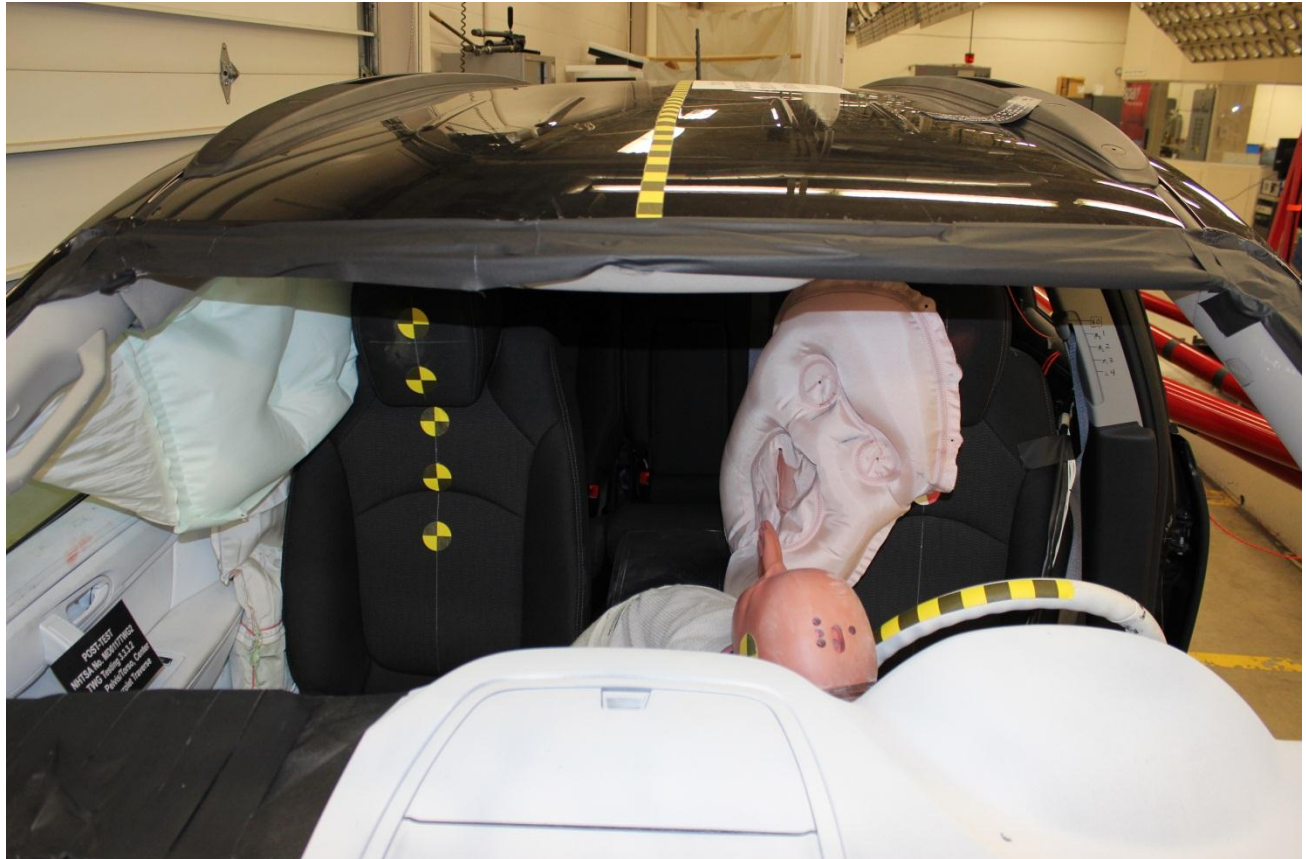
**Figure A-14: Post-Test HIII 3 Year Old Dummy Front View**

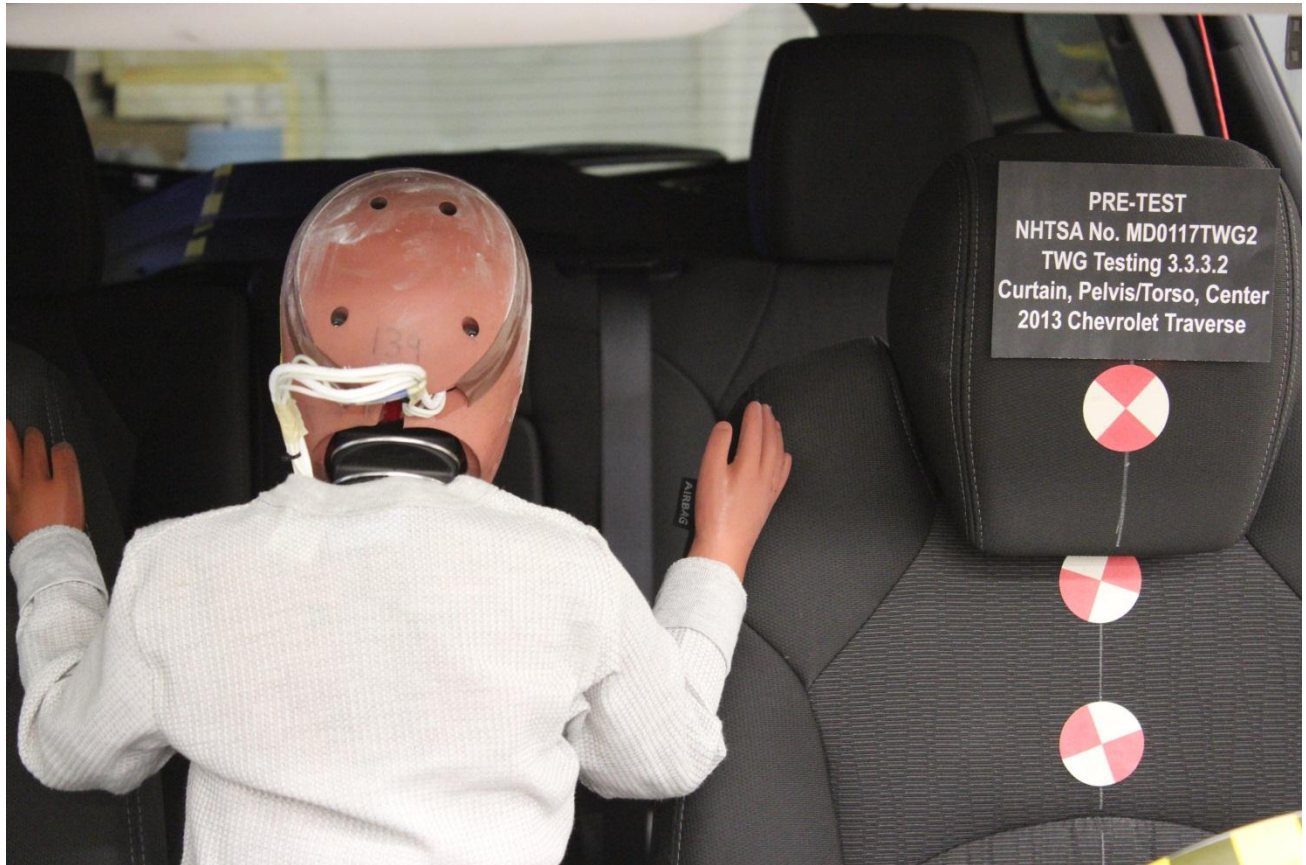
**Figure A-15: Pre-Test HIII 3 Year Old Dummy Front Close-up View**

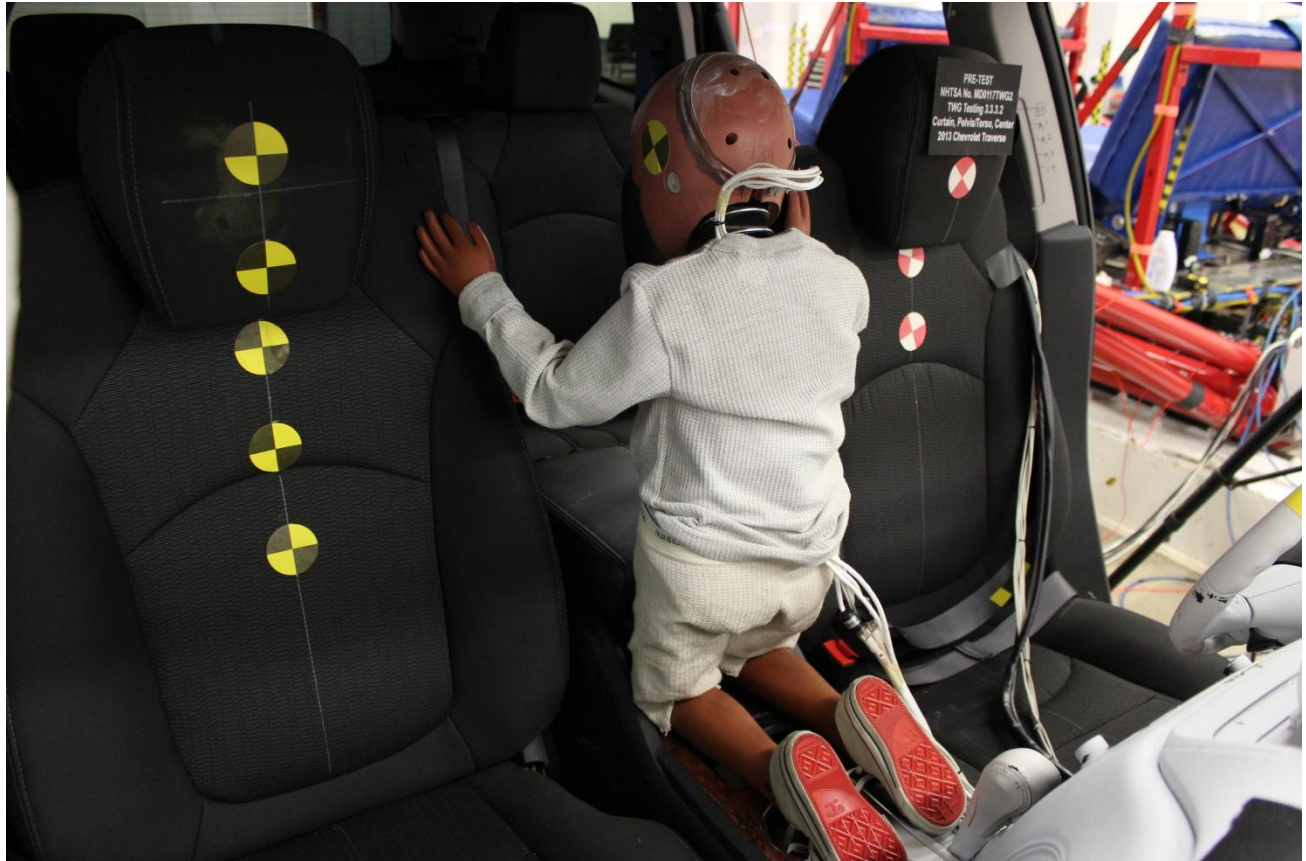
**Figure A-16: Pre-Test HIII 3 Year Old Dummy Right  $\frac{3}{4}$  Front View**

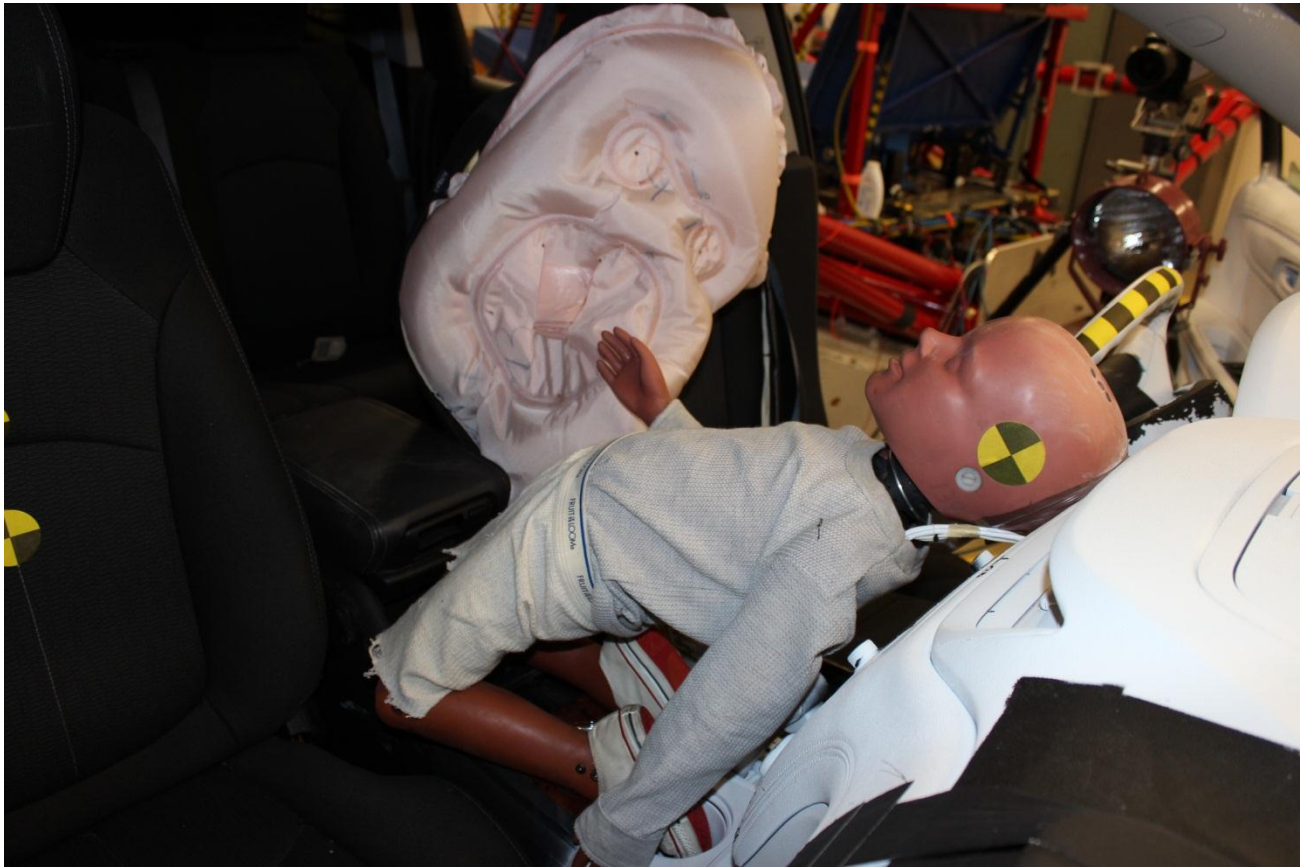
**Figure A-17: Post-Test HIII 3 Year Old Dummy Right  $\frac{3}{4}$  Front View**

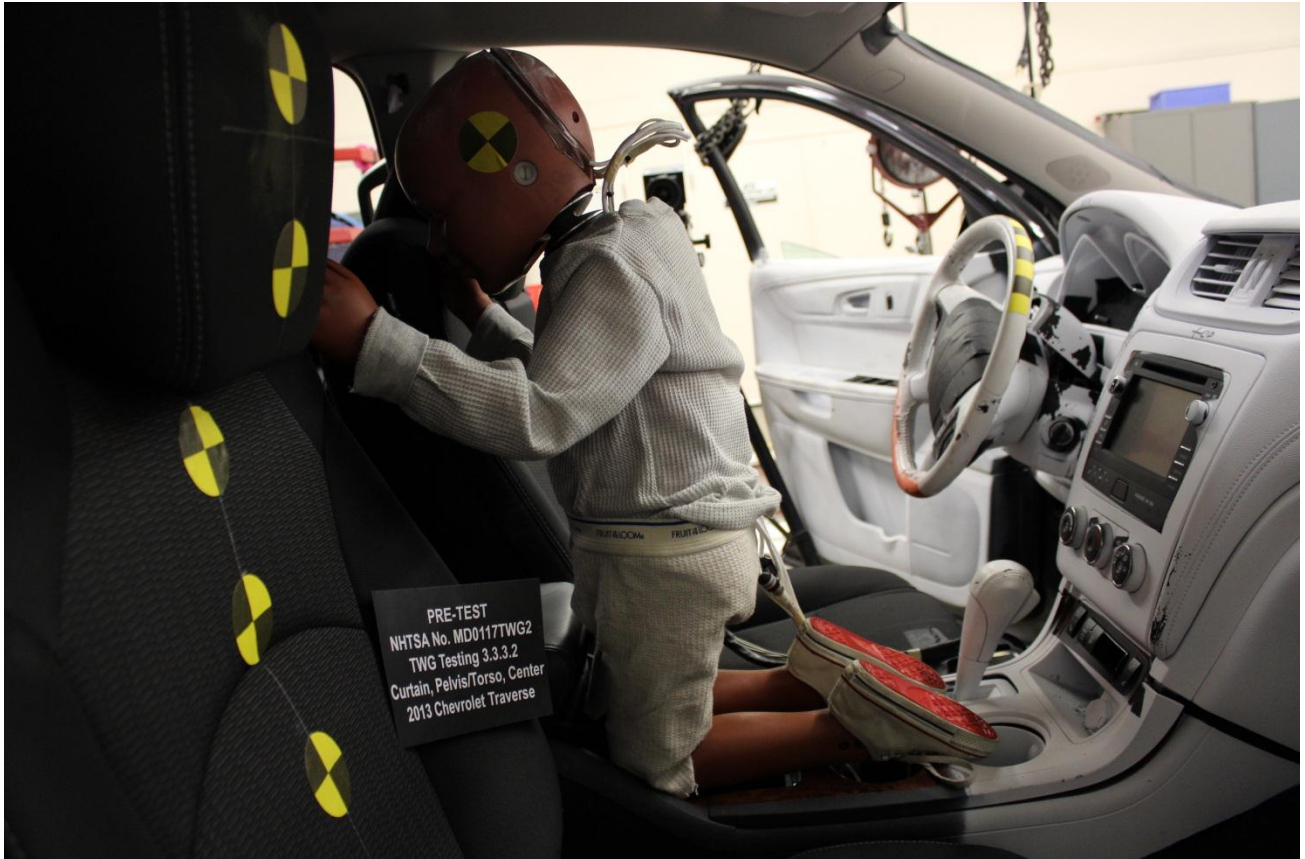
**Figure A-18: Pre-Test HIII 3 Year Old Dummy Right Side View**

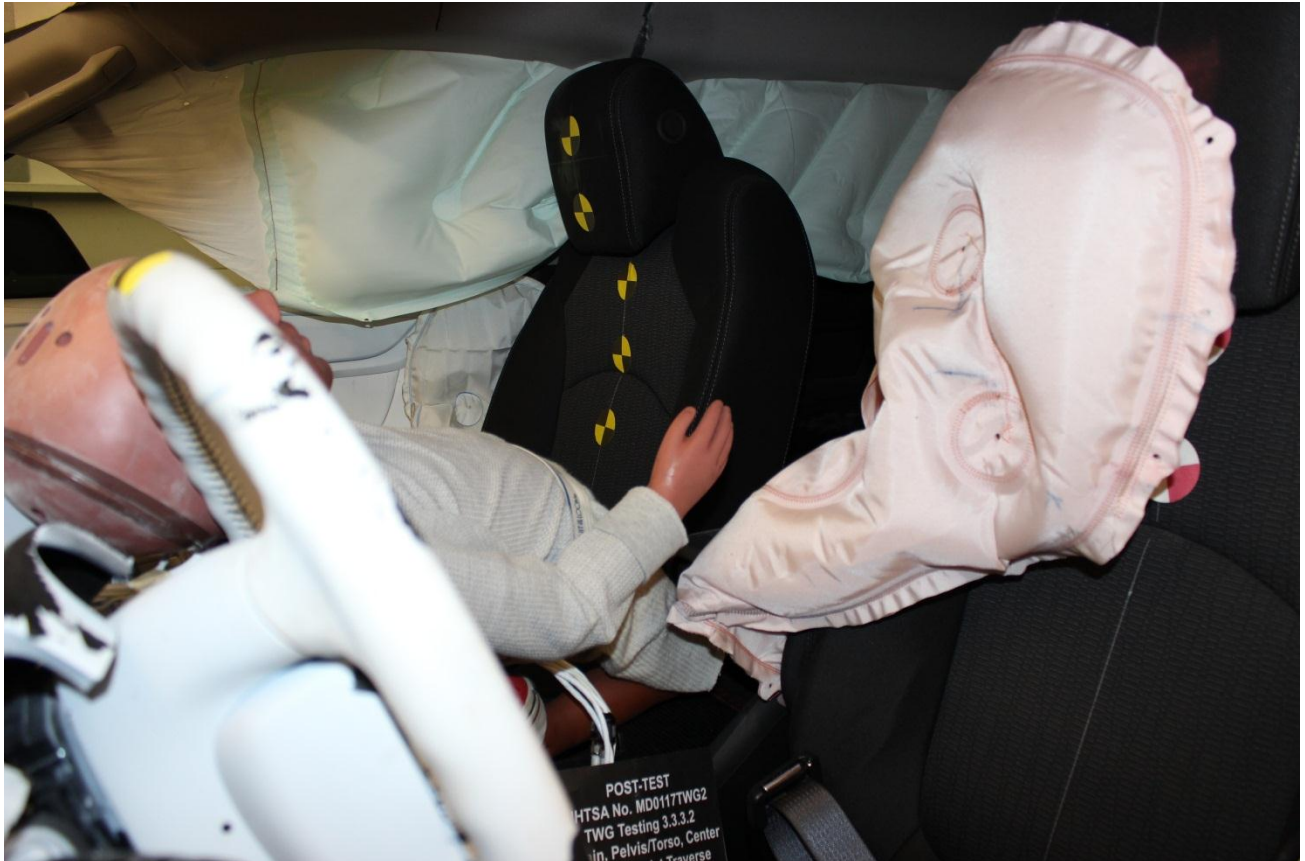
**Figure A-20: Post-Test Left ¾ Front View**

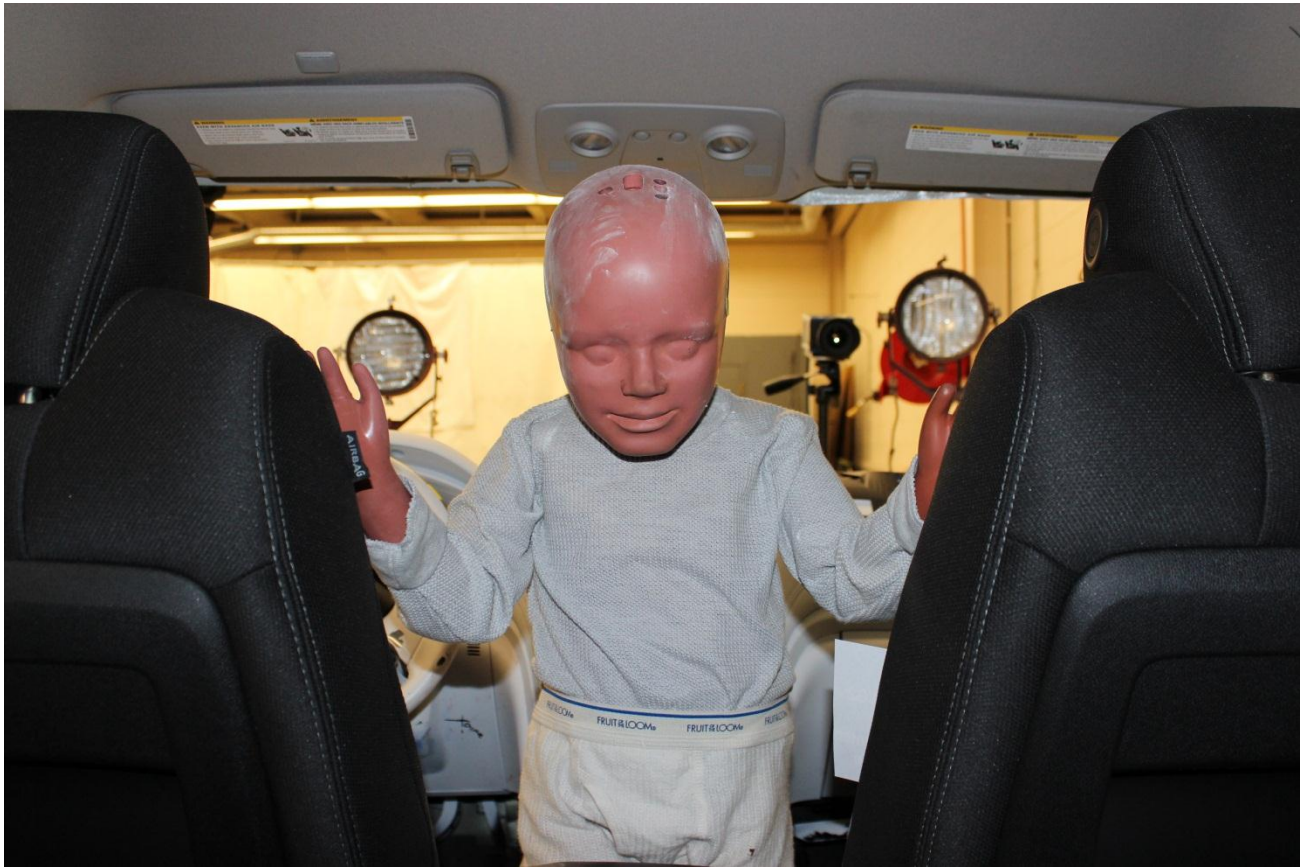
**Figure A-21: Pre-Test HIII 3 Year Old Dummy Rear View**

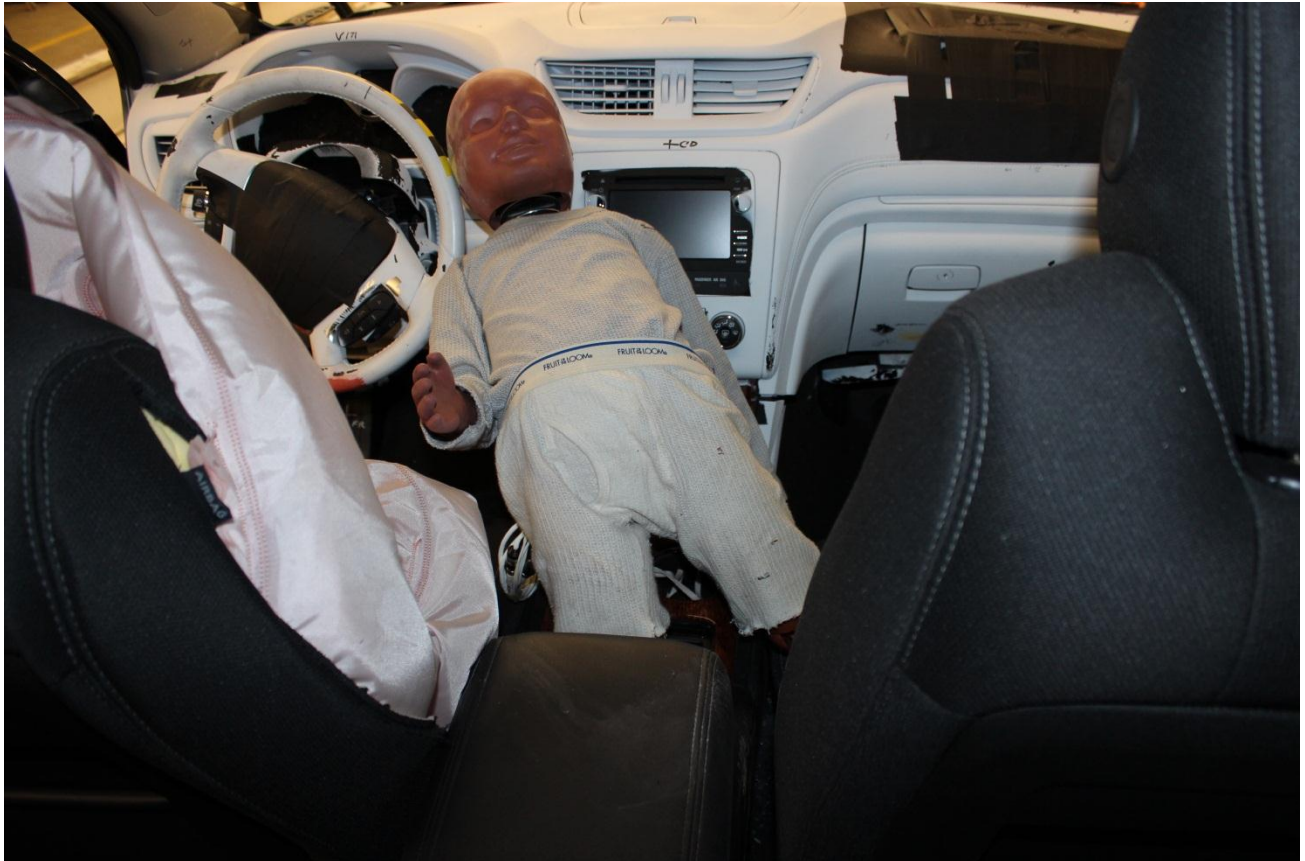
**Figure A-22: Post-Test HIII 3 Year Old Dummy Rear View**

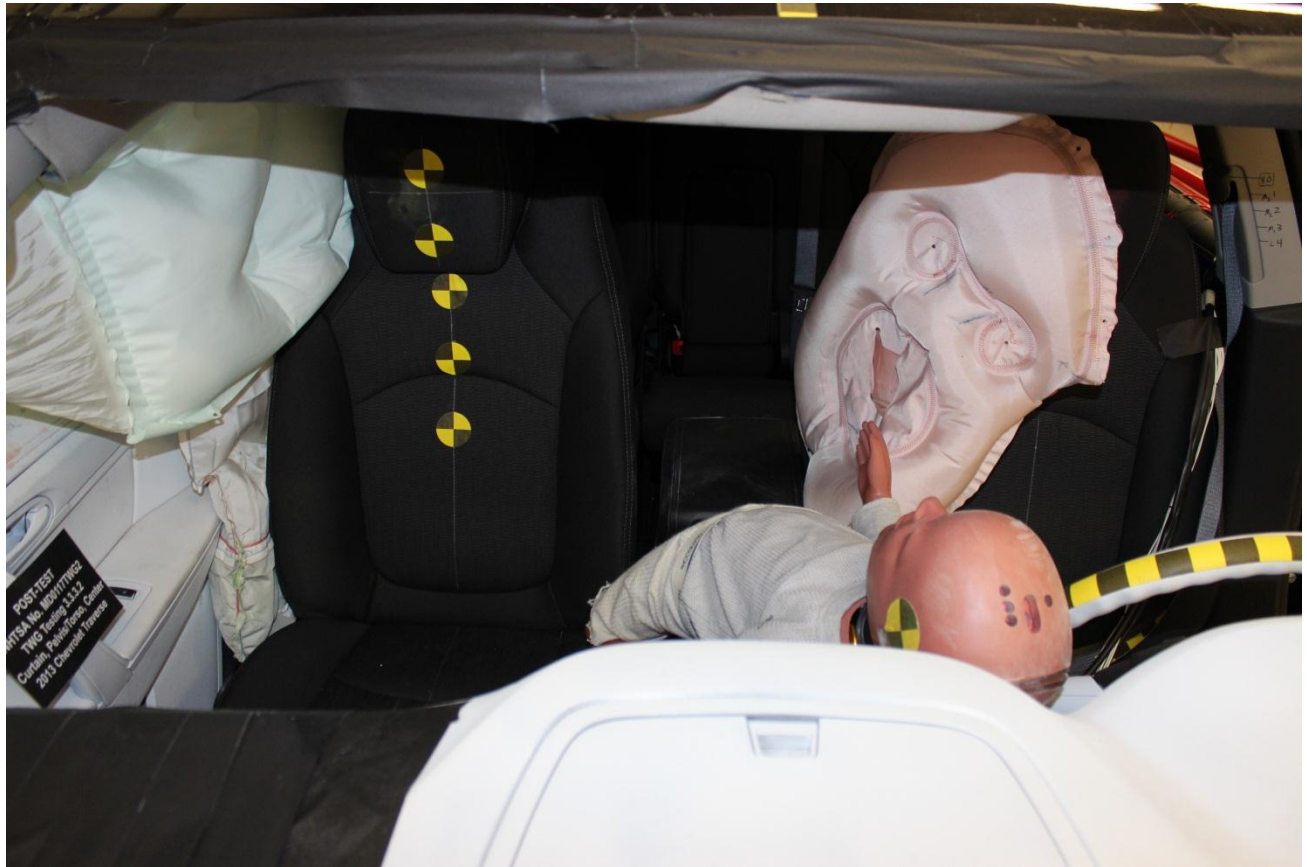
**Figure A-21: Post-Test Airbag Front View**

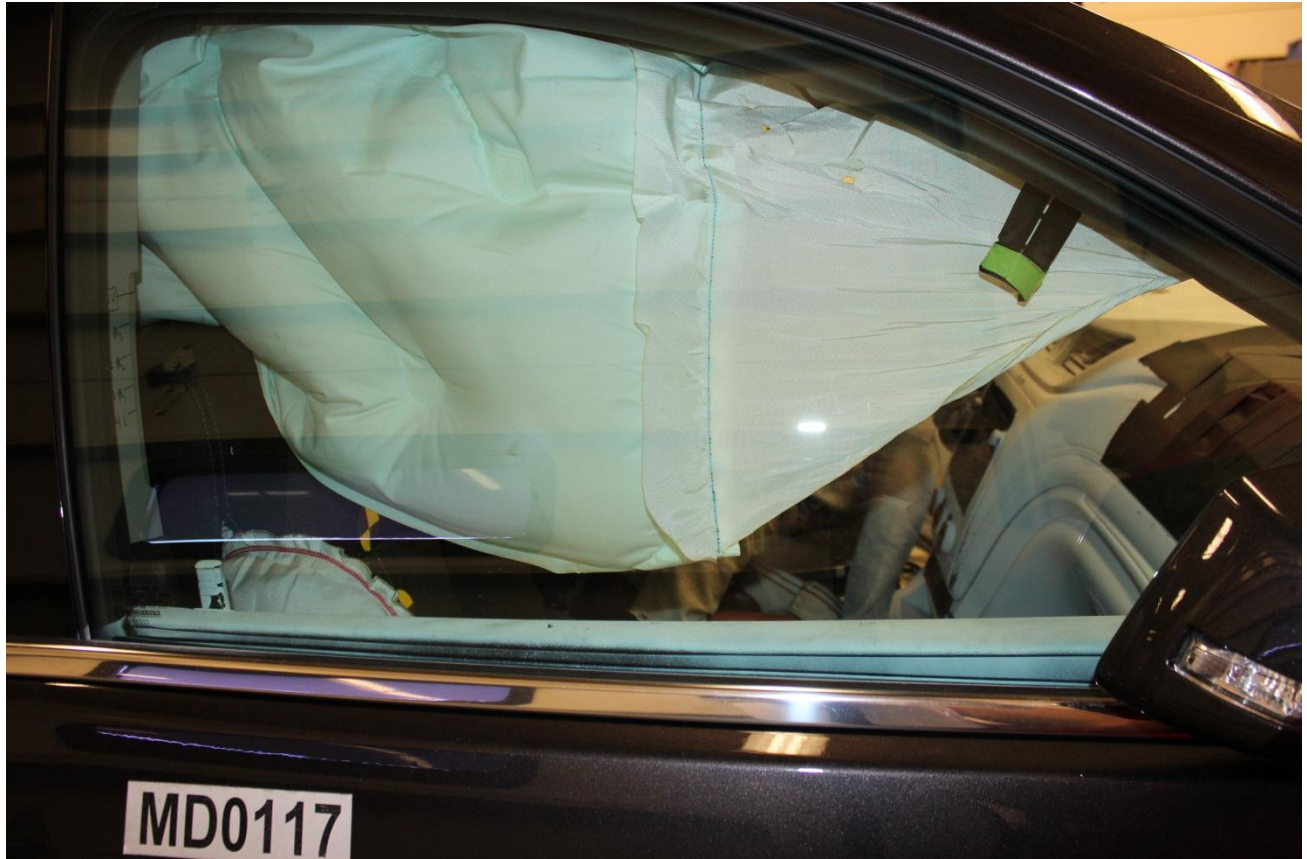
**Figure A-22: Post-Test Curtain Airbag Right Side View**
