REPORT NUMBER: TWG-CAL-13-08

**NEW CAR ASSESSMENT PROGRAM (NCAP)**  
SIDE AIRBAG OUT-OF-POSITION INJURY TESTING

**General Motors LLC**  
**2013 Chevrolet Traverse**  
**Four Door SUV**

NHTSA NUMBER: MD0117TWG2  
CALSPAN TEST NUMBER: CT2013-08

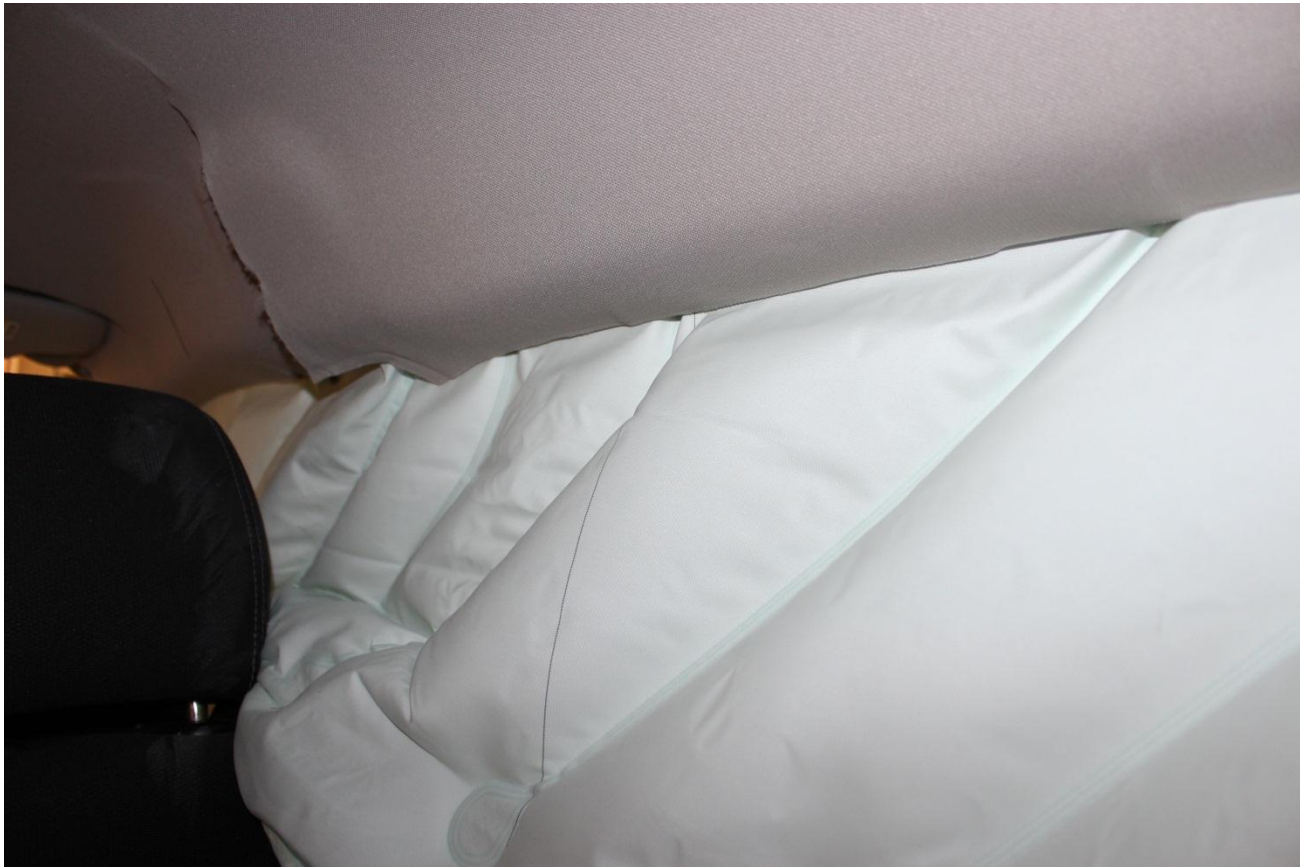
**Figure A-23: Post-Test Curtain Airbag Right  $\frac{3}{4}$  Rear View**

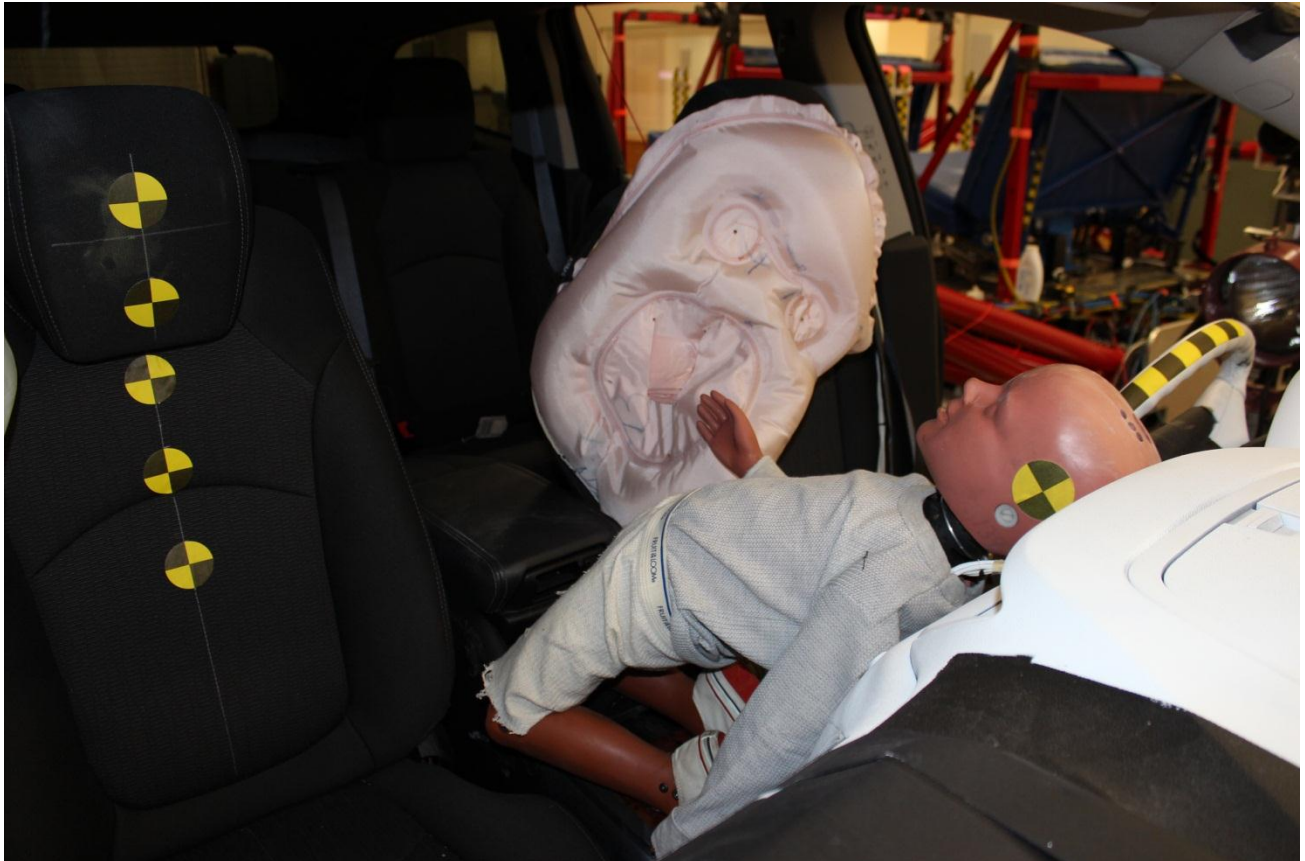
**Figure A-24: Post-Test Center Airbag Right  $\frac{3}{4}$  Front View**

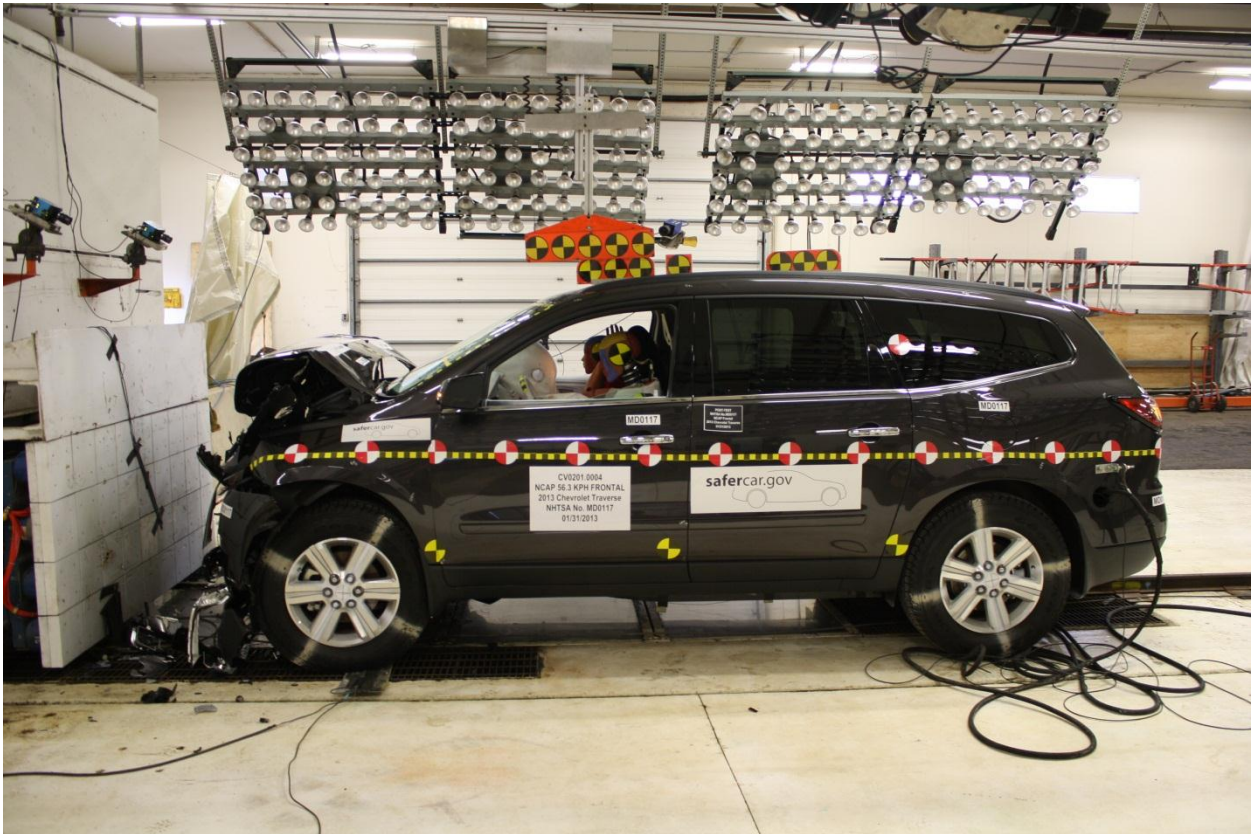
**Figure A-25: Post NCAP Left Side View**
