**FINAL REPORT NUMBER: SPNCAP-TRC-14-001**

**NEW CAR ASSESSMENT PROGRAM (NCAP)  
SIDE IMPACT POLE TEST**

**General Motors LLC  
2014 Chevrolet Impala 4-Door Sedan  
NHTSA NUMBER: M20140101**

**PREPARED BY:  
Transportation Research Center Inc.  
10820 State Route 347  
P. O. Box B-67  
East Liberty, OH 43319**

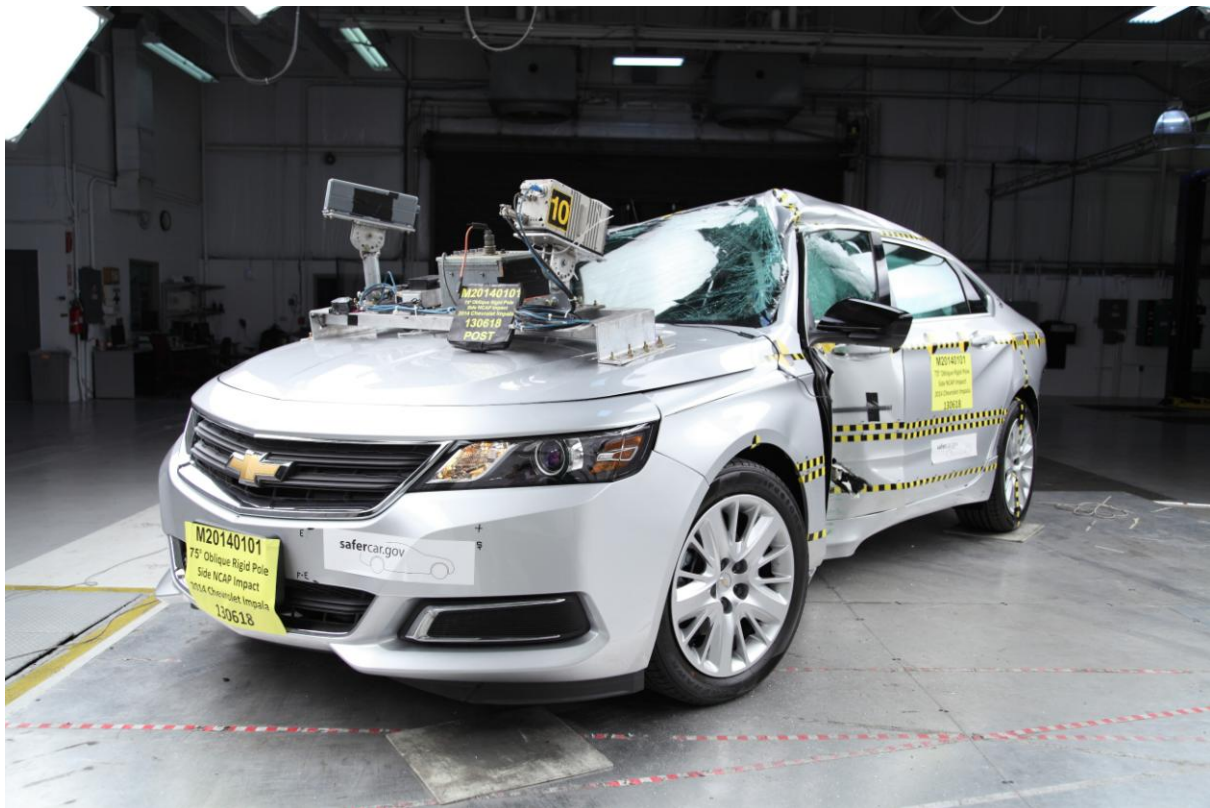
**006** Post-Test Left Front 3-4 View of Test Vehicle

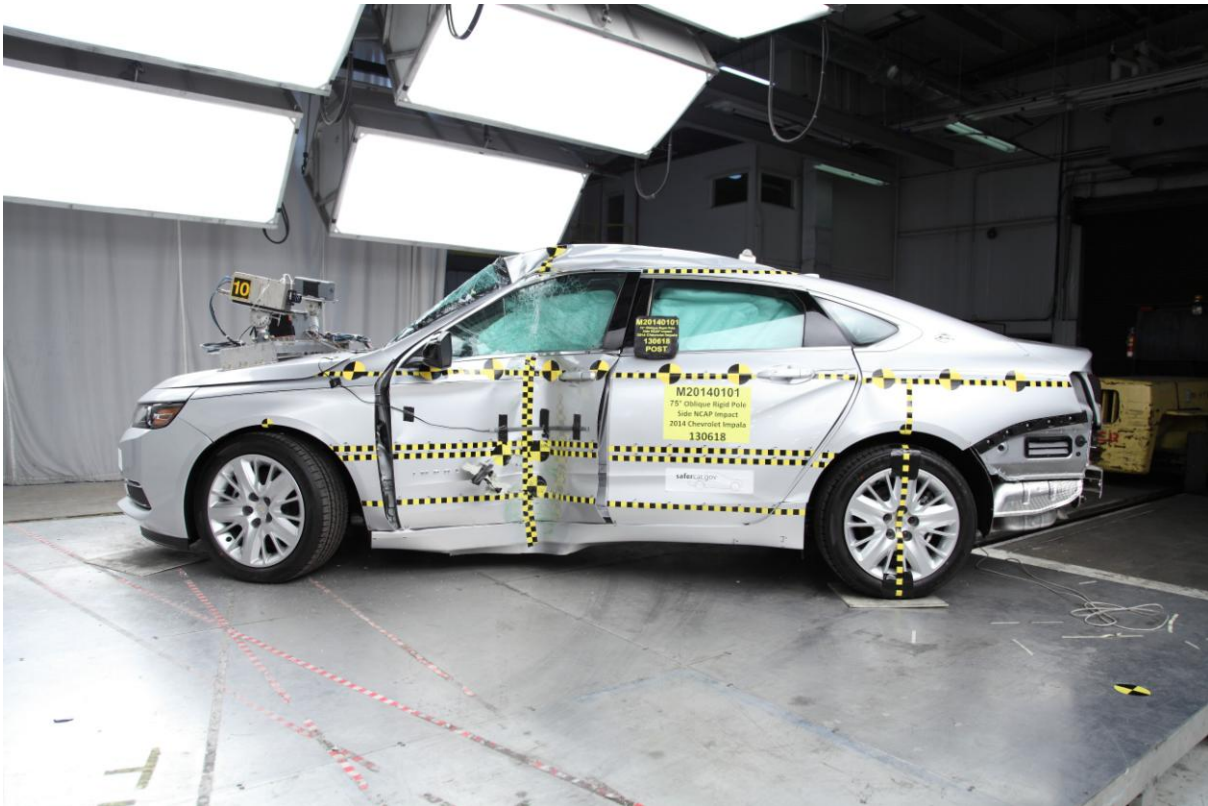
**008** Post-Test Left Side View of Test Vehicle

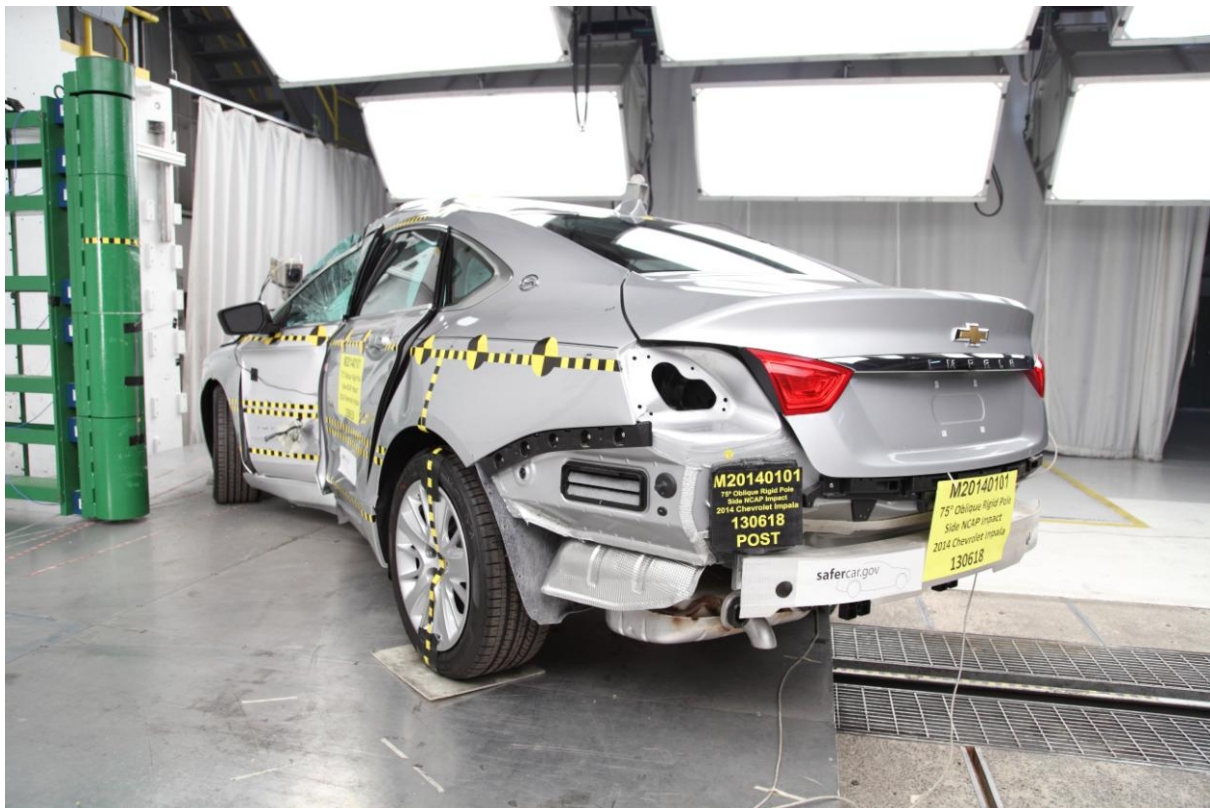
**010** Post-Test Left Rear 3-4 View of Test Vehicle

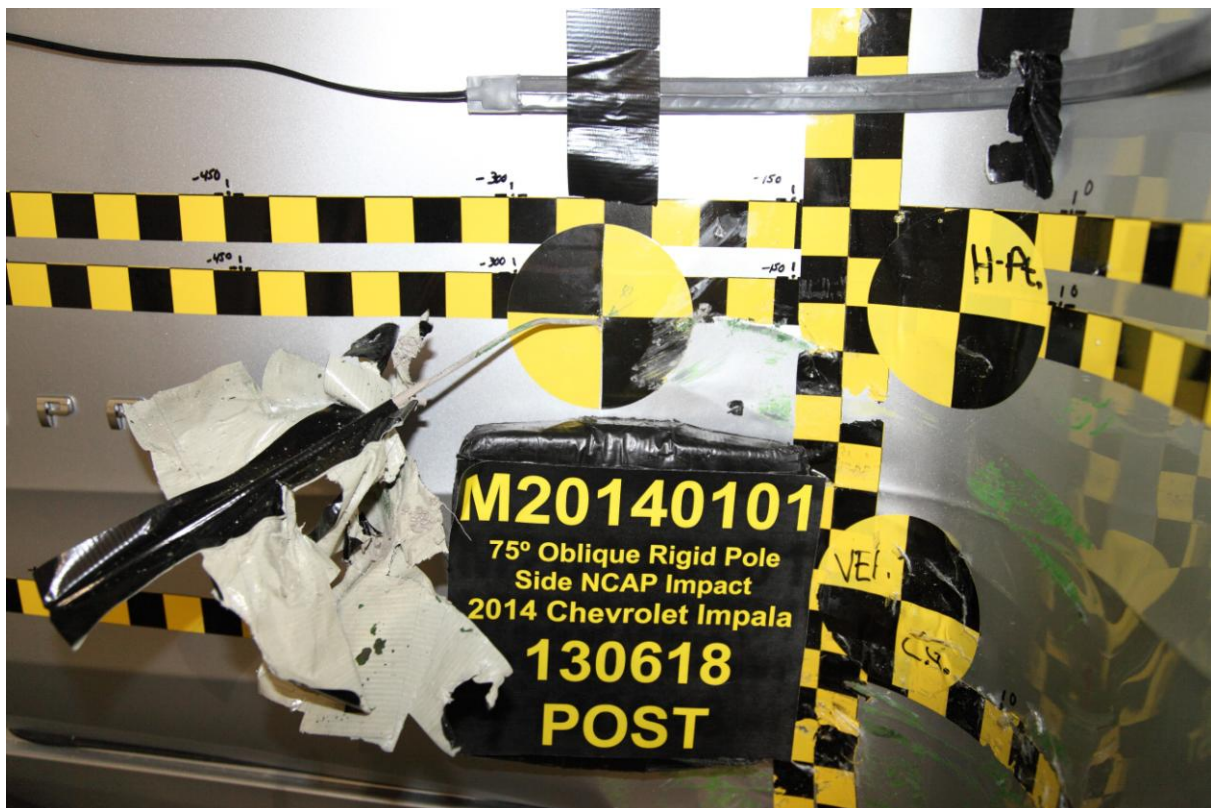
020 Post-Test Close-Up View of Impact Point Target Showing Impact Location

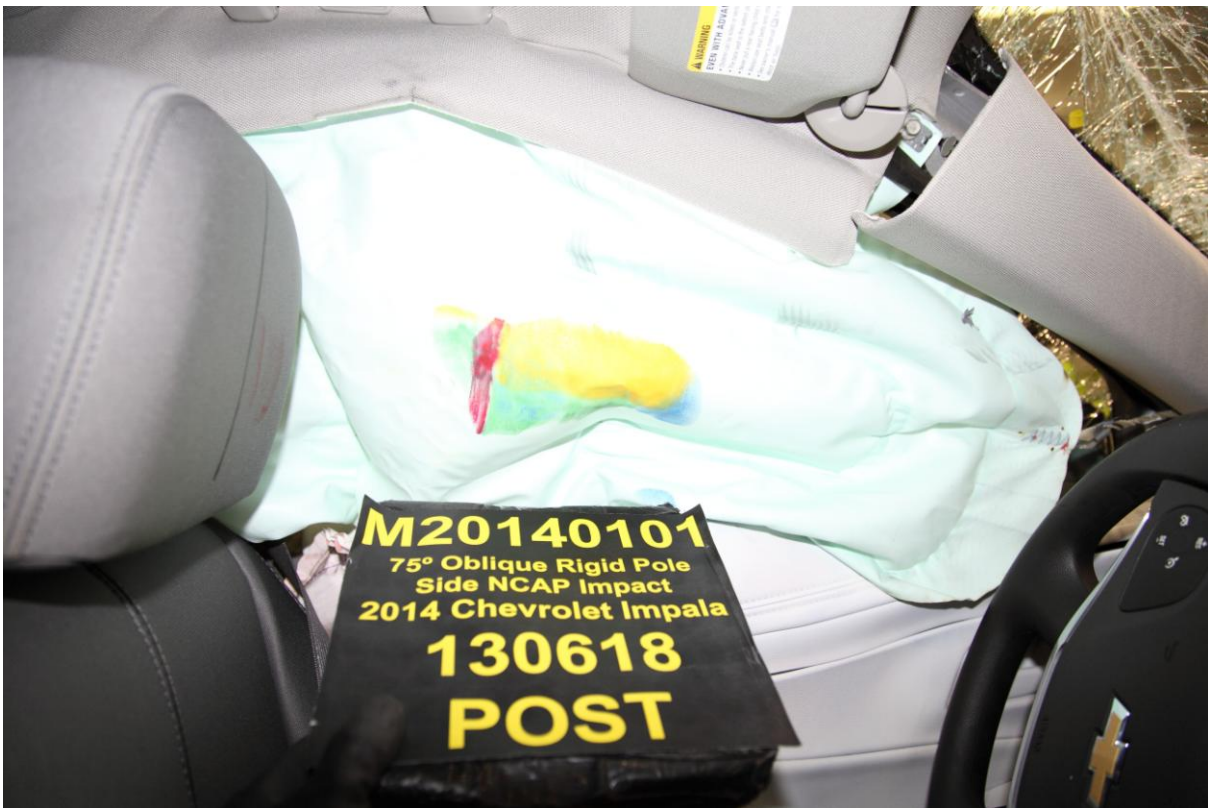
**046** Post-Test Dummy Close-Up Head Contact with Vehicle View

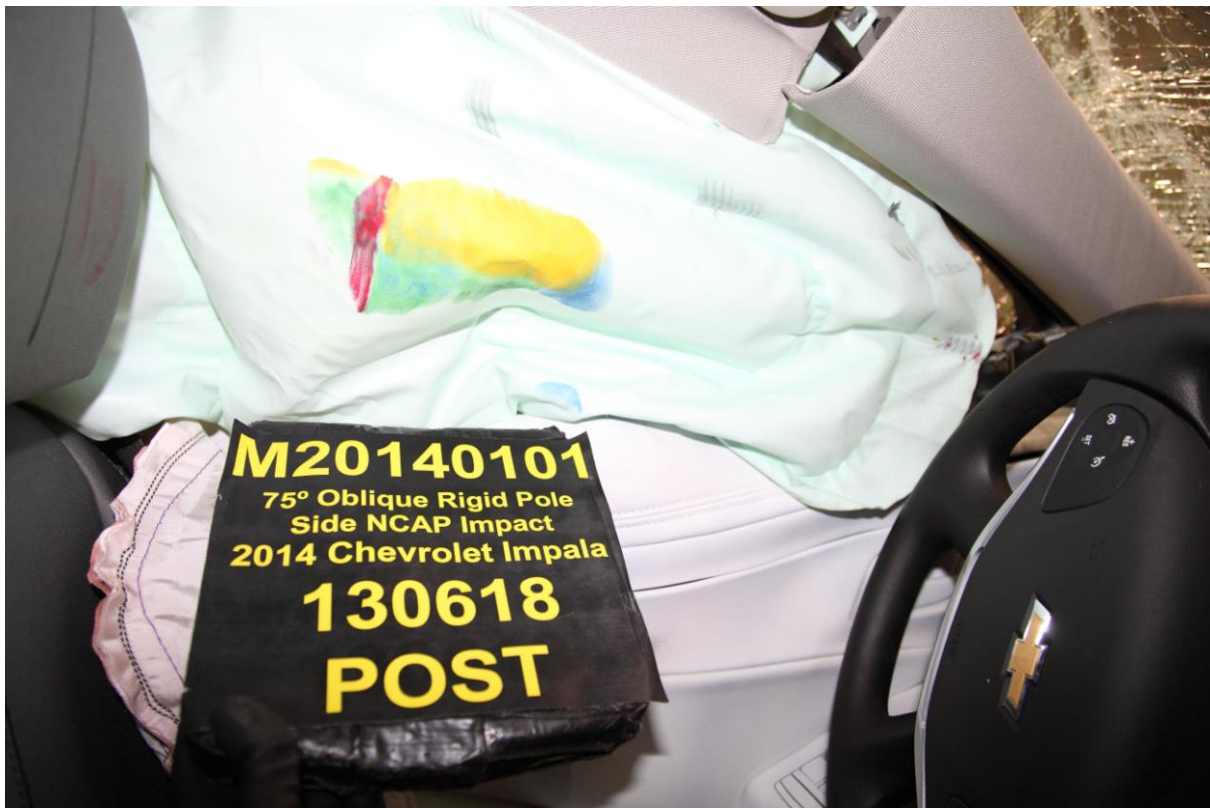
**047** Post-Test Dummy Close-Up Head Contact with Side Airbag View

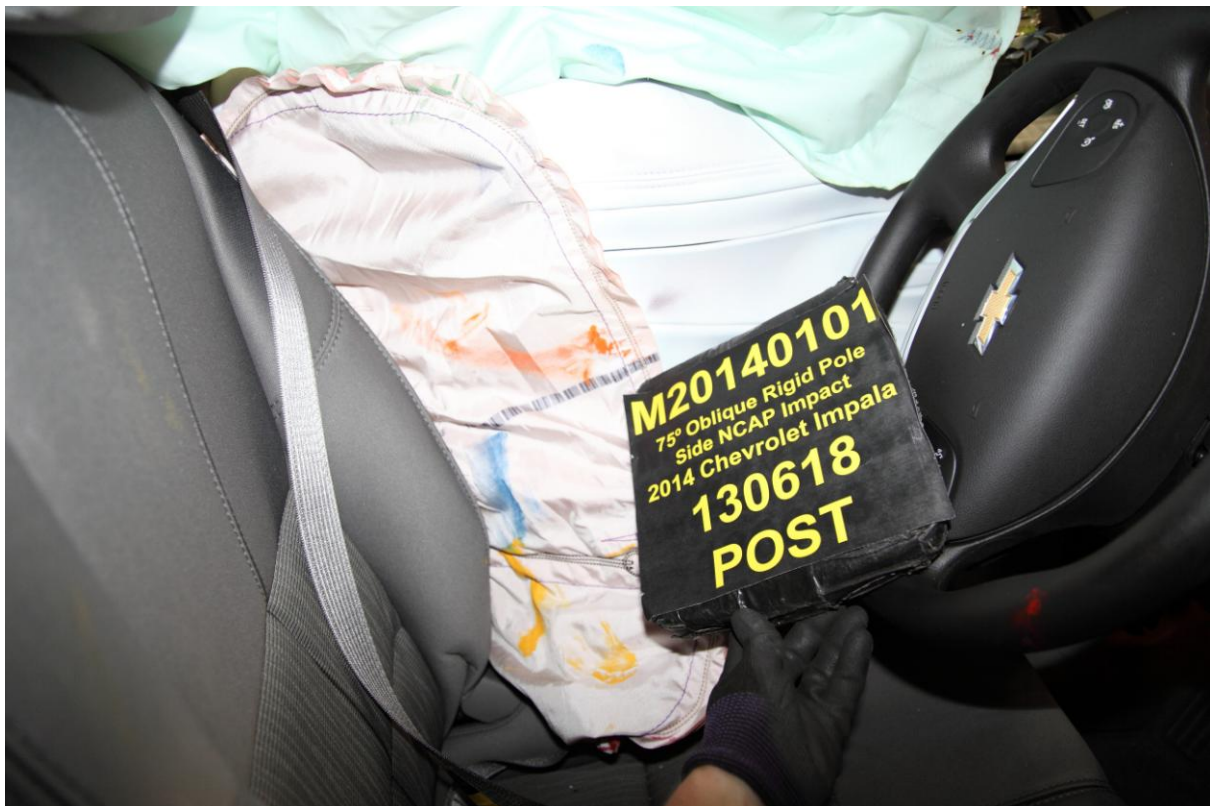
**048** Post-Test Dummy Close-Up Torso Contact with Vehicle Interior View

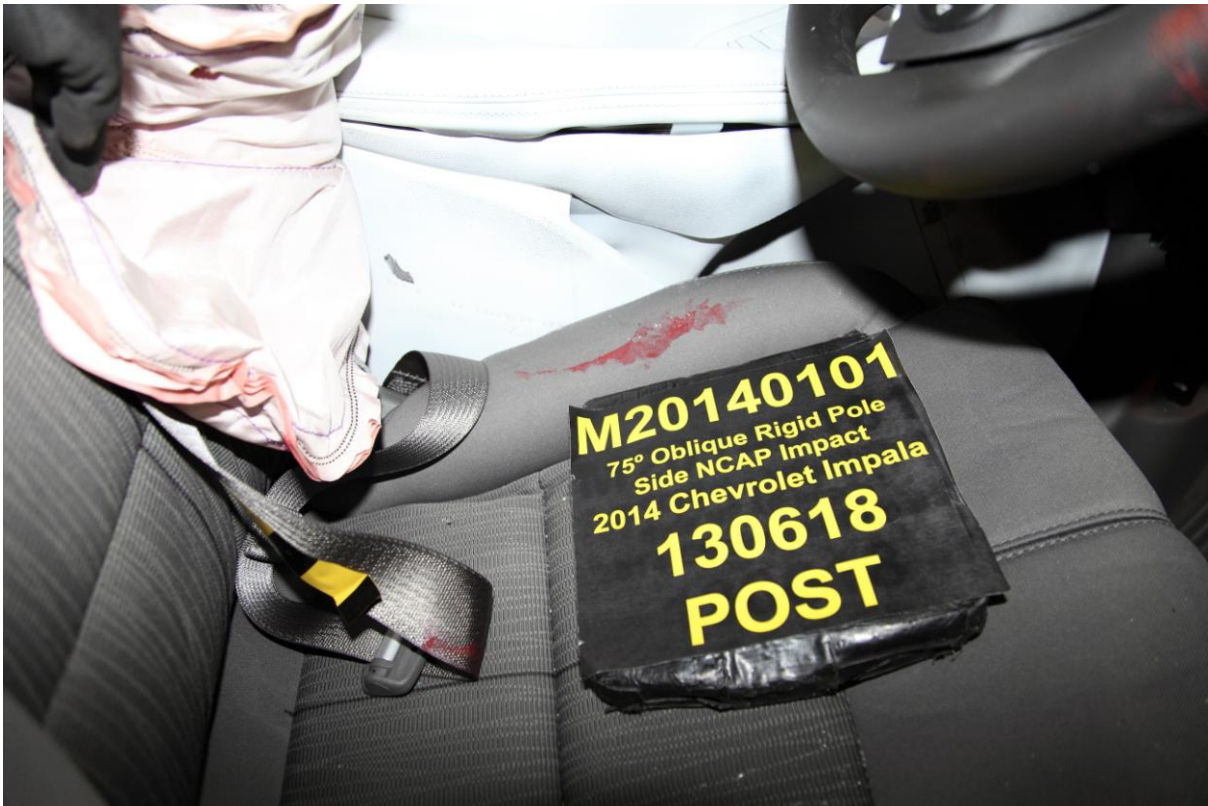
**050** Post-Test Dummy Close-Up Pelvis Contact with Vehicle Interior View

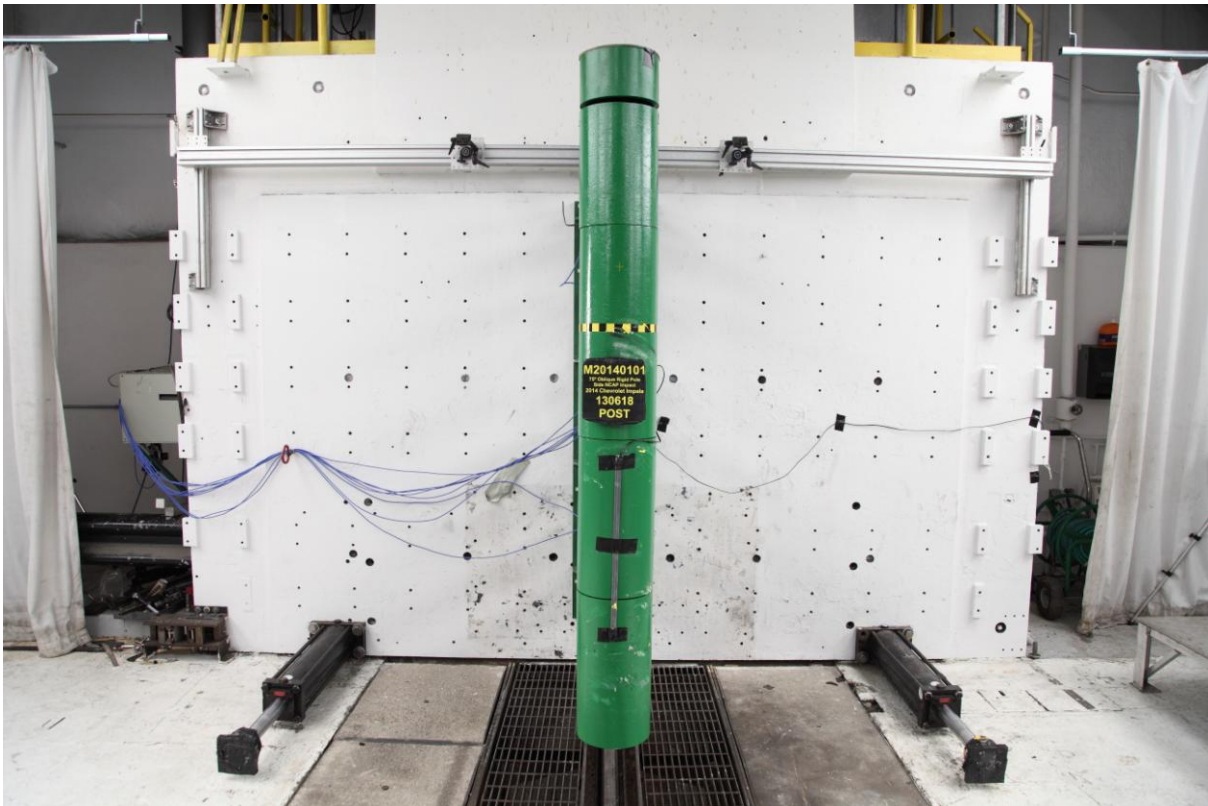
**058** Post-Test Pole Barrier Front View

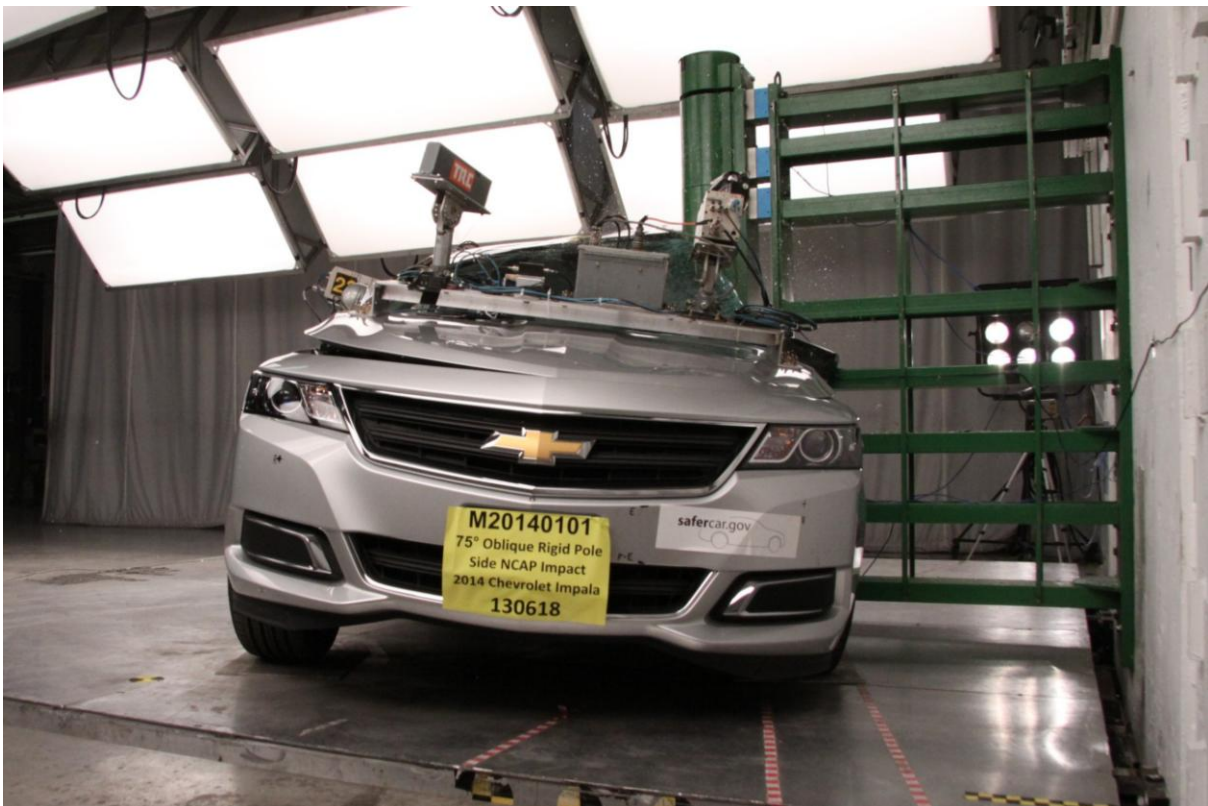
**068** Impact Event

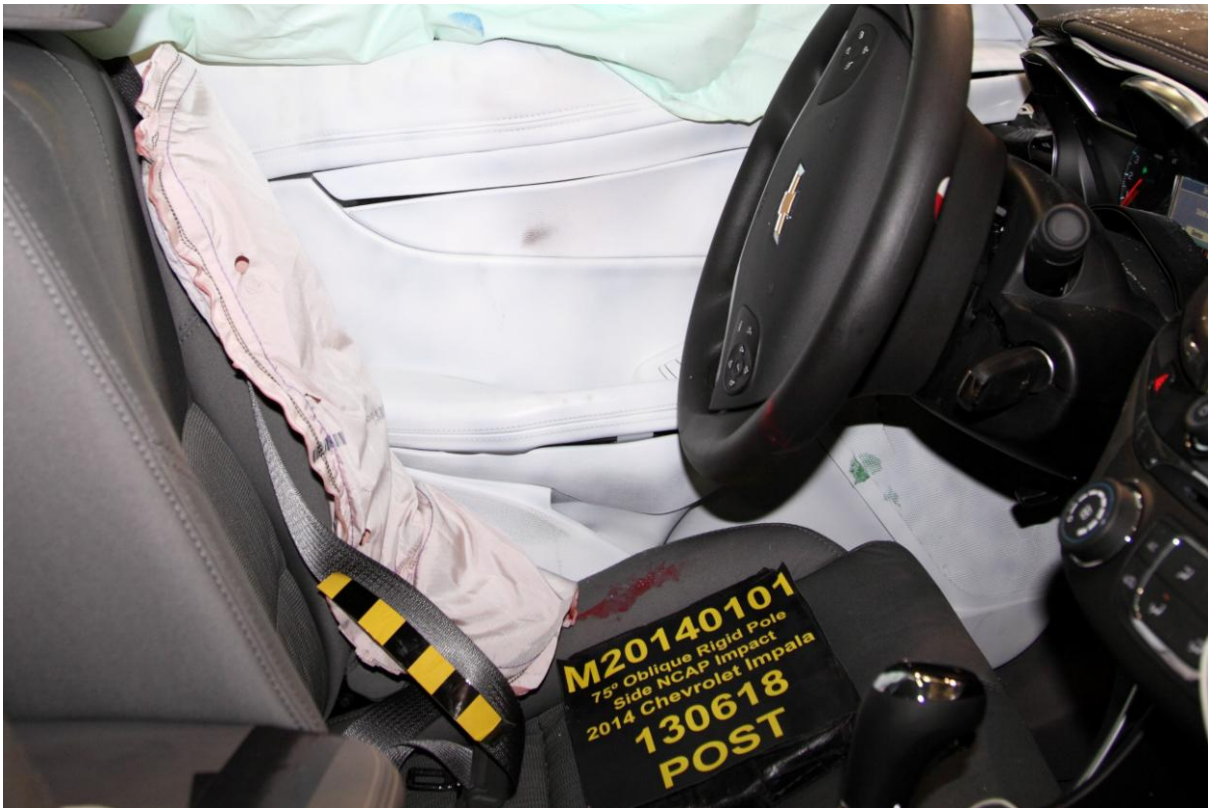
**071** Post-Test View of Shattered Vehicle Inner Door Panel
