**REPORT NUMBER: NCAP-CAL-14-001**

**NEW CAR ASSESSMENT PROGRAM (NCAP)  
FRONTAL BARRIER IMPACT TEST**

**Chrysler Group LLC  
2014 Jeep Grand Cherokee  
Utility Vehicle**

**FINAL REPORT**

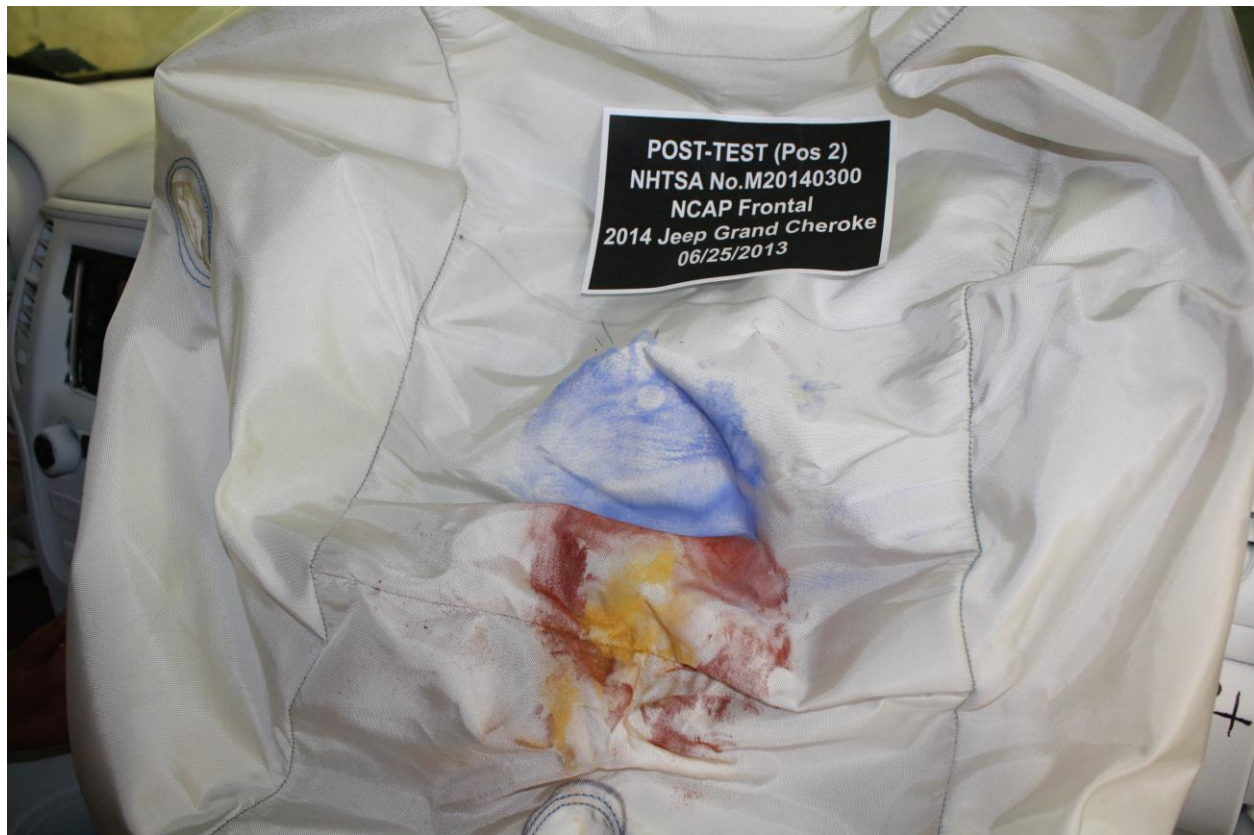
The passenger's visible contact points were as follows: The passenger's head contacted the frontal airbag and then the head restraint. The upper torso contacted the frontal airbag. Both knees contacted the glove box.

**Figure A-66: Post-Test Passenger Dummy Contact With Airbag**

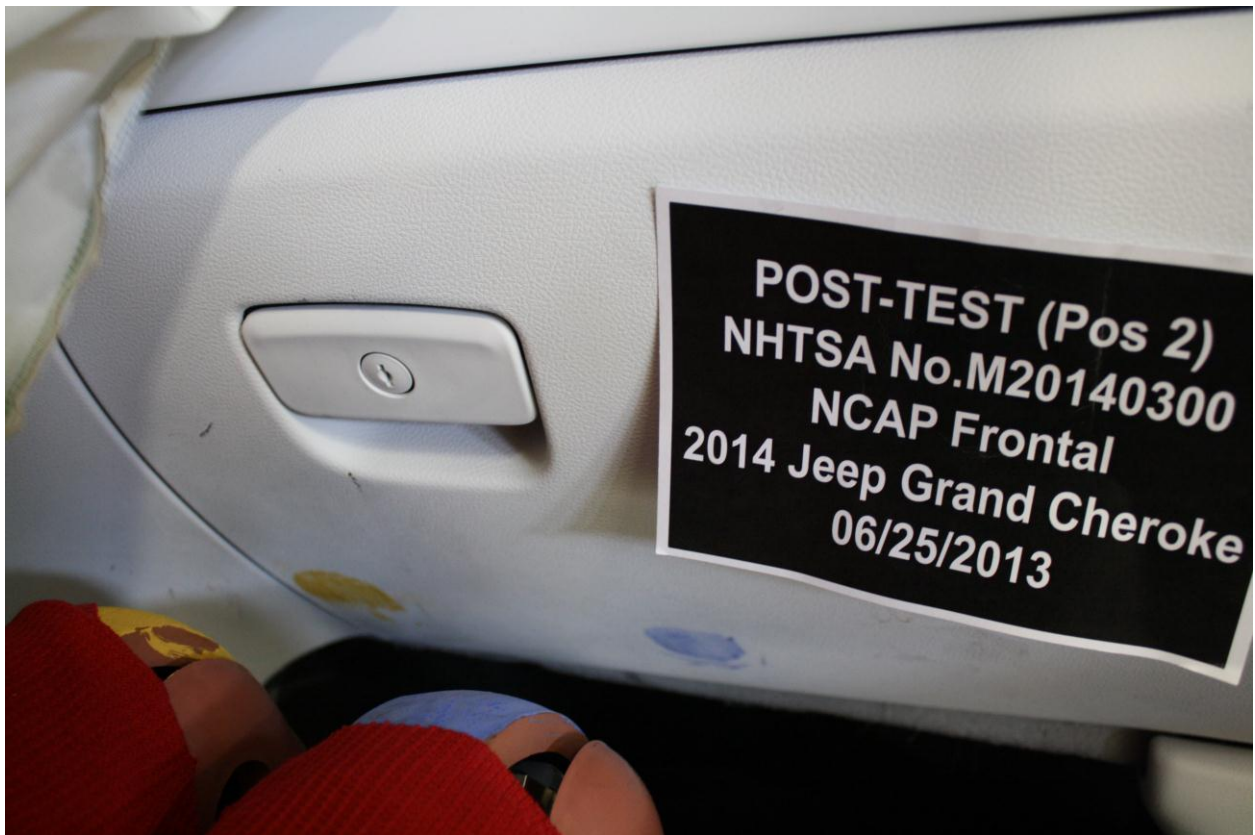
**Figure A-66b: Post-Test Passenger Dummy Contact With Glovebox**
