**REPORT NUMBER: NCAP-MGA-2014-002**

**NEW CAR ASSESSMENT PROGRAM (NCAP)  
Frontal Barrier Impact Test**

**KIA MOTORS CORPORATION  
2014 KIA Forte LX 4-Dr Sedan  
NHTSA No.: M20144200**

**FINAL REPORT**

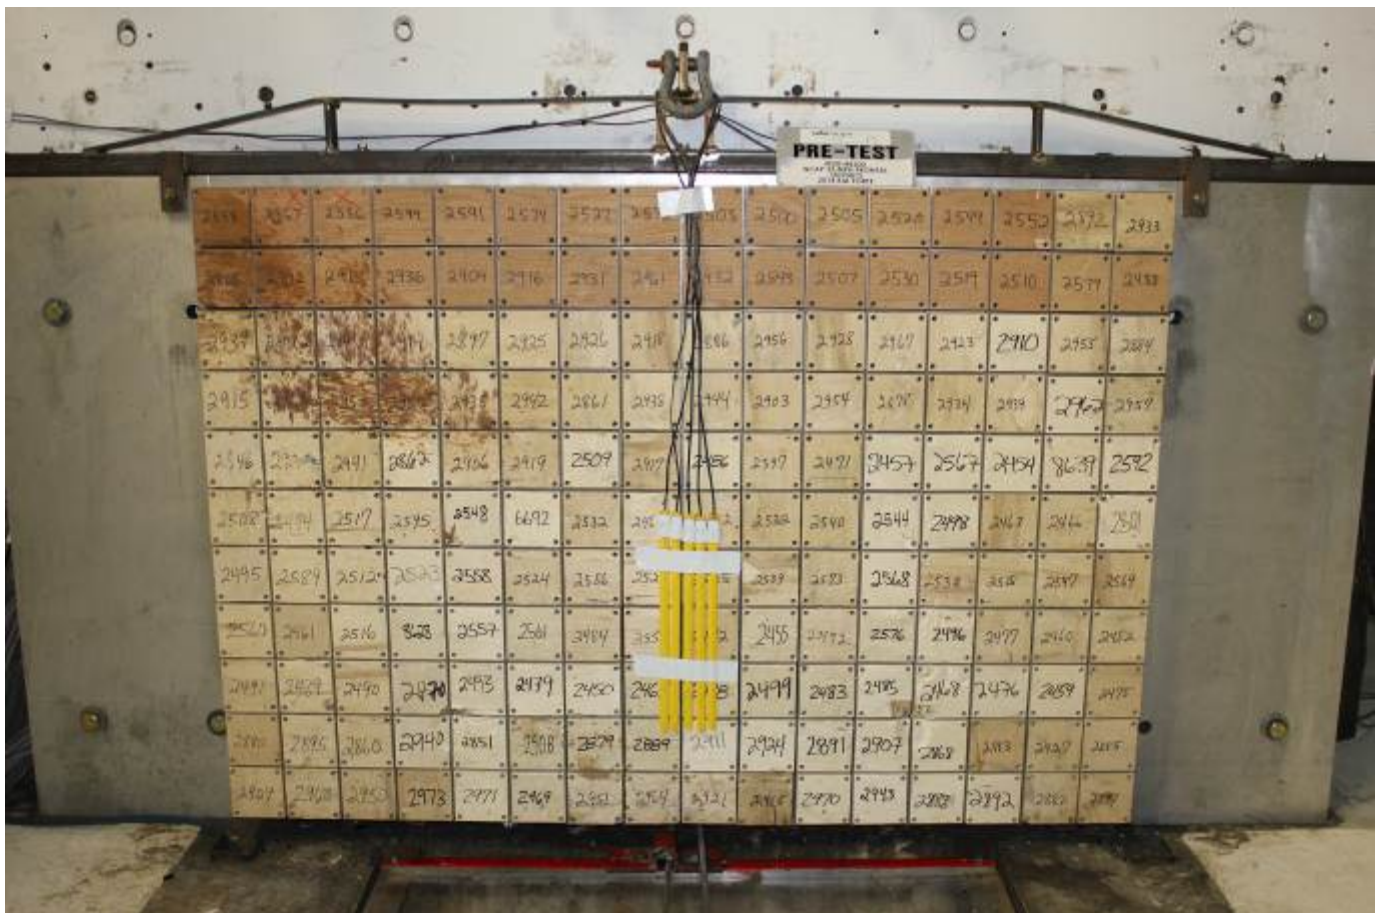
Load Cell Wall

A load cell barrier consisting of 176 load cells was impacted by a 2014 KIA Forte LX 4-Dr Sedan at a velocity of 56.1 km/h. The test was performed at MGA Research Corporation on July 8, 2013. Pre-test and post-test photographs of the vehicle and dummies can be found in Appendix A.

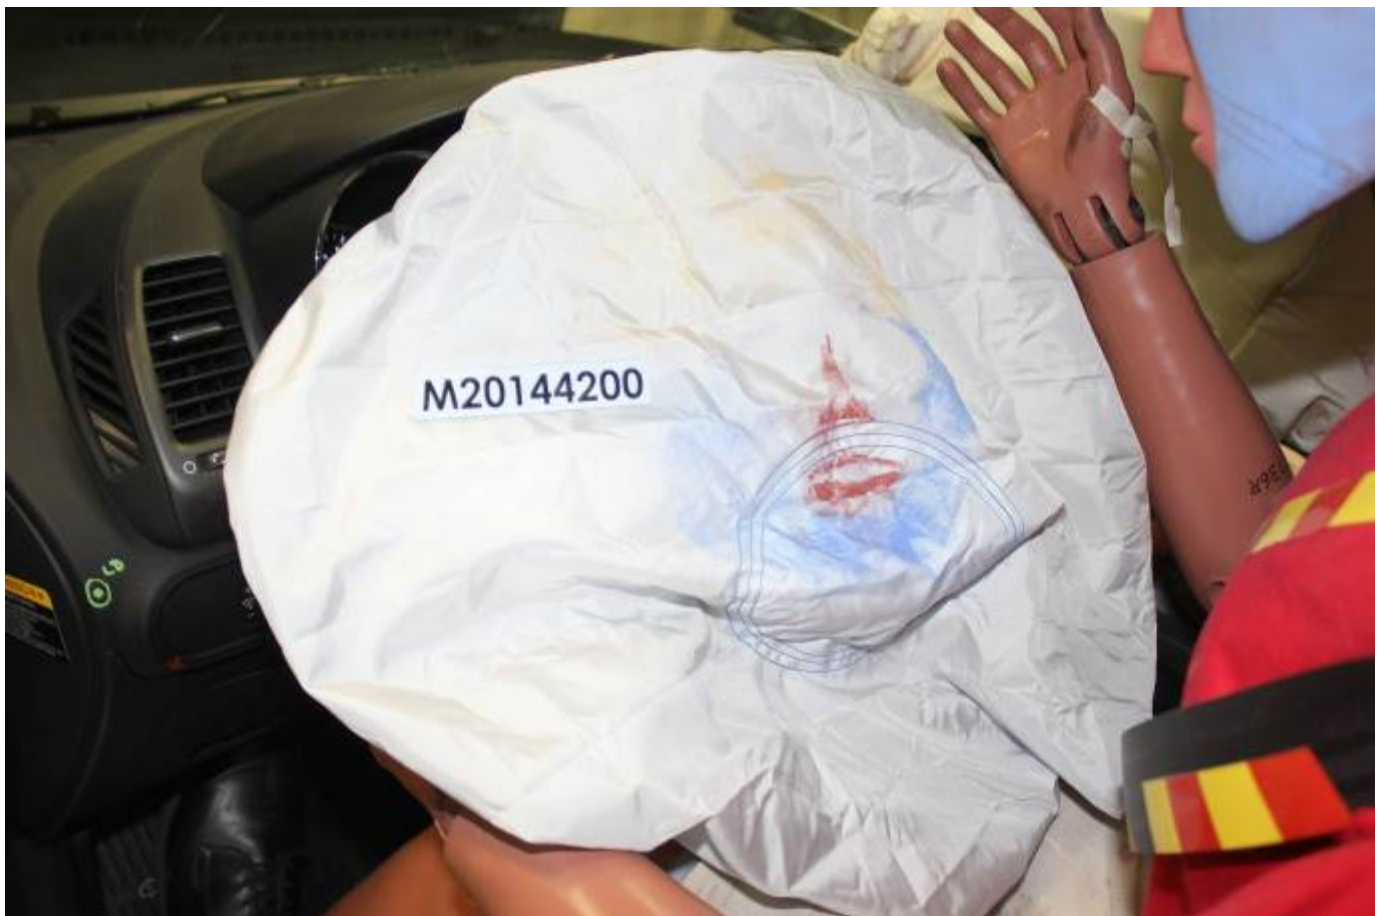
Post-Test Driver Dummy Contact with Airbag

The driver's visible contact points were as follows: The driver's head and chest contacted the airbag. The driver's head also contacted the headrest. The driver's knees contacted the knee bolster. The passenger's visible contact points were as follows: The passenger's head and chest contacted the airbag. The passenger's head also contacted the headrest. The passenger's knees contacted the glove box.

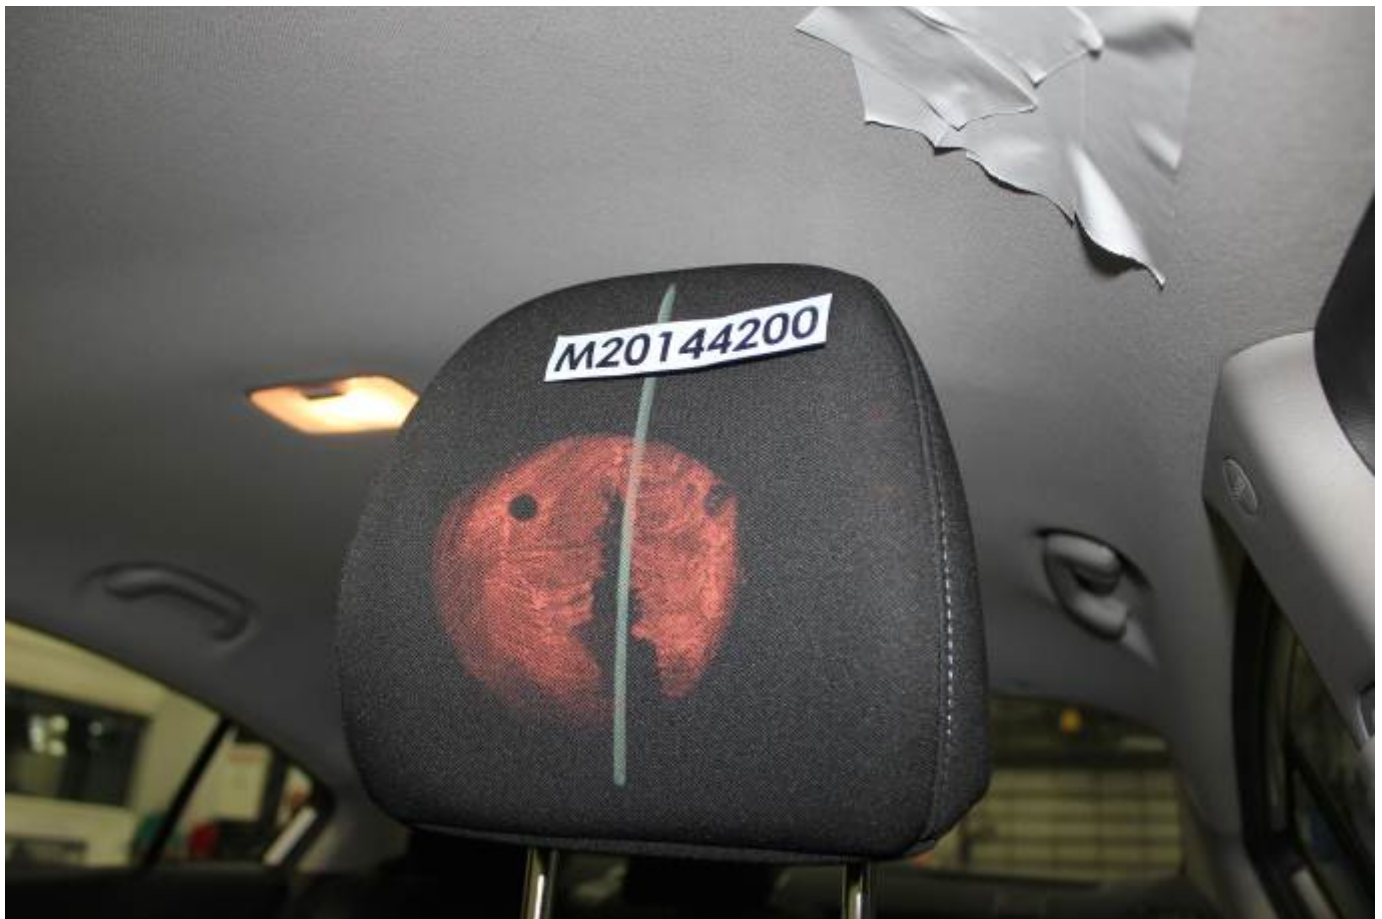
Post-Test Driver Dummy Contact with Headrest

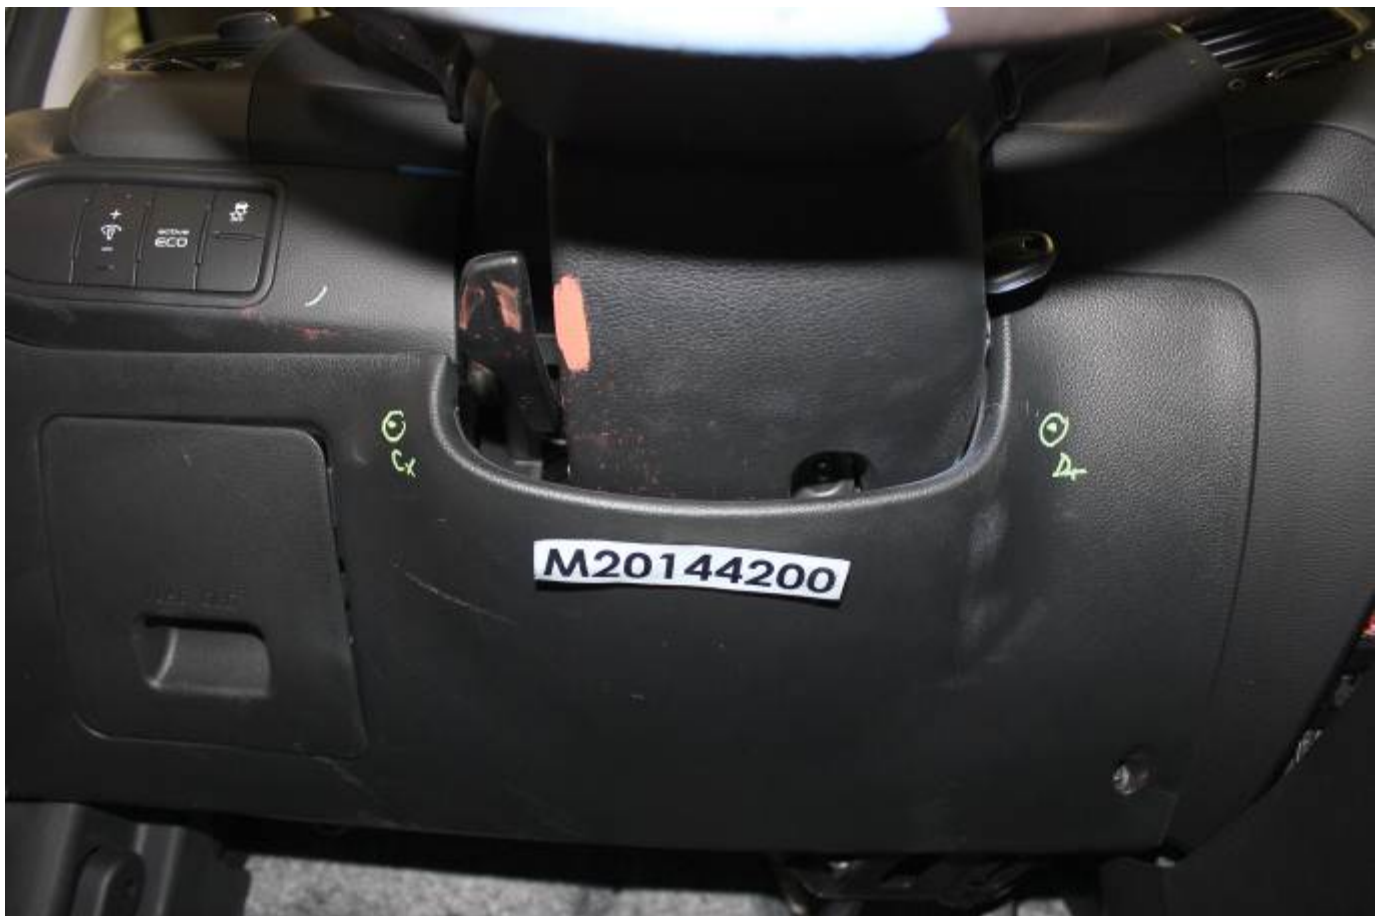
Post-Test Driver Dummy Contact with Knee Bolster

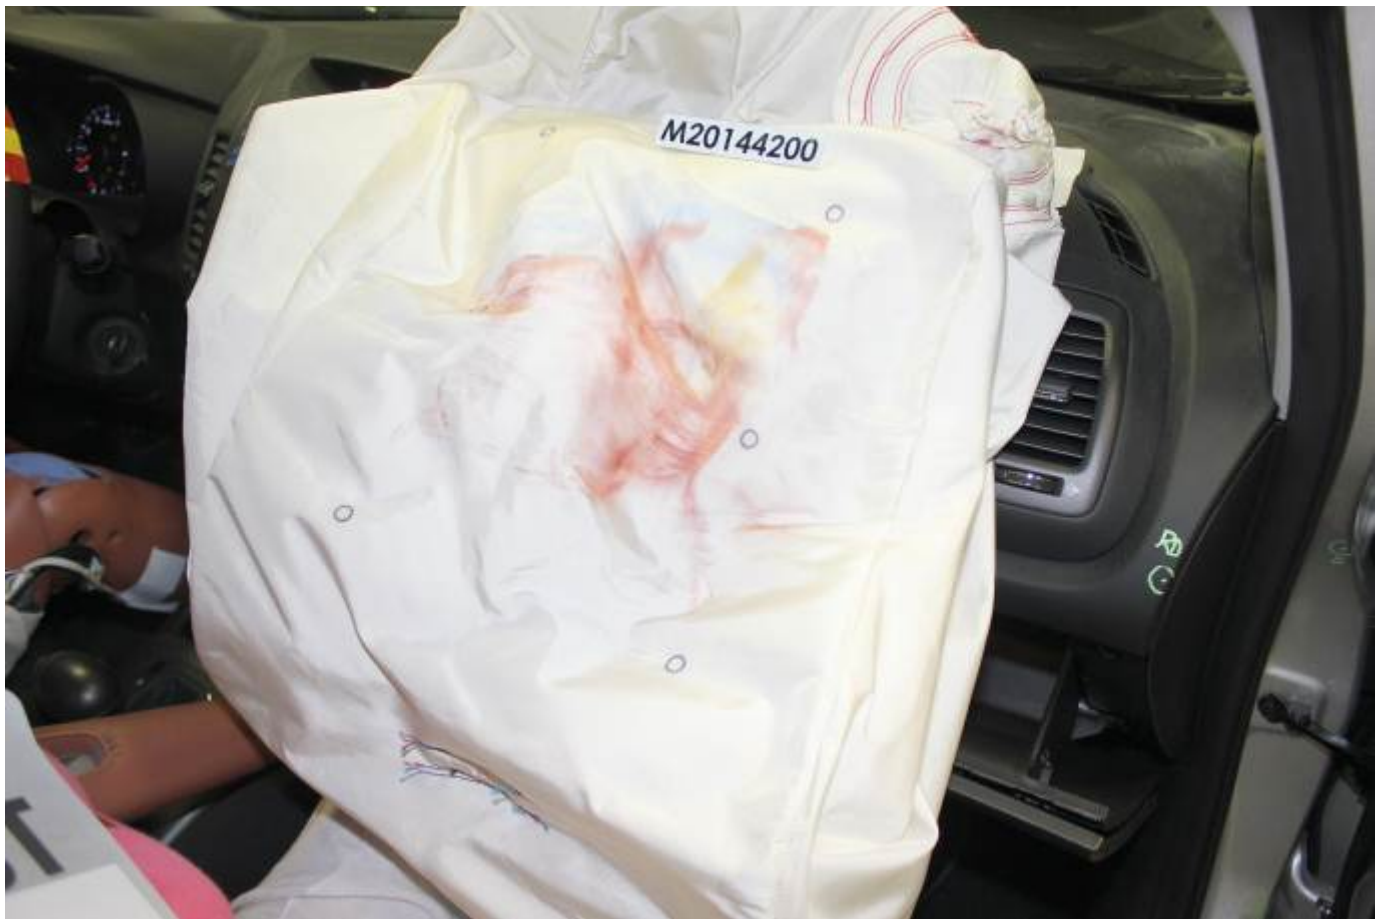
Post-Test Passenger Dummy Contact with Airbag

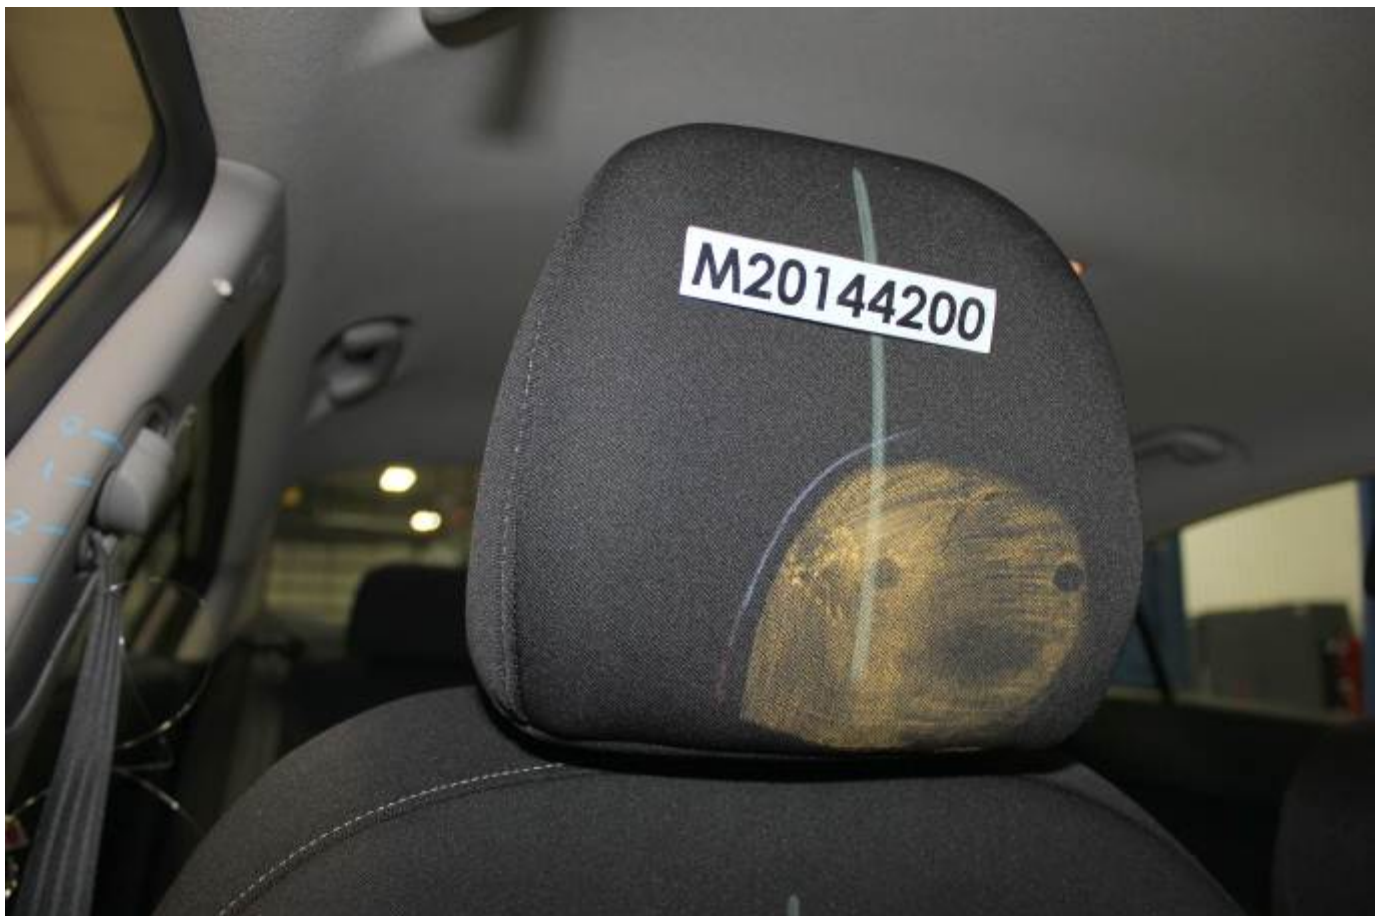
Post-Test Passenger Dummy Contact with Headrest

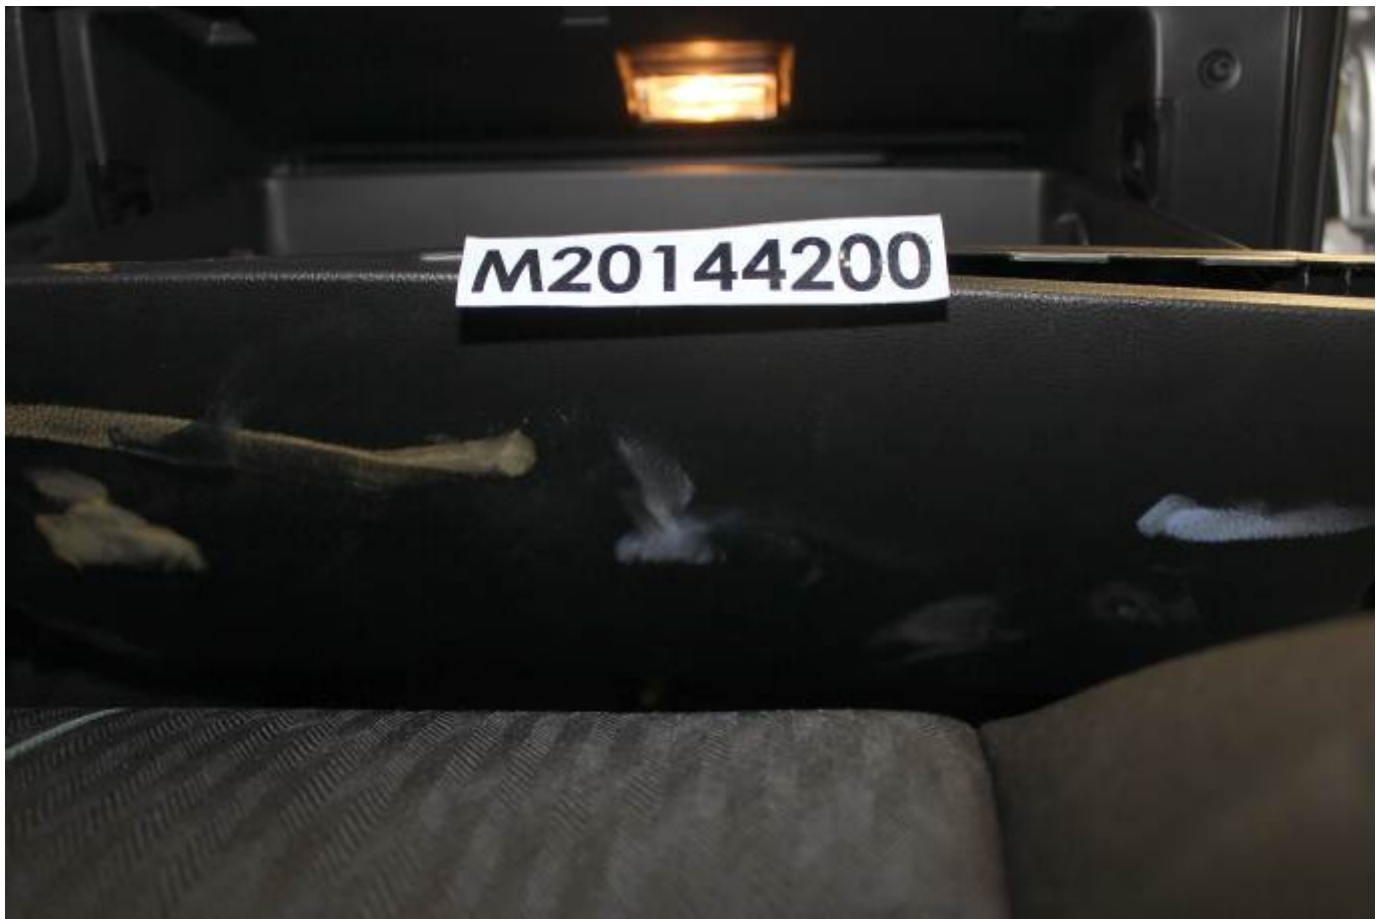
Post-Test Passenger Dummy Contact with Glove Box

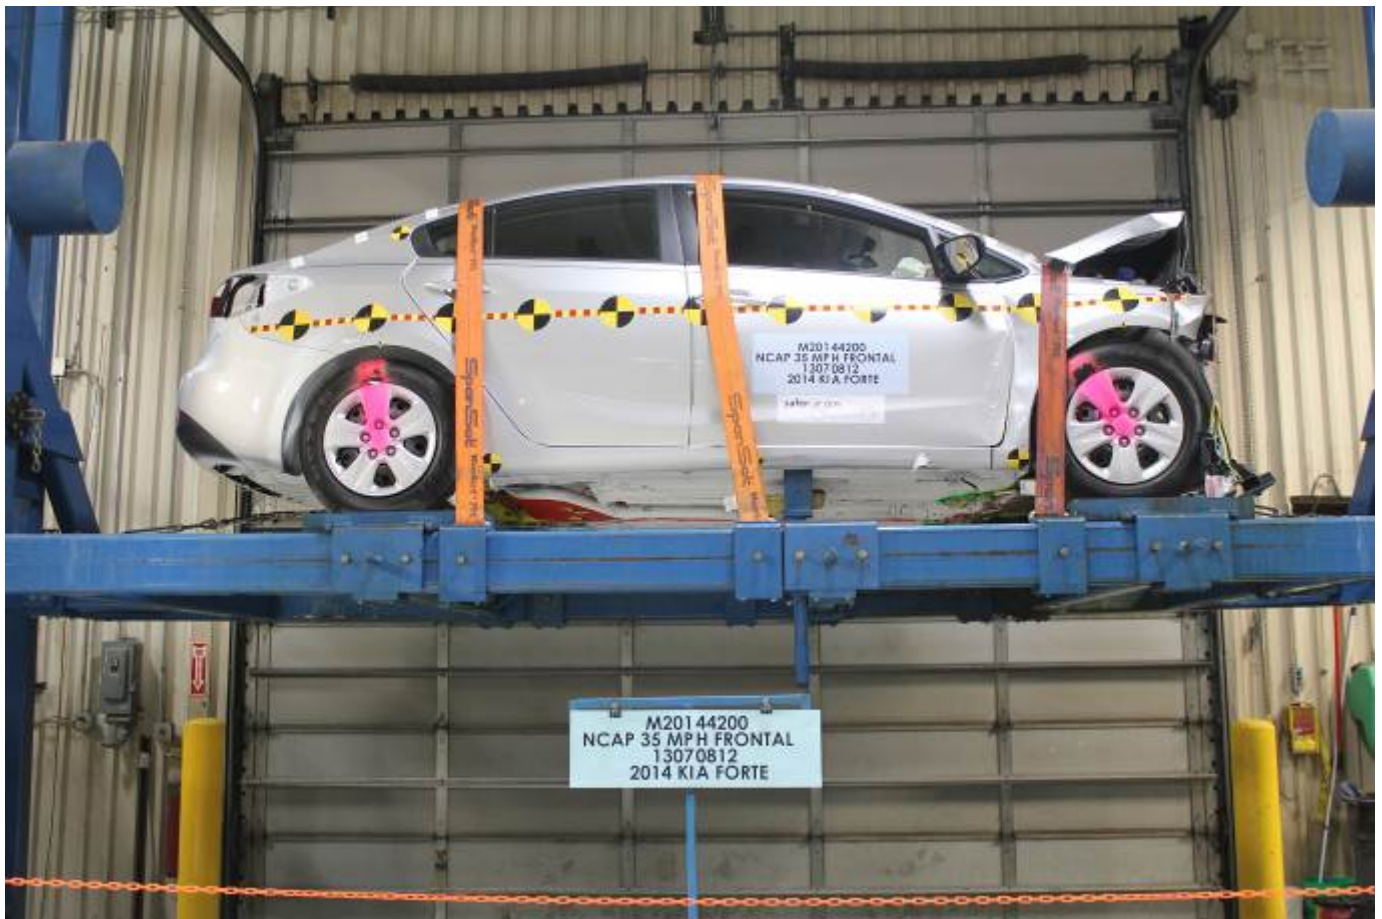
Vehicle at 0° on Static Rollover Device

There was 100 percent windshield retention and no intrusion into the protected zone of the windshield during the event. There was no Stoddard Solvent leakage after the event or during any phase of the static rollover.

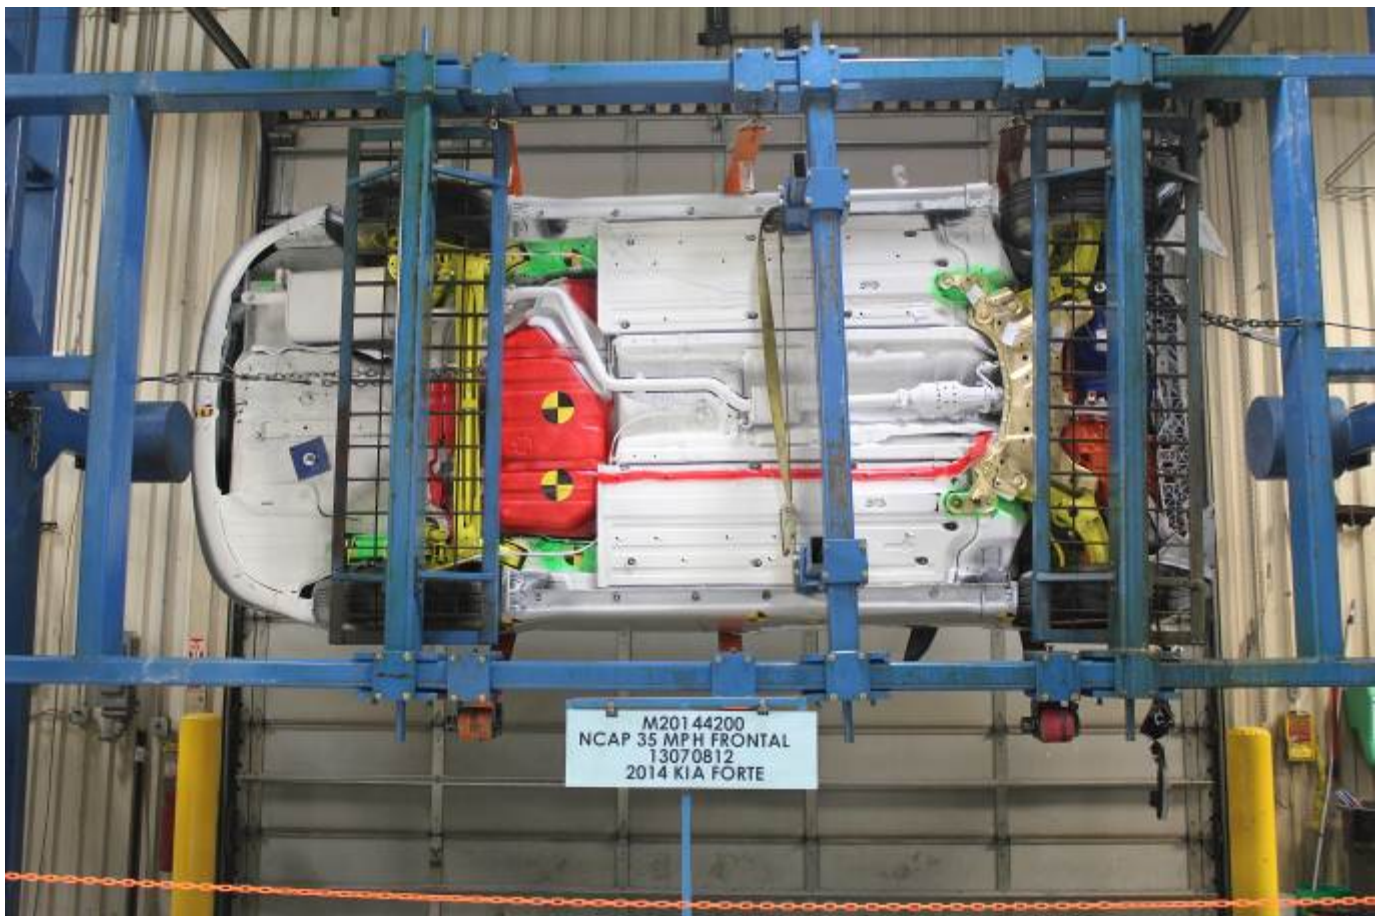
Vehicle at 90° on Static Rollover Device

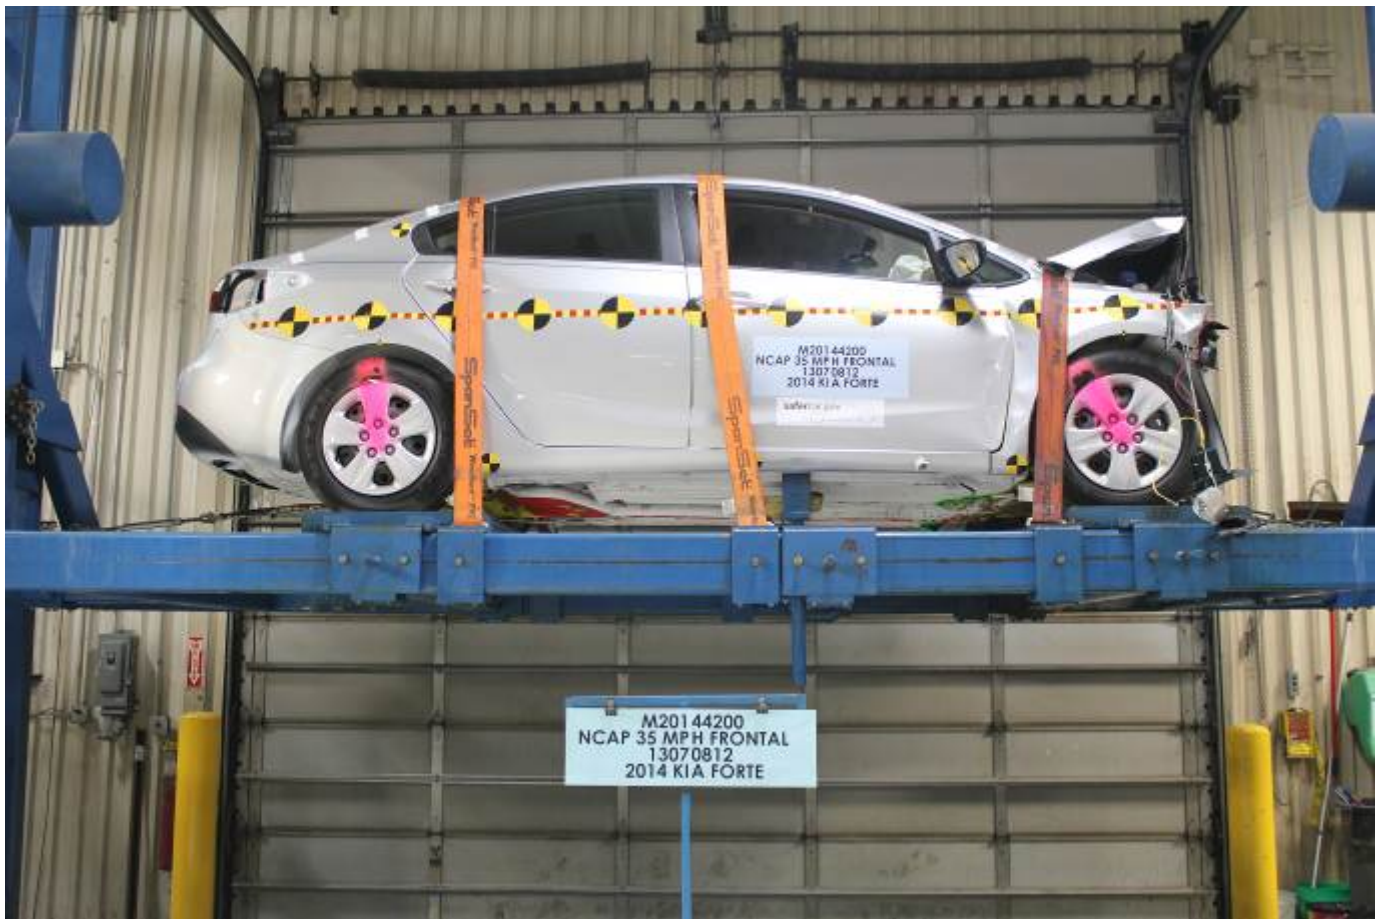
Vehicle at 360° on Static Rollover Device
