**REPORT NUMBER: SINCAP-MGA-2014-006**

**NEW CAR ASSESSMENT PROGRAM (NCAP)  
Moving Deformable Barrier Side Impact Test**

**KIA MOTORS MANUFACTURING GEORGIA, INC.  
2014 Kia Sorento LX SUV  
NHTSA No.: O20144202**

**MGA RESEARCH CORPORATION  
5000 Warren Road  
Burlington, WI 53105**

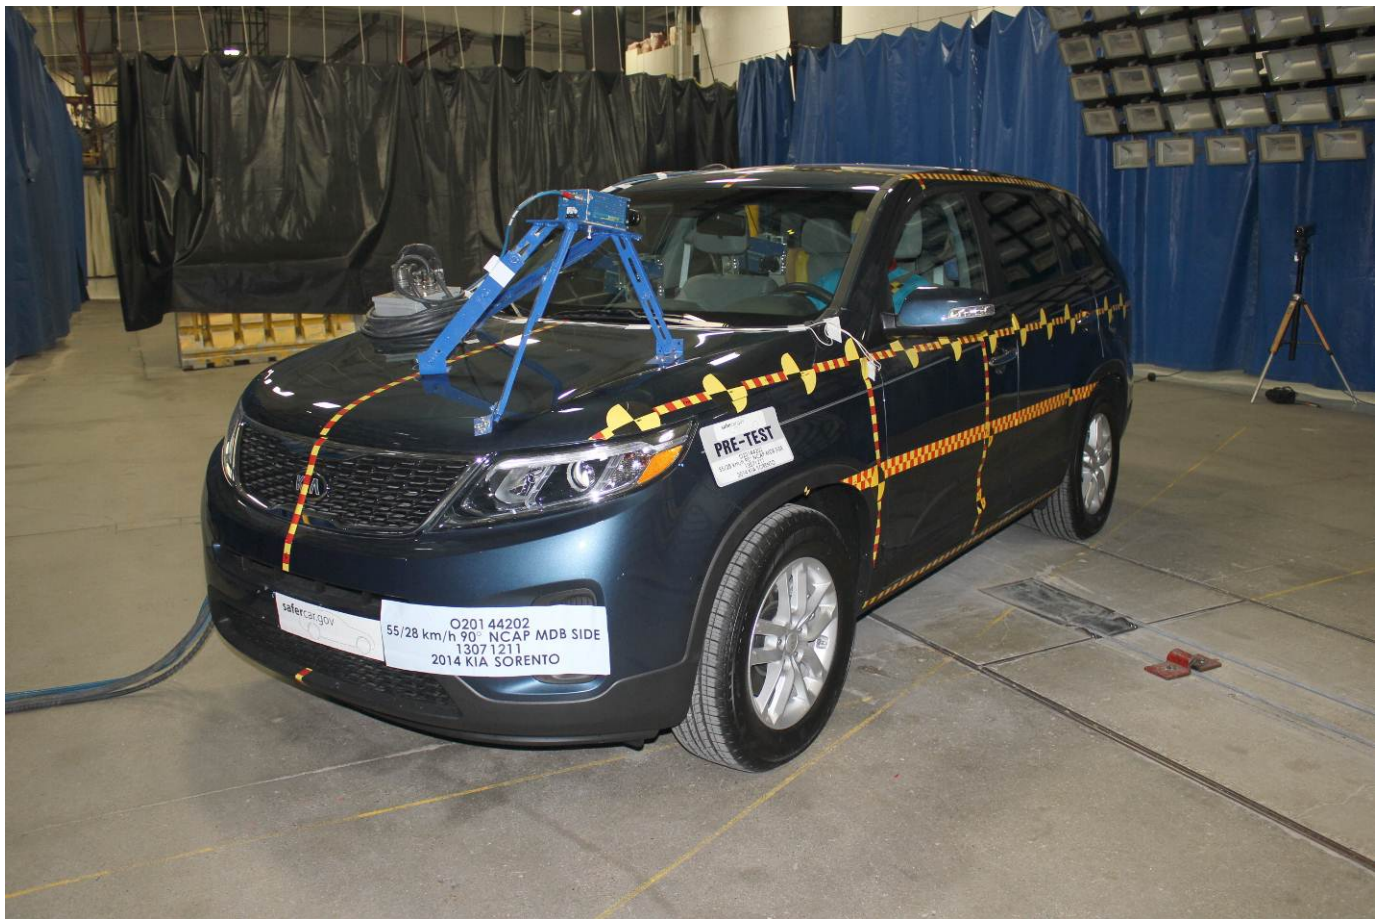
Post-Test Frontal View of Test Vehicle

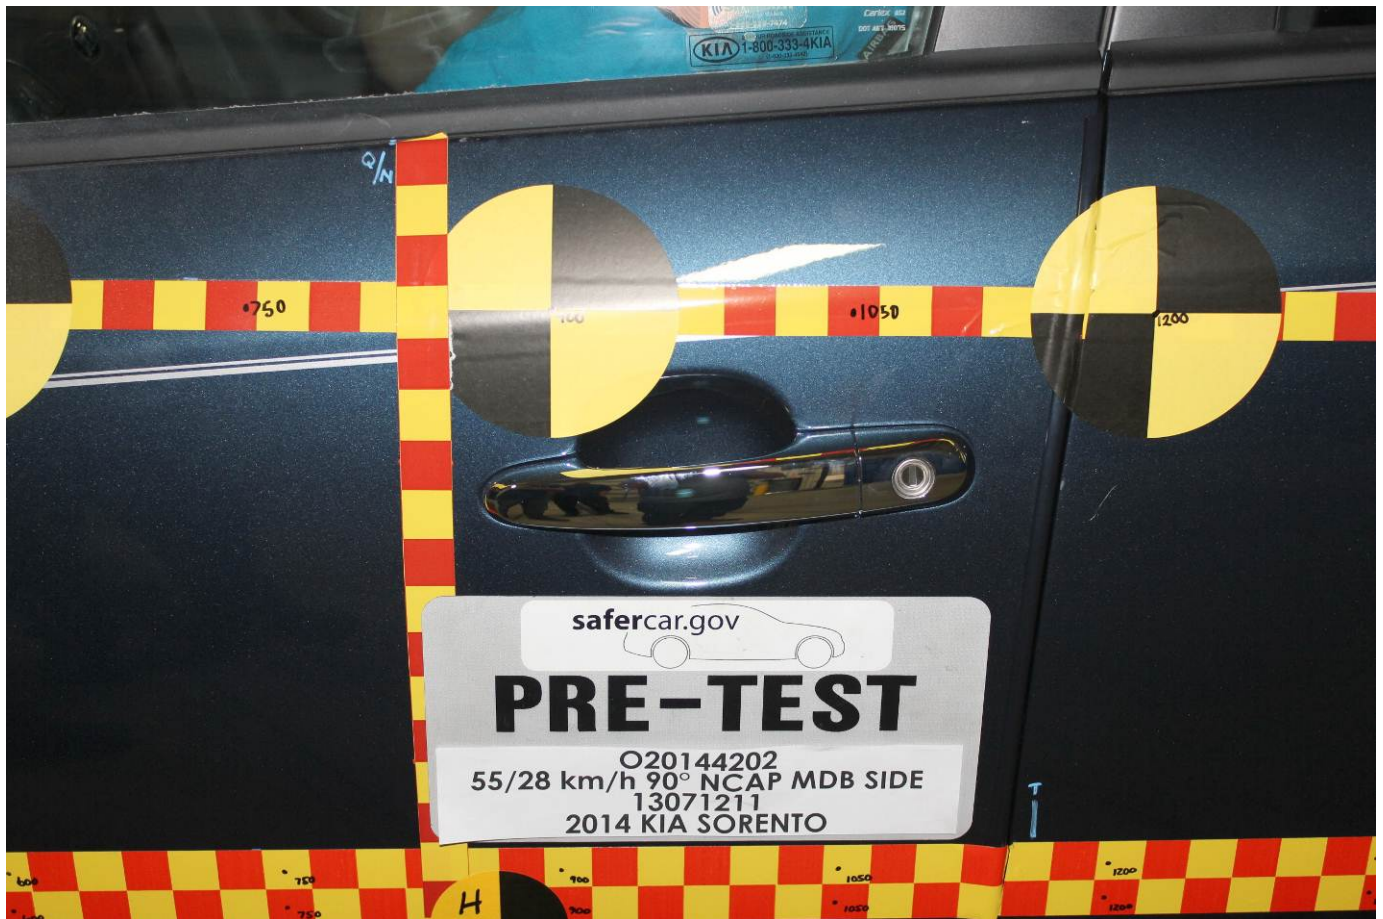
Post-Test Close-Up View of Impact Point Target

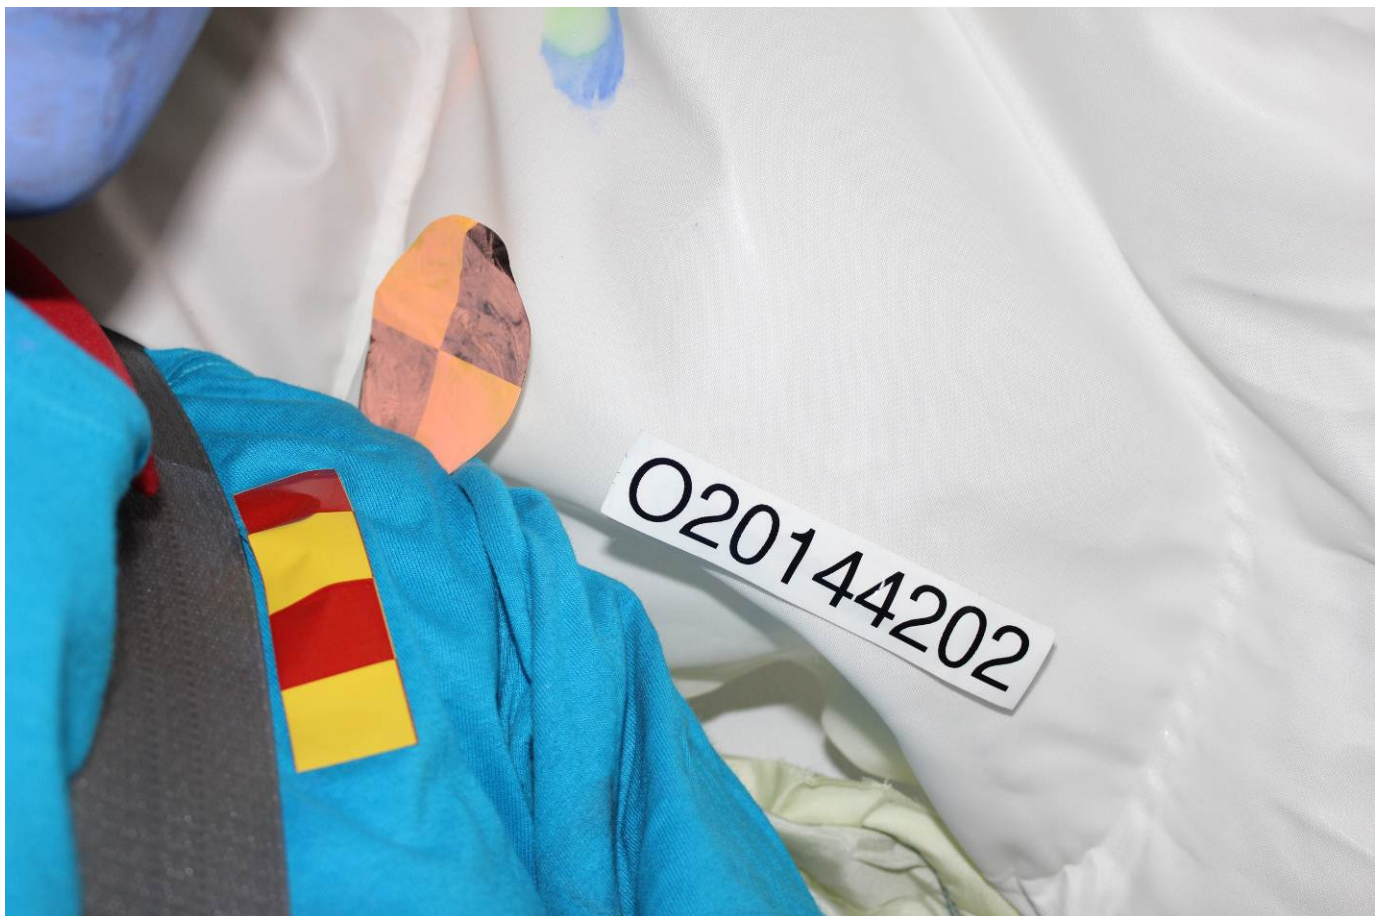
Post-Test Driver Dummy Close-up Torso Contact with Vehicle Interior View

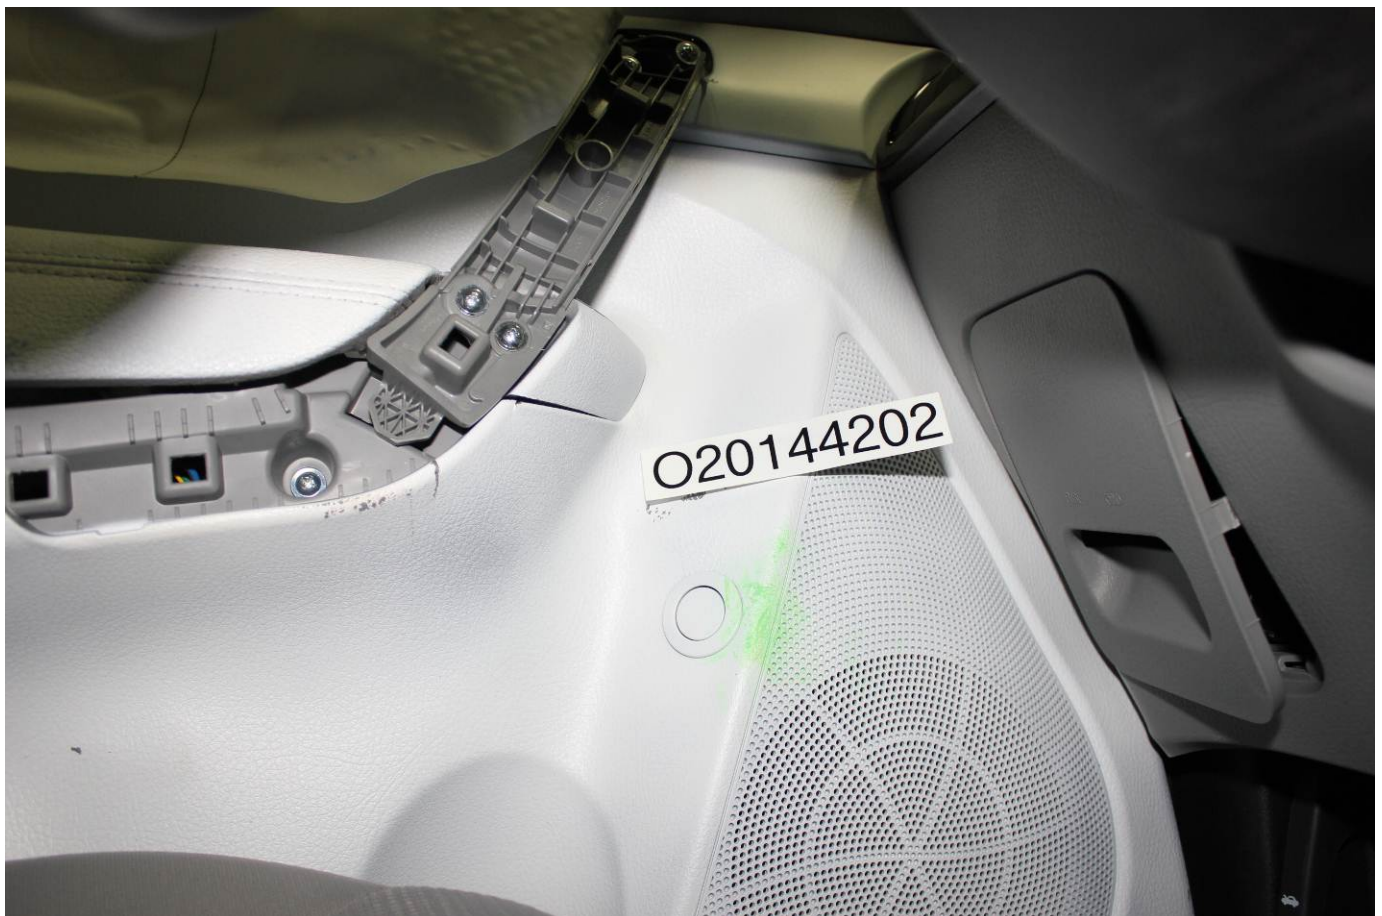
Post-Test Driver Dummy Close-up Pelvis Contact with Side Airbag View

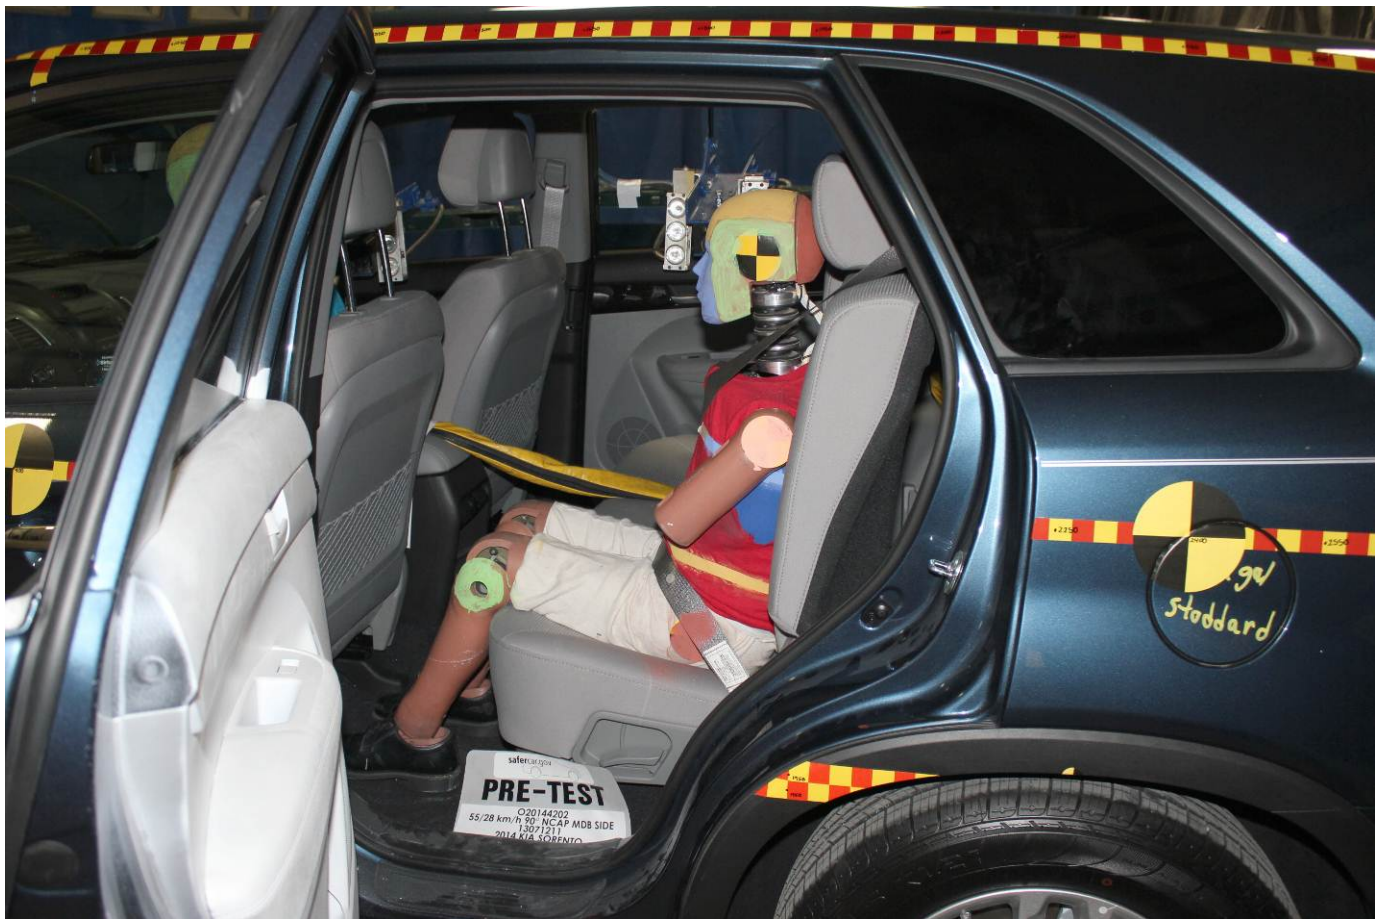
Post-Test Driver Dummy Close-up Knee Contact View
