**REPORT NUMBER: NCAP305I-KAR-13-052**

**NEW CAR ASSESSMENT PROGRAM (NCAP)  
FMVSS NO. 305 INDICANT TEST**

**TESLA MOTORS, INC.  
2013 TESLA MODEL S 5-DOOR HATCHBACK**

**FINAL REPORT**

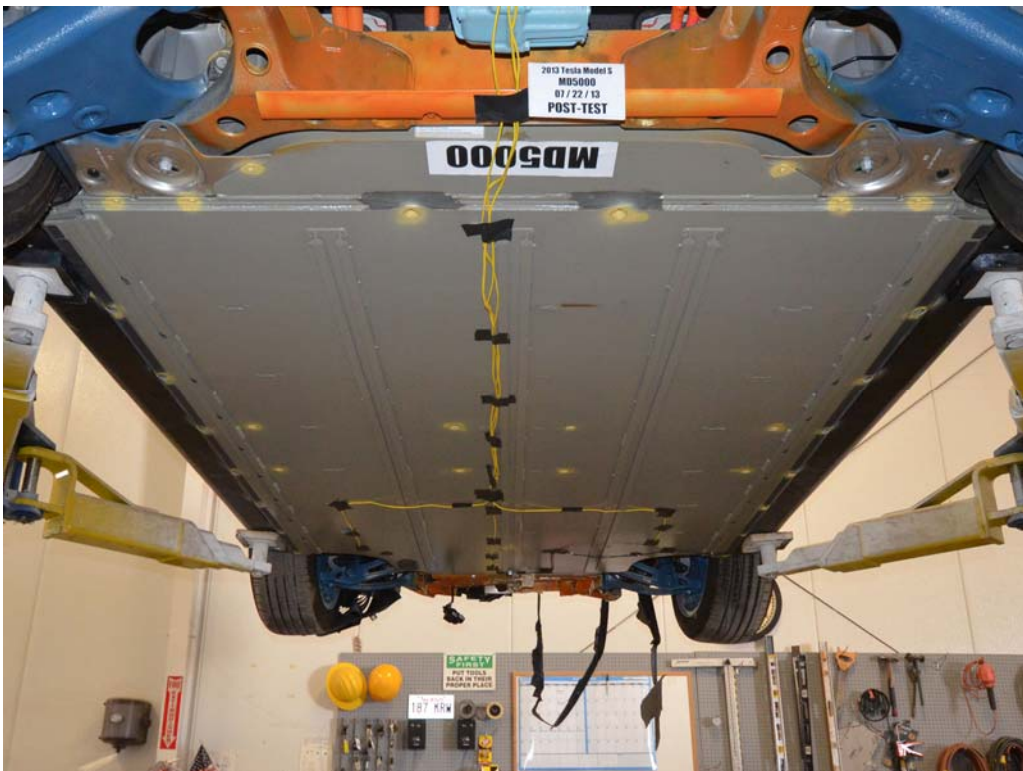
FIGURE 10. Post-Impact Front View of Propulsion Battery

Has the propulsion battery module moved within the passenger compartment: No

Describe any movement: There was no movement of the propulsion battery.

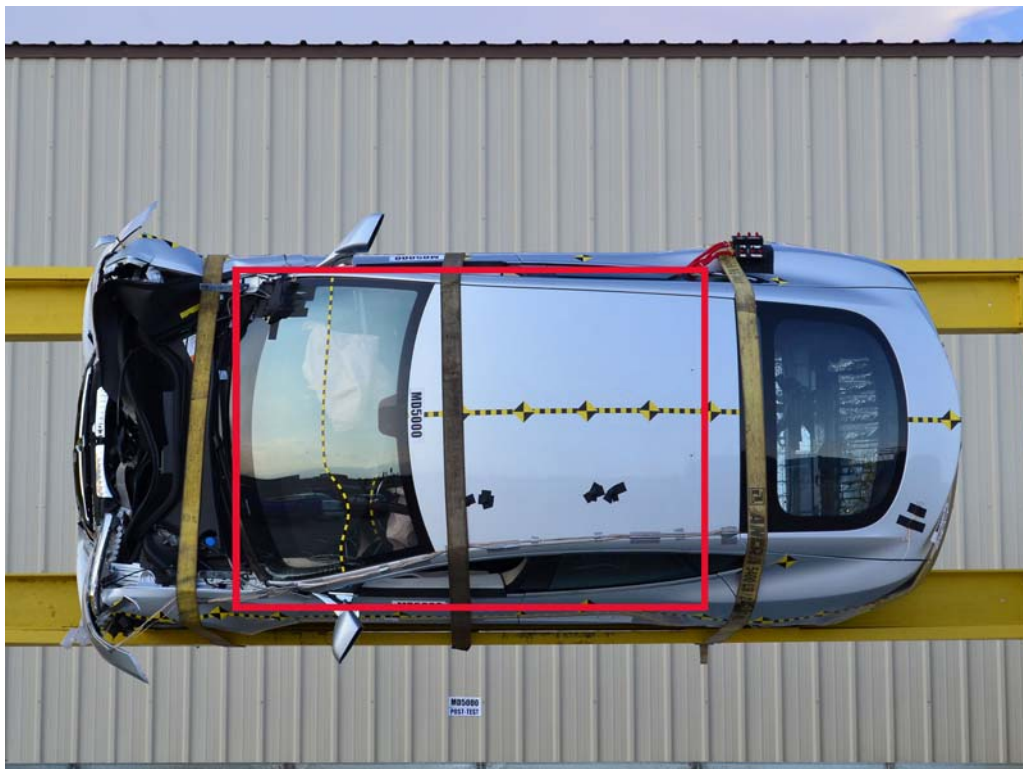
FIGURE 29. FMVSS No. 305 Static Rollover at 90°

| Test Phase | Propulsion Battery Electrolyte Spillage (L) | Spillage Location |
|---|---|---|
| 0° To 90° | 0.0 | N/A |

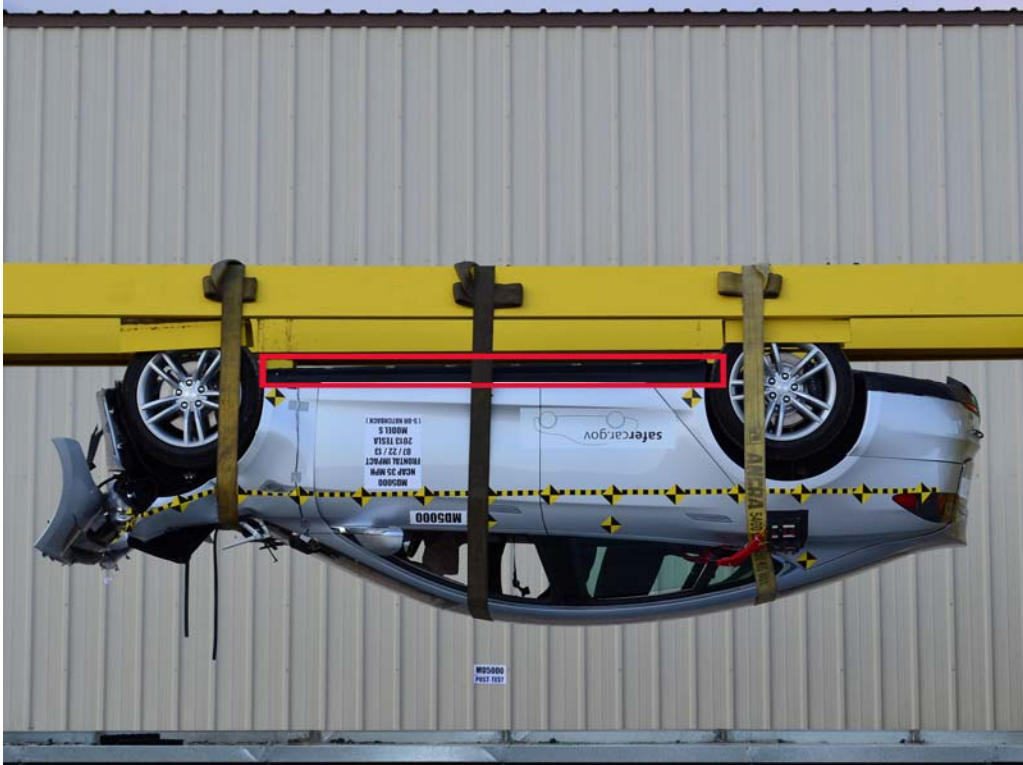
FIGURE 30. FMVSS No. 305 Static Rollover at 180°

| Test Phase | Propulsion Battery Electrolyte Spillage (L) | Spillage Location |
|---|---|---|
| 90° To 180° | 0.0 | N/A |

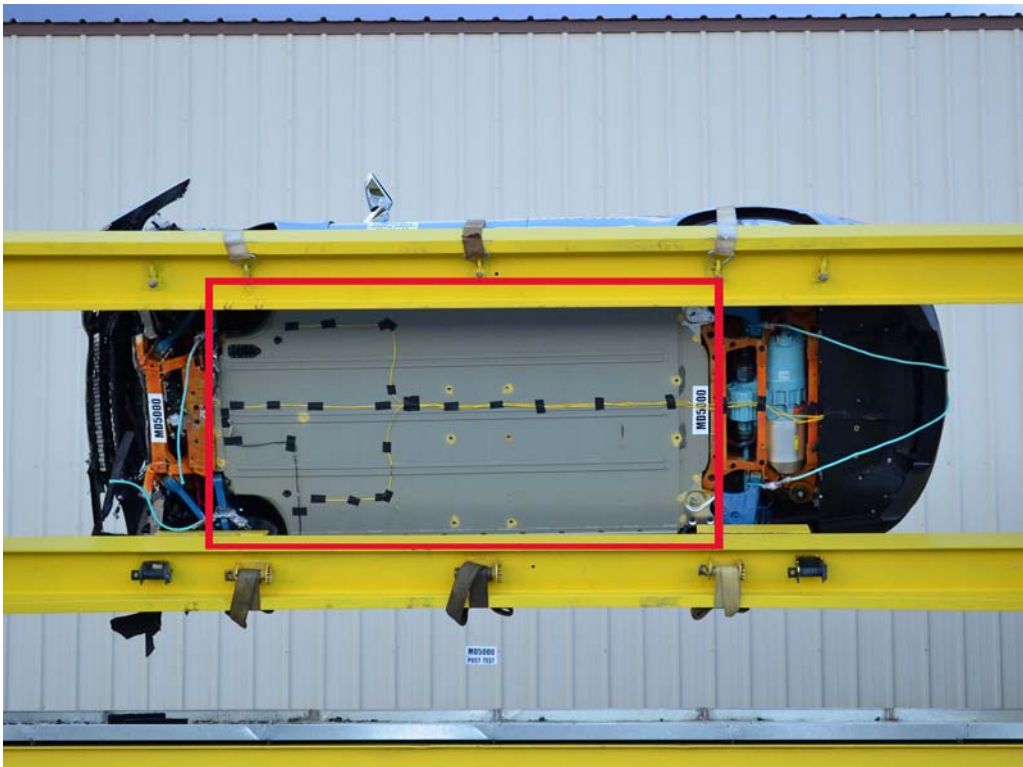
FIGURE 31. FMVSS No. 305 Static Rollover at 270°

| Test Phase | Propulsion Battery Electrolyte Spillage (L) | Spillage Location |
|---|---|---|
| 180° To 270° | 0.0 | N/A |

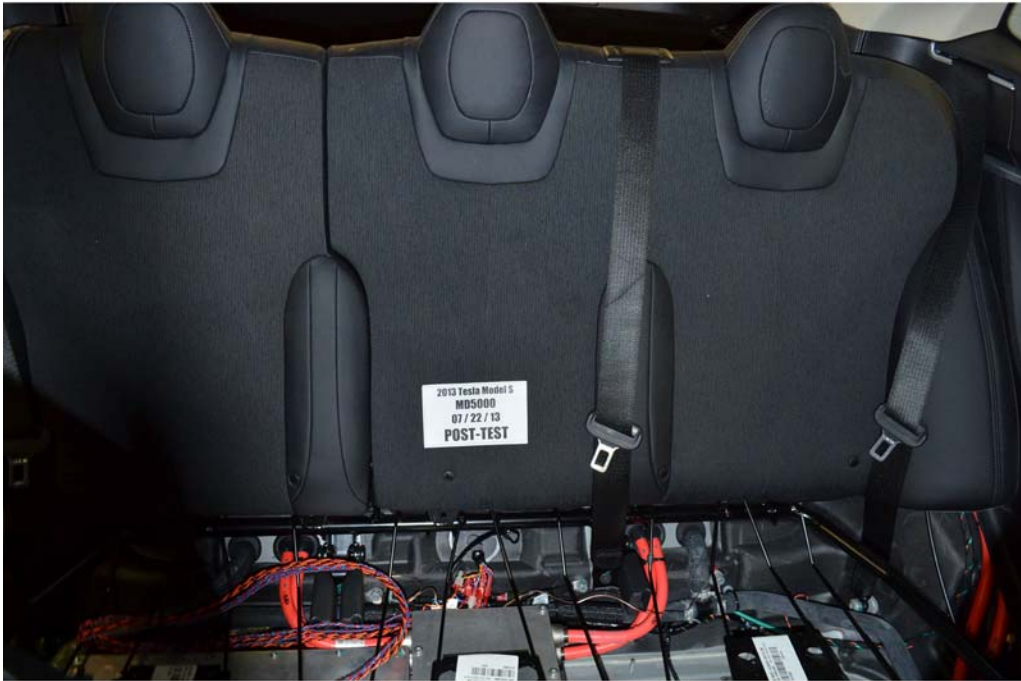
FIGURE 34. Post-Impact View of the Vehicle Passenger Compartment  
Adjacent to Propulsion Battery

Describe any intrusion: There was no intrusion of the propulsion battery into the occupant compartment.

Is there propulsion battery electrolyte spillage visible in the passenger compartment: No
