**REPORT NUMBER: SPNCAP-KAR-13-054**

**NEW CAR ASSESSMENT PROGRAM (NCAP)  
SIDE IMPACT POLE TEST**

**TESLA MOTORS, INC.  
2013 TESLA MODEL S 5-DOOR HATCHBACK**

**PREPARED BY:  
KARCO ENGINEERING, LLC.  
9270 HOLLY ROAD  
ADELANTO, CA 92301**

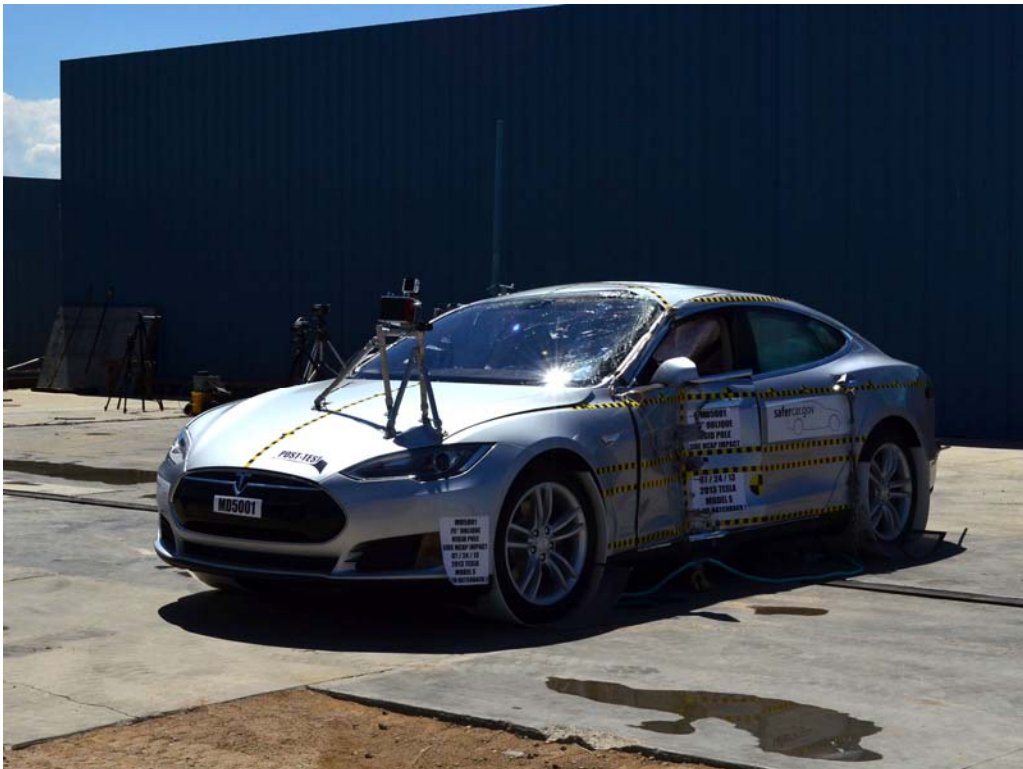
FIGURE 6. Post-Test Left Front  $\frac{3}{4}$  View of Test Vehicle

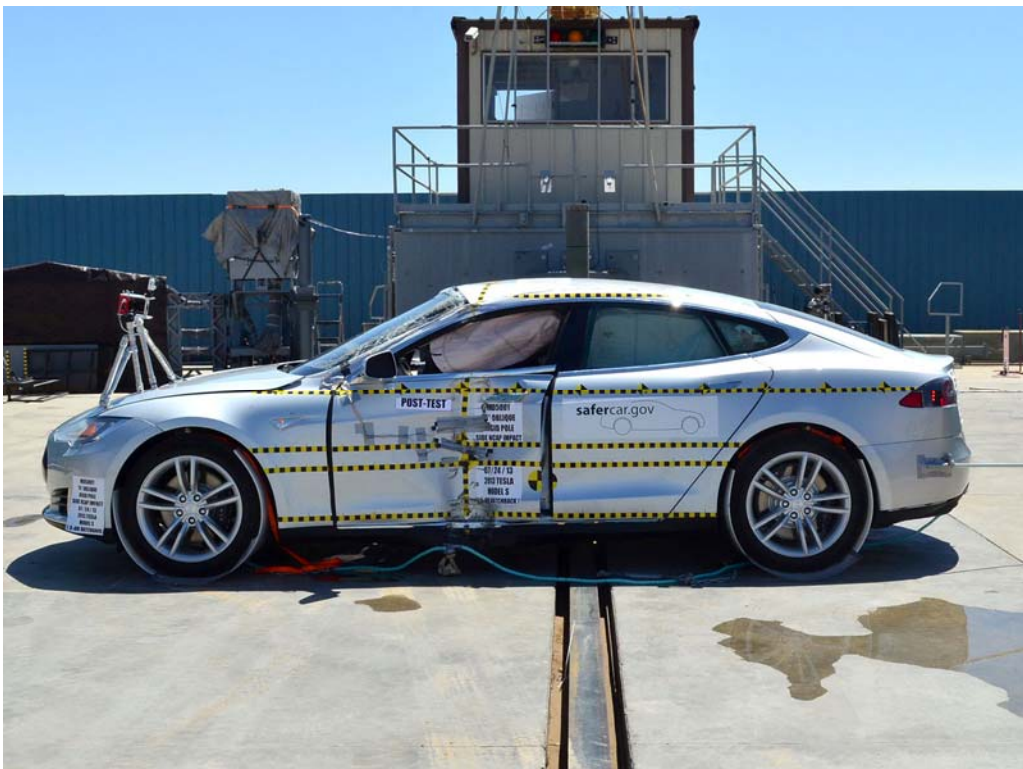
FIGURE 8. Post-Test Left Side View of Test Vehicle

Both the front and rear doors on the struck side of the vehicle remained closed and latched. There was no separation at the hinges or latches. Both doors on the non-struck side remained closed and latched. There were no ATD values that exceeded limits.

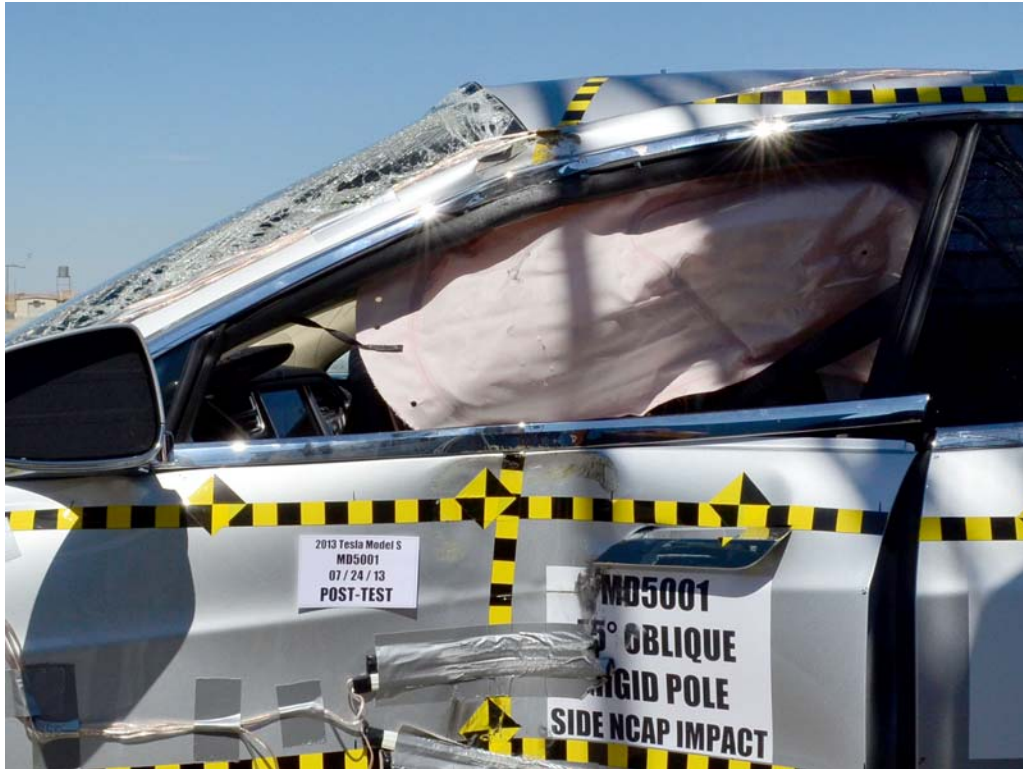
FIGURE 25. Post-Test Left Side View of Dummy Shoulder and Door Top View

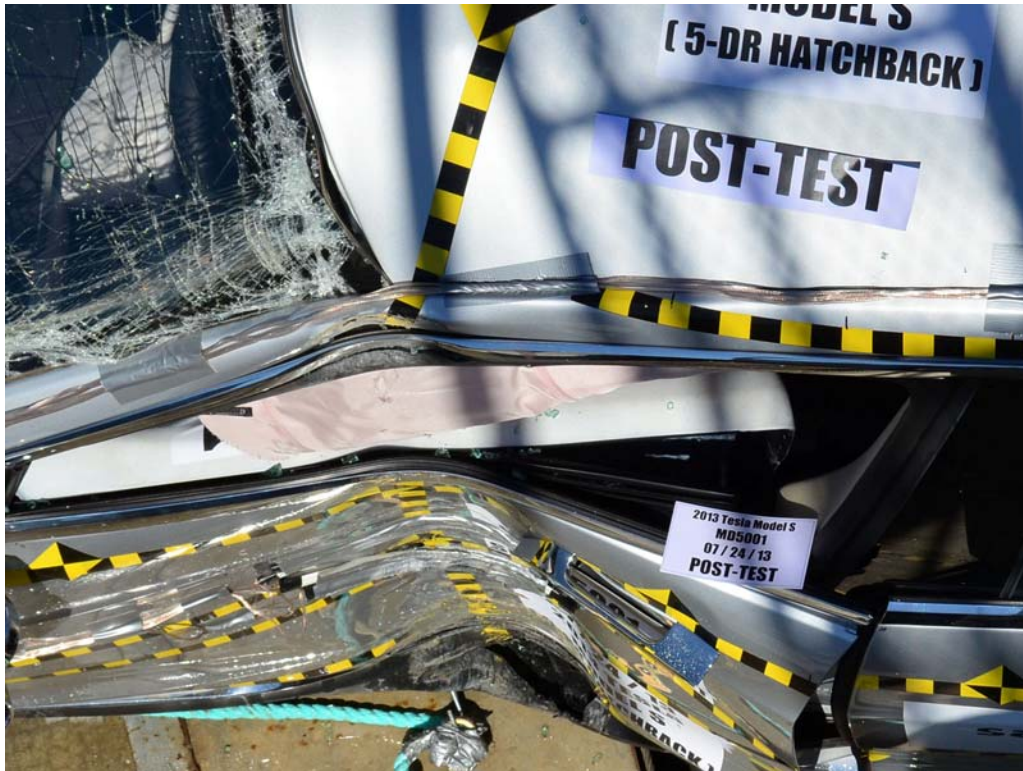
FIGURE 41. Post-Test Dummy and Door Clearance View

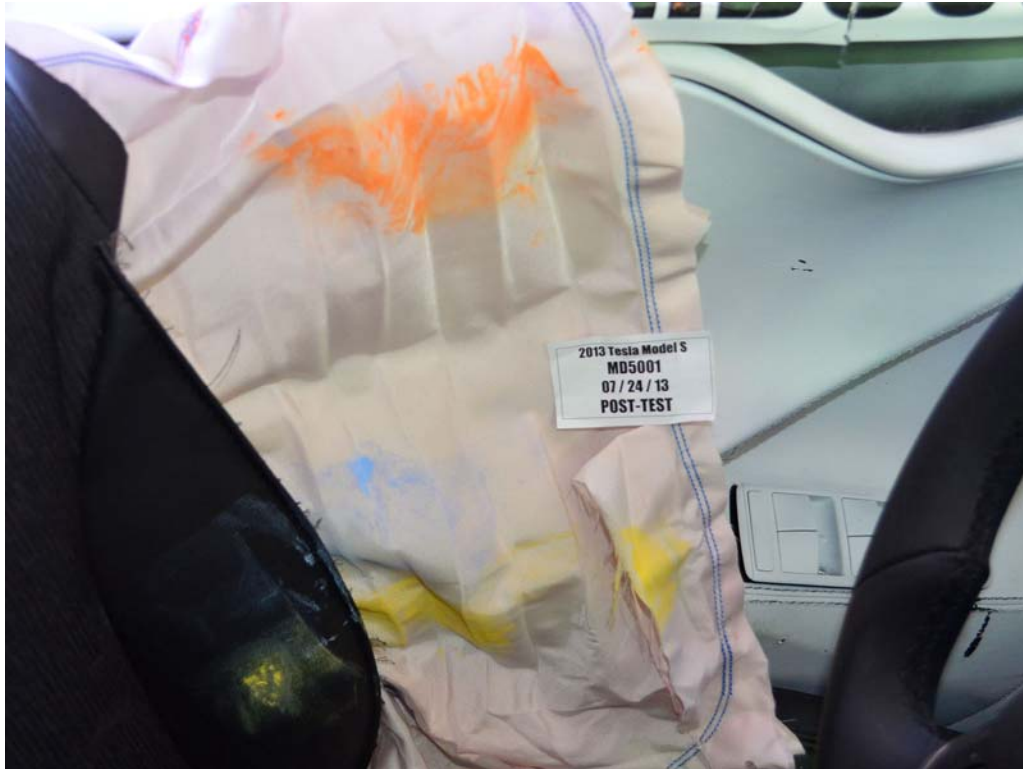
FIGURE 49. Post-Test Dummy Close-Up Torso Contact With Side Airbag View

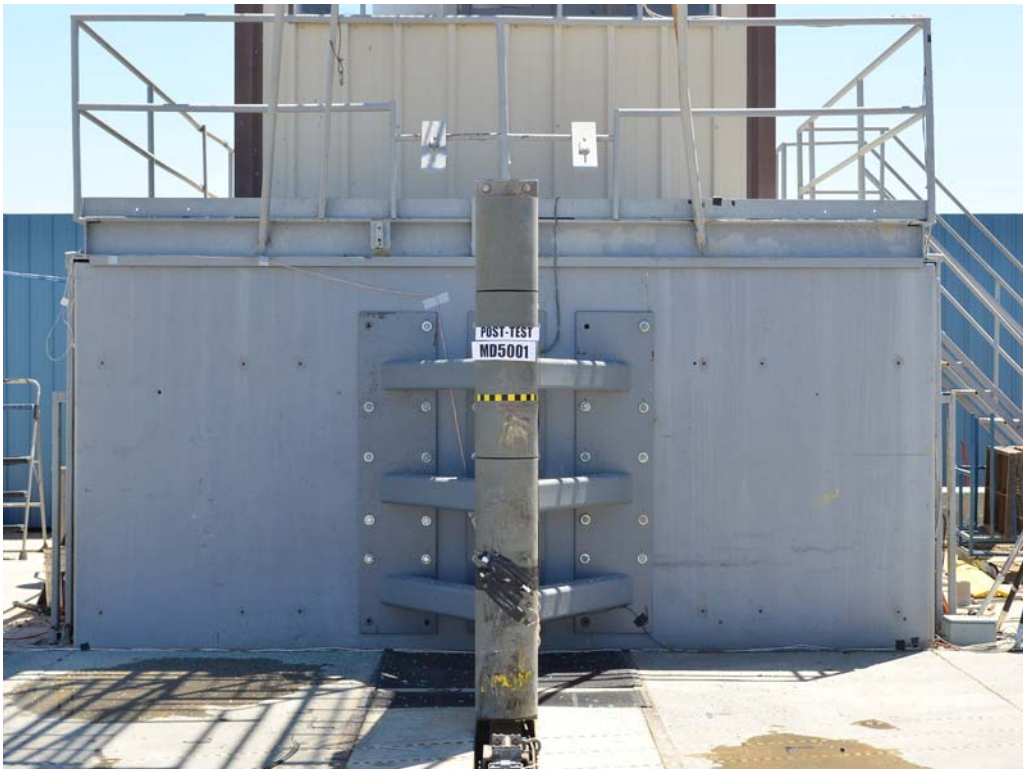
FIGURE 58. Post-Test Pole Barrier Front View

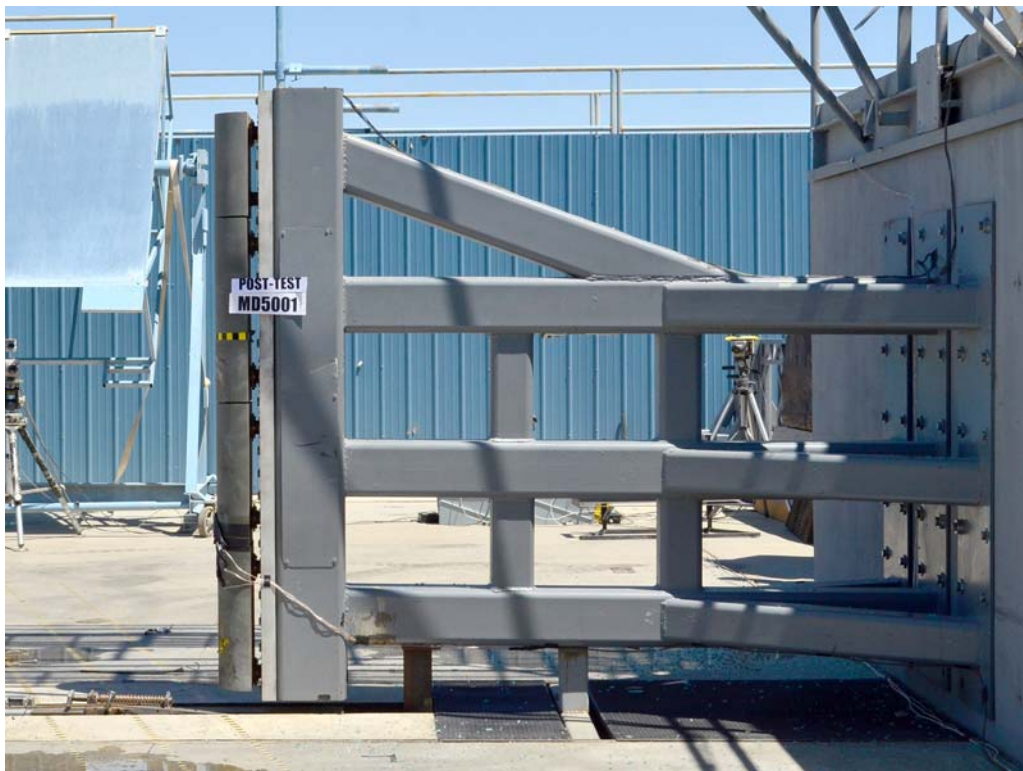
FIGURE 60. Post-Test Pole Barrier Side View

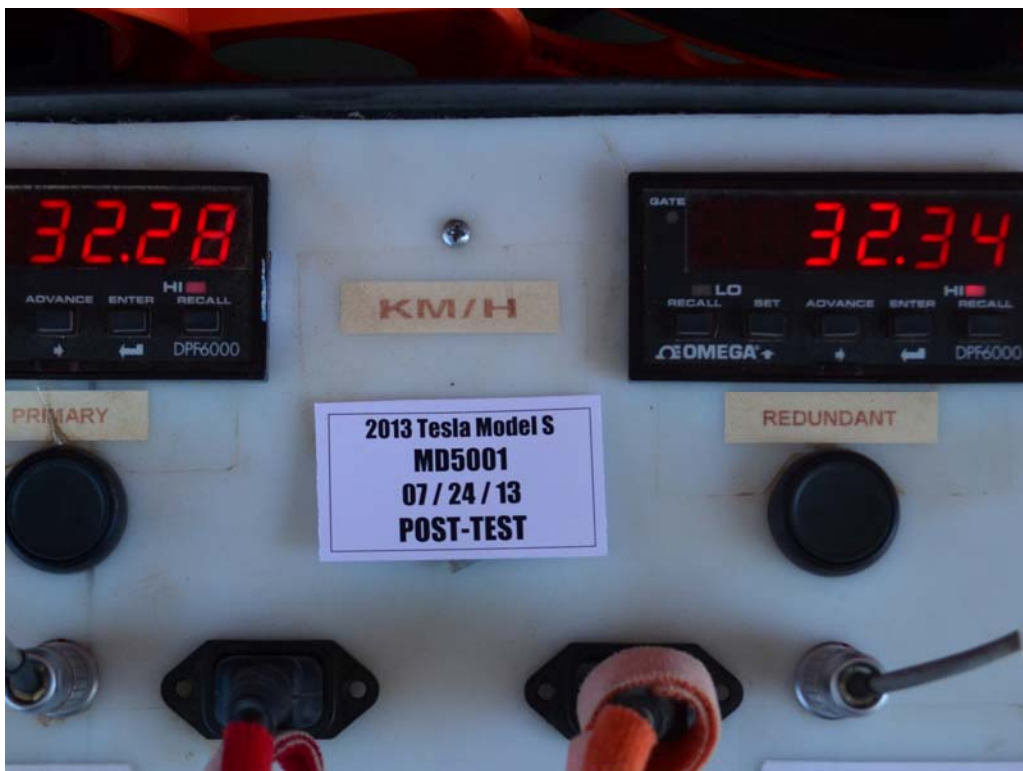
FIGURE 62. Post-Test Primary and Redundant Speed Trap Read-Out

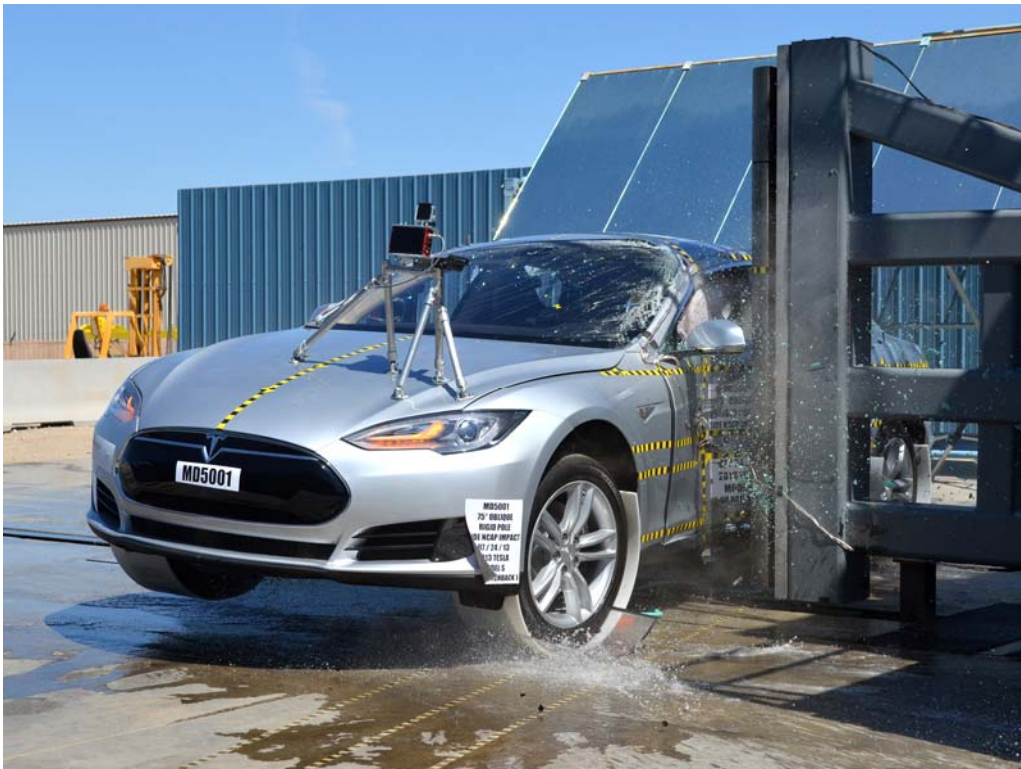
FIGURE 68. Impact Event
