**REPORT NUMBER: SINCAP-MGA-2014-007**

**NEW CAR ASSESSMENT PROGRAM (NCAP)  
Moving Deformable Barrier Side Impact Test**

**GENERAL MOTORS DE MEXICO, S. DE R.L. DE C.V.  
2014 Chevrolet Silverado 1500 1WT Crew Cab  
NHTSA No.: M20140105**

**FINAL REPORT**

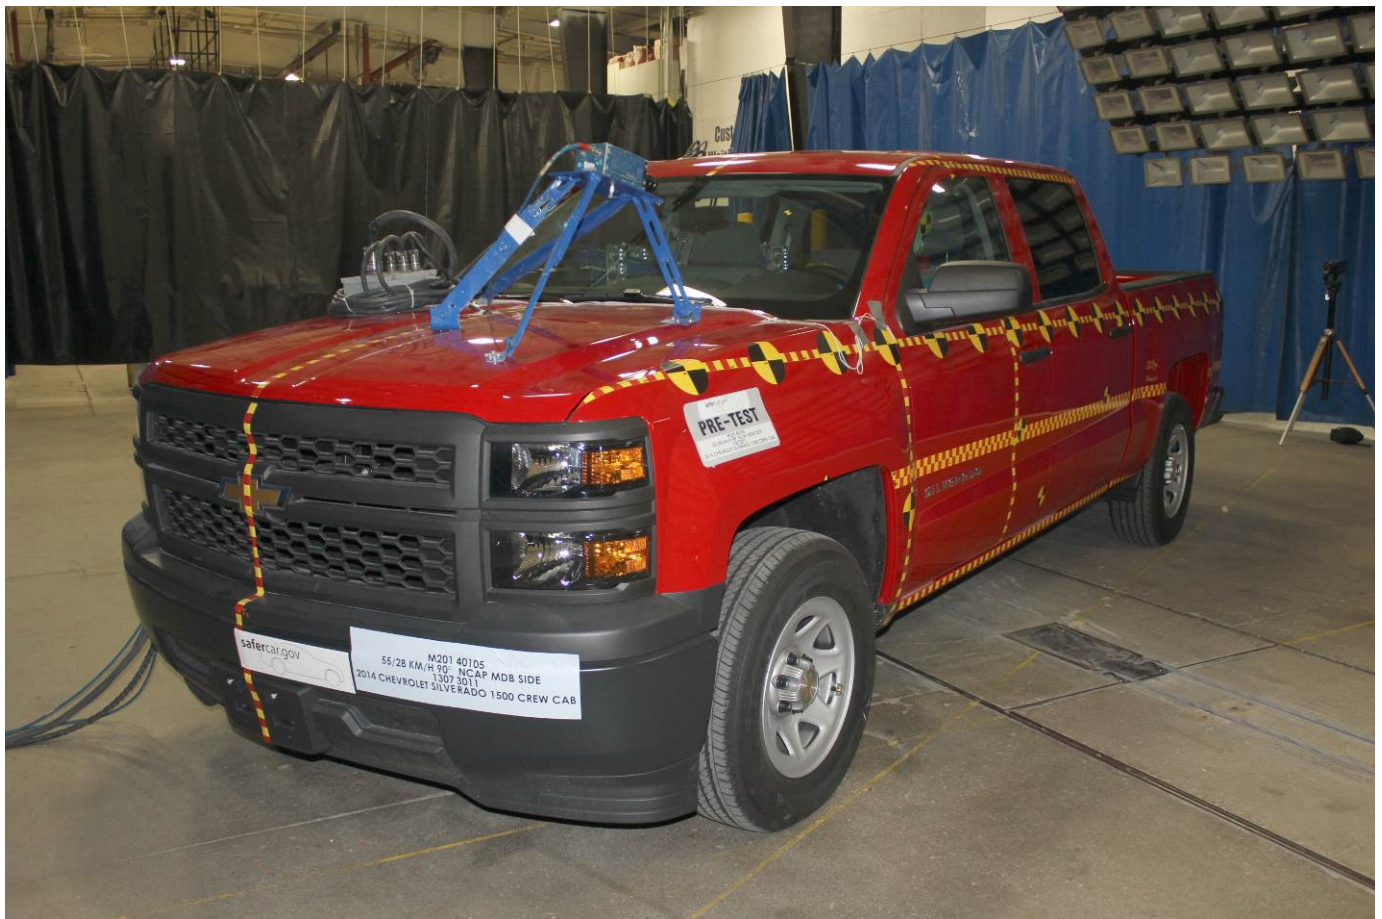
Post-Test Frontal View of Test Vehicle

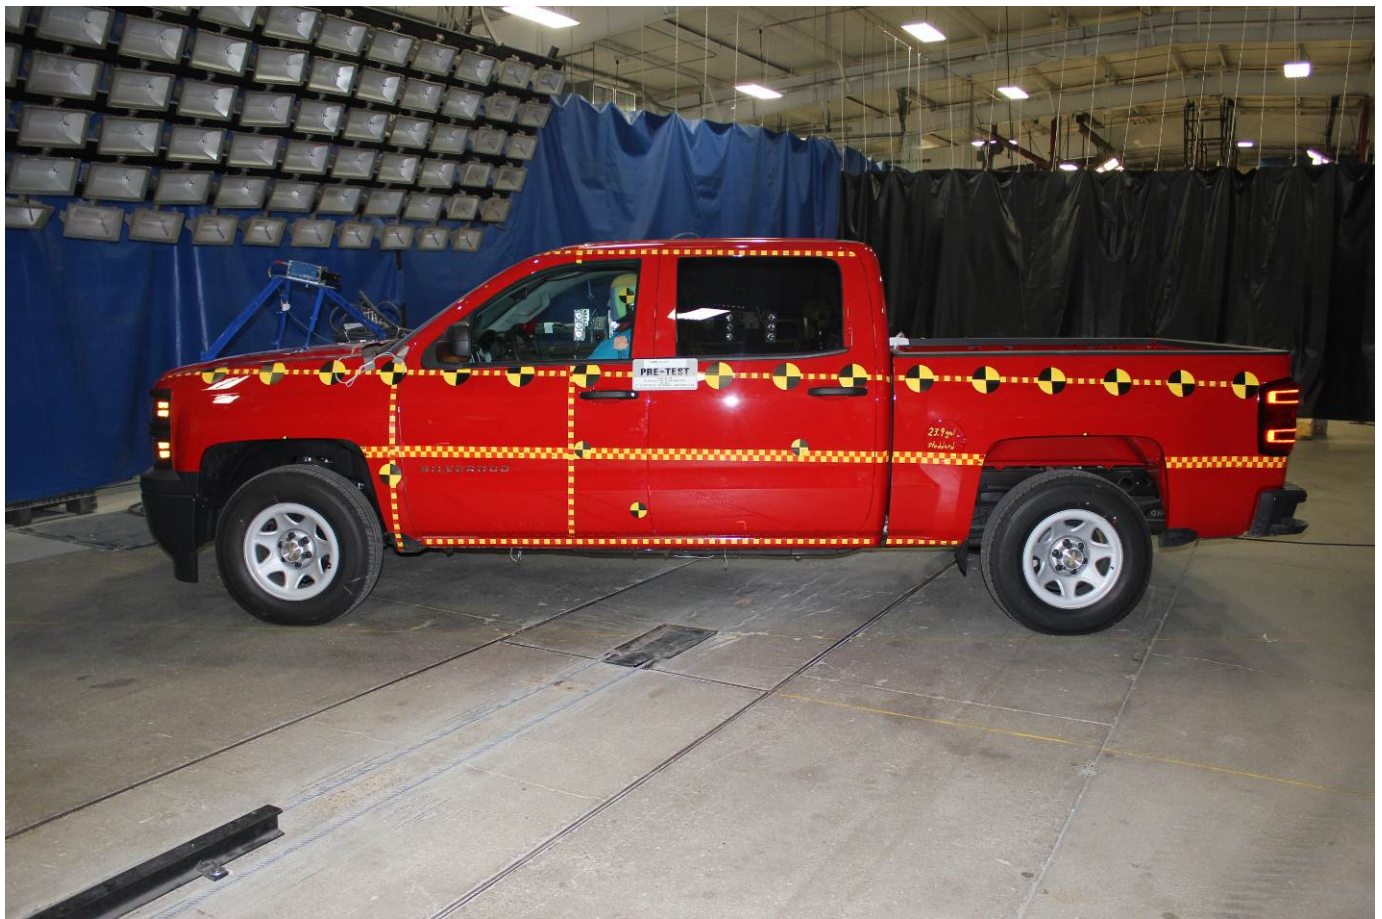
Post-Test Left Front Three-Quarter View of Test Vehicle

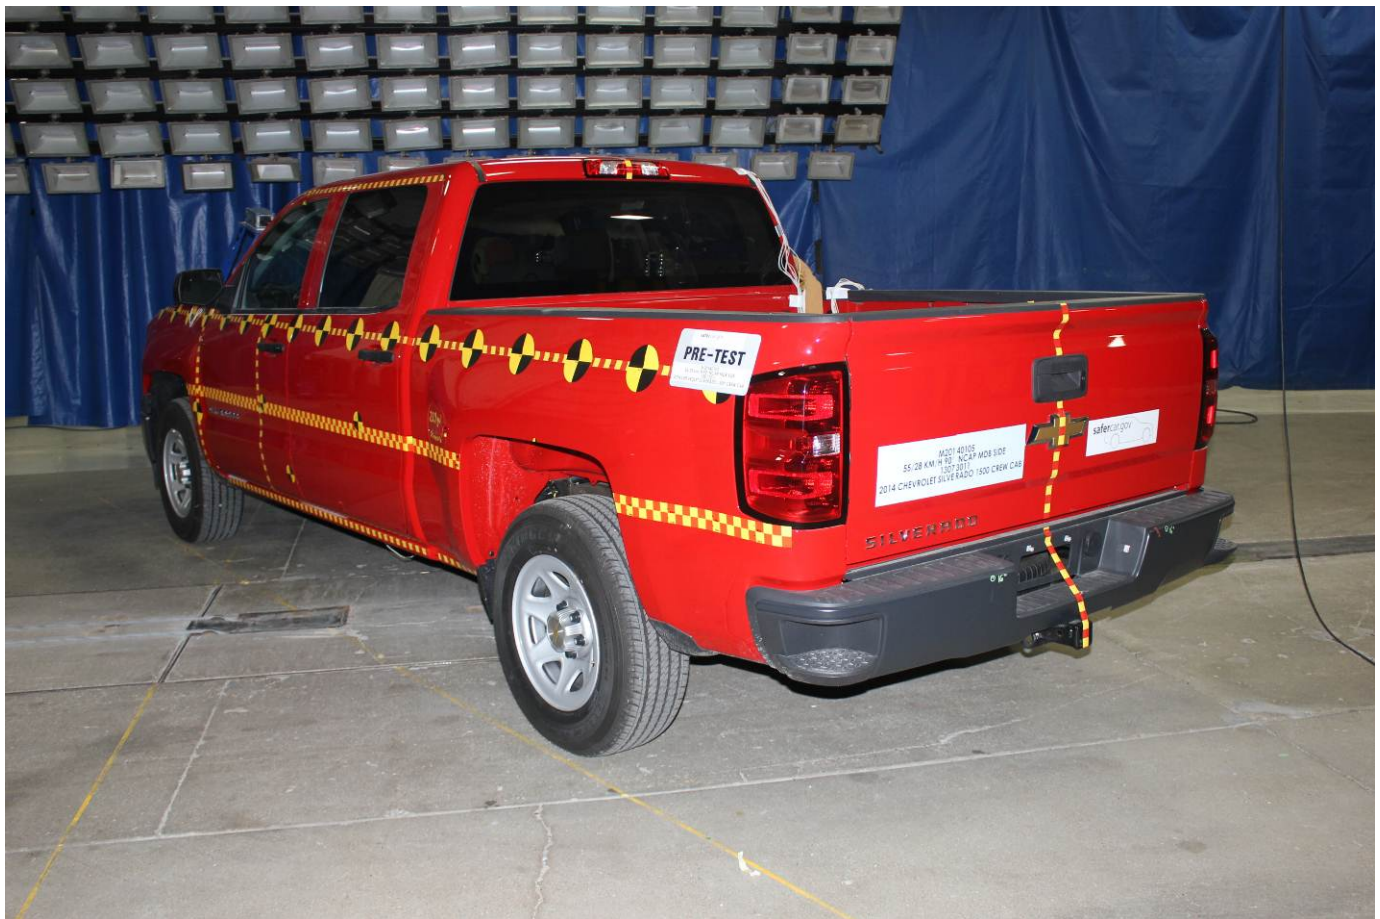
Post-Test Left Side View of Test Vehicle

| Critical Areas of Performance | Observations and Conclusions |
|---|---|
| Side Window Damage | Left Rear Window Broken |

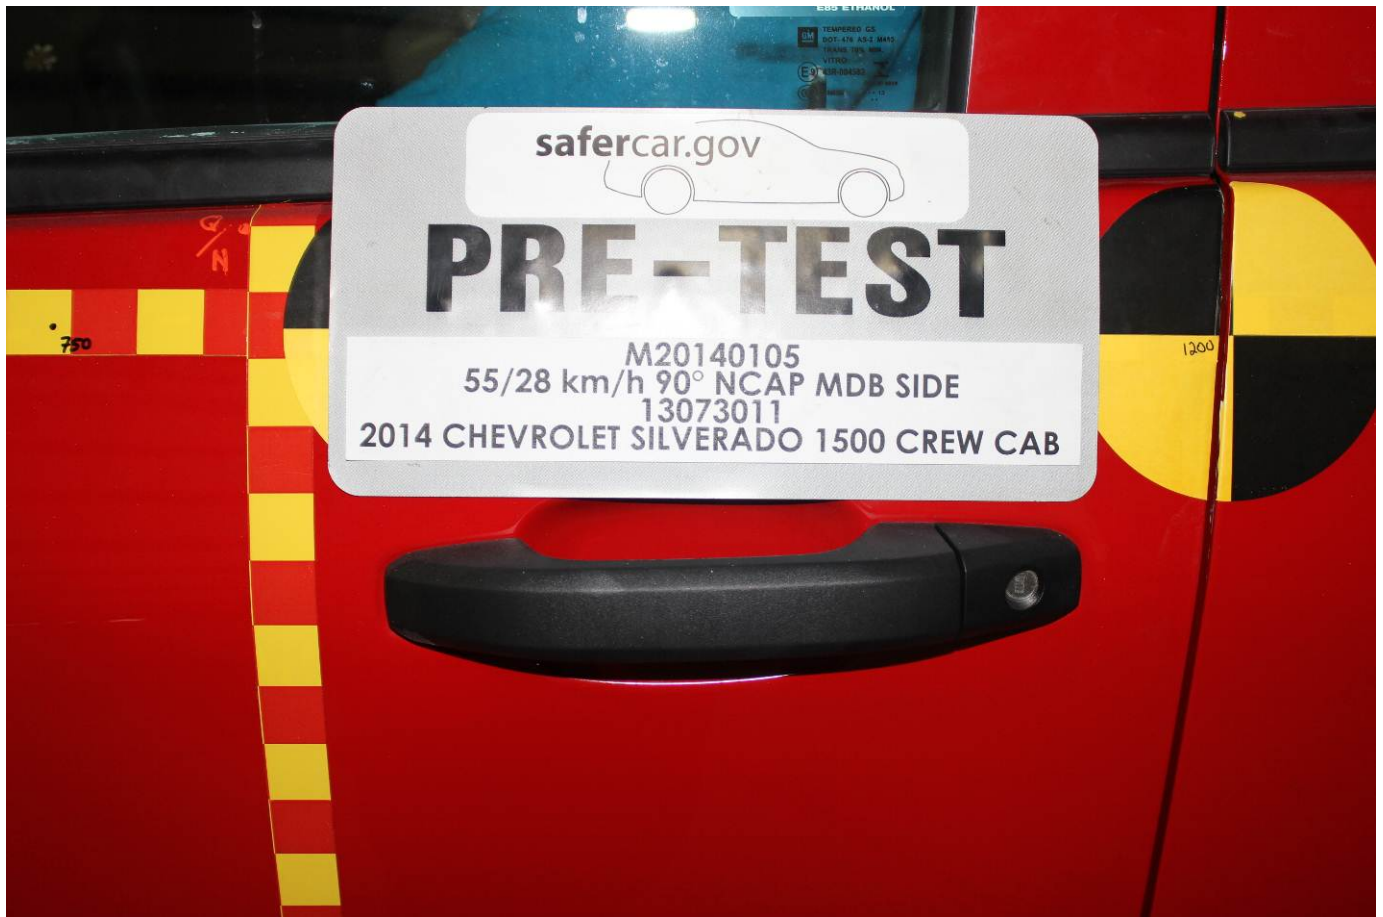
Post-Test Close-Up View of Impact Point Target

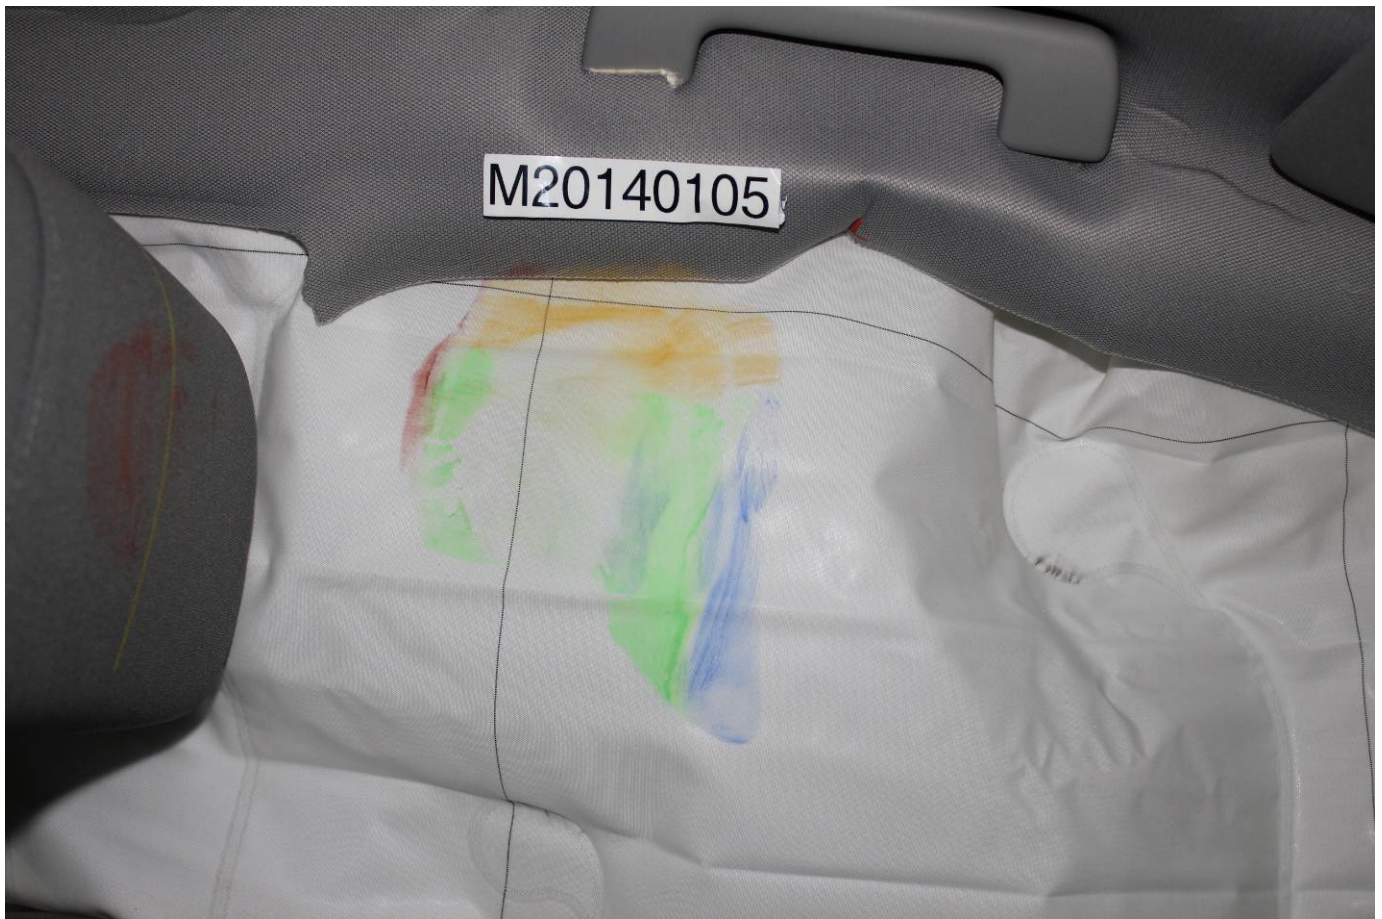
Post-Test Driver Dummy Close-up Head Contact with Vehicle Interior View

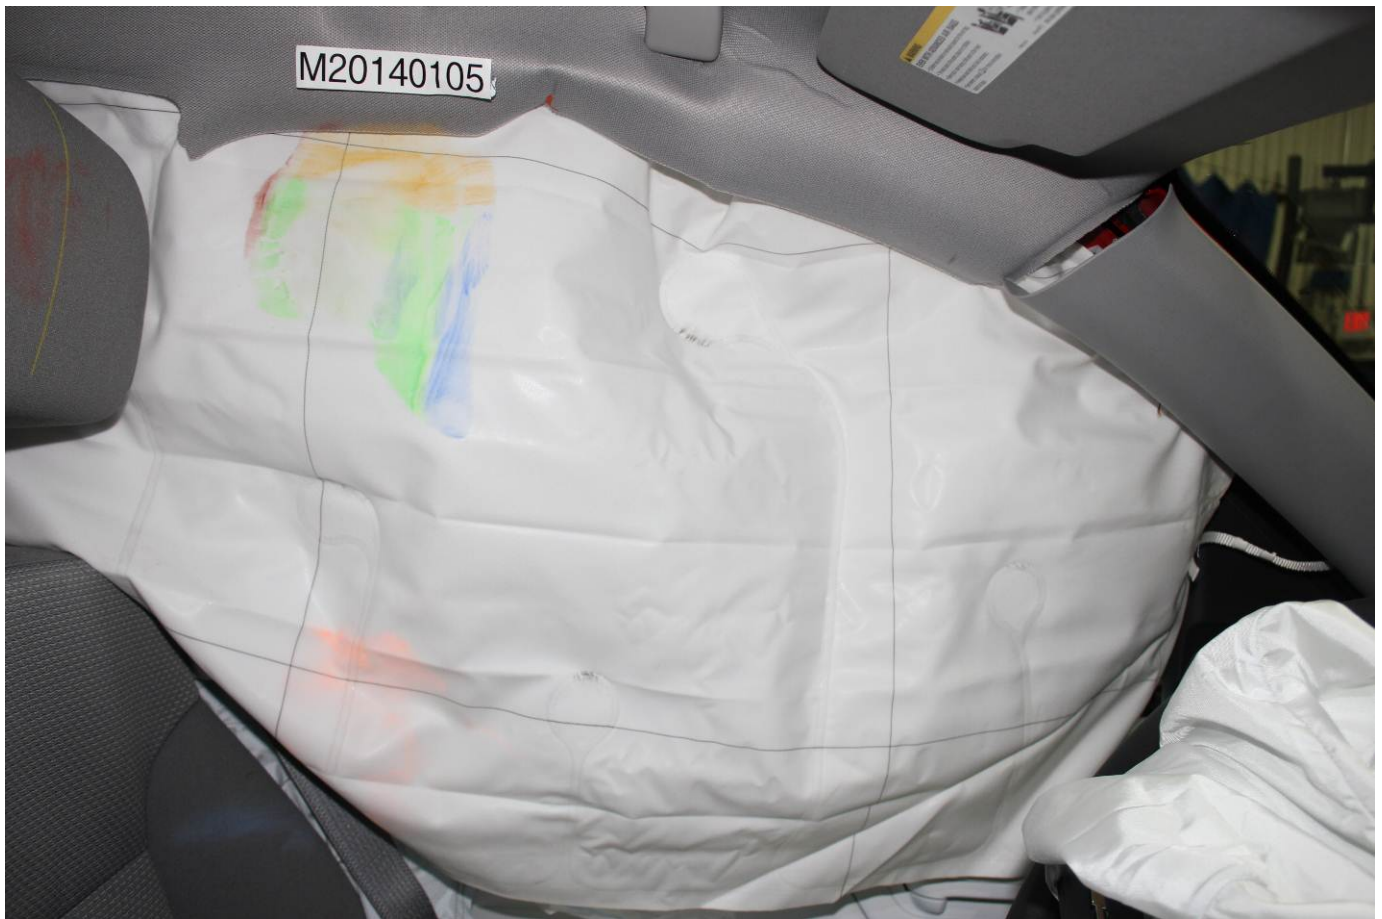
Post-Test Driver Dummy Close-up Torso Contact with Vehicle Interior View

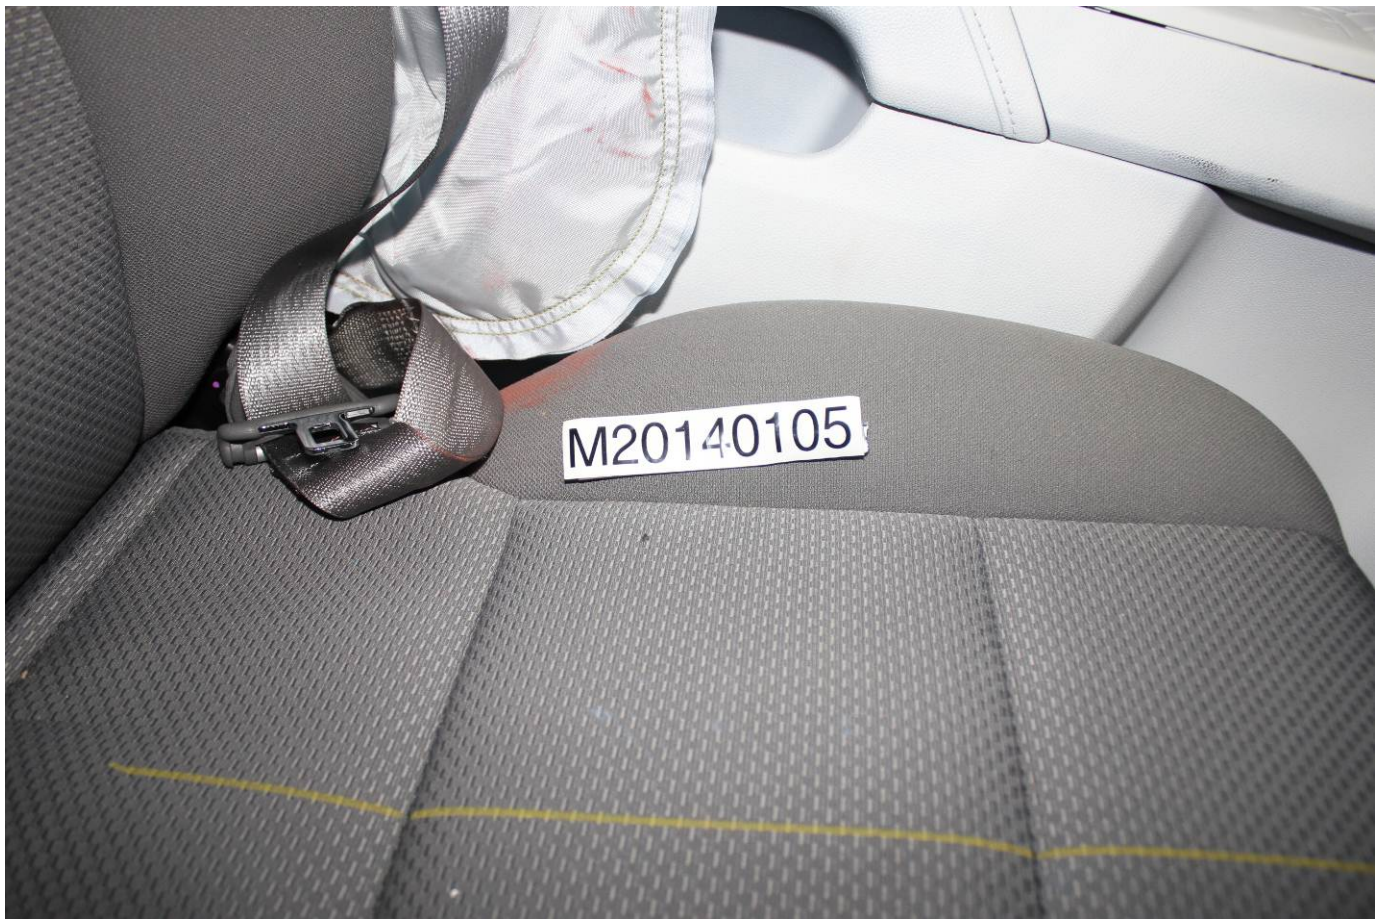
Post-Test Driver Dummy Close-up Pelvis Contact with Vehicle Interior View

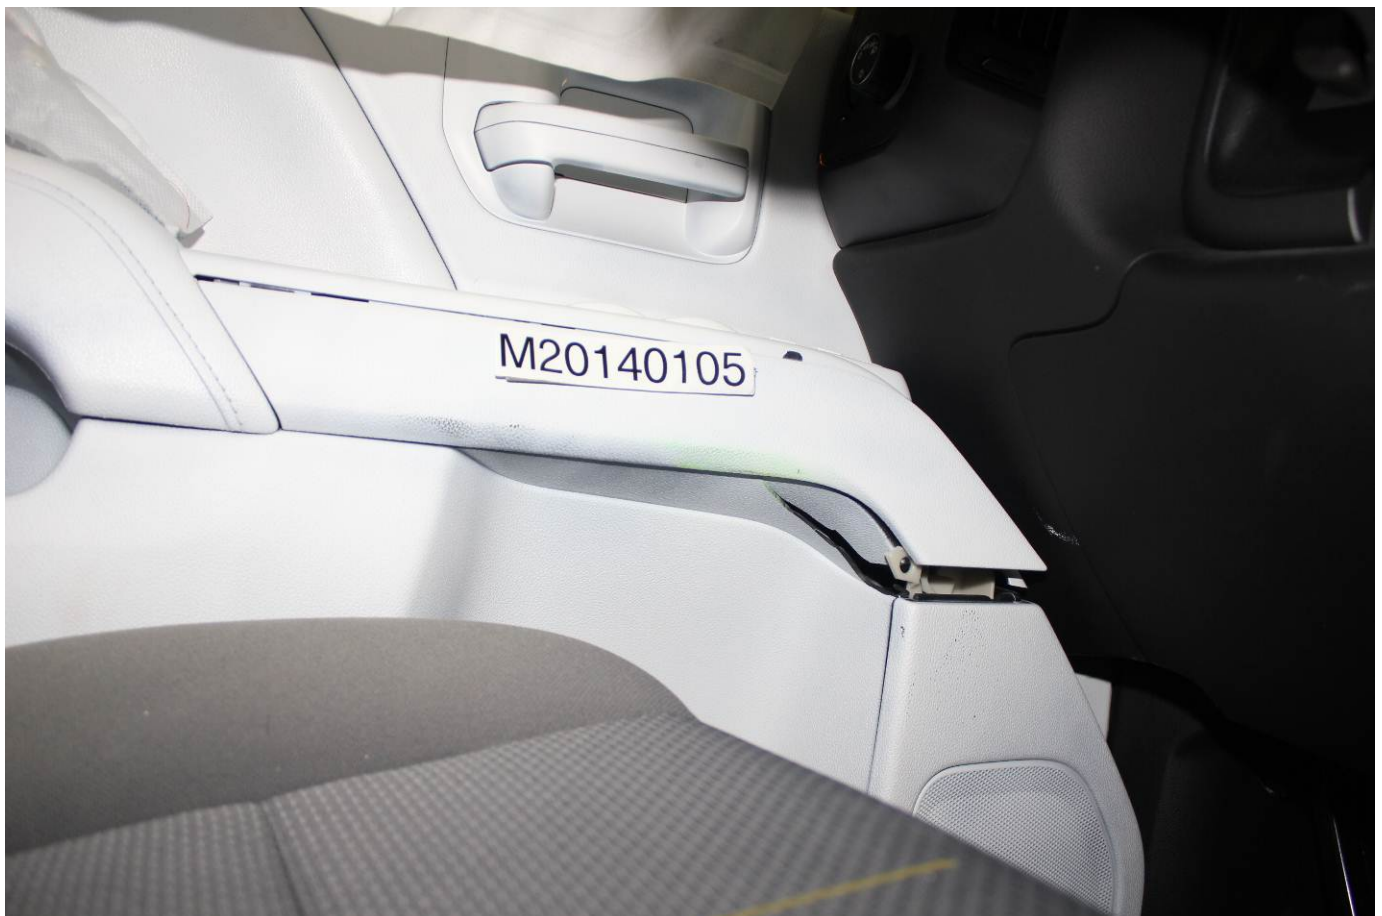
Post-Test Driver Dummy Close-up Pelvis Contact with Side Airbag View

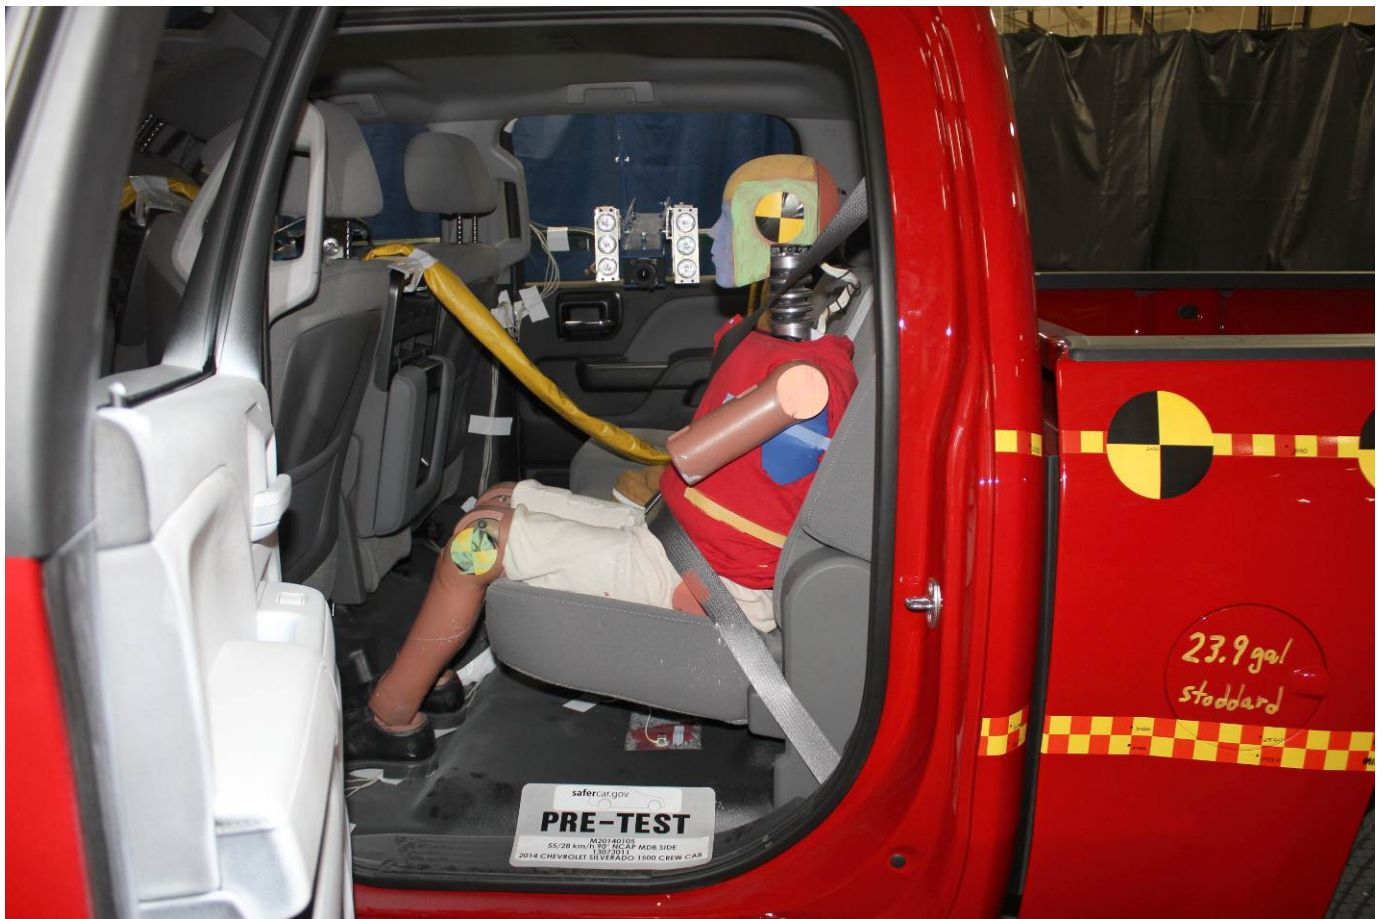
Post-Test Driver Dummy Close-up Knee Contact View
