**REPORT NUMBER: SPNCAP-MGA-2014-010**

**NEW CAR ASSESSMENT PROGRAM (NCAP)  
Side Impact Pole Test**

**TOYOTA MOTOR CORPORATION  
2014 Lexus IS250 4-Dr Sedan  
NHTSA No.: M20145101**

**FINAL REPORT**

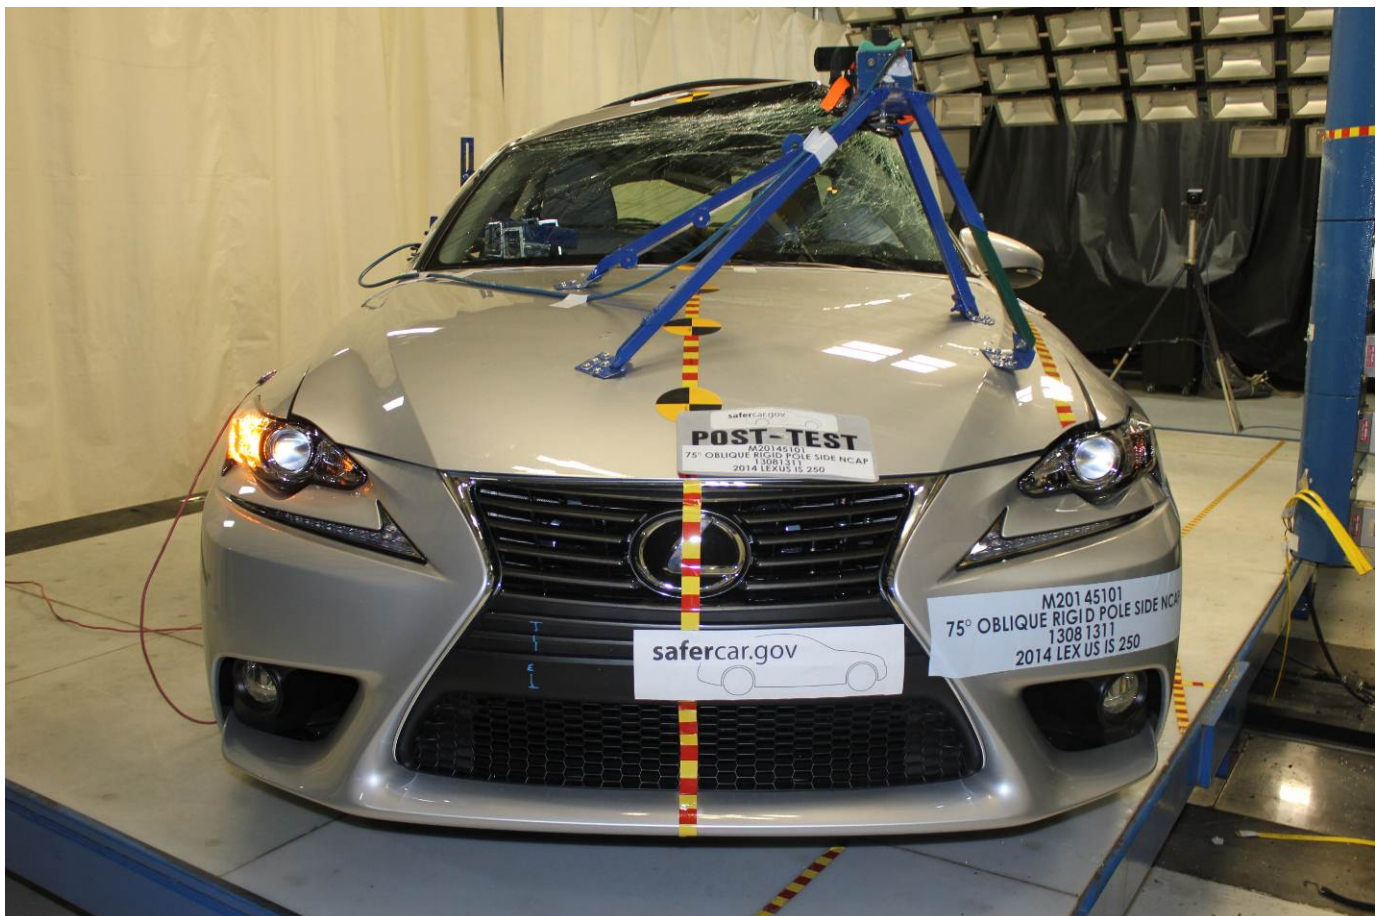
Post-Test Frontal View of Test Vehicle

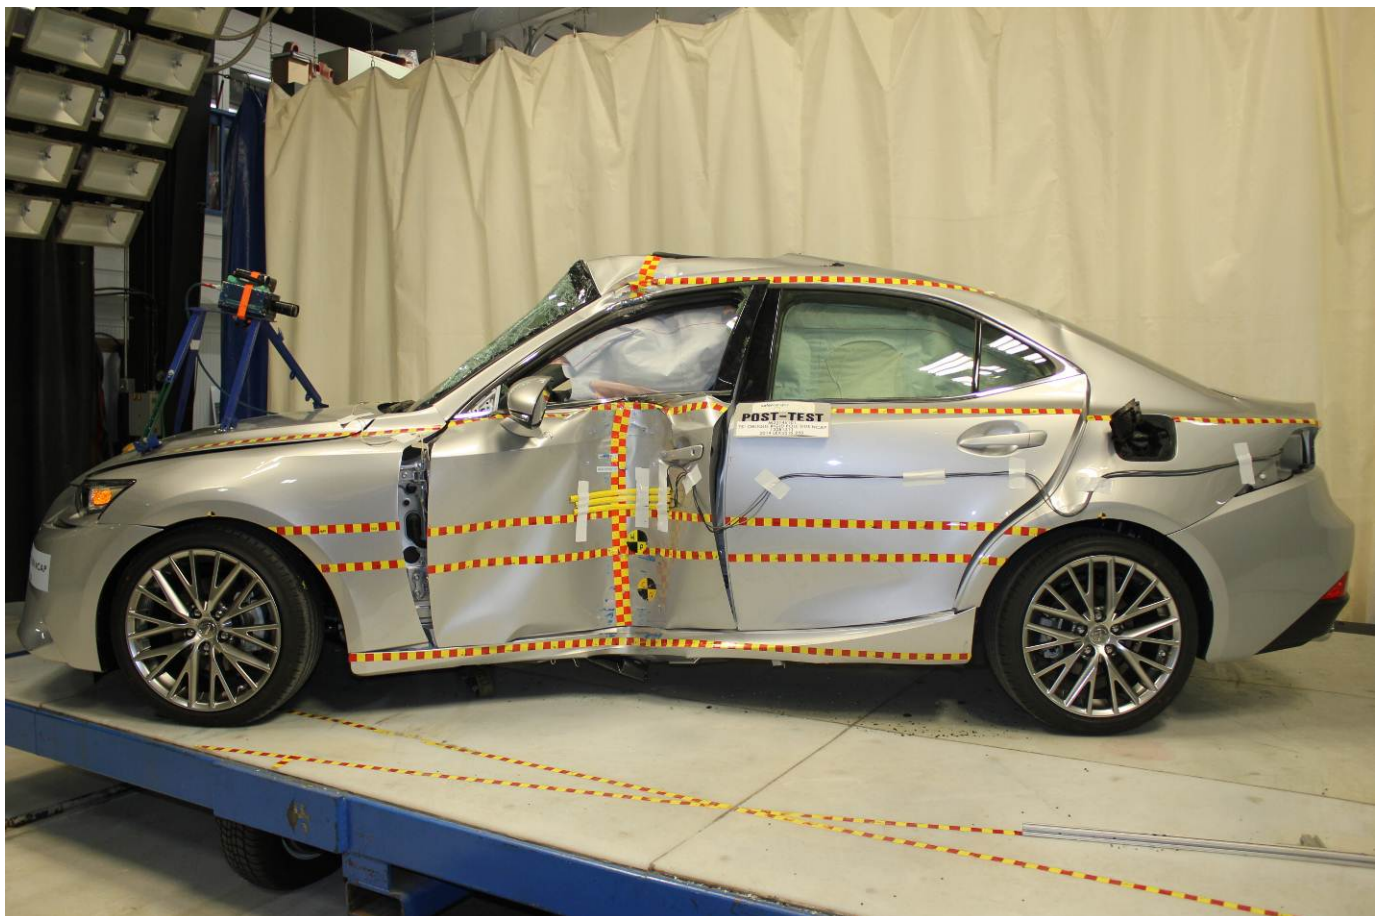
Post-Test Left Side View of Test Vehicle

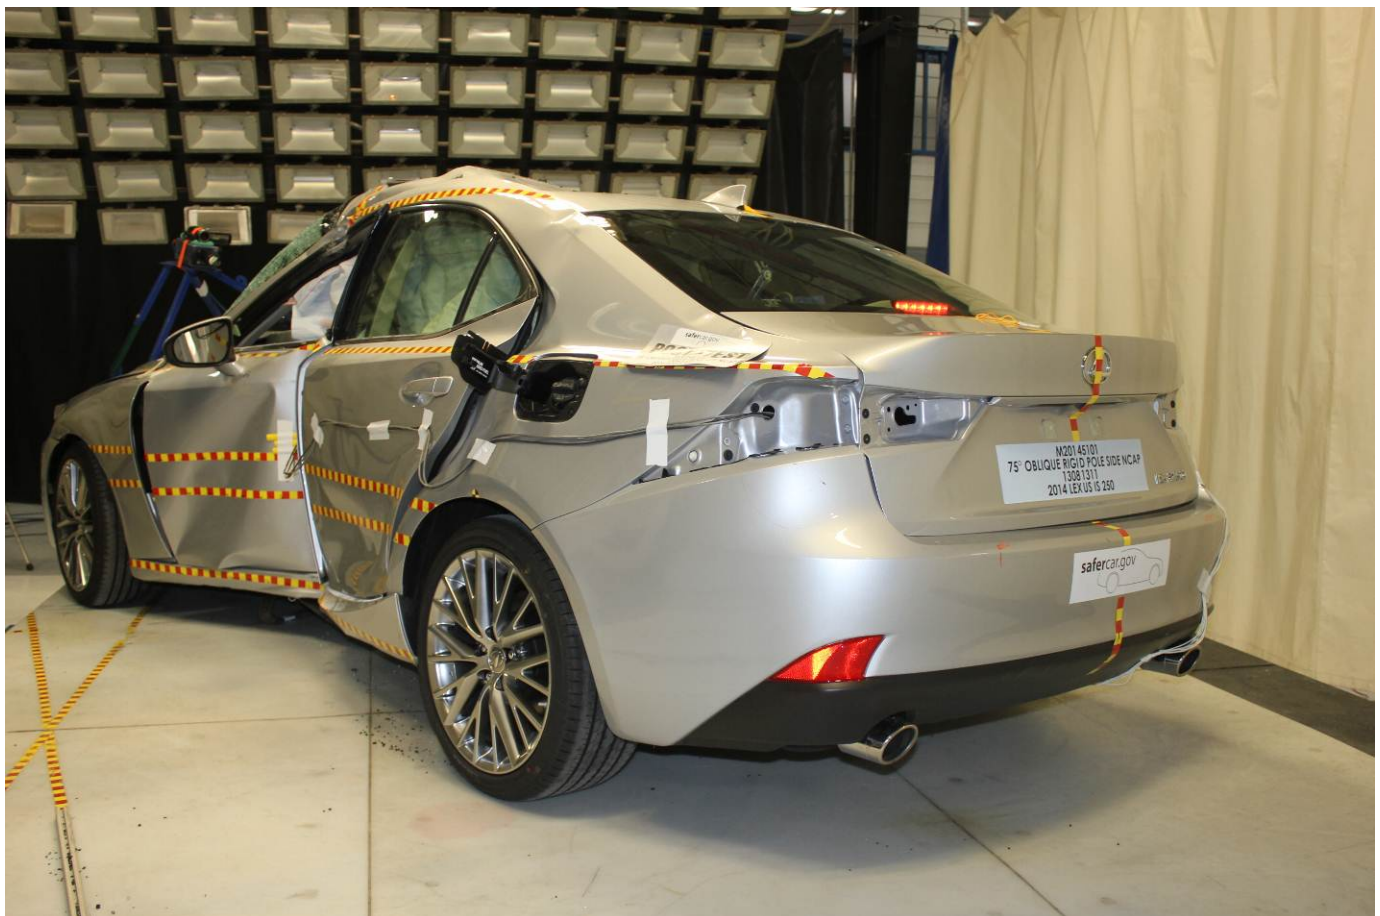
Post-Test Left Rear  $\frac{3}{4}$  View of Test Vehicle

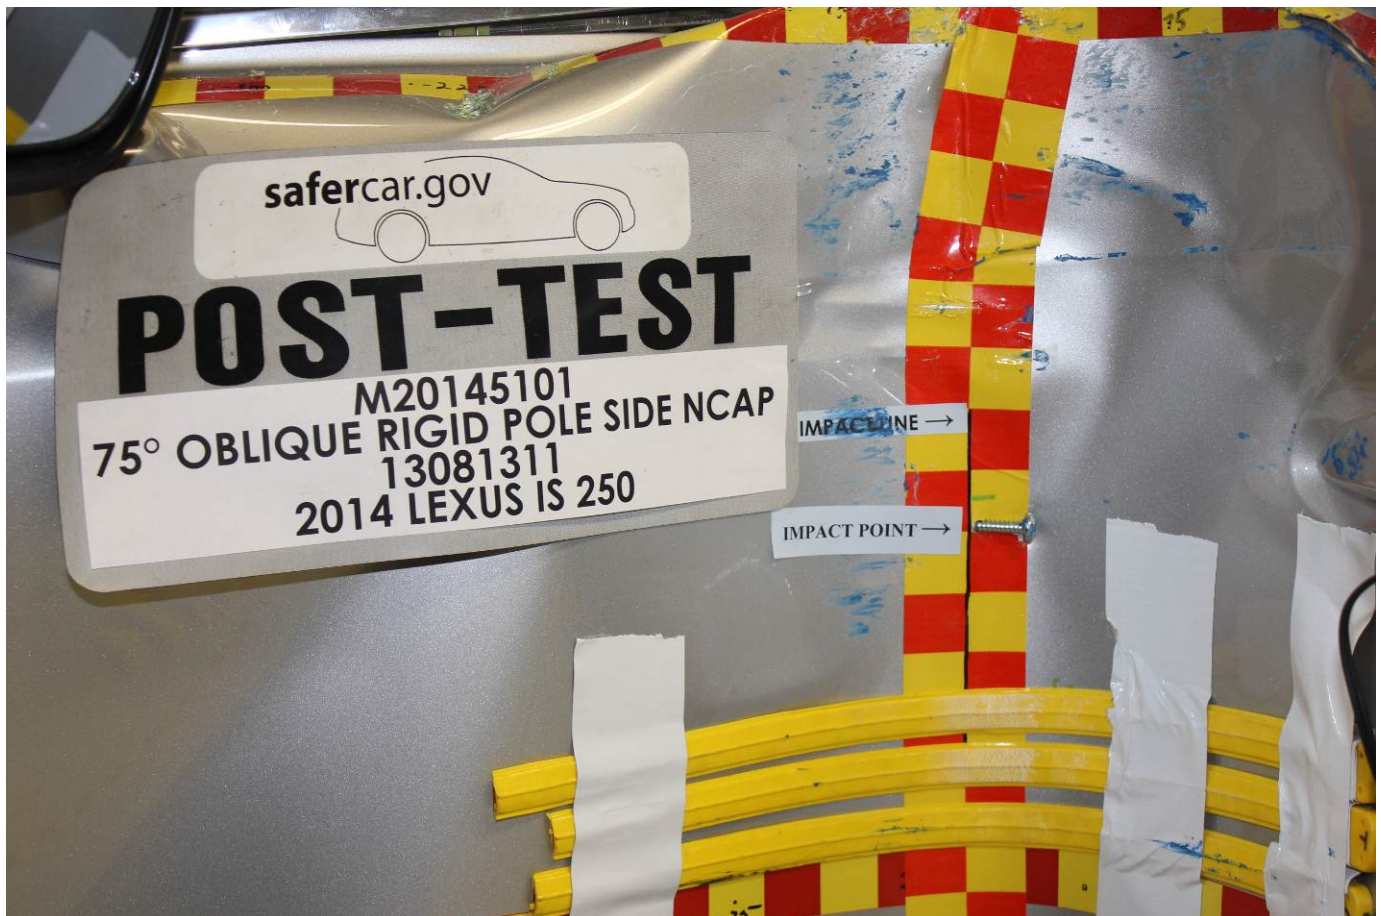
Post-Test Close-Up View of Impact Point Target Showing Impact Location

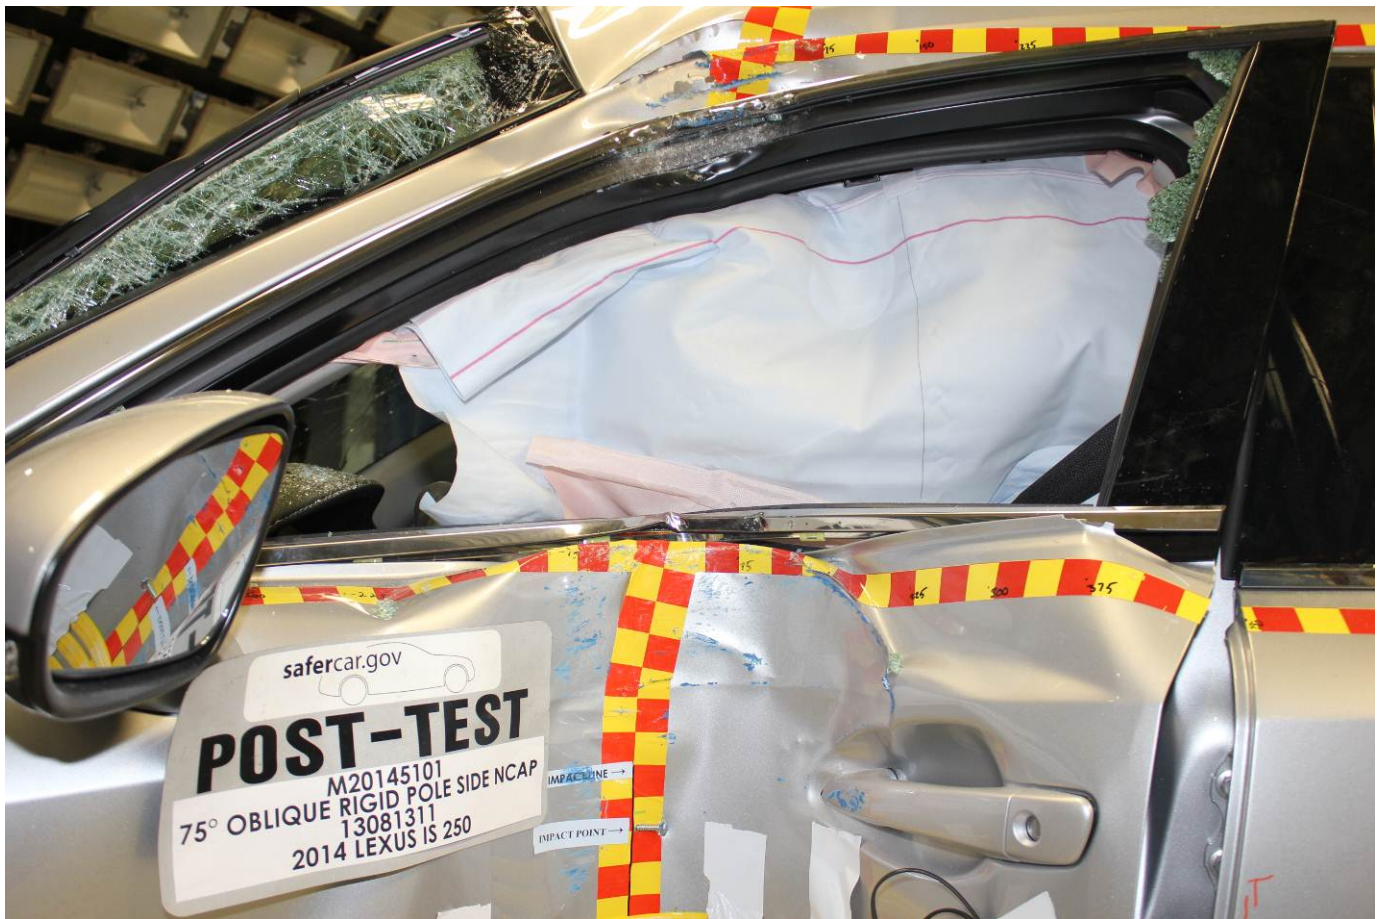
Post-Test Left Side View of Dummy Shoulder and Door Top View

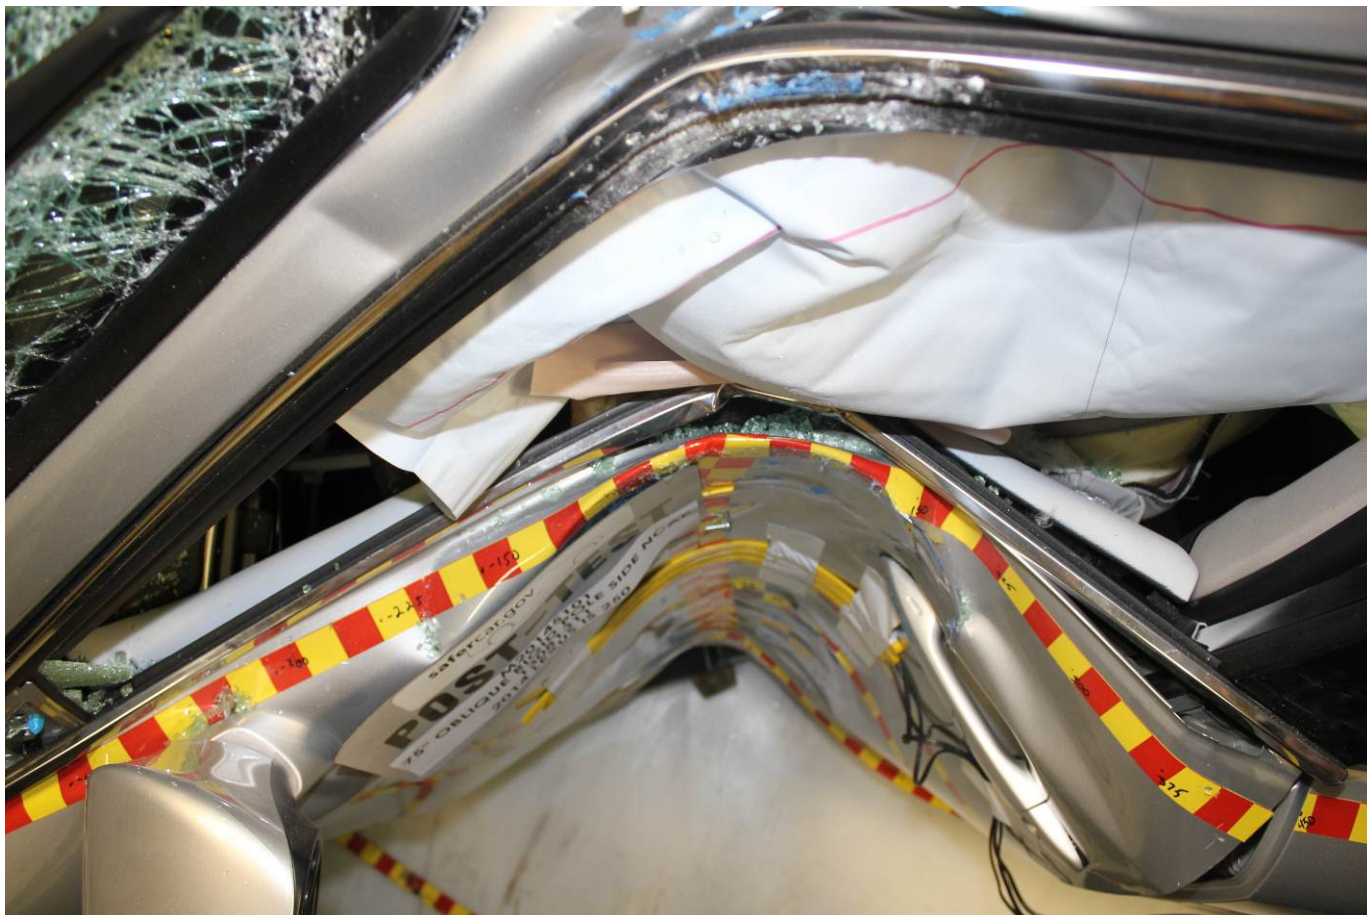
Post-Test Dummy and Door Clearance View

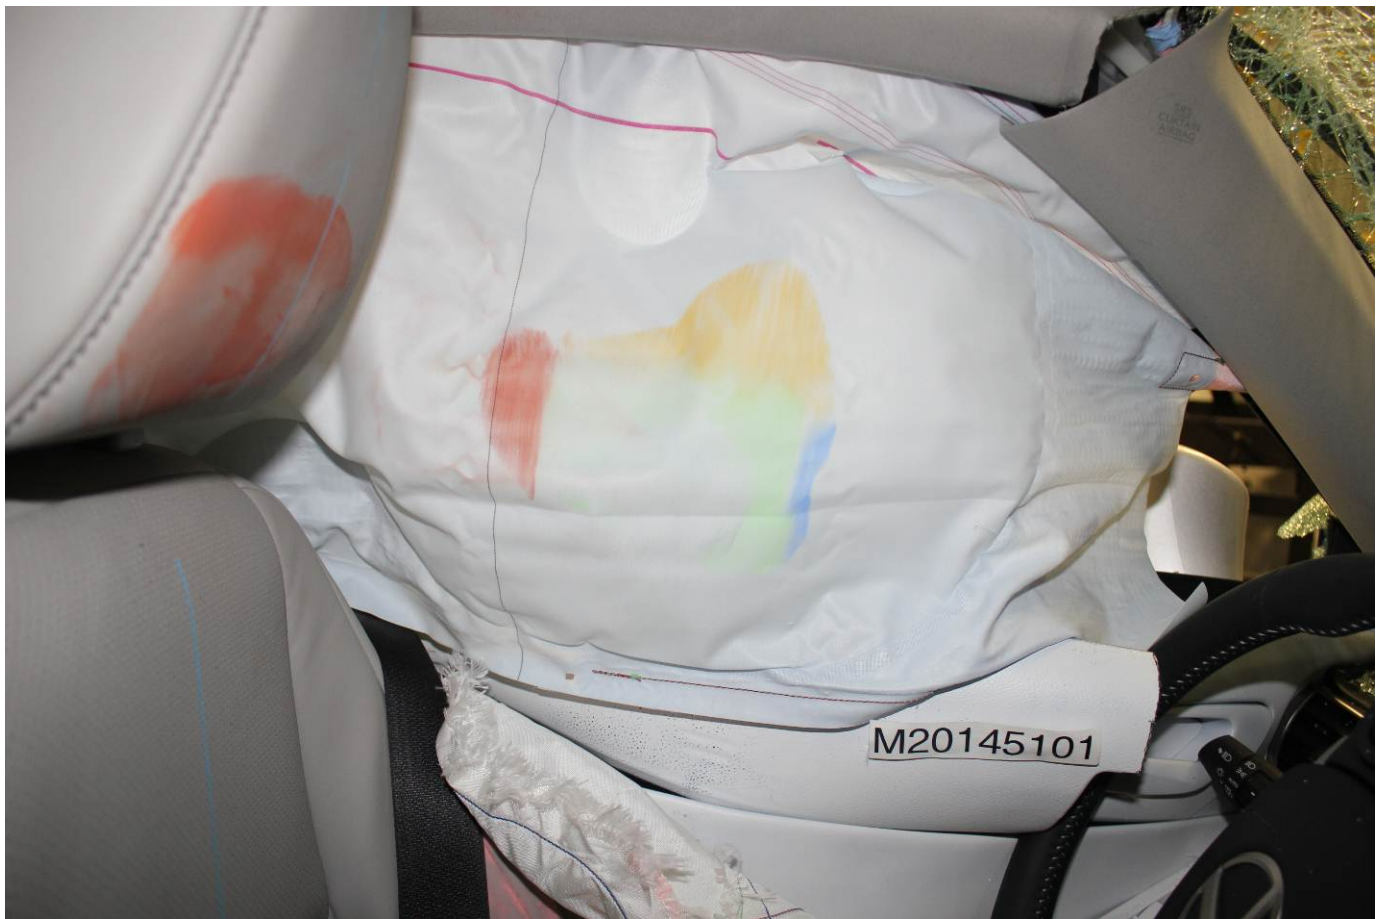
Post-Test Dummy Close-Up Head Contact with Side Air Bag View

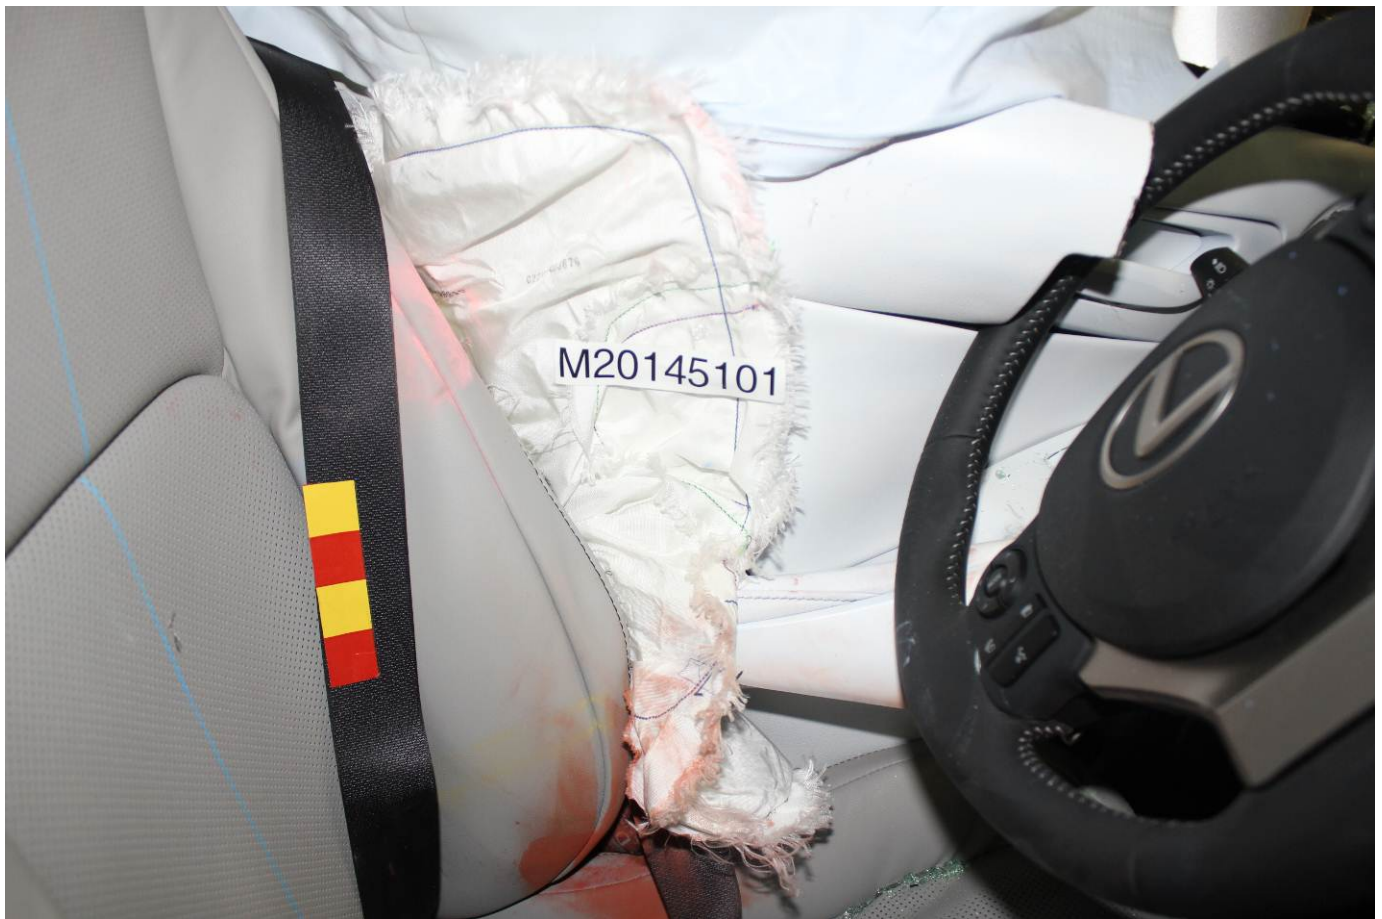
Post-Test Dummy Close-Up Torso Contact with Side Air Bag View

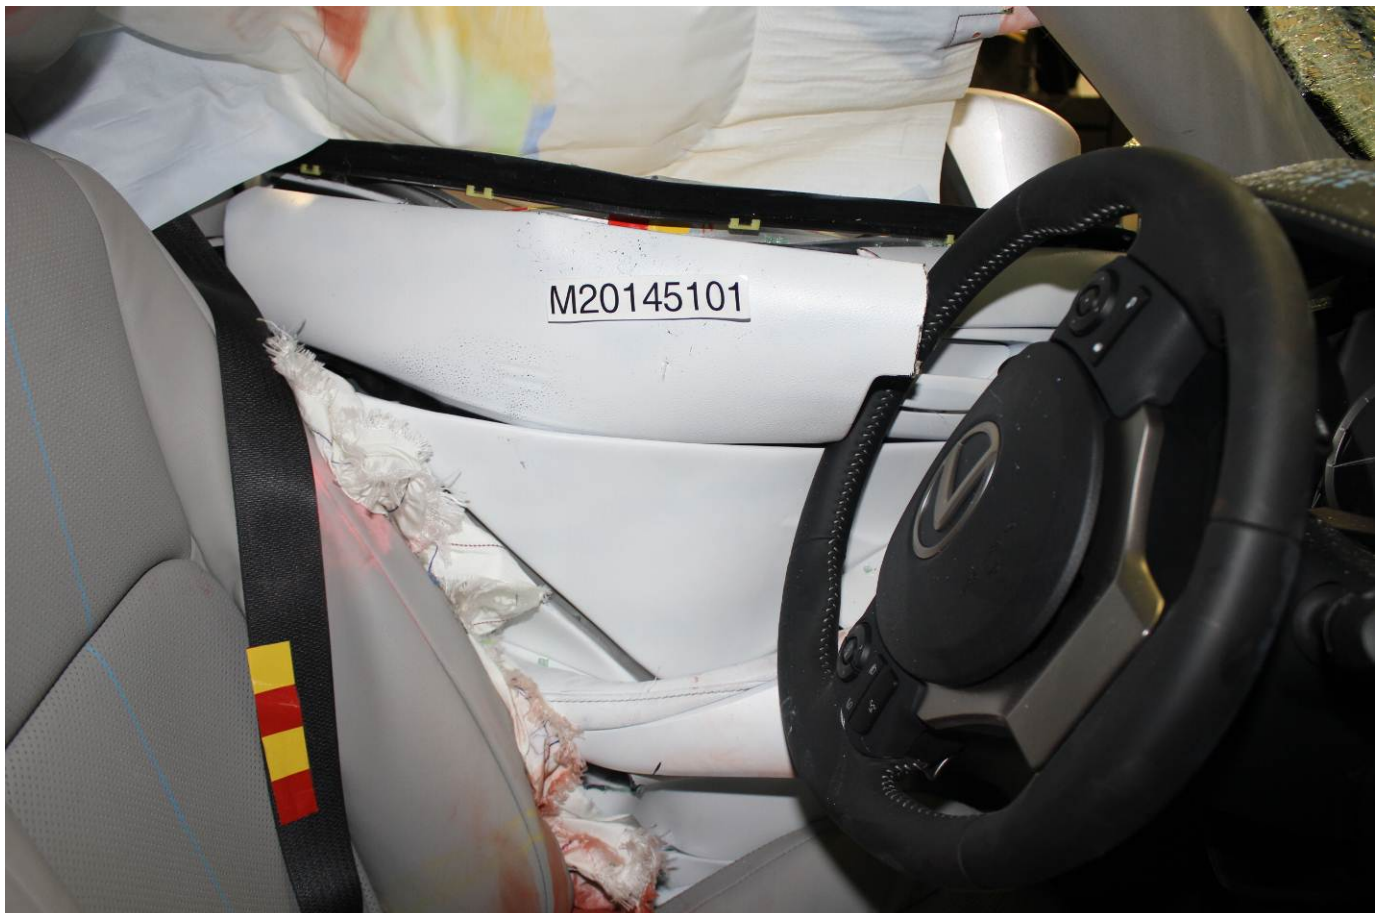
Post-Test View of Shattered Vehicle Inner Door Panel
