**REPORT NUMBER: NCAP-MGA-2014-012**

**NEW CAR ASSESSMENT PROGRAM (NCAP)  
Frontal Barrier Impact Test**

**TOYOTA MOTOR CORPORATION  
2014 Lexus IS250 AWD 4-Dr Sedan  
NHTSA No.: M20145100**

**MGA RESEARCH CORPORATION  
5000 Warren Road  
Burlington, WI 53105**

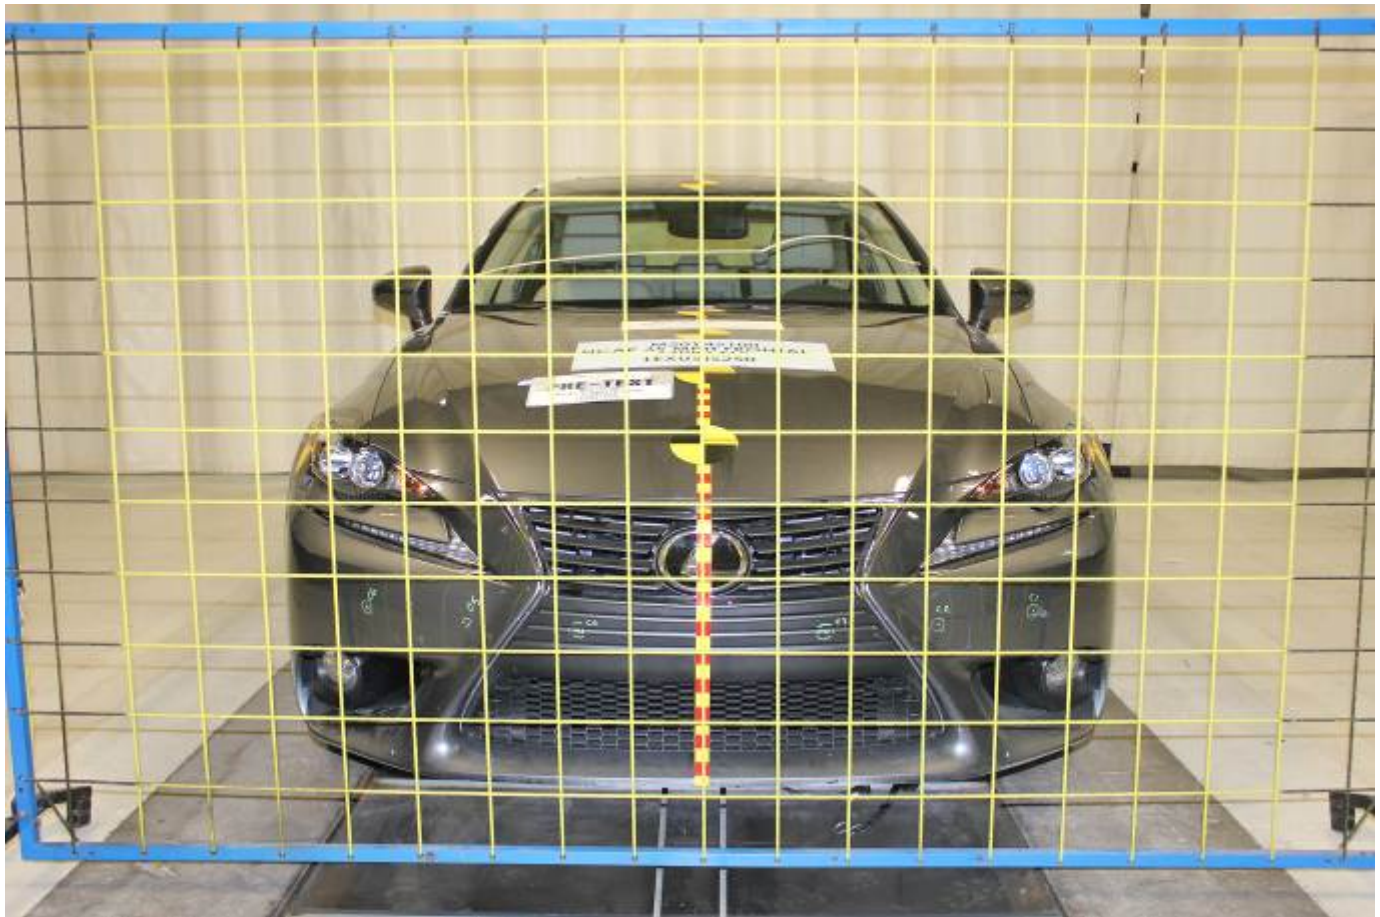
Load Cell Location

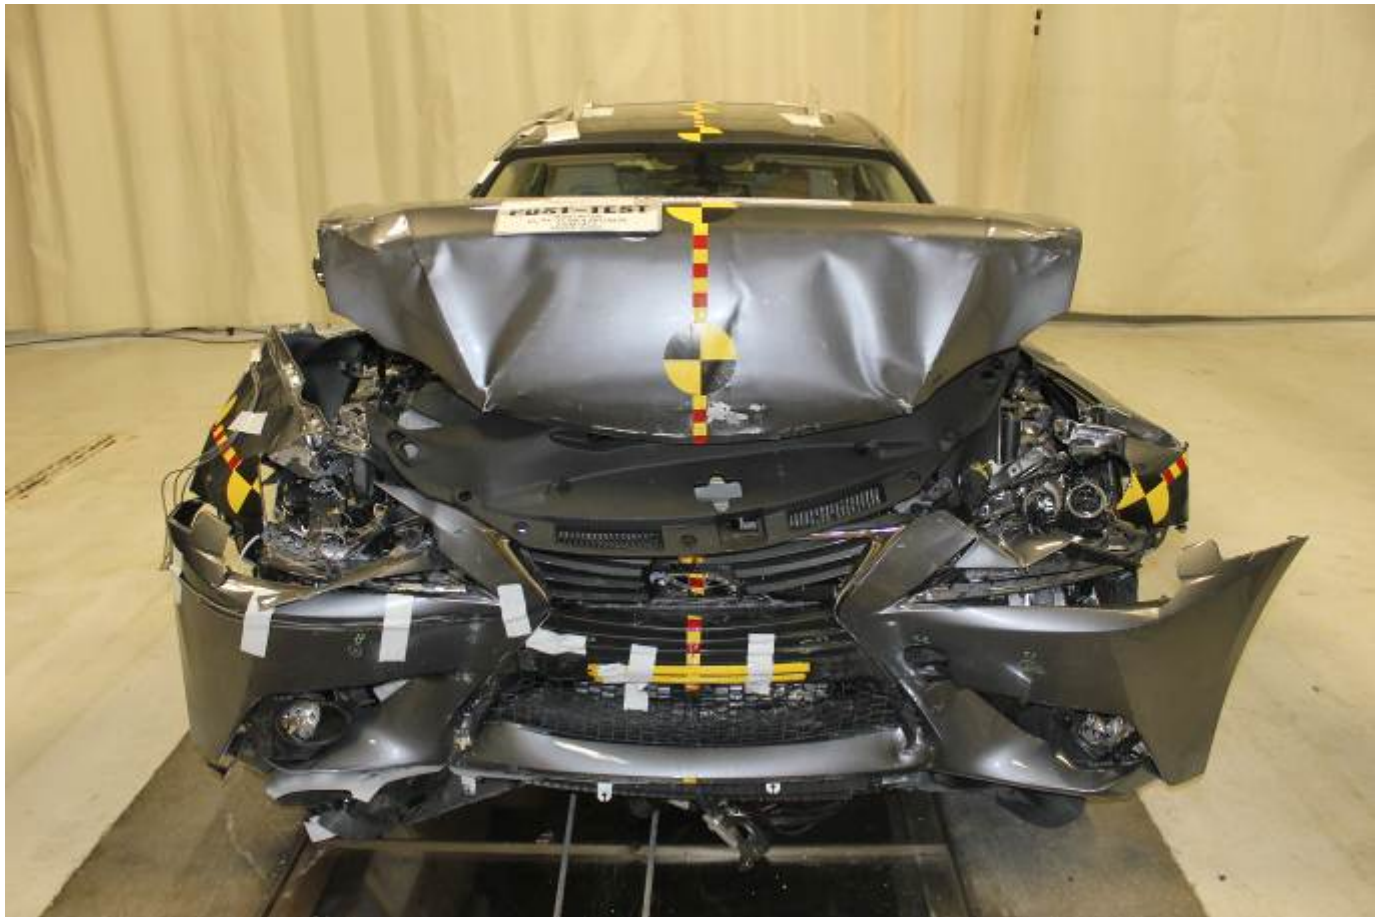
Post-Test Front View of Test Vehicle

The maximum static crush of the vehicle was 530 mm and both the driver and passenger side doors remained closed during the impact event and were operable after the impact.

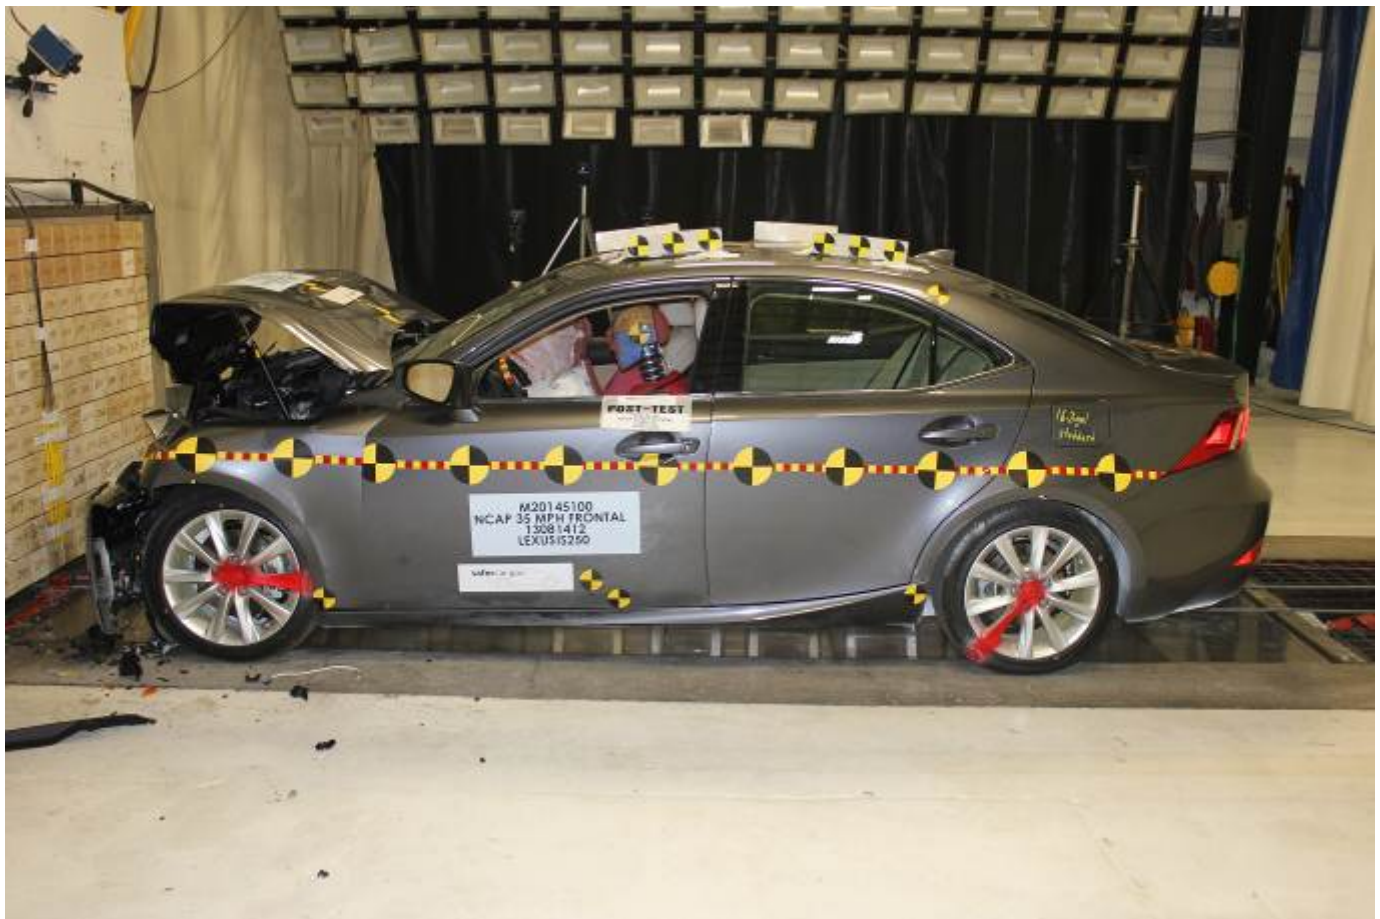
Post-Test Left View of Test Vehicle

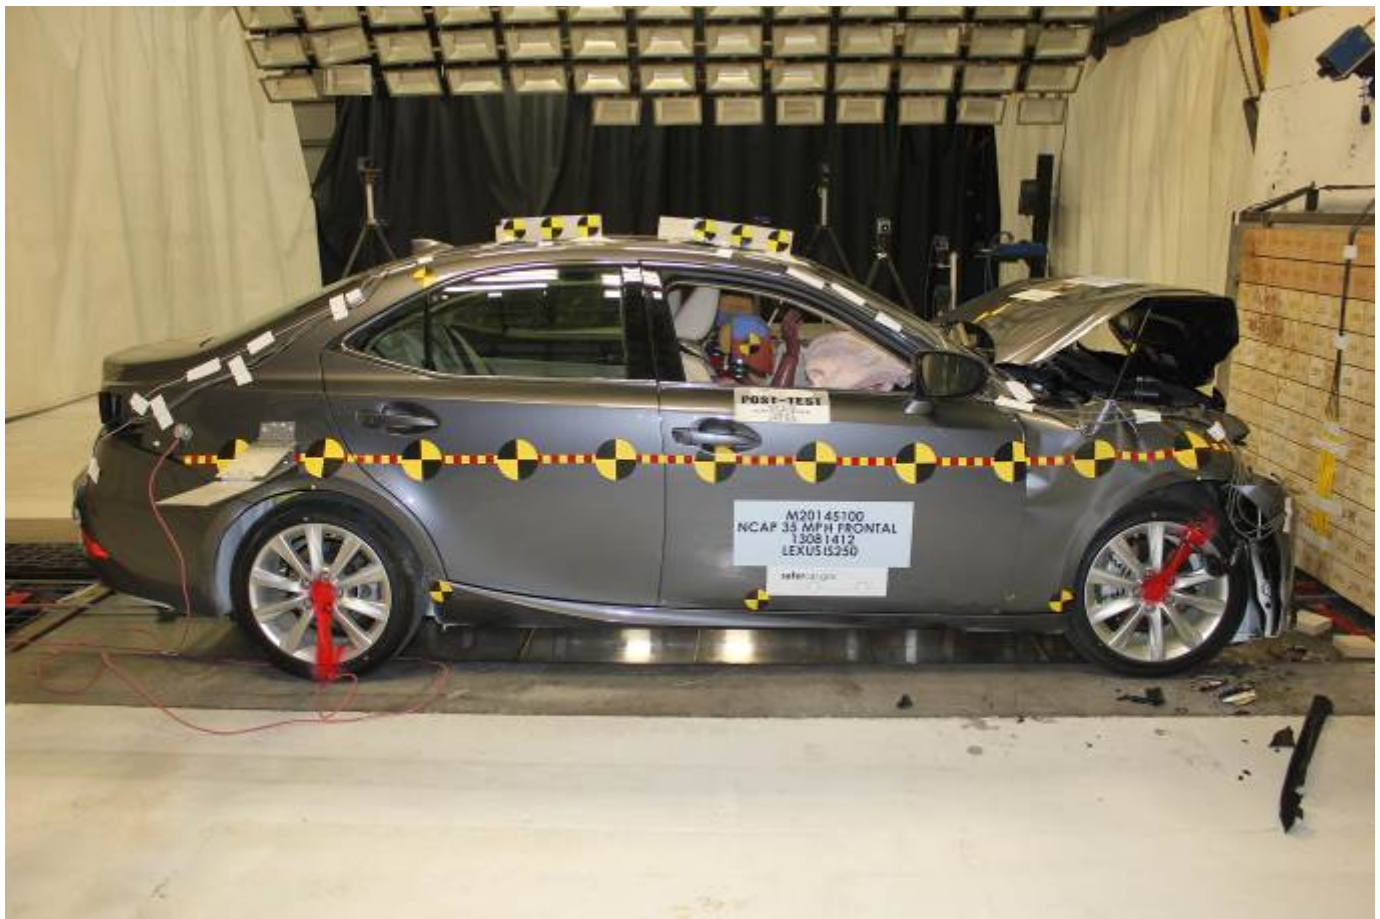
Post-Test Right View of Test Vehicle

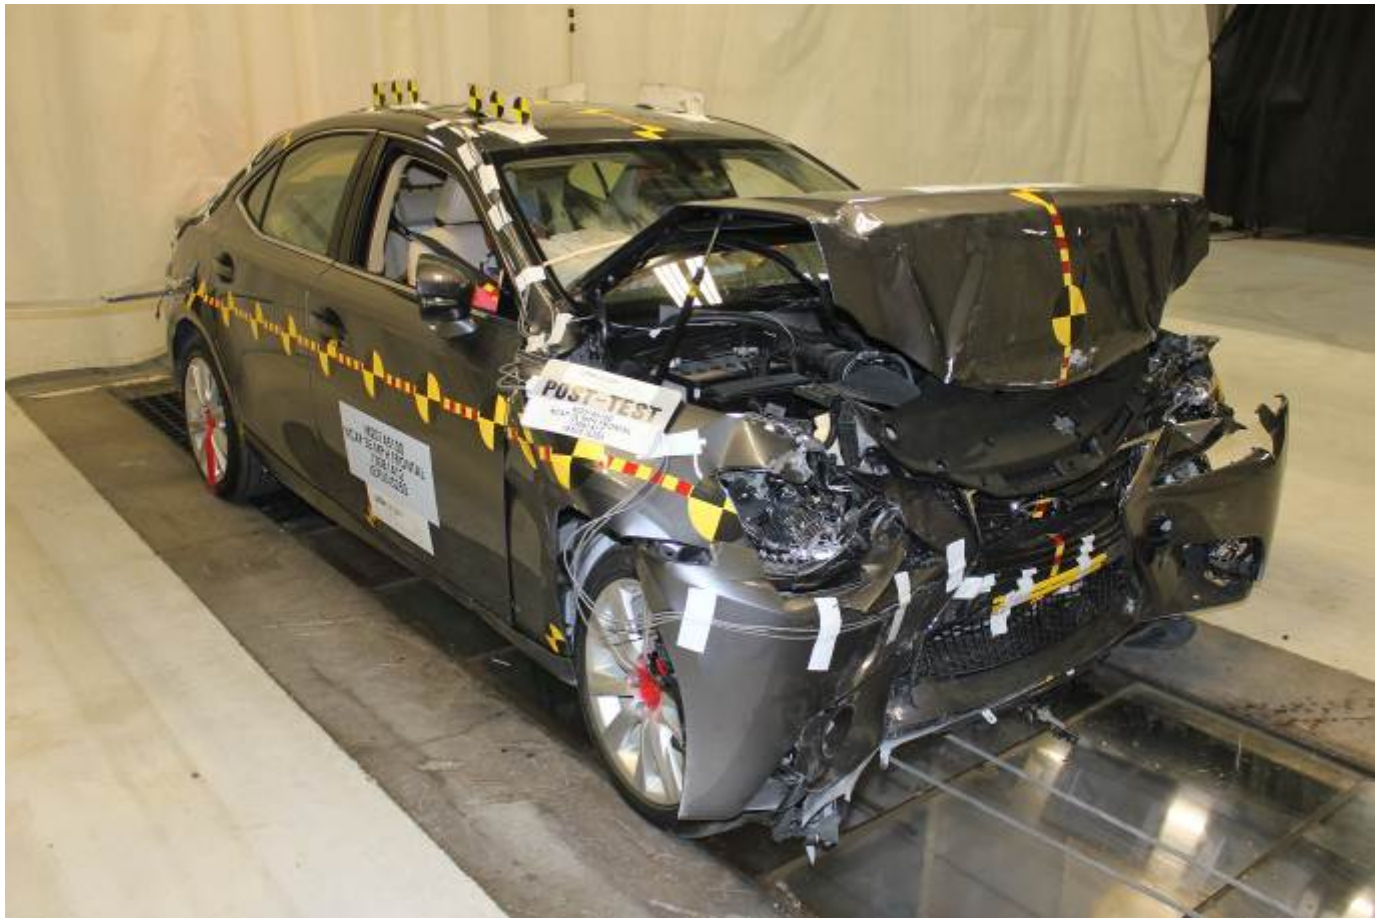
Post-Test Right Front 3-4 View

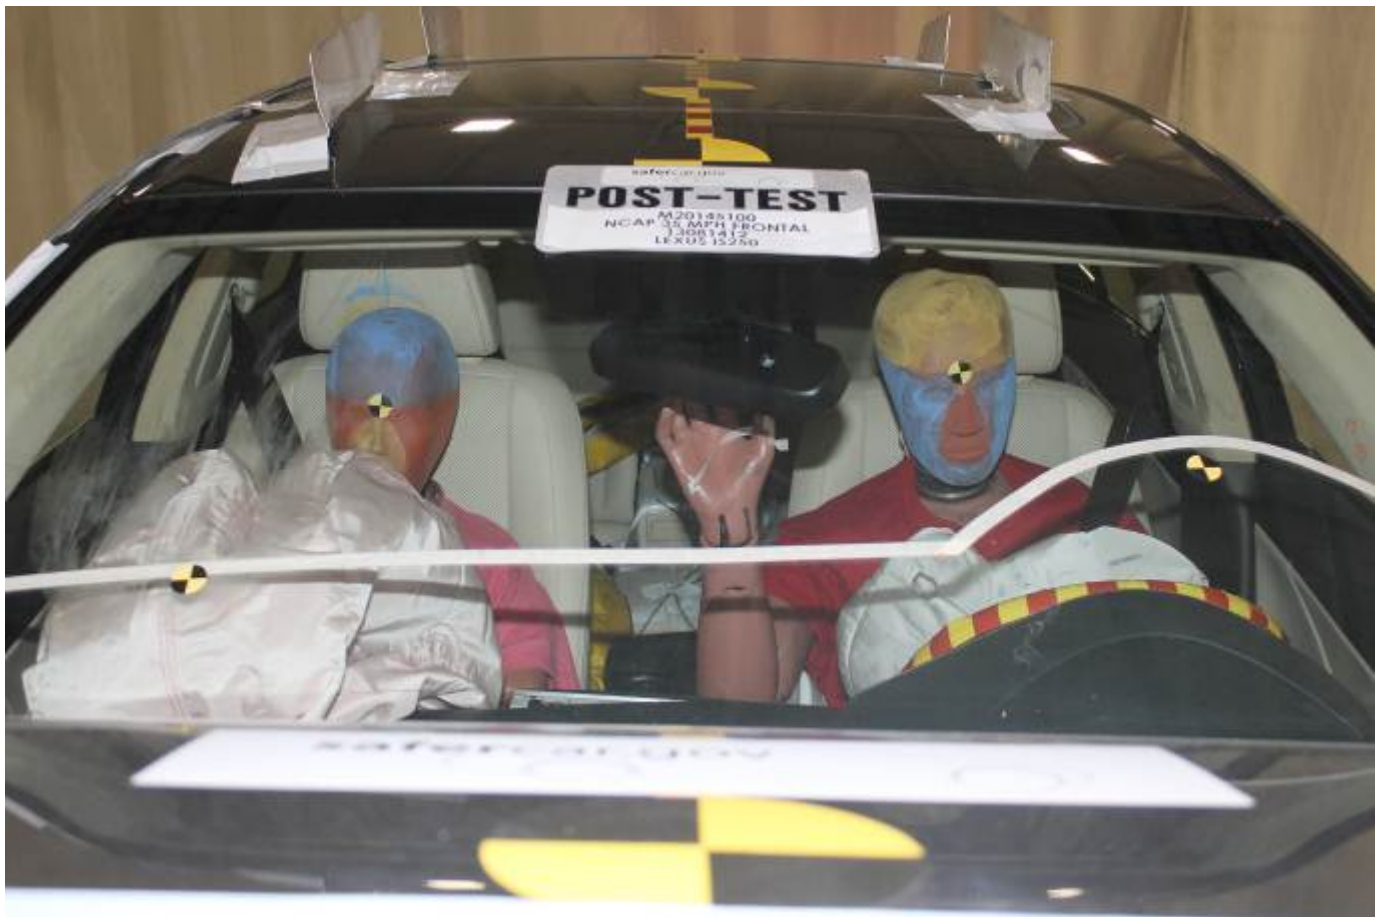
Post-Test Windshield View

There was 100 percent windshield retention and no intrusion into the protected zone of the windshield during the event. There was no Stoddard Solvent leakage after the event or during any phase of the static rollover.

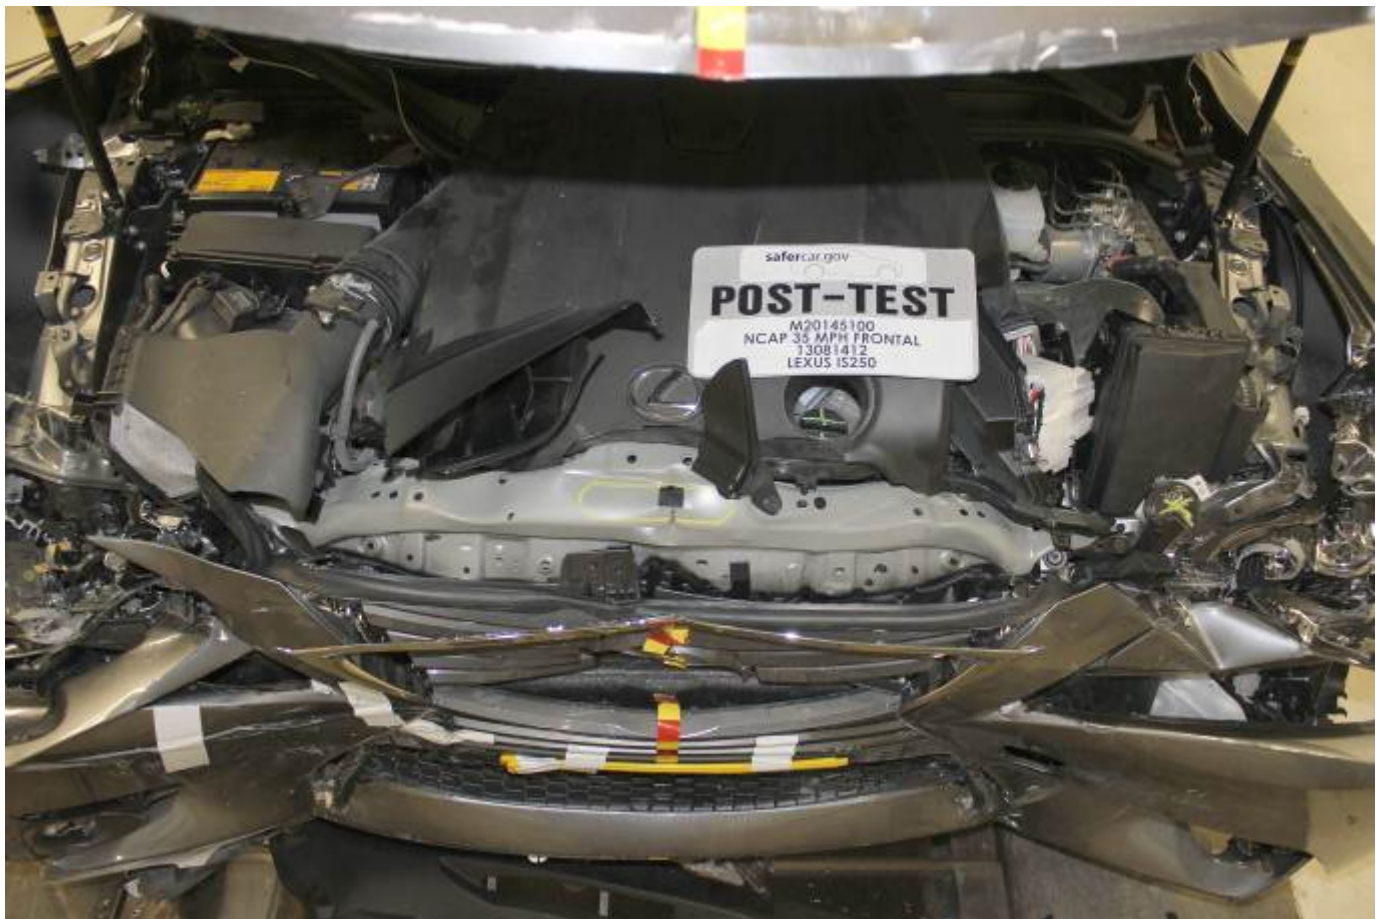
Post-Test Engine Compartment View

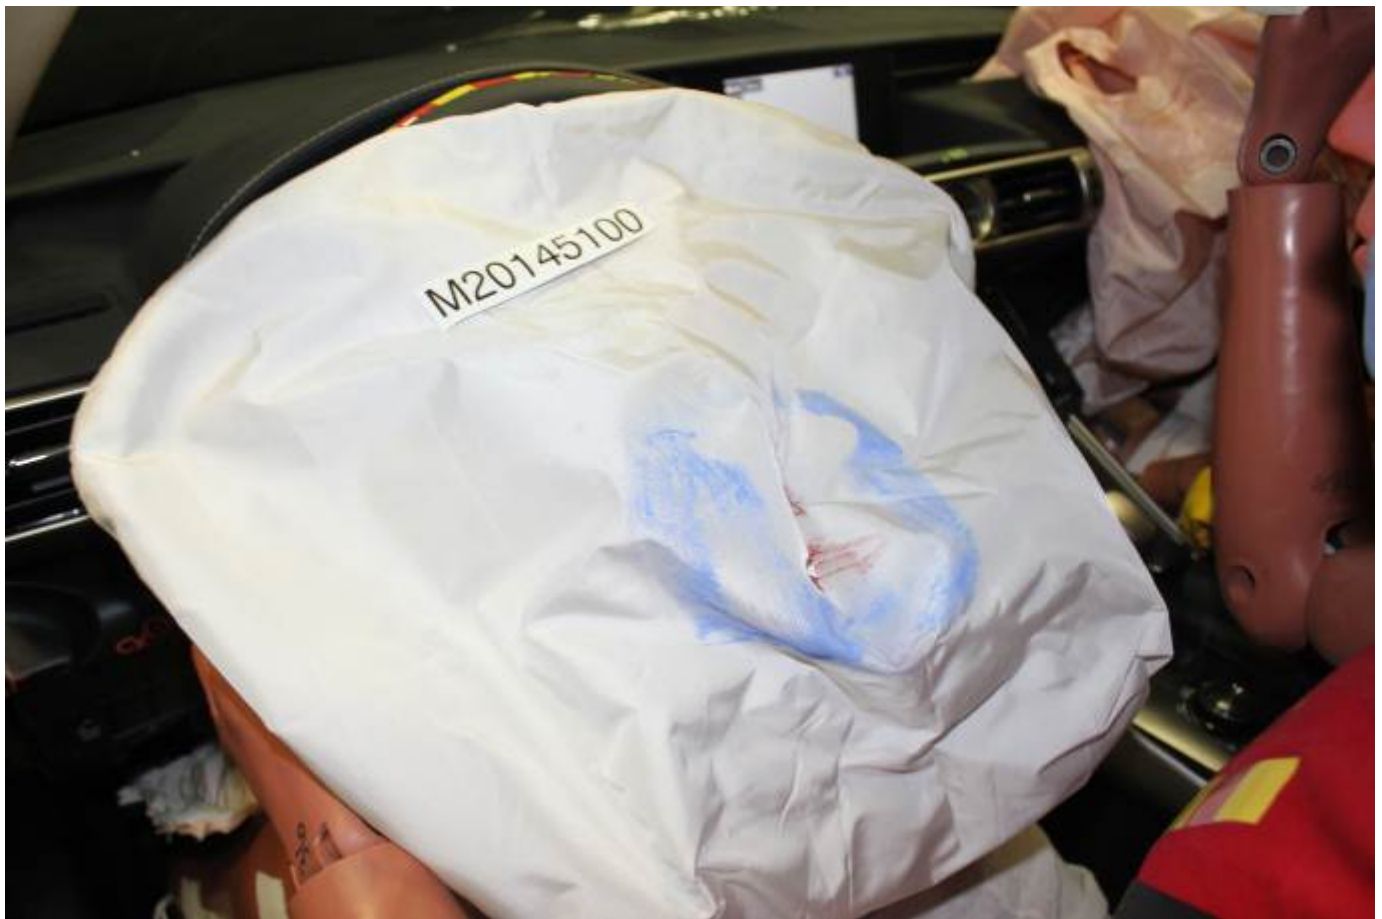
Post-Test Driver Dummy Contact with Airbag

The driver's visible contact points were as follows: The driver's head and chest contacted the airbag. The driver's head also contacted the headrest. The driver's knees contacted the knee air bag, the left knee contacted the knee bolster. The passenger's visible contact points were as follows: The passenger's head and chest contacted the airbag. The passenger's head also contacted the headrest. The passenger's knees contacted the knee airbag.

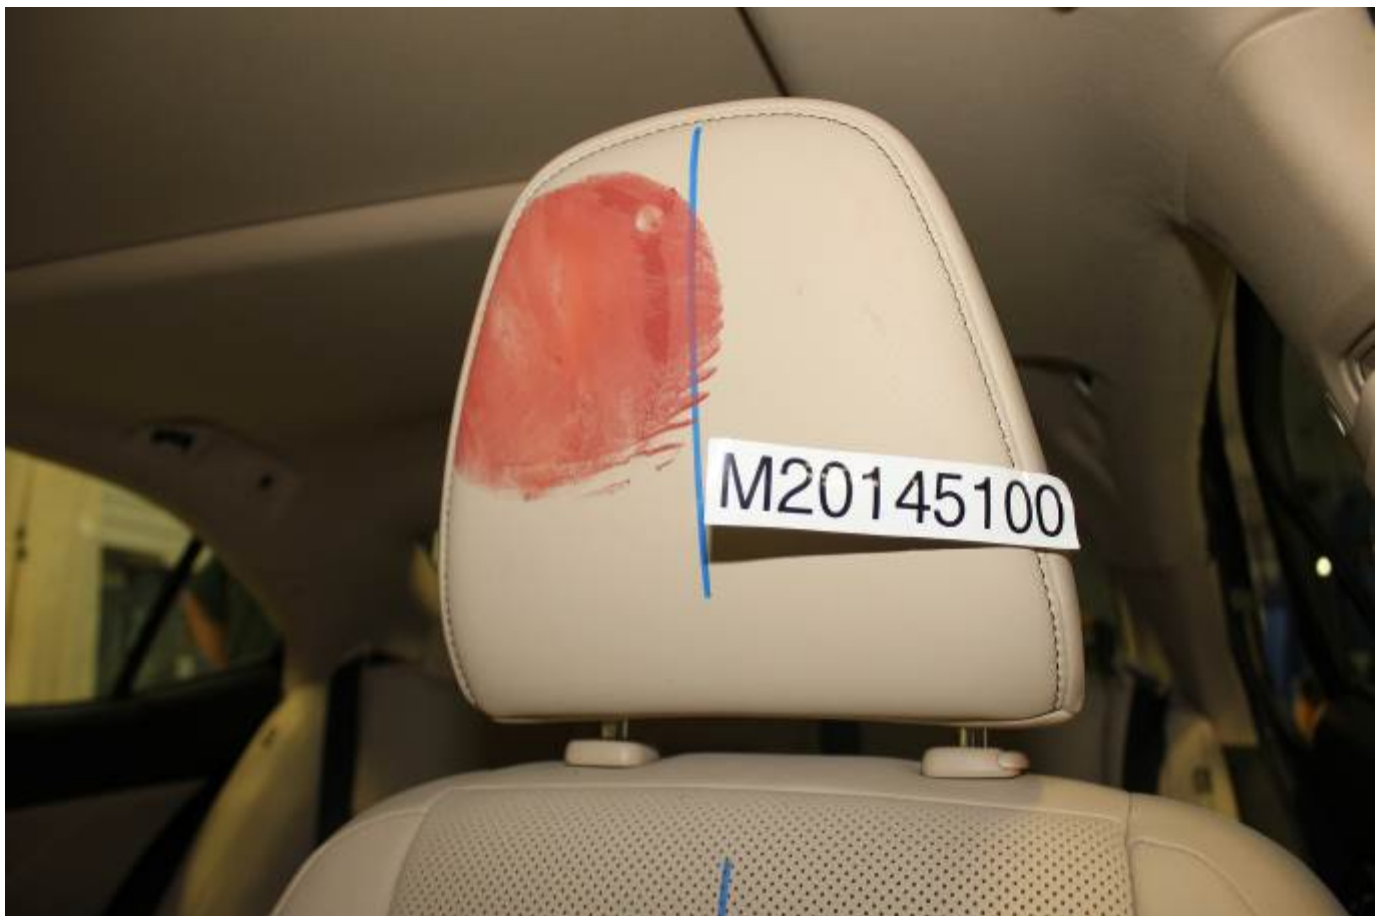
Post-Test Driver Dummy Contact with Headrest

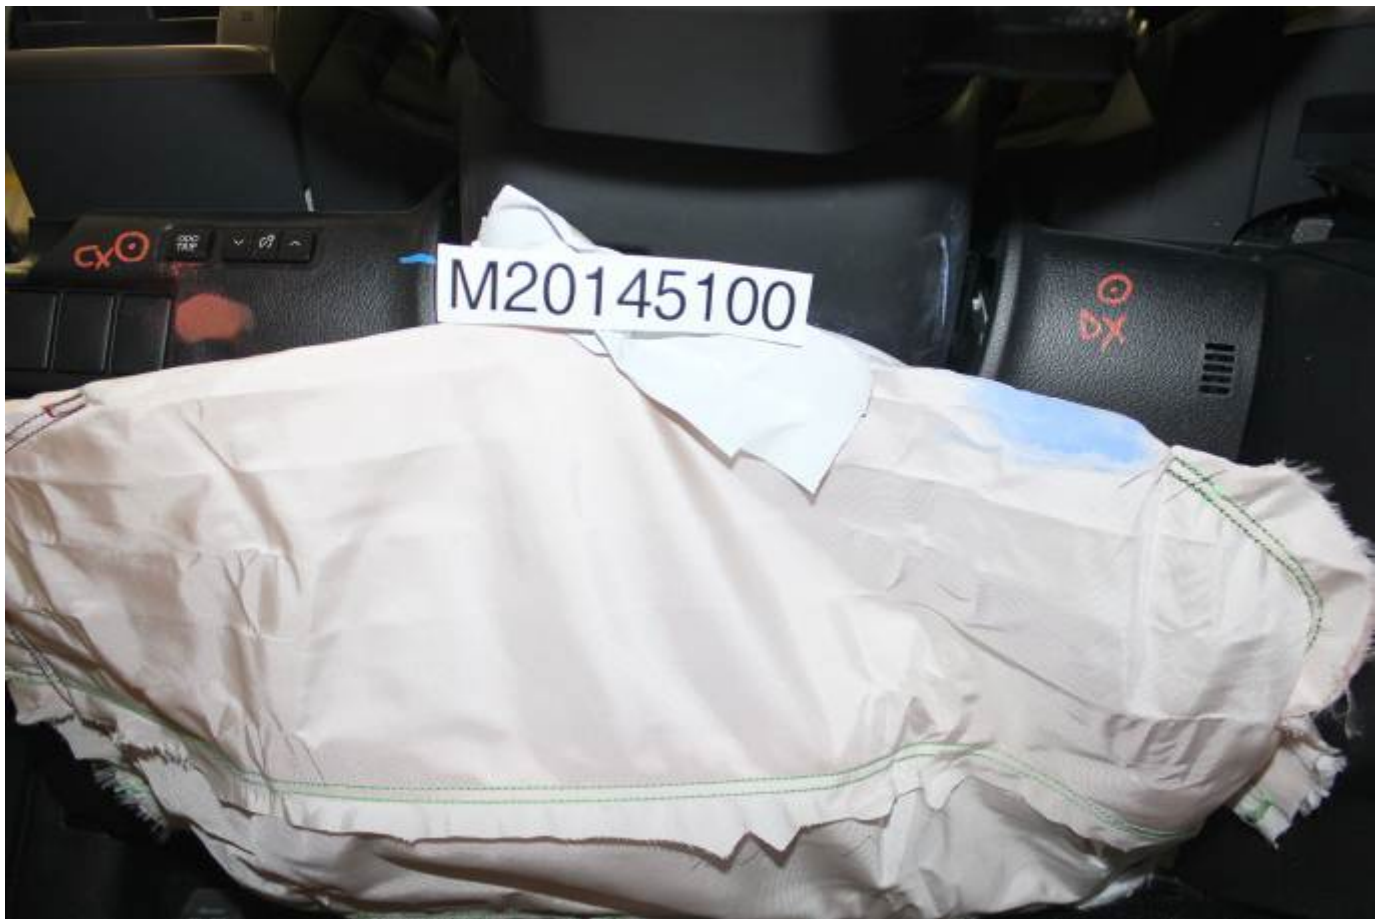
Post-Test Driver Dummy Contact with Knee Airbag

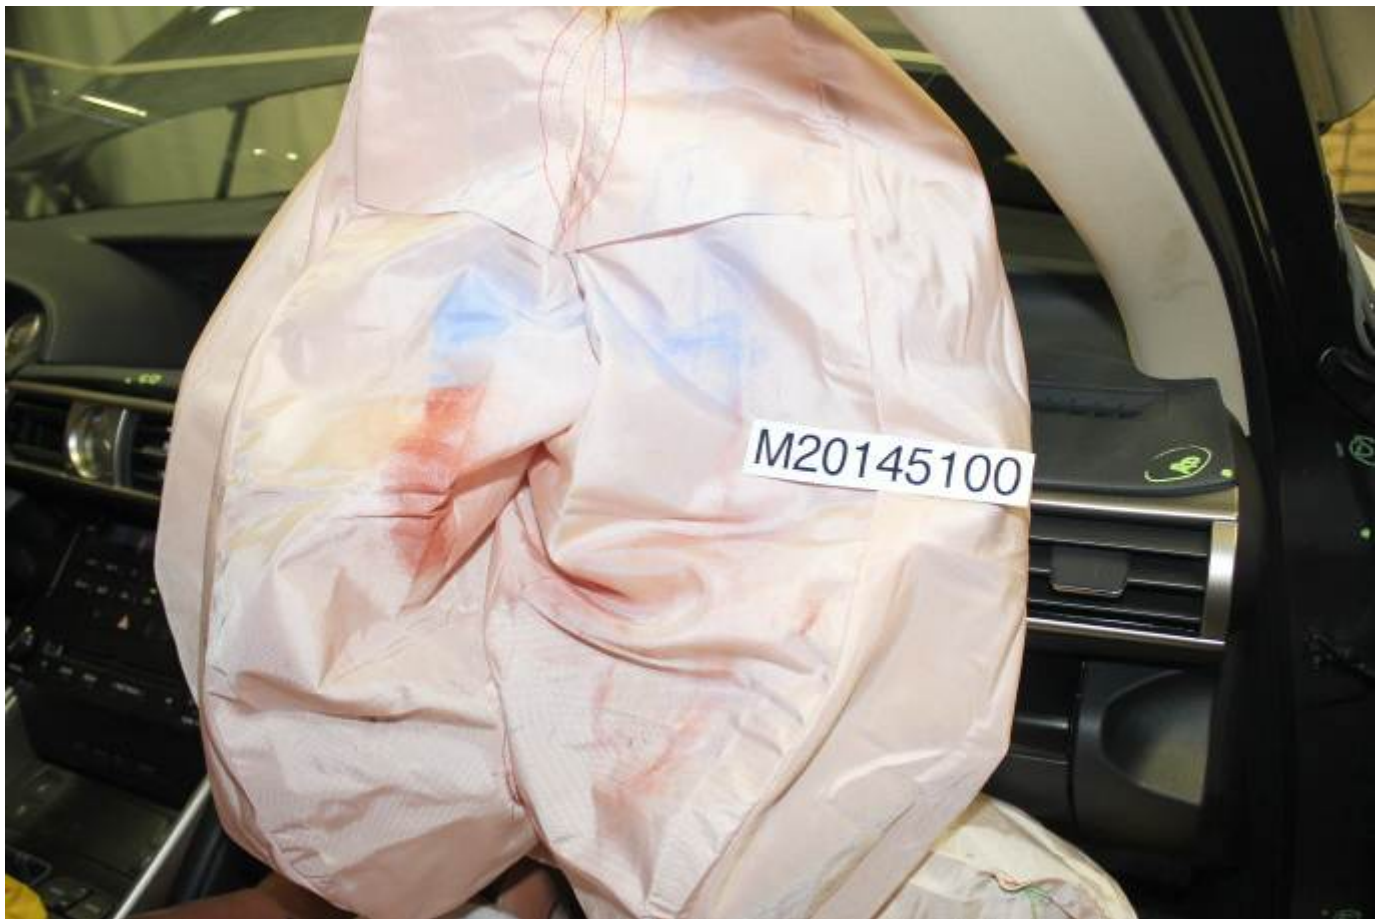
Post-Test Passenger Dummy Contact with Airbag

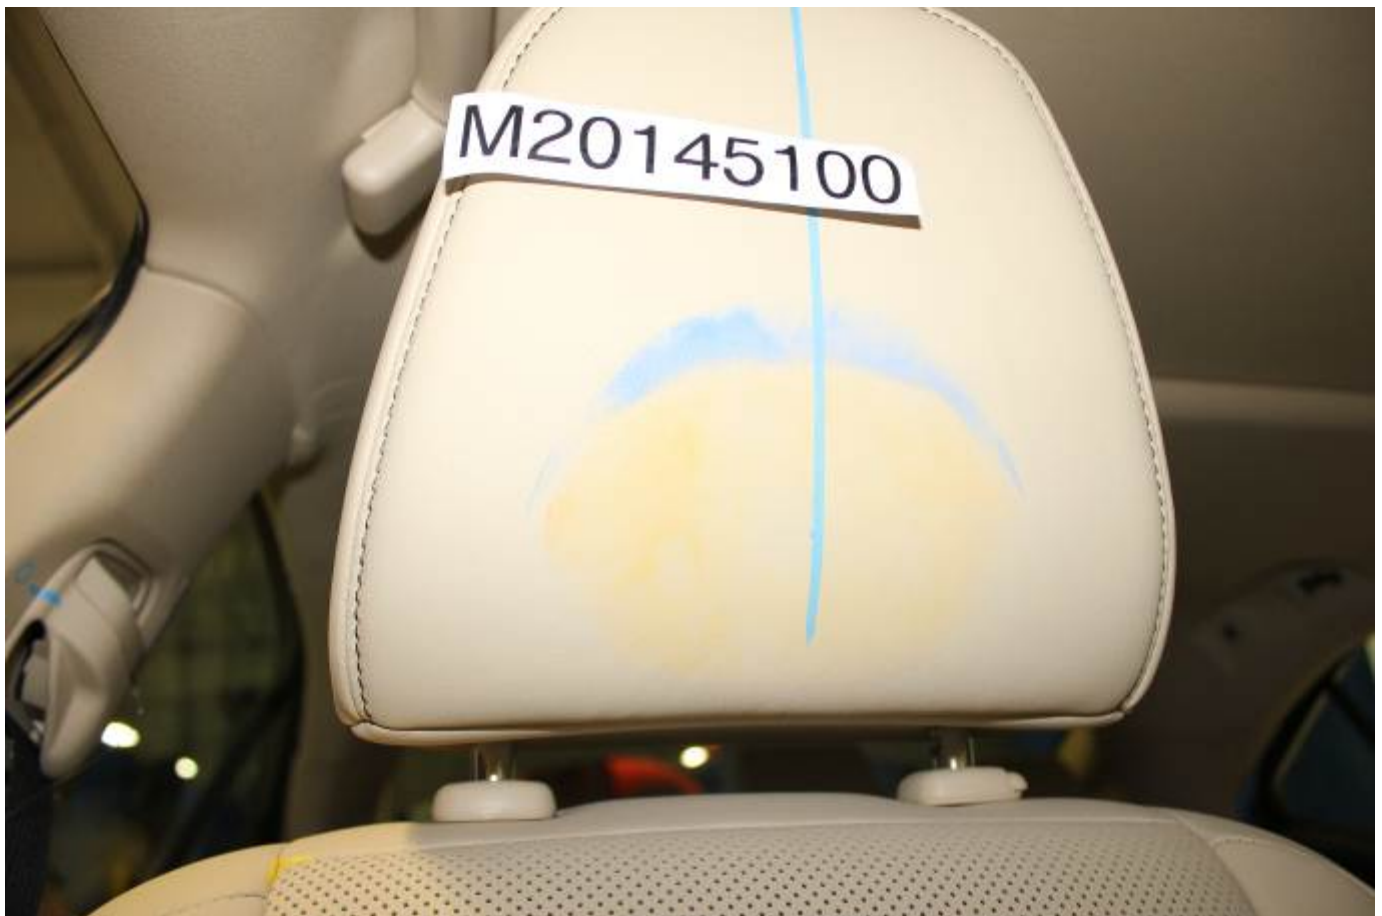
Post-Test Passenger Dummy Contact with Headrest

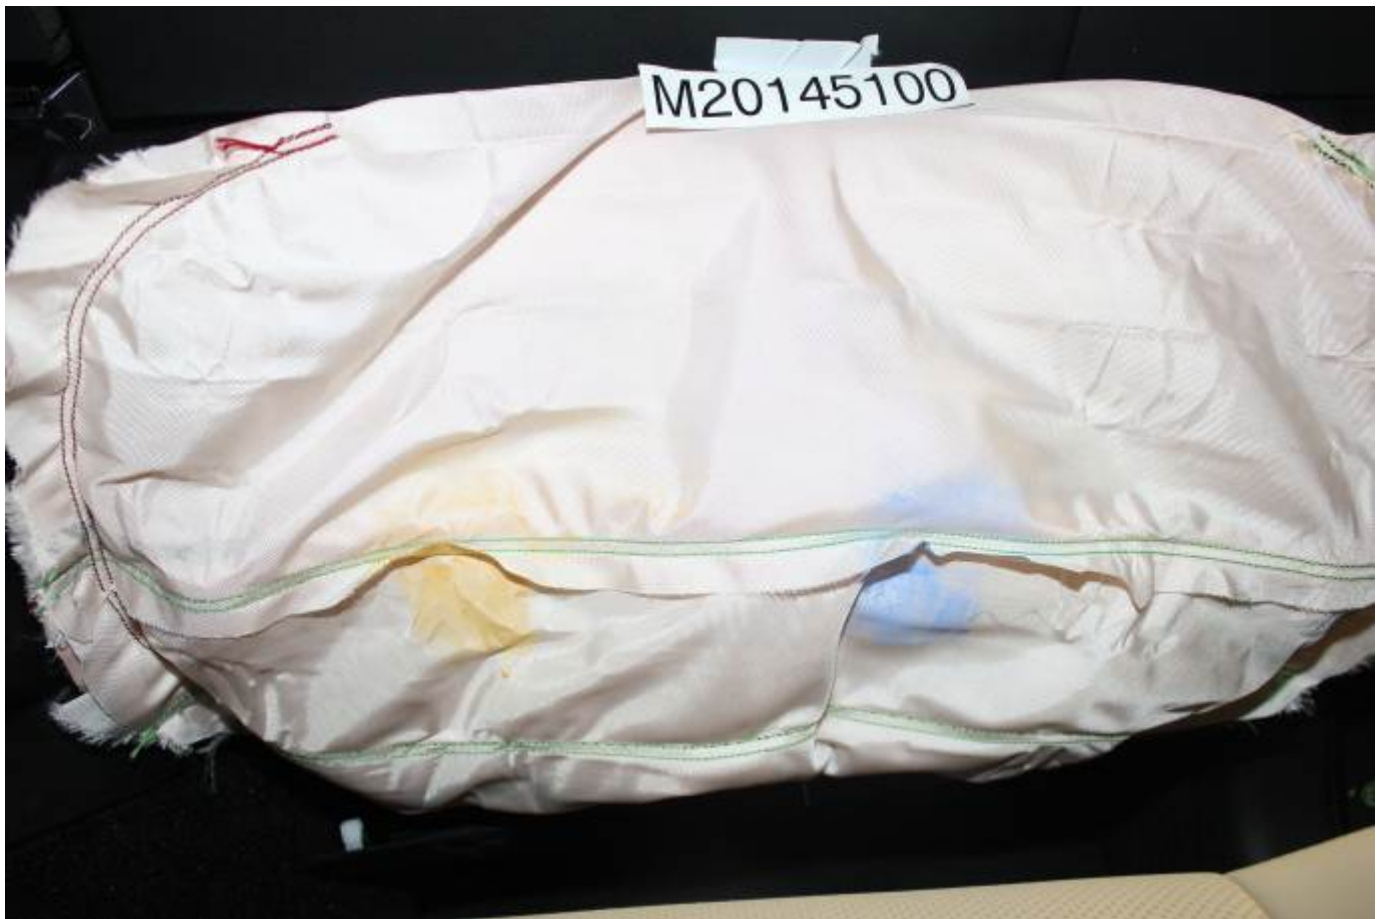
Post-Test Passenger Dummy Contact with Knee Airbag

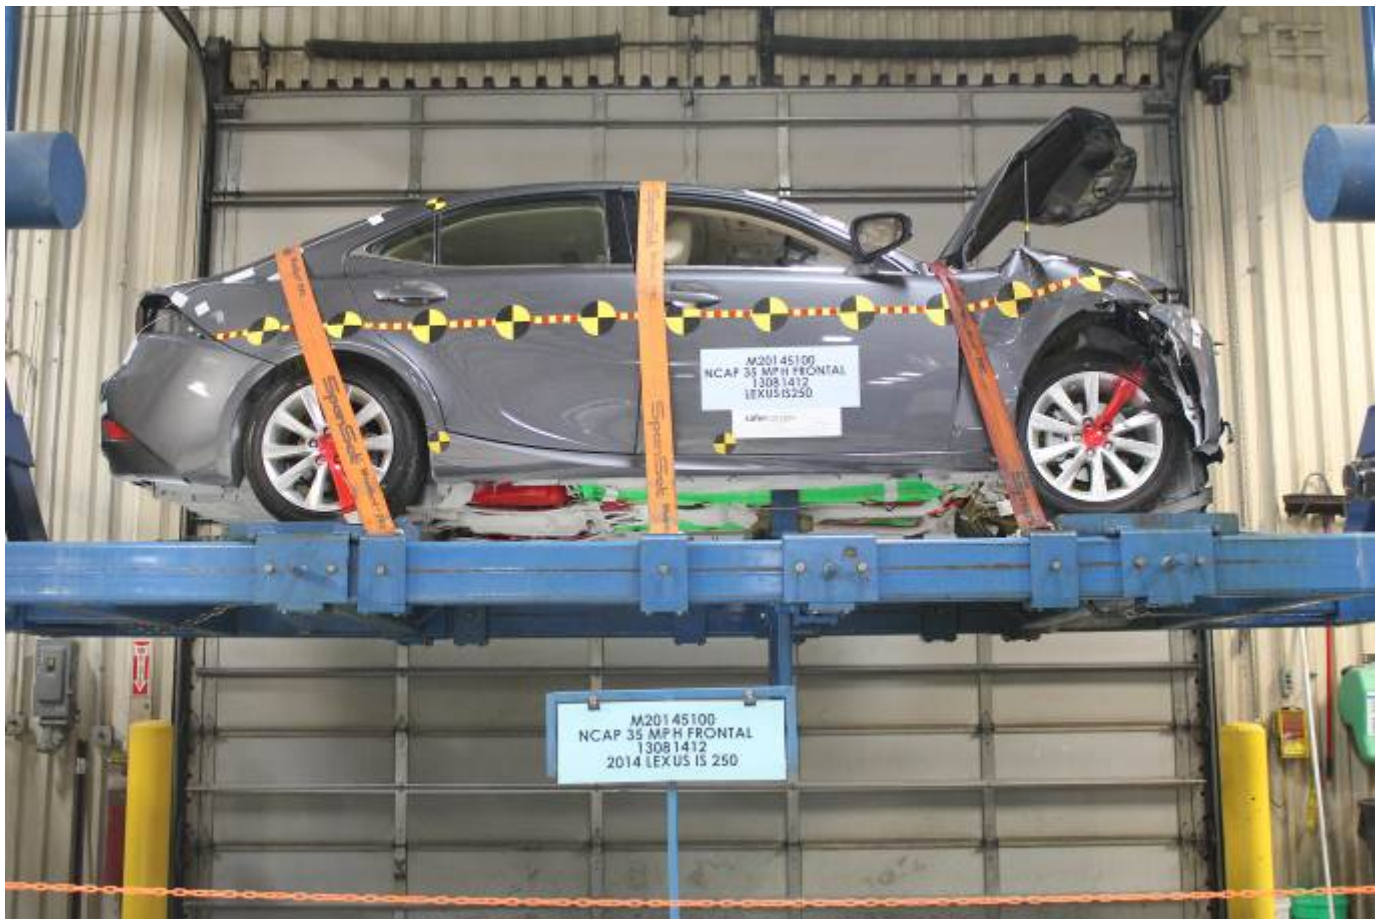
Vehicle at 0° on Static Rollover Device

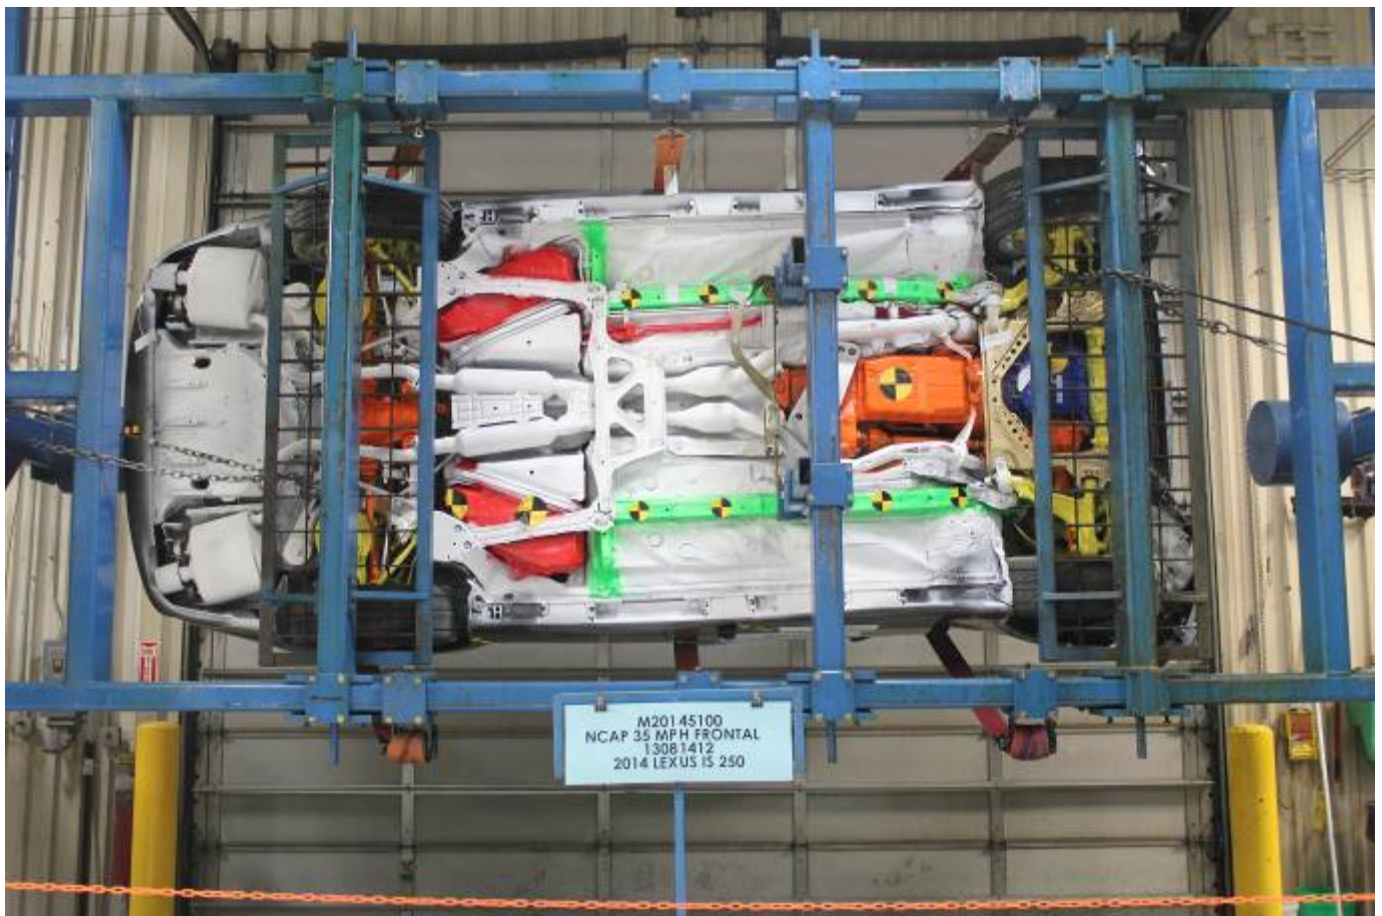
Vehicle at 90° on Static Rollover Device

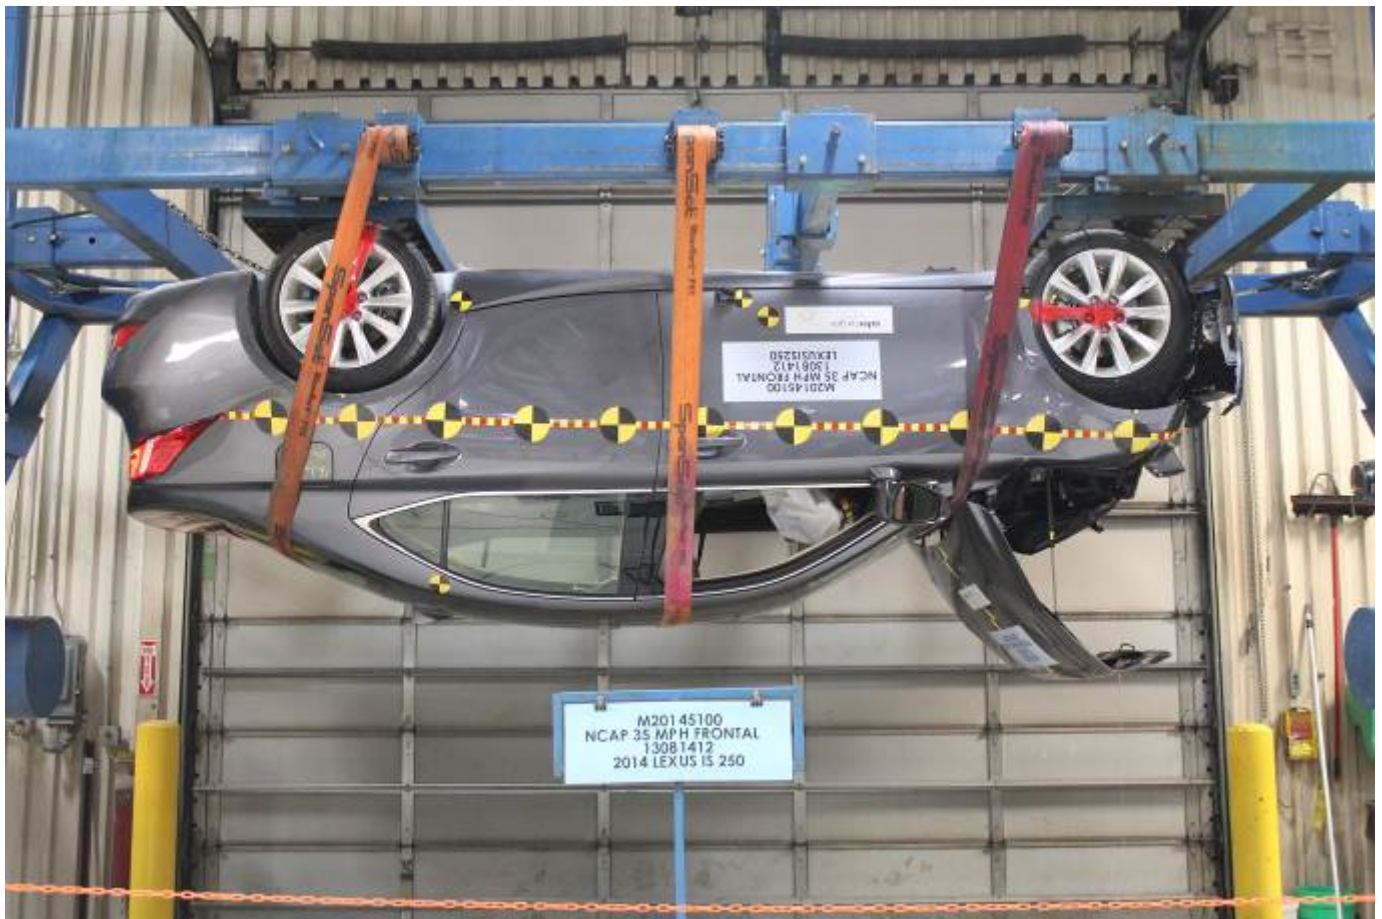
Vehicle at 180° on Static Rollover Device

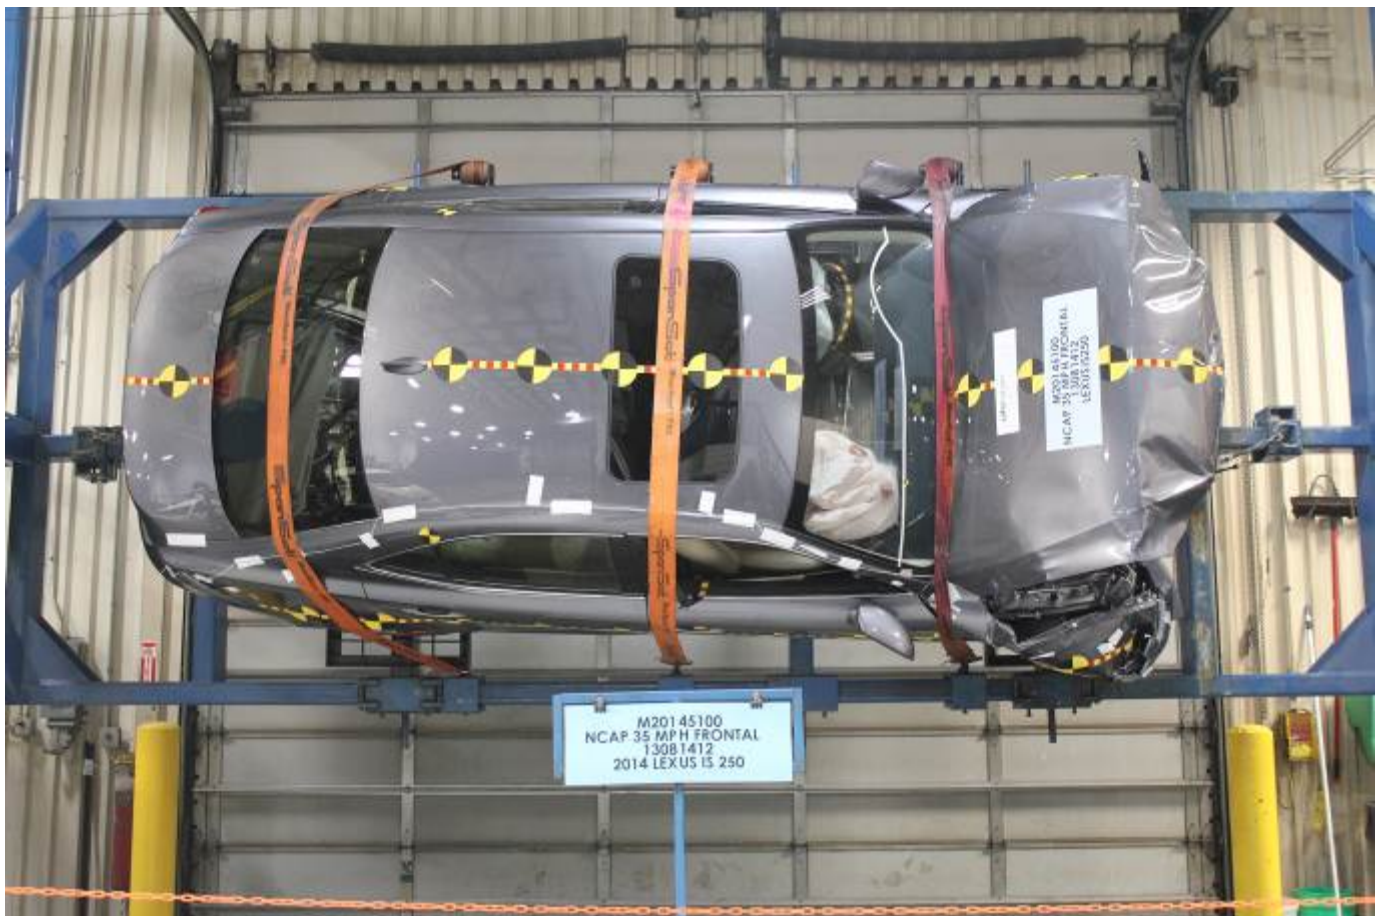
Vehicle at 270° on Static Rollover Device

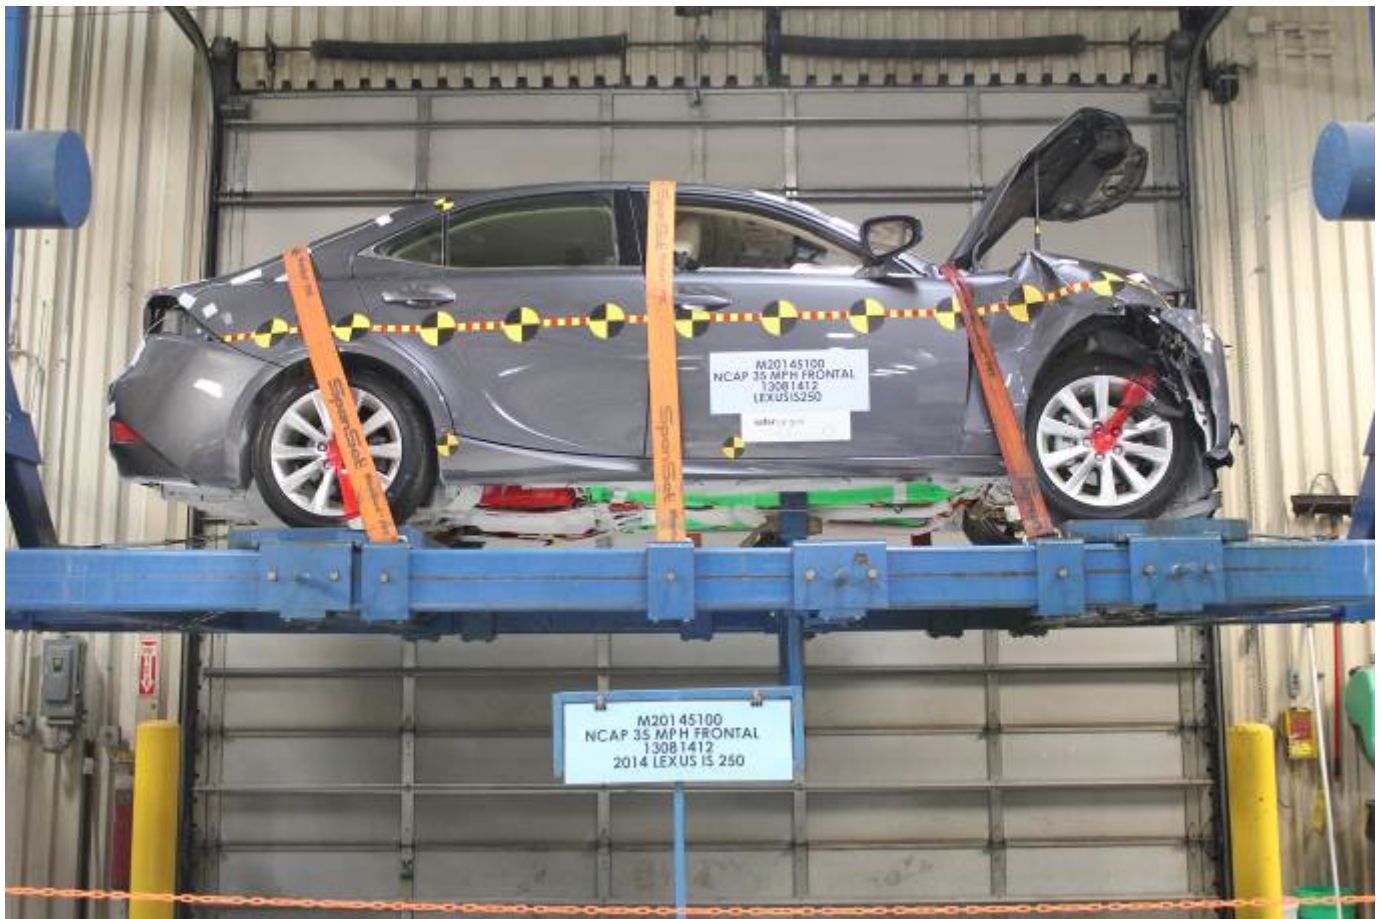
Vehicle at 360° on Static Rollover Device
