**REPORT NUMBER: SINCAP-MGA-2014-011**

**NEW CAR ASSESSMENT PROGRAM (NCAP)  
Moving Deformable Barrier Side Impact Test**

**TOYOTA MOTOR CORPORATION  
2014 Lexus IS250 4-Dr Sedan  
NHTSA No.: M20145102**

**FINAL REPORT**

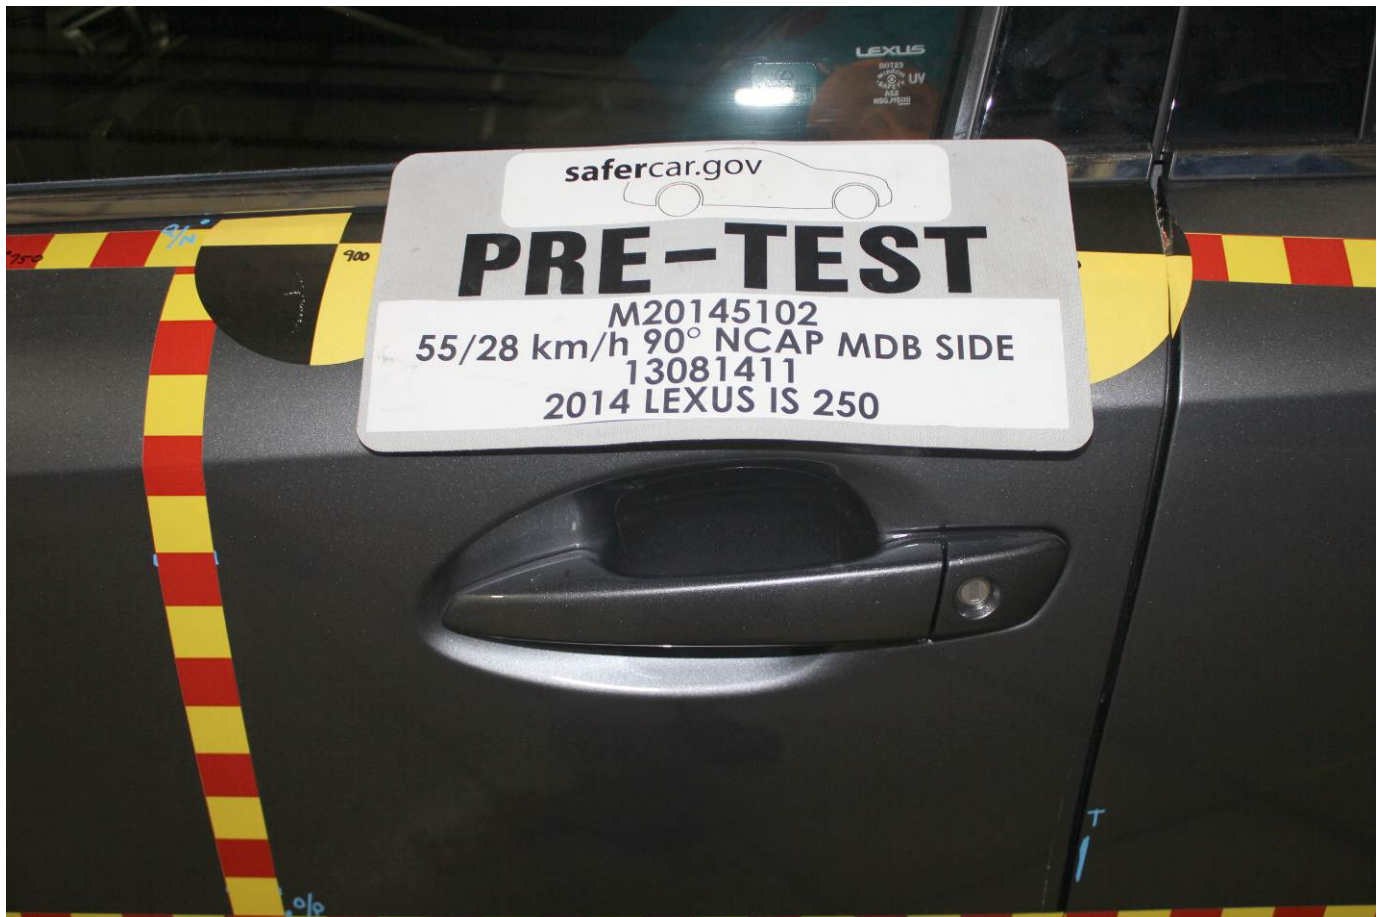
Post-Test Close-Up View of Impact Point Target

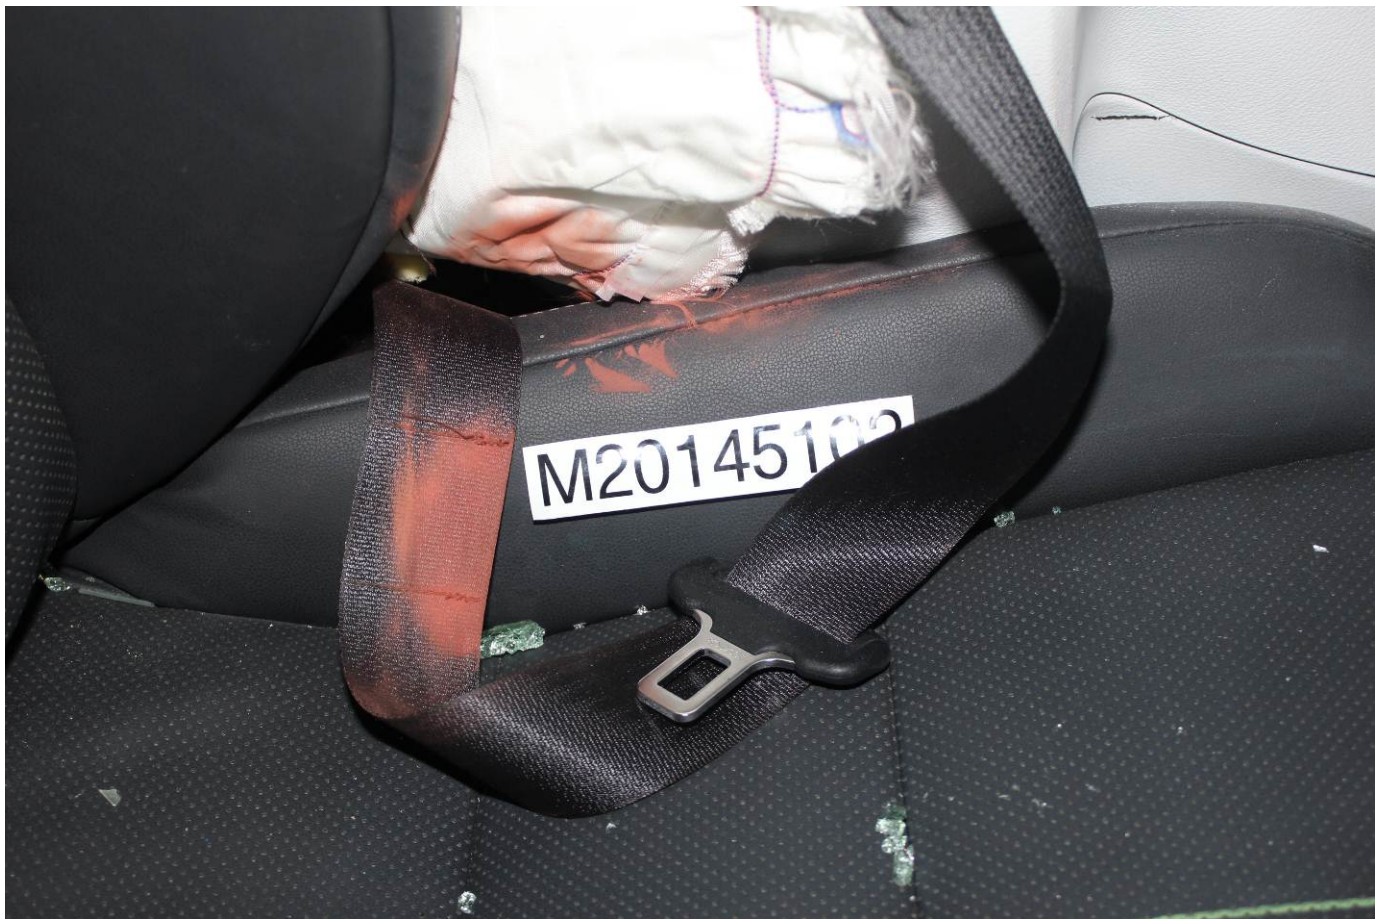
Post-Test Driver Dummy Close-up Torso Contact with Side Airbag View

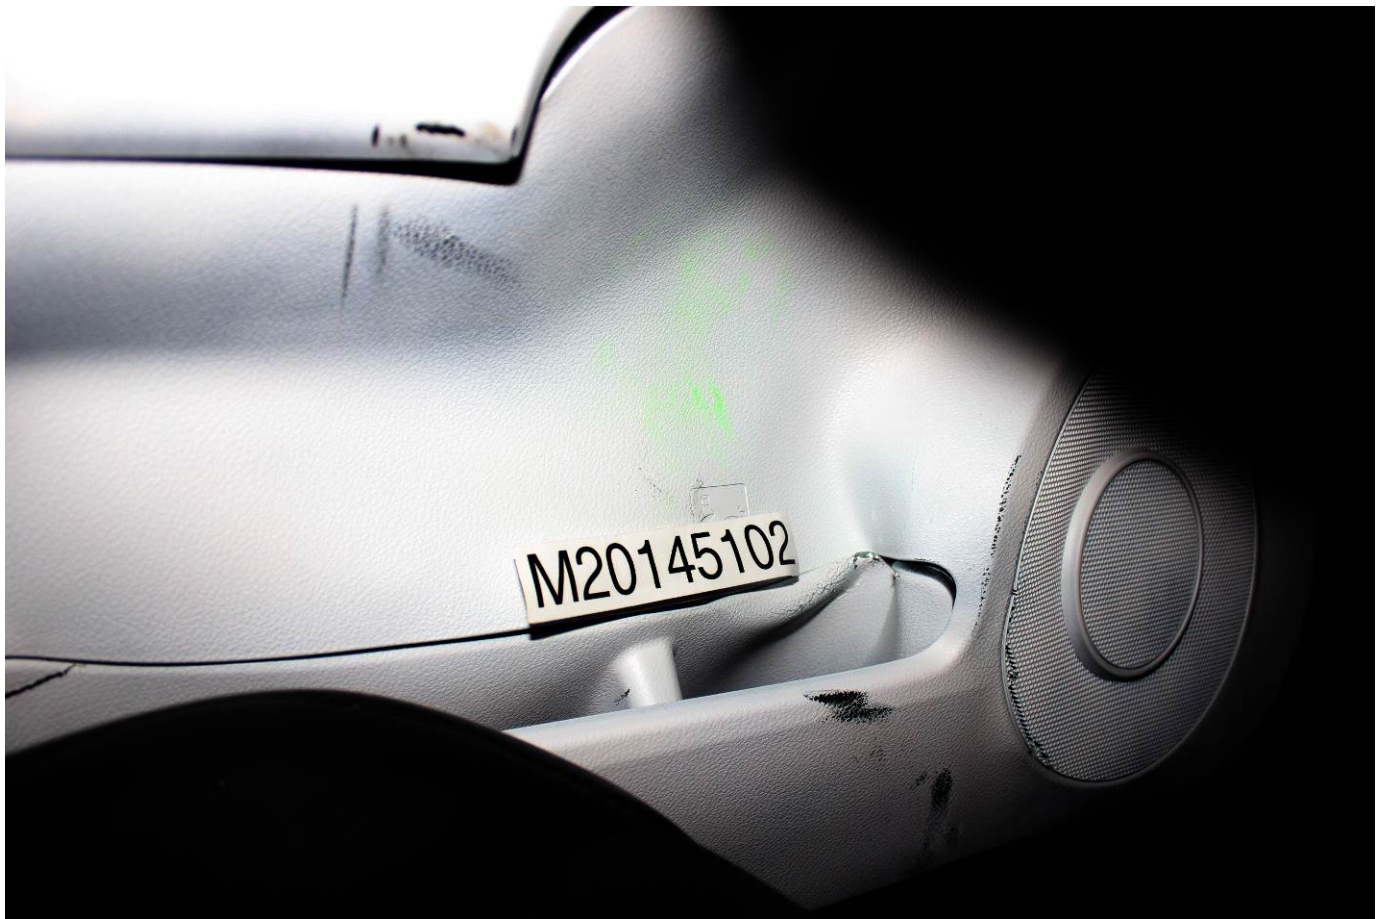
Post-Test Driver Dummy Close-up Pelvis Contact with Side Airbag View

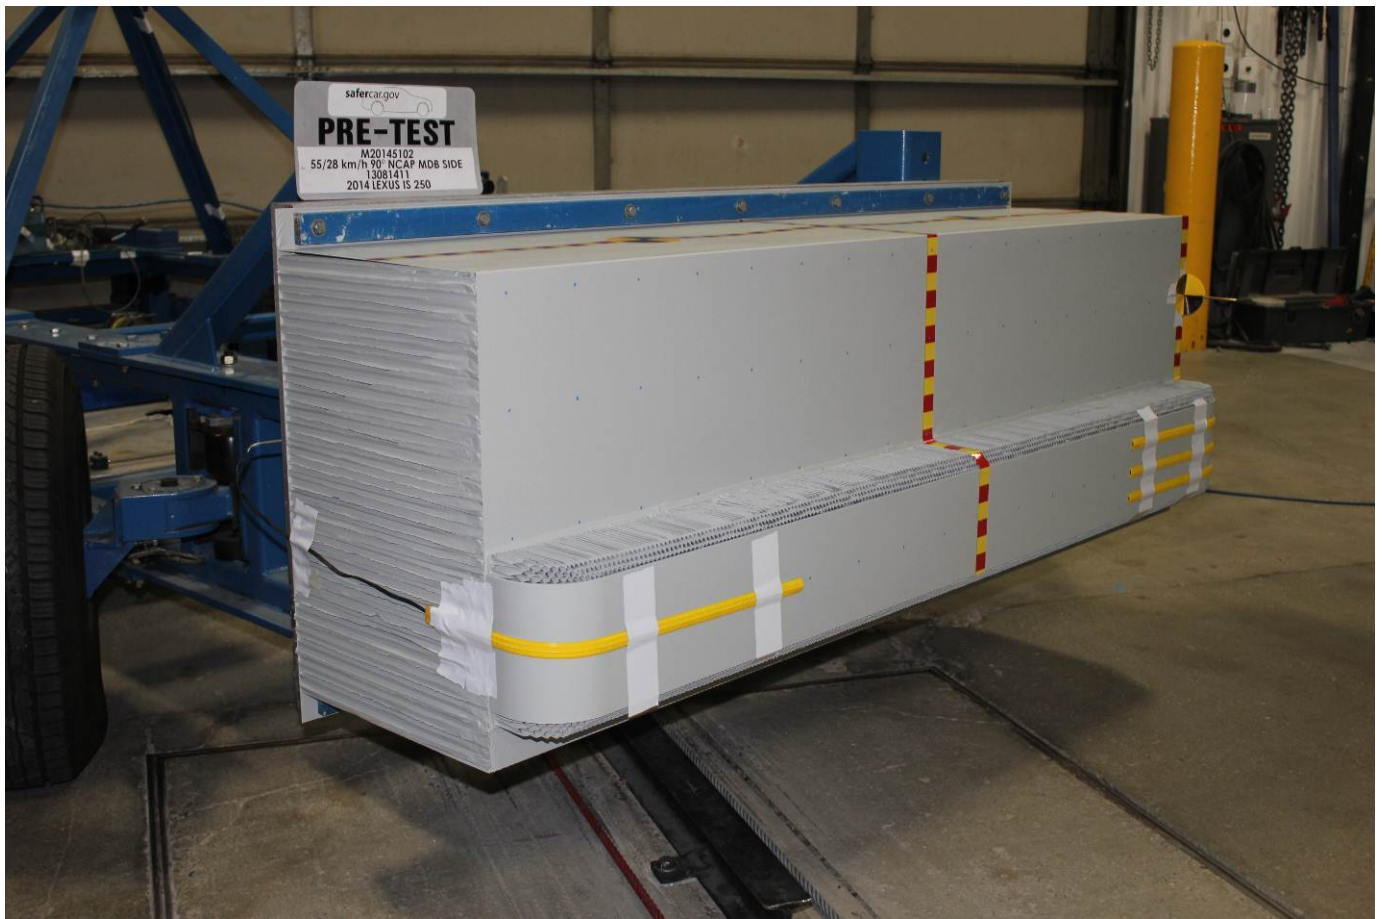
Post-Test Left Side View of MDB Impactor Face
