**REPORT NUMBER: SPNCAP-KAR-13-060**

**NEW CAR ASSESSMENT PROGRAM (NCAP)  
SIDE IMPACT POLE TEST**

**NISSAN MOTOR CO., LTD.  
2014 NISSAN VERSA NOTE S 5-DOOR HATCHBACK**

**FINAL REPORT**

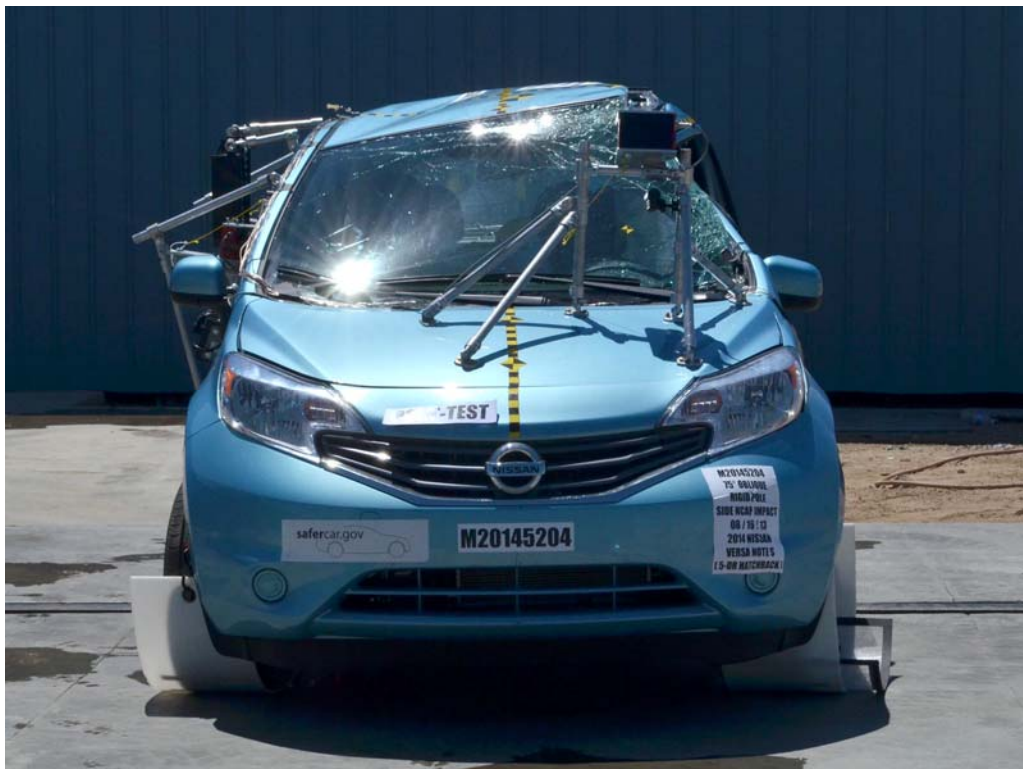
FIGURE 4. Post-Test Frontal View of Test Vehicle

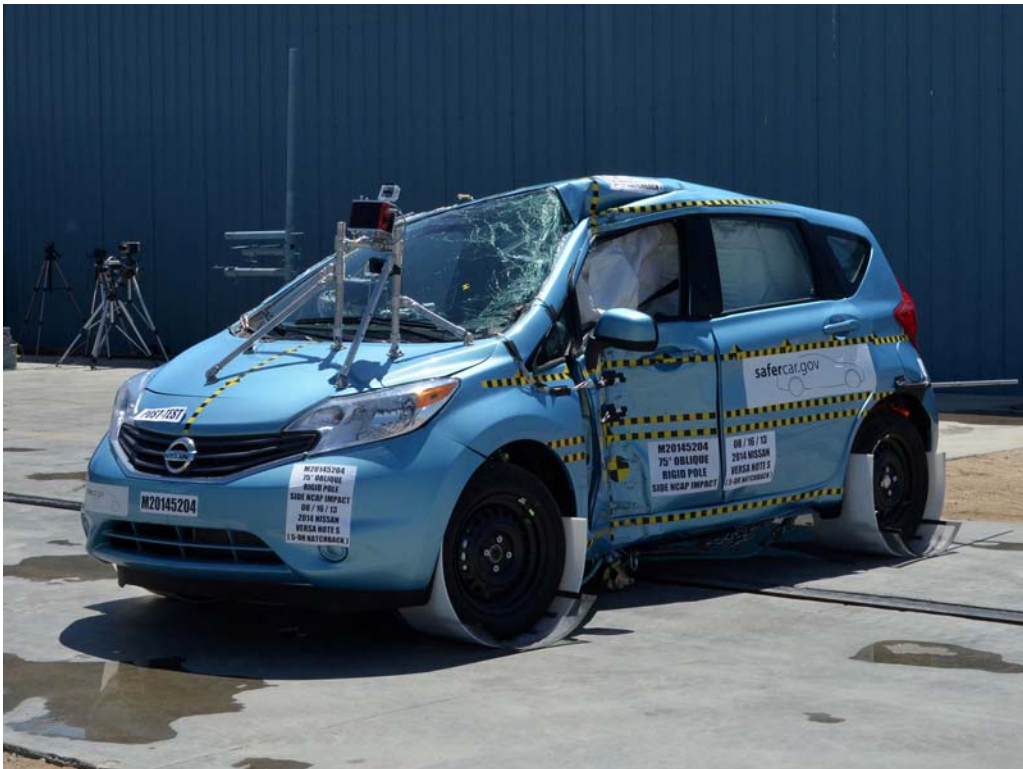
FIGURE 6. Post-Test Left Front  $\frac{3}{4}$  View of Test Vehicle

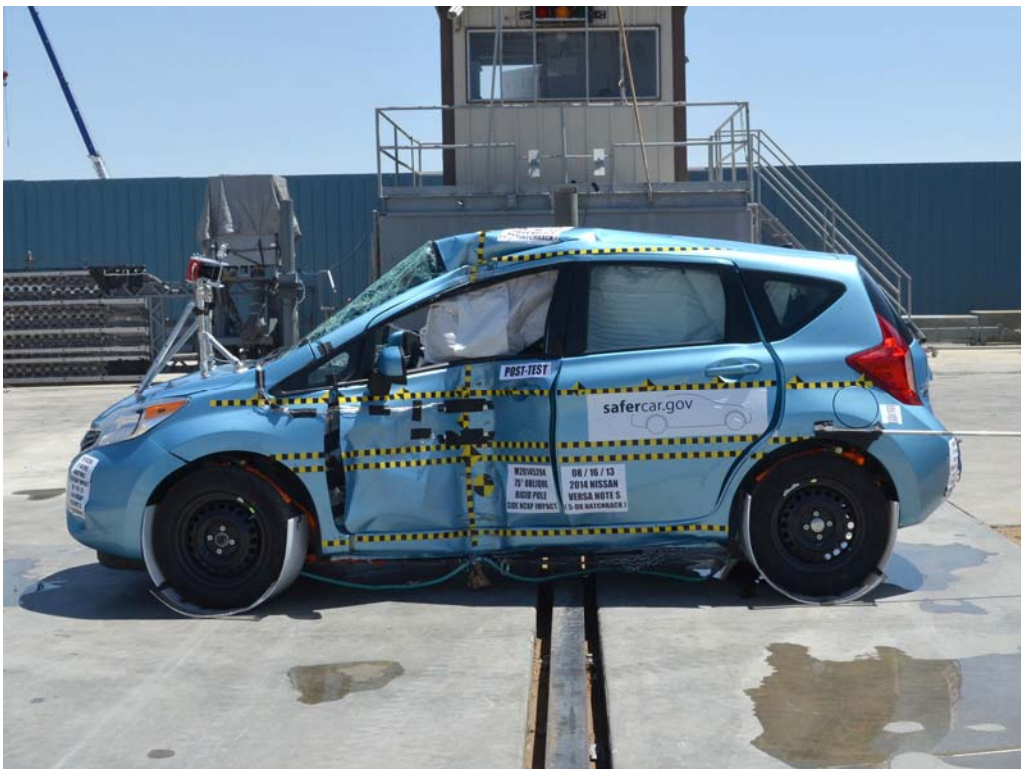
FIGURE 8. Post-Test Left Side View of Test Vehicle

Both the front and rear doors on the struck side of the vehicle remained closed and latched. There was no separation at the hinges or latches. Both doors on the non-struck side remained closed and latched. There were no ATD values that exceeded limits.

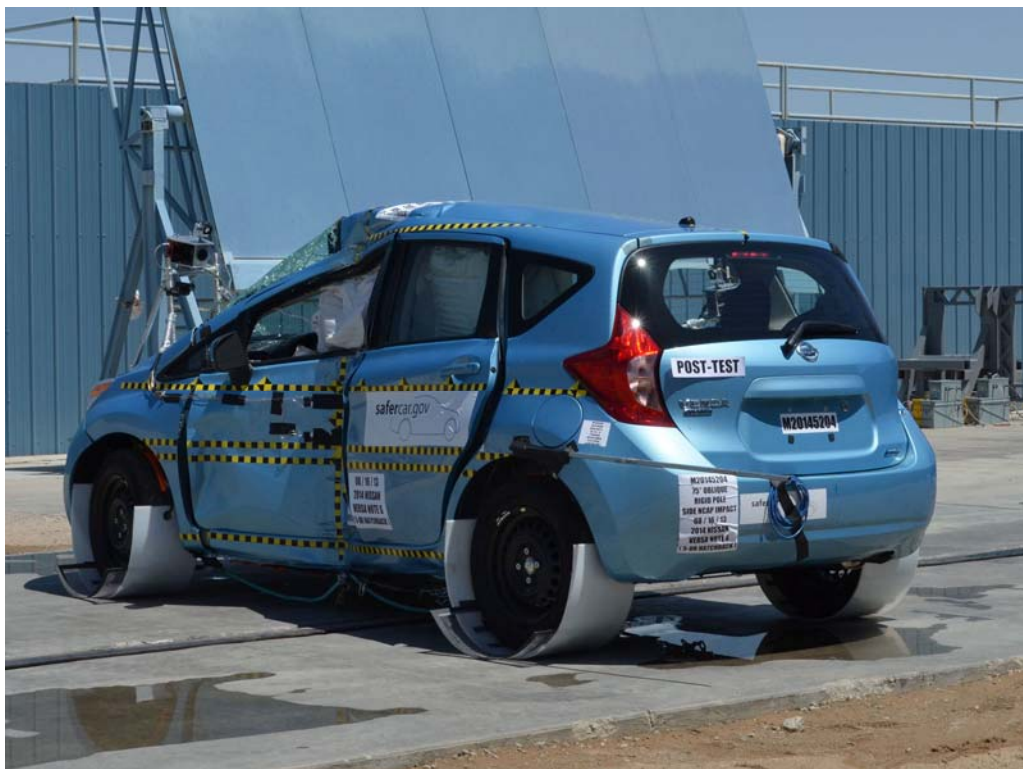
FIGURE 10. Post-Test Left Rear  $\frac{3}{4}$  View of Test Vehicle

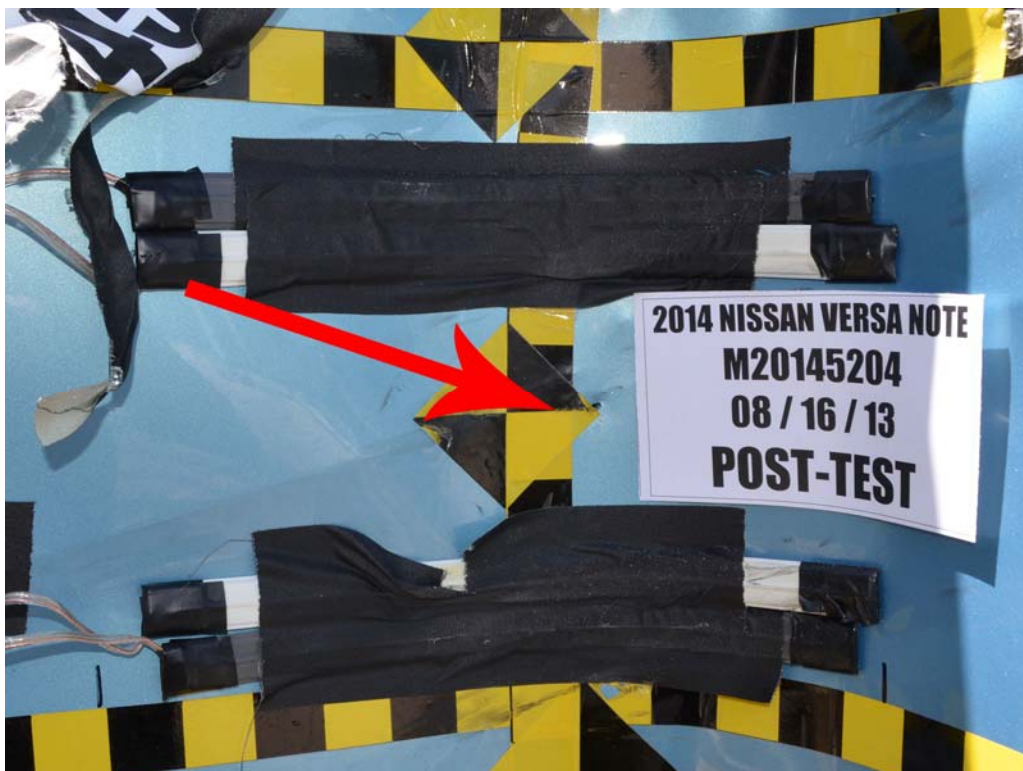
FIGURE 20. Post-Test Close-Up View of Impact Point Target  
Showing Impact Location

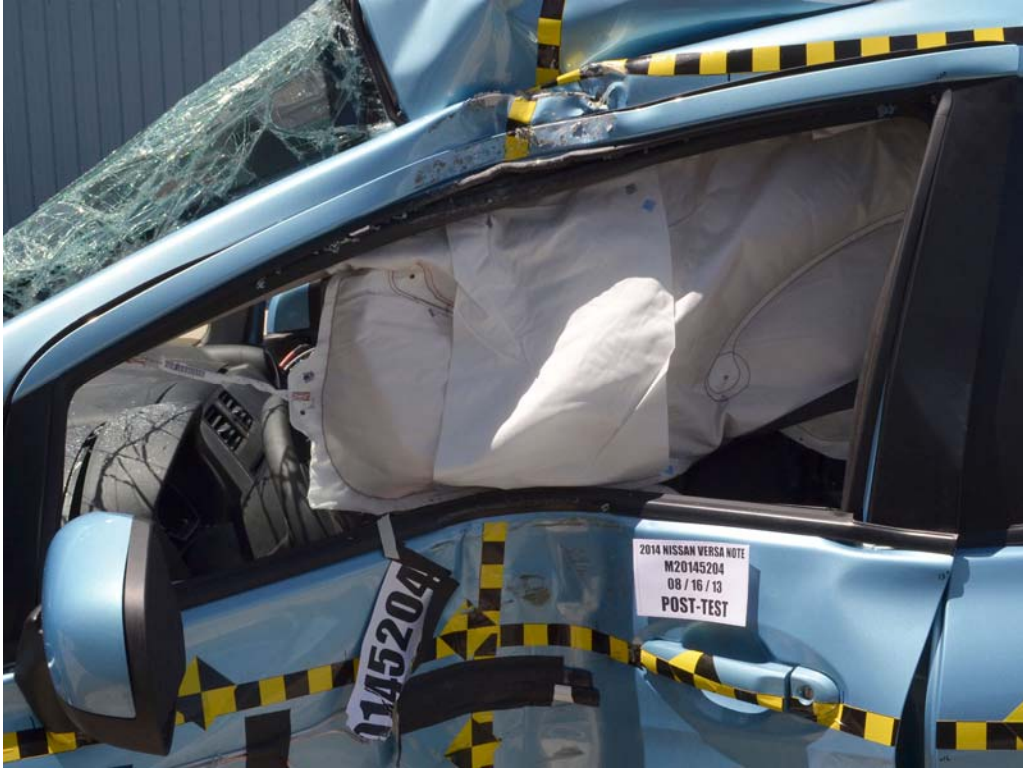
FIGURE 25. Post-Test Left Side View of Dummy Shoulder and Door Top View

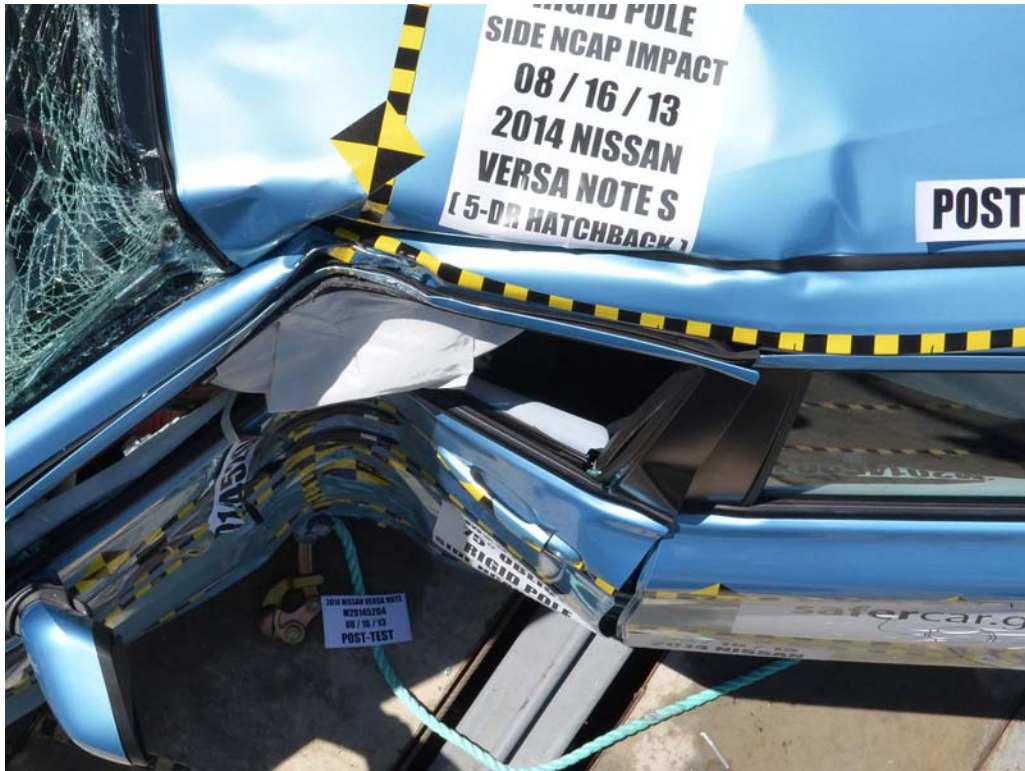
FIGURE 41. Post-Test Dummy and Door Clearance View

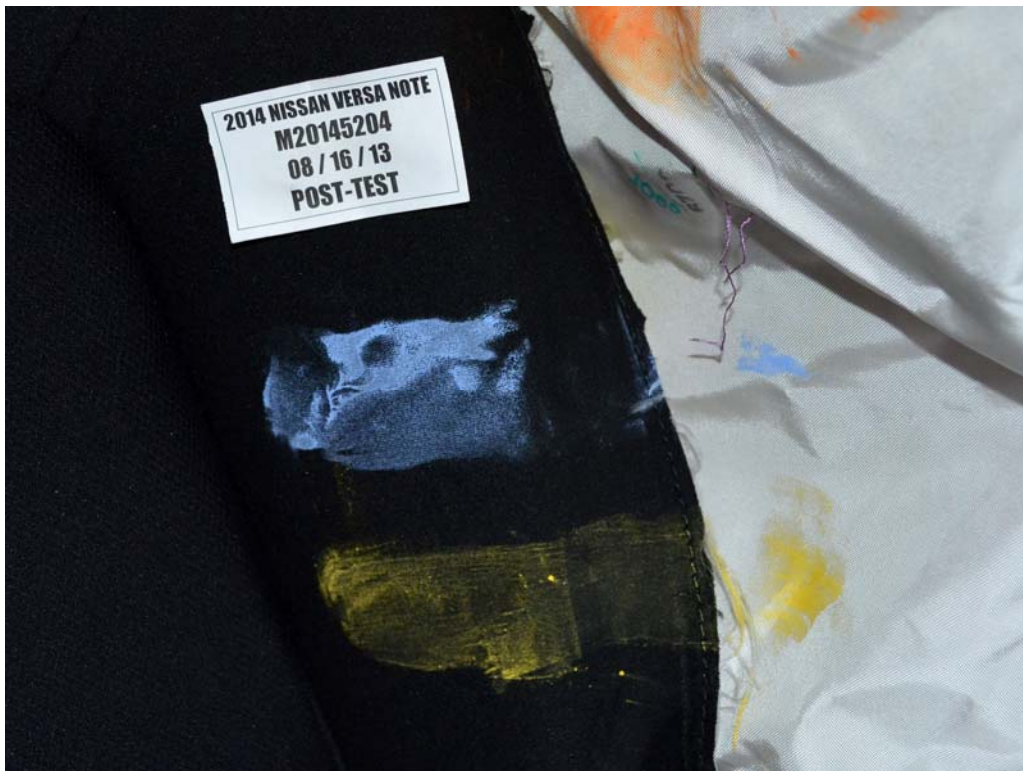
FIGURE 48. Post-Test Dummy Close-Up Torso Contact With Vehicle Interior View

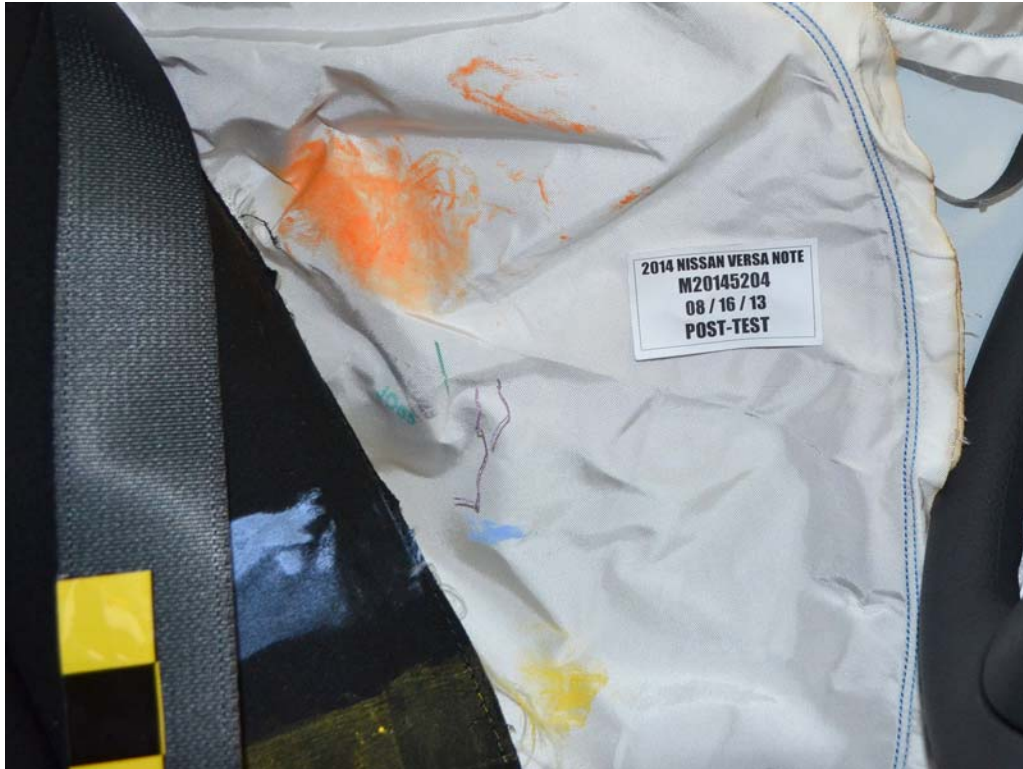
FIGURE 49. Post-Test Dummy Close-Up Torso Contact With Side Airbag View

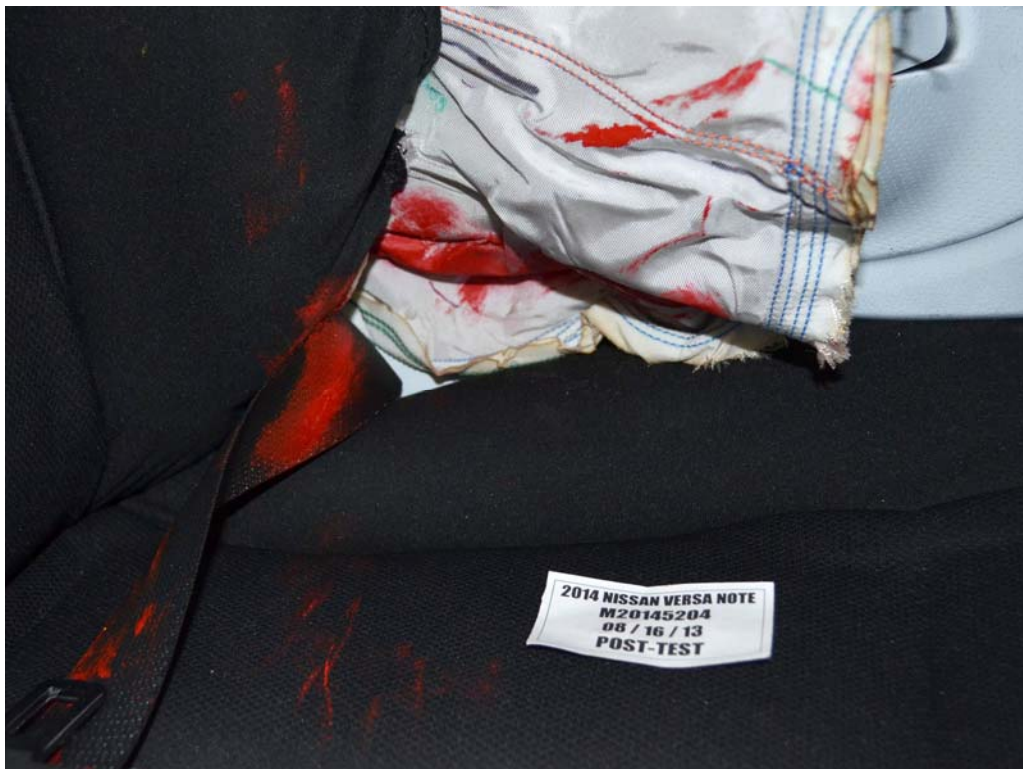
FIGURE 50. Post-Test Dummy Close-Up Pelvis Contact With Vehicle Interior View

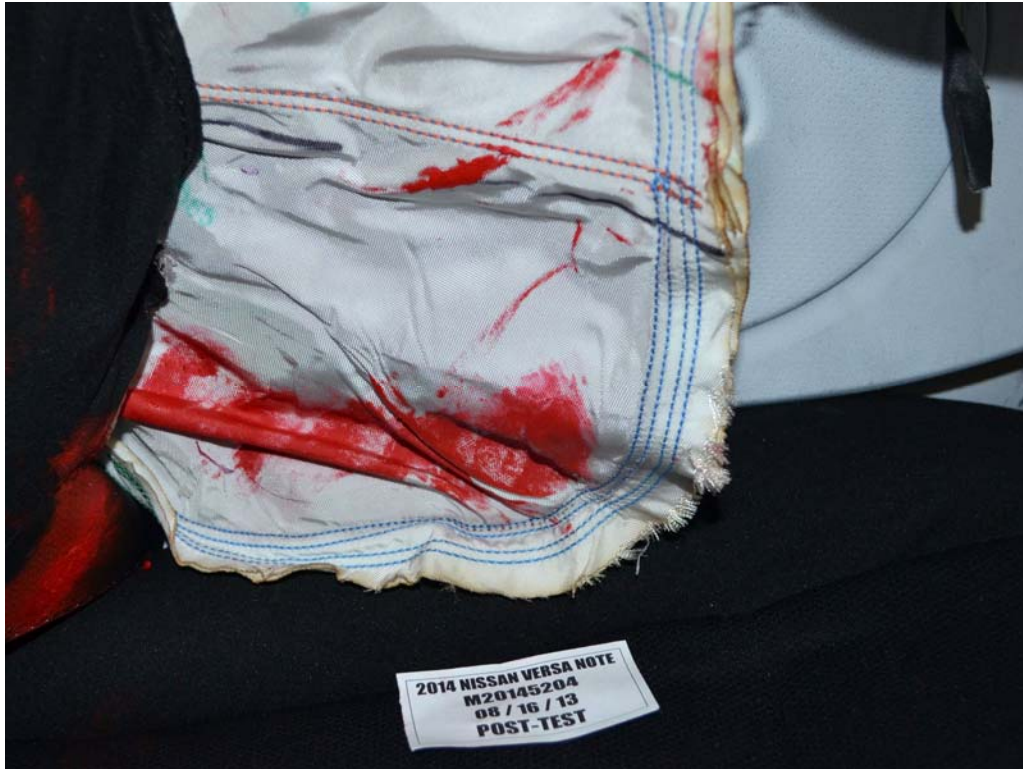
FIGURE 51. Post-Test Dummy Close-Up Pelvis Contact With Side Airbag View

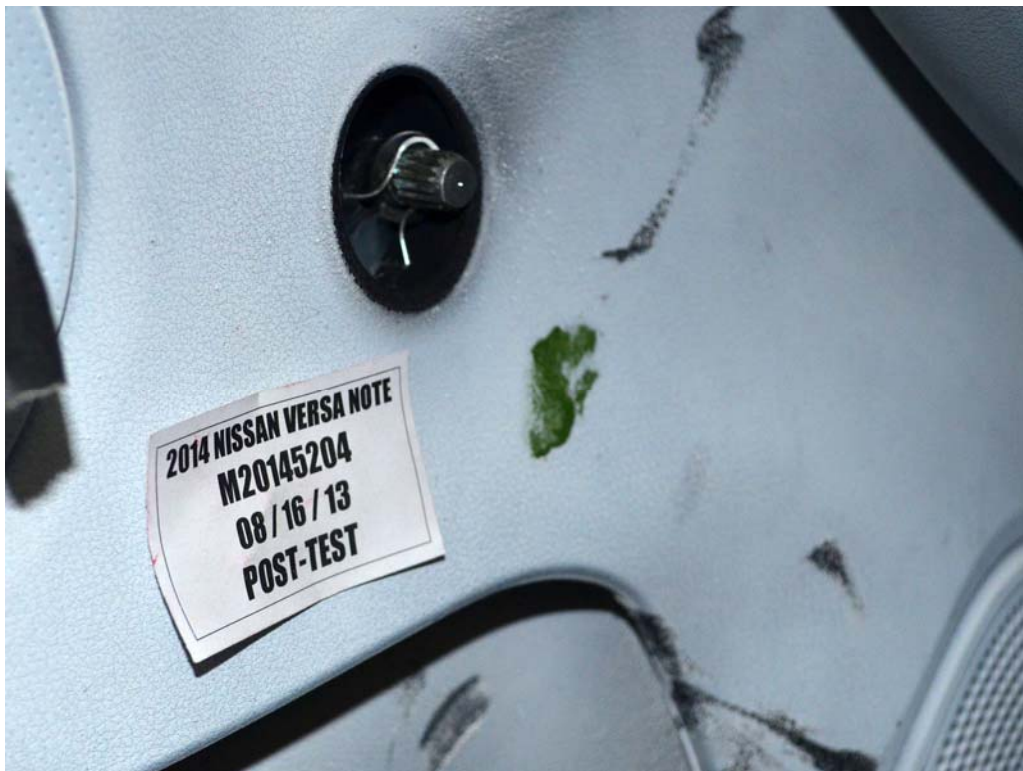
FIGURE 52. Post-Test Dummy Close-Up Knee Contact with Vehicle Interior View

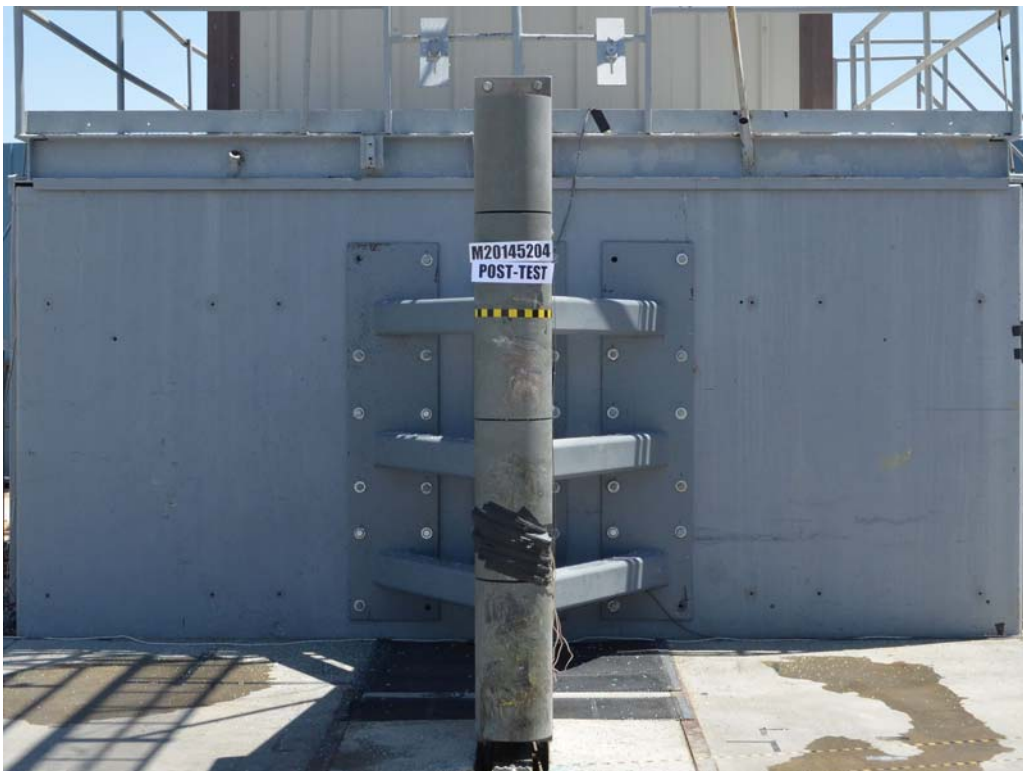
FIGURE 58. Post-Test Pole Barrier Front View

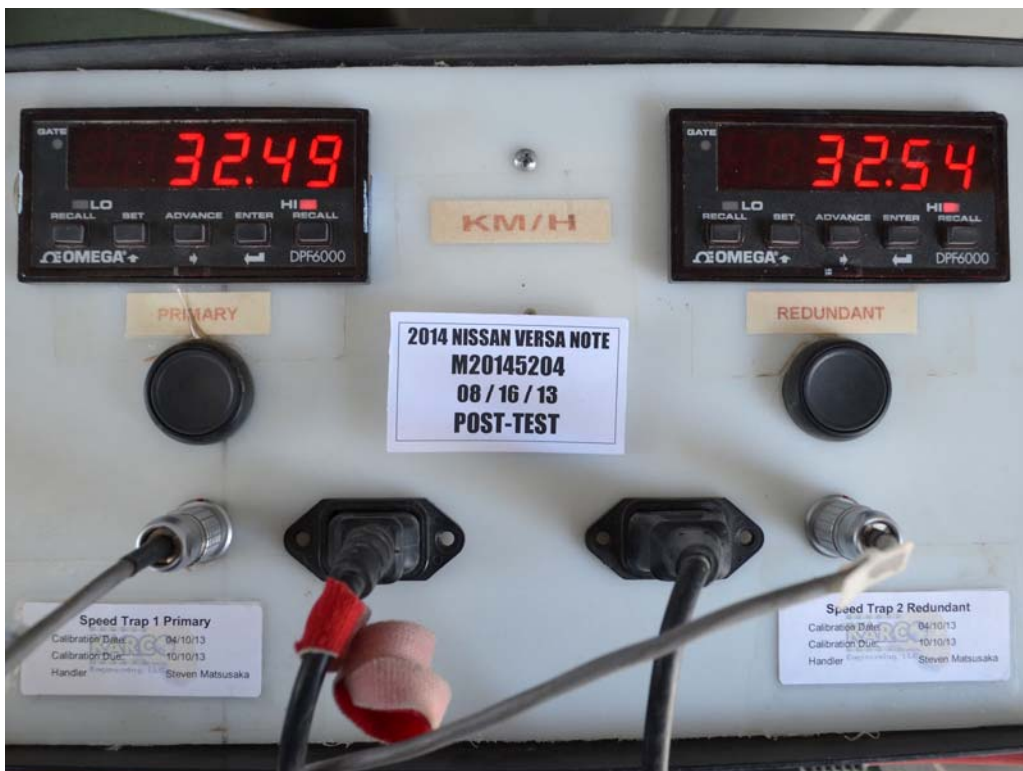
FIGURE 62. Post-Test Primary and Redundant Speed Trap Read-Out

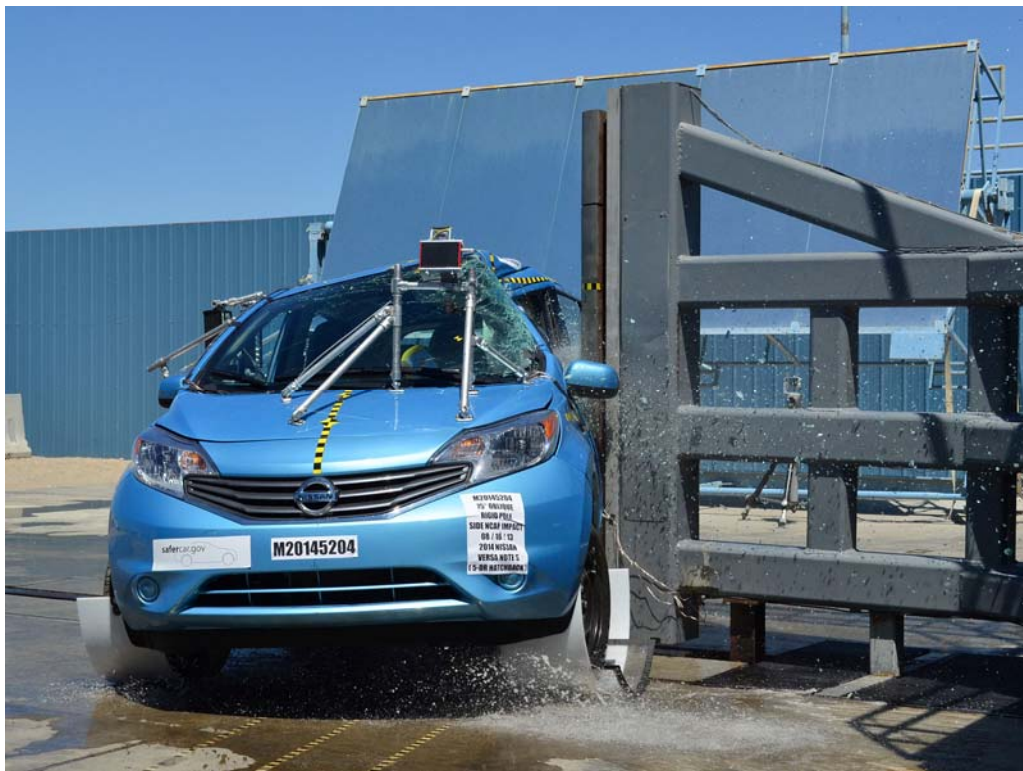
FIGURE 68. Impact Event
