**REPORT NUMBER: SINCAP-MGA-2014-014**

**NEW CAR ASSESSMENT PROGRAM (NCAP)  
Moving Deformable Barrier Side Impact Test**

**HONDA OF AMERICA MFG., INC.  
2014 Acura RDX SUV  
NHTSA No.: O20145305**

**MGA RESEARCH CORPORATION  
5000 Warren Road  
Burlington, WI 53105**

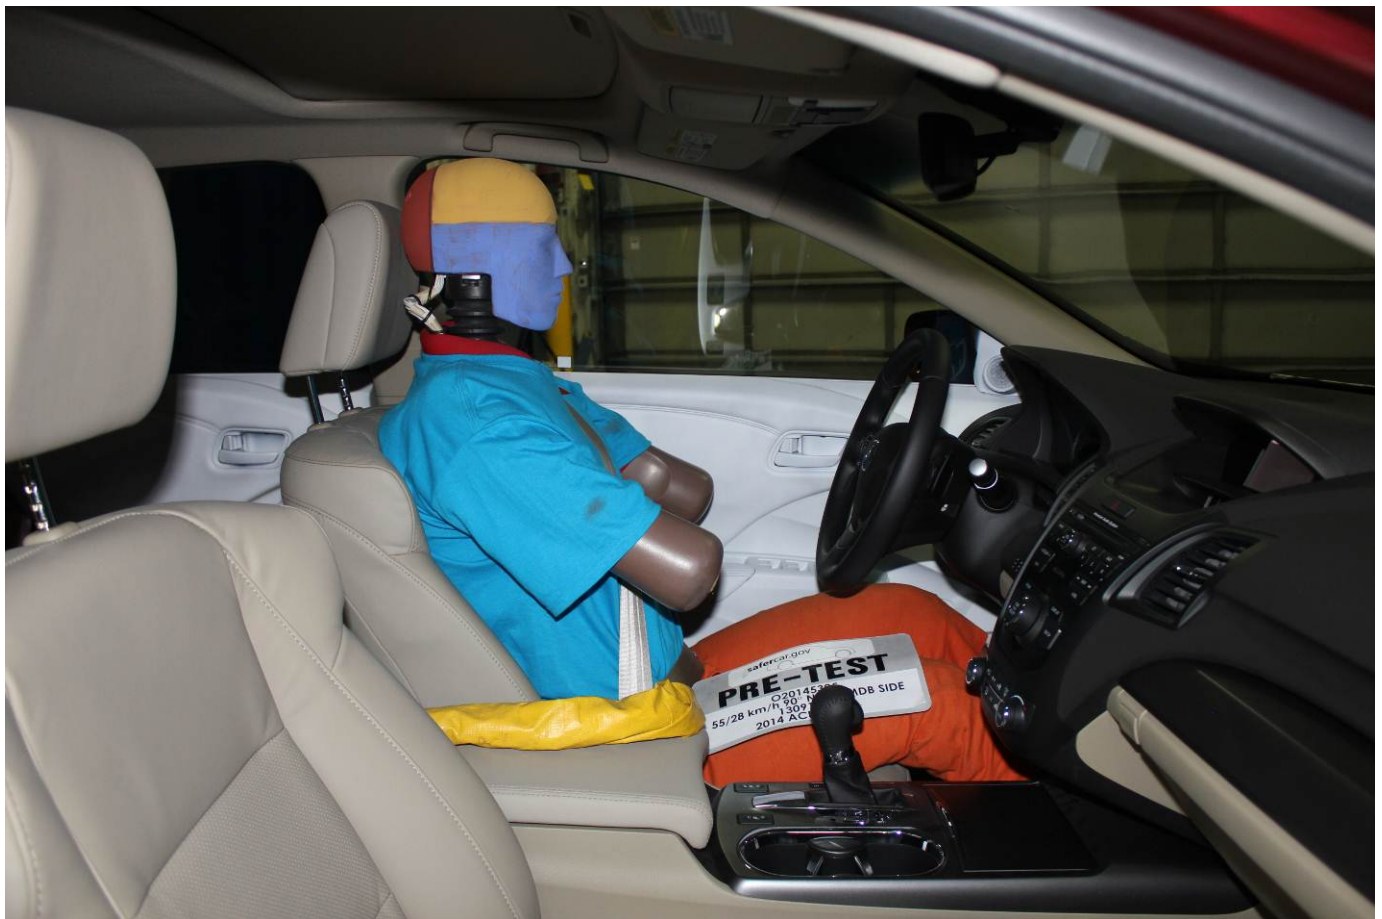
Post-Test Driver Dummy and Door Clearance View

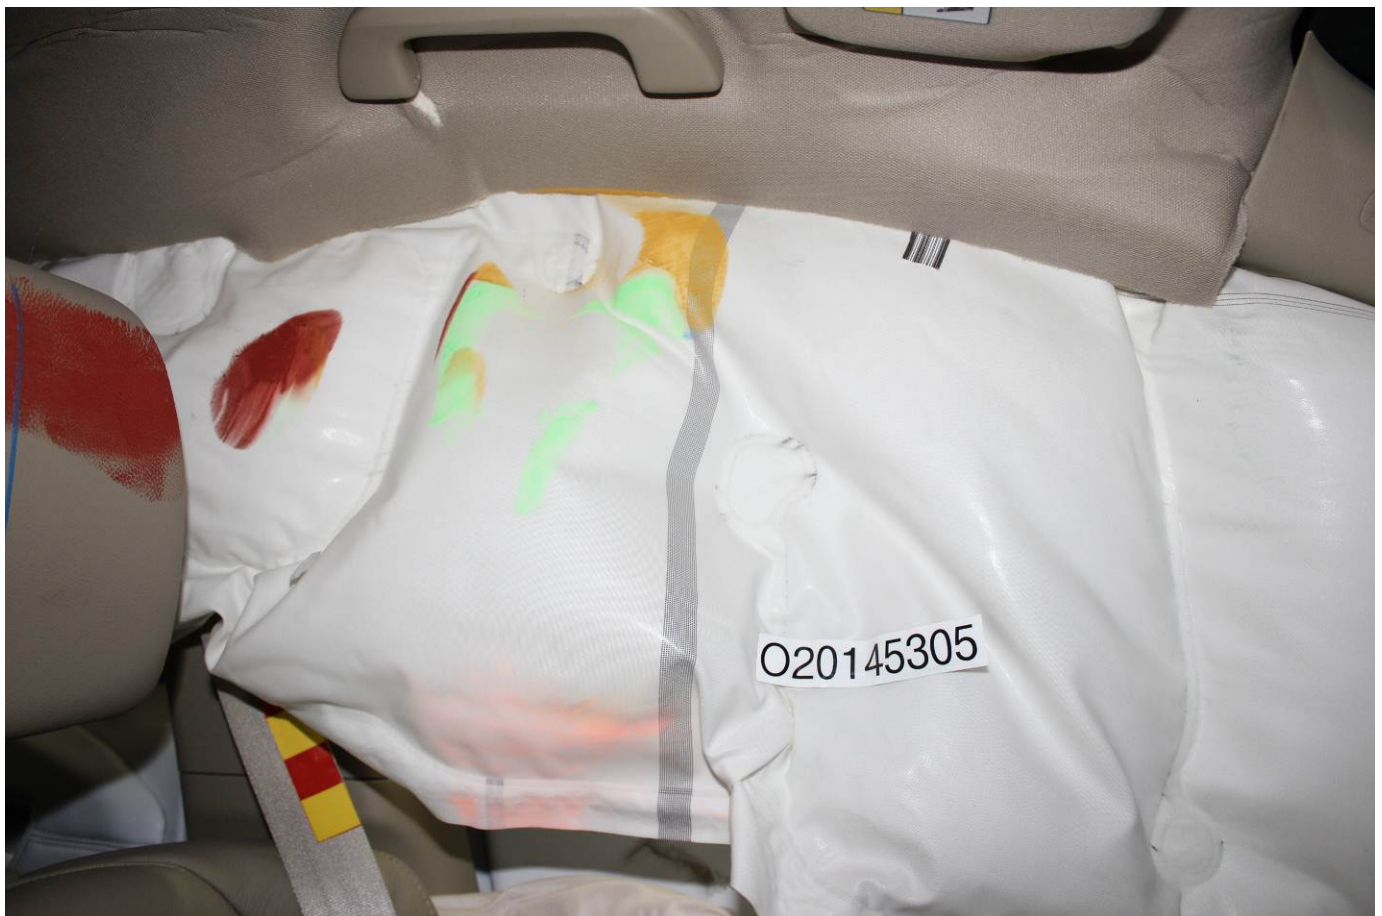
Post-Test Driver Dummy Close-up Head Contact with Vehicle Interior View

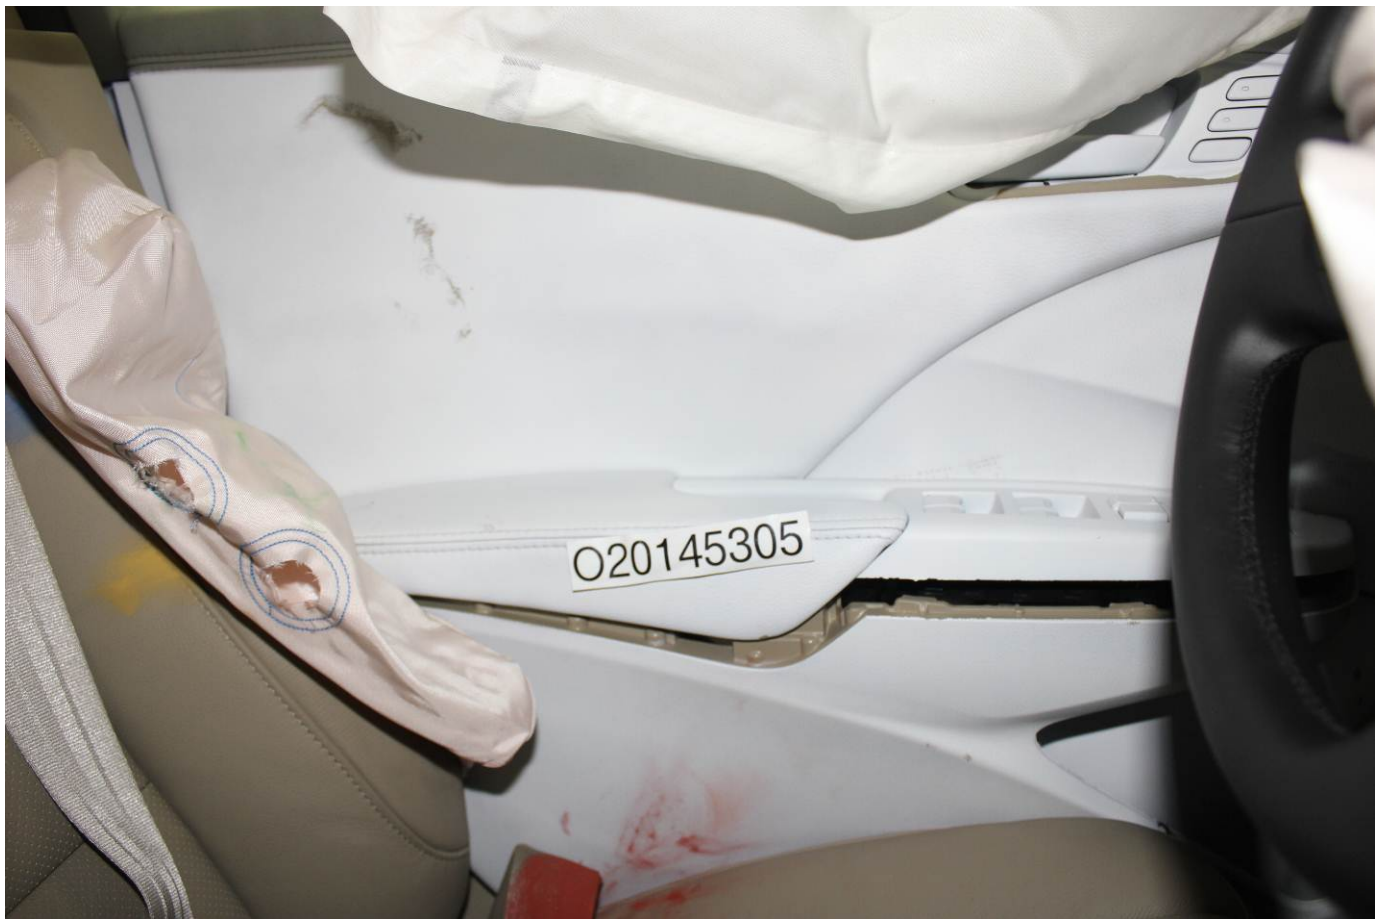
Post-Test Driver Dummy Close-up Head Contact with Side Airbag View

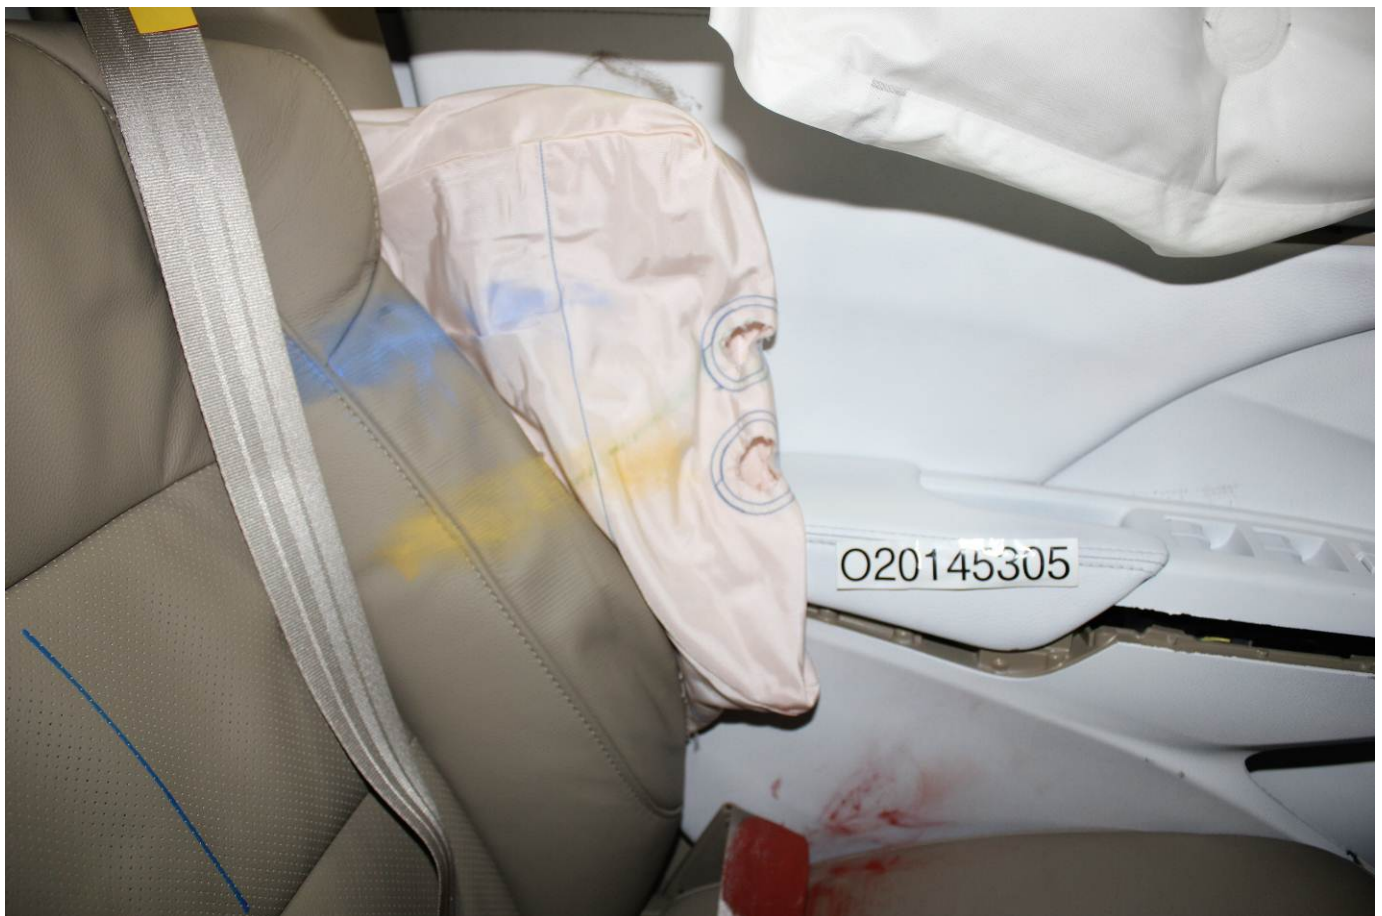
Post-Test Driver Dummy Close-up Torso Contact with Vehicle Interior View

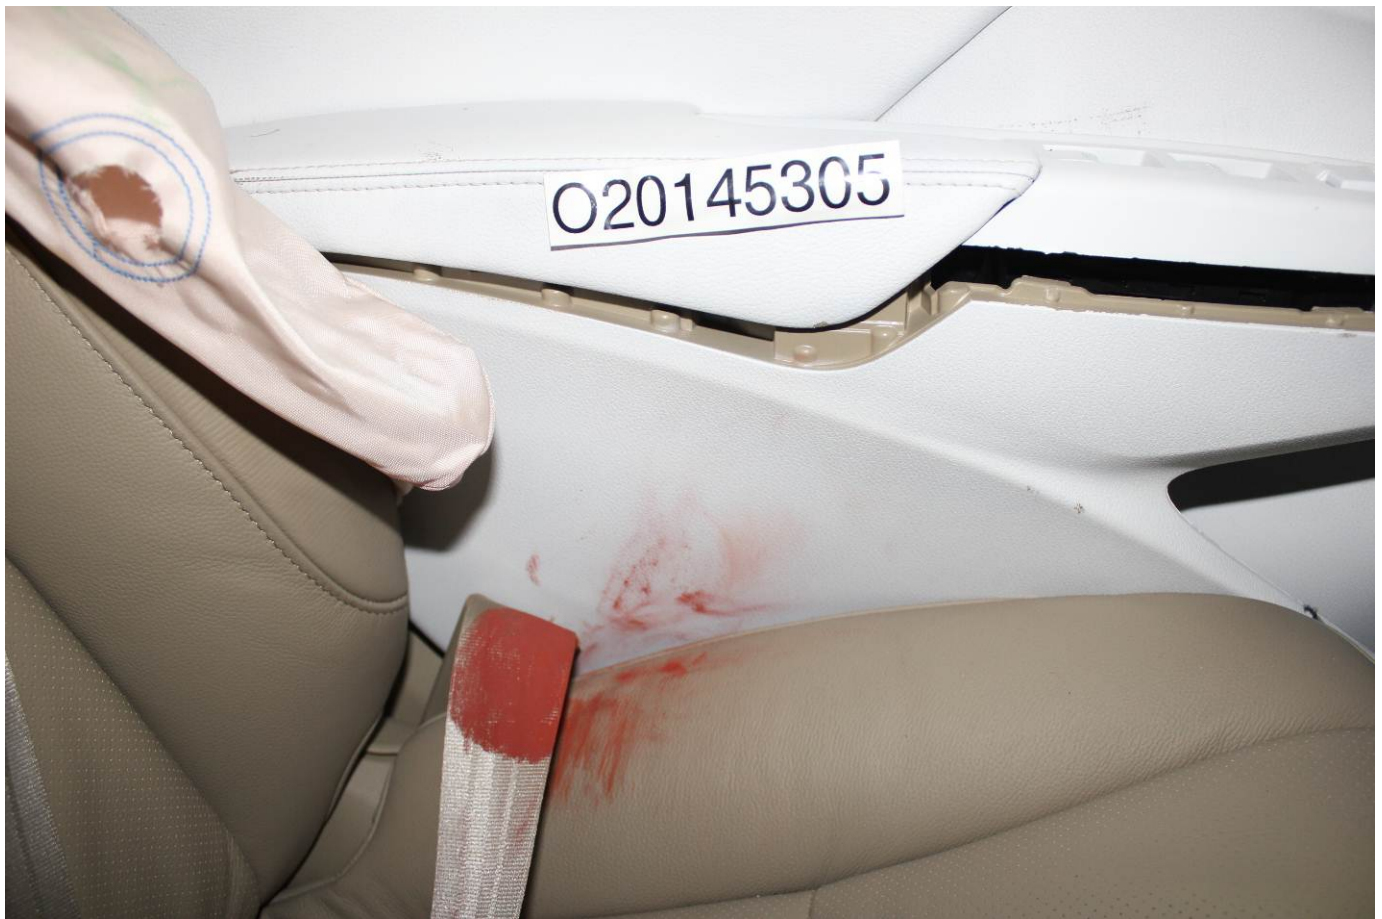
Post-Test Driver Dummy Close-up Torso Contact with Side Airbag View

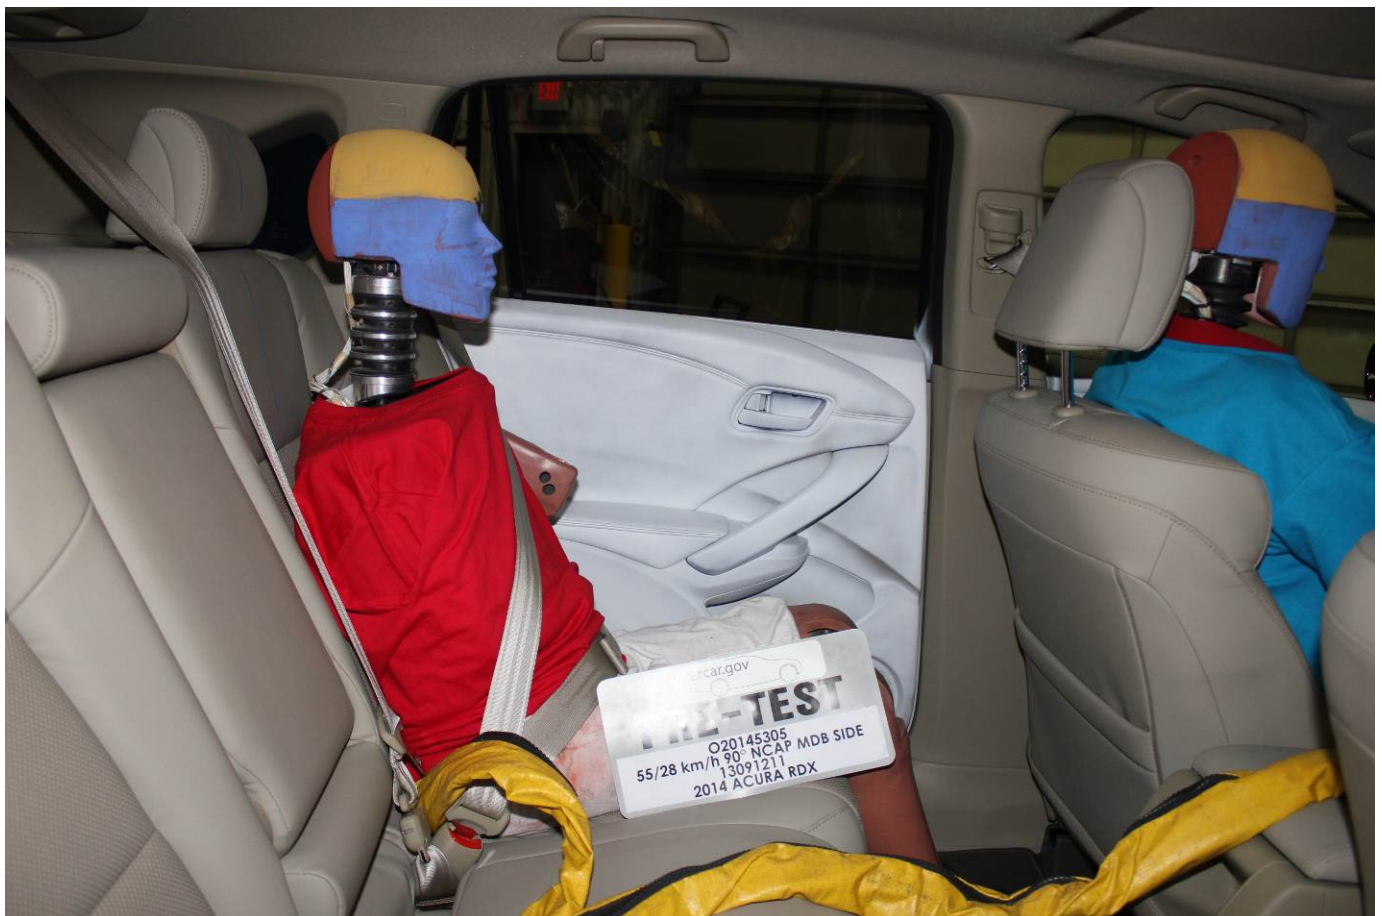
Post-Test Rear Passenger Dummy and Door Clearance View

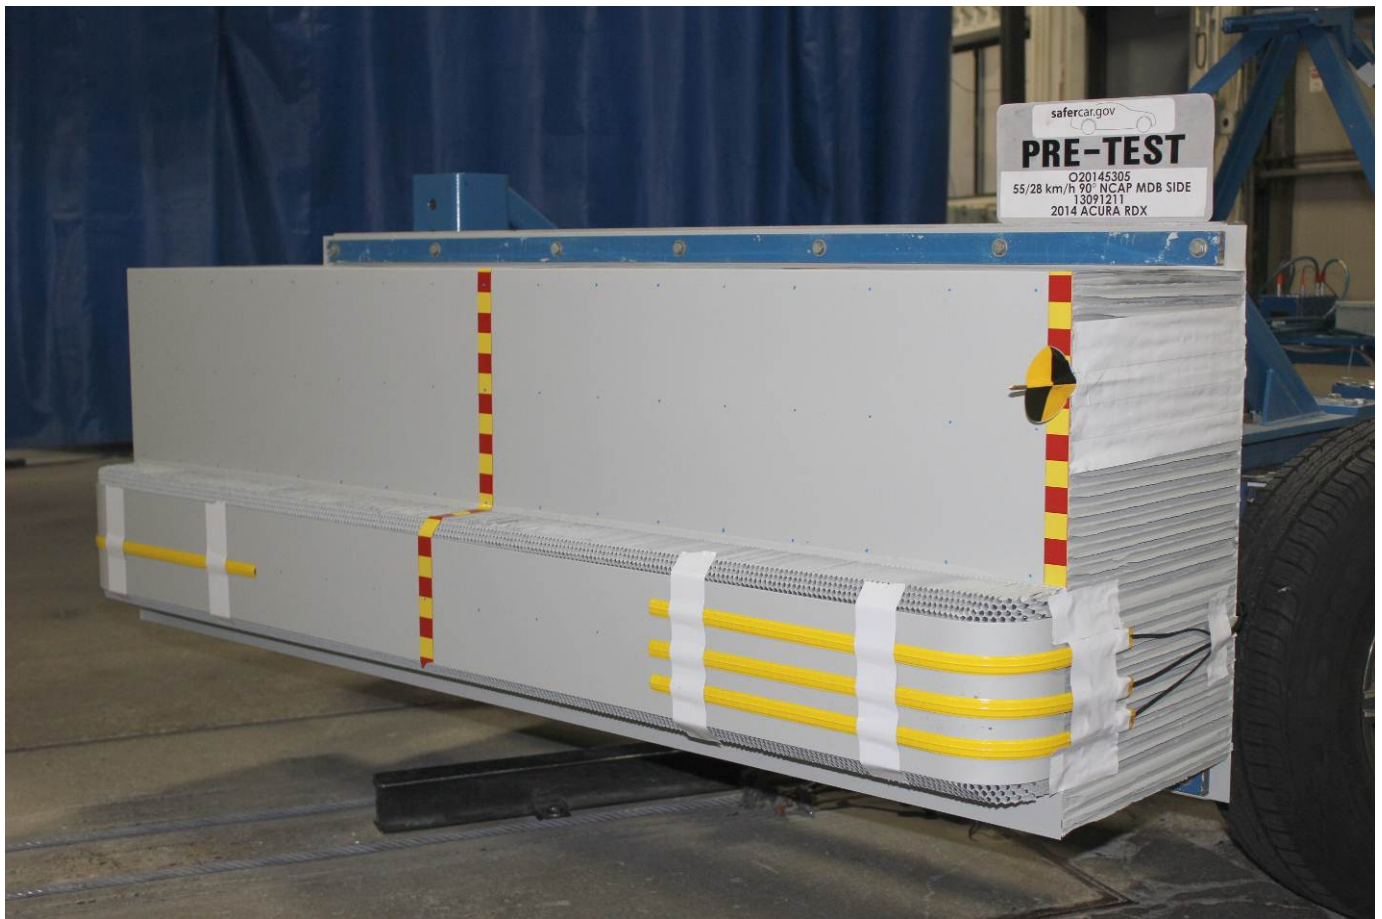
Post-Test Top View of MDB Impactor Face

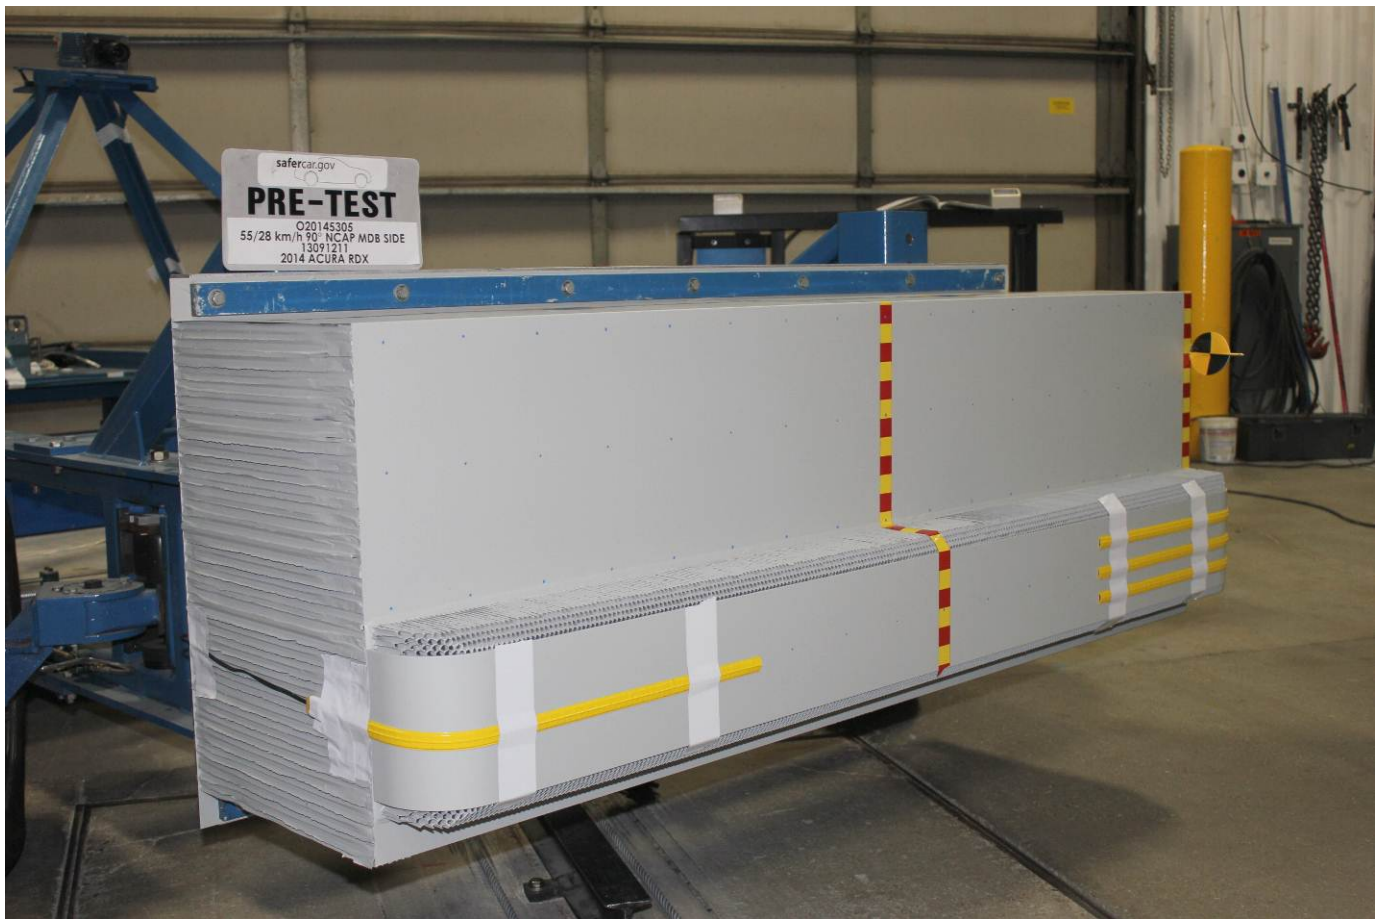
Post-Test Left Side View of MDB Impactor Face
