**REPORT NUMBER: NCAP-MGA-2014-016**

**NEW CAR ASSESSMENT PROGRAM (NCAP)  
Frontal Barrier Impact Test**

**HONDA OF AMERICA MFG., INC.  
2014 Acura RDX AWD SUV  
NHTSA No.: O20145303**

**FINAL REPORT**

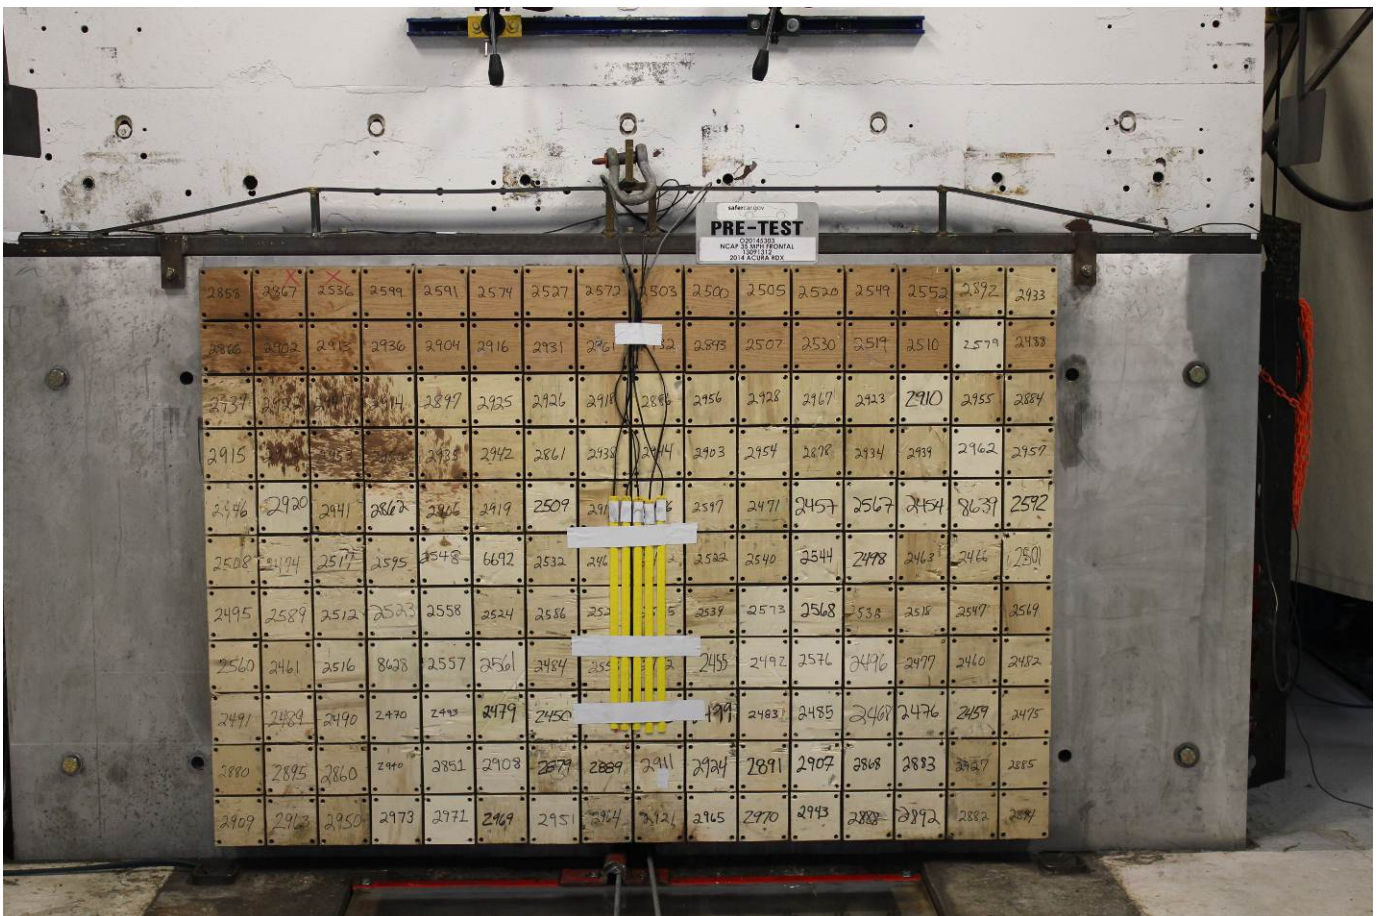
Load Cell Wall

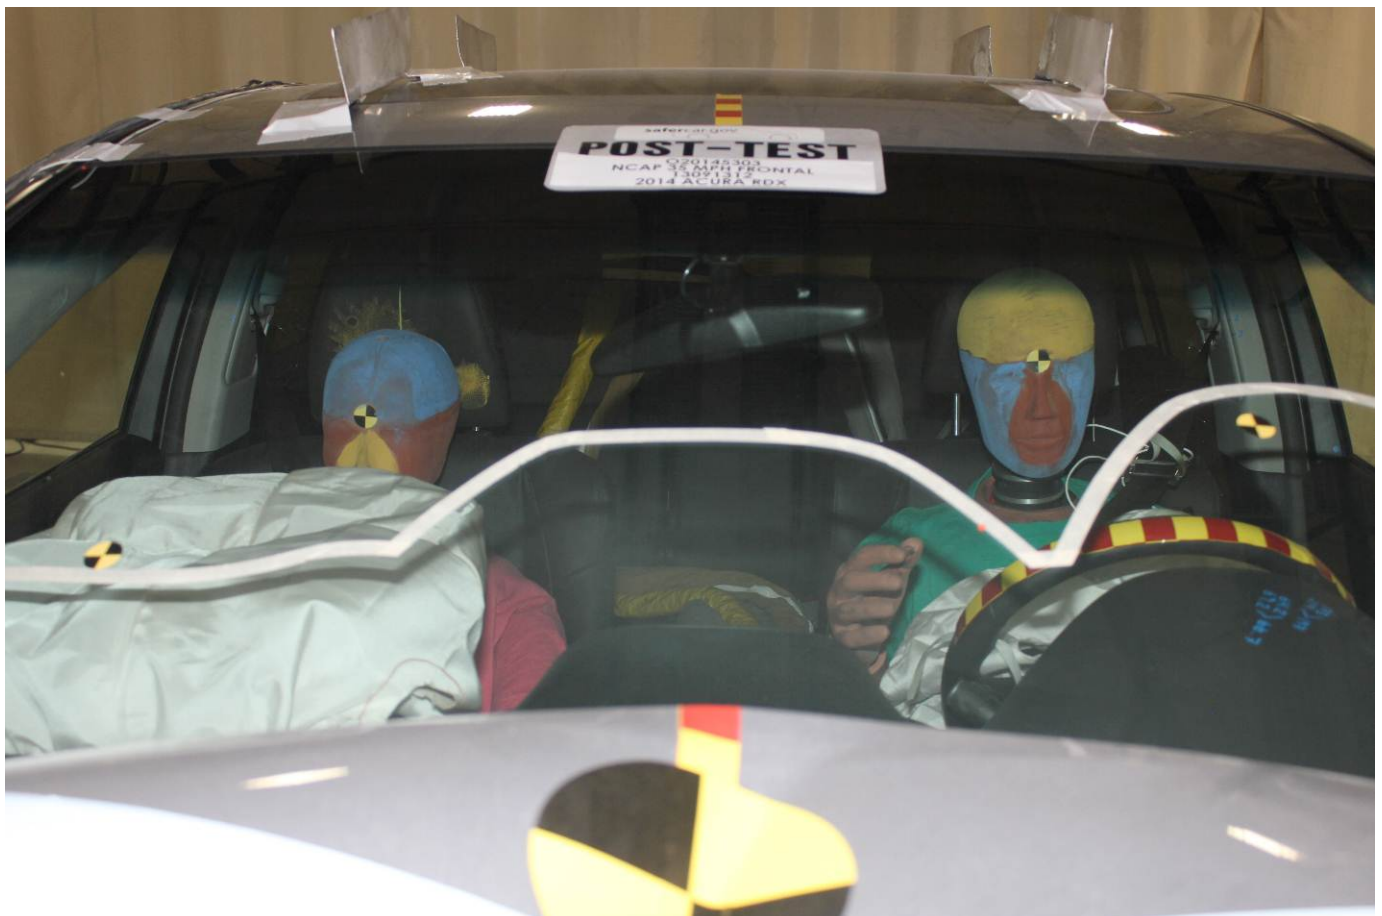
Post-Test Windshield View

There was 100 percent windshield retention and no intrusion into the protected zone of the windshield during the event. There was no Stoddard Solvent leakage after the event or during any phase of the static rollover.

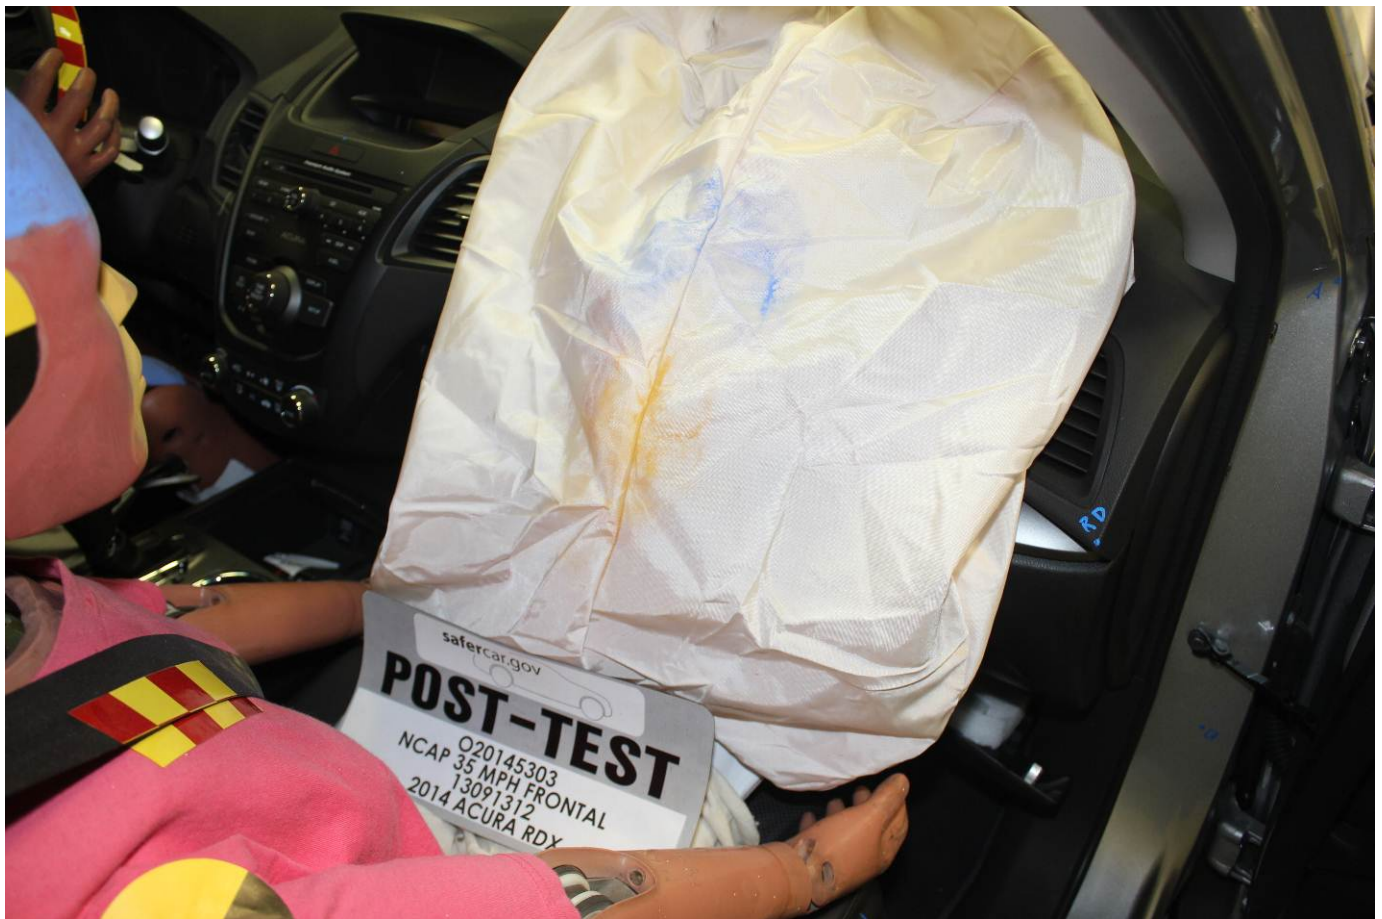
Post-Test Passenger Dummy Contact with Airbag

The driver's visible contact points were as follows: The driver's head and chest contacted the airbag. The driver's head also contacted the headrest. The driver's knees contacted the knee bolster. The passenger's visible contact points were as follows: The passenger's head and chest contacted the airbag. The passenger's head also contacted the headrest. The passenger's knees contacted the glovebox.

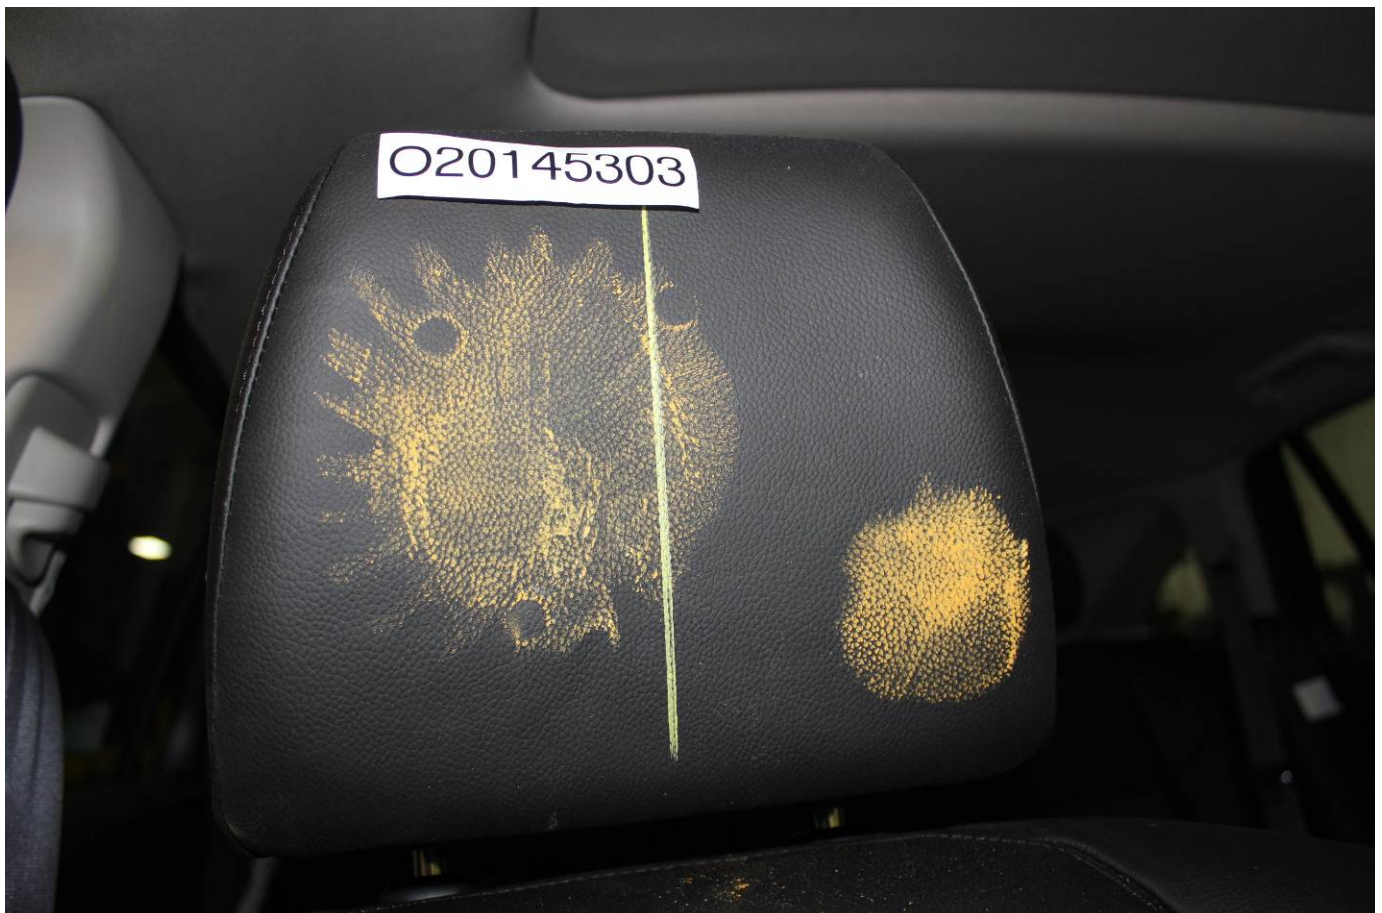
Post-Test Passenger Dummy Contact with Headrest

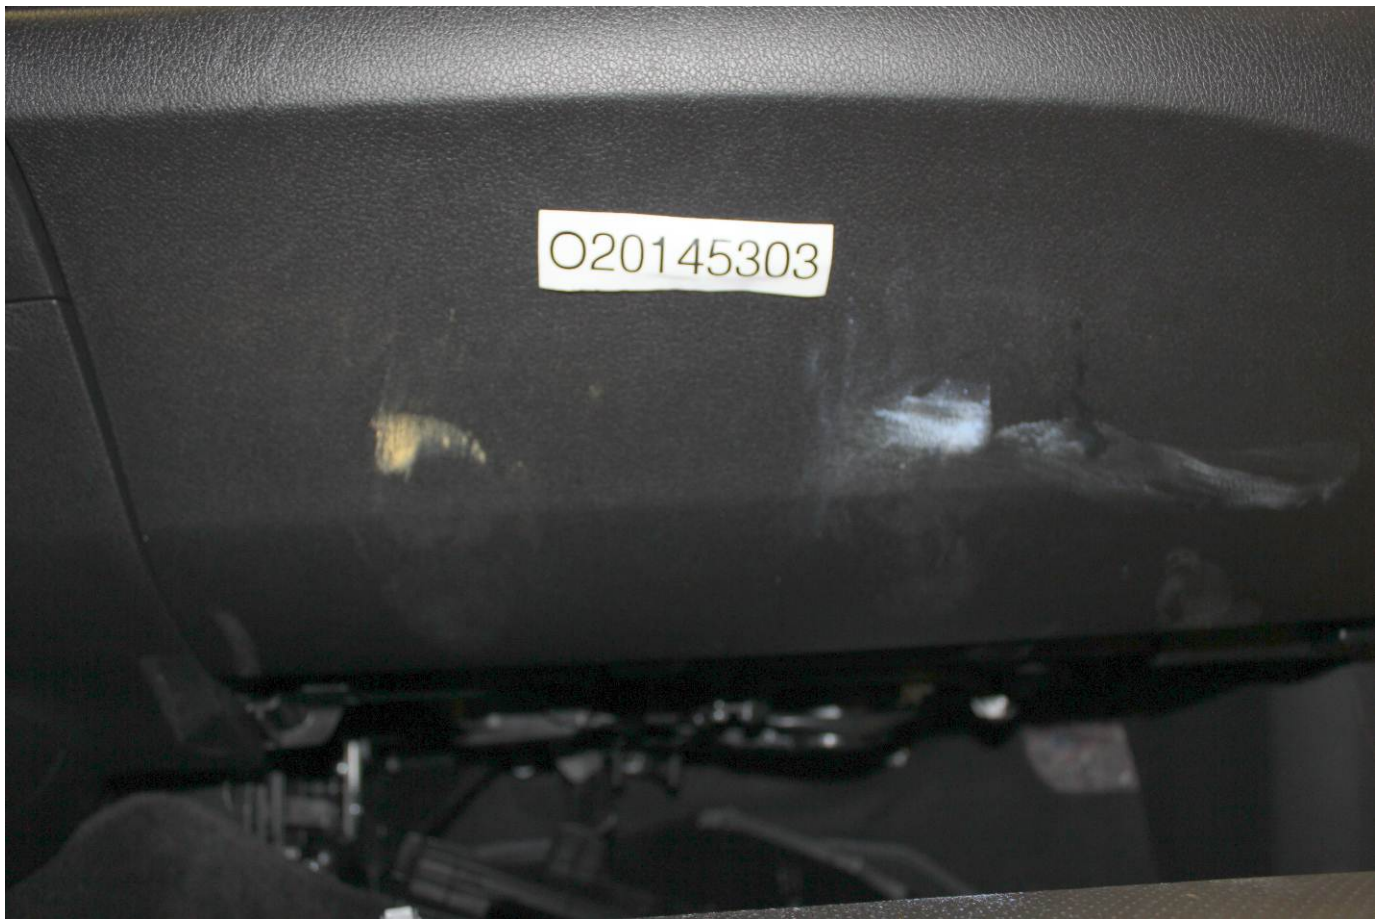
Post-Test Passenger Dummy Contact with Glovebox

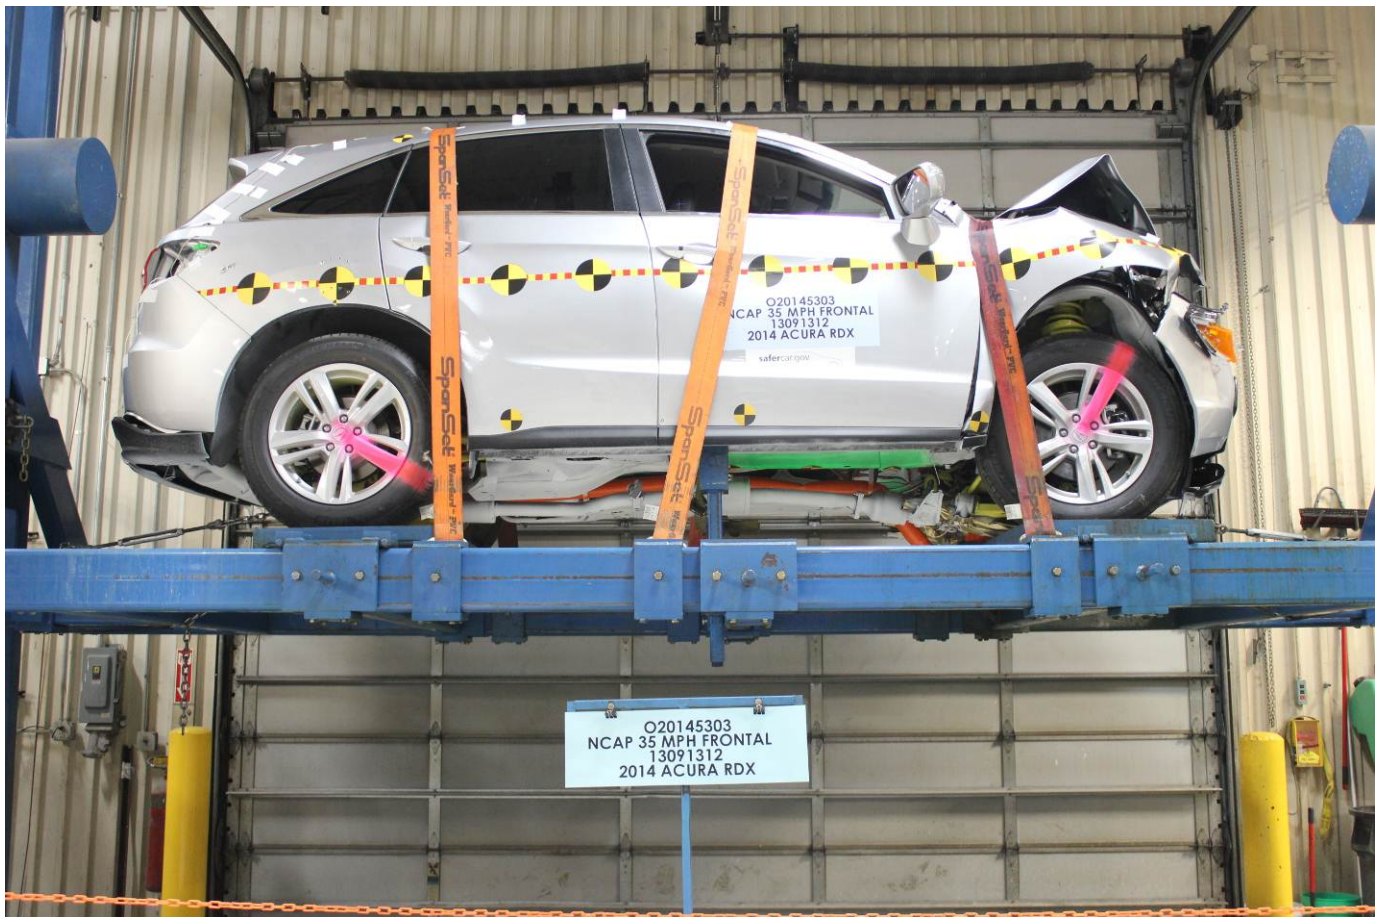
Vehicle at 0 Degree on Static Rollover Device

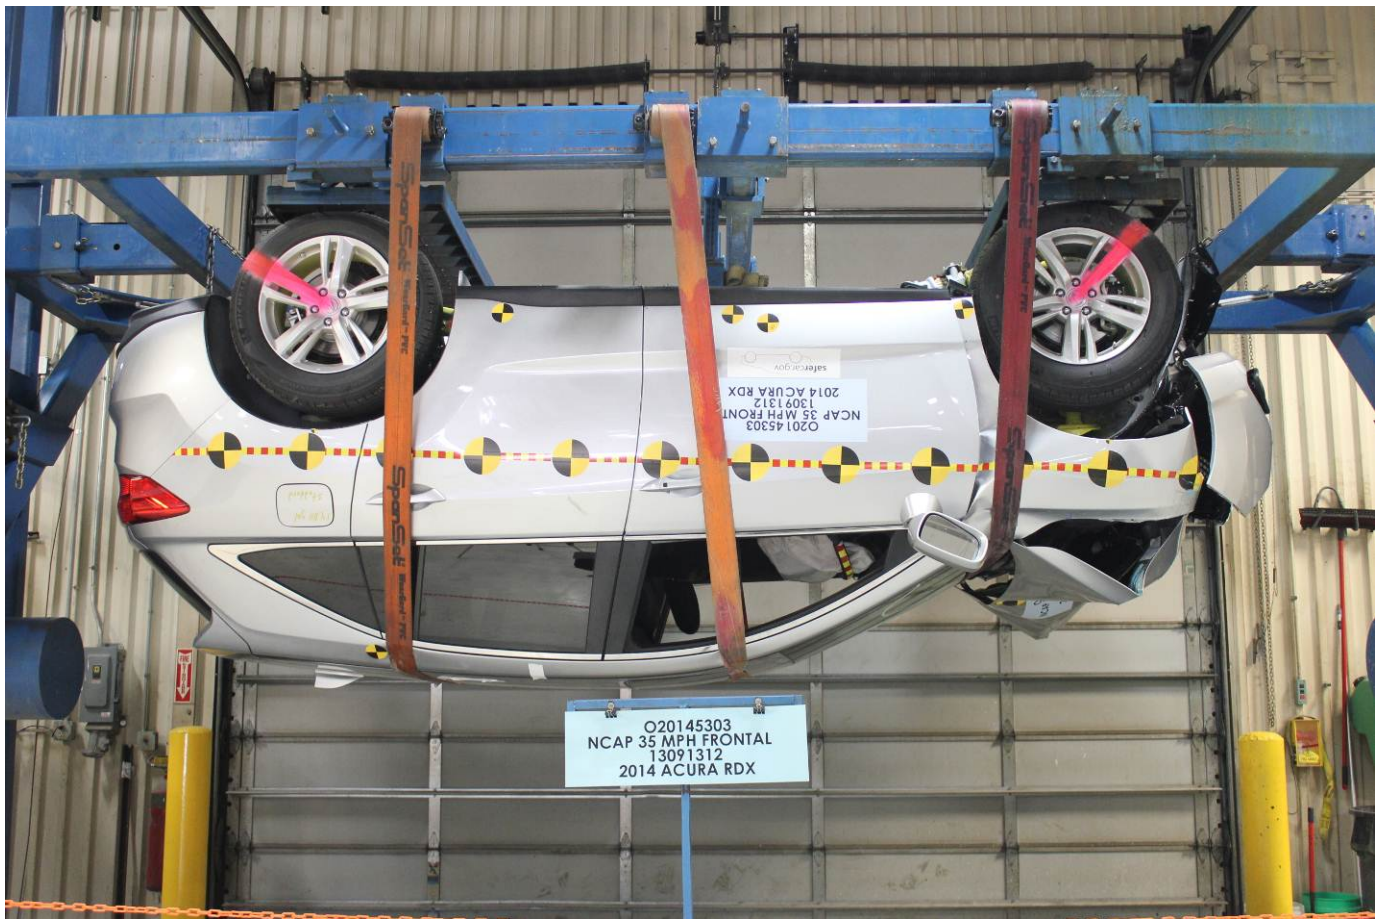
Vehicle at 180 Degrees on Static Rollover Device

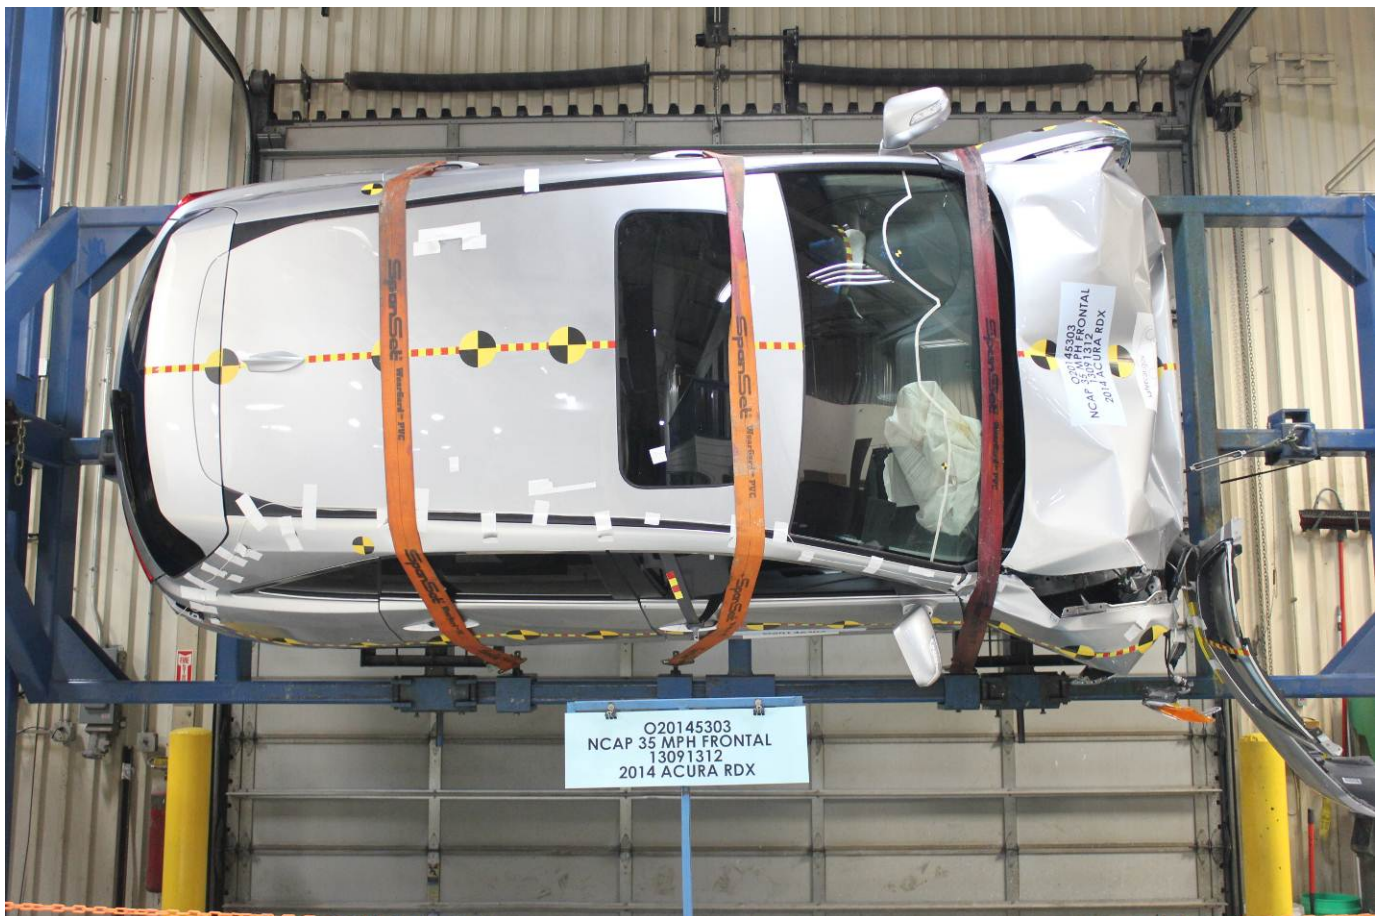
Vehicle at 270 Degrees on Static Rollover Device

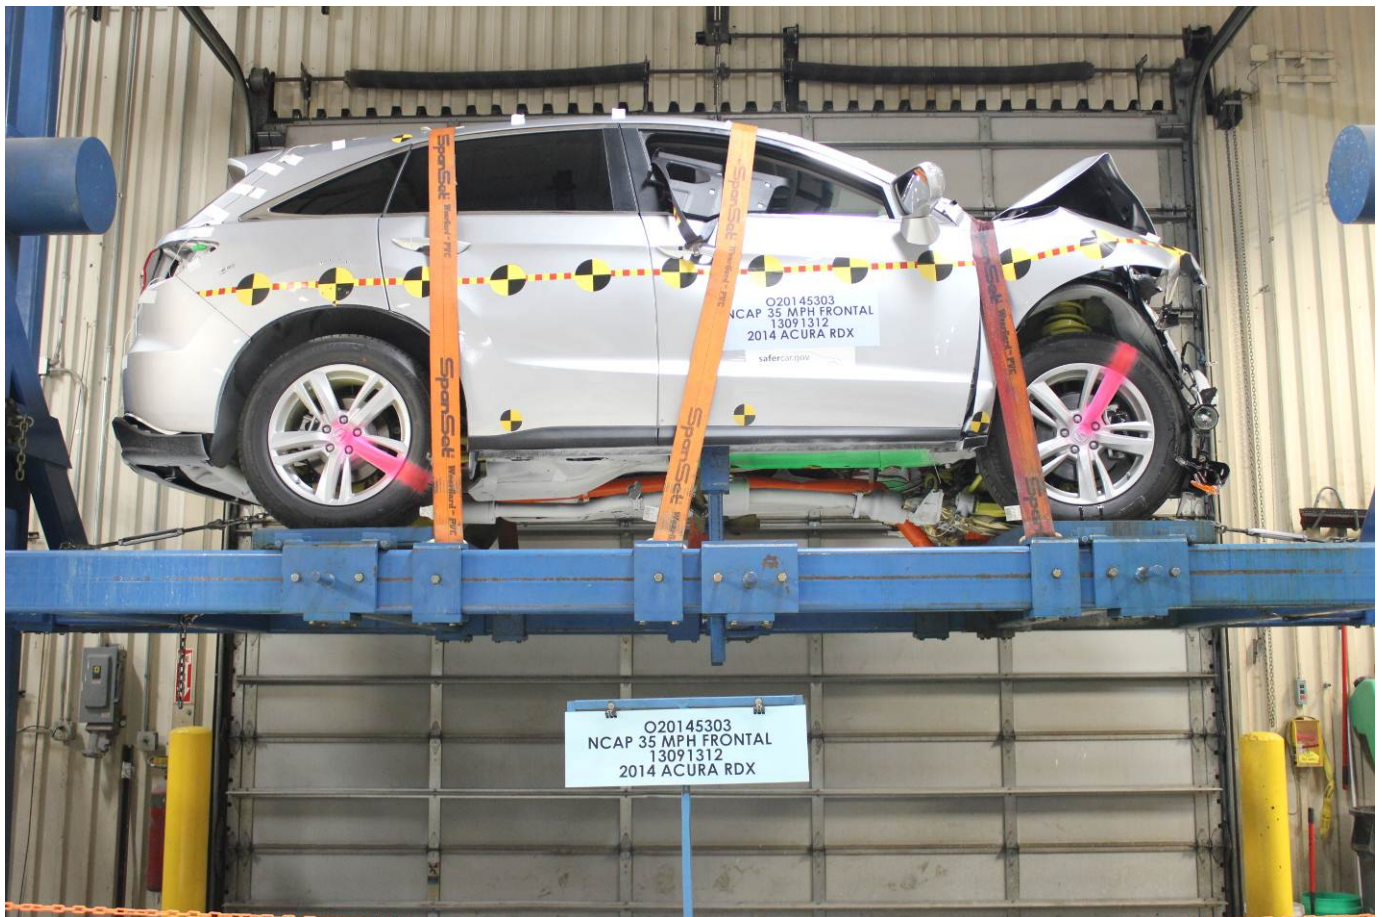
Vehicle at 360 Degrees on Static Rollover Device
