**SAFETY PRE-STANDARD TESTING FOR FMVSS 201U  
Occupant Protection In Interior Impact  
Upper Interior Head Impact Protection**

**FORD MOTOR COMPANY  
1998 Ford Explorer 4-Door  
NHTSA No. PW0202**

**Test Dates: August 30-31, 2004  
Report Date: September 1, 2004**

**FINAL REPORT**

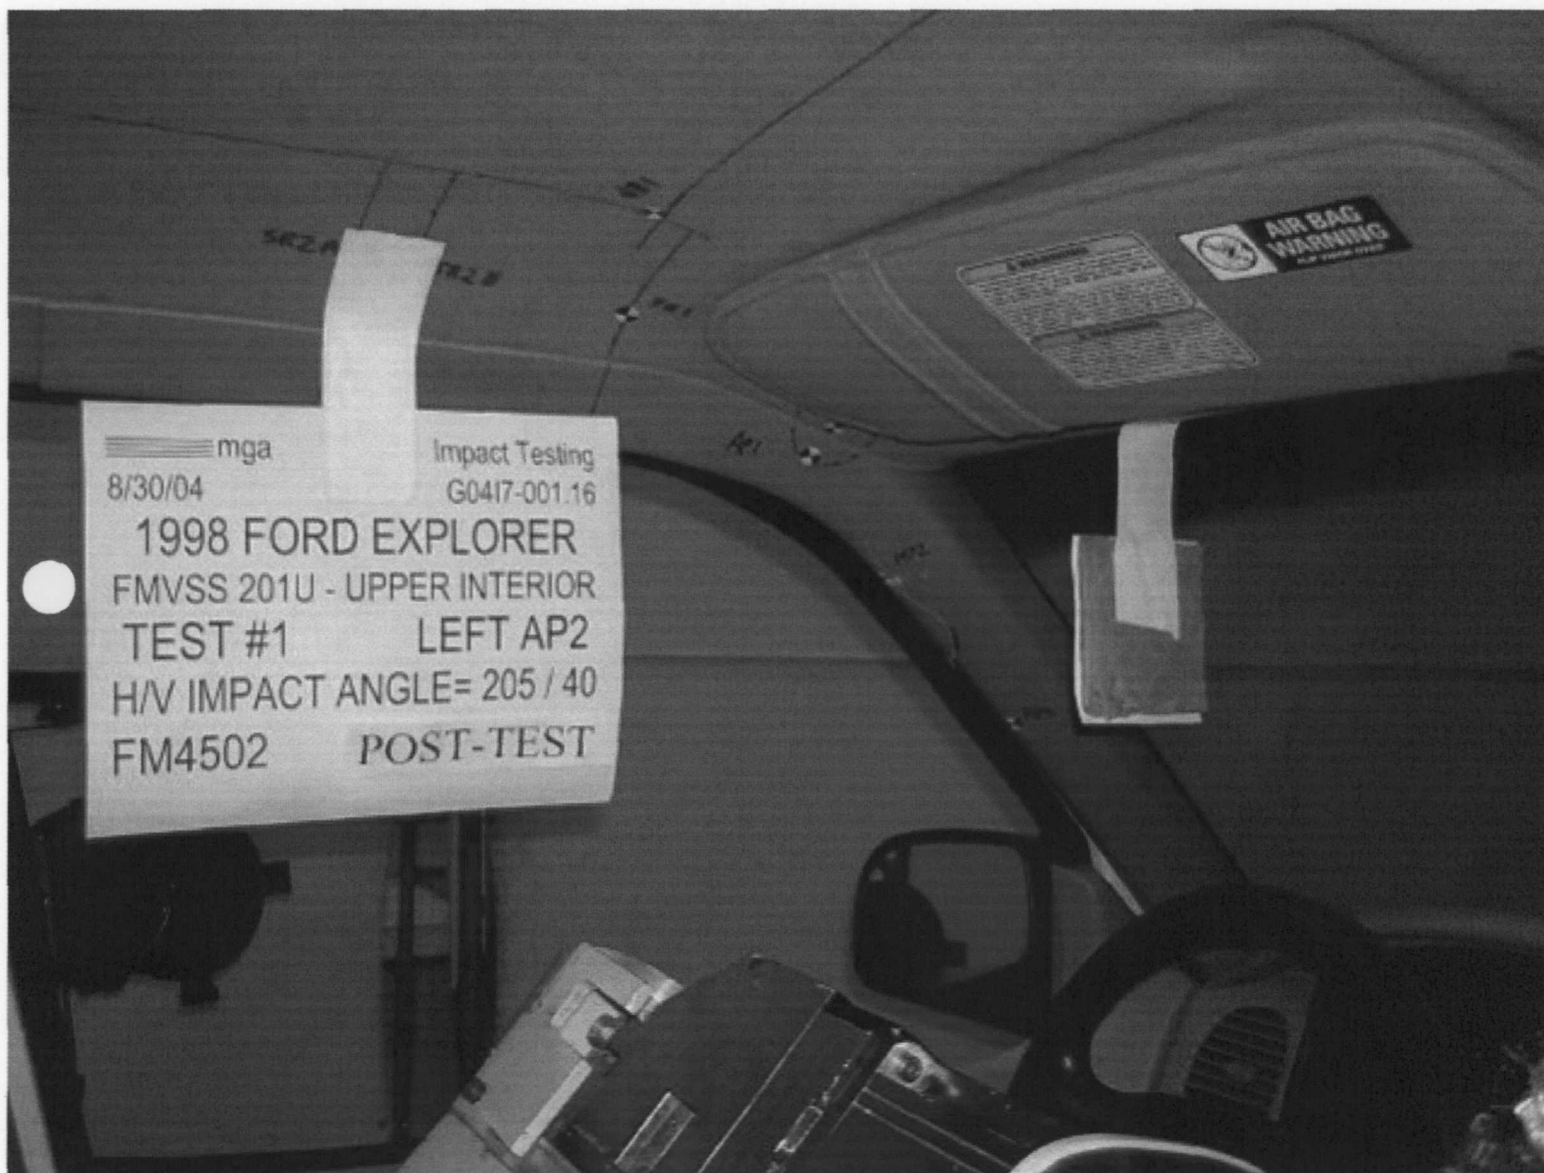
1998 FORD EXPLORER  
FMVSS 201U - UPPER INTERIOR  
TEST #1 LEFT AP2  
H/V IMPACT ANGLE= 205 / 40  
FM4502 POST-TEST

AP2 Left: Pillar trim cracked.

Pillar trim cracked

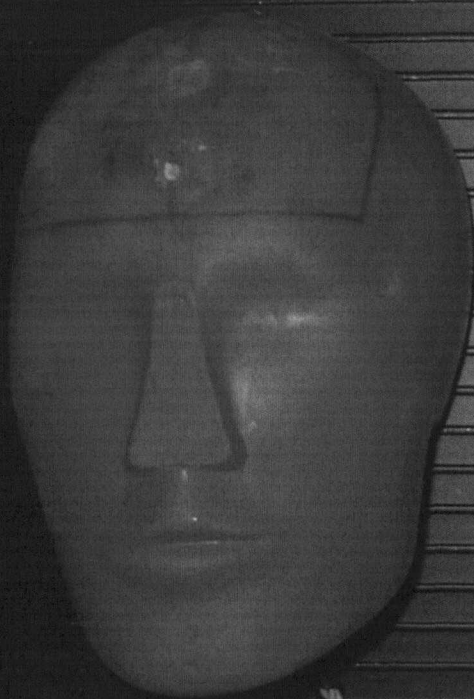
Impact Testing  
G0417-001.16

AP3 Right: Pillar trim cracked.

1998 FORD EXPLORER  
FMVSS 201U - UPPER INTERIOR  
TEST #6      RIGHT AP3  
H/V IMPACT ANGLE= 155 / 35  
FM4507      POST-TEST

Cracked pillar trim

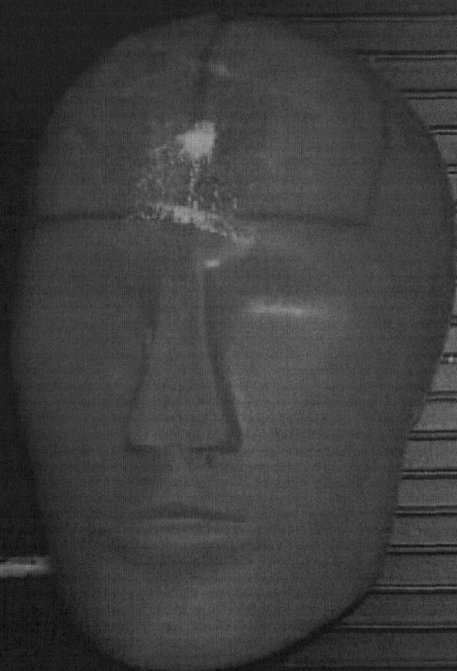
PW0202  
FM4503  
BP2 L/C

1998 FORD EXPLORER  
FMVSS 201U - UPPER INTERIOR  
TEST #2 LEFT BP2  
H/V IMPACT ANGLE= 270 / 4  
FM4503 POST-TEST

No visible damage

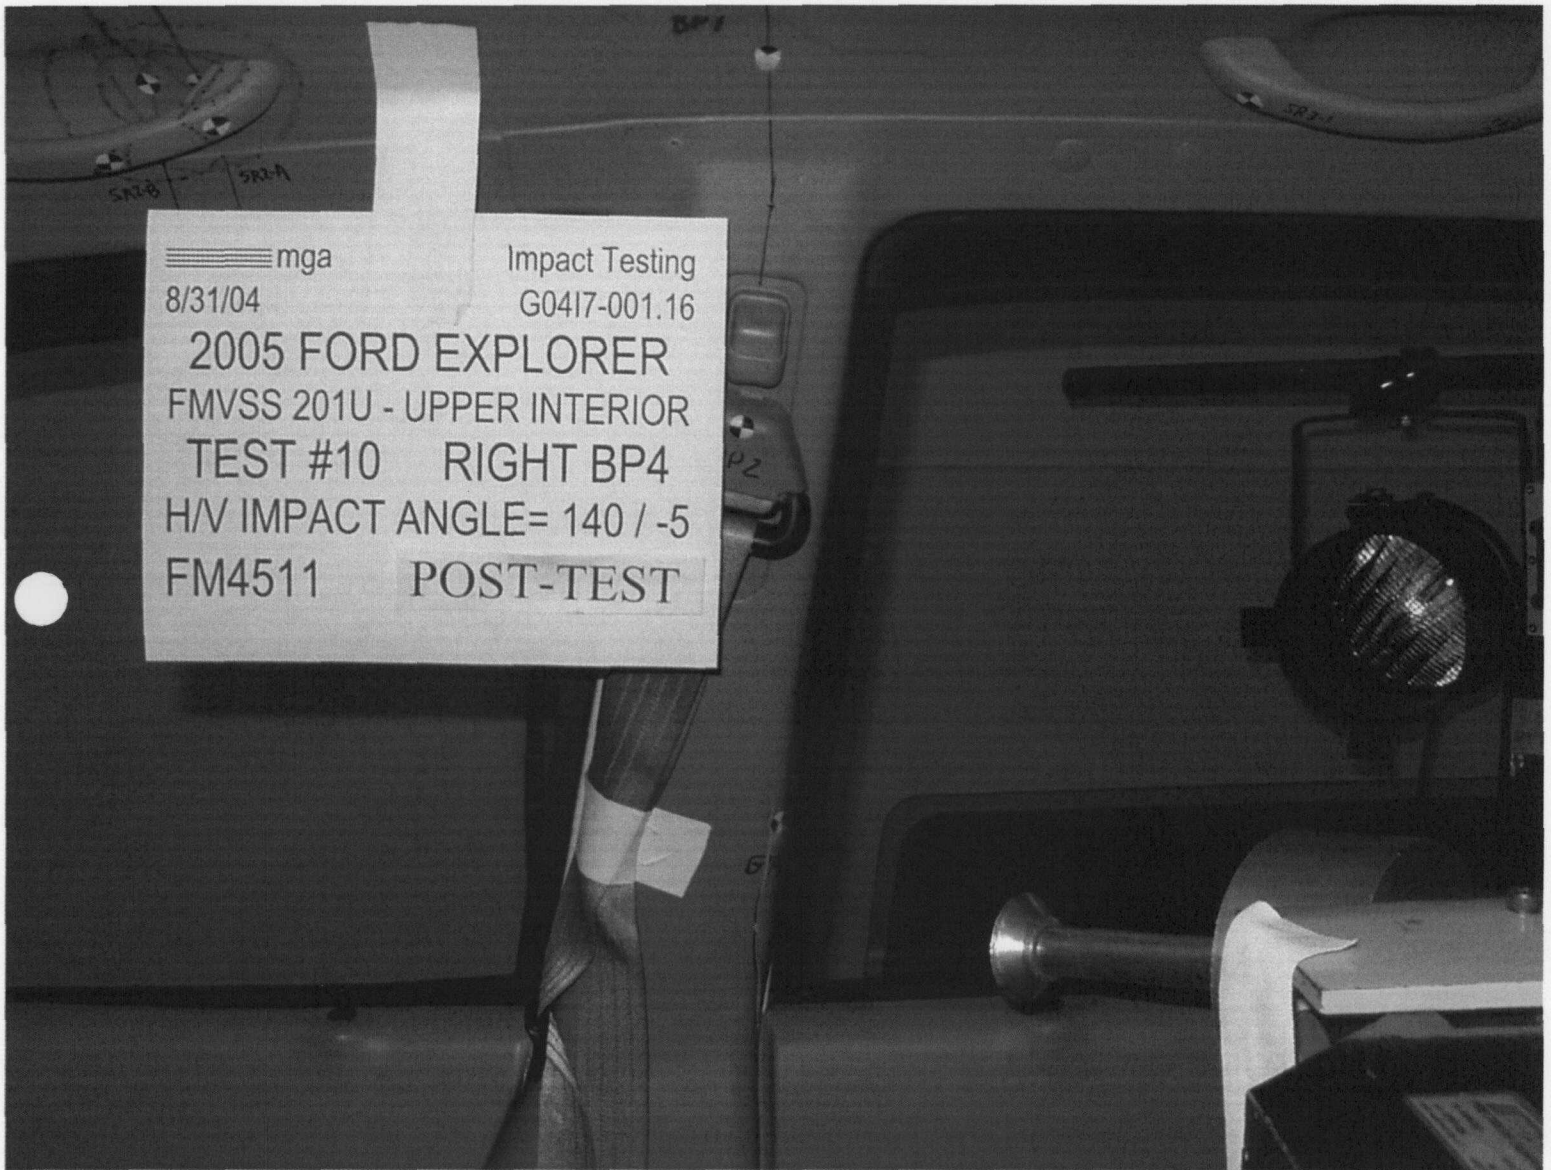
2005 FORD EXPLORER  
FMVSS 201U - UPPER INTERIOR  
TEST #10 RIGHT BP4  
H/V IMPACT ANGLE= 140 / -5  
FM4511 POST-TEST

BP4 Right: Pillar trim cracked.

Cracked pillar trim

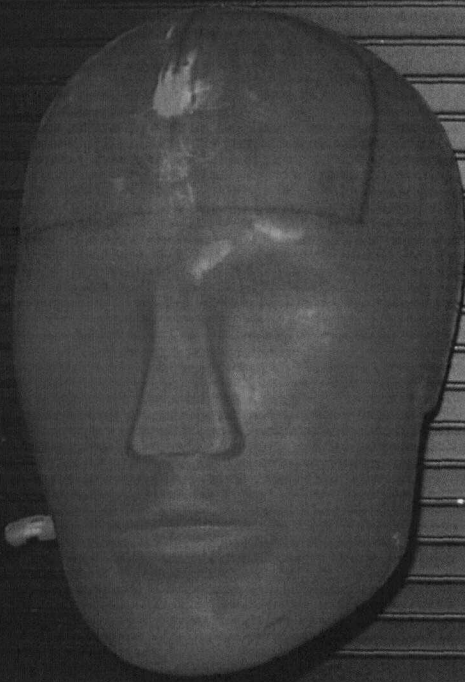
H/V IMPACT ANGLE= 270 / 50

FM4505 POST-TEST
