**REPORT NUMBER: SINCAP-MGA-2014-017**

**NEW CAR ASSESSMENT PROGRAM (NCAP)  
Moving Deformable Barrier Side Impact Test**

**HONDA MFG. OF ALABAMA, LLC  
2014 Acura MDX SUV  
NHTSA No.: O20145302**

**FINAL REPORT**

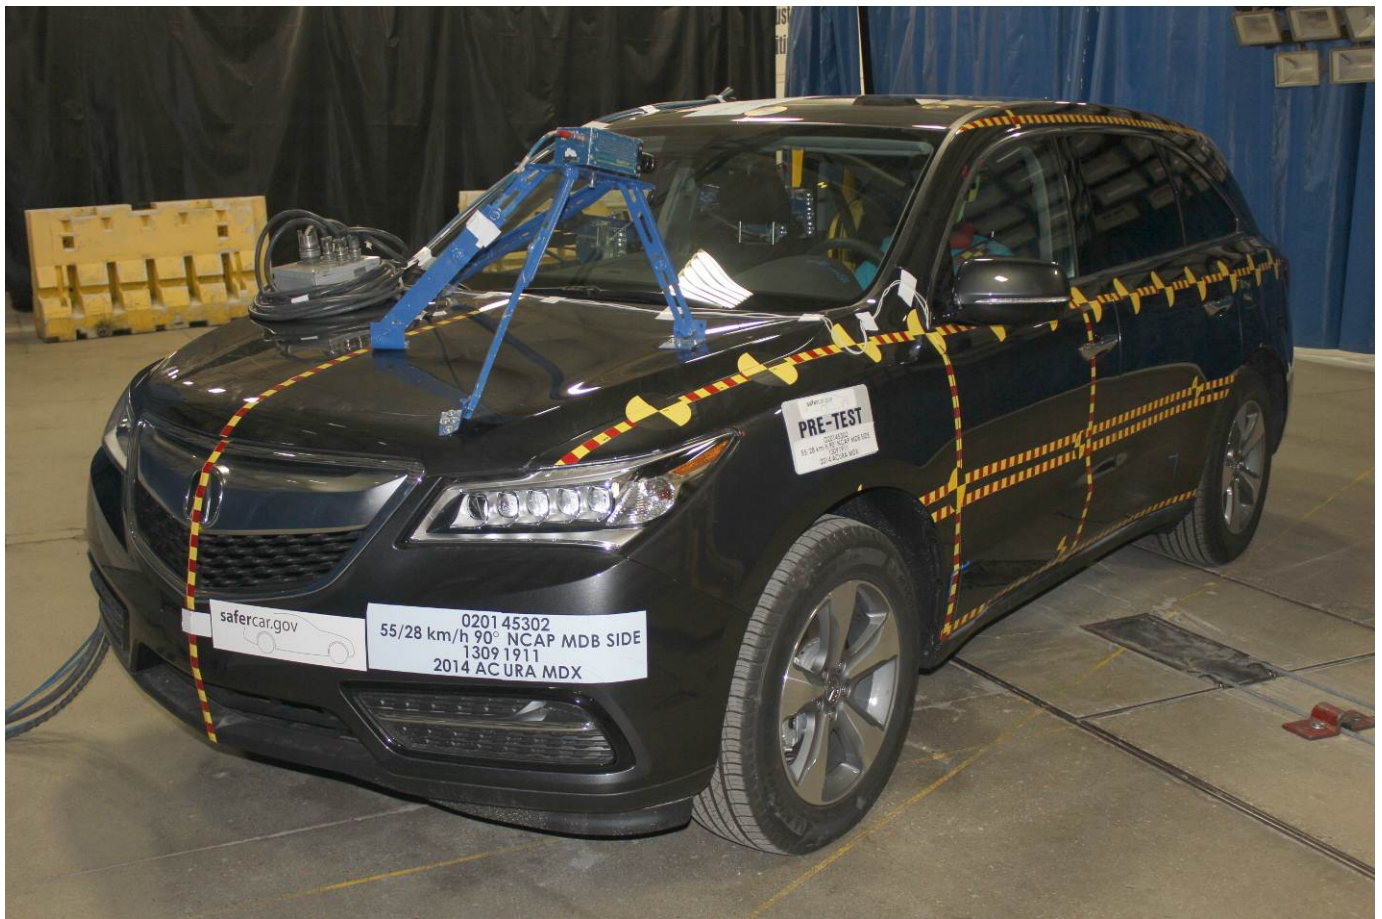
Post-Test Frontal View of Test Vehicle

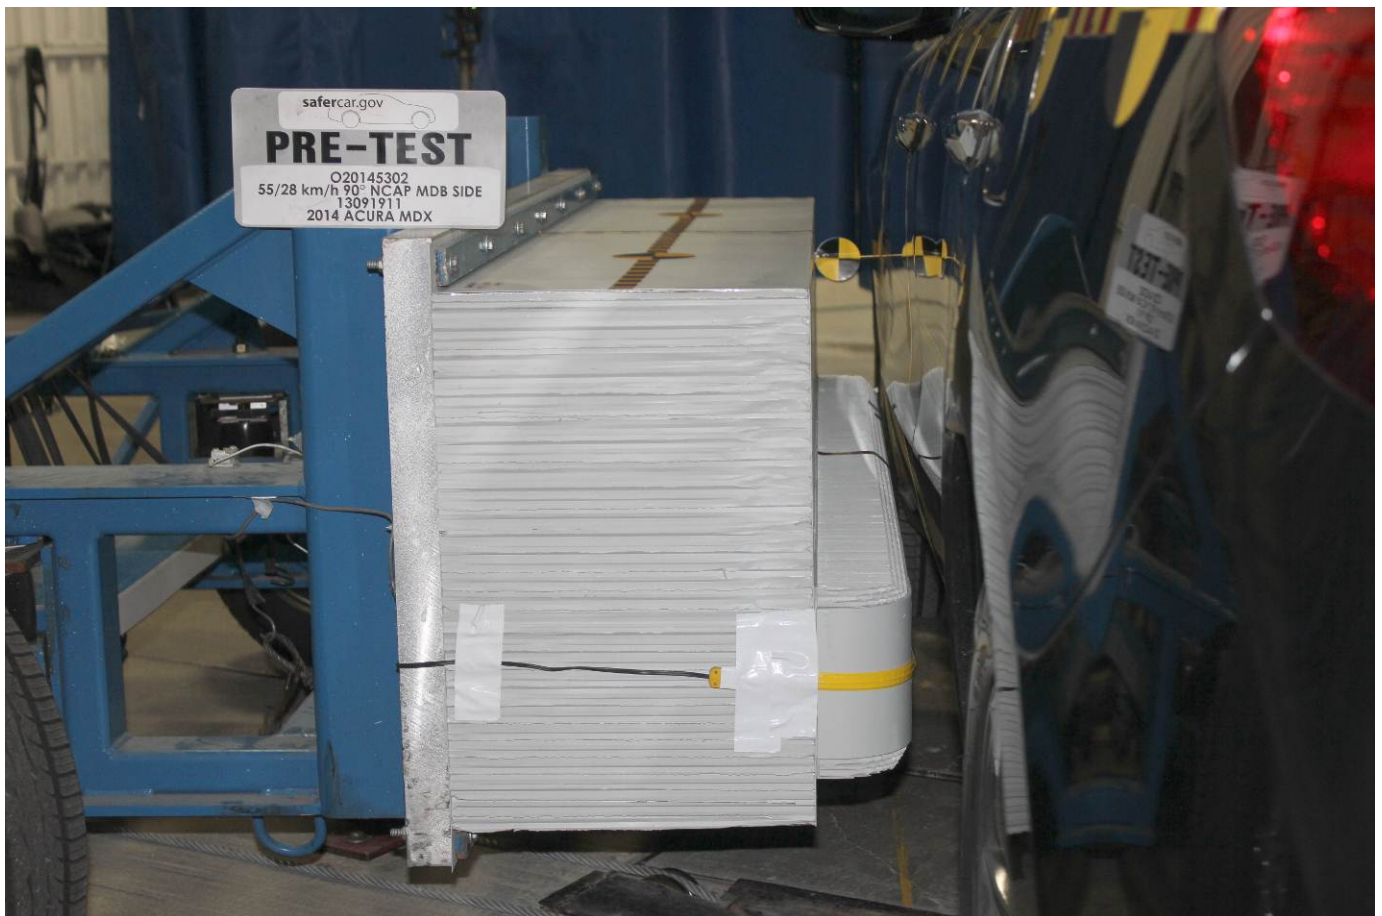
Pre-Test Left Side View of MDB Positioned Against Side of Test Vehicle

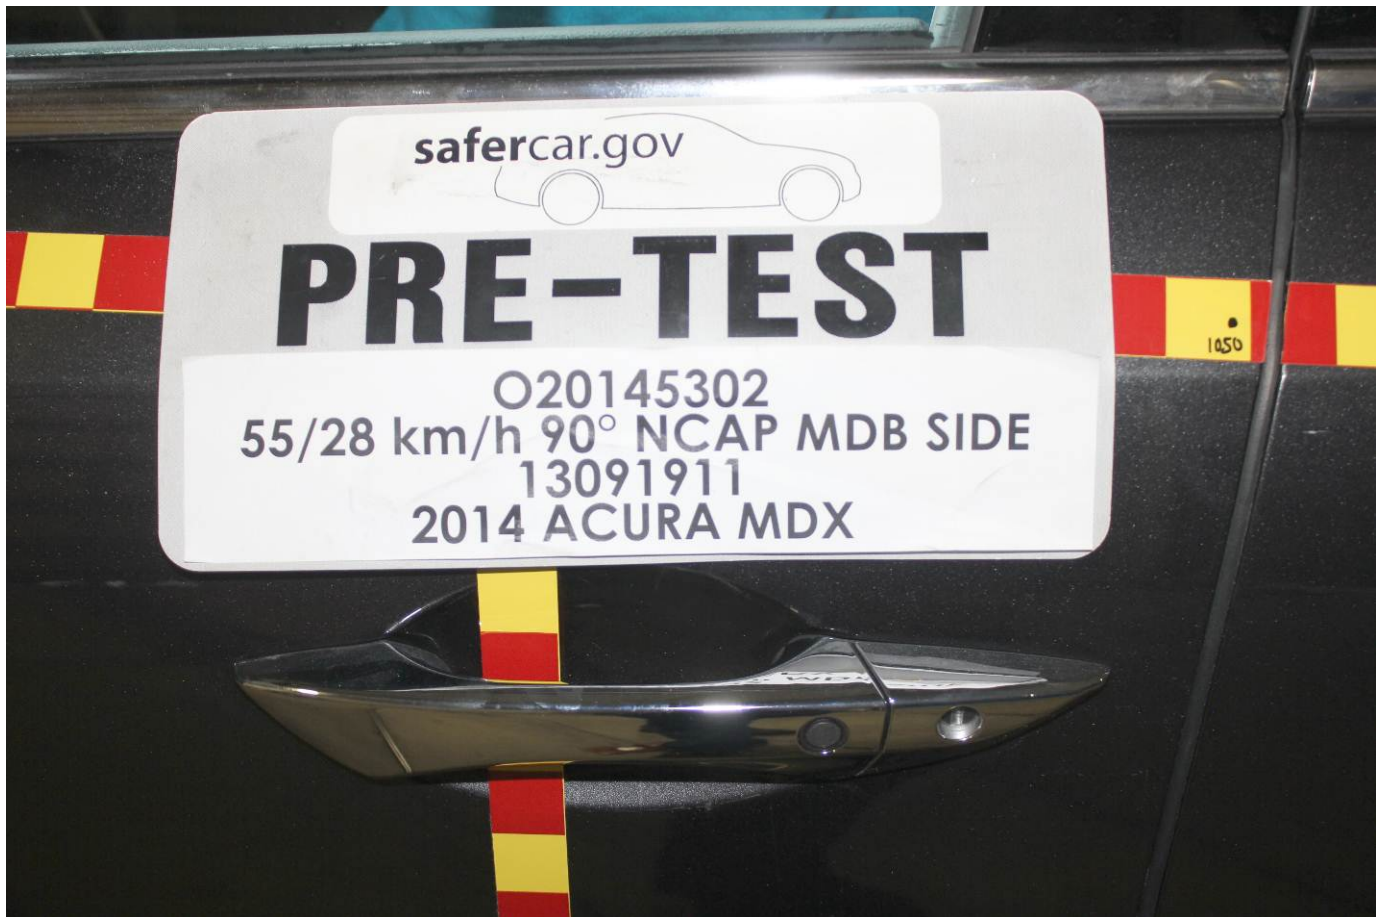
Post-Test Close-Up View of Impact Point Target

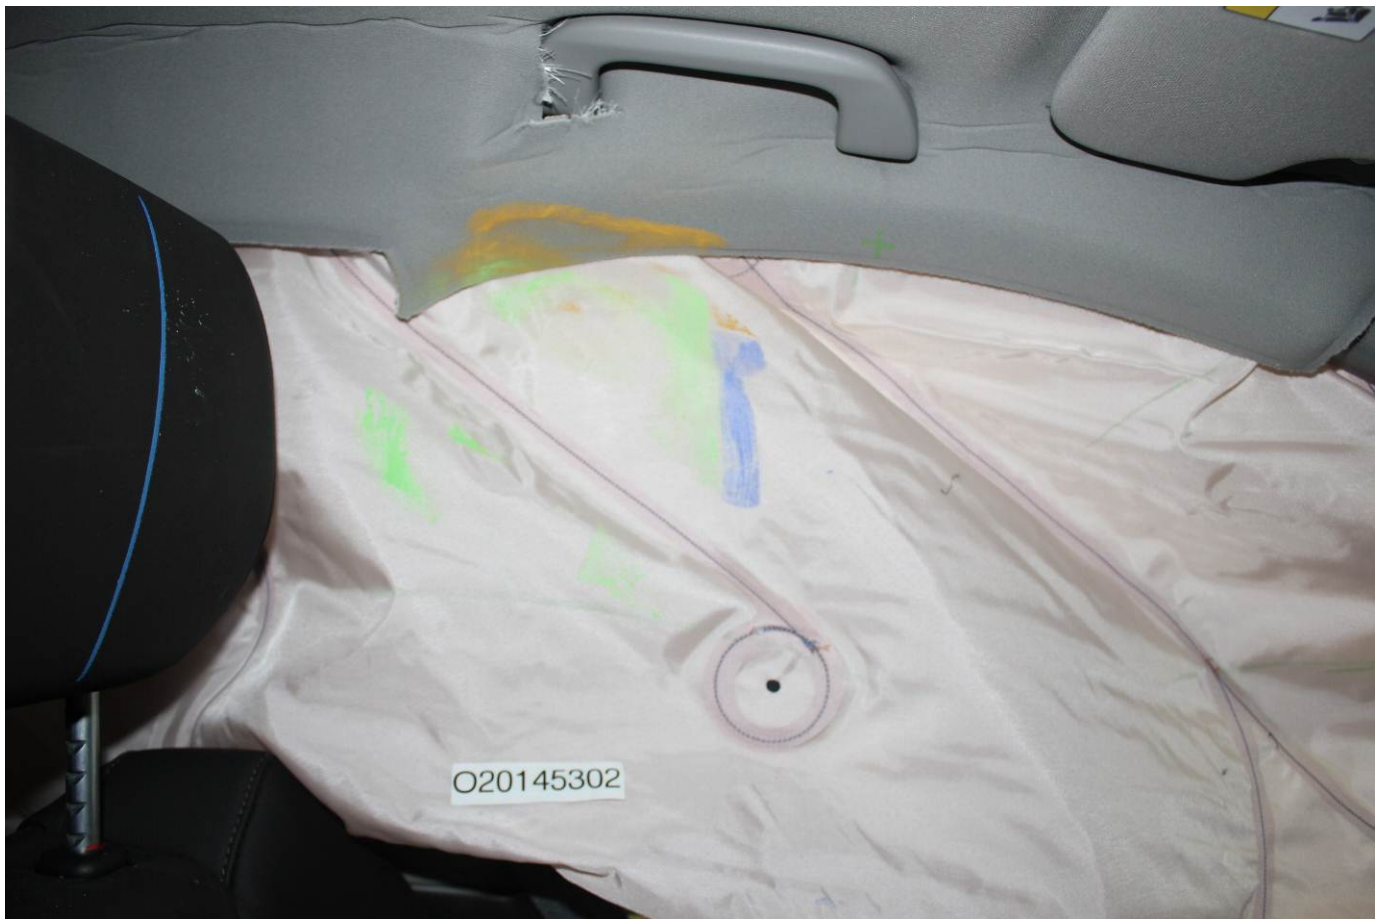
Post-Test Driver Dummy Close-up Head Contact with Vehicle Interior View

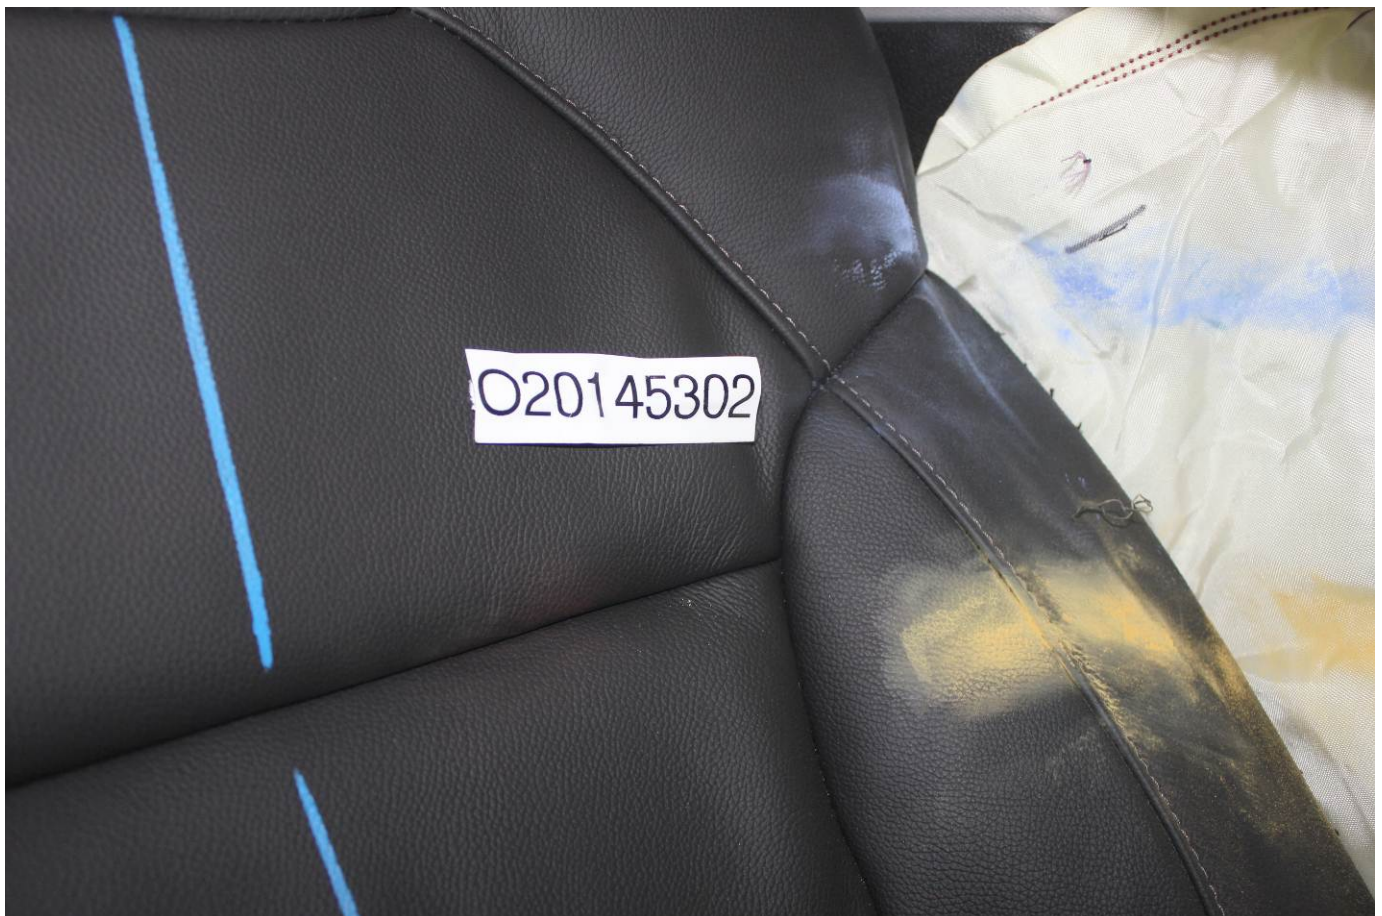
Post-Test Driver Dummy Close-up Head Contact with Side Airbag View

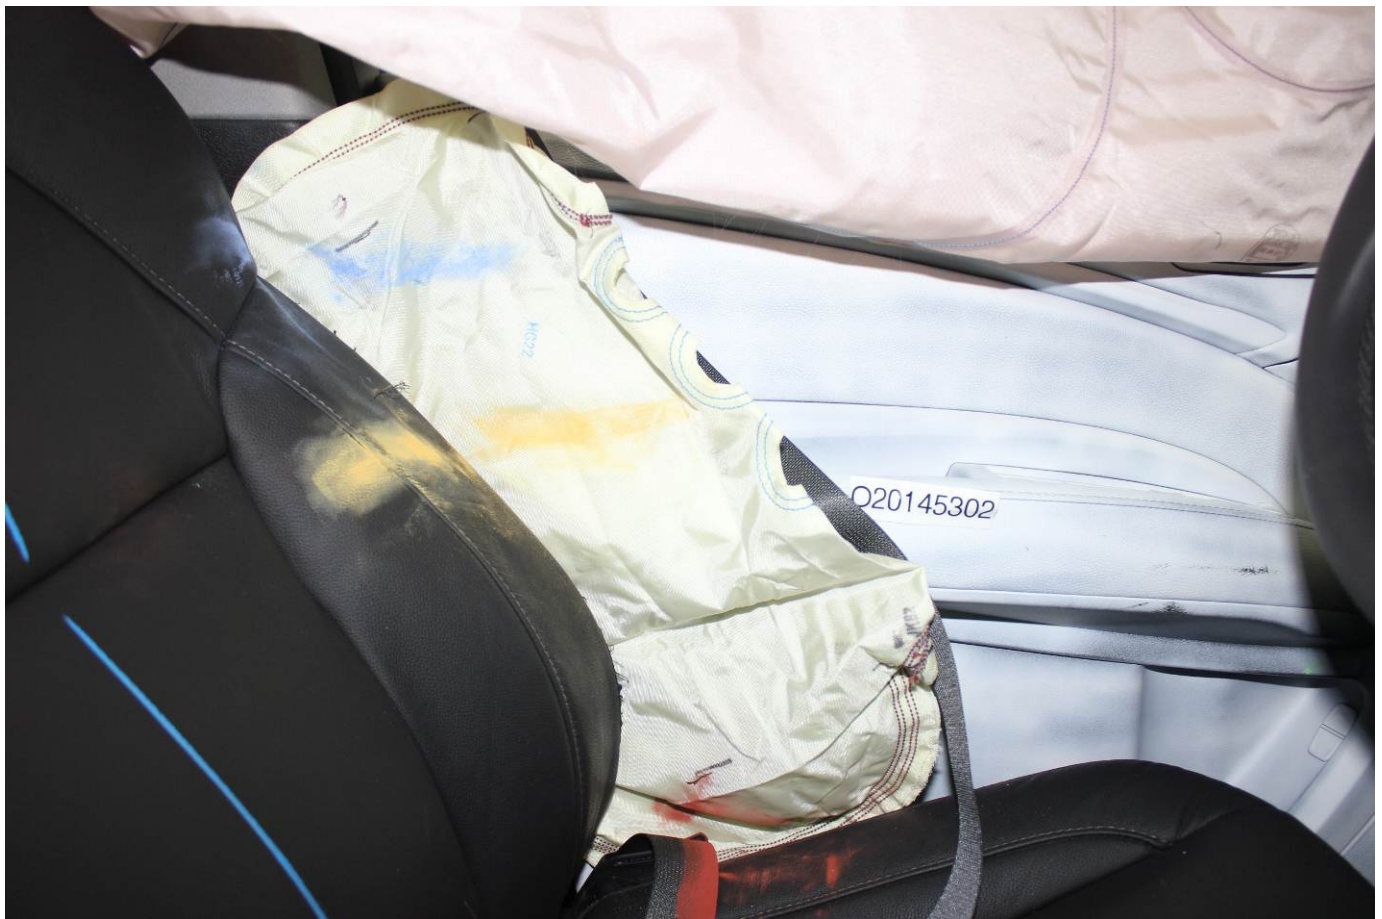
Post-Test Driver Dummy Close-up Torso Contact with Vehicle Interior View

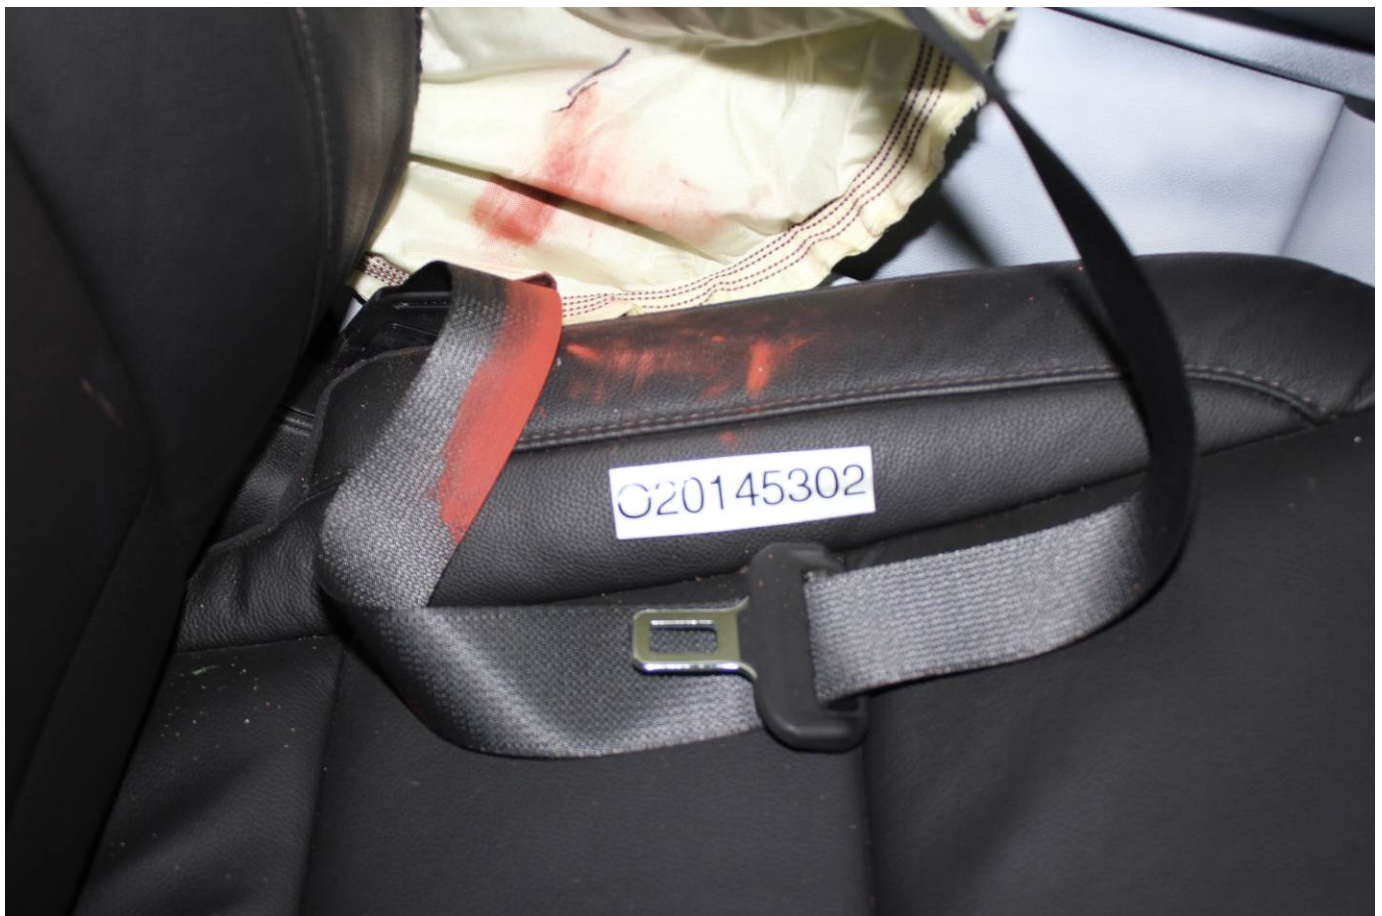
Post-Test Driver Dummy Close-up Torso Contact with Side Airbag View

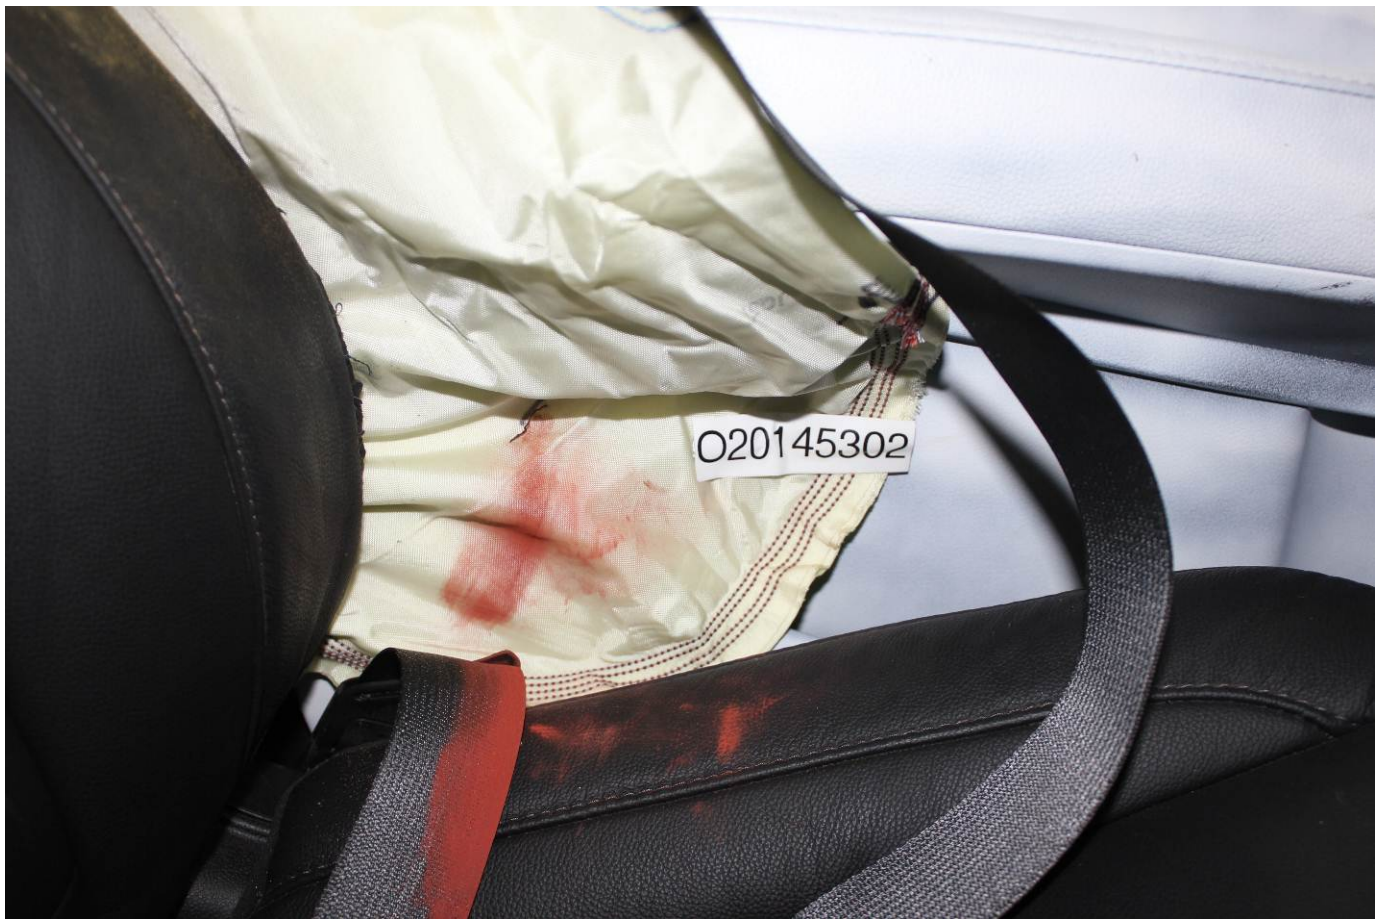
Post-Test Driver Dummy Close-up Pelvis Contact with Vehicle Interior View

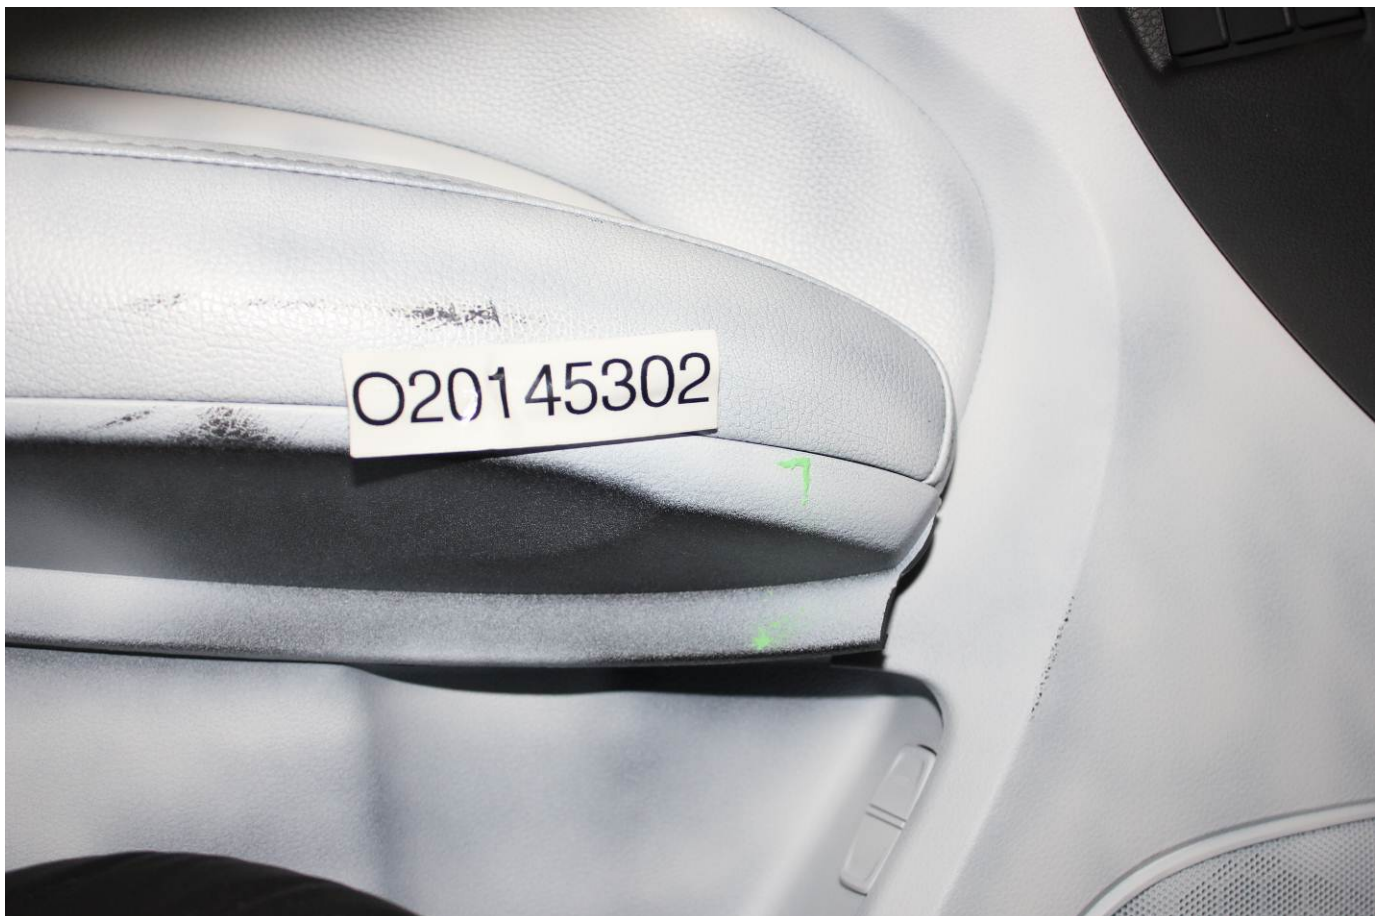
Post-Test Driver Dummy Close-up Pelvis Contact with Side Airbag View

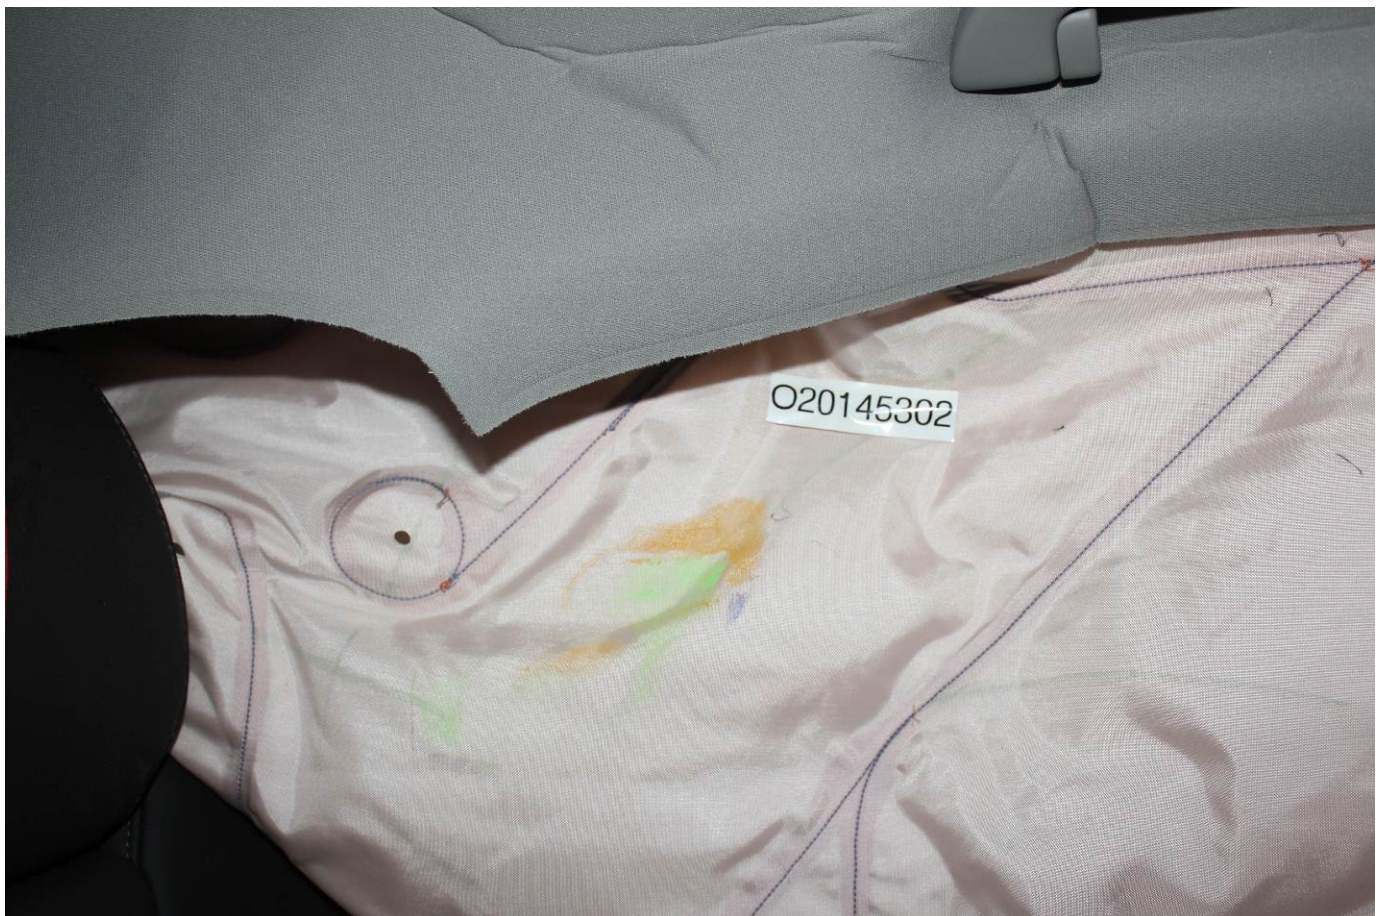
Post-Test Rear Passenger Dummy Close-up Head Contact with Vehicle Interior View

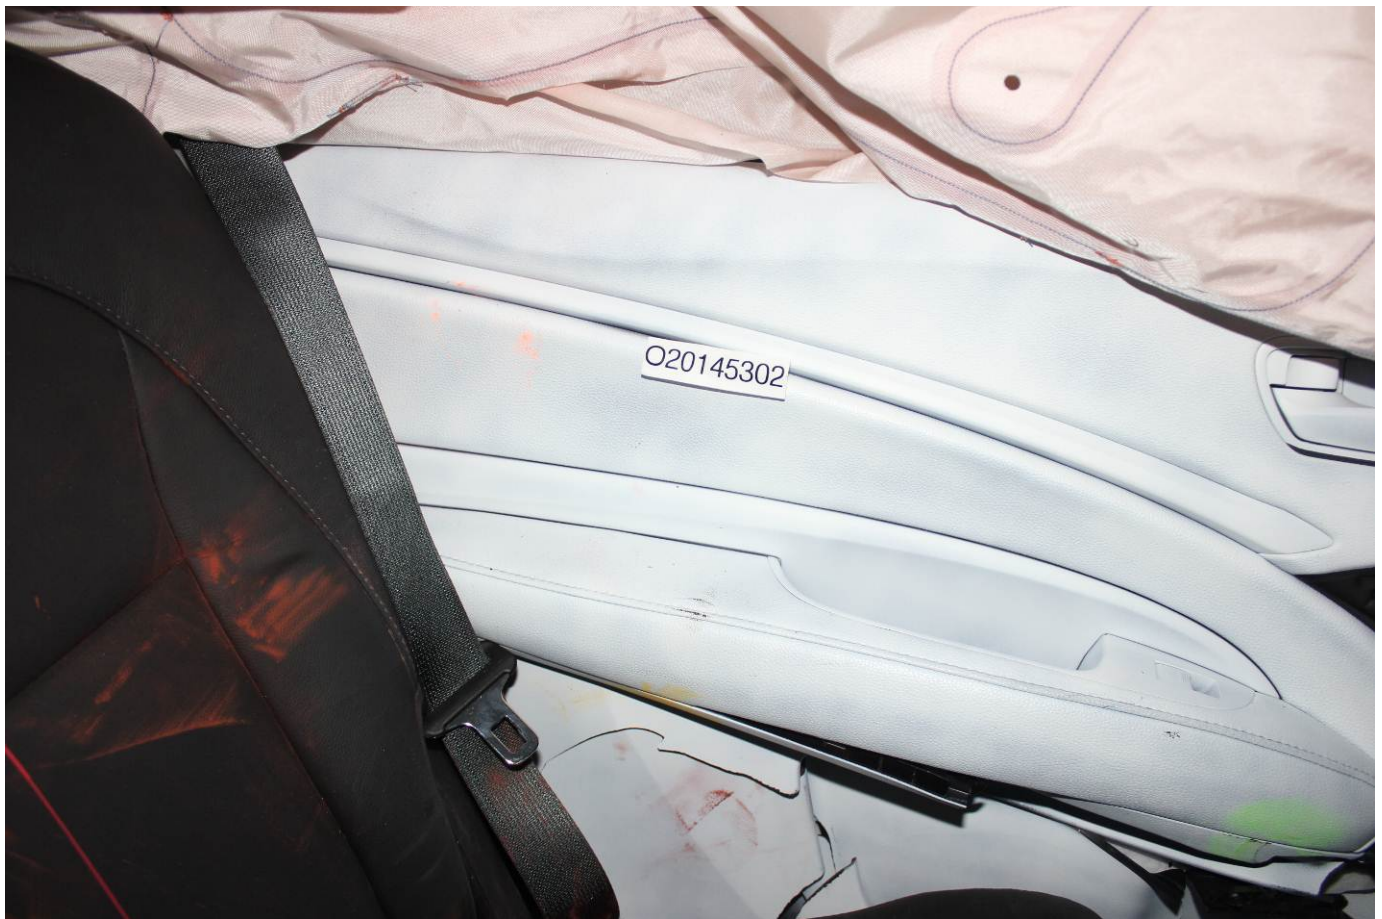
Post-Test Rear Passenger Dummy Close-up Head Contact with Side Airbag View
