**REPORT NUMBER: SPNCAP-MGA-2014-019**

**NEW CAR ASSESSMENT PROGRAM (NCAP)  
Side Impact Pole Test**

**HONDA MFG. OF ALABAMA, LLC  
2014 Acura MDX SUV  
NHTSA No.: O20145301**

**FINAL REPORT**

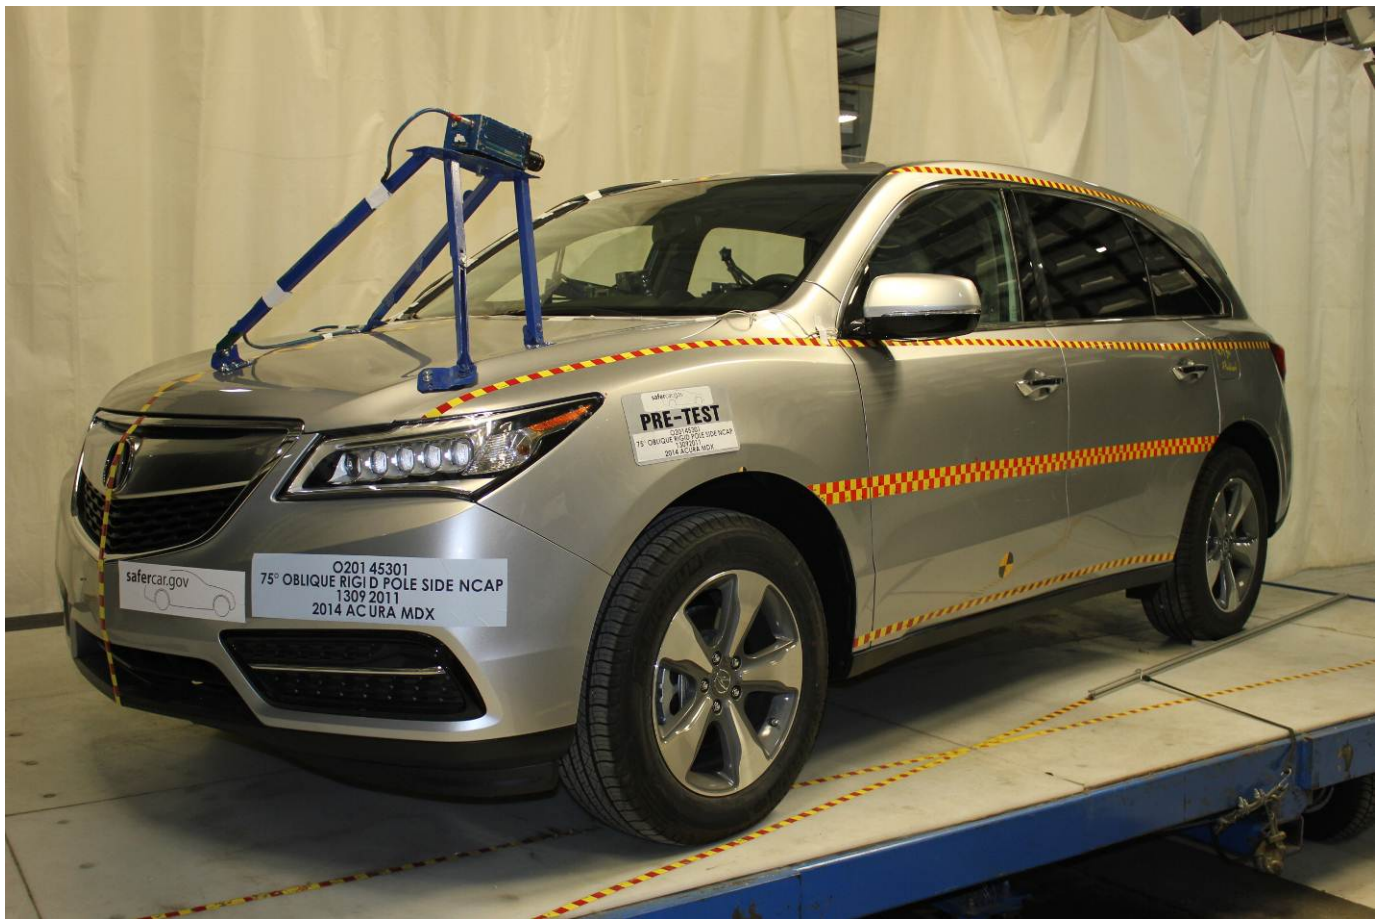
Post-Test Frontal View of Test Vehicle

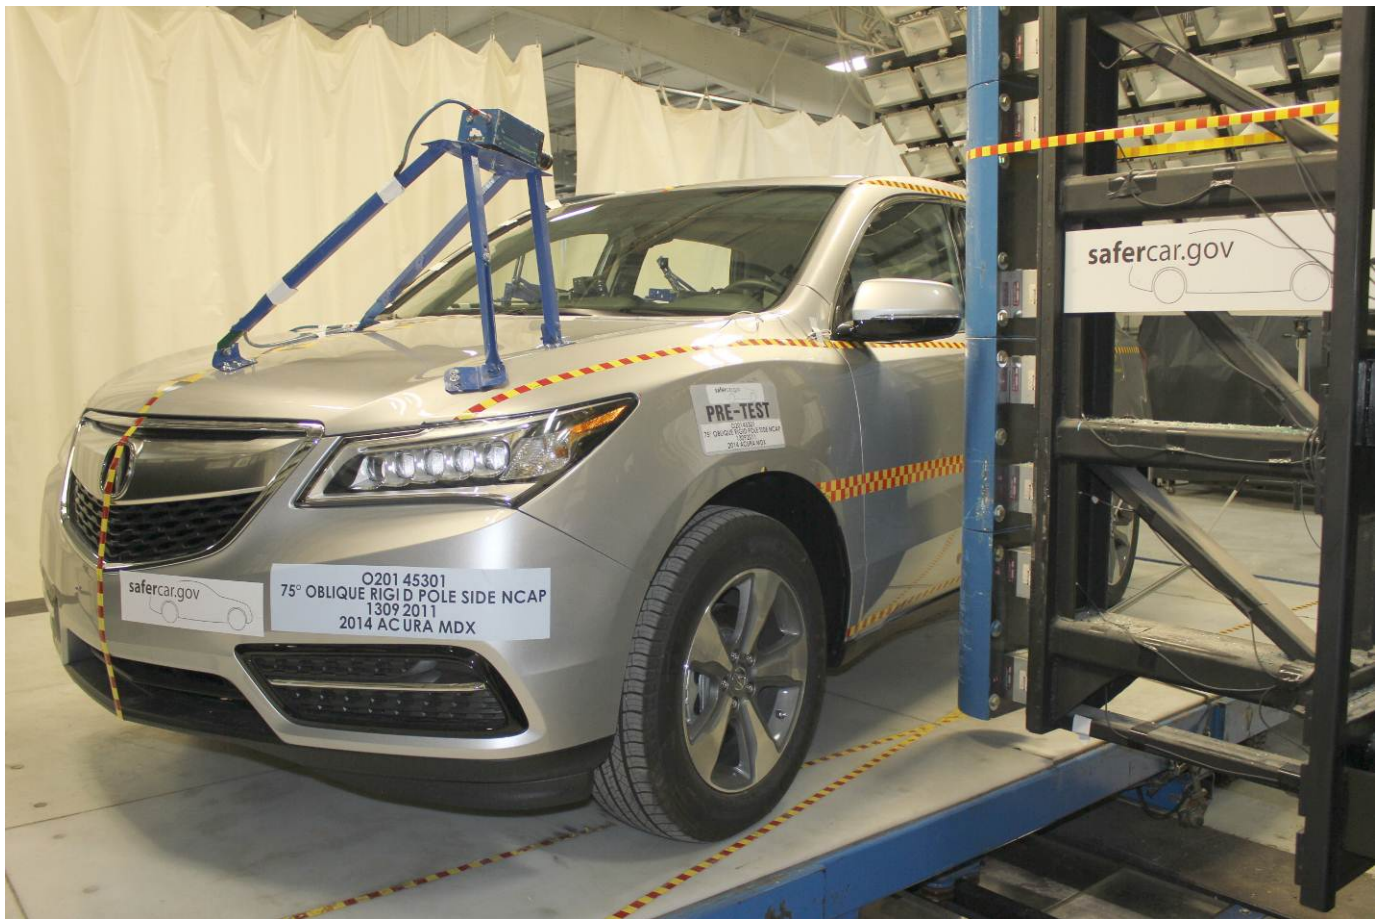
Post-Test Overhead View of Test Area

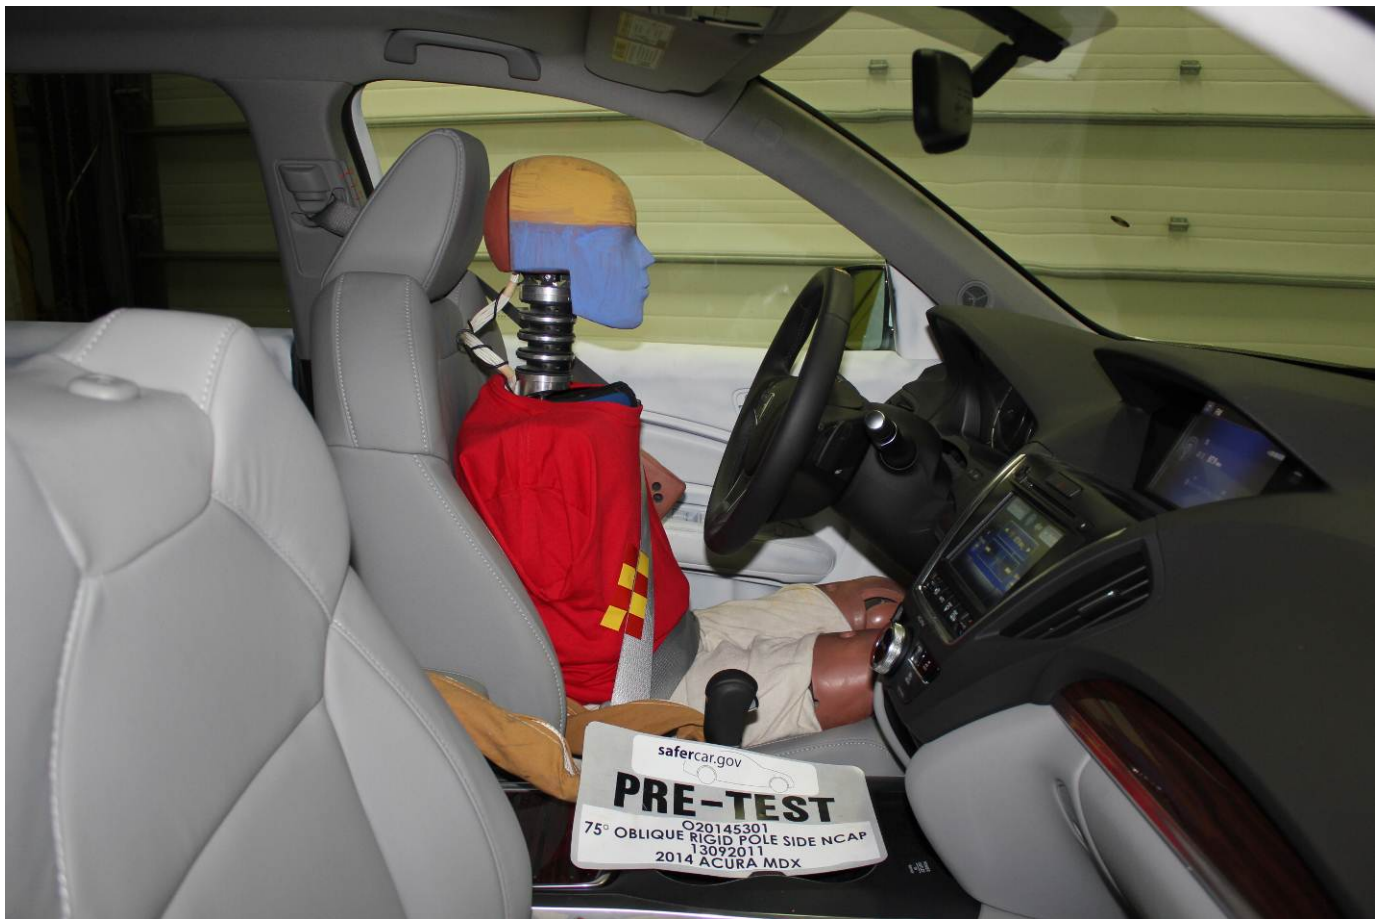
Post-Test Dummy and Door Clearance View

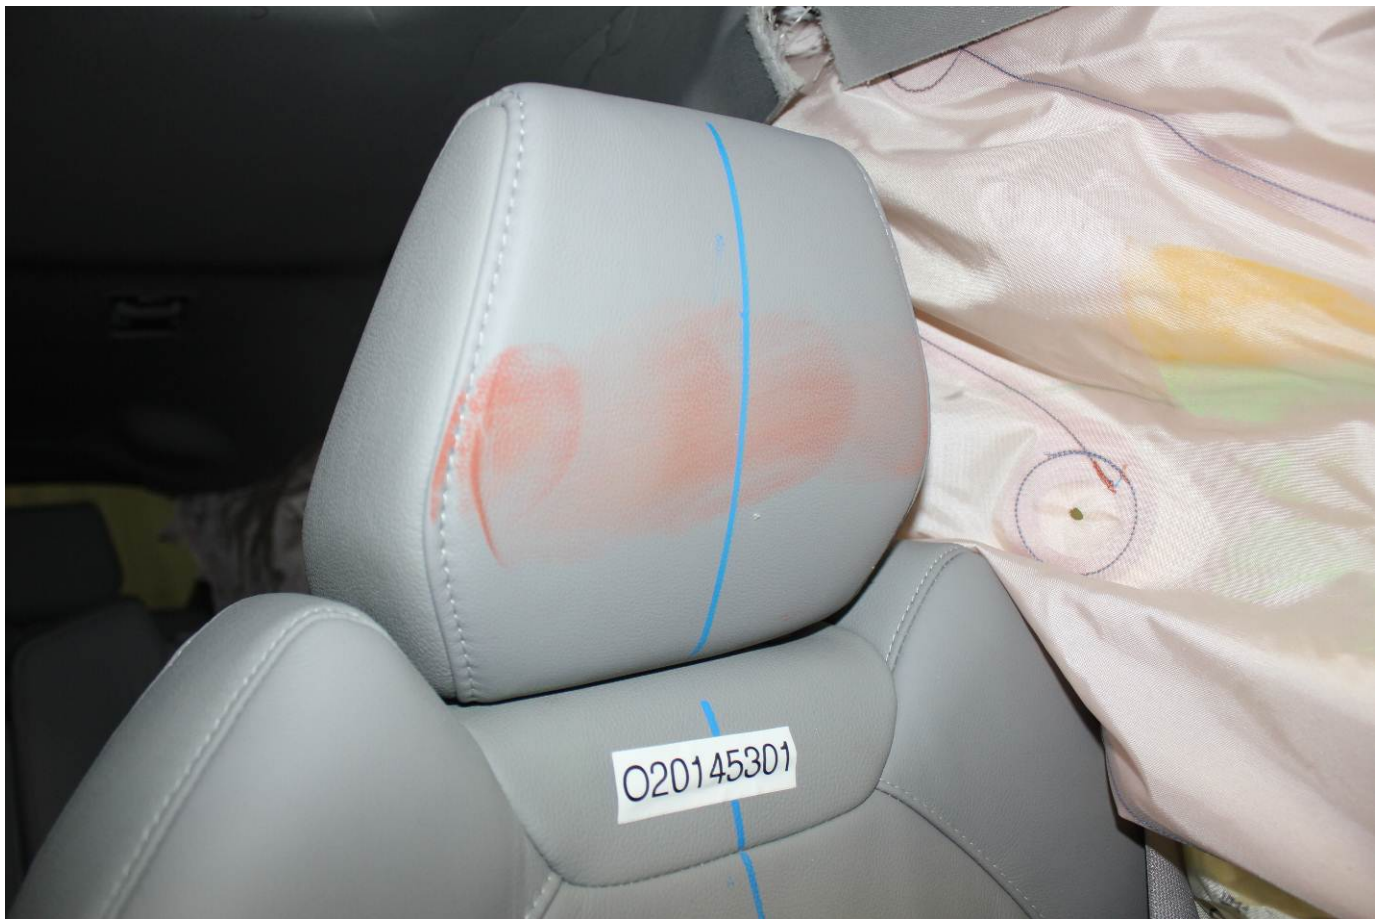
Post-Test Inner Door Panel View Showing Dummy Contact Location

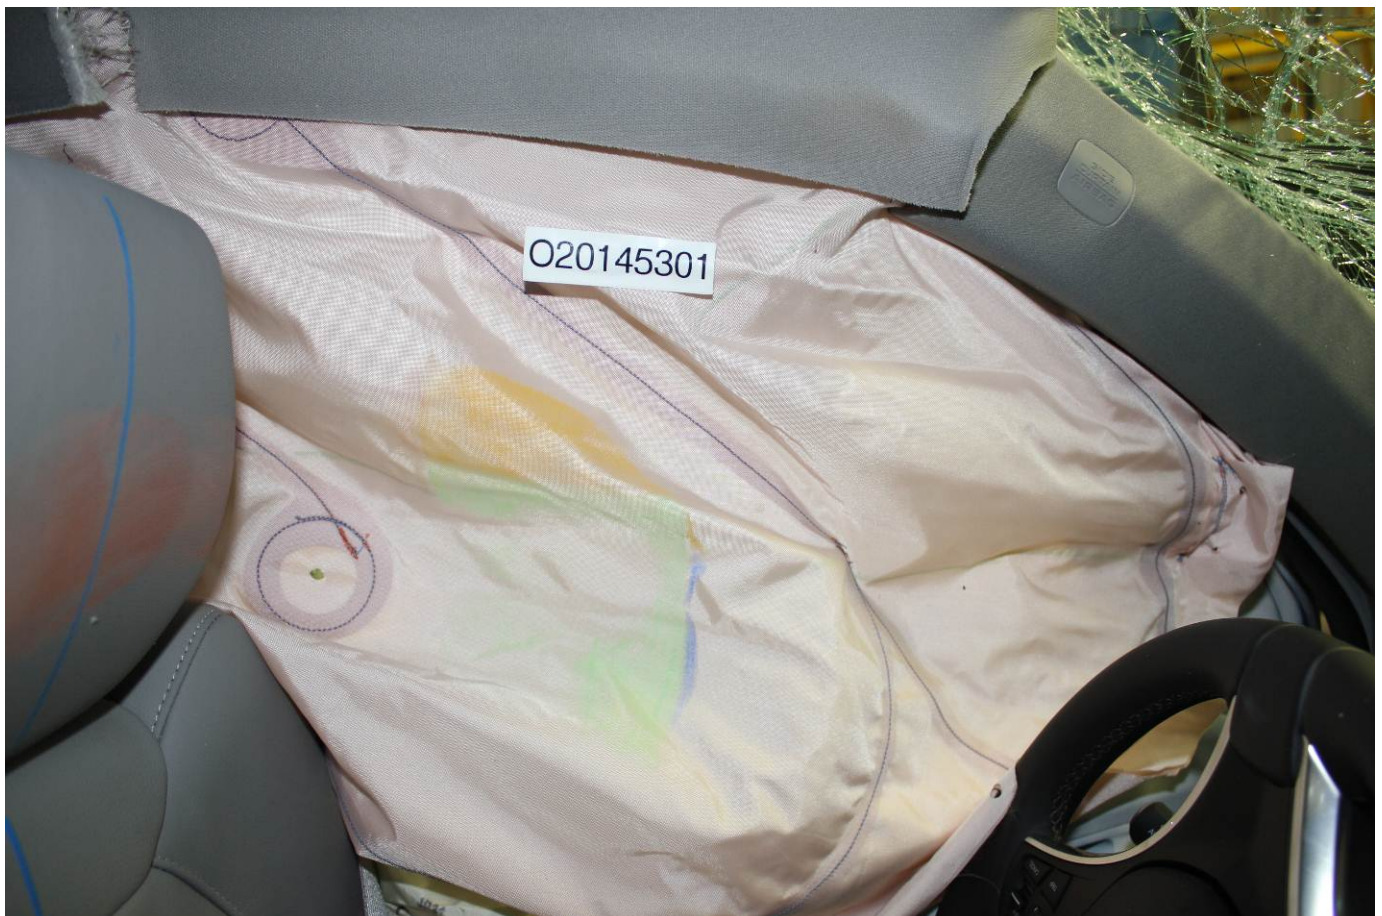
Post-Test Dummy Close-Up Head Contact with Vehicle Interior View

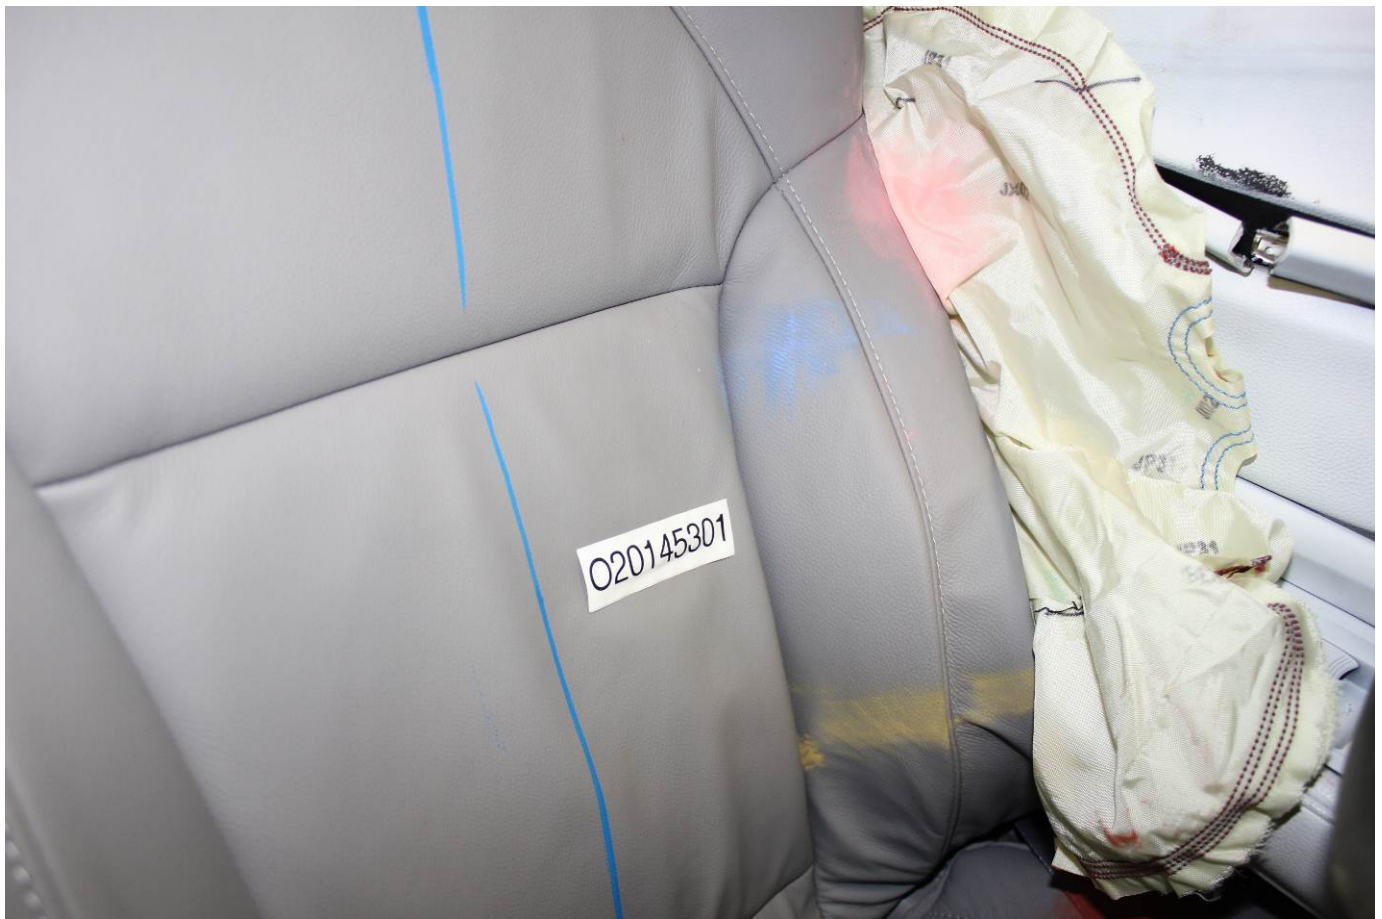
Post-Test Dummy Close-Up Head Contact with Side Air Bag View

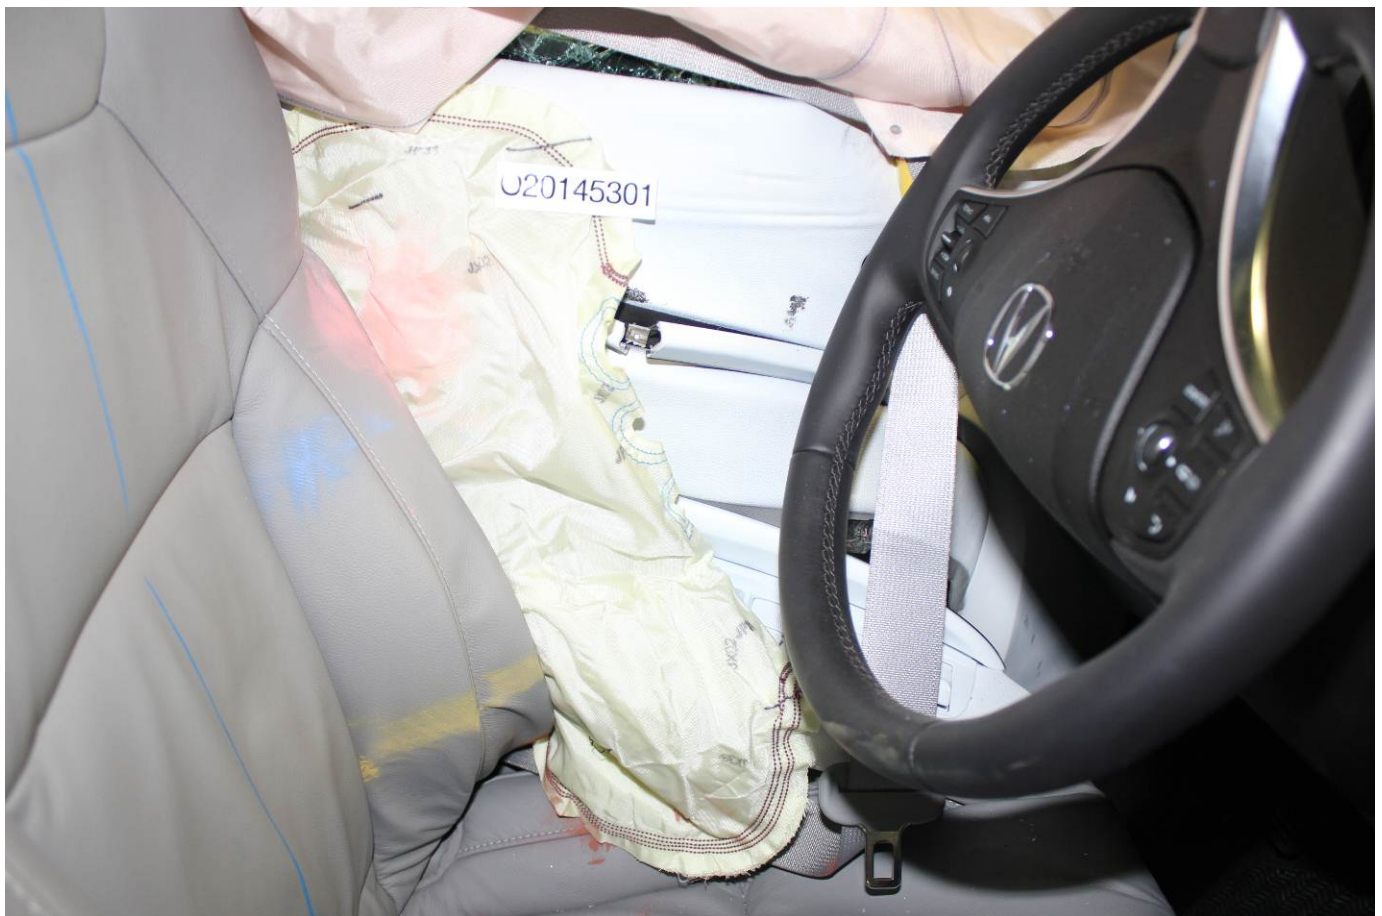
Post-Test Dummy Close-Up Torso Contact with Vehicle Interior View

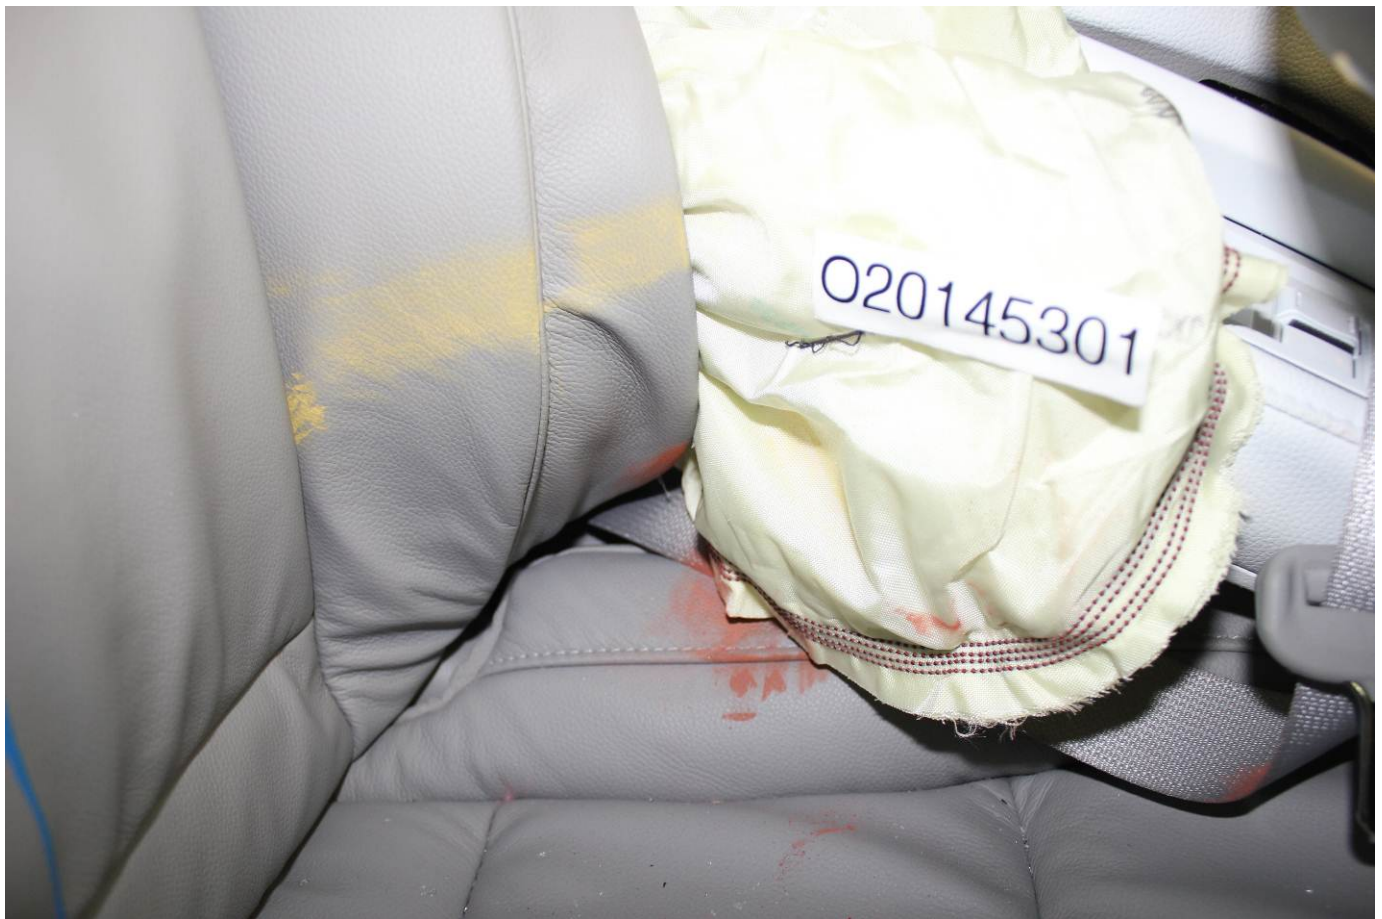
Post-Test Dummy Close-Up Torso Contact with Side Air Bag View

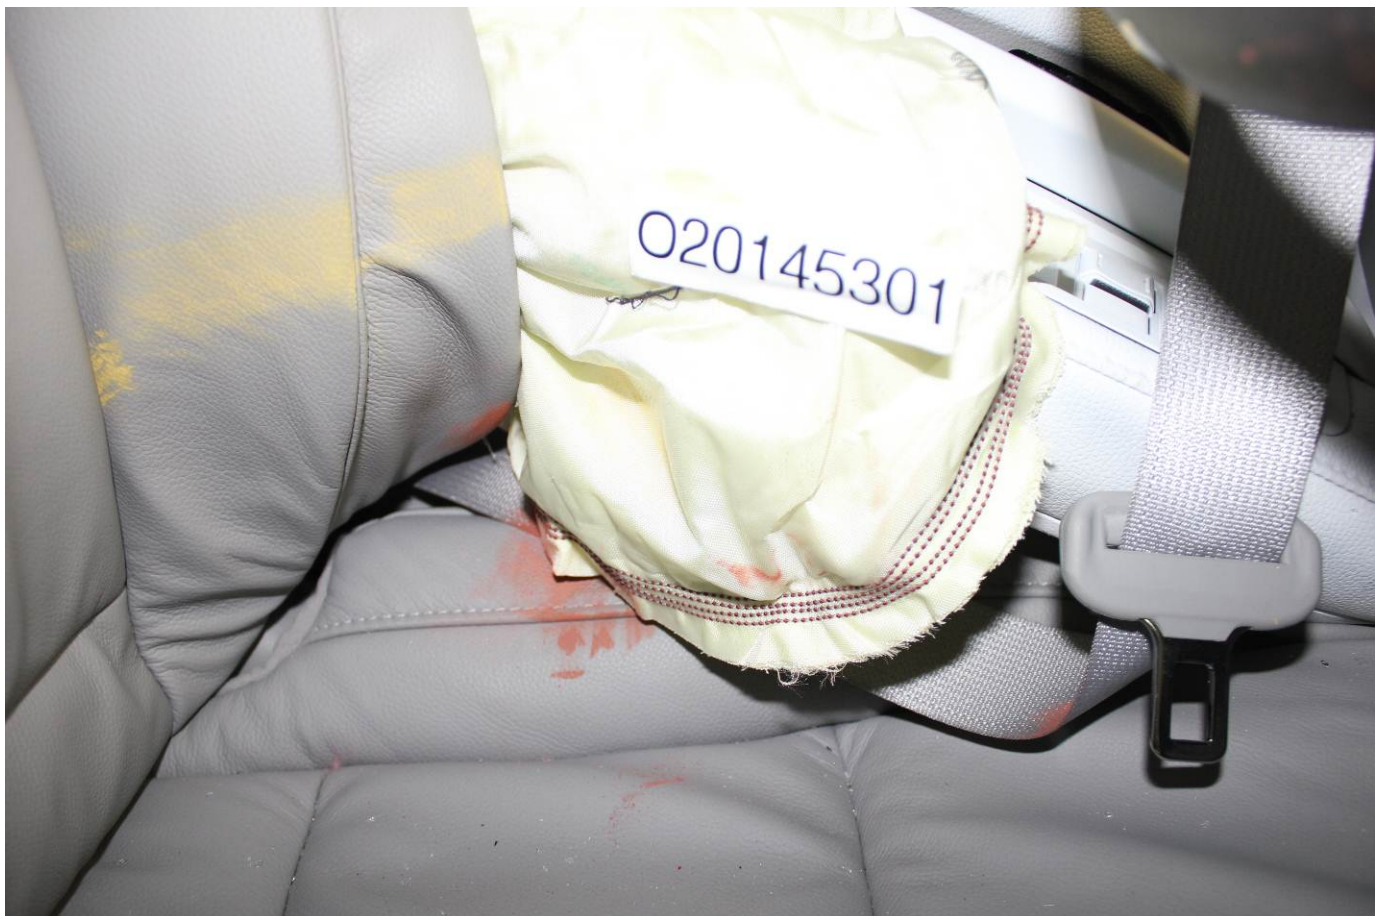
Post-Test Dummy Close-Up Pelvis Contact with Vehicle Interior View

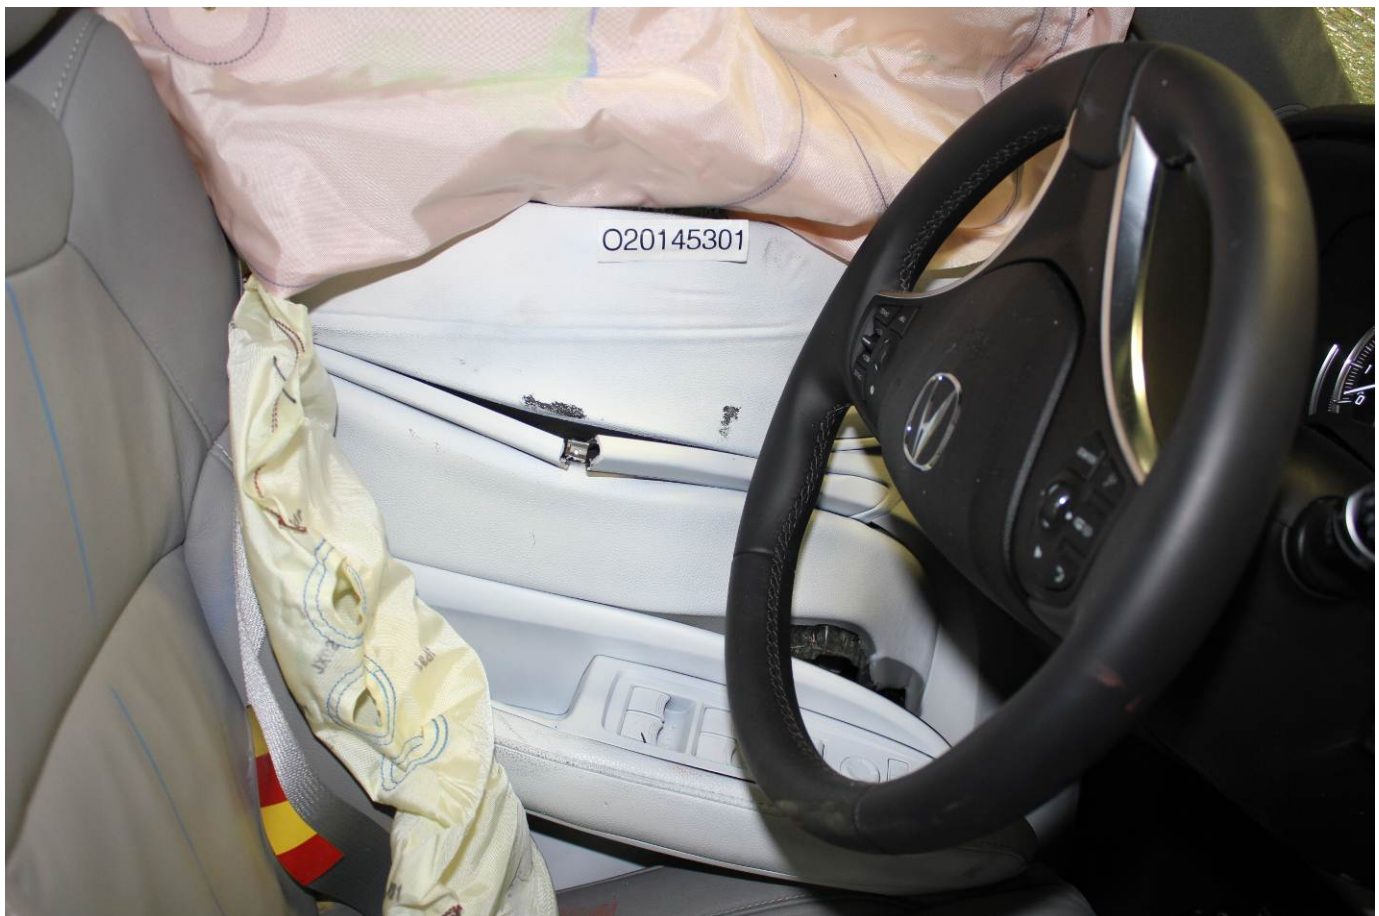
Post-Test View of Shattered Vehicle Inner Door Panel
