**REPORT NUMBER: SINCAP-MGA-2014-020**

**NEW CAR ASSESSMENT PROGRAM (NCAP)  
Moving Deformable Barrier Side Impact Test**

**TOYOTA MOTOR MANUFACTURING, INDIANA, INC.  
2014 Toyota Sienna LE Minivan  
NHTSA No.: O20145104**

**FINAL REPORT**

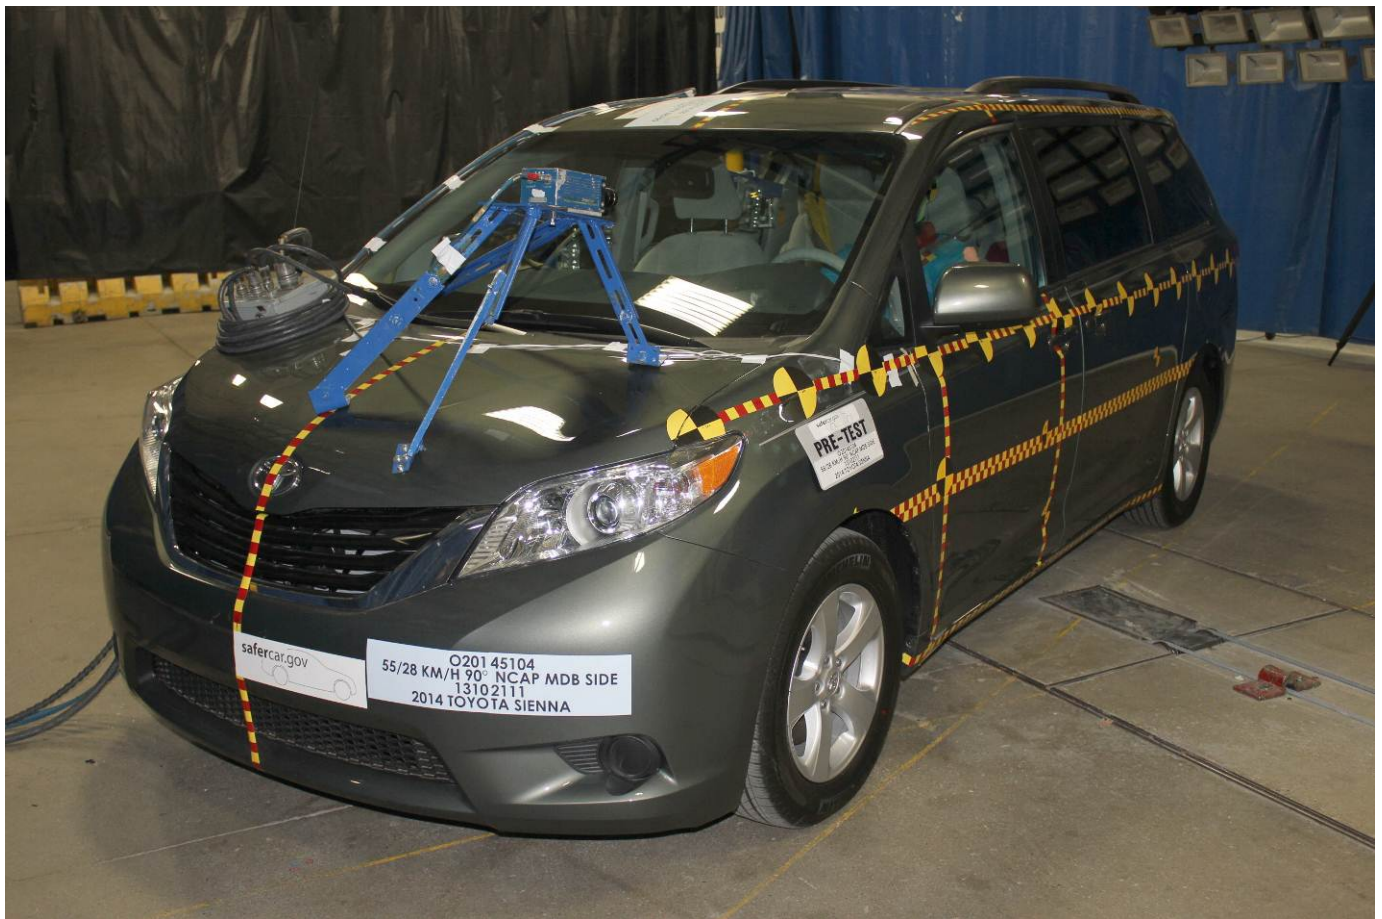
Post-Test Frontal View of Test Vehicle

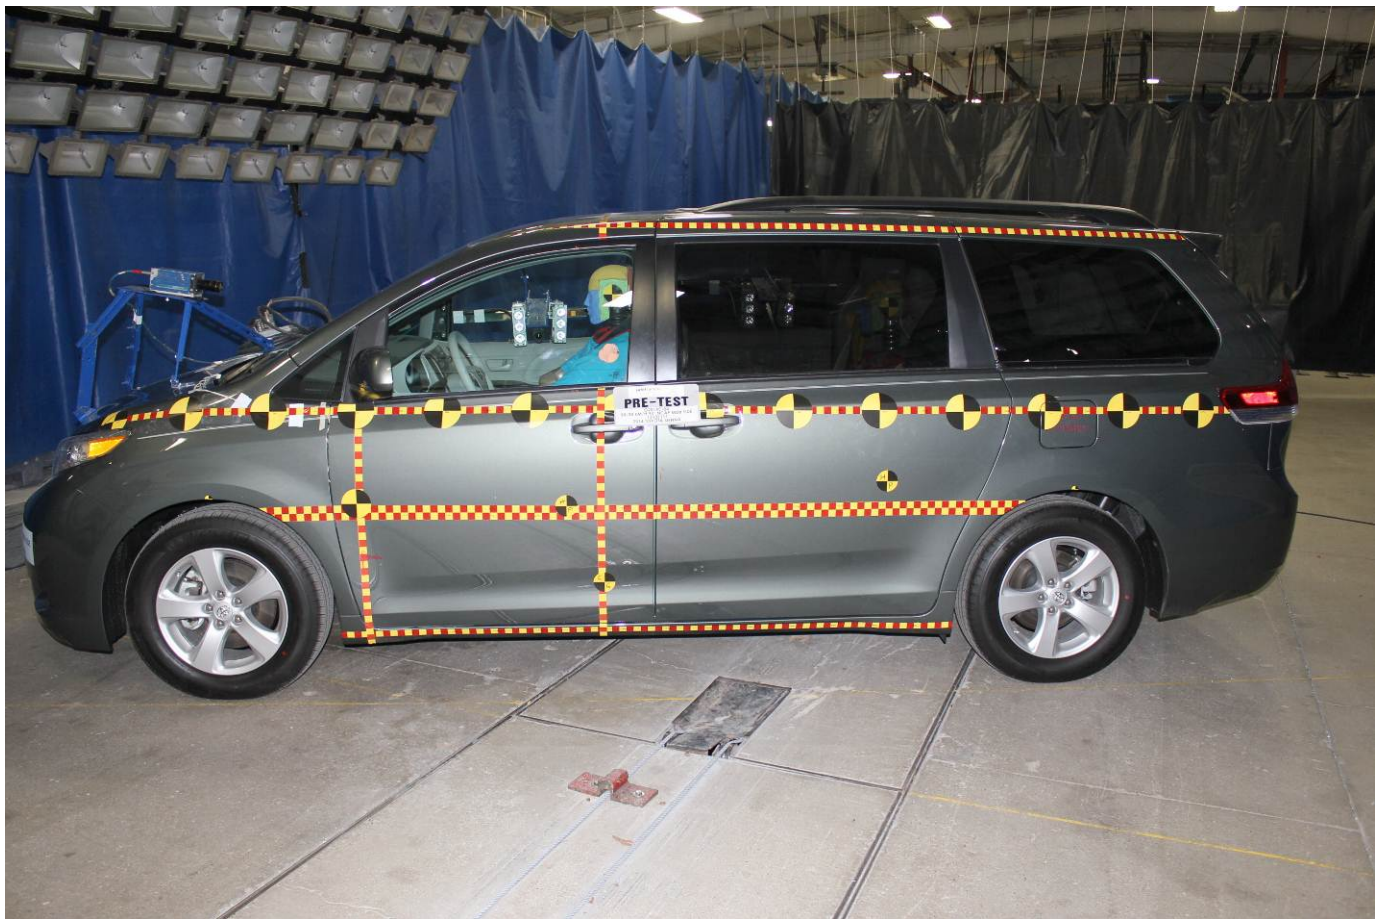
Post-Test Left Front Three-Quarter View of Test Vehicle

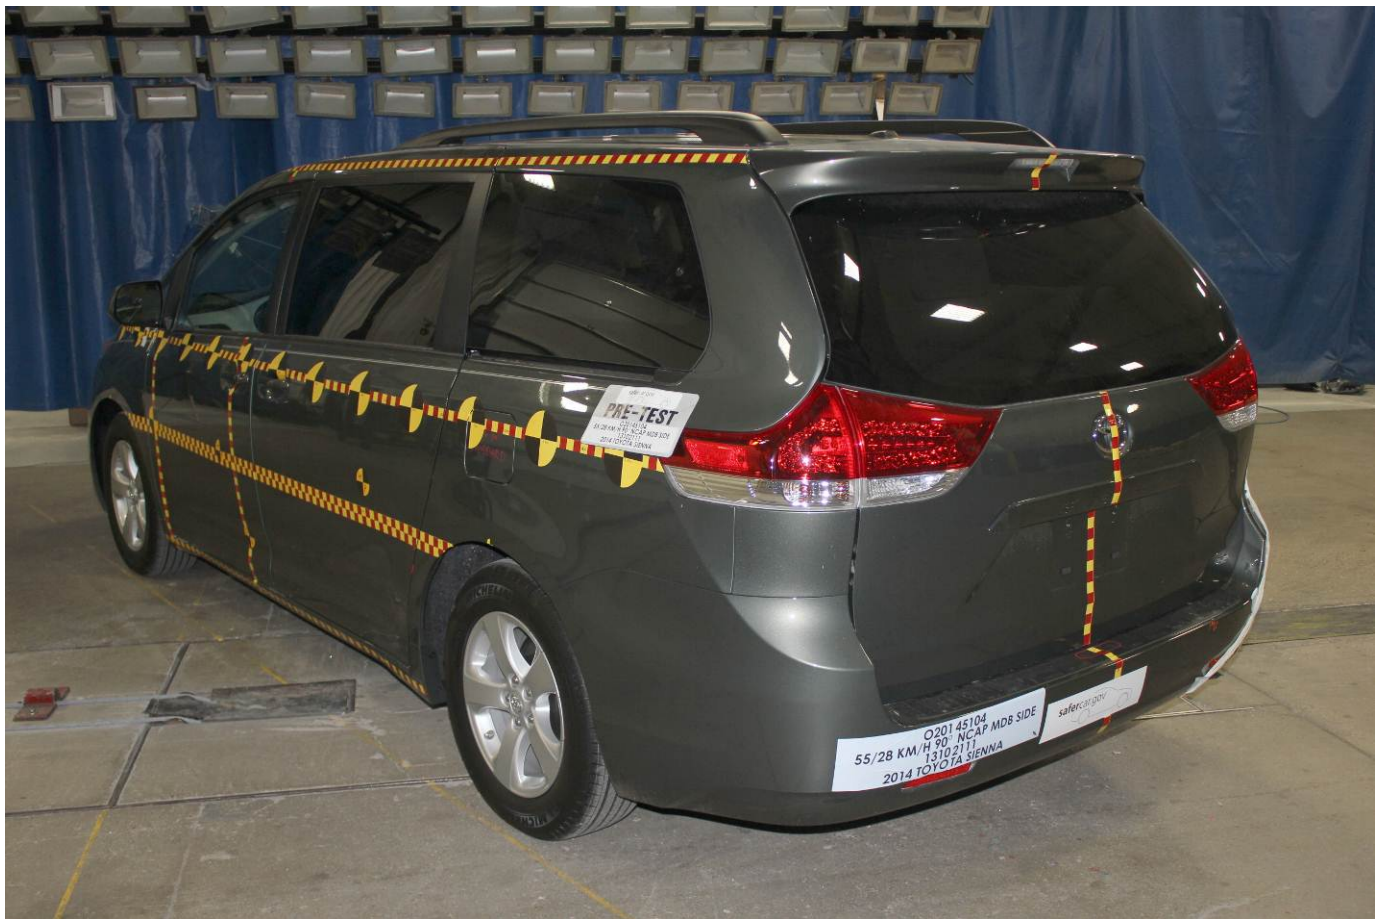
Post-Test Left Side View of Test Vehicle

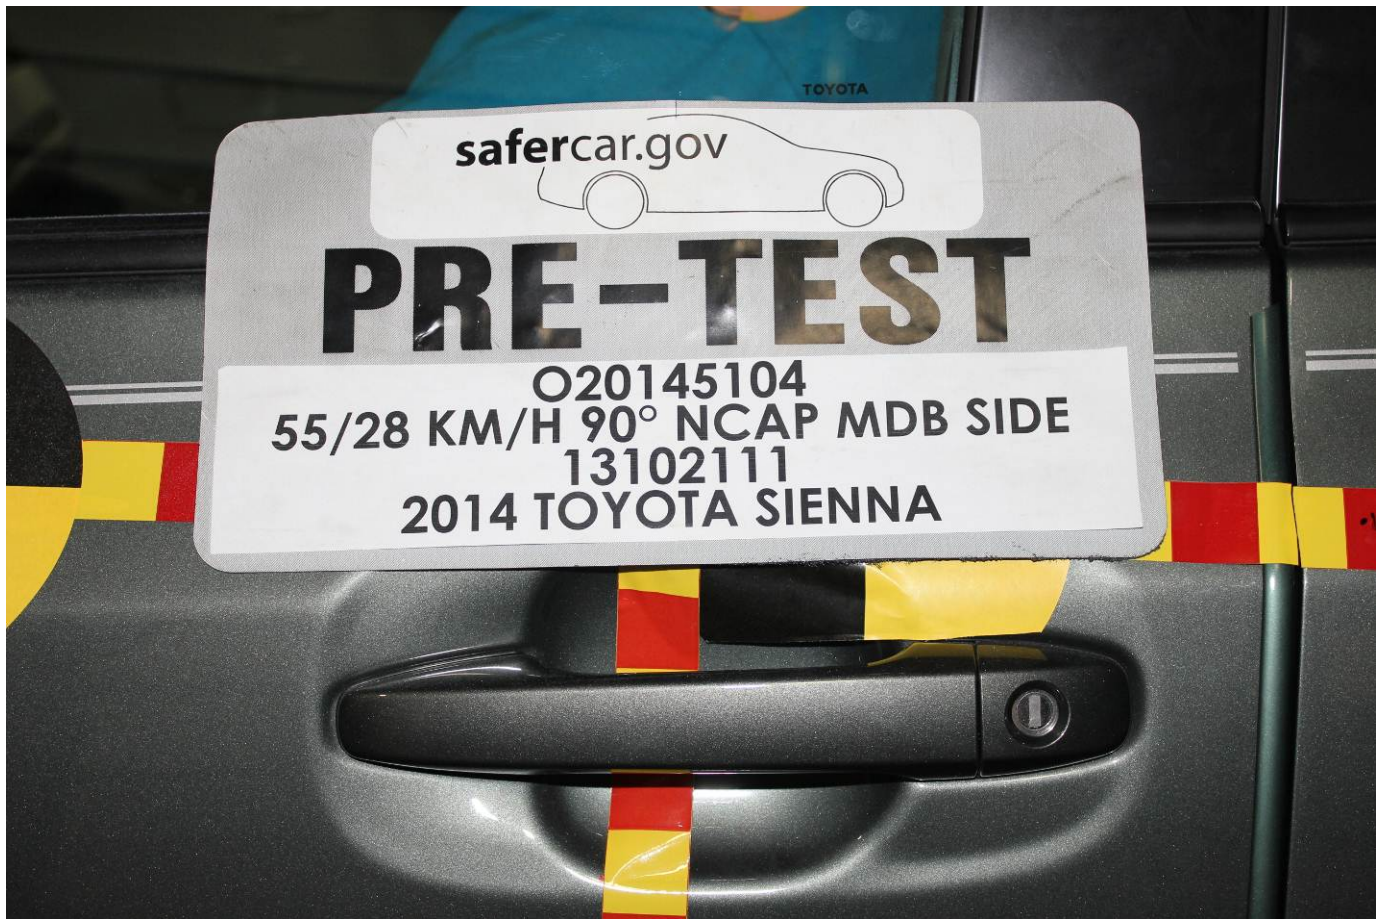
Post-Test Close-Up View of Impact Point Target

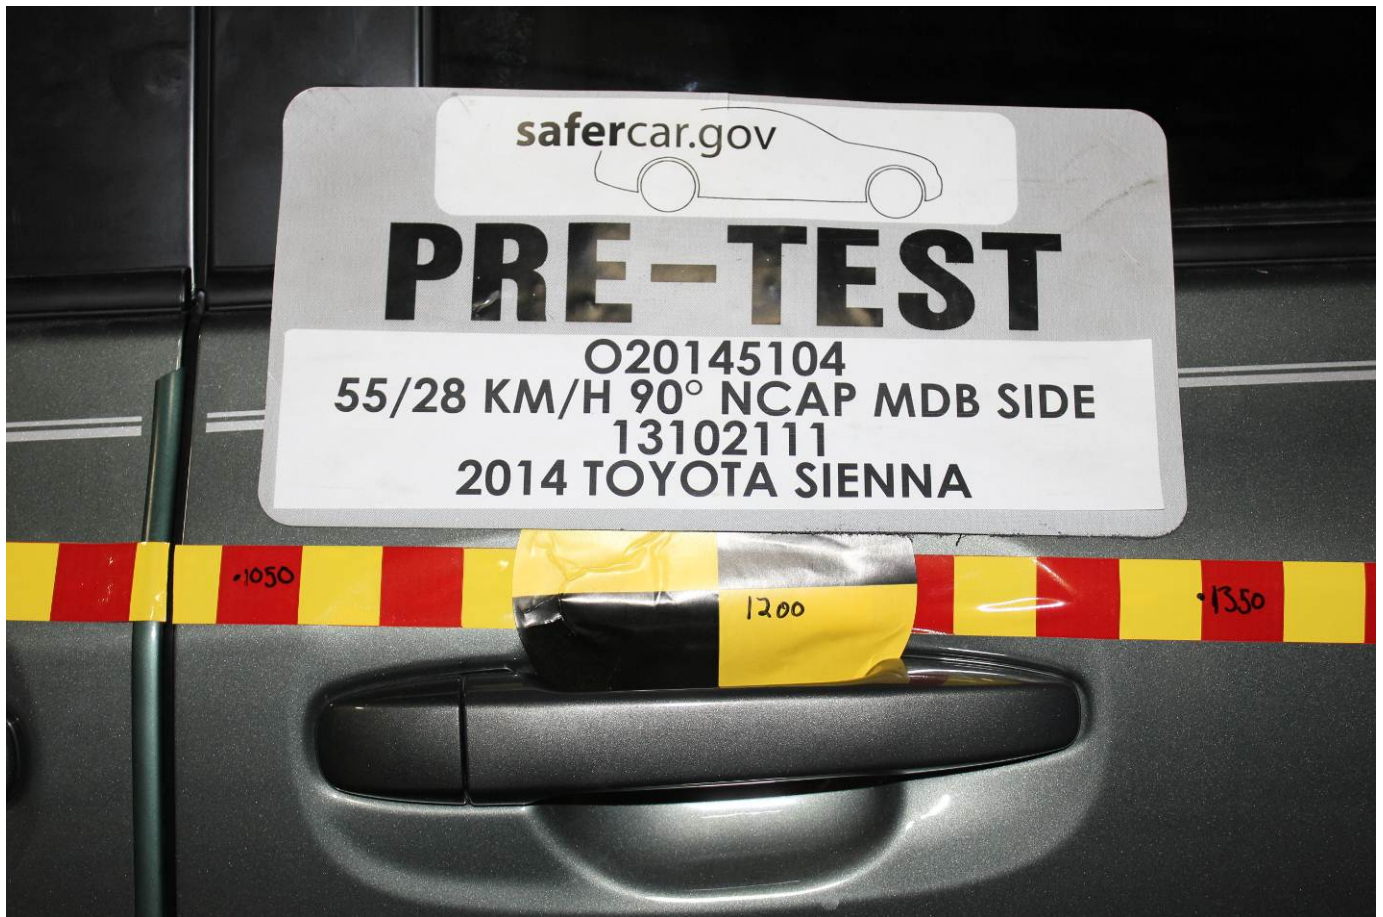
Post-Test Left Front Door Latch Close-Up
