**REPORT NUMBER TR-P33007-14-NC**

**SIDE AIRBAG OCCUPANT RISK PROGRAM  
OCCUPANT OUT-OF-POSITION TESTS**

**VOLKSWAGEN DE MEXICO S.A. DE C.V.  
2013 VOLKSWAGEN BEETLE  
2-DOOR COUPE**

**NHTSA NUMBER: MD5801TWG2-2**

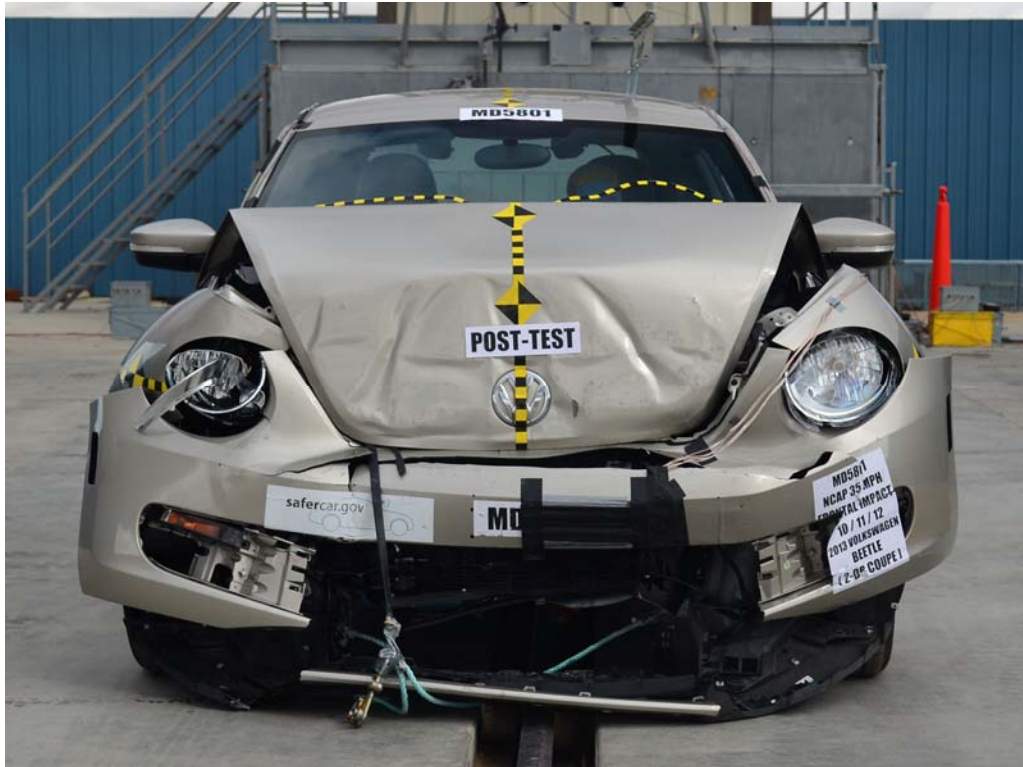
FIGURE 3. Post-Test Front View of NCAP Frontal Impact Test

\* Vehicle underwent New Car Assessment Program Frontal Impact Testing on October 12, 2012

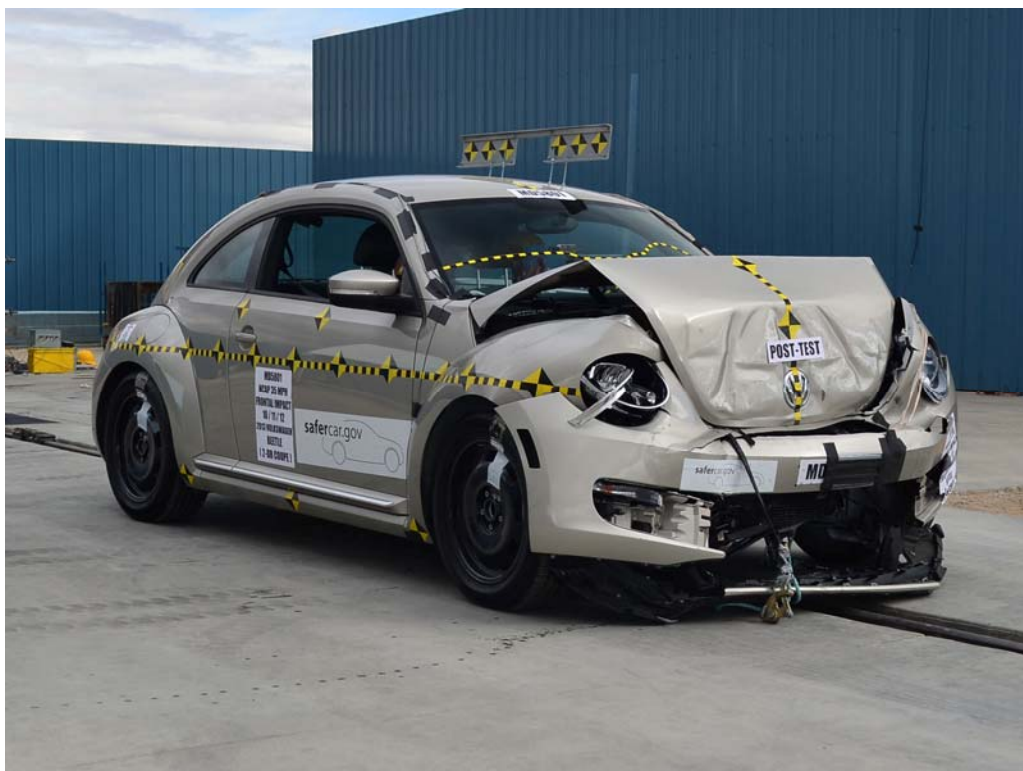
FIGURE 4. Post-Test Right Front 3/4 View of NCAP Frontal Impact Test

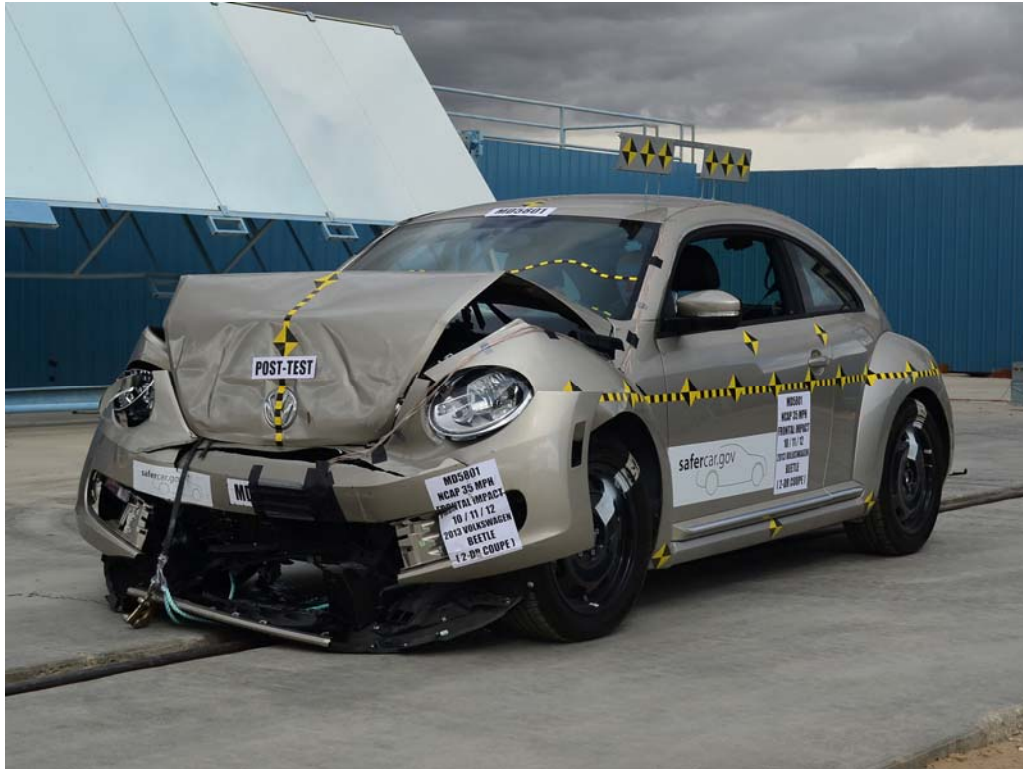
FIGURE 5. Post-Test Left Front  $\frac{3}{4}$  View of NCAP Frontal Impact Test

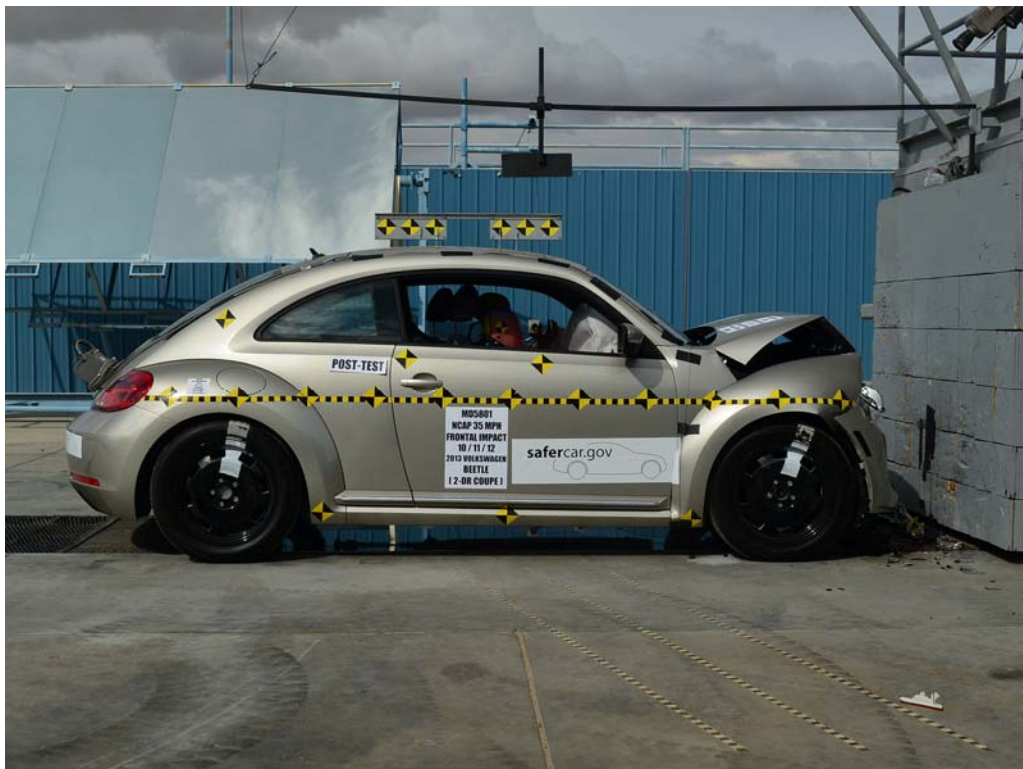
FIGURE 6. Post-Test Right Side View of NCAP Frontal Impact Test

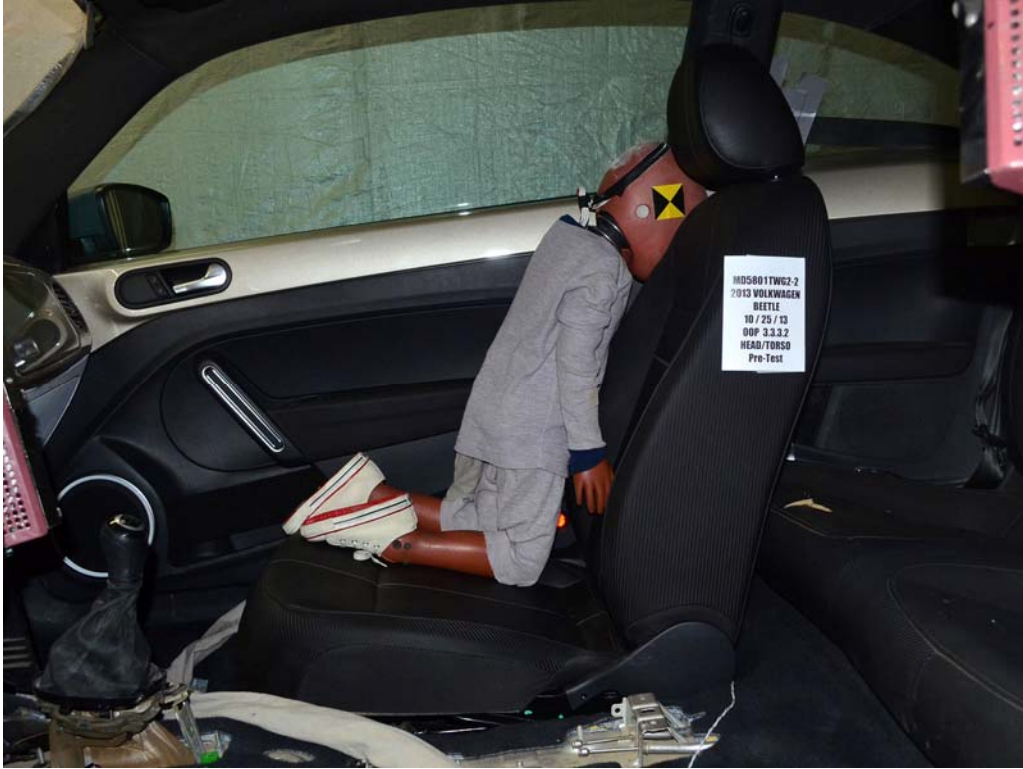
FIGURE 7. Pre-Test Dummy Position, Left Side View

Orientation of the 3 year old dummy was in the rearward facing position leaning against the seat. The dummy's upper sternum was aligned with the deploying trajectory of the airbag. This orientation complies with section 3.3.3.2 of the Technical Working Group (TWG) recommendation in the Recommended Procedures for Evaluating Occupant Injury Risk from Deploying Side Airbags.

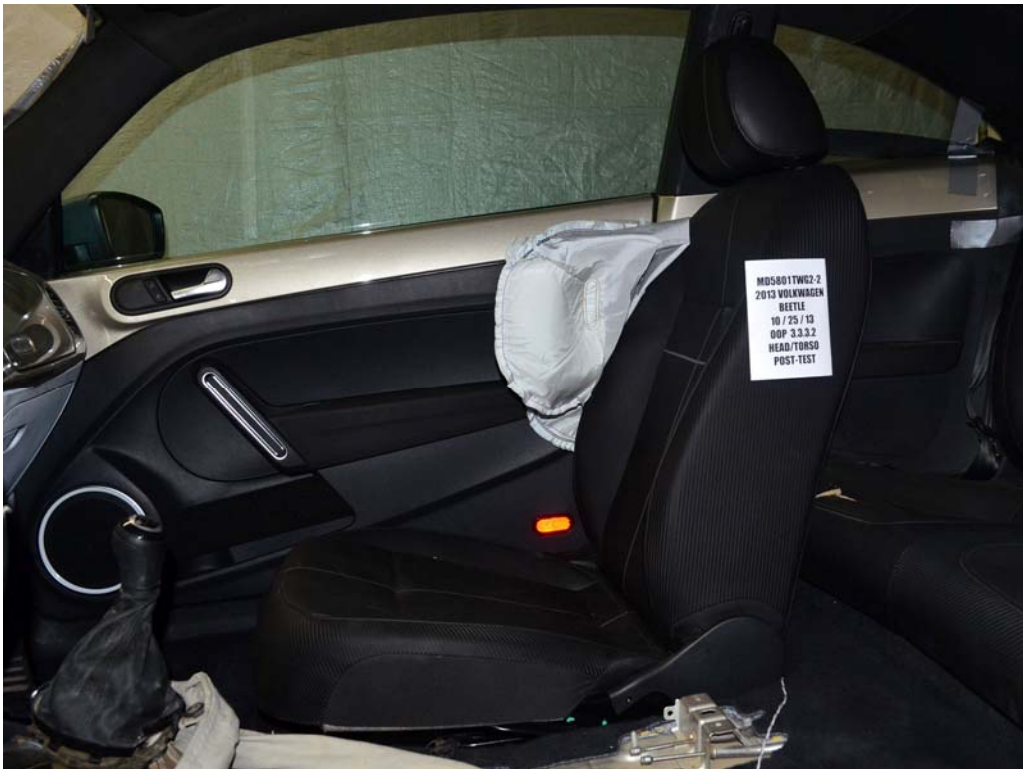
FIGURE 8. Post-Test Dummy Position, Left Side View

The 3 year old dummy's visible contact points were as follows: The head/torso side airbag contacted the ATD's head, abdomen, pelvis and legs.

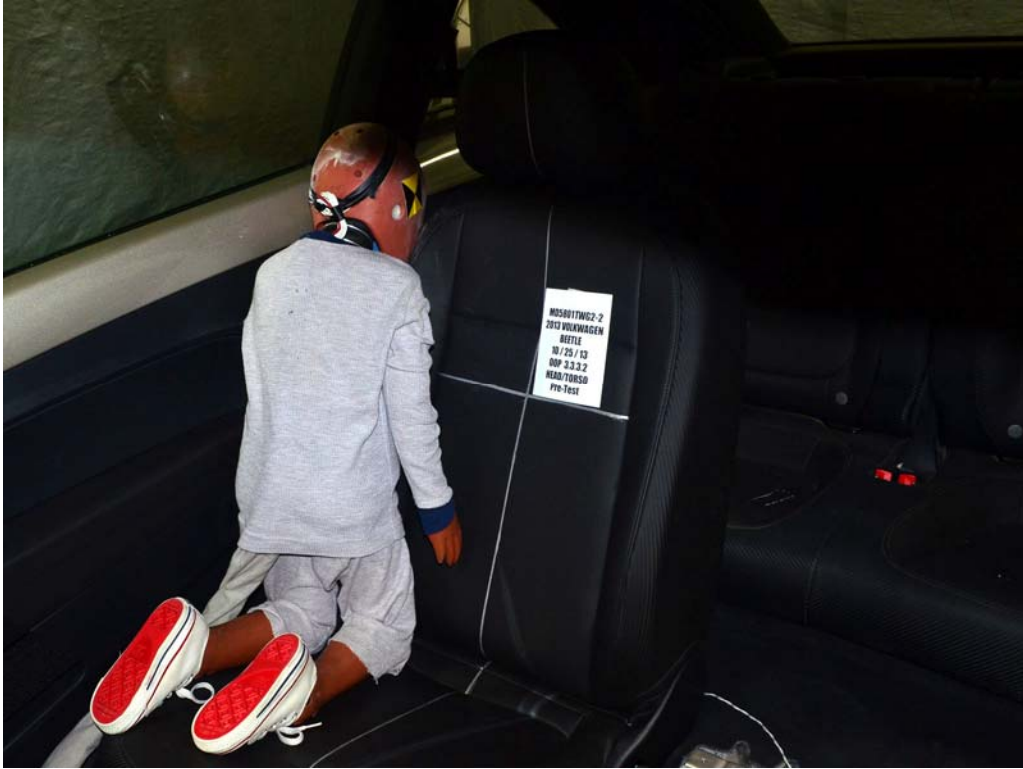
FIGURE 9. Pre-Test Dummy Position,  $\frac{3}{4}$  View

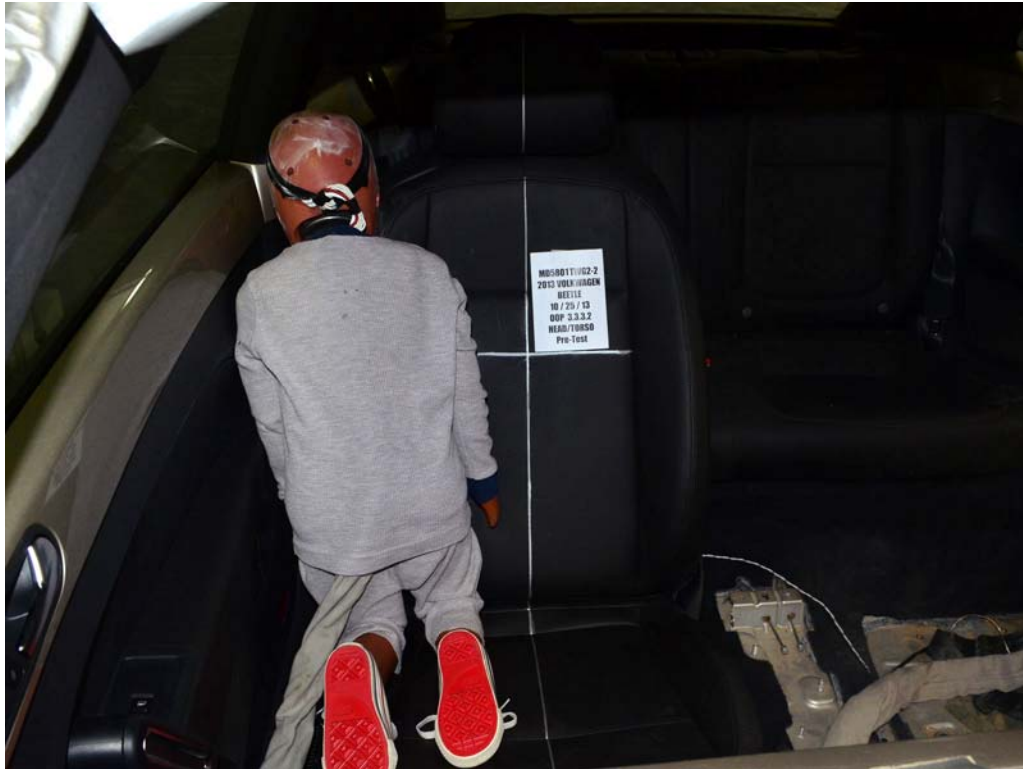
FIGURE 11. Pre-Test Dummy Position, Front View

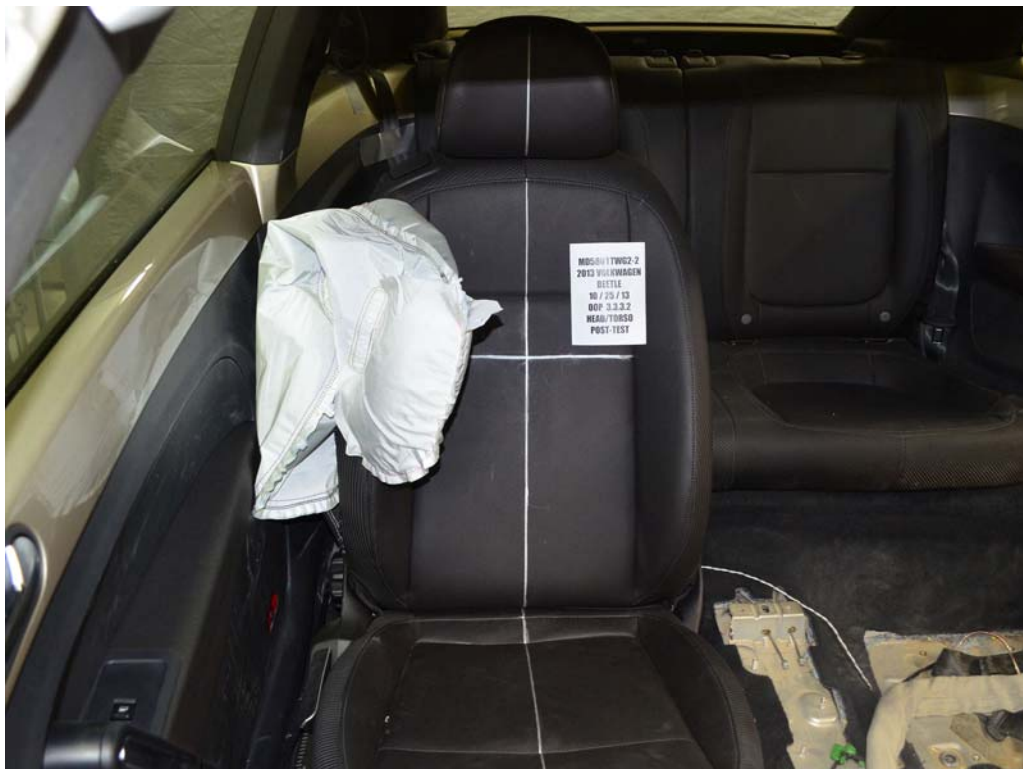
FIGURE 12. Post-Test Dummy Position, Front View

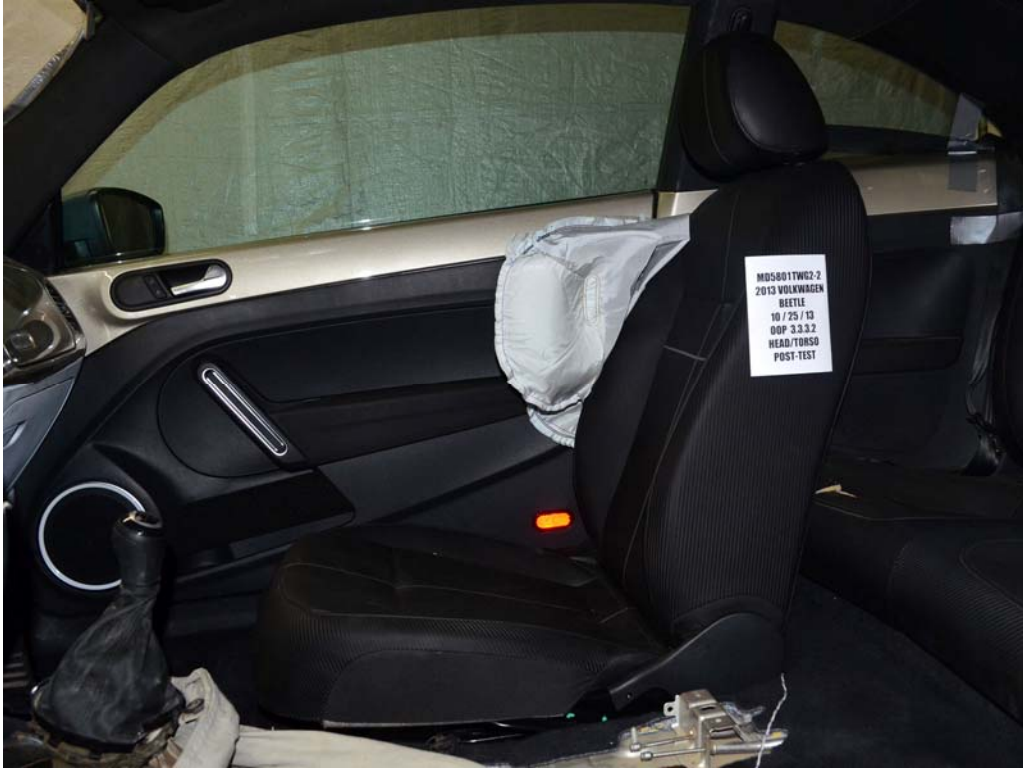
FIGURE 13. Post-Test Airbags, Left Side View
