**REPORT NUMBER: NCAP-MGA-2014-022**

**NEW CAR ASSESSMENT PROGRAM (NCAP)  
Frontal Barrier Impact Test**

**CHRYSLER GROUP LLC  
2014 Jeep Grand Cherokee Laredo 4X4 SUV  
NHTSA No.: O20140300**

**MGA RESEARCH CORPORATION  
5000 Warren Road  
Burlington, WI 53105**

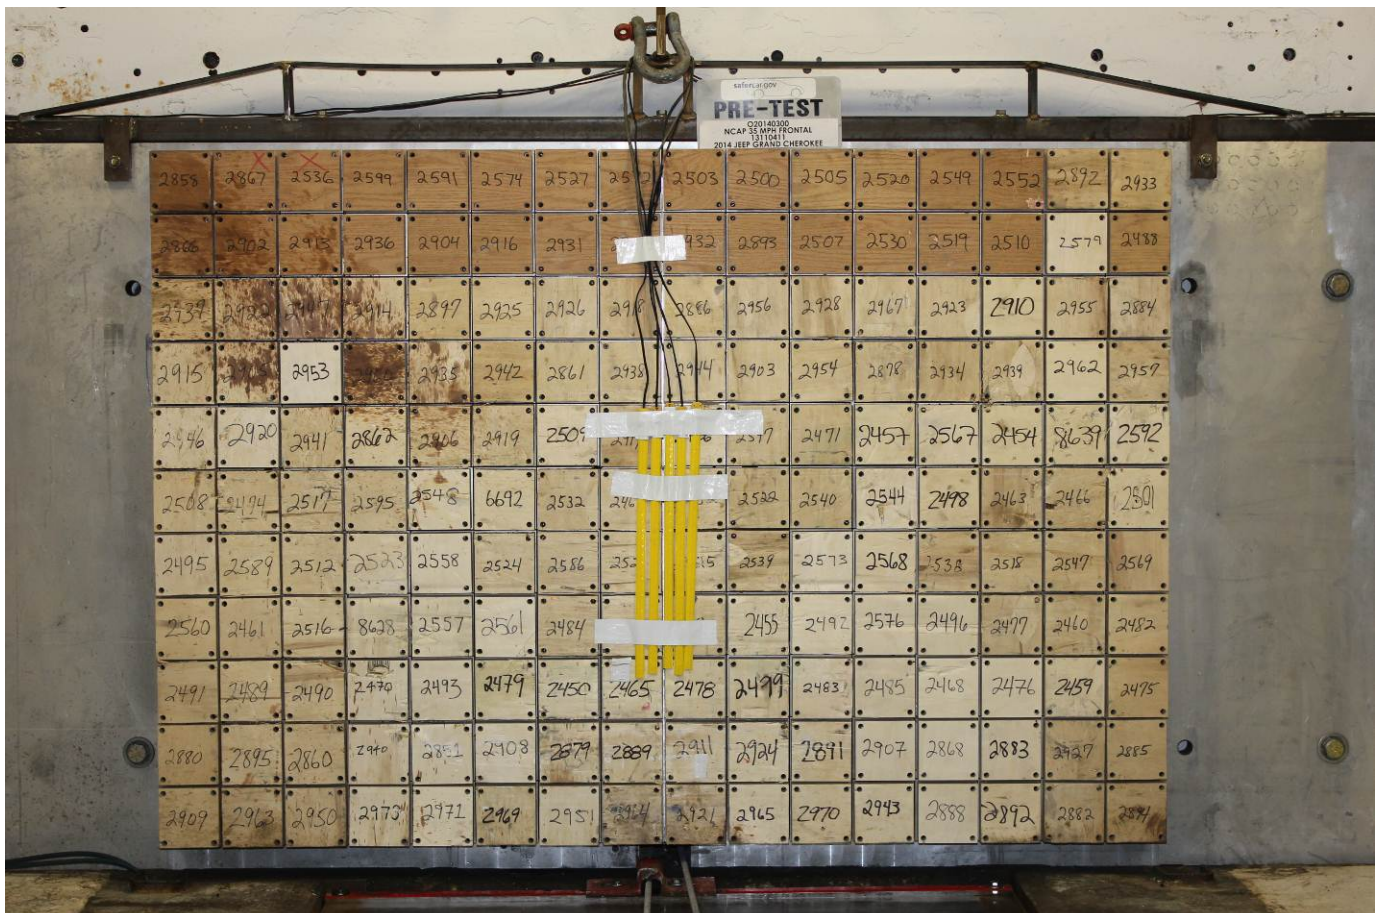
Load Cell Wall

A load cell barrier consisting of 176 load cells was impacted by a 2014 Jeep Grand Cherokee Laredo 4X4 SUV at a velocity of 56.3 km/h. The test was performed at MGA Research Corporation on November 4, 2013. Pre-test and post-test photographs of the vehicle and dummies can be found in Appendix A.

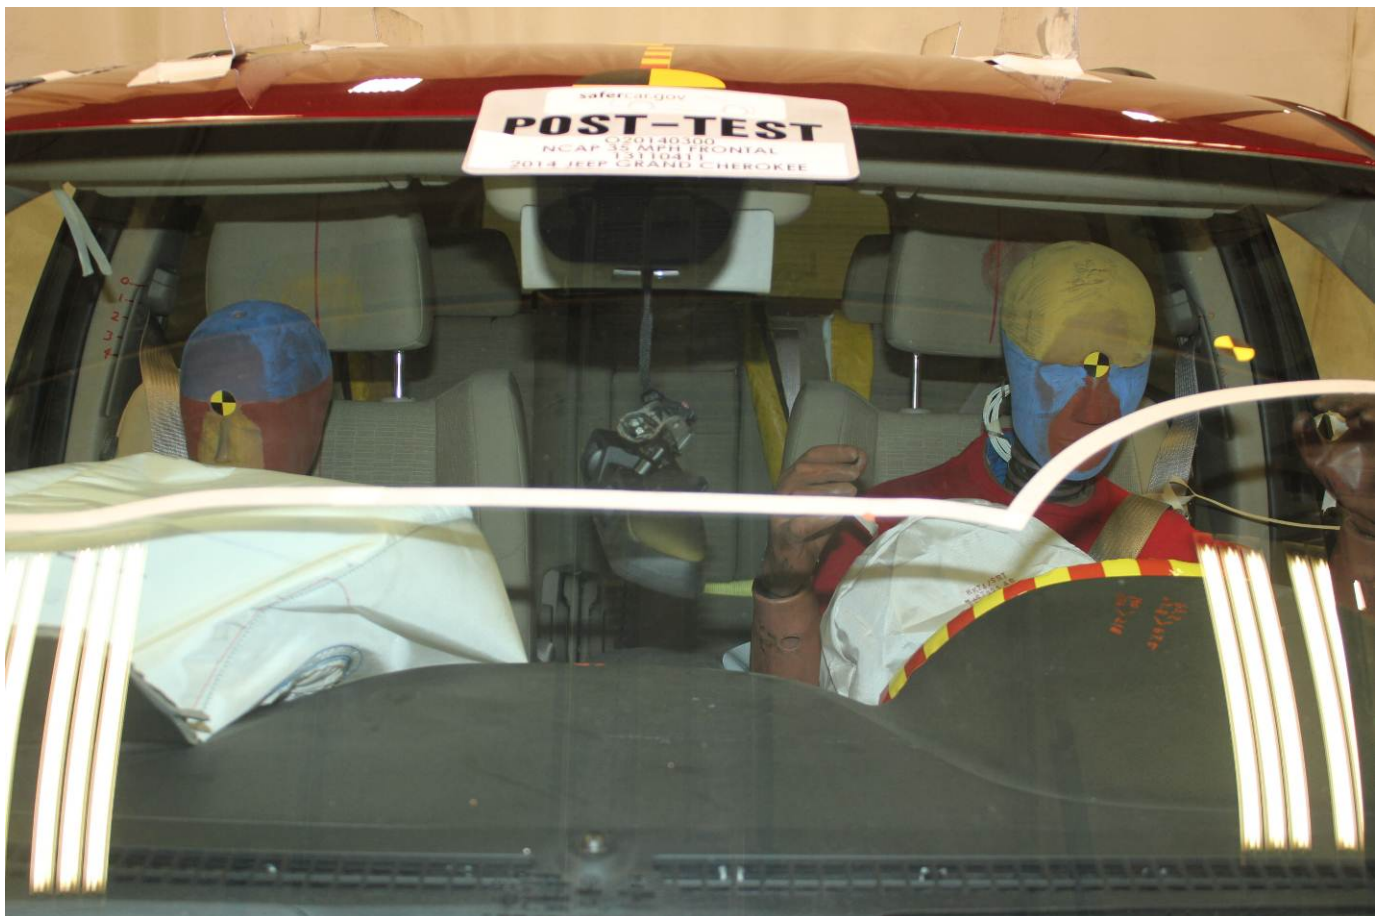
Post-Test Windshield View

There was 100 percent windshield retention and no intrusion into the protected zone of the windshield during the event. There was no Stoddard Solvent leakage after the event or during any phase of the static rollover.

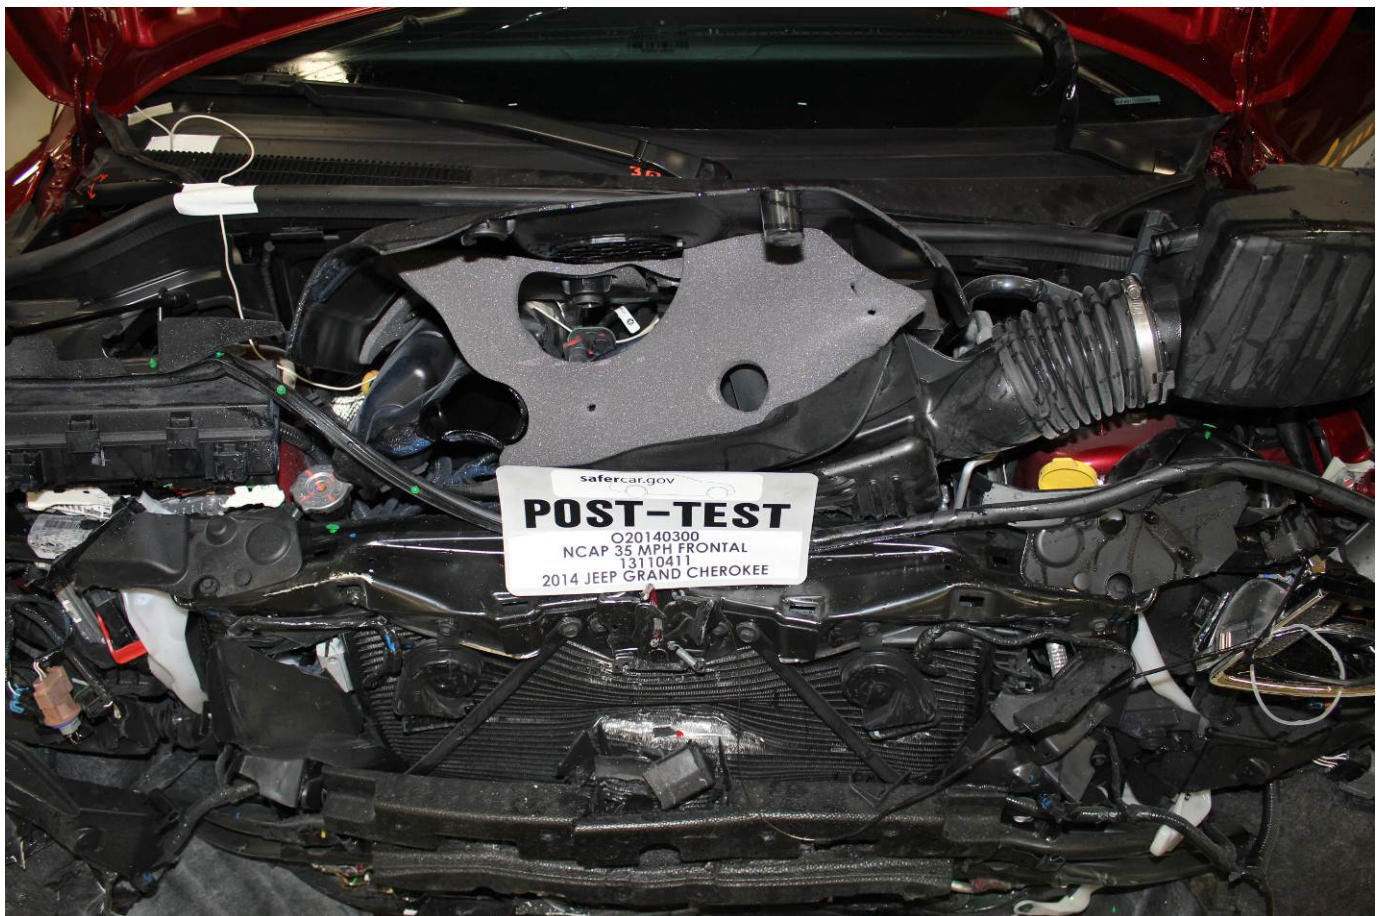
Post-Test Engine Compartment View

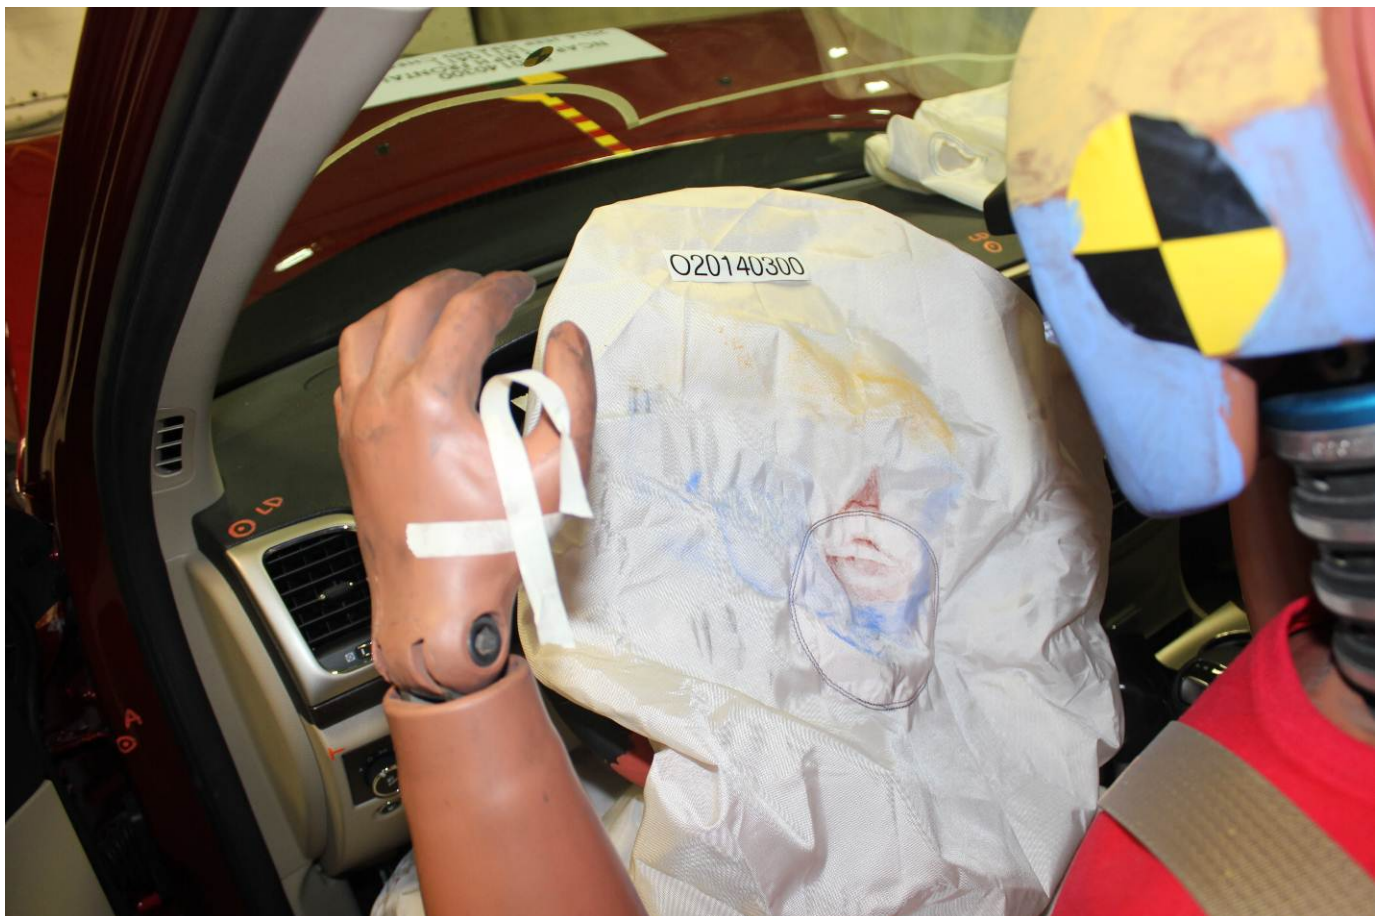
Post-Test Driver Dummy Contact with Airbag

The driver's visible contact points were as follows: The driver's head and chest contacted the airbag. The driver's head also contacted the headrest. The driver's knees contacted the knee airbag. The passenger's visible contact points were as follows: The passenger's head and chest contacted the airbag. The passenger's head also contacted the headrest. The passenger's knees contacted the glovebox.

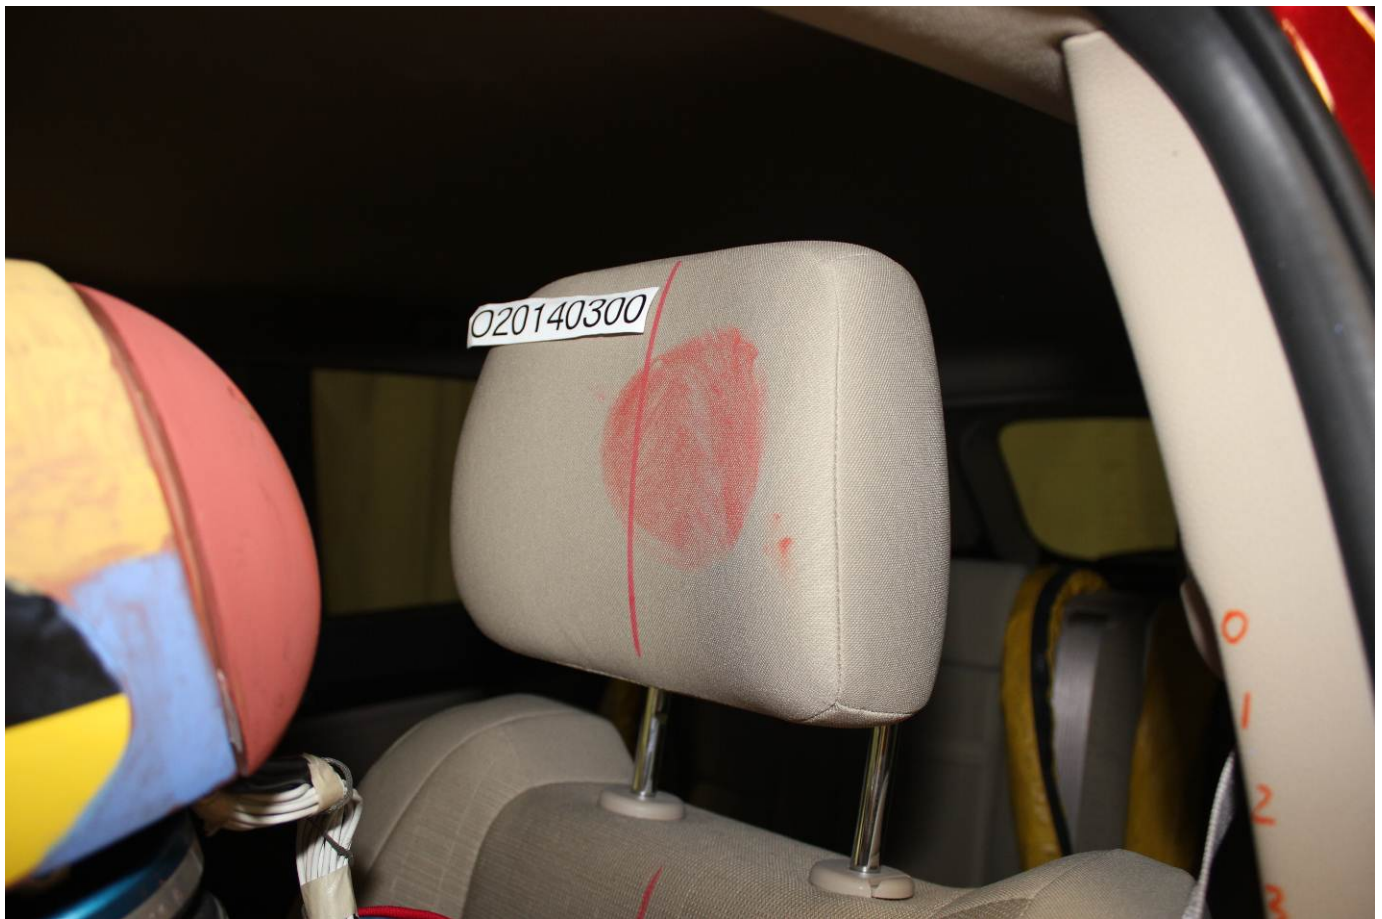
Post-Test Driver Dummy Contact with Headrest

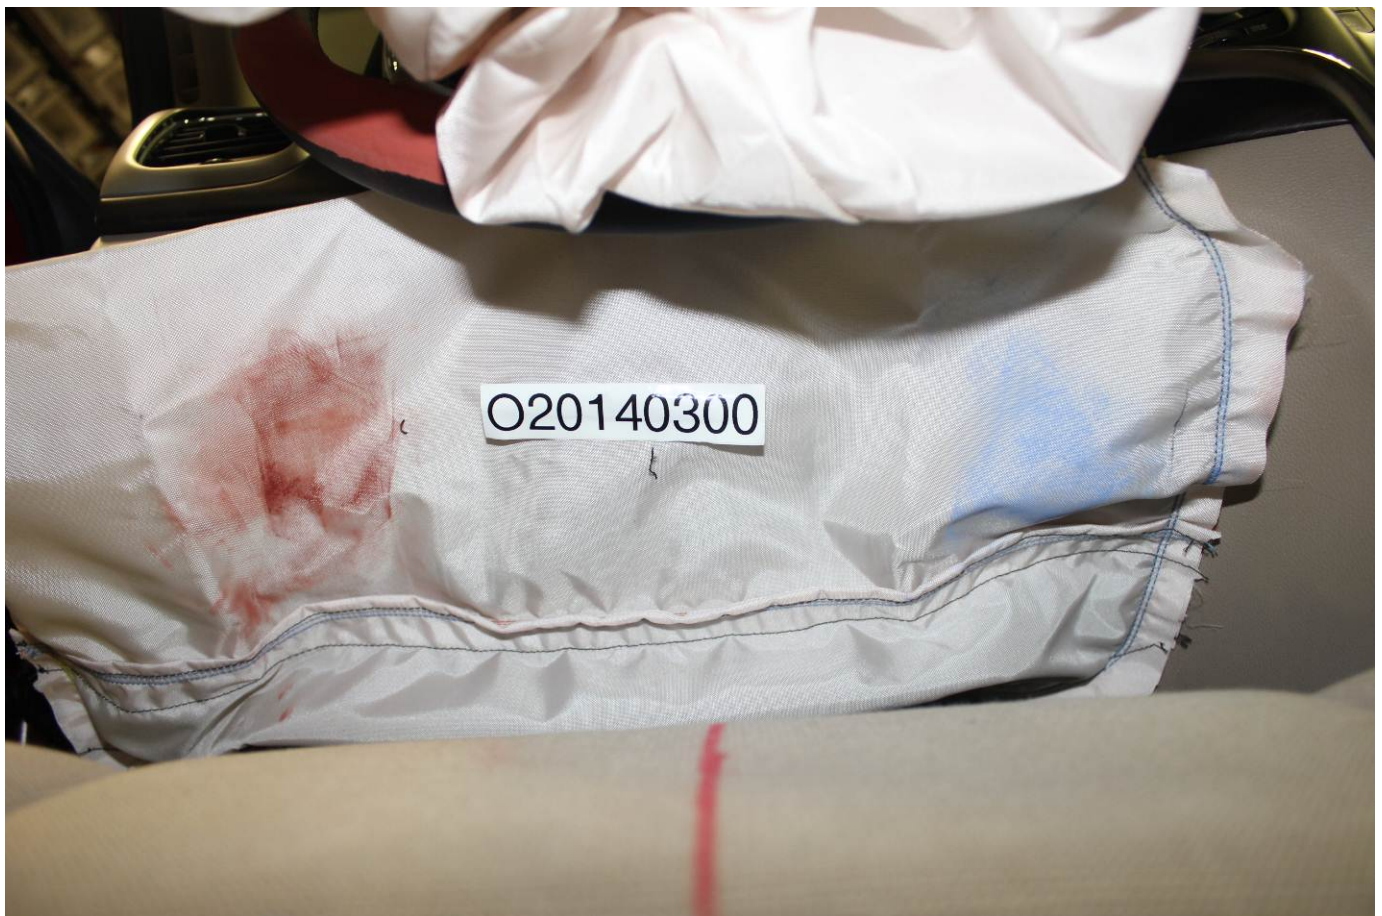
Post-Test Driver Dummy Contact with Knee Airbag

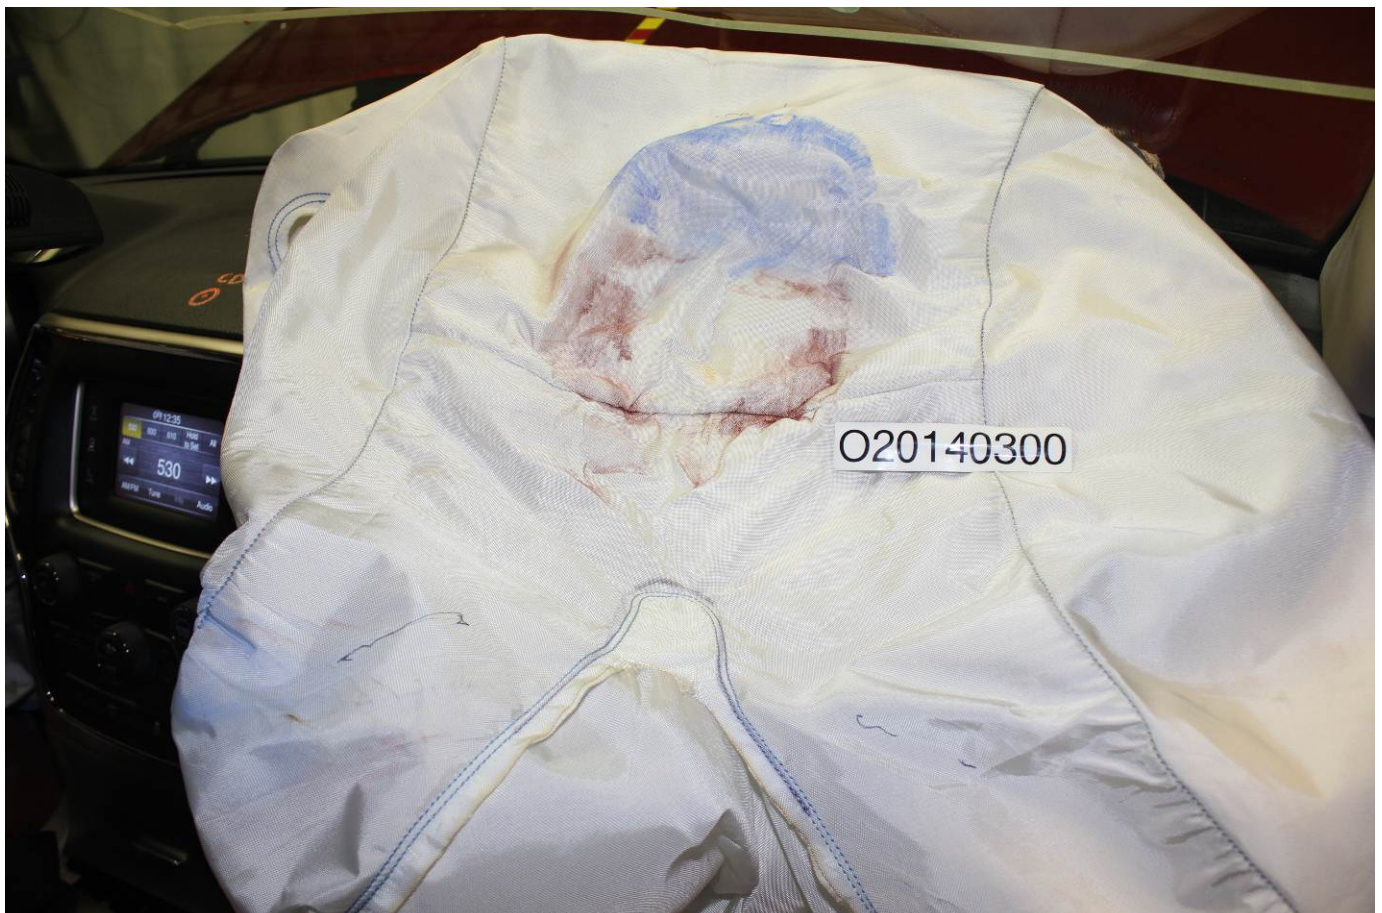
Post-Test Passenger Dummy Contact with Airbag

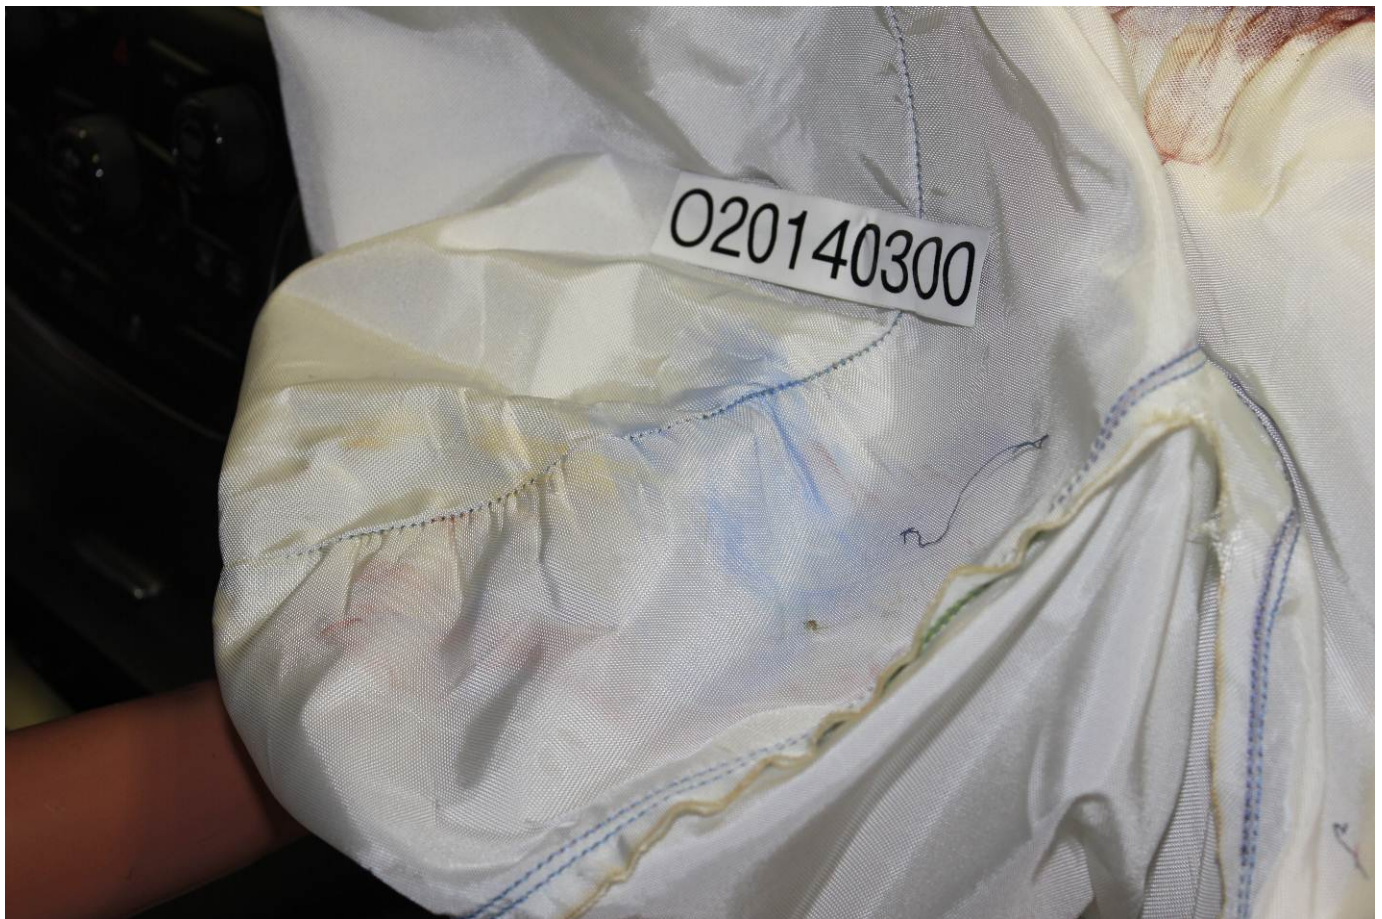
Post-Test Passenger Dummy Contact with Airbag

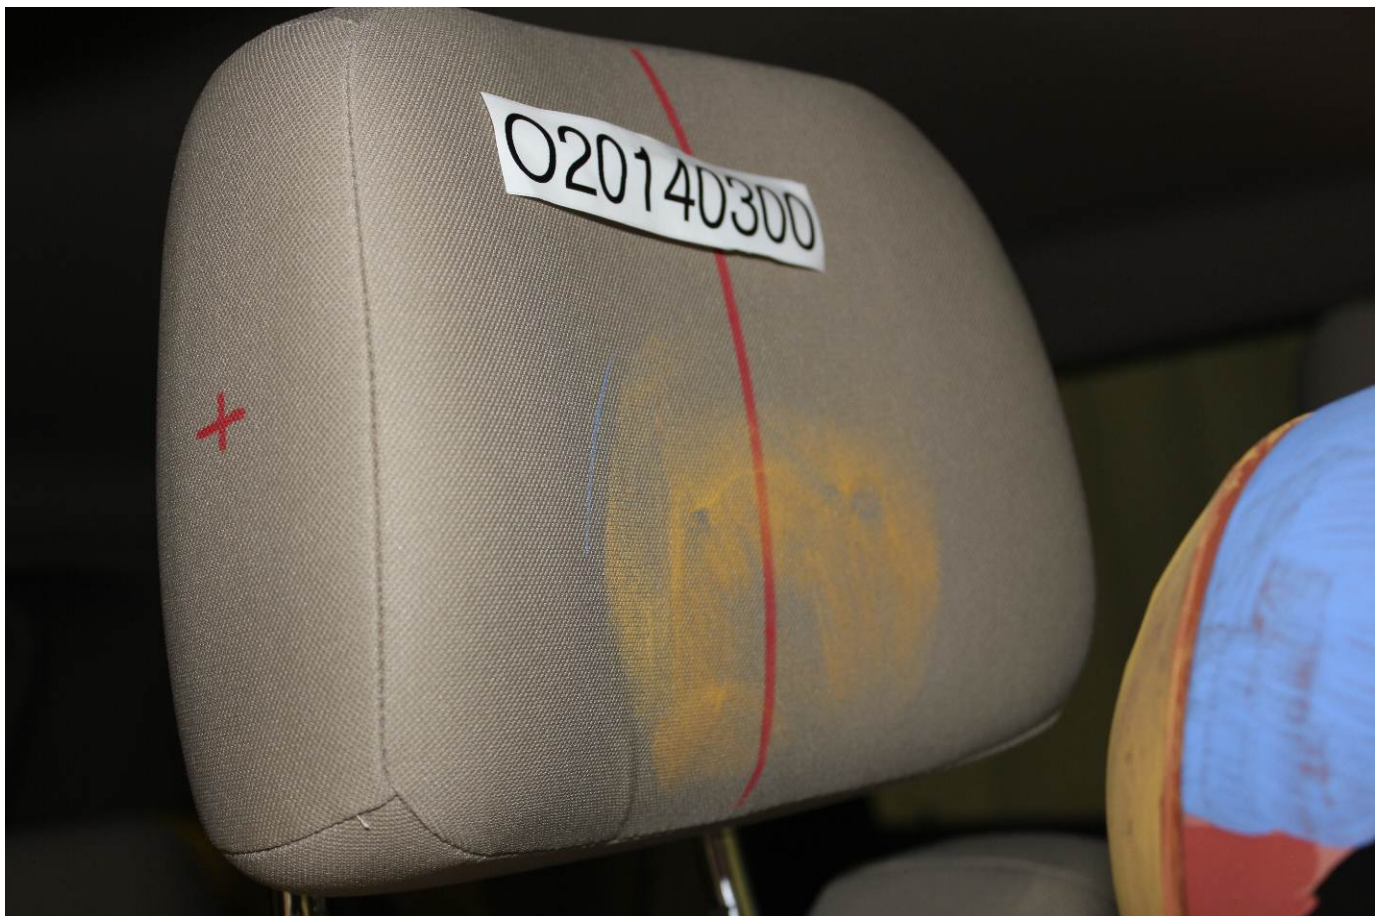
Post-Test Passenger Dummy Contact with Headrest

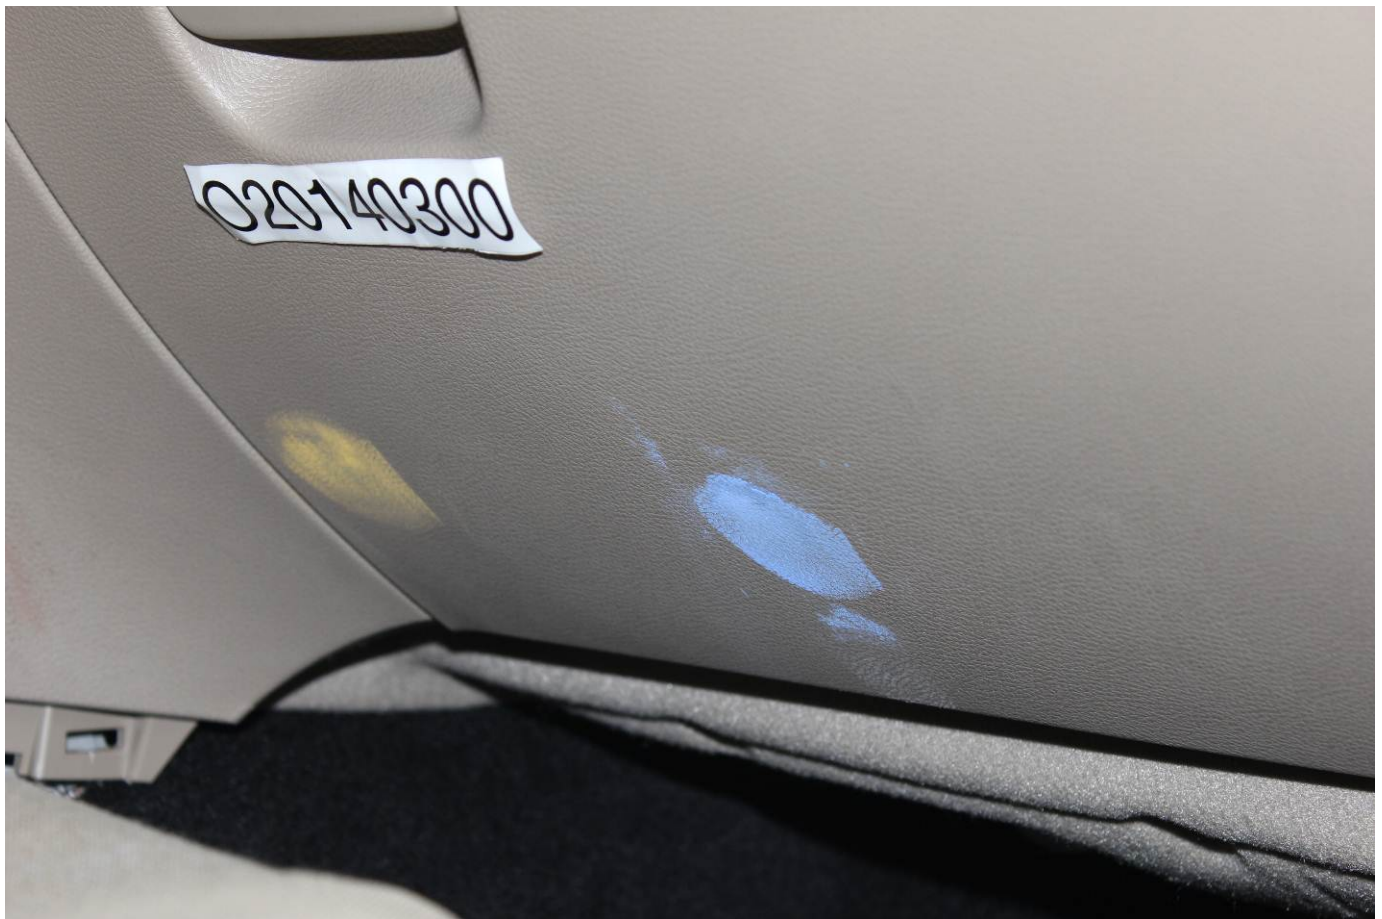
Post-Test Passenger Dummy Contact with Glovebox

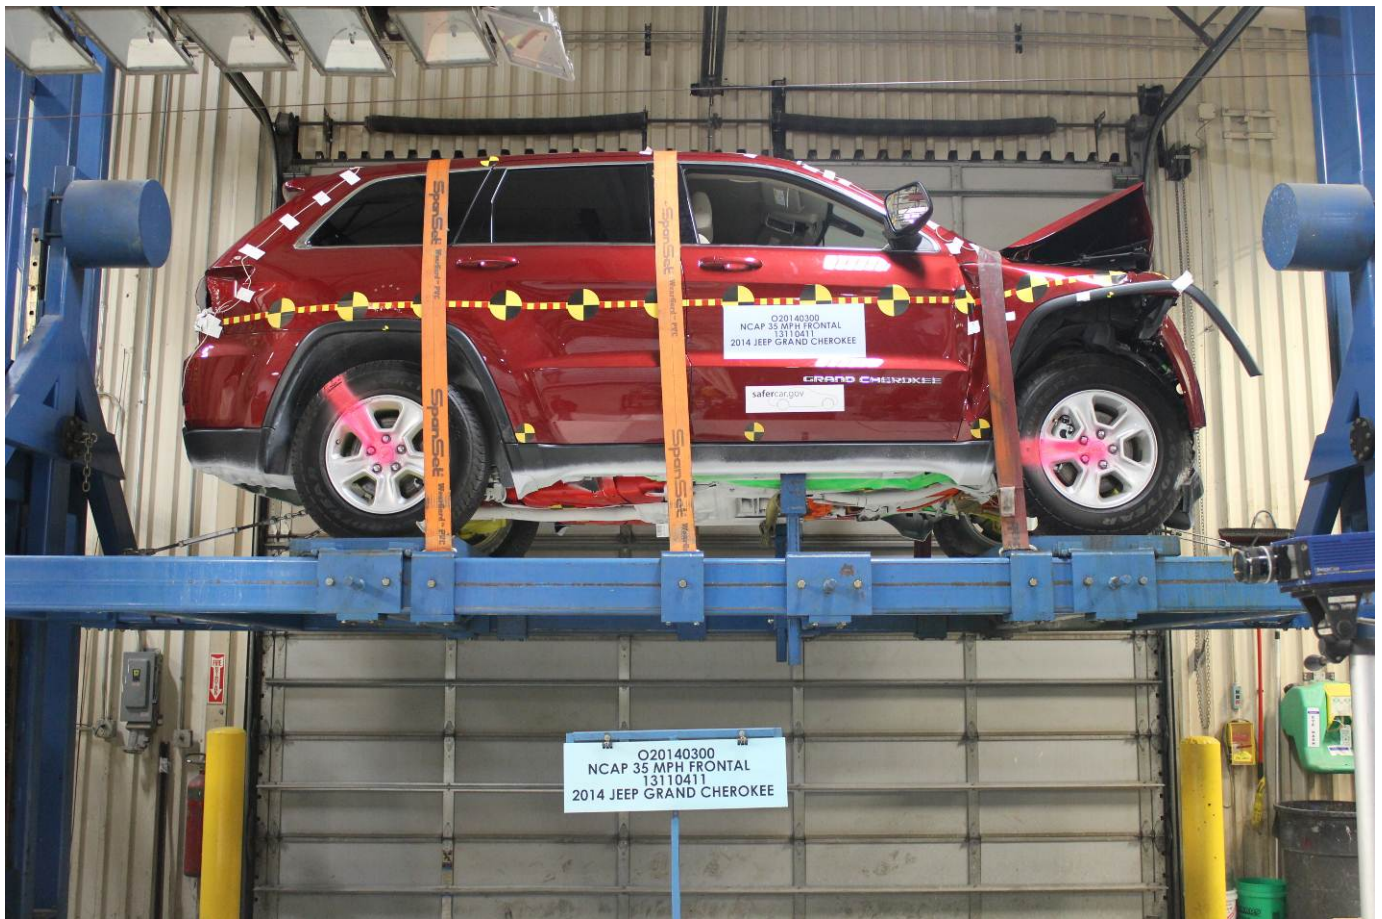
Vehicle at 0 Degree on Static Rollover Device

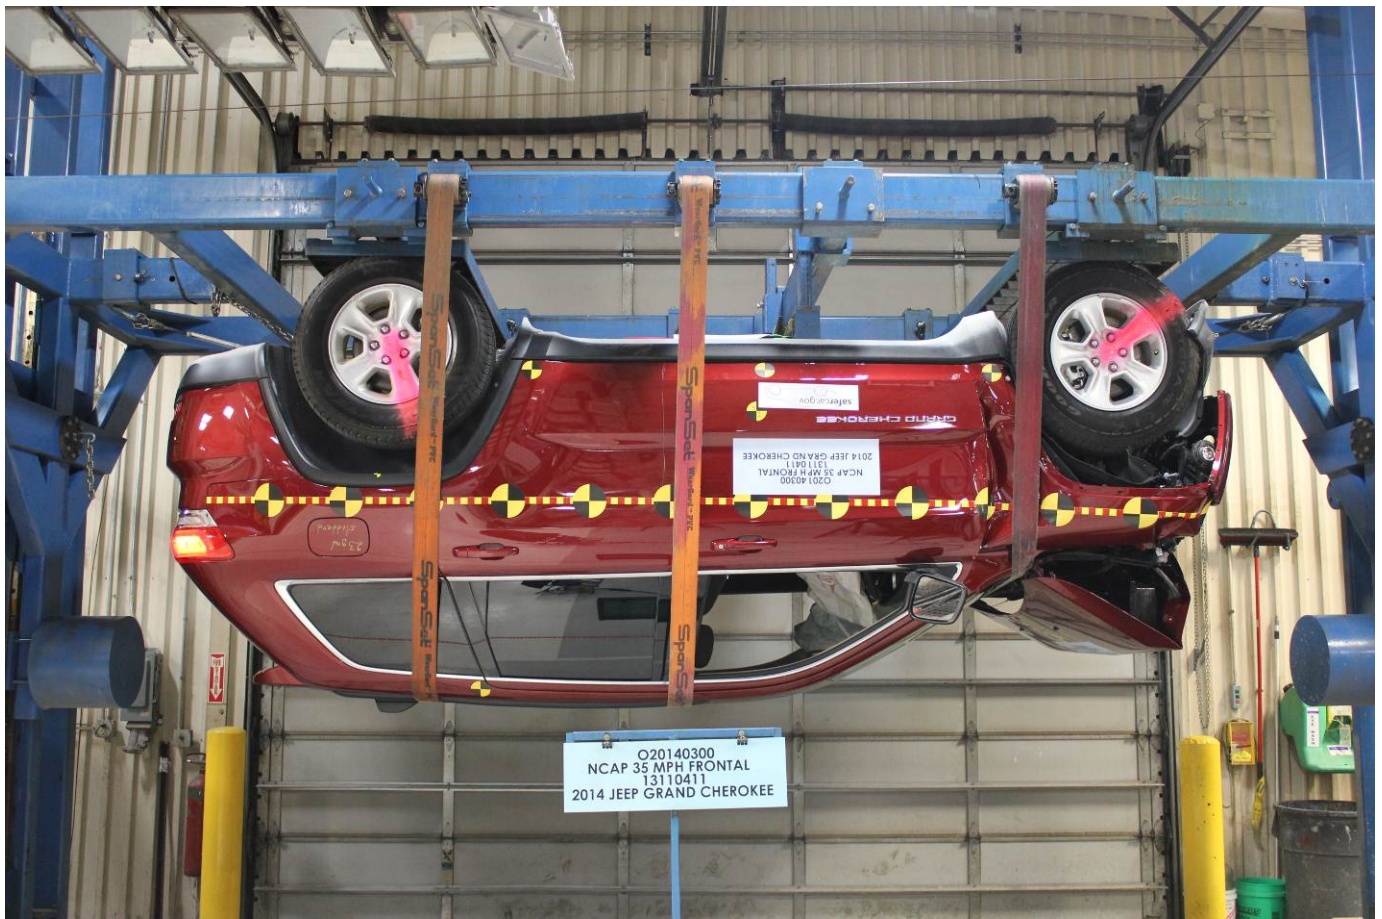
Vehicle at 180 Degrees on Static Rollover Device

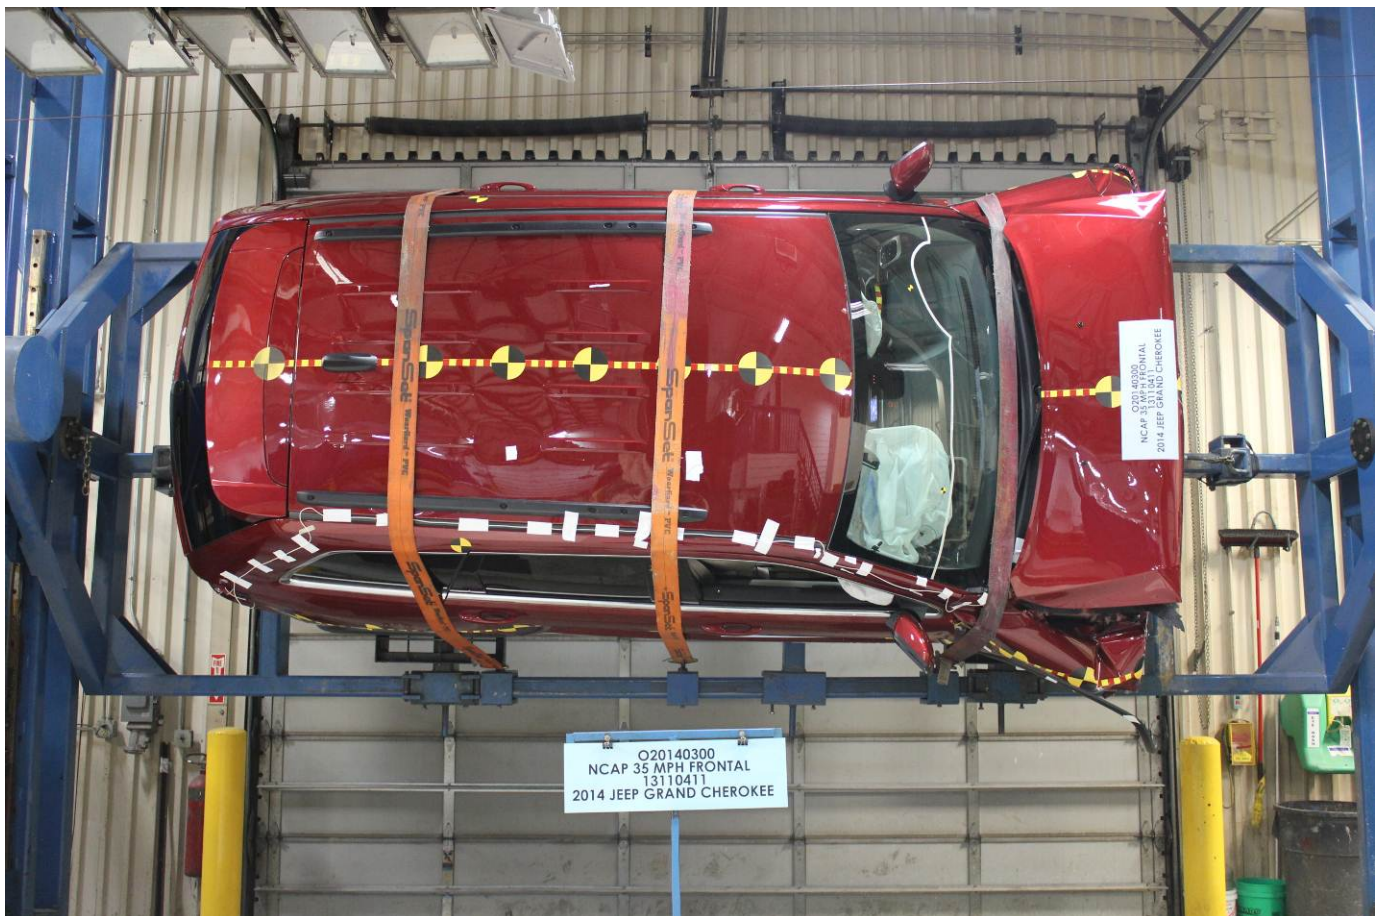
Vehicle at 270 Degree on Static Rollover Device

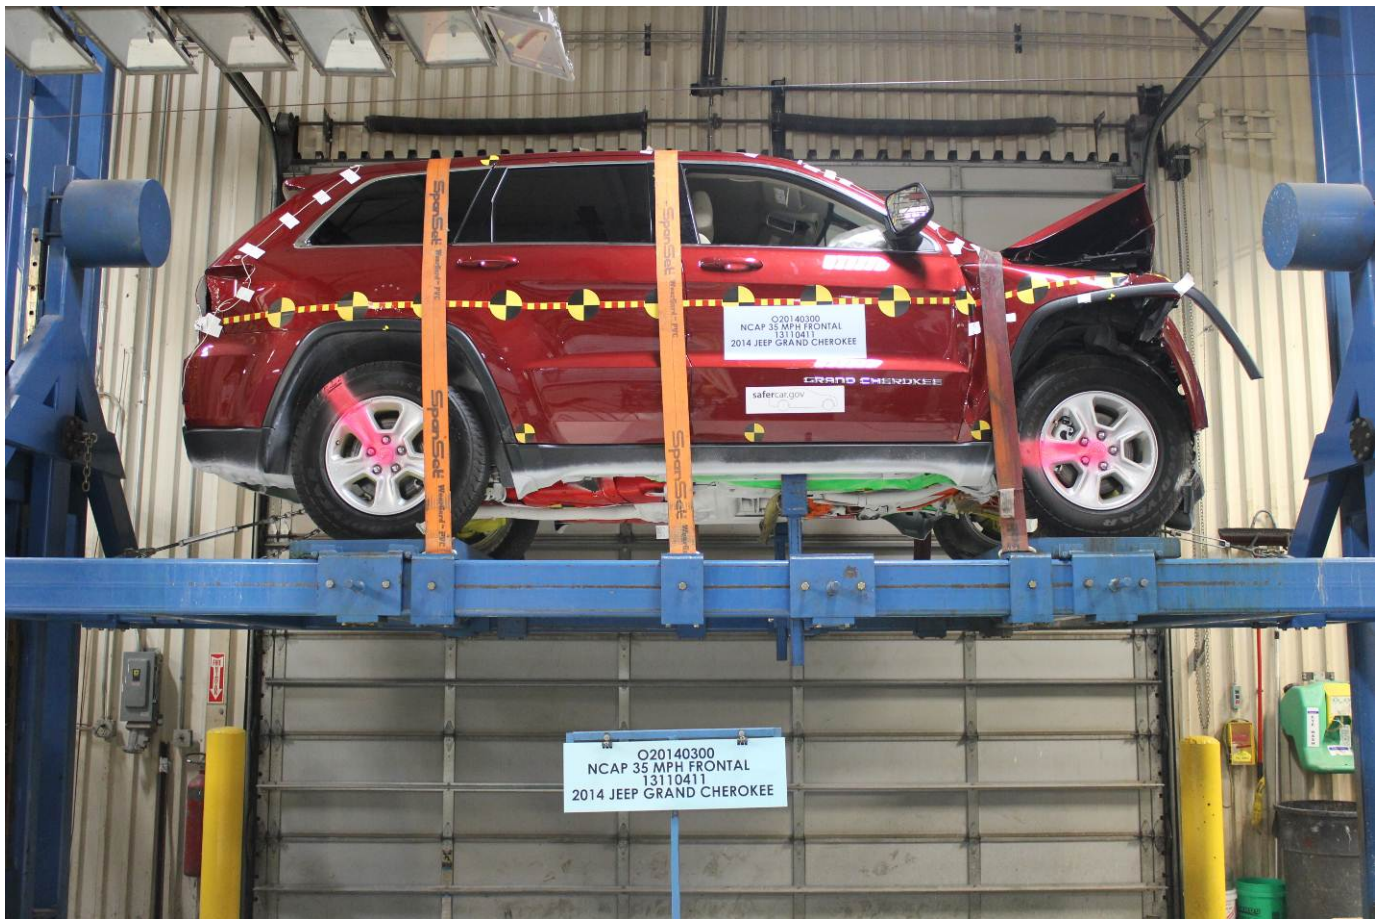
Vehicle at 360 Degrees on Static Rollover Device
