**REPORT NUMBER: NCAP-MGA-2014-024**

**NEW CAR ASSESSMENT PROGRAM (NCAP)  
Frontal Barrier Impact Test**

**TOYOTA MOTOR MANUFACTURING MISSISSIPPI INC.  
2014 Toyota Corolla LE 4-Dr Sedan  
NHTSA No.: O20145100**

**FINAL REPORT**

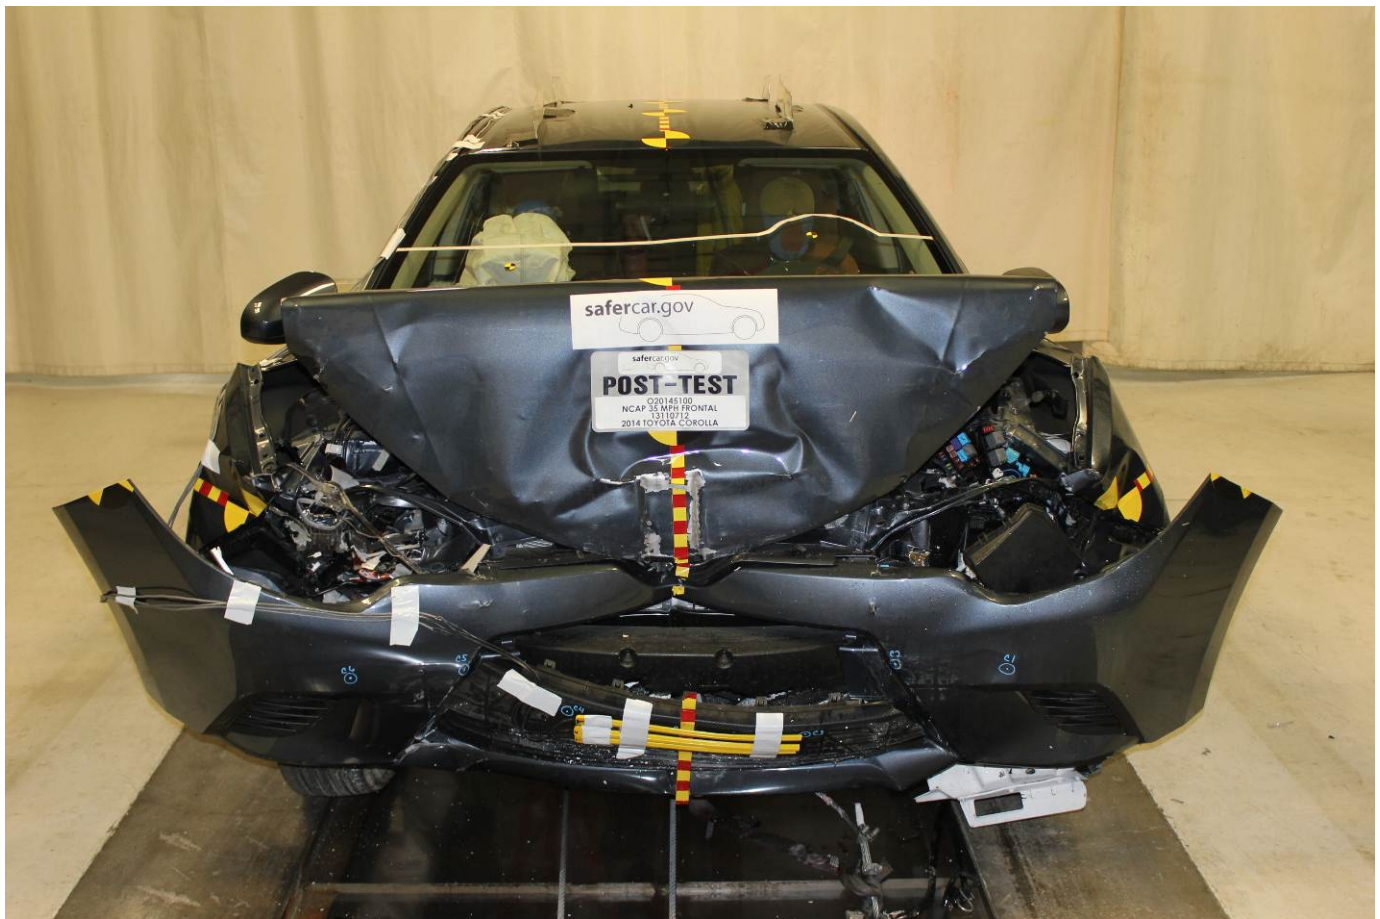
Post-Test Front View of Test Vehicle

The maximum static crush of the vehicle was 521 mm and both the driver and passenger side doors remained closed during the impact event and were operable after the impact.

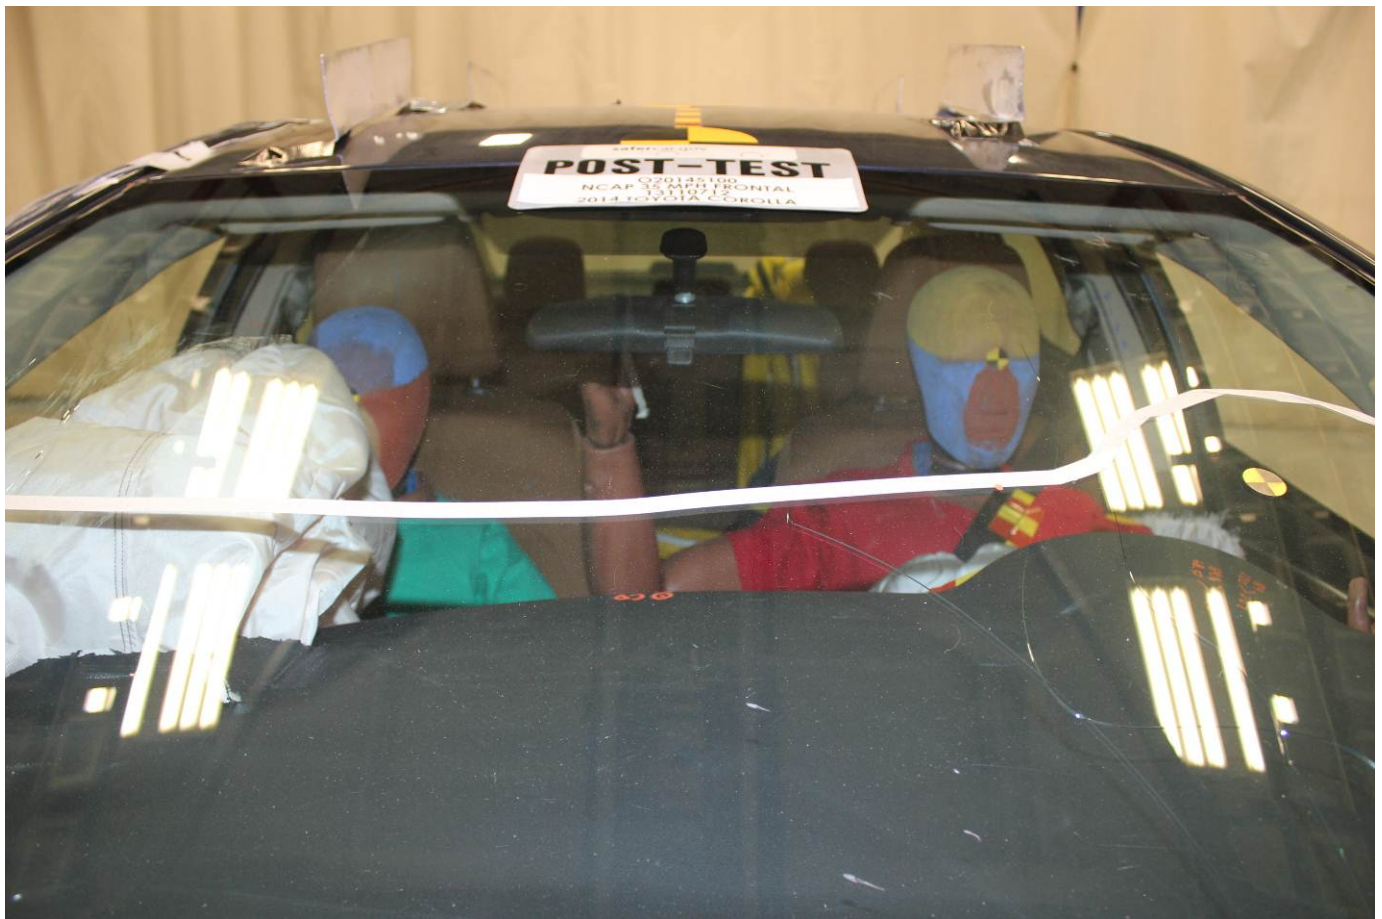
Post-Test Windshield View

There was 100 percent windshield retention and no intrusion into the protected zone of the windshield during the event. There was no Stoddard Solvent leakage after the event or during any phase of the static rollover.

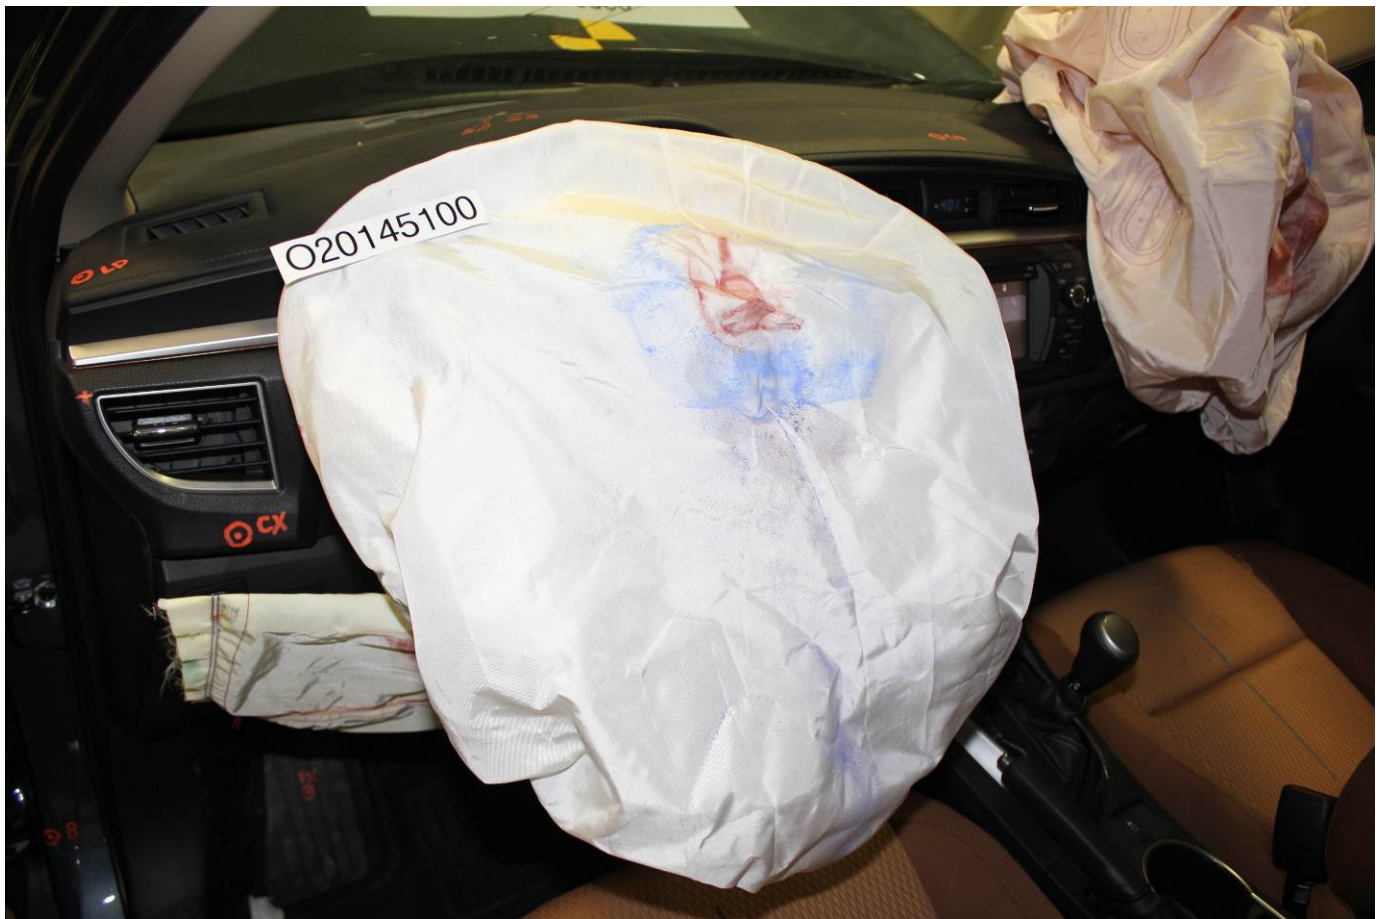
Post-Test Driver Dummy Contact with Airbag

The driver's visible contact points were as follows: The driver's head and chest contacted the airbag. The driver's head also contacted the headrest. The driver's knees contacted the knee airbag. The passenger's visible contact points were as follows: The passenger's head and chest contacted the airbag. The passenger's head also contacted the headrest. The passenger's knees contacted the glovebox.
