**REPORT NUMBER: SPNCAP-MGA-2014-026**

**NEW CAR ASSESSMENT PROGRAM (NCAP)  
Side Impact Pole Test**

**KIA MOTORS CORPORATION  
2014 Kia Sedona LX Minivan  
NHTSA No.: O20144207**

**FINAL REPORT**

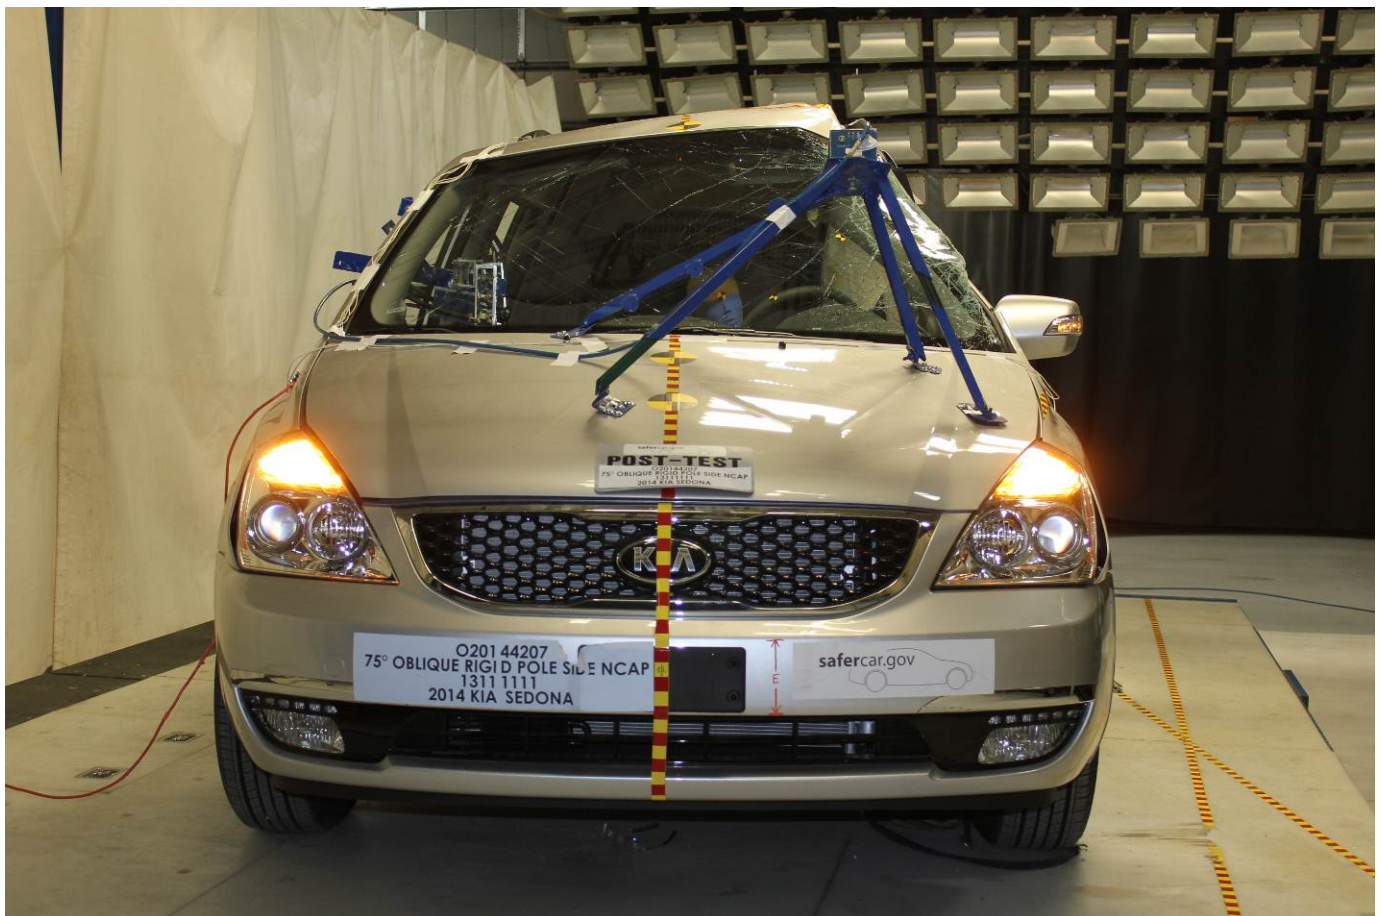
Post-Test Frontal View of Test Vehicle

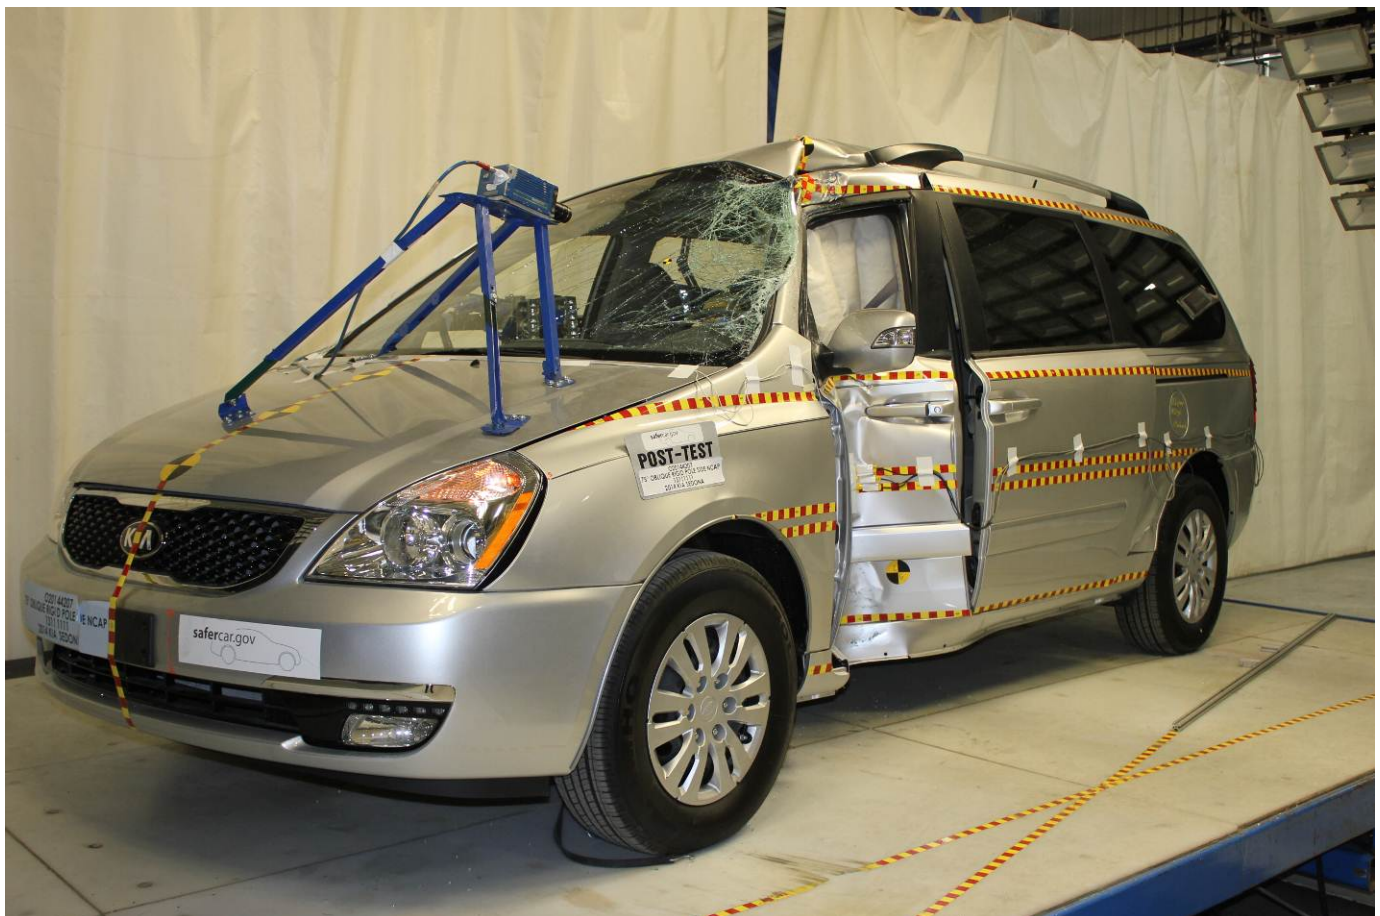
Post-Test Left Front  $\frac{3}{4}$  View of Test Vehicle

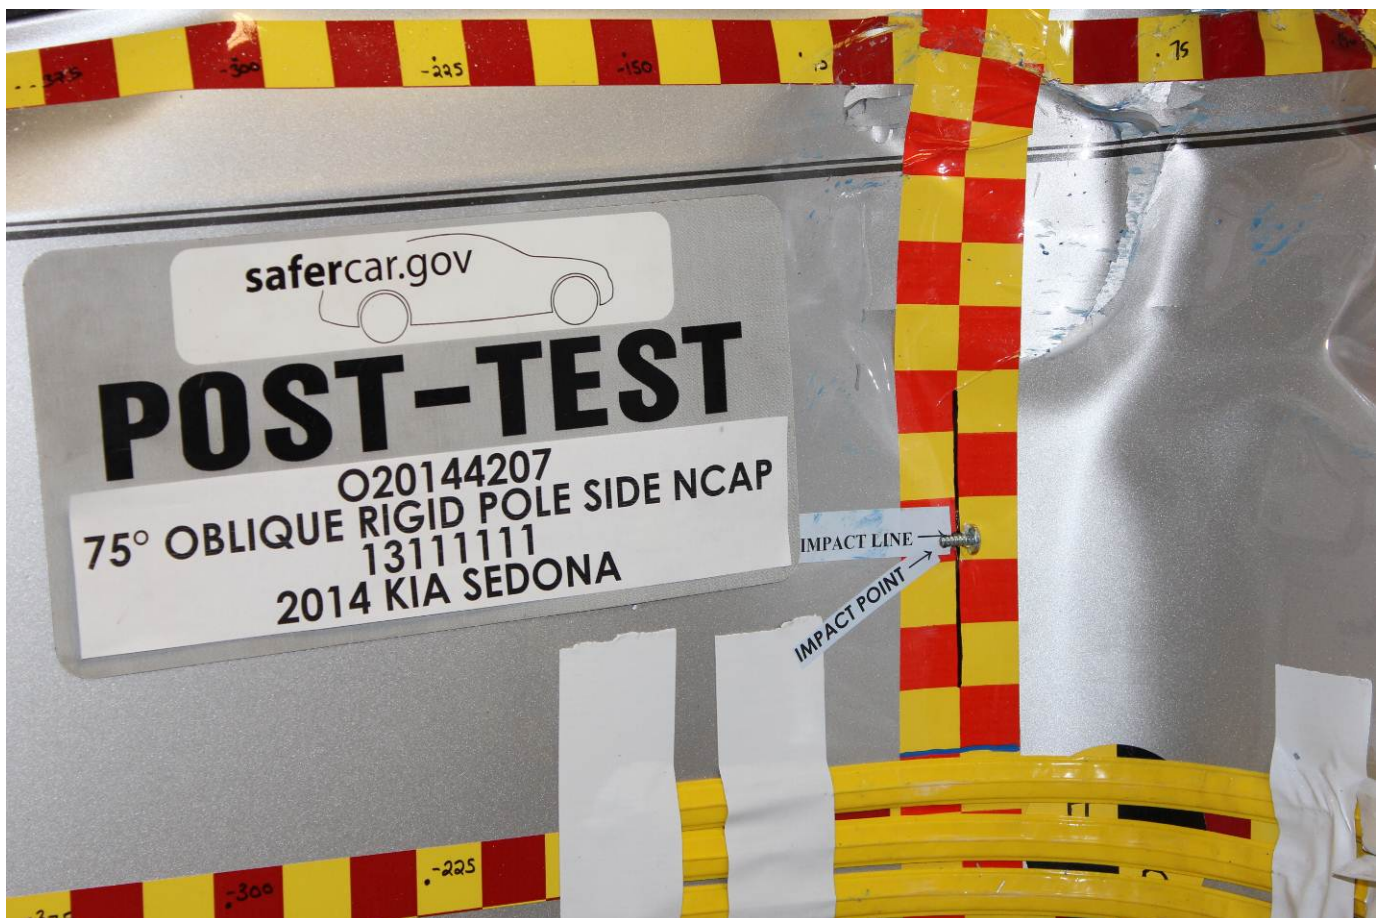
Post-Test Close-Up View of Impact Point Target Showing Impact Location

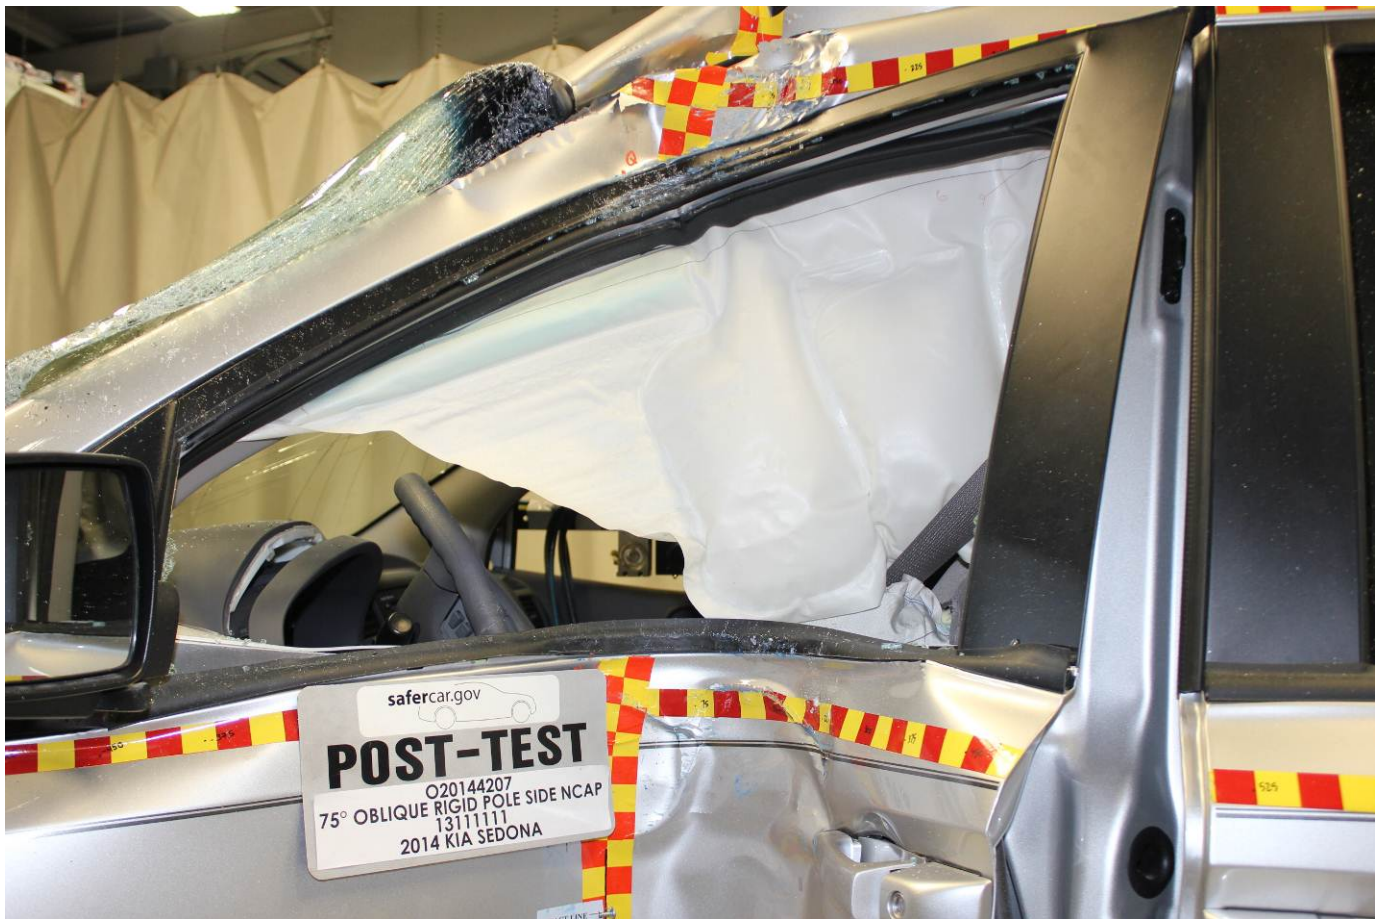
Post-Test Left Side View of Dummy Shoulder and Door Top View

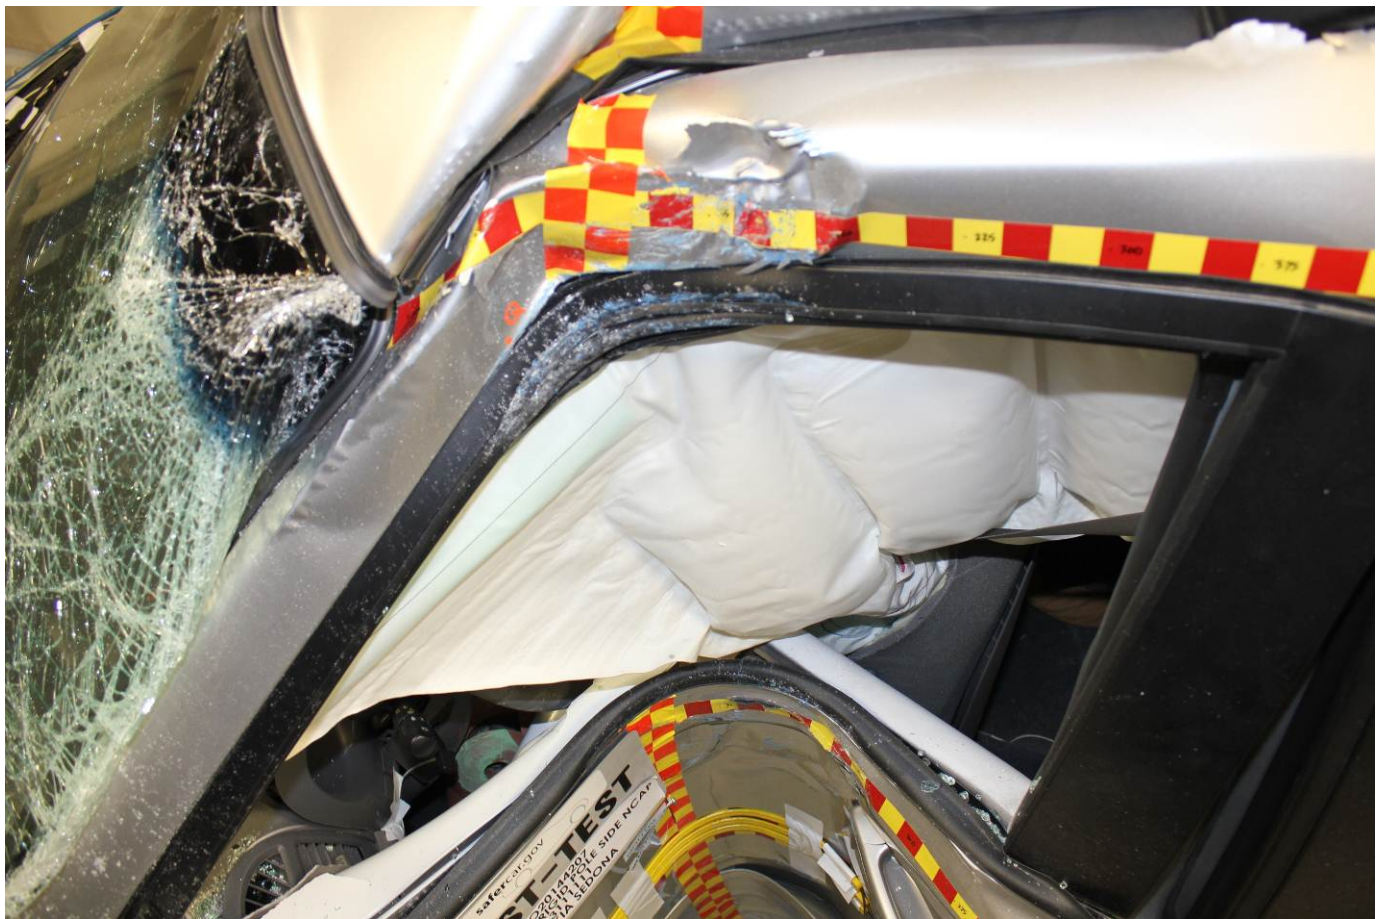
Post-Test Dummy and Door Clearance View

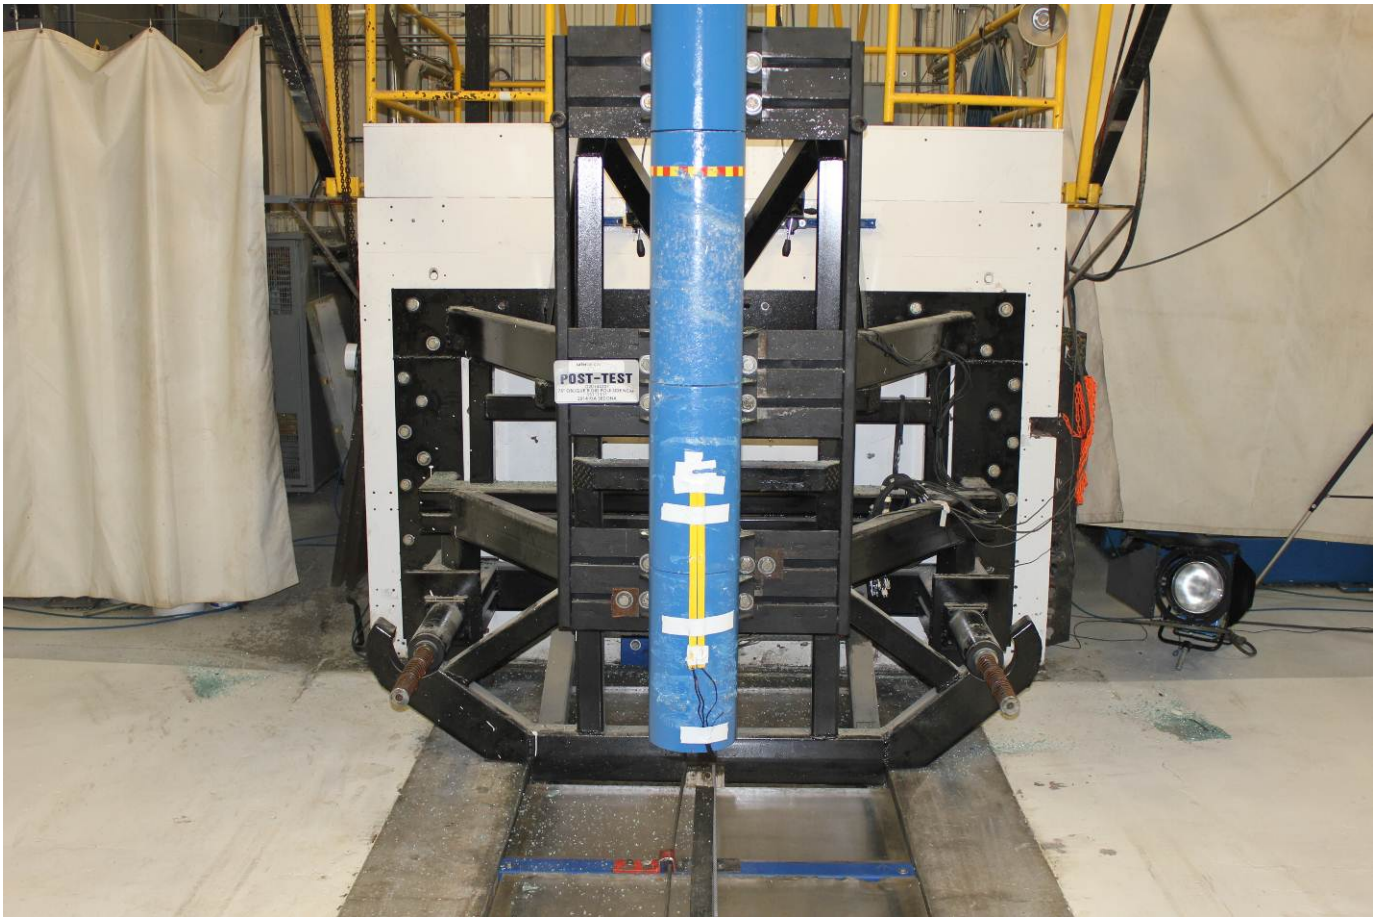
Post-Test Pole Barrier Front View

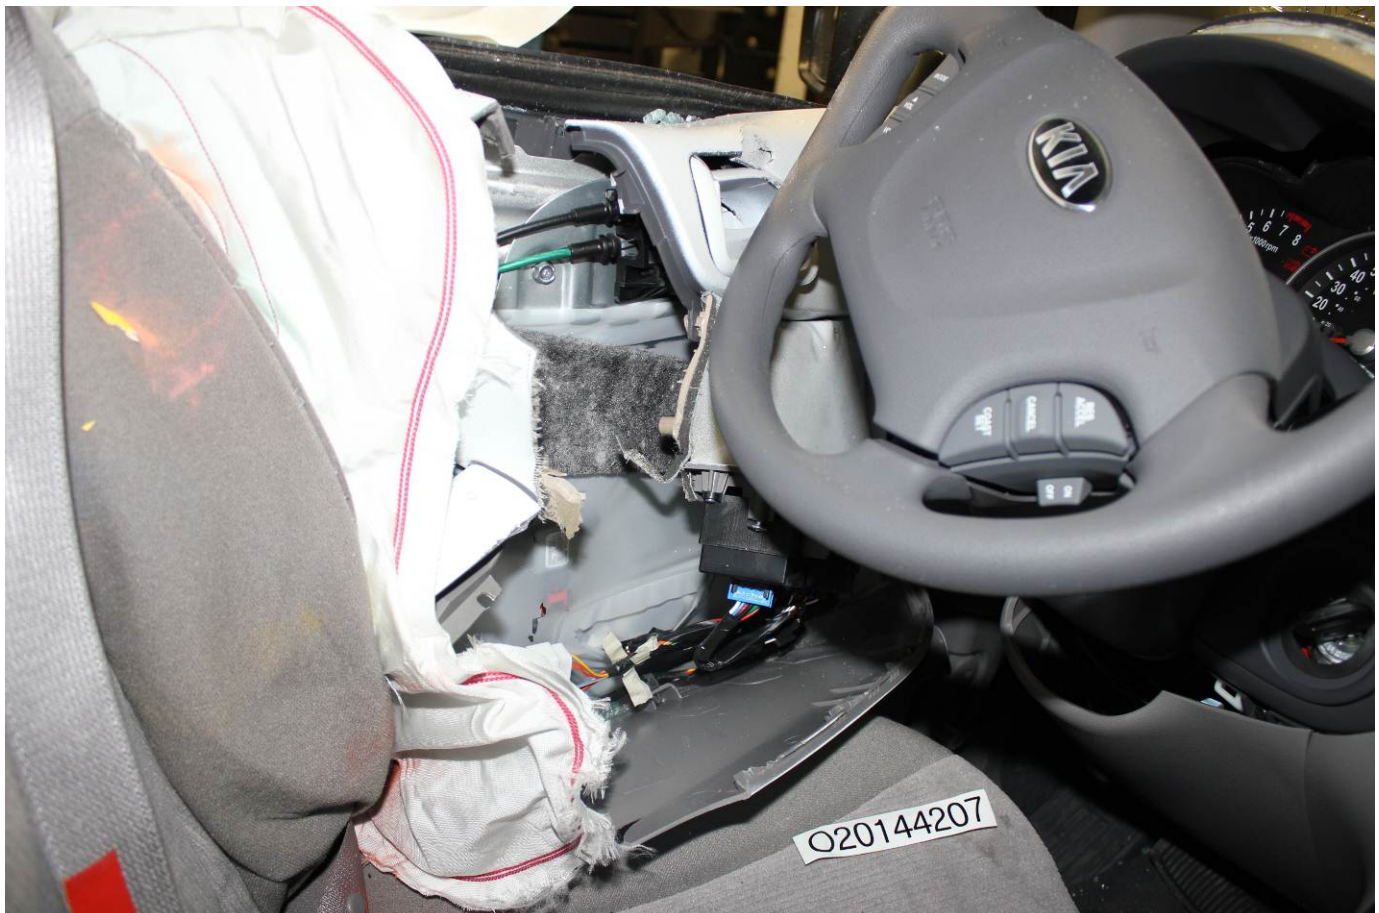
Post-Test View of Shattered Vehicle Inner Door Panel
