**REPORT NUMBER: SPNCAP-KAR-14-004**

**NEW CAR ASSESSMENT PROGRAM (NCAP)  
SIDE IMPACT POLE TEST**

**NISSAN MOTOR CO., LTD  
2014 INFINITI Q50 3.7 PREMIUM 4-DOOR SEDAN**

**FINAL REPORT**

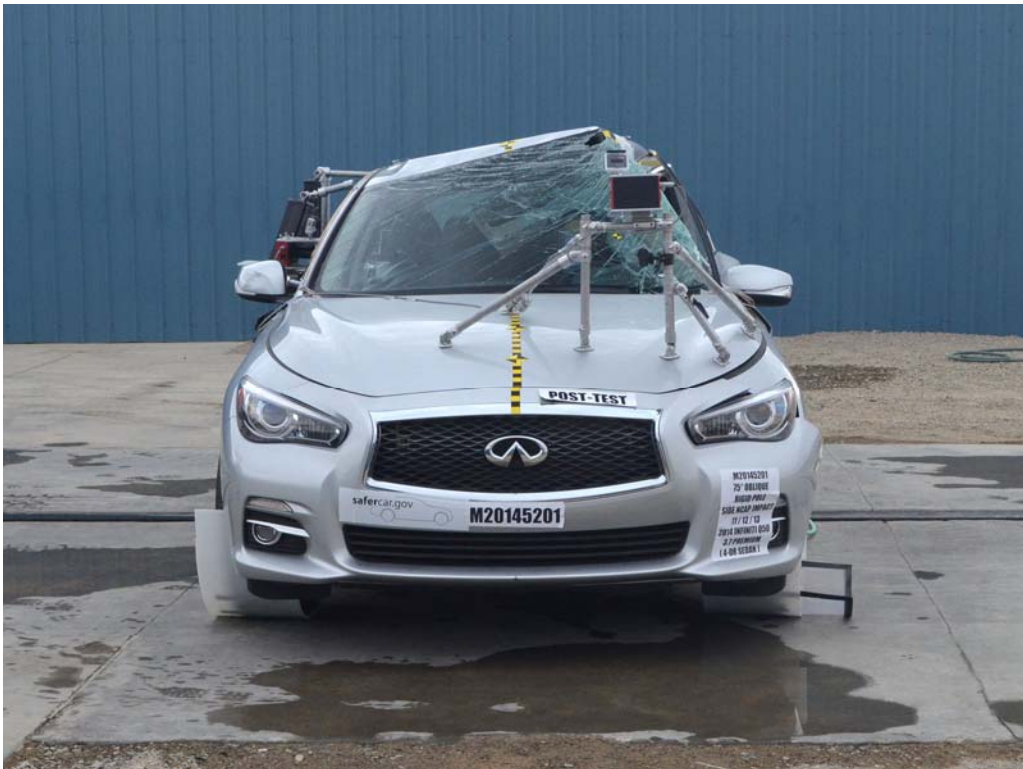
FIGURE 4. Post-Test Frontal View of Test Vehicle

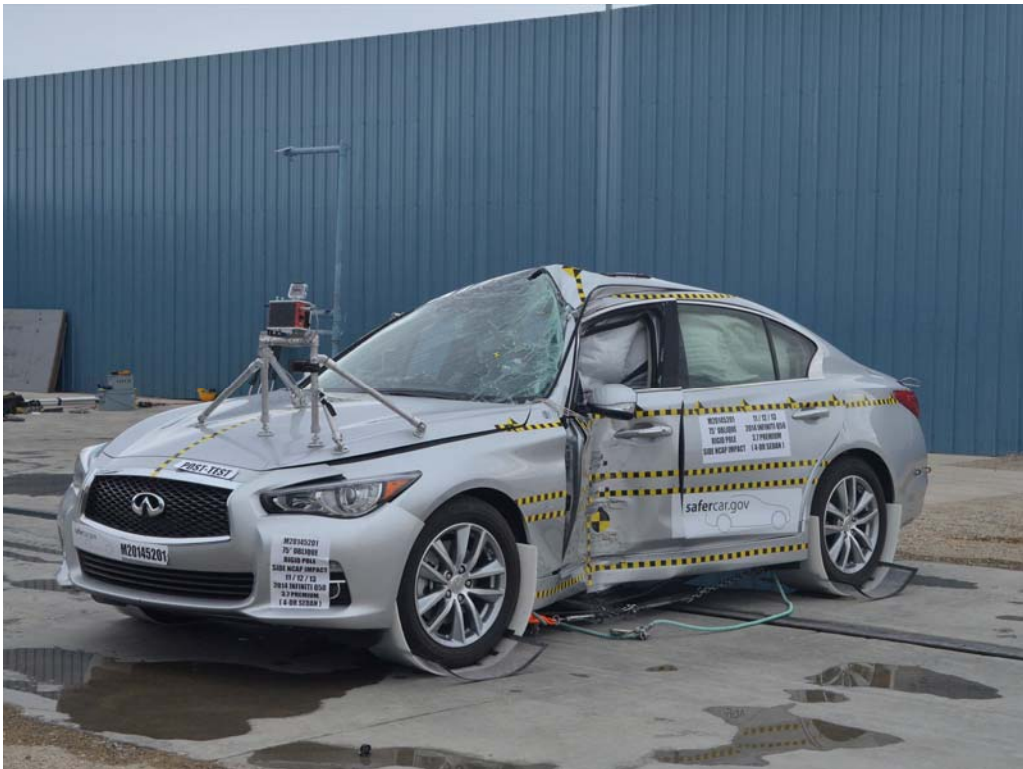
FIGURE 6. Post-Test Left Front  $\frac{3}{4}$  View of Test Vehicle

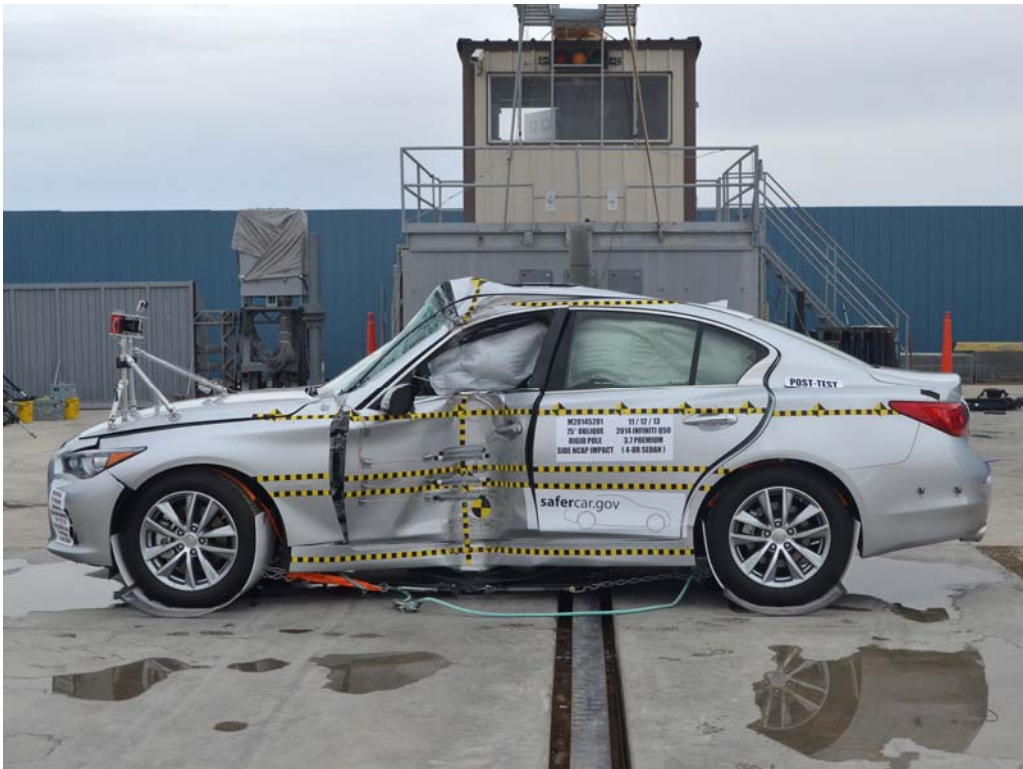
FIGURE 8. Post-Test Left Side View of Test Vehicle

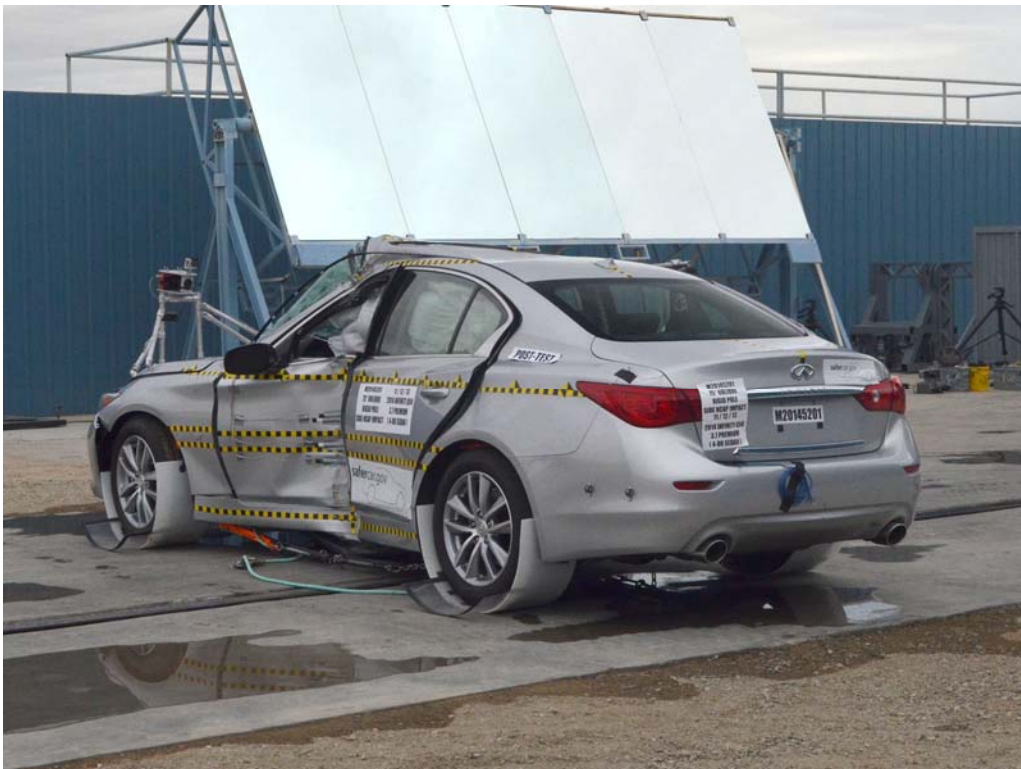
FIGURE 10. Post-Test Left Rear  $\frac{3}{4}$  View of Test Vehicle

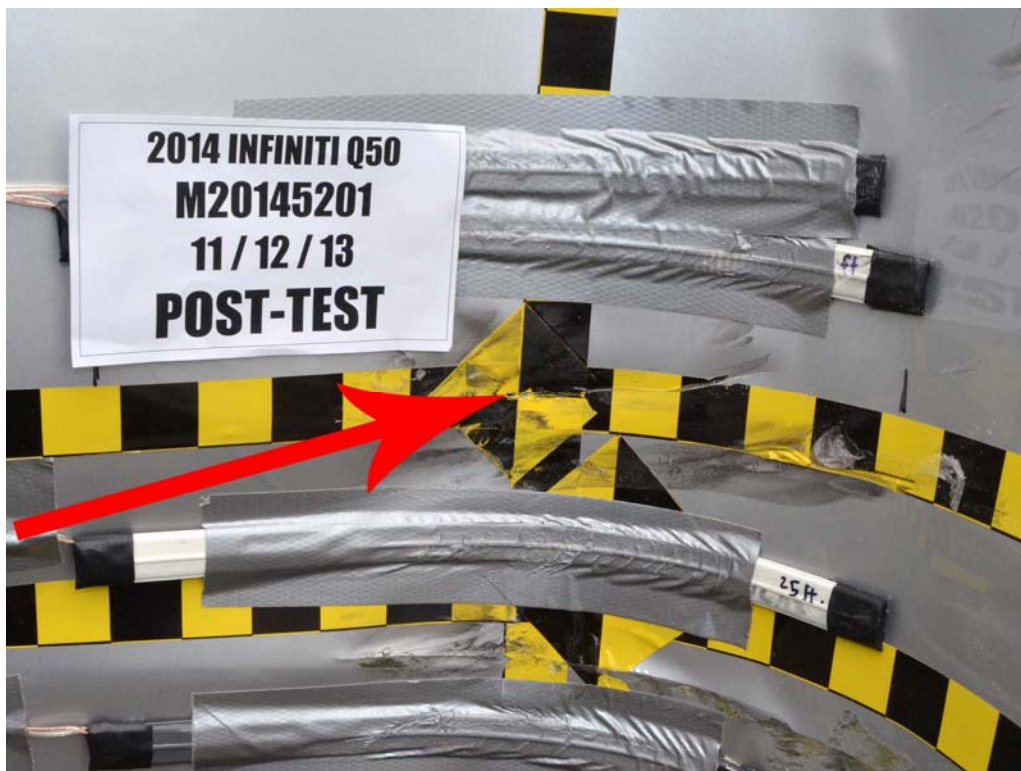
FIGURE 20. Post-Test Close-Up View of Impact Point Target  
Showing Impact Location

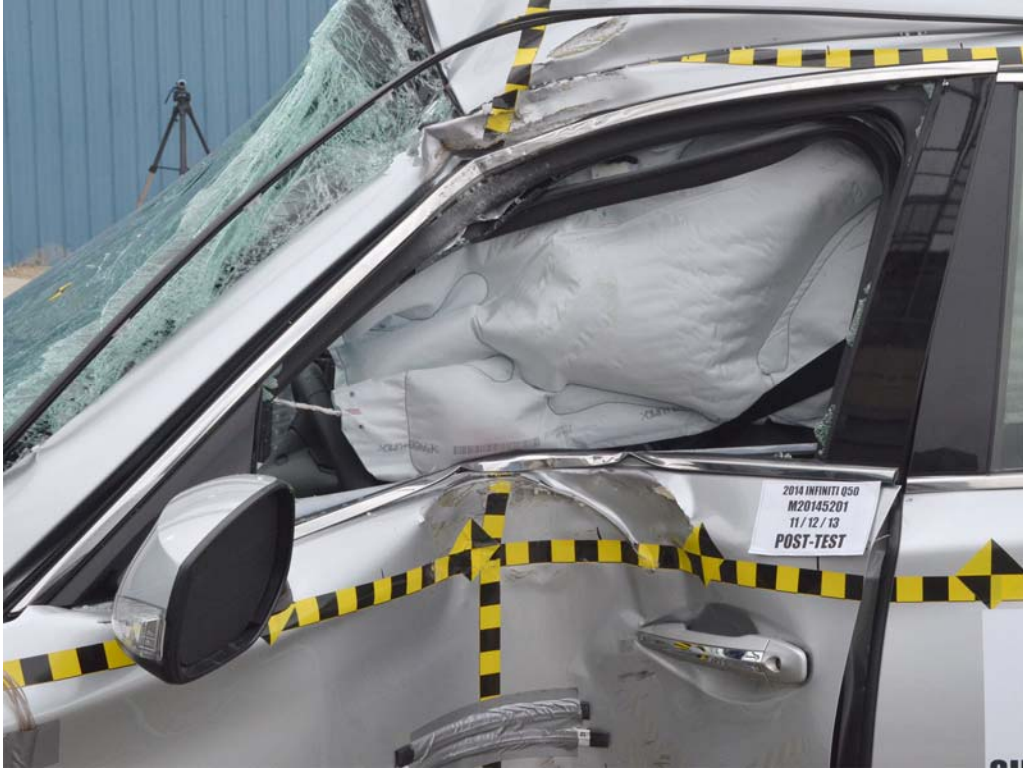
FIGURE 25. Post-Test Left Side View of Dummy Shoulder and Door Top View

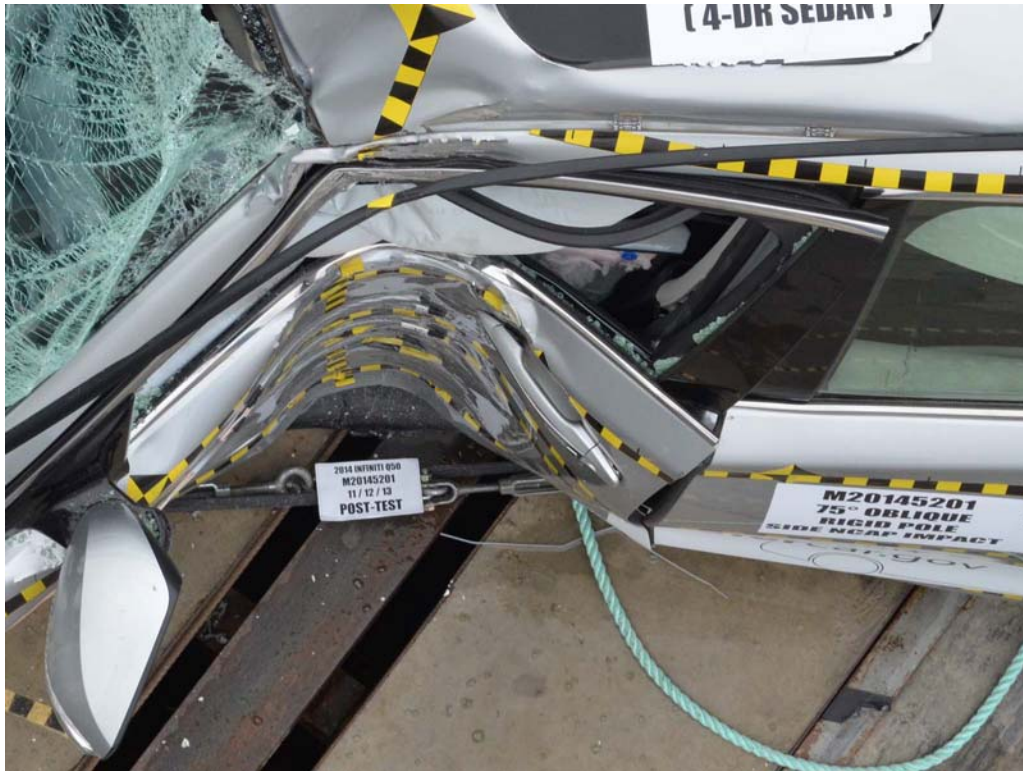
FIGURE 41. Post-Test Dummy and Door Clearance View

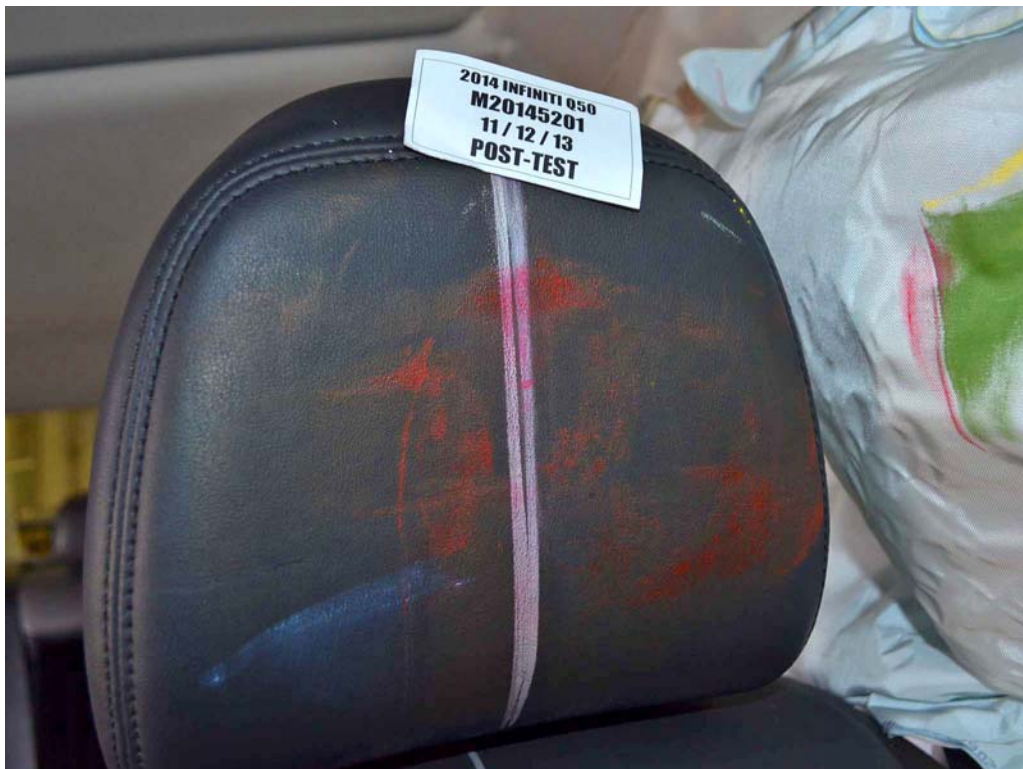
FIGURE 46. Post-Test Dummy Close-Up Head Contact with Vehicle Interior View

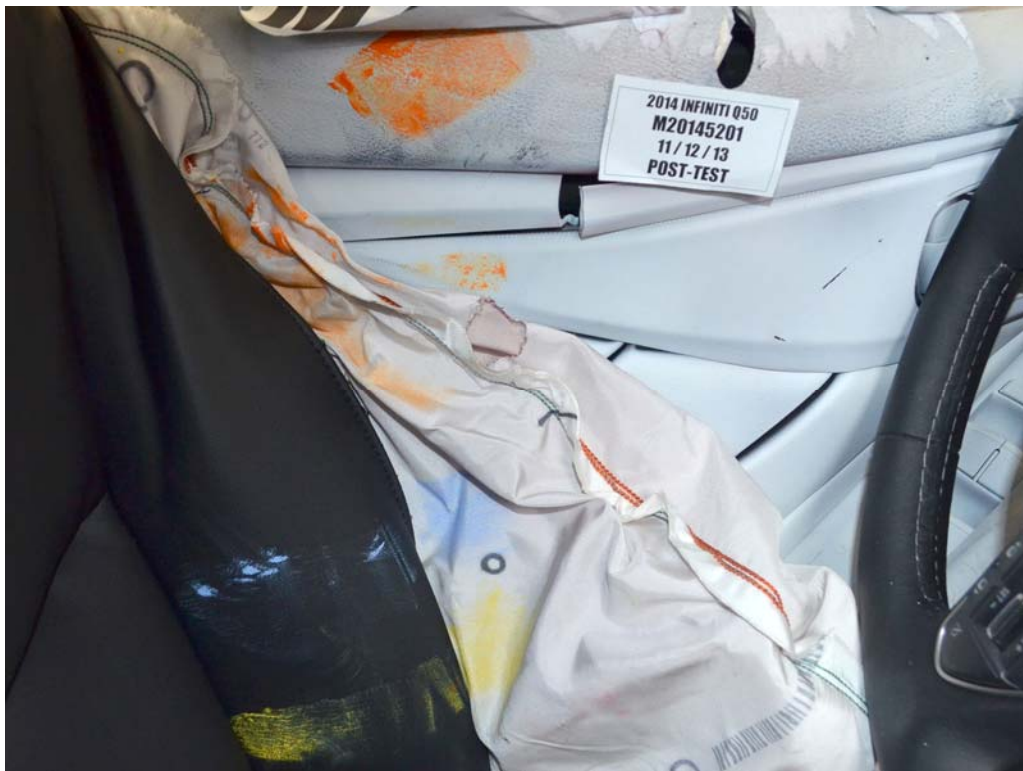
FIGURE 48. Post-Test Dummy Close-Up Torso Contact With Vehicle Interior View

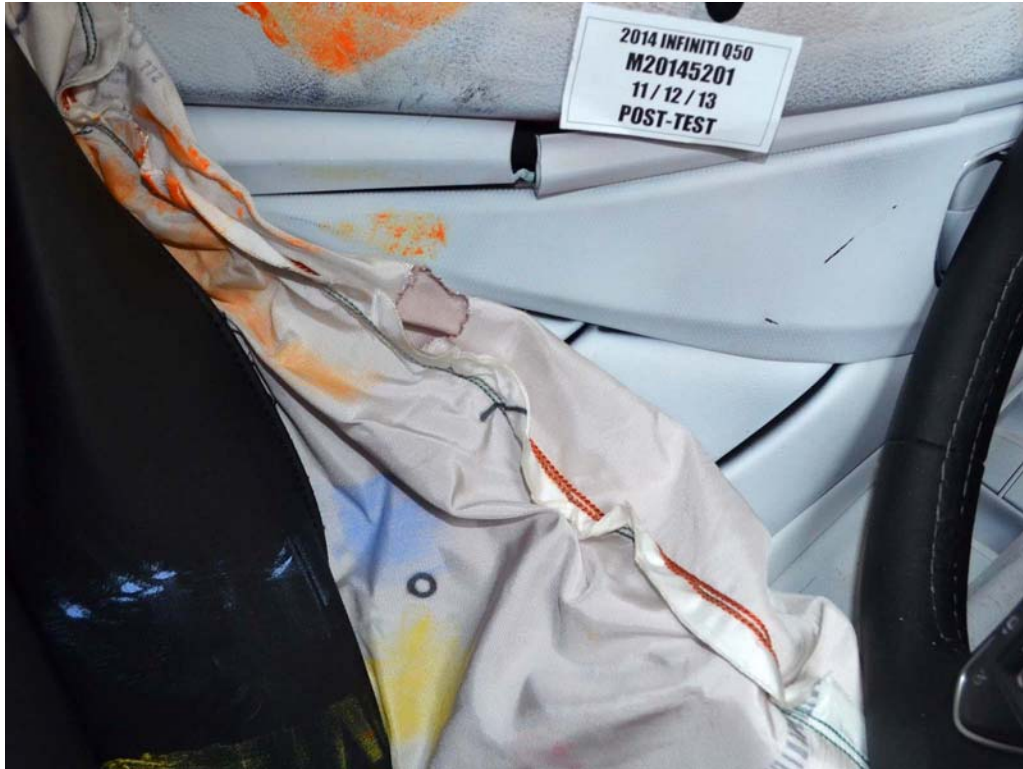
FIGURE 49. Post-Test Dummy Close-Up Torso Contact With Side Airbag View

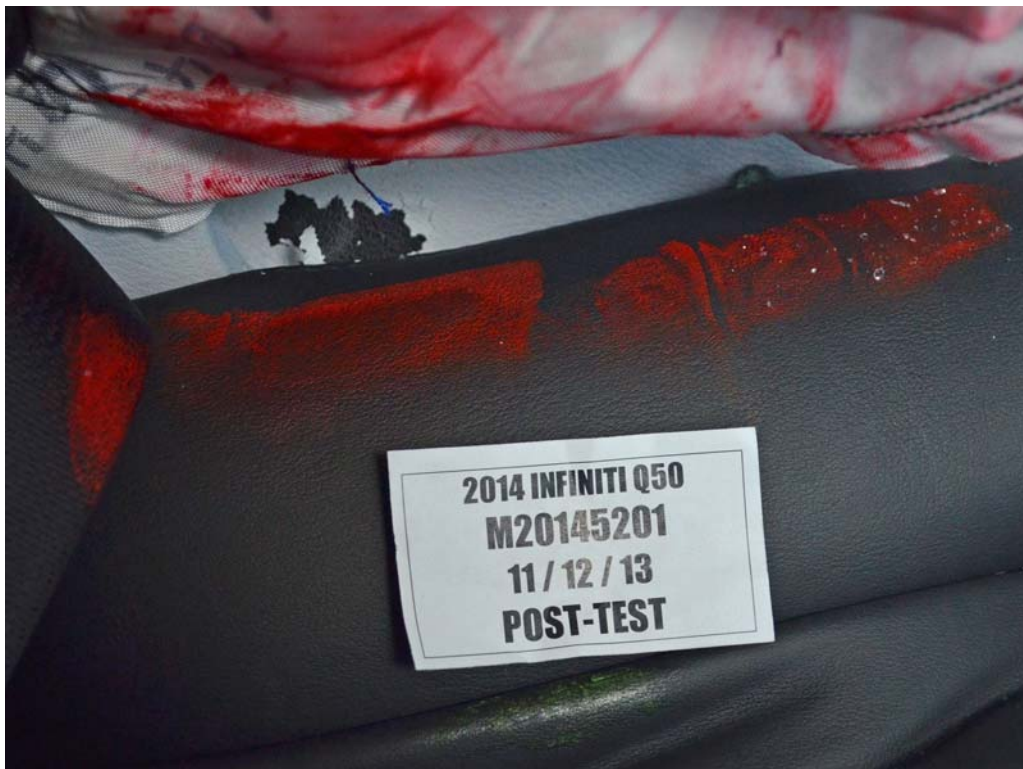
FIGURE 50. Post-Test Dummy Close-Up Pelvis Contact With Vehicle Interior View

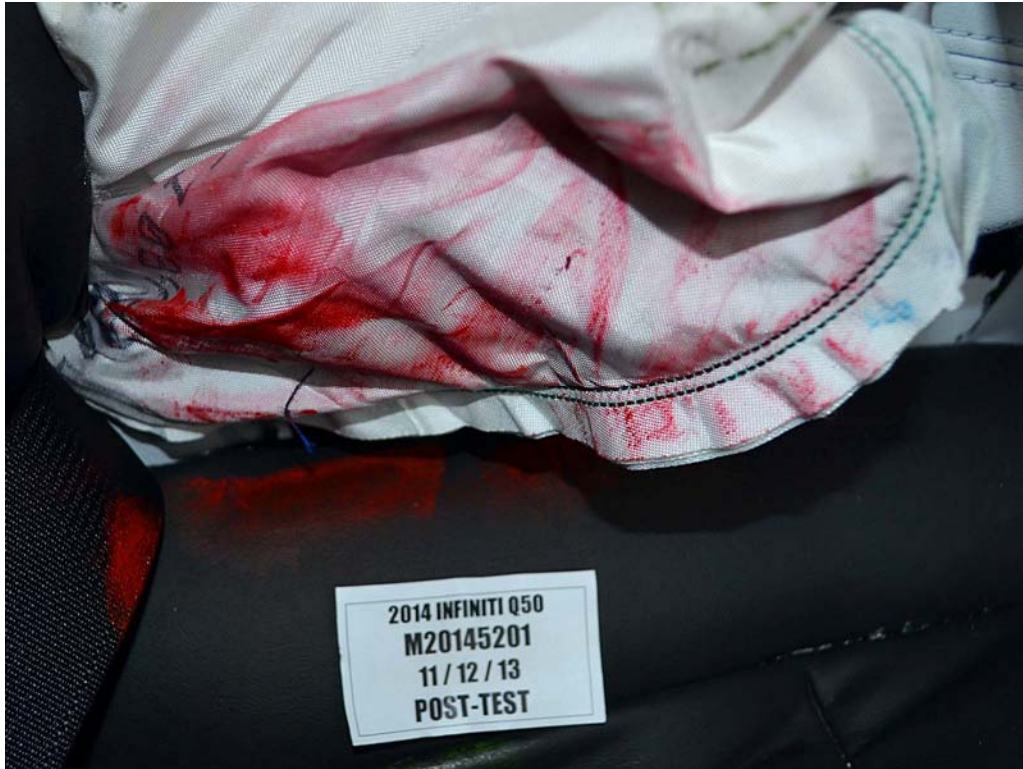
FIGURE 51. Post-Test Dummy Close-Up Pelvis Contact With Side Airbag View

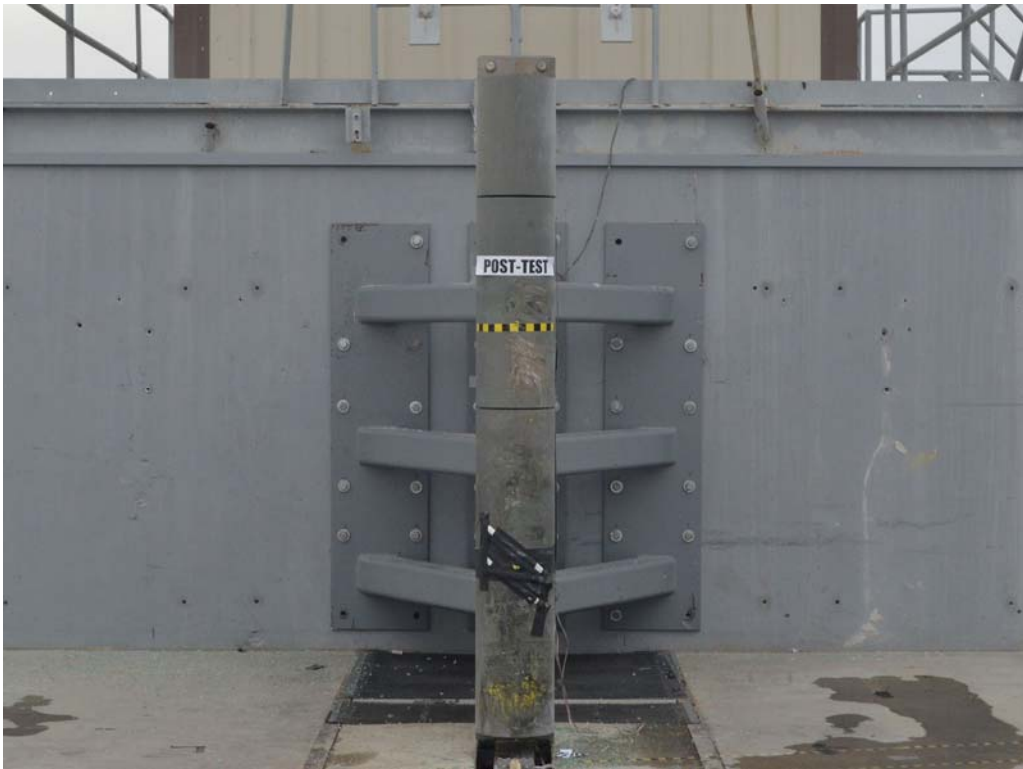
FIGURE 58. Post-Test Pole Barrier Front View

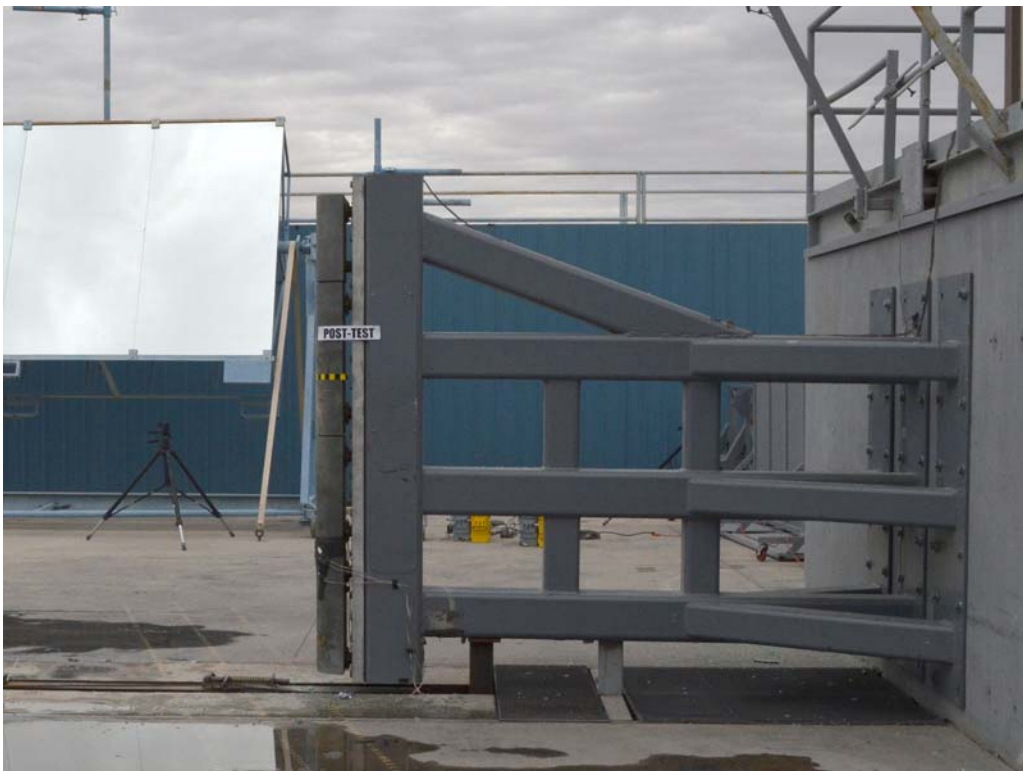
FIGURE 60. Post-Test Pole Barrier Side View

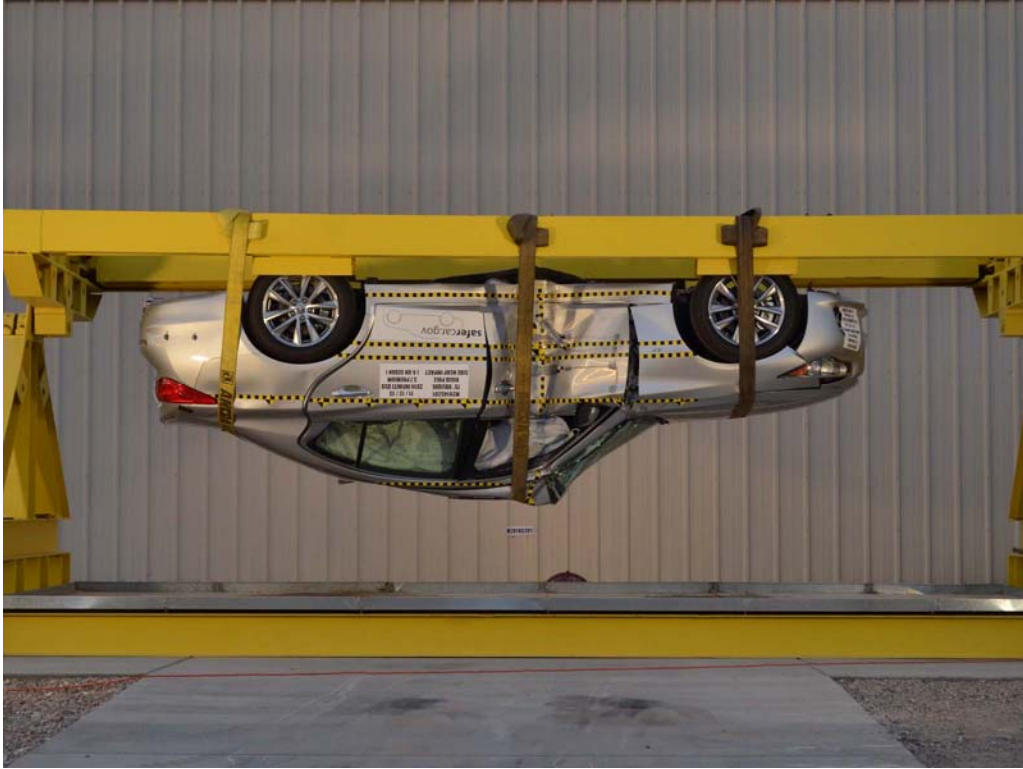
FIGURE 65. FMVSS No. 301 Static Rollover 180 Degrees

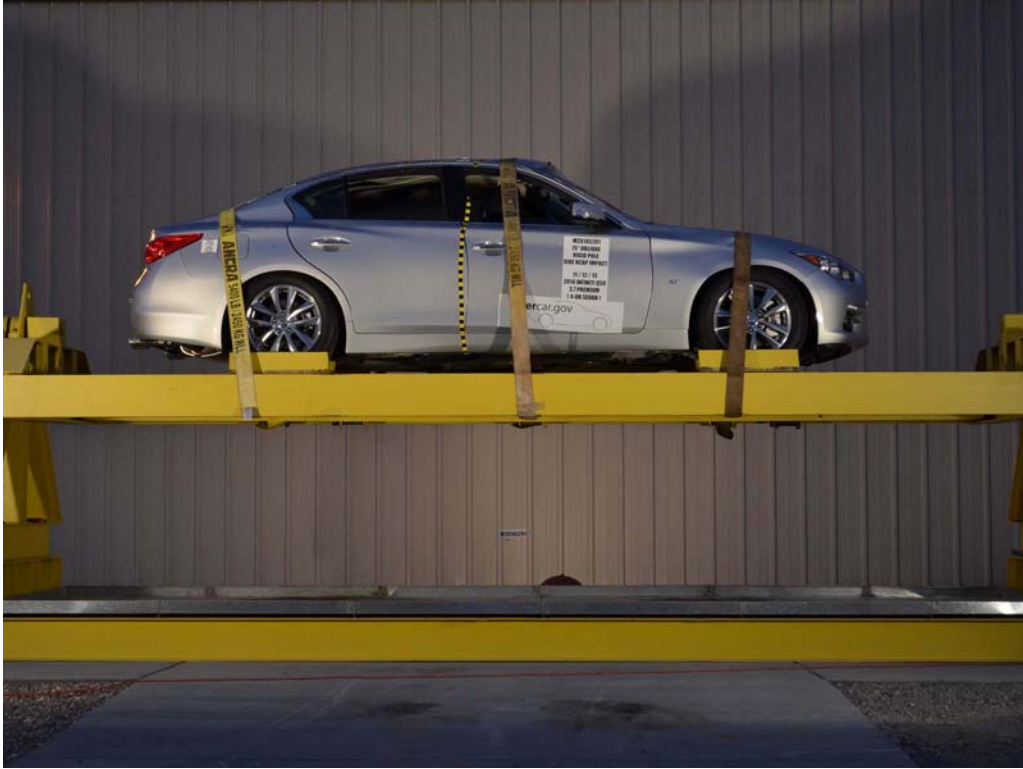
FIGURE 67. FMVSS No. 301 Static Rollover 360 Degrees

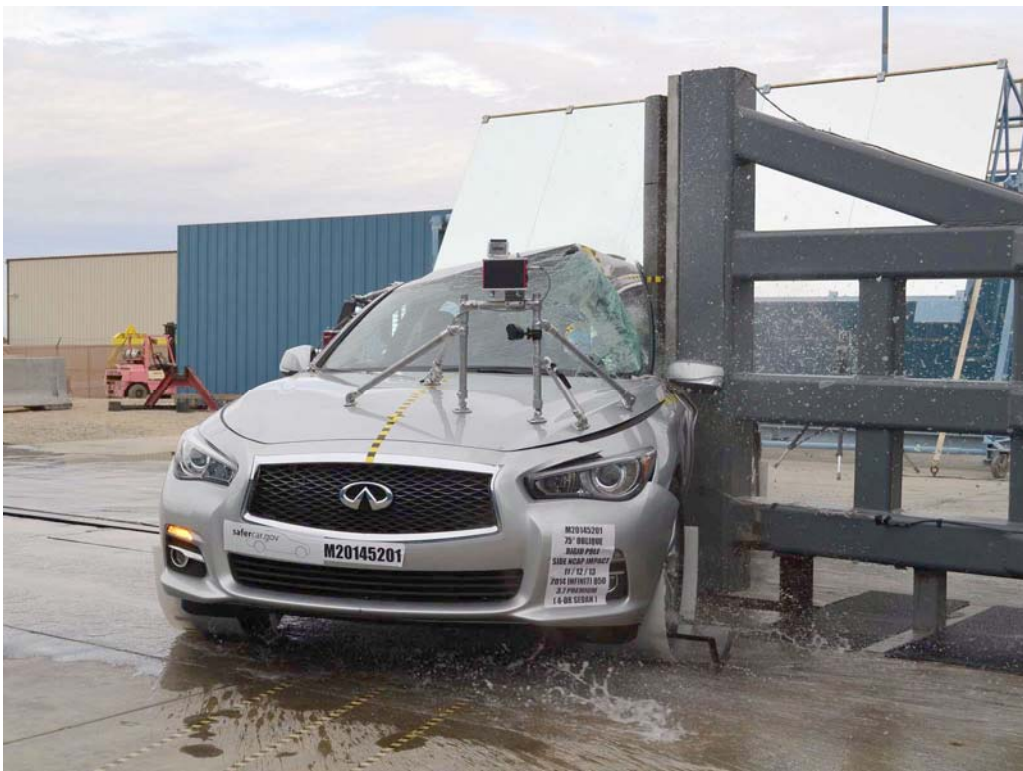
FIGURE 68. Impact Event
