REPORT NUMBER: SINCAP-MCW-14-001

**NEW CAR ASSESSMENT PROGRAM (NCAP)
MOVING DEFORMABLE BARRIER SIDE IMPACT TEST**

**CHRYSLER GROUP, LLC
2014 JEEP PATRIOT 5-DOOR SUV
NHTSA NUMBER: M20140308**

**PREPARED BY:
MEDICAL COLLEGE OF WISCONSIN
5000 WEST NATIONAL AVENUE
RESEARCH 151
MILWAUKEE, WISCONSIN 53295**

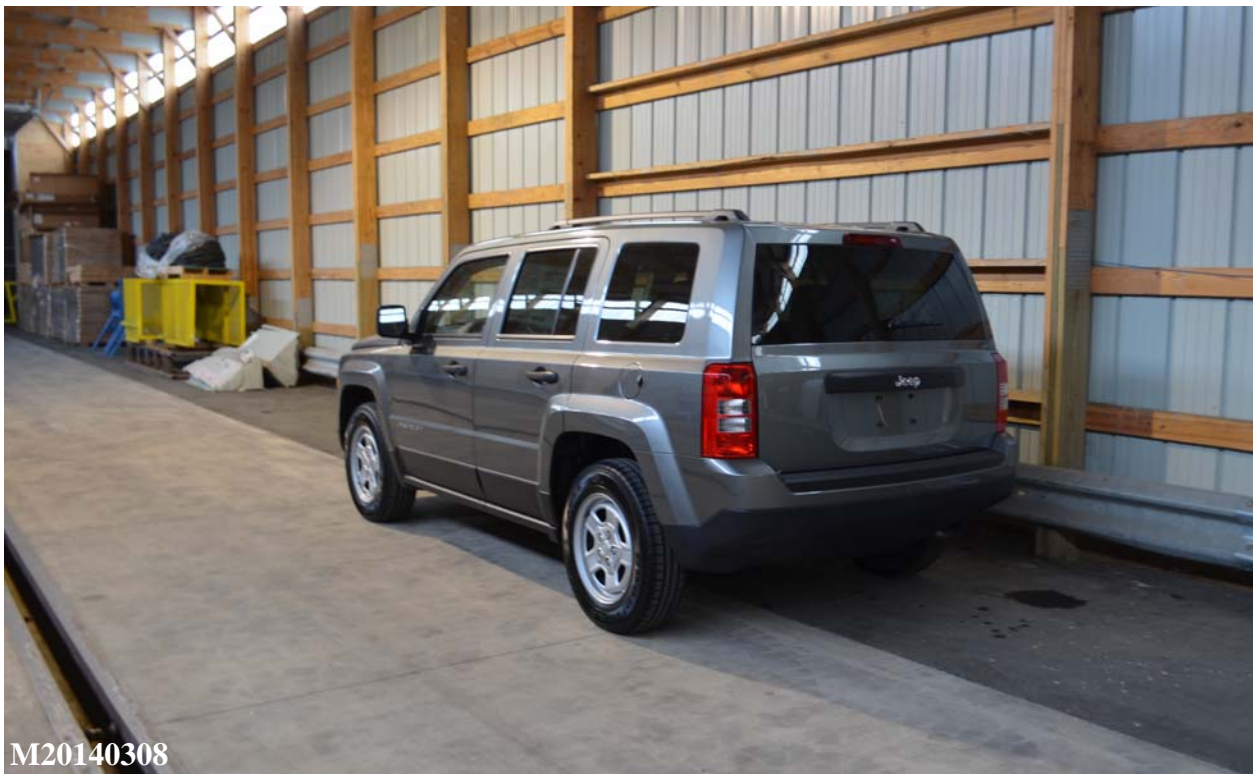
Figure A-2: As-Delivered Left Rear 3-4 View of Test Vehicle

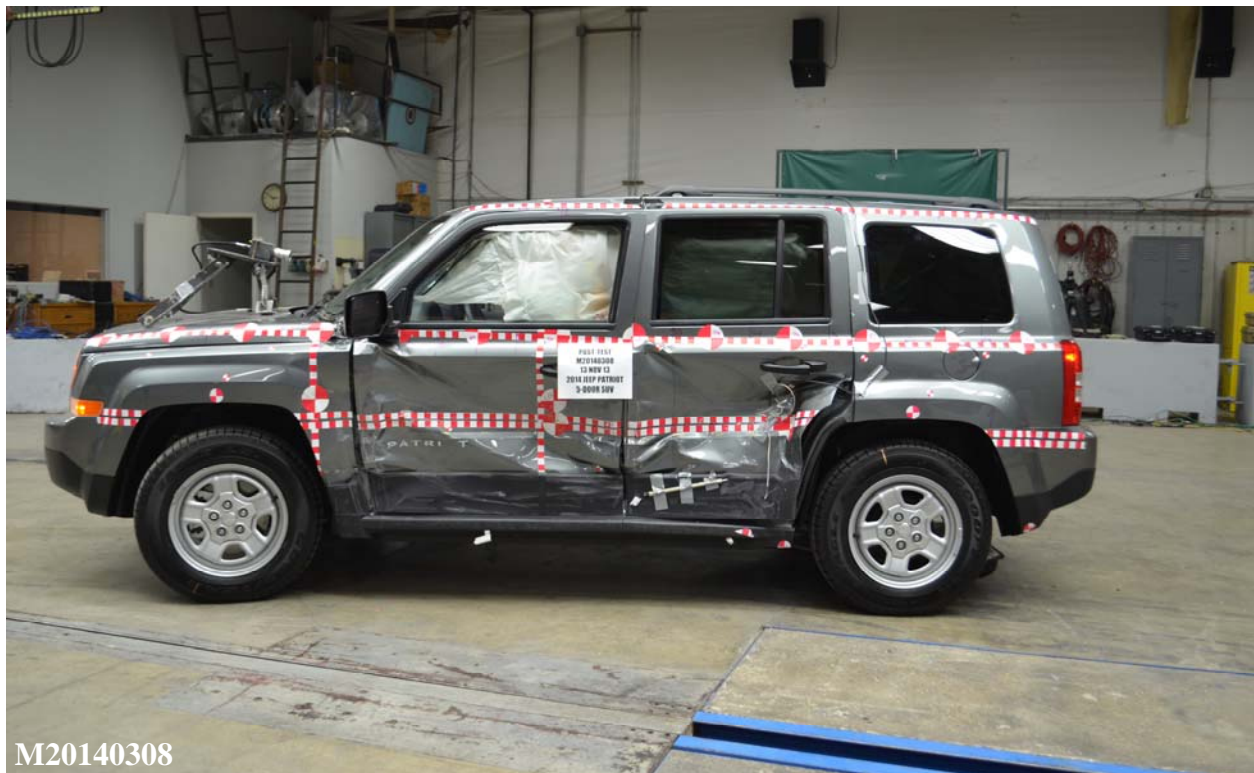
Figure A-8: Post-Test Left Side View of Test Vehicle

POST TEST STRUCTURAL OBSERVATIONS	
Critical Areas of Performance	Observations/Conclusions
Pillar Performance	No Damage
Sill Separation	Max Sill Separation of 90 mm at 1950 Line
Windshield Damage	No Damage
Window Damage	No Damage
Other Notable Effects	None Noted

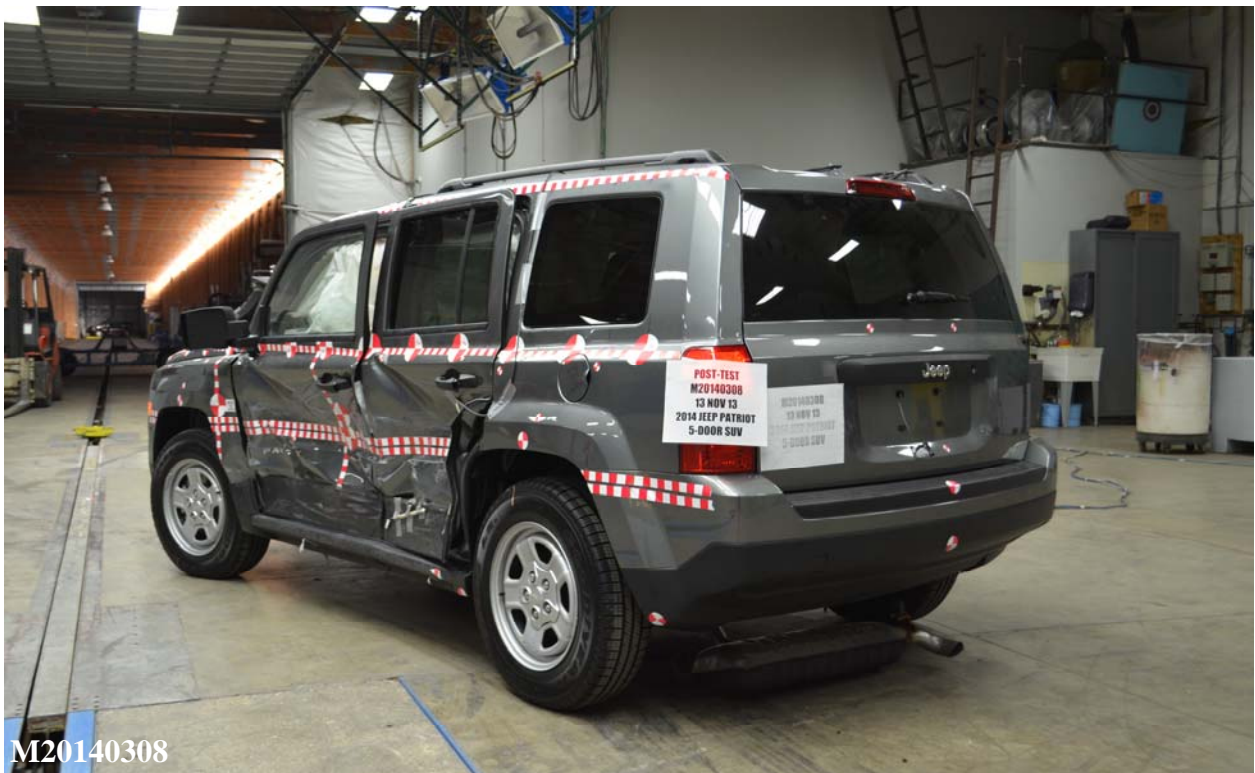
Figure A-10: Post-Test Left Rear 3-4 View of Test Vehicle

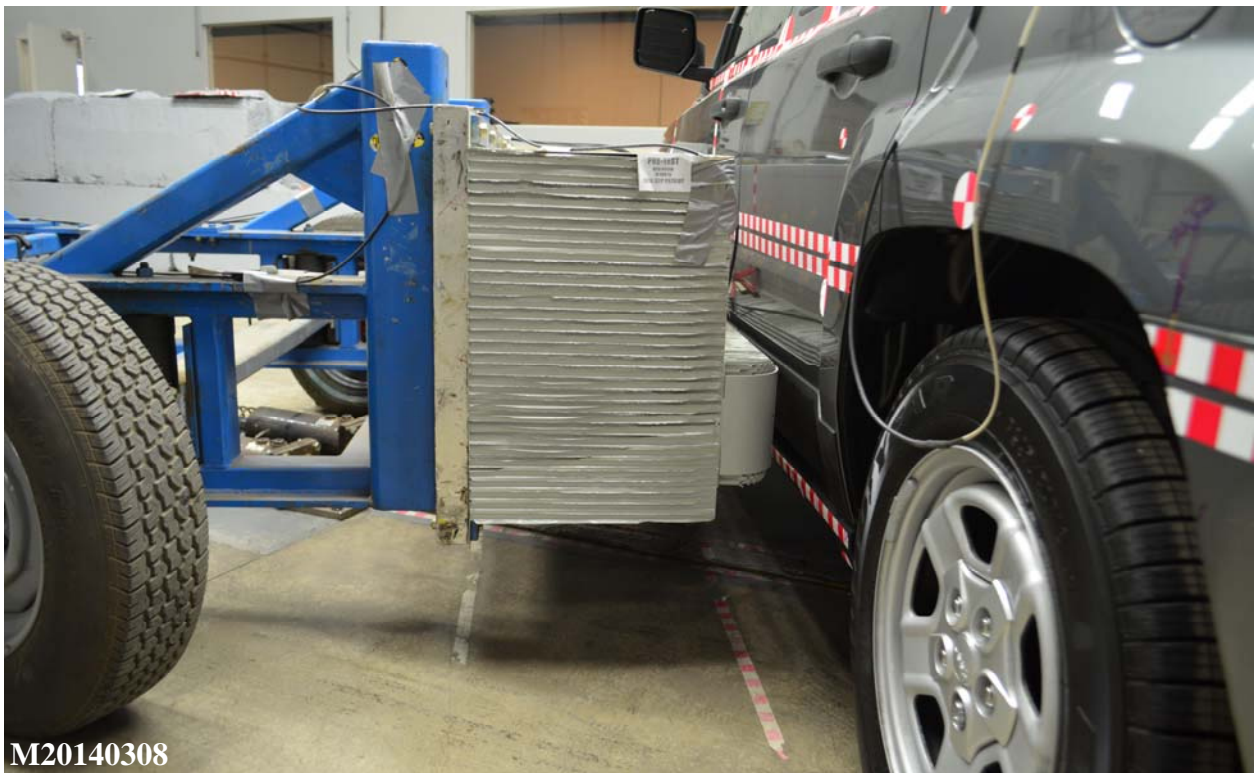
Figure A-18: Pre-Test Right Side View of MDB Positioned Against Side of Test Vehicle

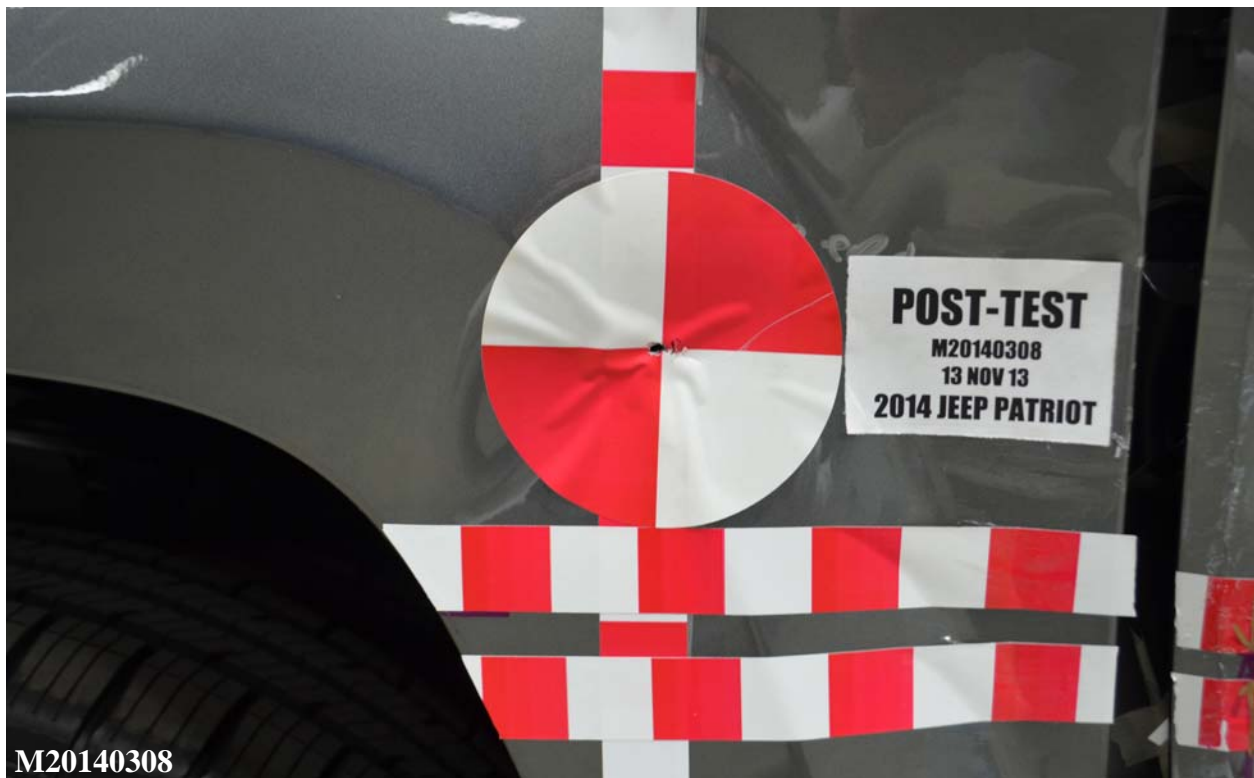
Figure A-20: Post-Test Close-Up View of Impact Point Target

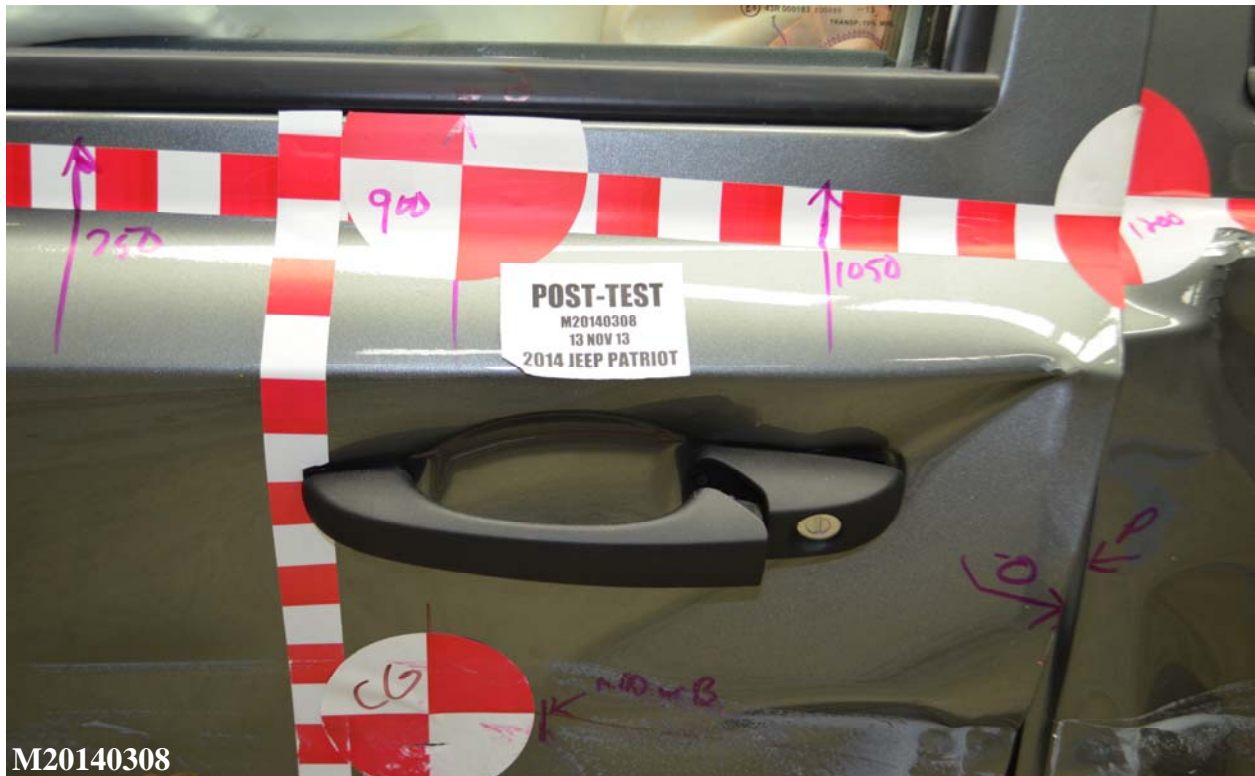
Figure A-22: Post-Test Left Front Door Latch Close-Up

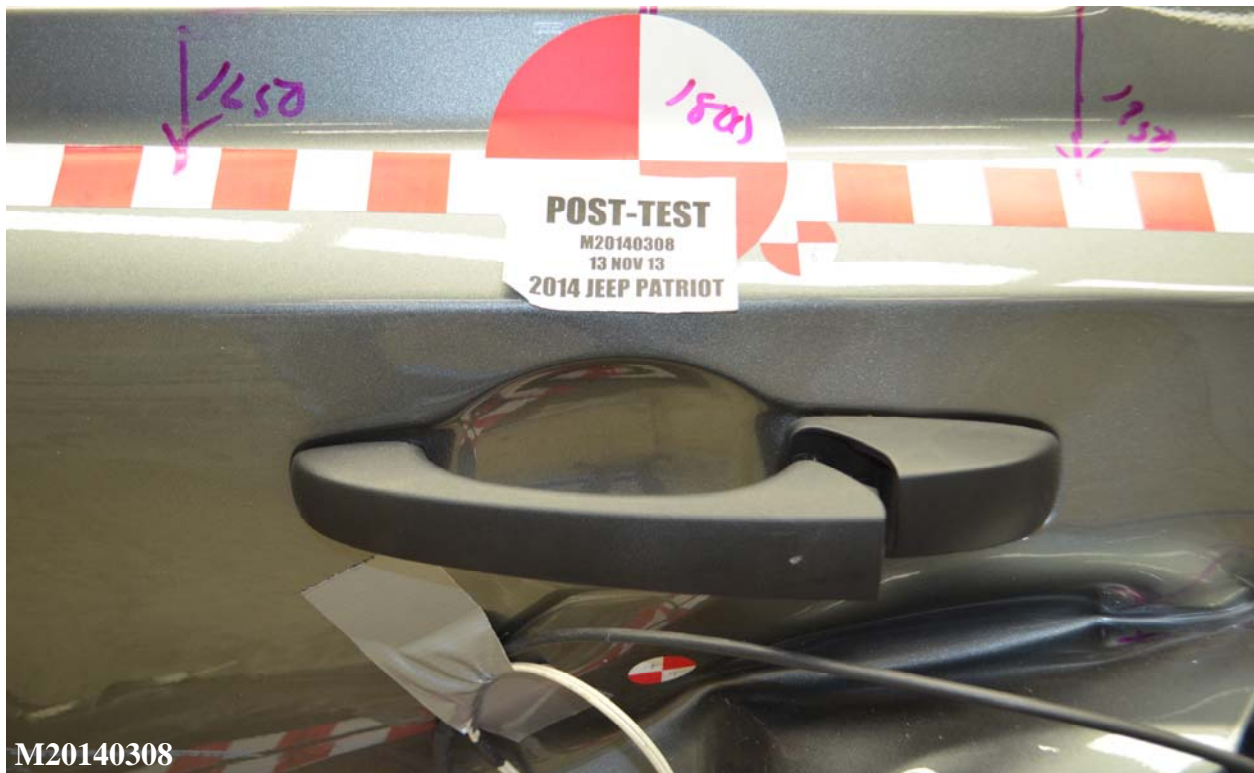
Figure A-24: Post-Test Left Rear Door Latch Close-Up

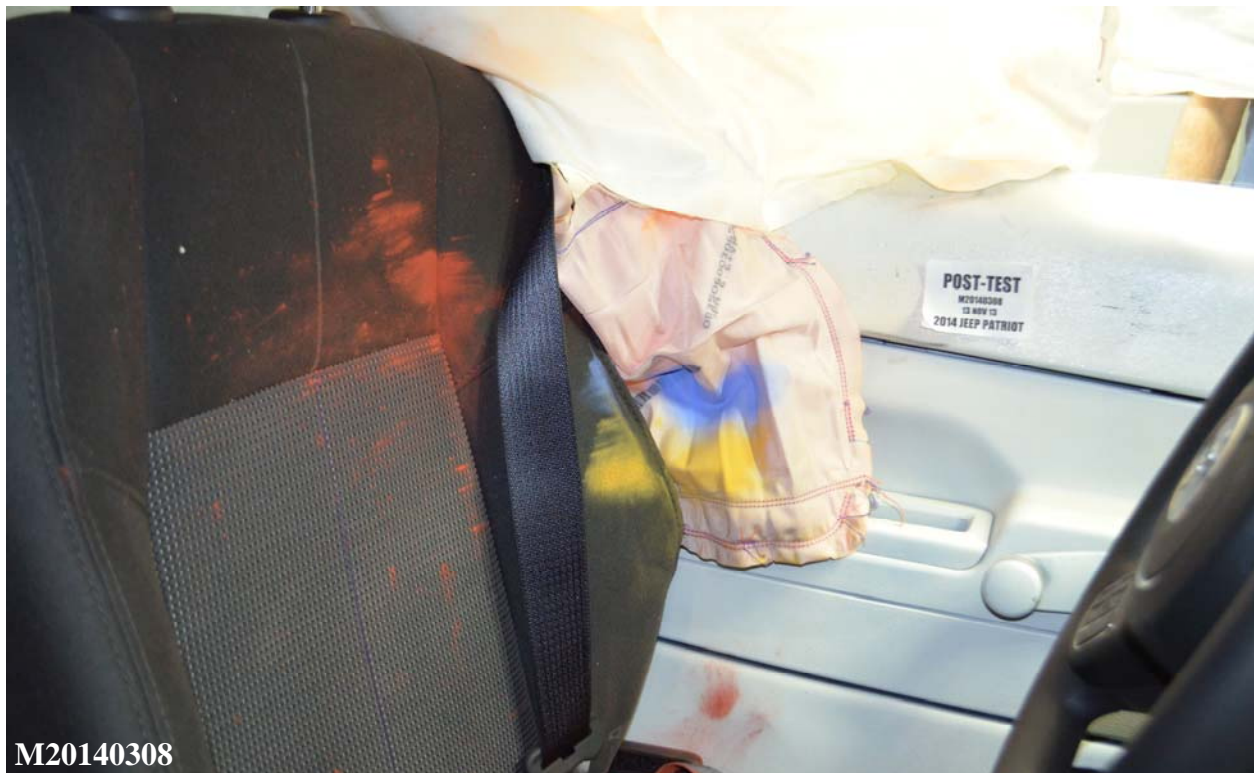
Figure A-50: Post-Test Driver Dummy Close-Up Torso Contact with Vehicle Interior View

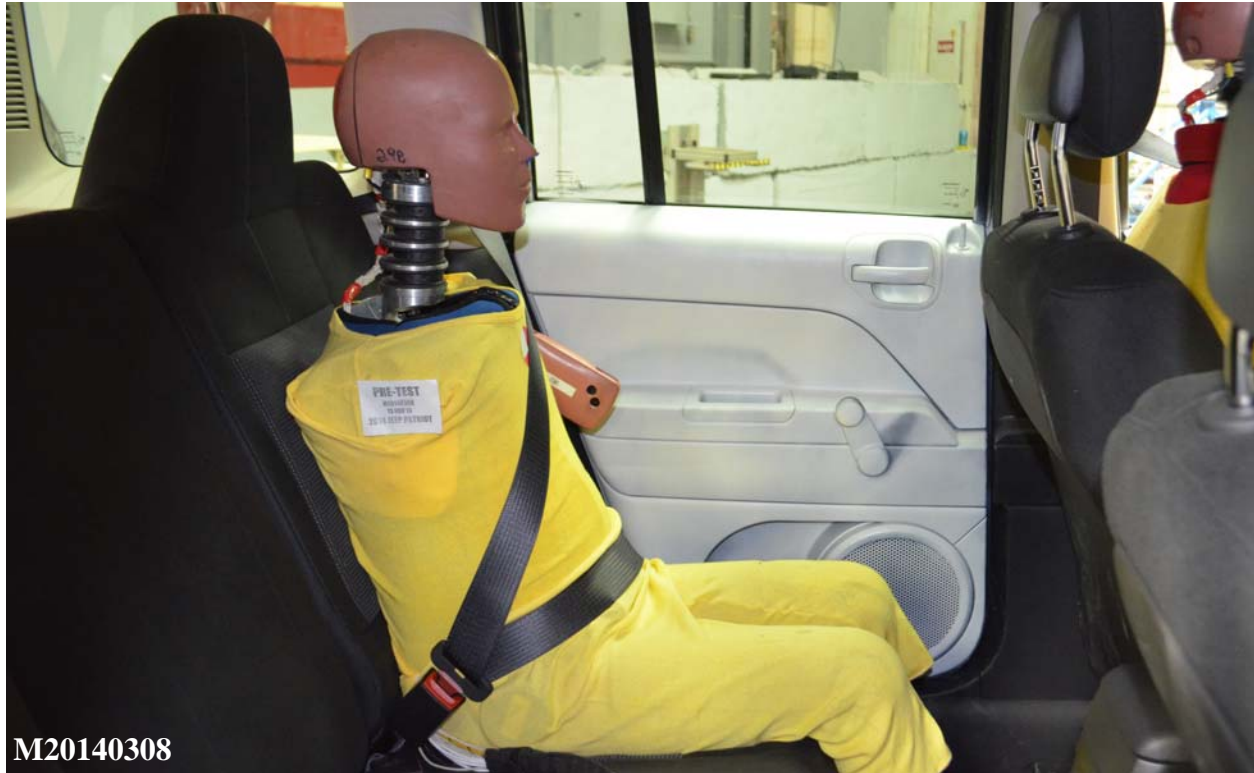
Figure A-70: Post-Test Rear Passenger Dummy and Door Clearance View

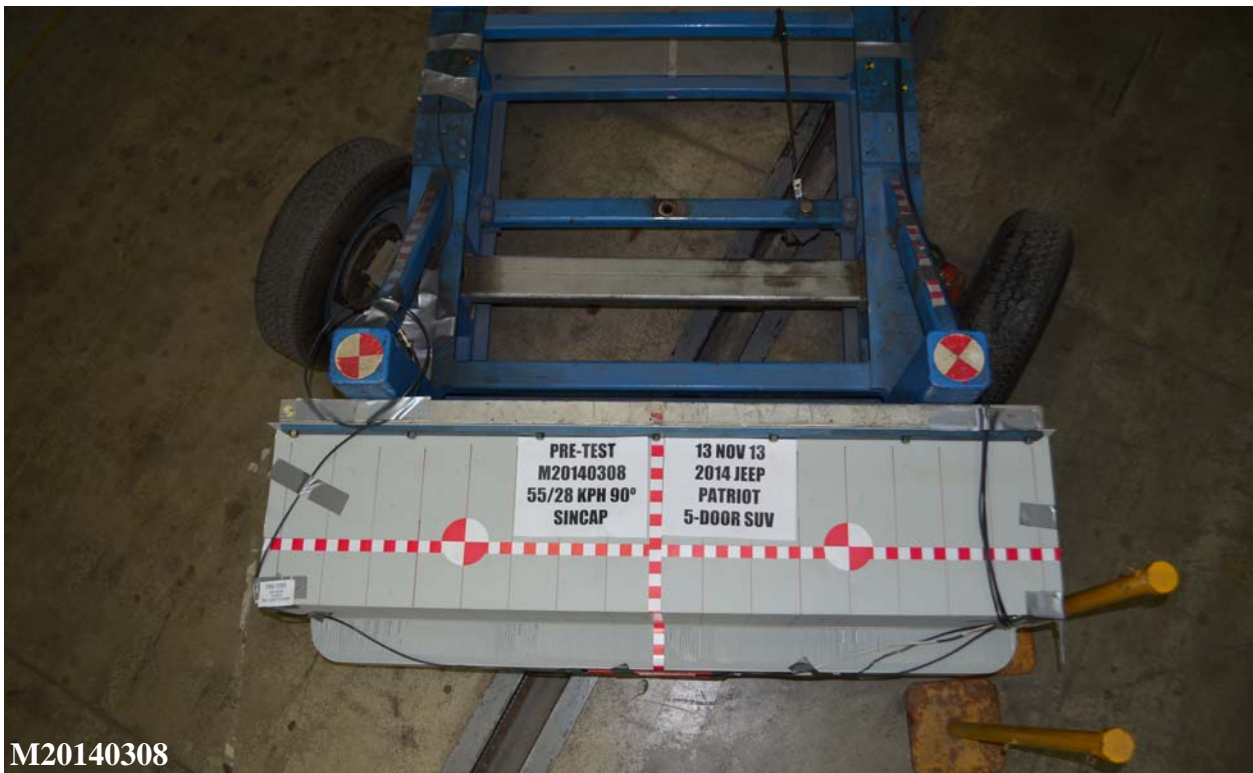
Figure A-85: Post-Test Front View of MDB Impactor Face

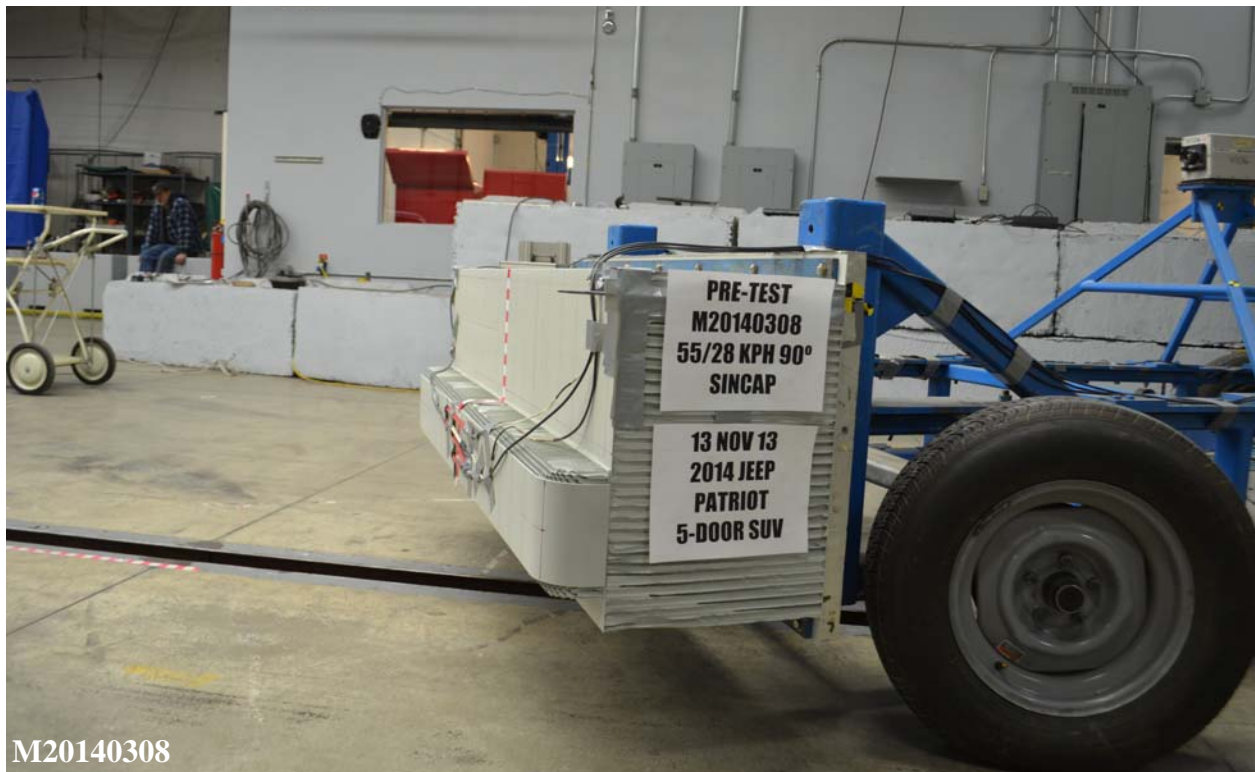
Figure A-87: Post-Test Top View of MDB Impactor Face
