**REPORT NUMBER: SINCAP-MGA-2014-028**

**NEW CAR ASSESSMENT PROGRAM (NCAP)  
Moving Deformable Barrier Side Impact Test**

**KIA MOTORS CORPORATION  
2014 Kia Sedona LX Minivan  
NHTSA No.: O20144208**

**FINAL REPORT**

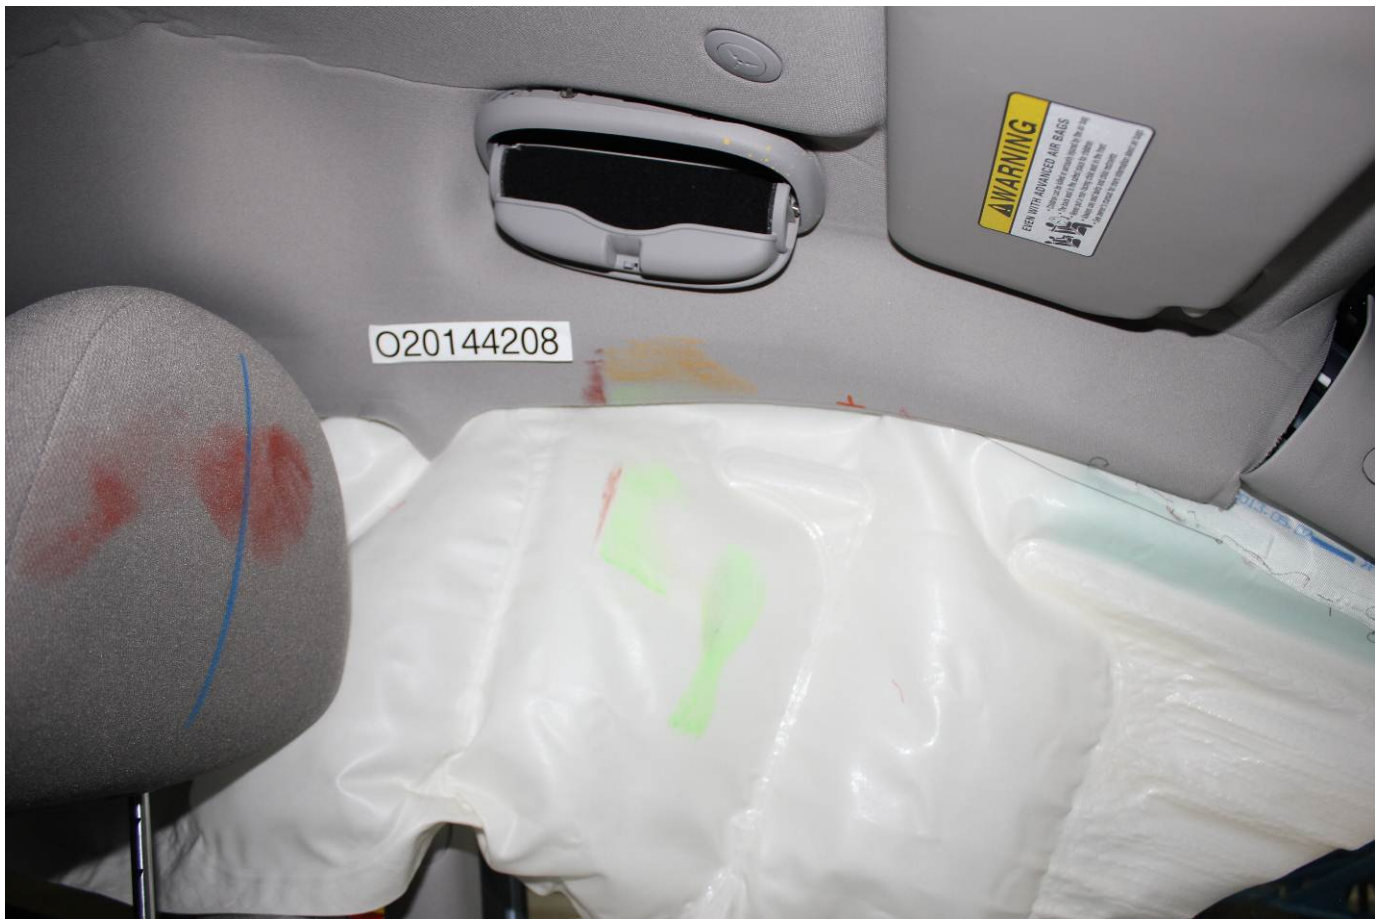
Post-Test Driver Dummy Close-up Head Contact with Vehicle Interior View
