FINAL REPORT NUMBER: SPNCAP-TRC-14-002

**NEW CAR ASSESSMENT PROGRAM (NCAP)
SIDE IMPACT POLE TEST**

**General Motors LLC
2014 Mercedes-Benz E-350 4-Door Sedan
NHTSA NUMBER: M20144301**

**PREPARED BY:
Transportation Research Center Inc.
10820 State Route 347
P. O. Box B-67
East Liberty, OH 43319**

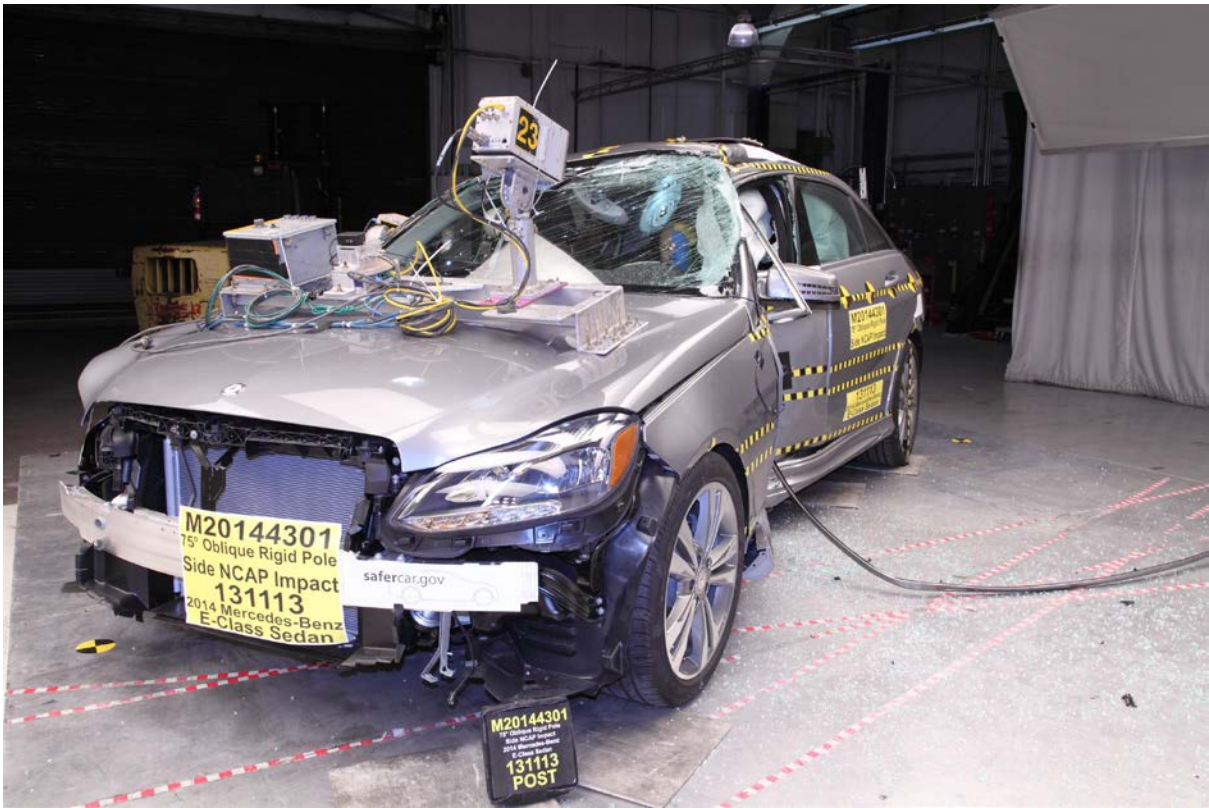
006 Post-Test Left Front 3-4 View of Test Vehicle

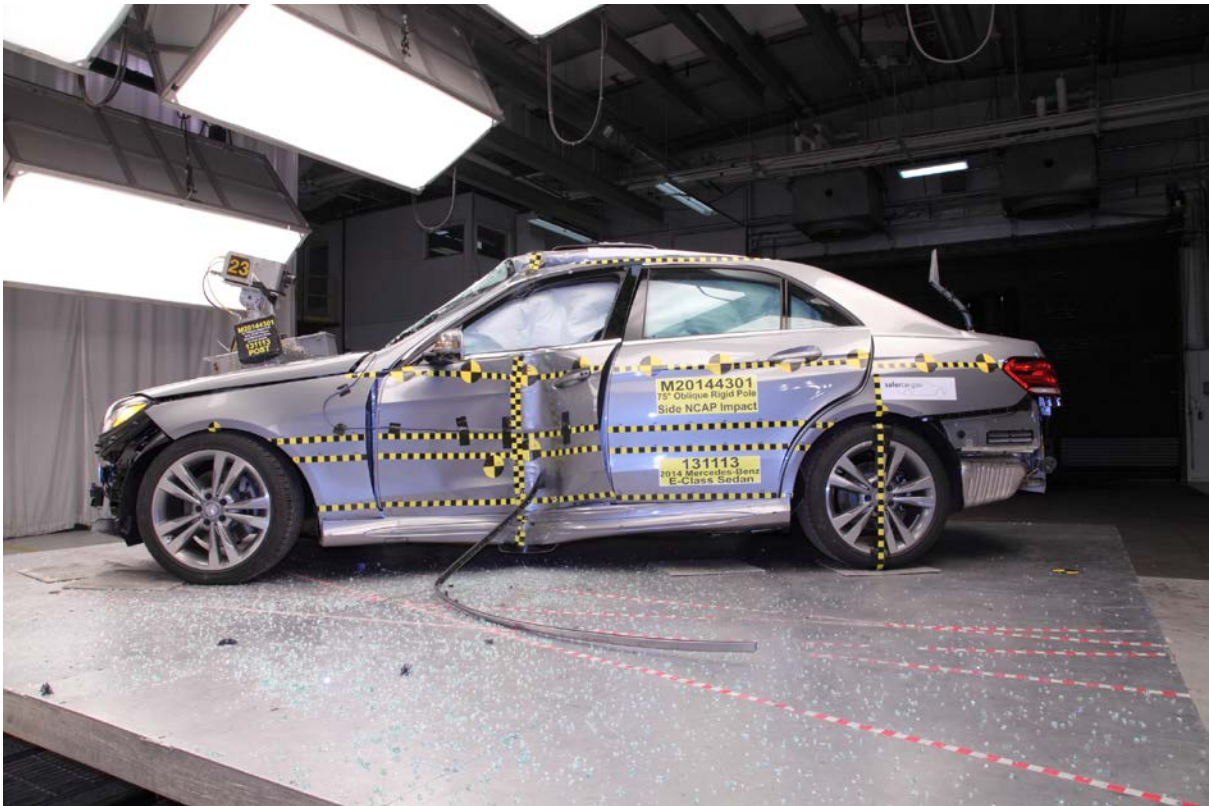
008 Post-Test Left Side View of Test Vehicle

Critical Areas of Performance	Observations and Conclusions
Pillar Performance	Severe deformation of B-pillar
Sill Separation	None
Windshield Damage	Broken
Side Window Damage	Broken
Other Notable Effects	None

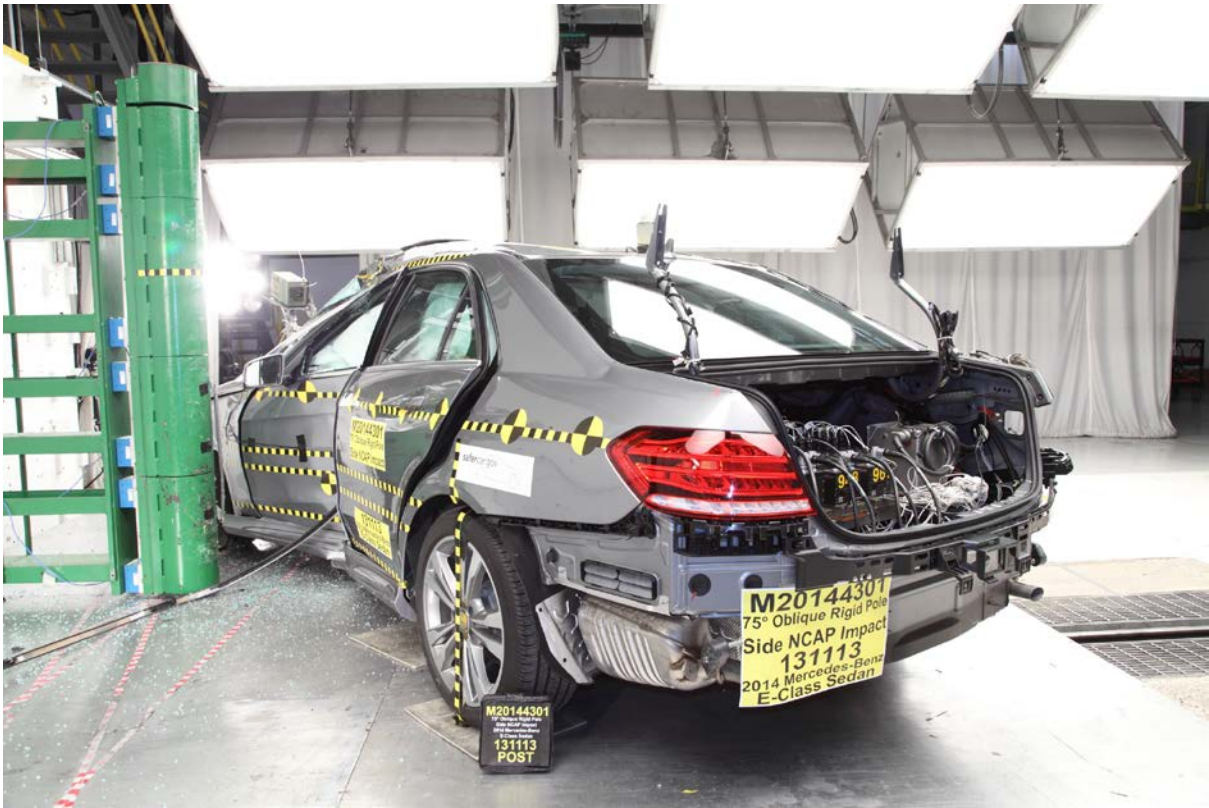
010 Post-Test Left Rear 3-4 View of Test Vehicle

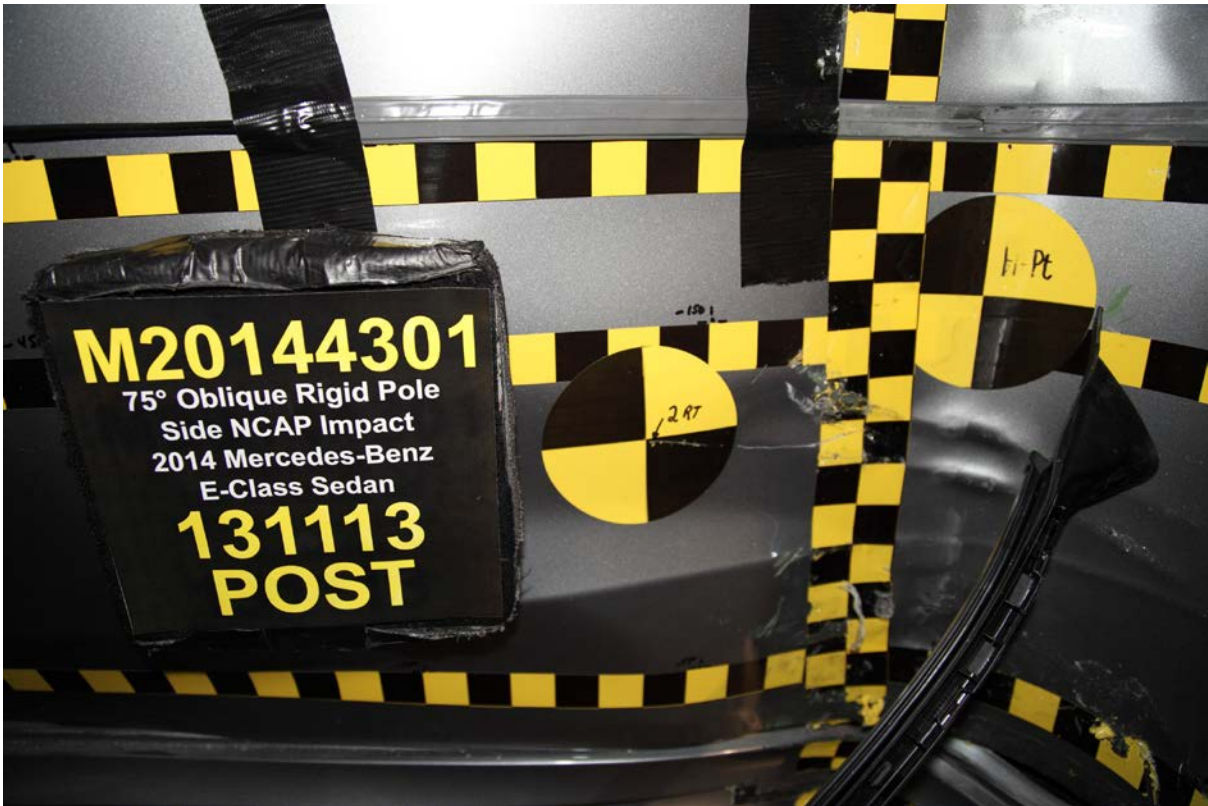
020 Post-Test Close-Up View of Impact Point Target Showing Impact Location

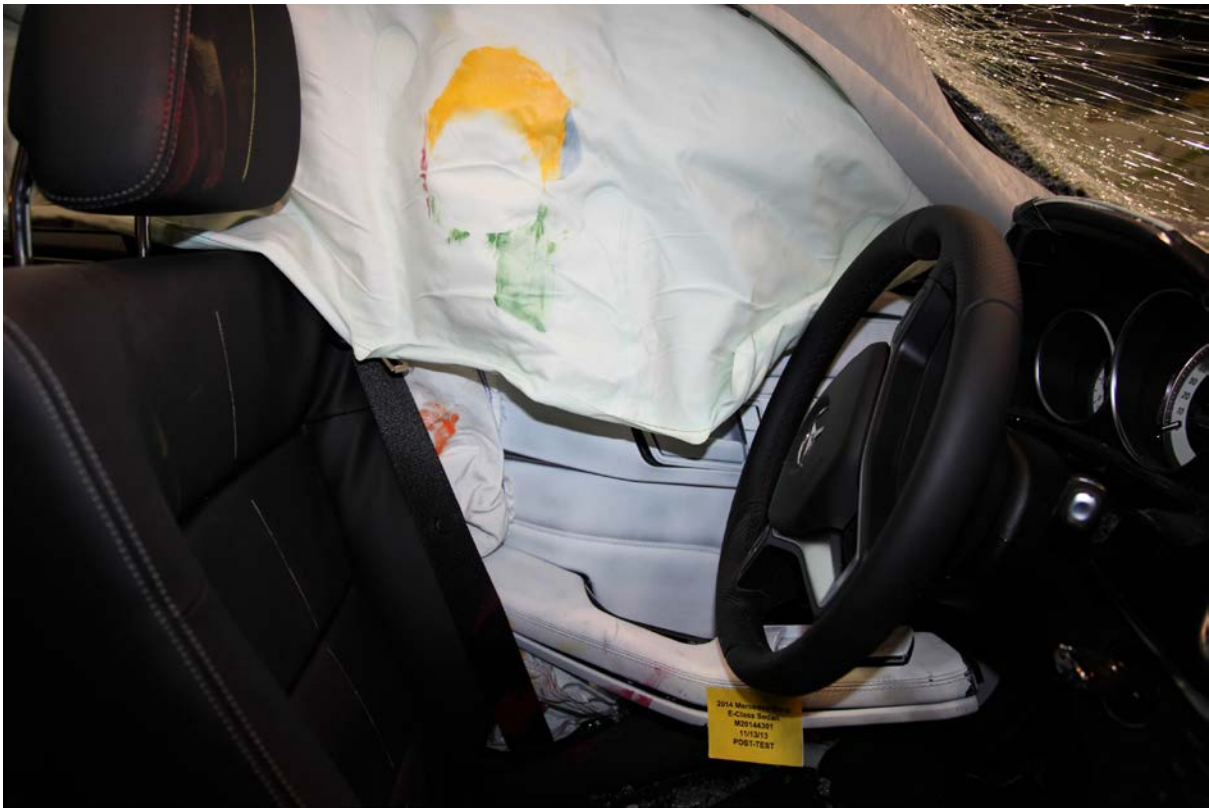
045 Post-Test Inner Driver Door Panel View Showing Dummy Contact Location

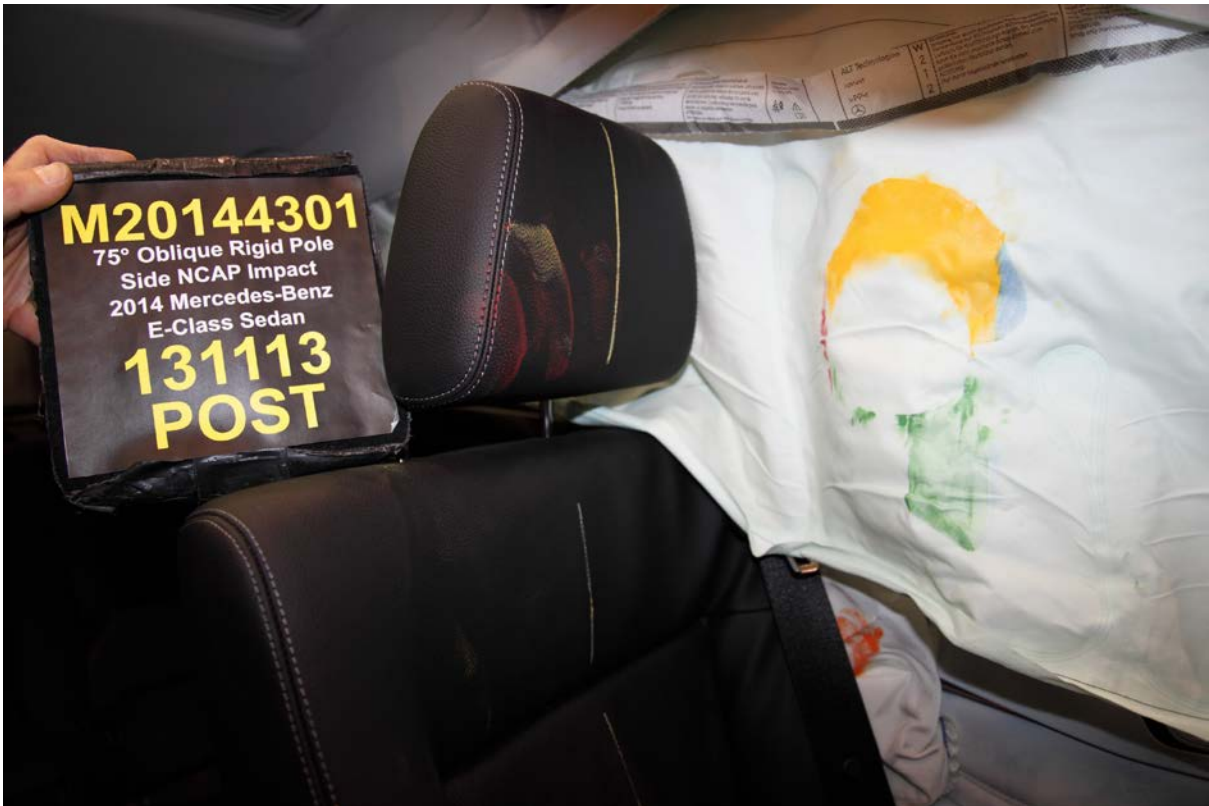
046 Post-Test Dummy Close-Up Head Contact with Vehicle View

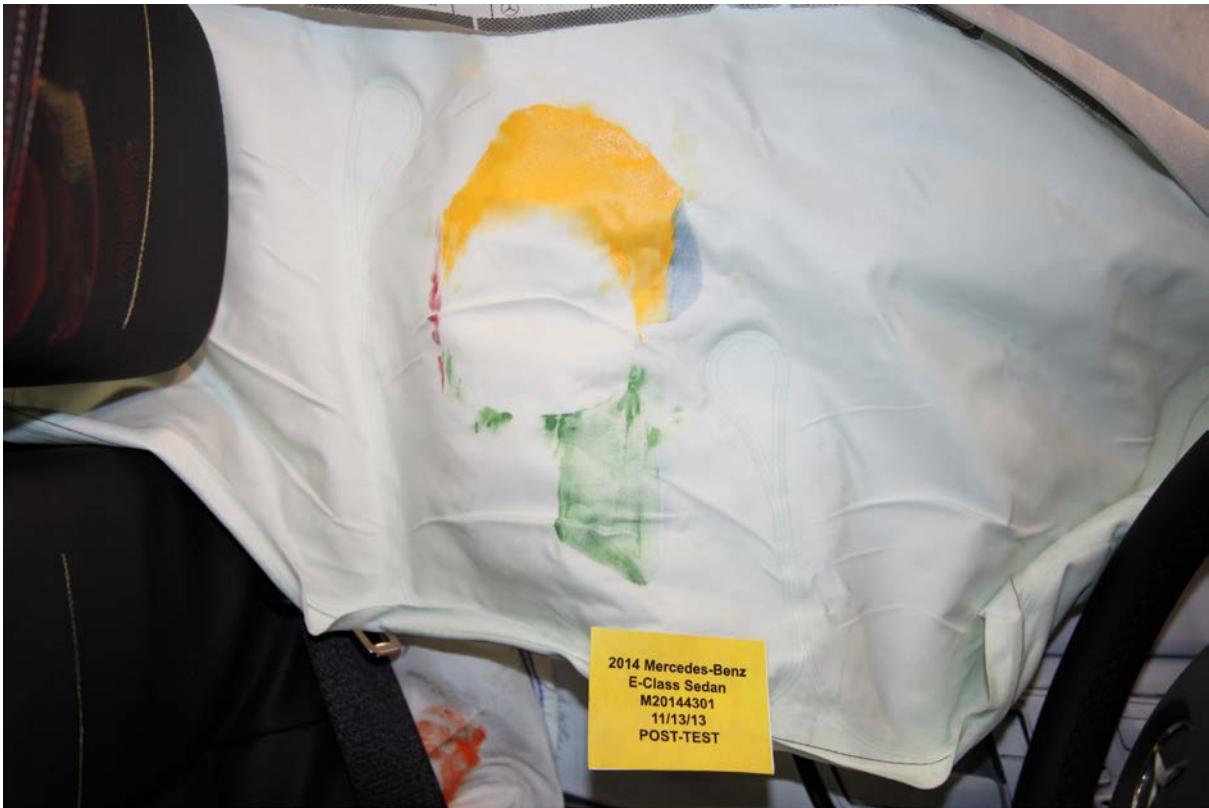
047 Post-Test Dummy Close-Up Head Contact with Side Airbag View

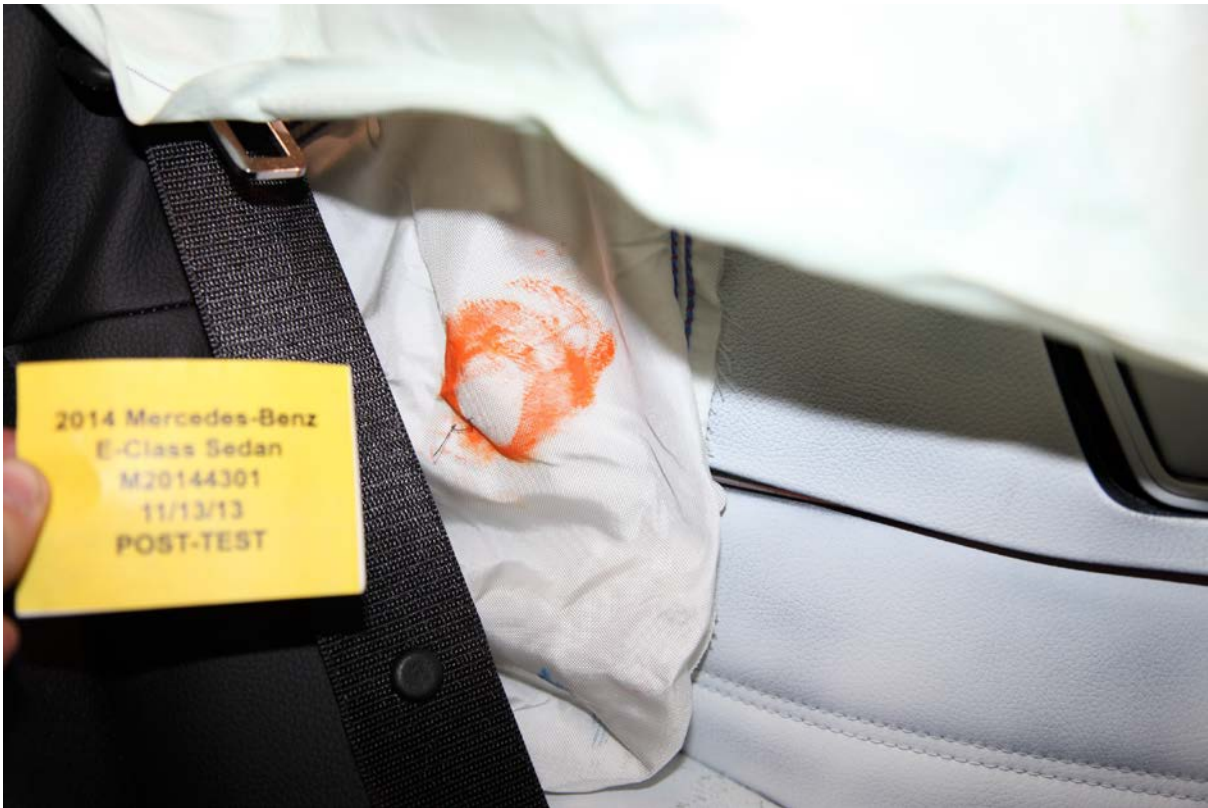
049 Post-Test Dummy Close-Up Torso Contact with Side Airbag View

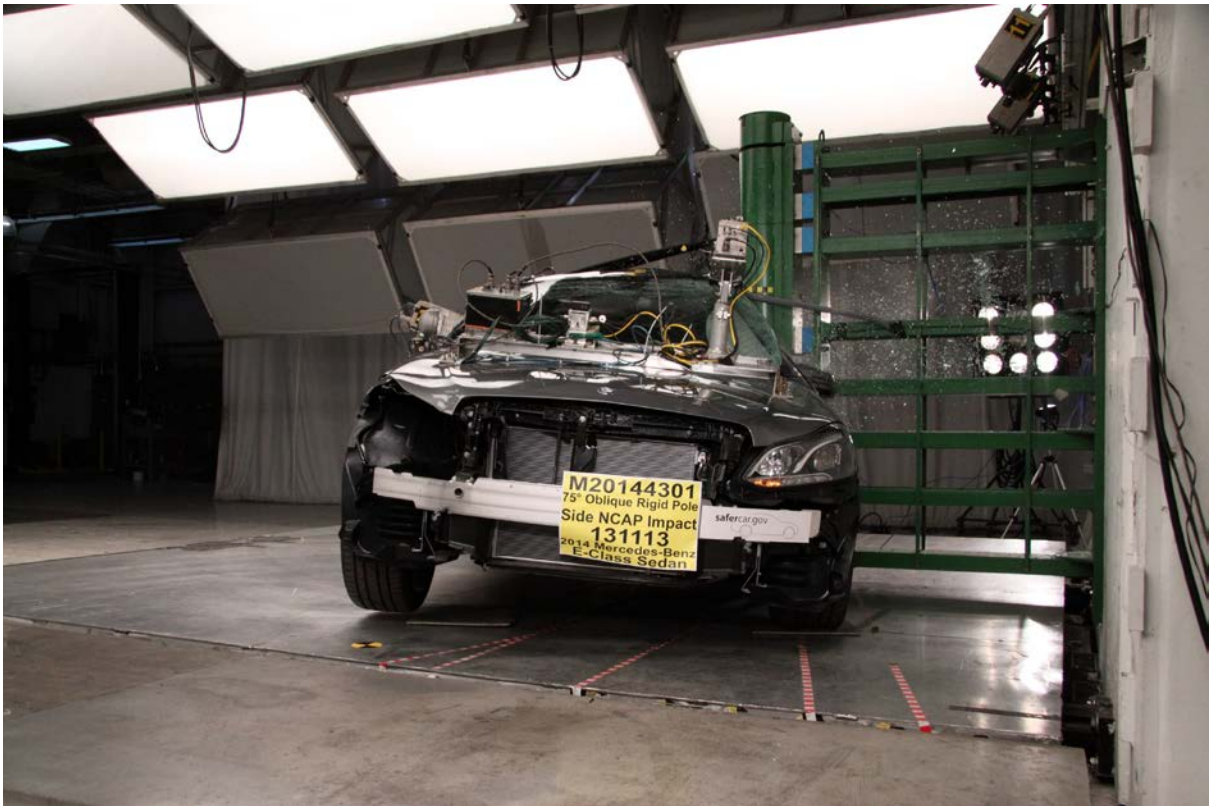
068 Impact Event

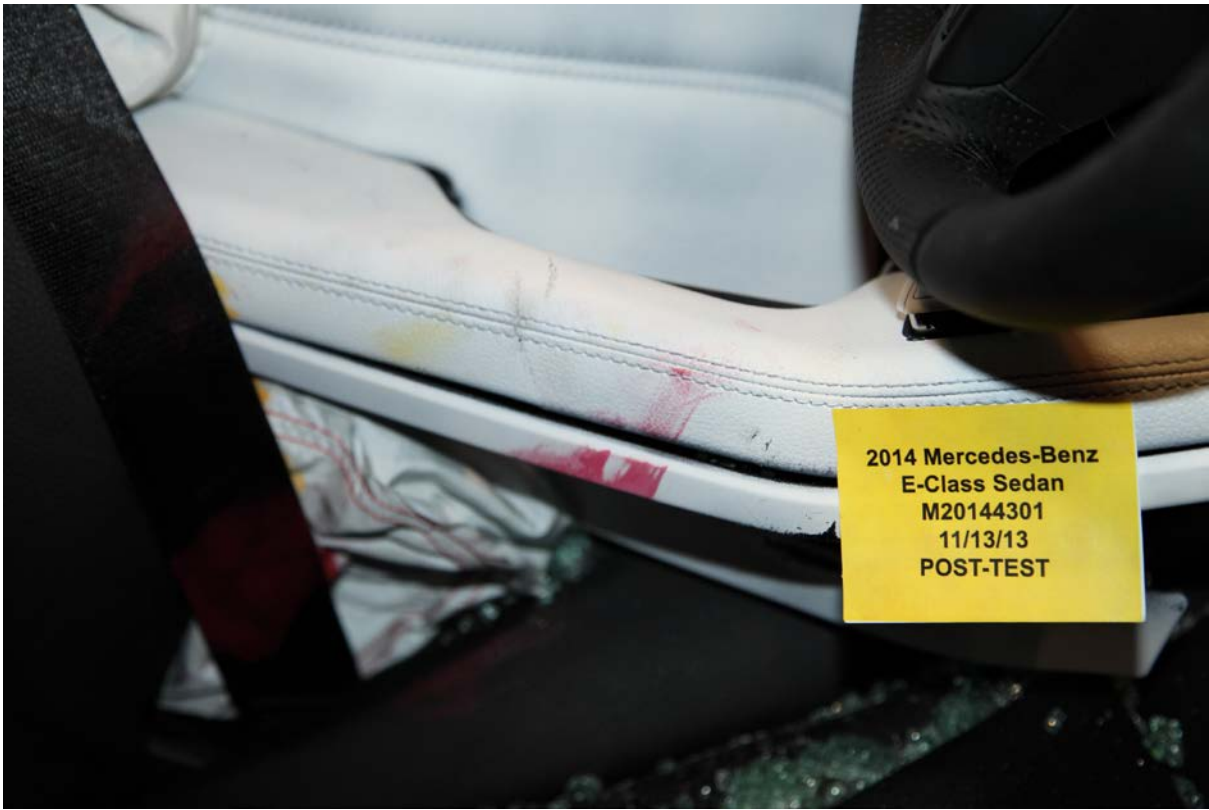
071 Post-Test View of Shattered Vehicle Inner Door Panel
