**REPORT NUMBER: SPNCAP-MCW-14-002**

**NEW CAR ASSESSMENT PROGRAM (SPNCAP)  
SIDE IMPACT POLE TEST**

**CHRYSLER GROUP, LLC  
2014 JEEP PATRIOT 5-DOOR SUV  
NHTSA NUMBER: M20140307**

**PREPARED BY:  
MEDICAL COLLEGE OF WISCONSIN  
5000 WEST NATIONAL AVENUE  
RESEARCH 151  
MILWAUKEE, WISCONSIN 53295**

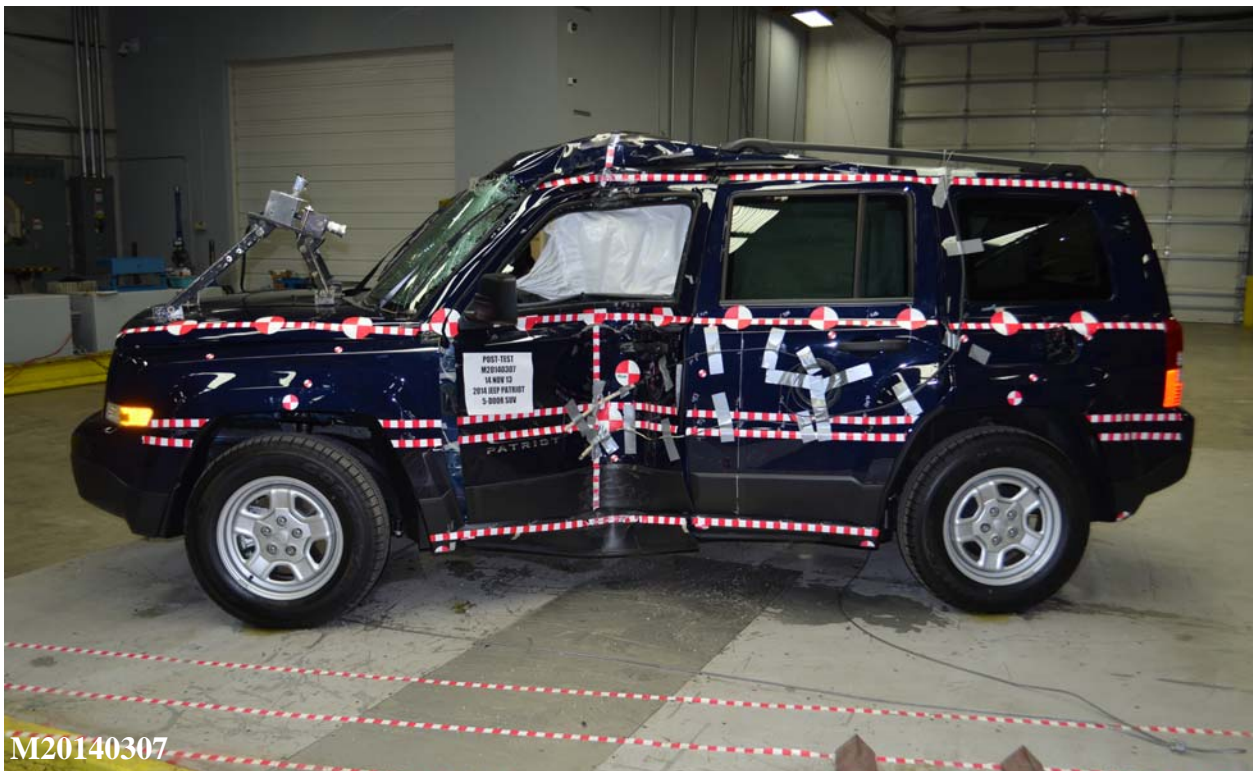
Figure 008: Post-Test Left Side View of Test Vehicle

<b>POST TEST STRUCTURAL OBSERVATIONS</b>	
<b>Critical Areas of Performance</b>	<b>Observations/Conclusions</b>
Pillar Performance	No Separation
Sill Separation	Max Sill Separation of 77 mm at C-Pillar at Roof Line
Windshield Damage	Cracking Along Entire Windshield; Heaviest Concentration along Upper Impacted Side
Window Damage	Front Window Shattered at Impact
Other Notable Effects	None Noted

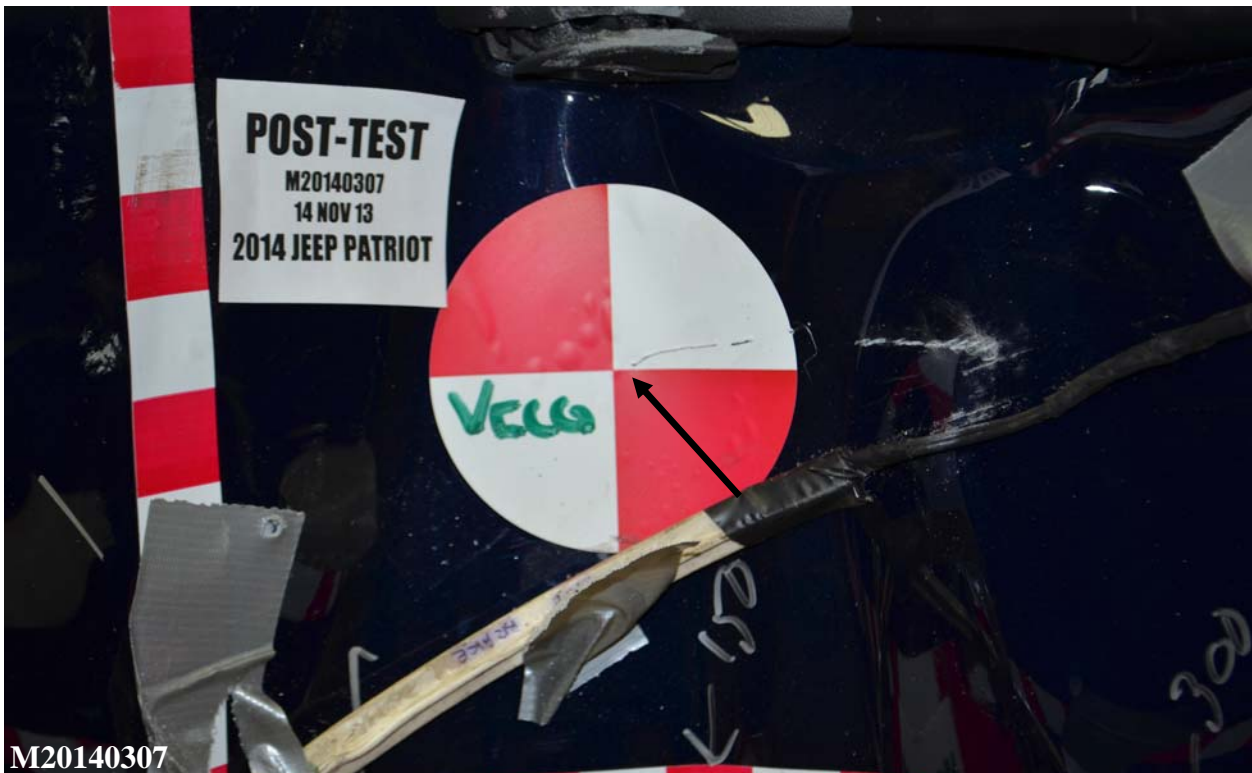
Figure 020: Post-Test Close-Up View of Impact Point Target Showing Impact Location

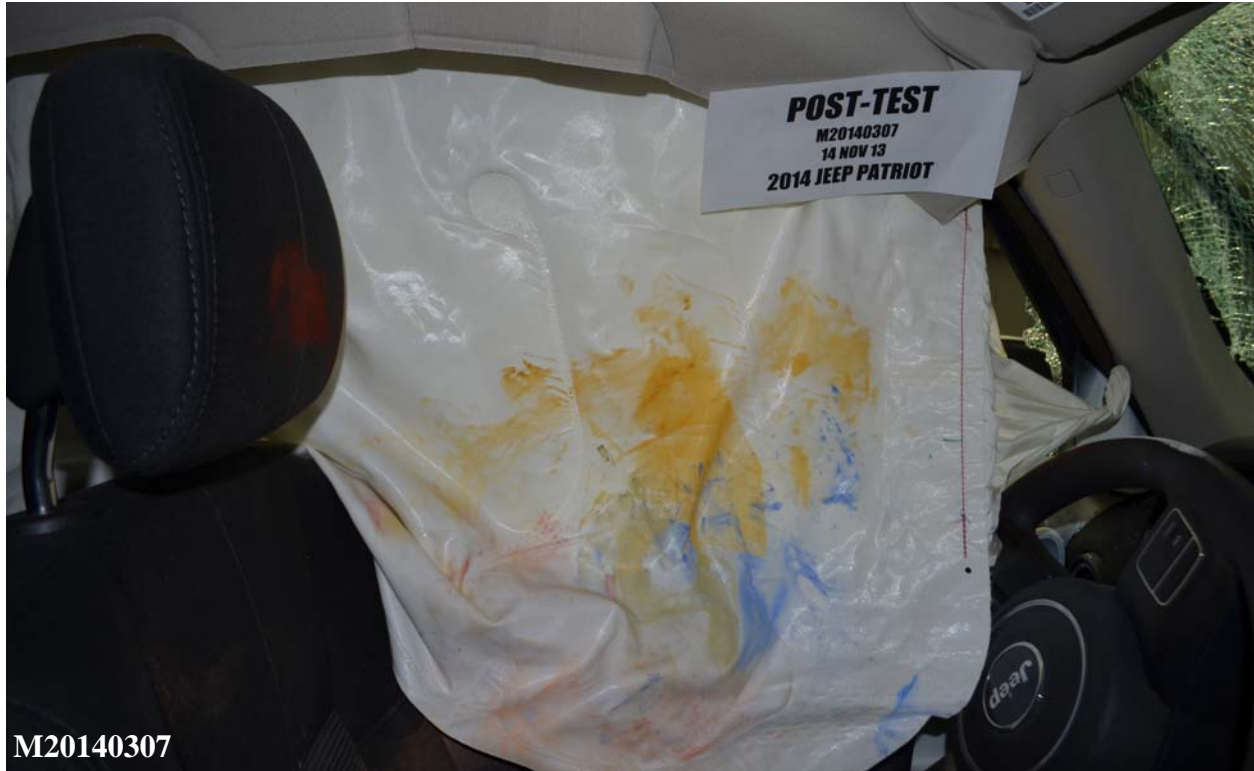
Figure 047: Post-Test Dummy Close-Up Head Contact with Side Air bag View

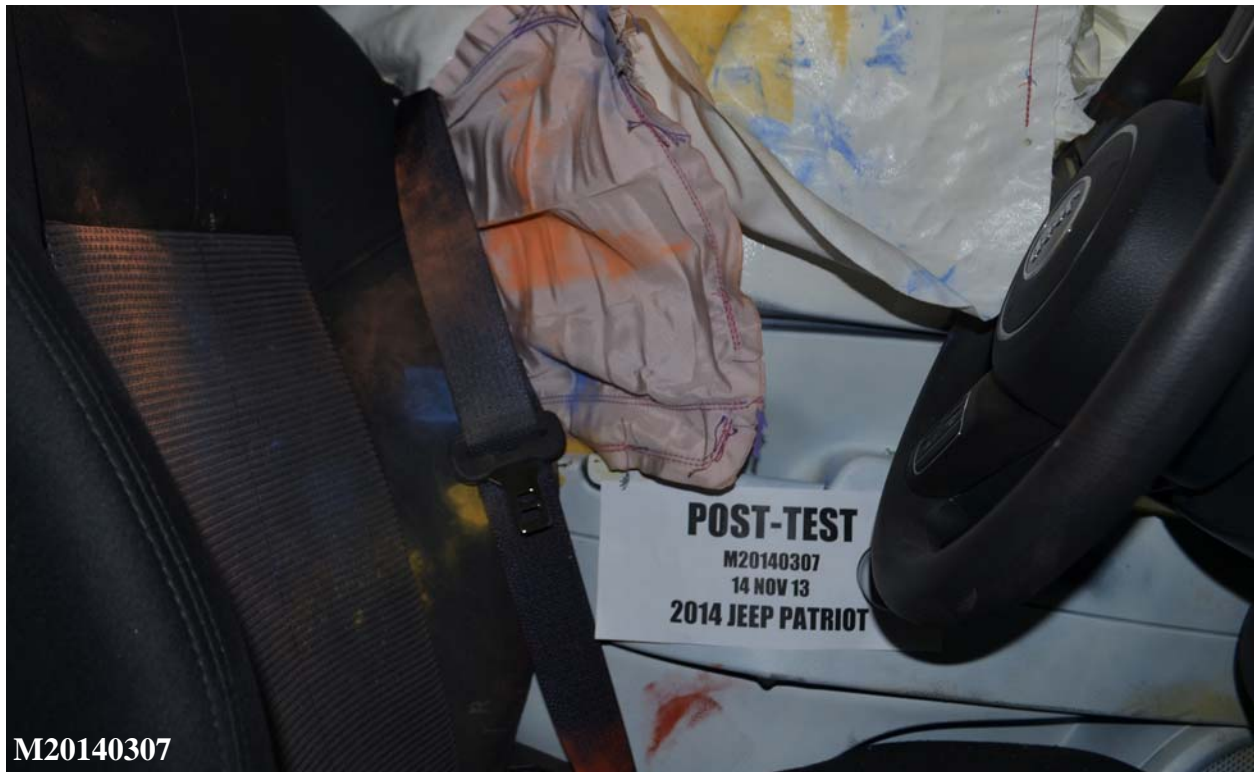
Figure 049: Post-Test Dummy Close-Up Torso Contact with Side Air bag View
