**REPORT NUMBER: SPNCAP-MCW-14-004**

**NEW CAR ASSESSMENT PROGRAM (SPNCAP)  
SIDE IMPACT POLE TEST**

**CHRYSLER GROUP, LLC  
2014 JEEP COMPASS 5-DOOR MPV  
NHTSA NUMBER: M20140305**

**FINAL REPORT**

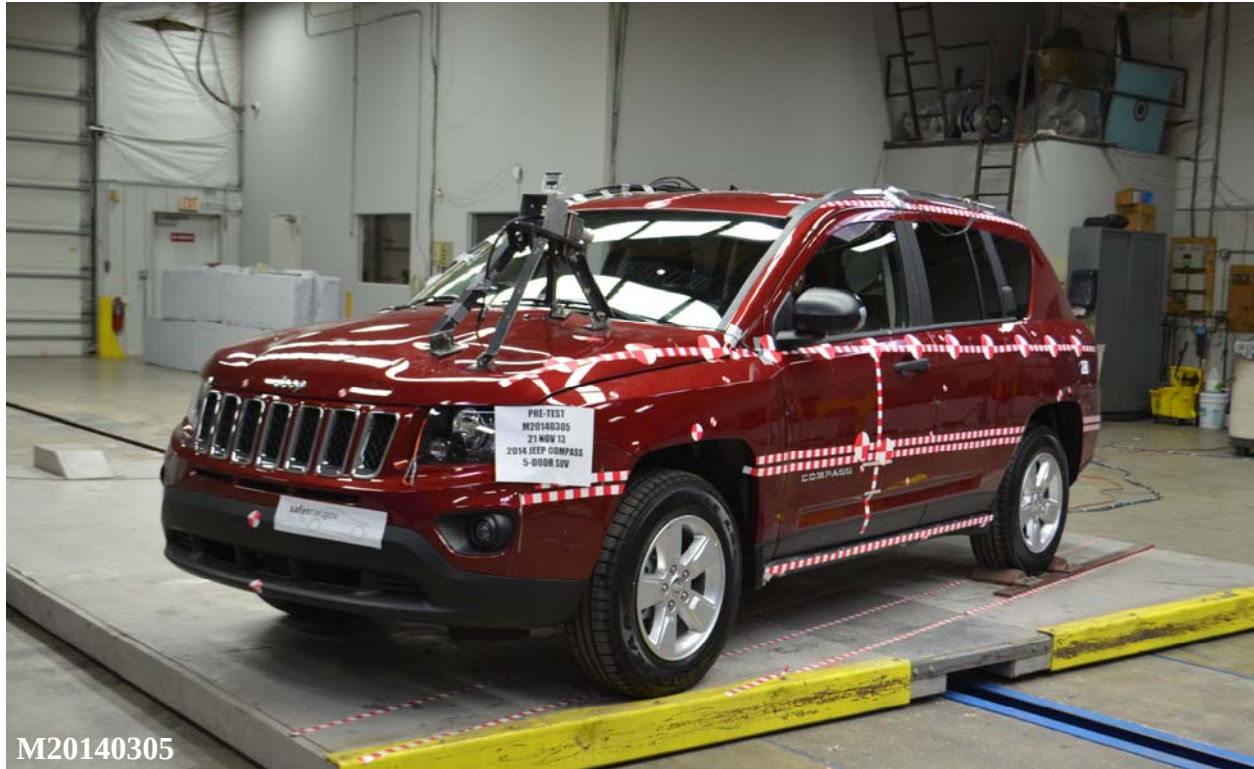
Figure 004: Post-Test Frontal View of Test Vehicle

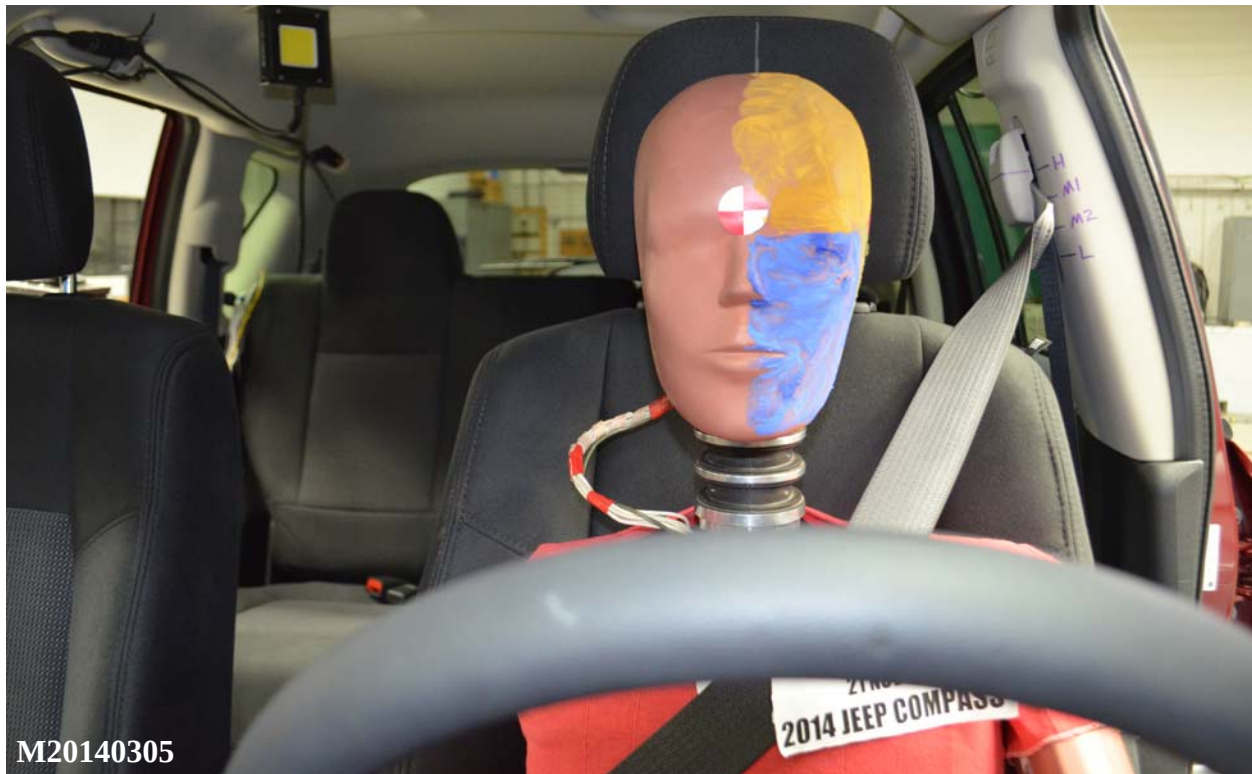
Figure 020: Post-Test Close-Up View of Impact Point Target Showing Impact Location

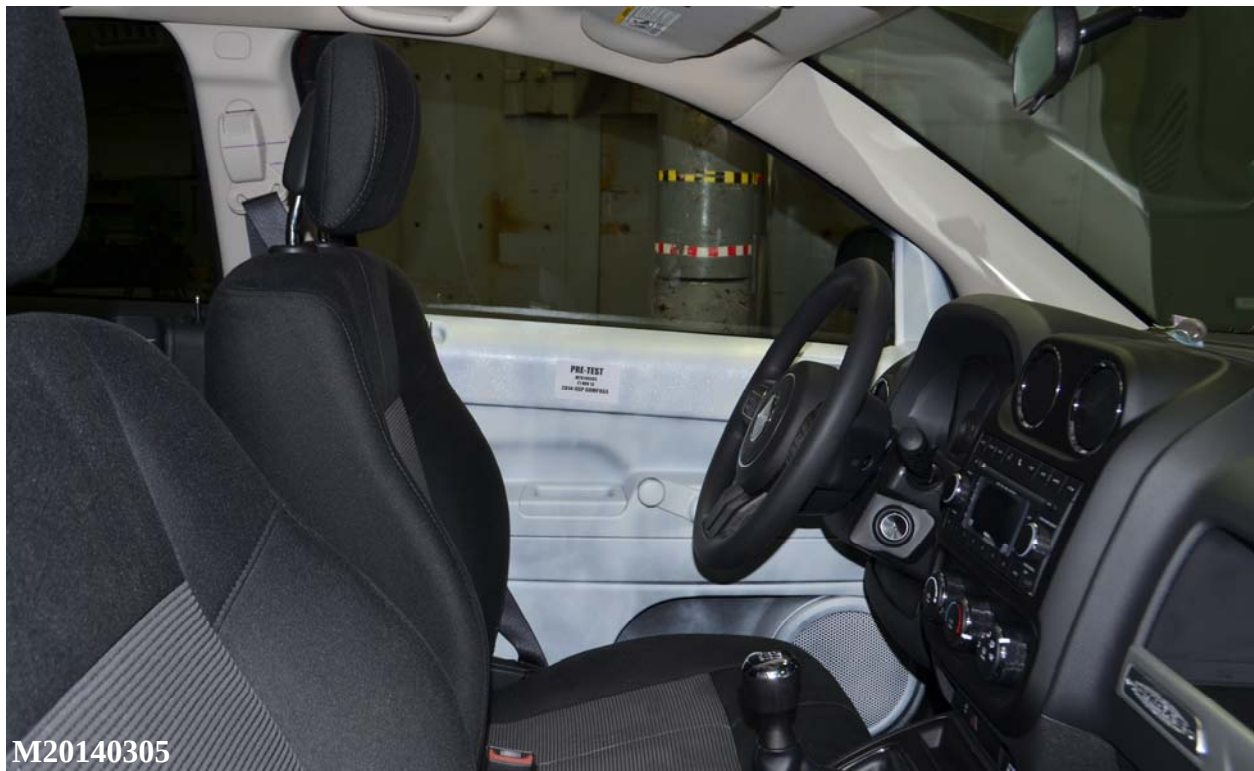
Figure 043: Post-Test Right Side View of Dummy and Front Seat of Occupant Compartment

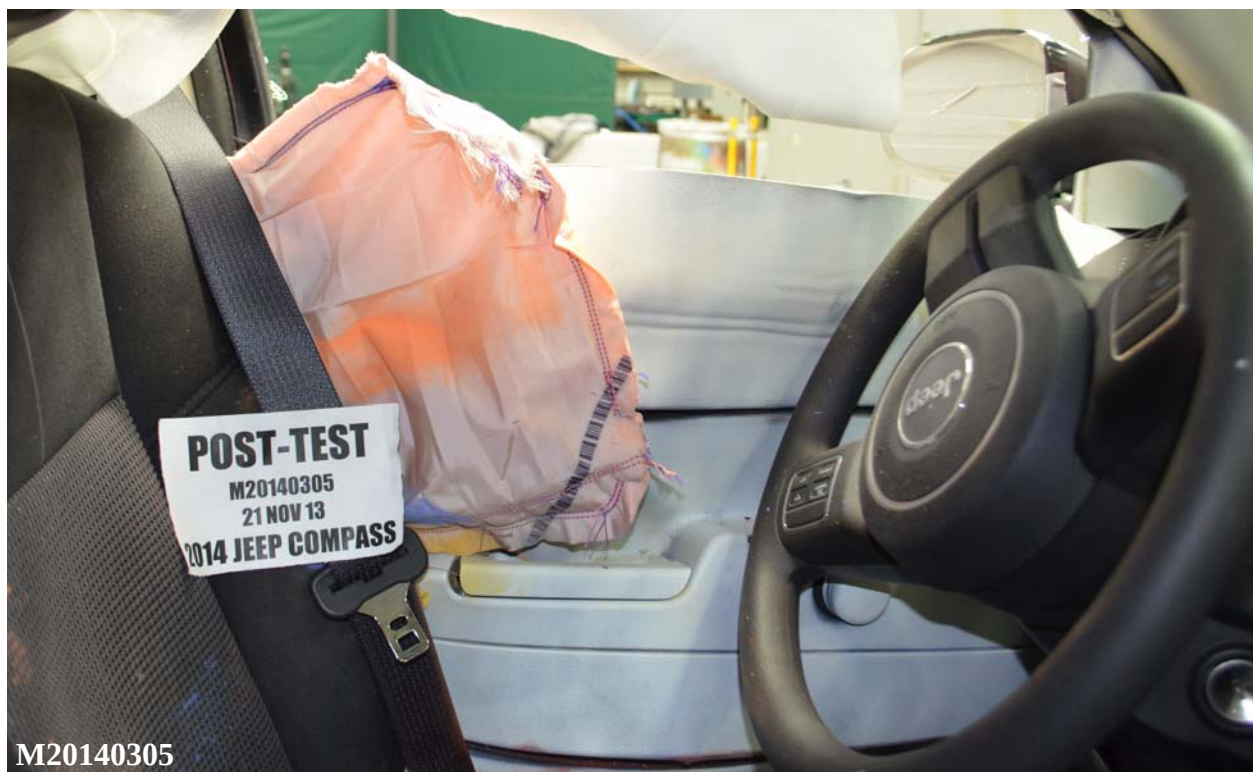
Figure 047: Post-Test Dummy Close-Up Head Contact with Side Air bag View

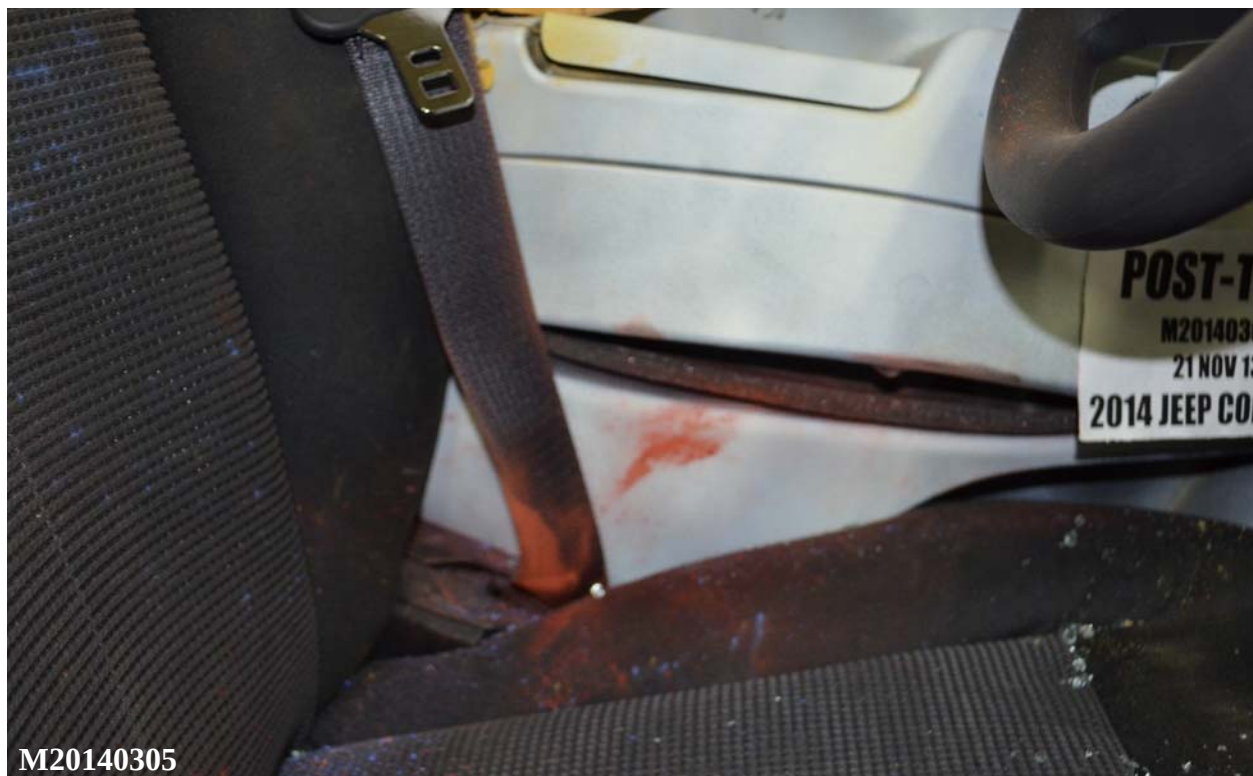
Figure 049: Post-Test Dummy Close-Up Torso Contact with Side Air bag View

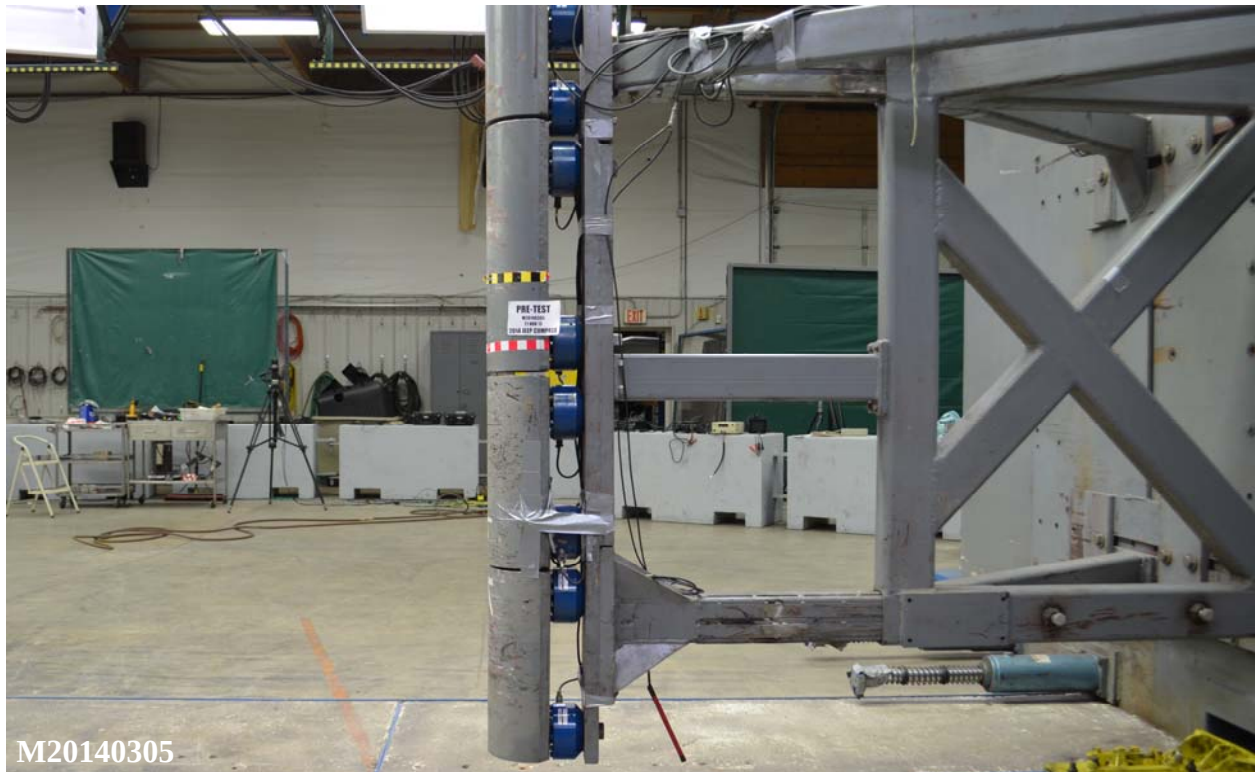
Figure 058: Post-Test Pole Barrier Front View
