**REPORT NUMBER: SINCAP-MGA-2014-031**

**NEW CAR ASSESSMENT PROGRAM (NCAP)  
Moving Deformable Barrier Side Impact Test**

**GENERAL MOTORS LLC  
2014 Chevrolet Silverado 1500 Double Cab  
NHTSA No.: M20140113**

**FINAL REPORT**

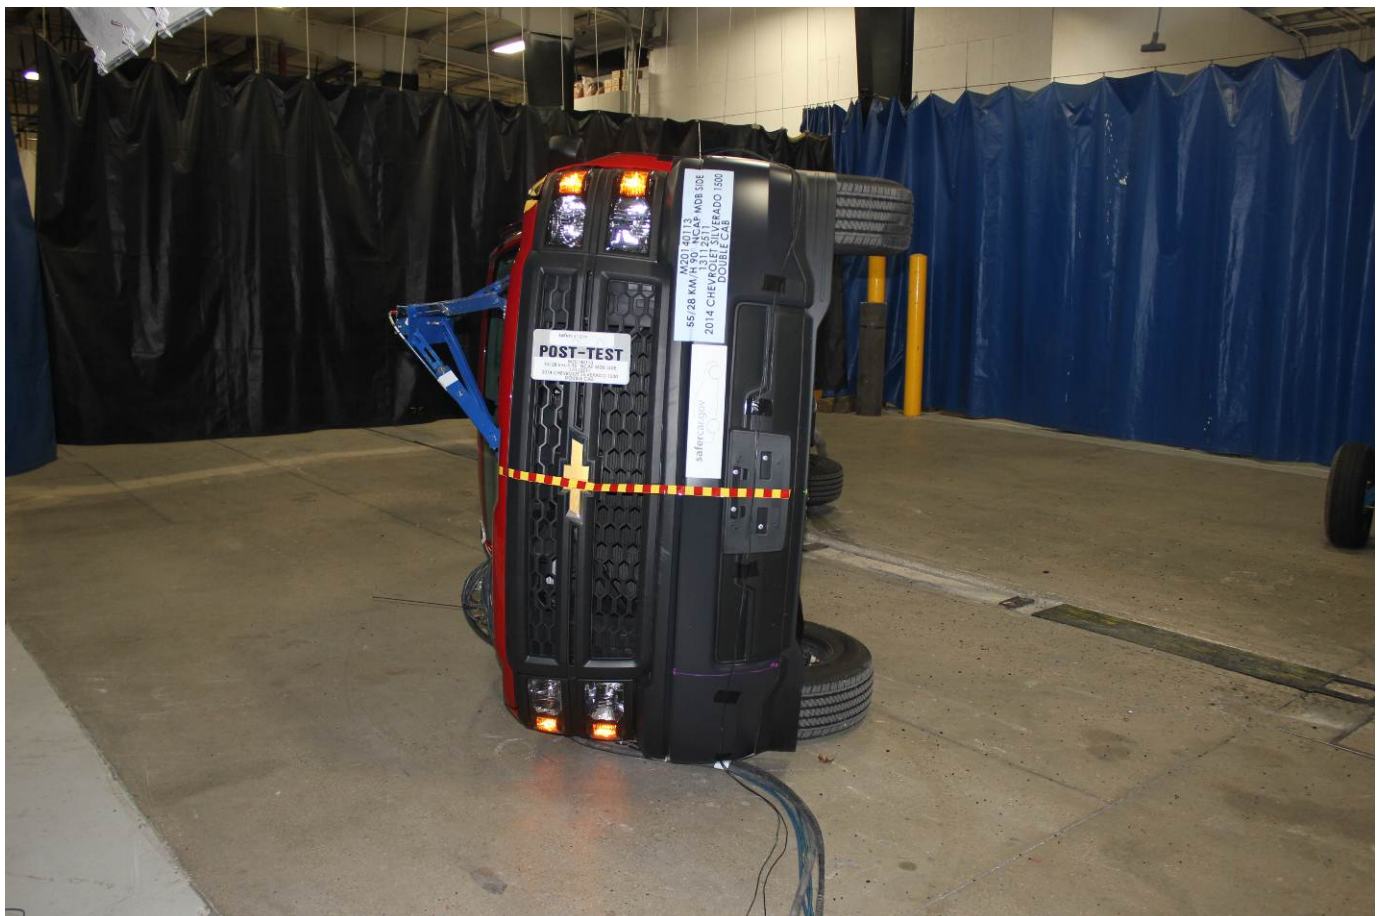
Post-Test Frontal View of Test Vehicle

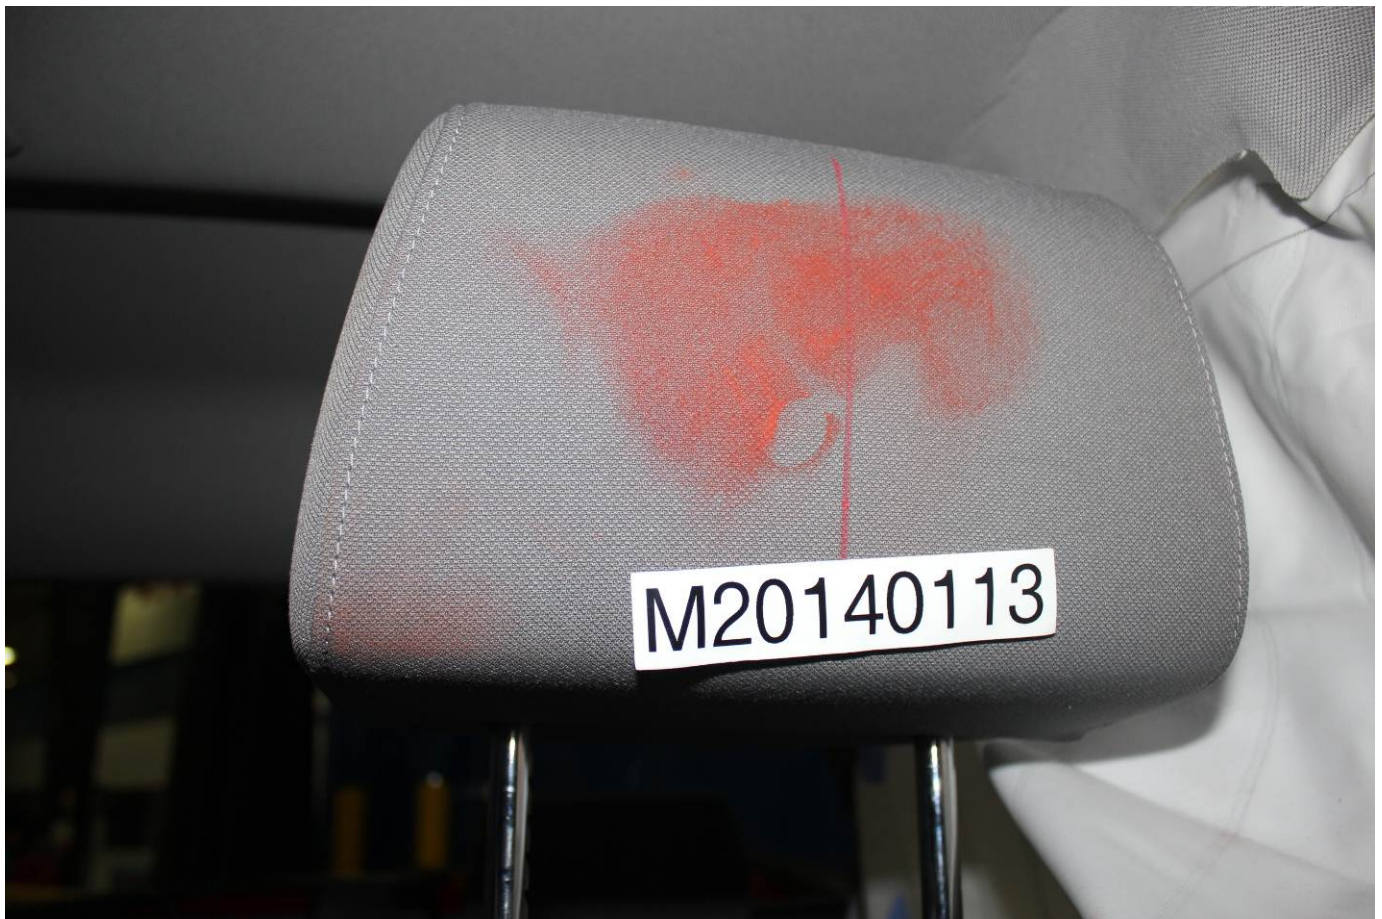
Post-Test Driver Dummy Close-up Head Contact with Vehicle Interior View

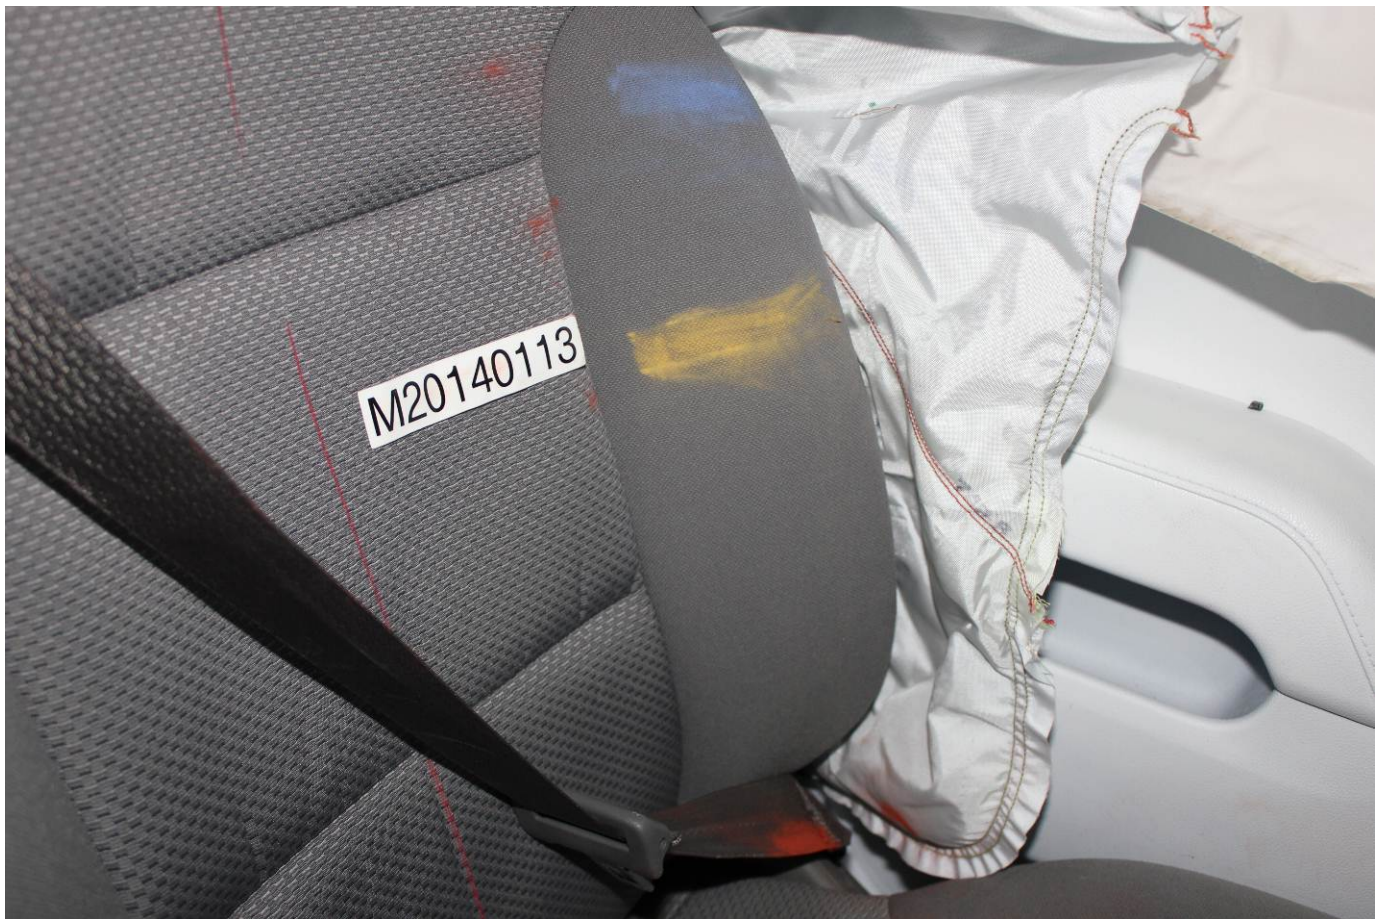
Post-Test Driver Dummy Close-up Torso Contact with Vehicle Interior View
