**REPORT NUMBER: SPNCAP-MGA-2014-032**

**NEW CAR ASSESSMENT PROGRAM (NCAP)  
Side Impact Pole Test**

**GENERAL MOTORS LLC  
2014 Chevrolet Silverado 1500 Double Cab  
NHTSA No.: M20140112**

**FINAL REPORT**

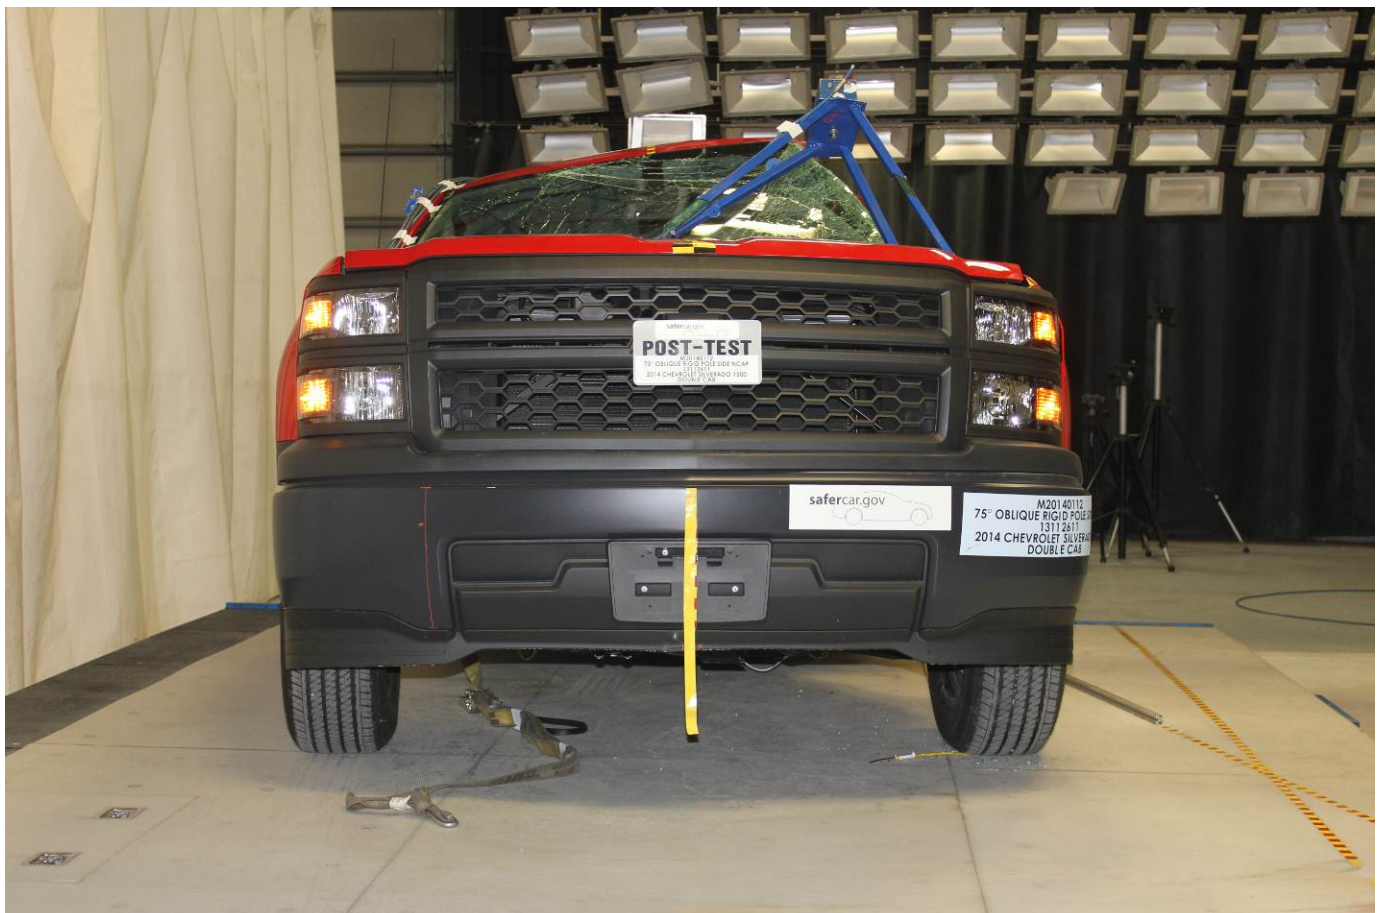
Post-Test Frontal View of Test Vehicle

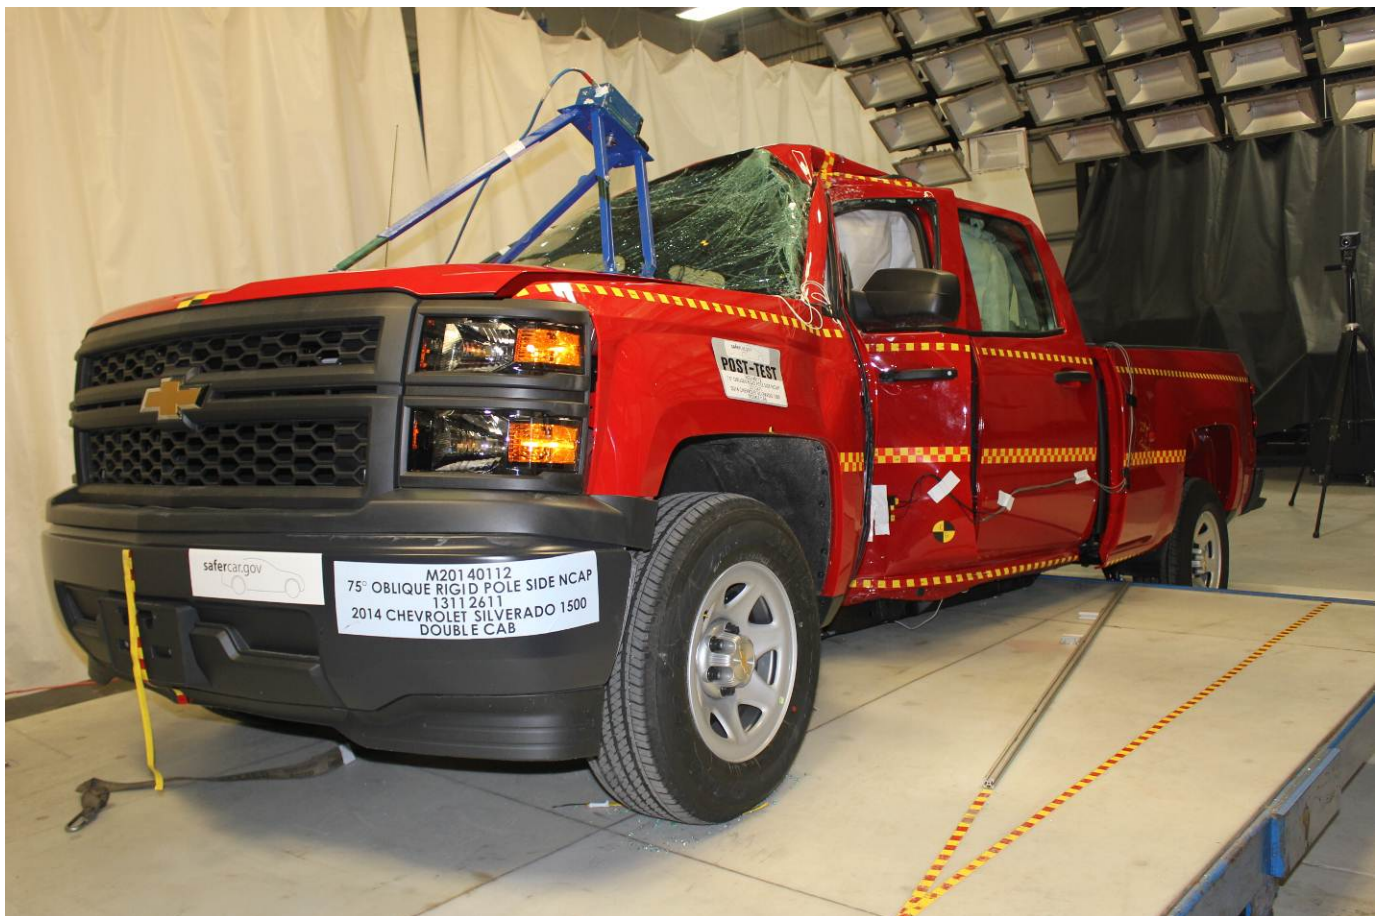
Post-Test Left Front  $\frac{3}{4}$  View of Test Vehicle

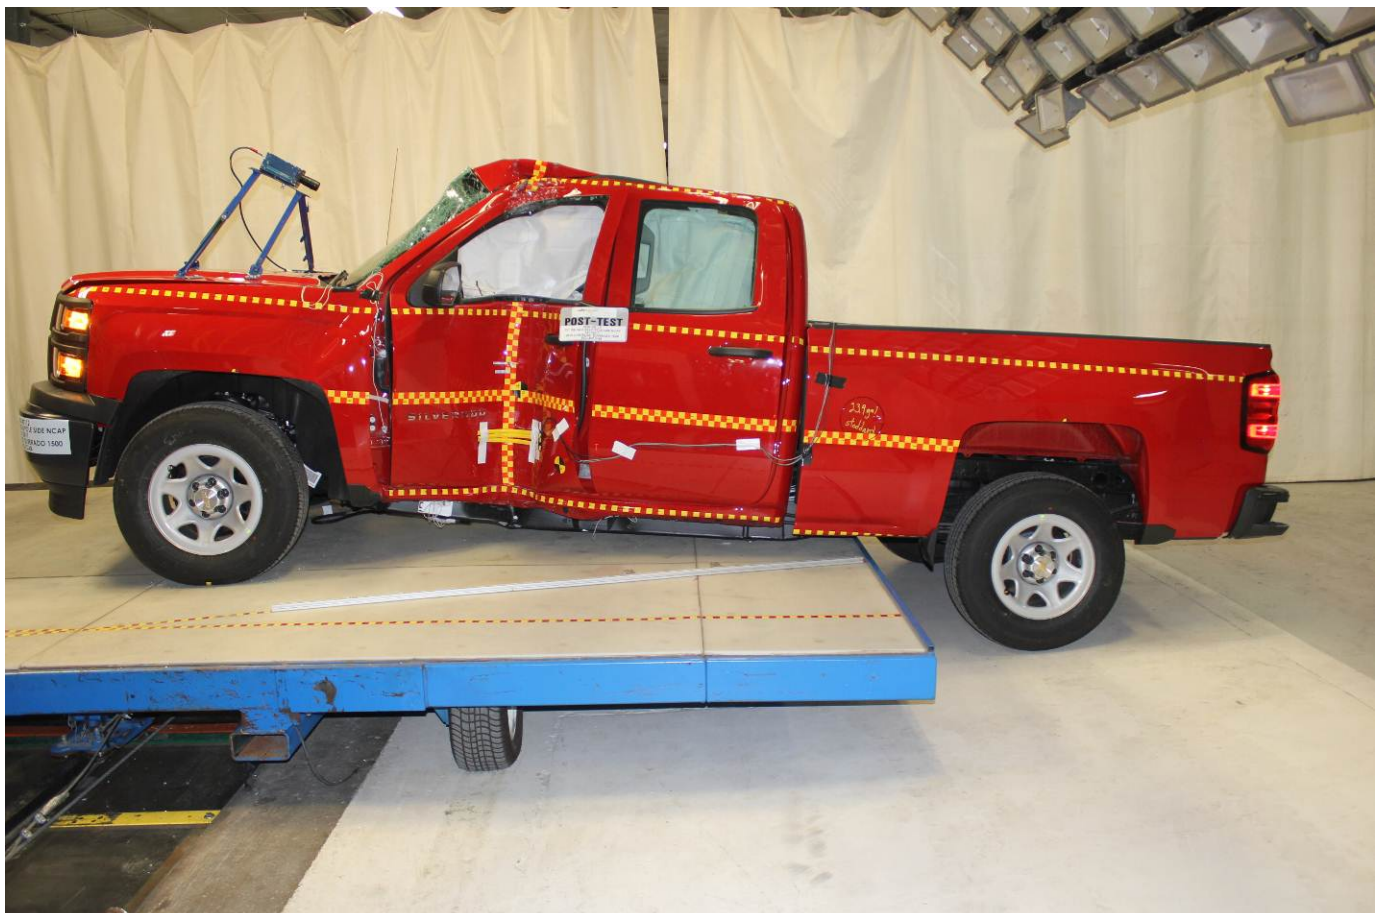
Post-Test Left Side View of Test Vehicle

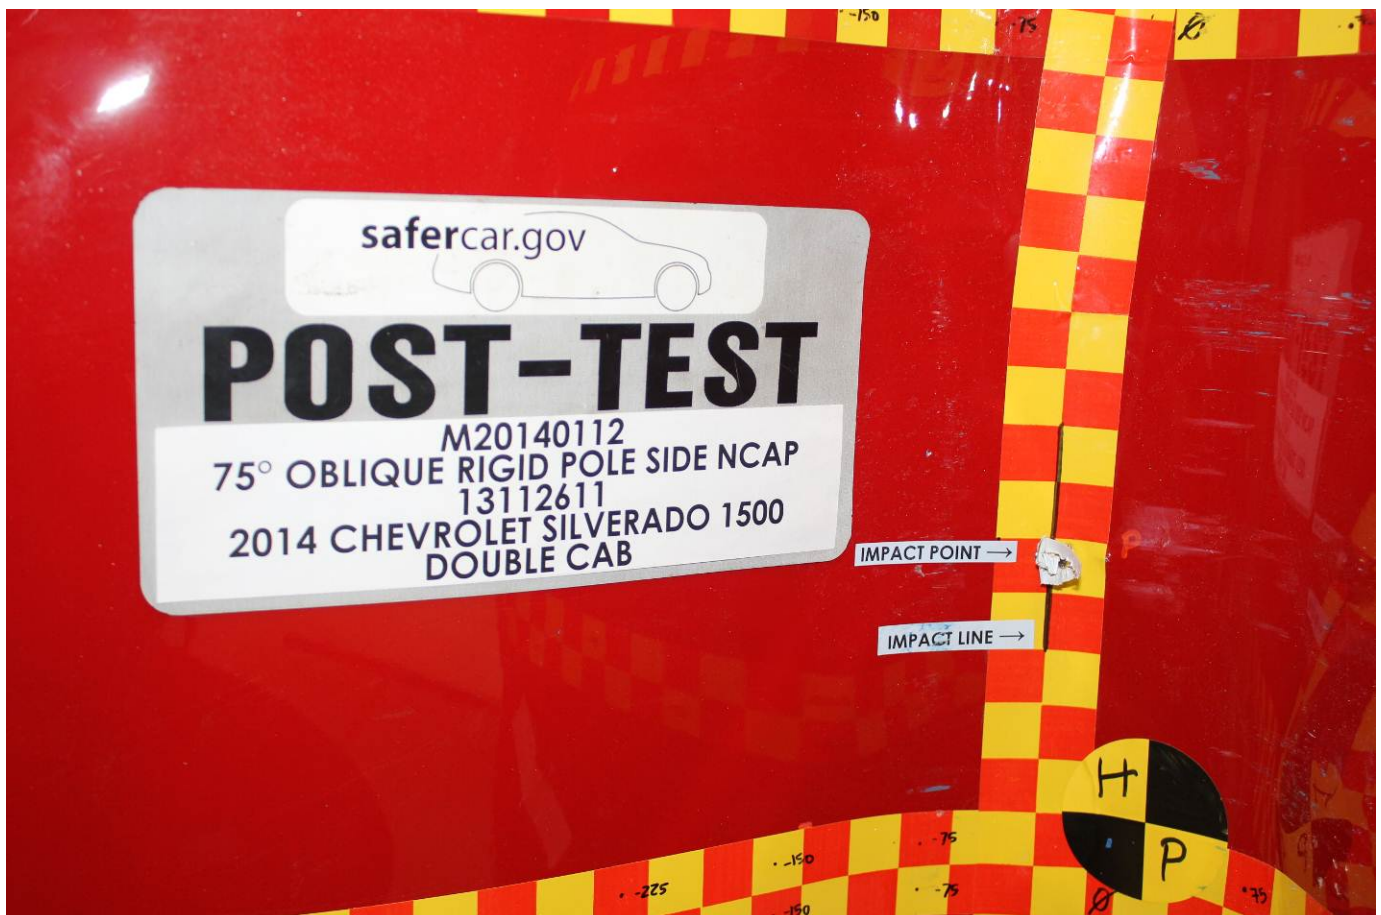
Post-Test Close-Up View of Impact Point Target Showing Impact Location

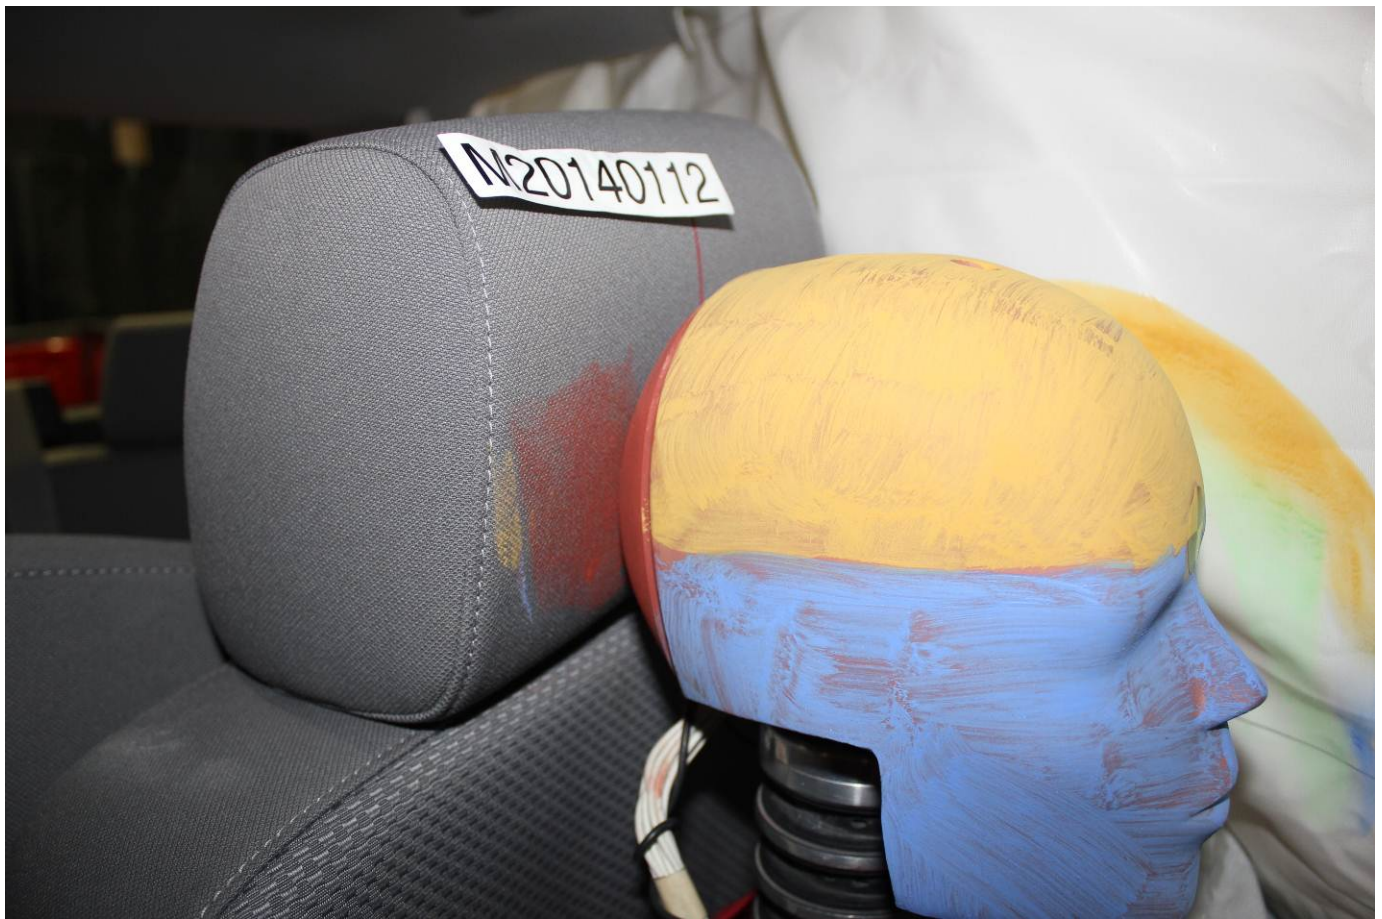
Post-Test Dummy Close-Up Head Contact with Vehicle Interior View

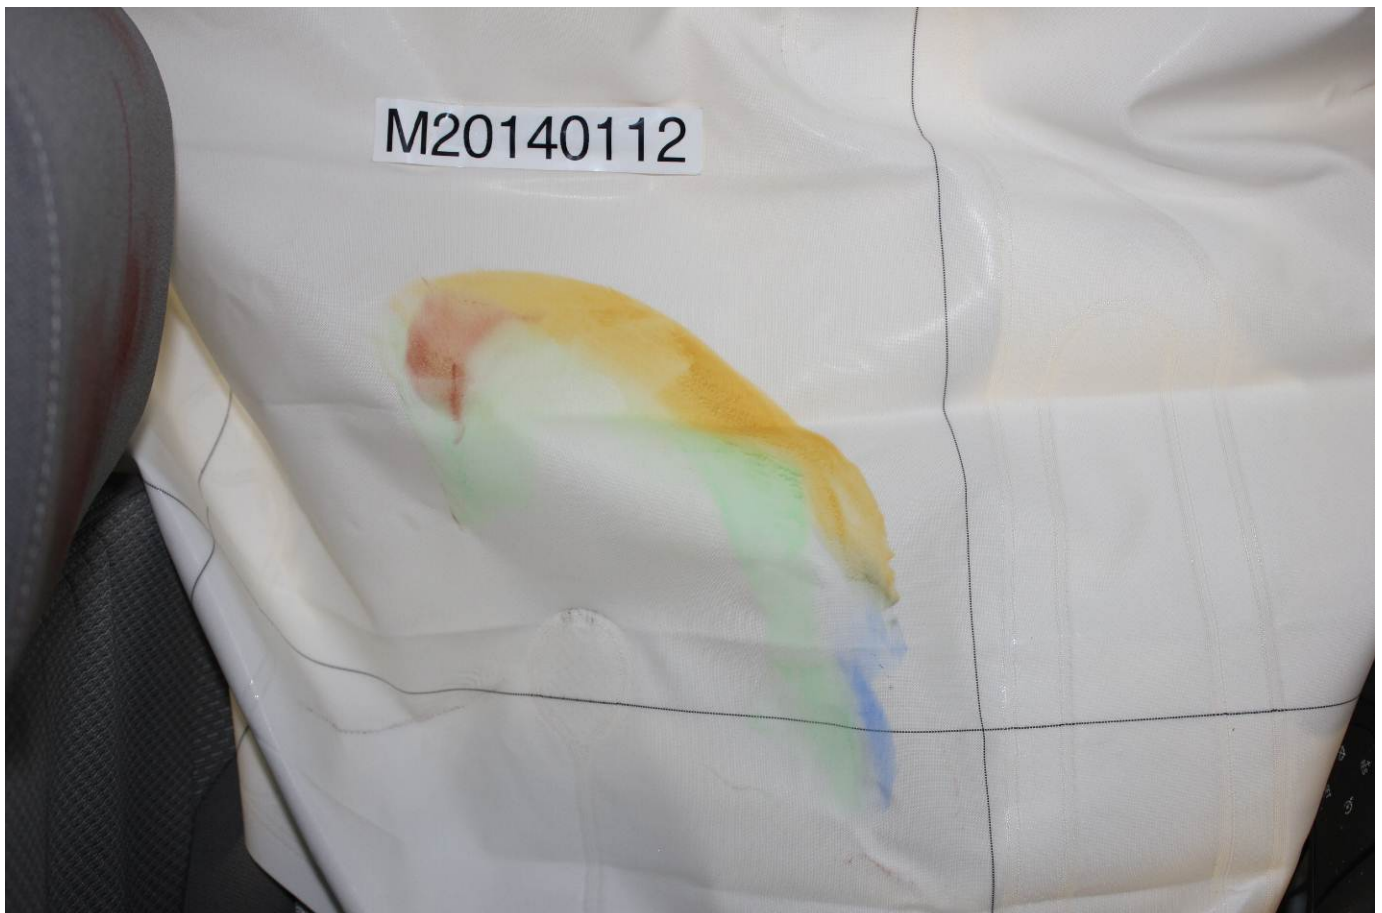
Post-Test Dummy Close-Up Head Contact with Side Air Bag View

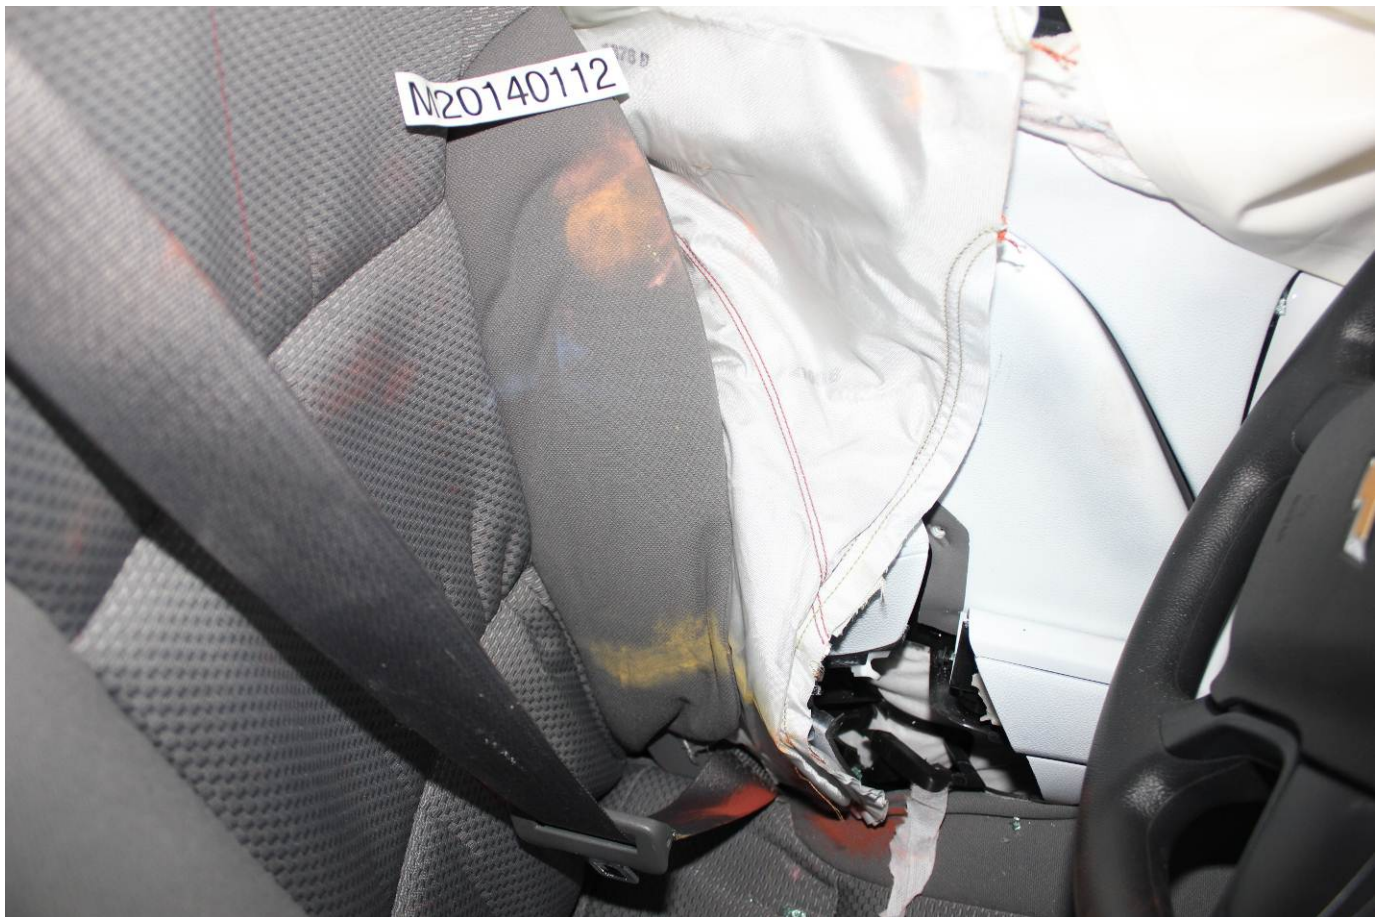
Post-Test Dummy Close-Up Torso Contact with Vehicle Interior View

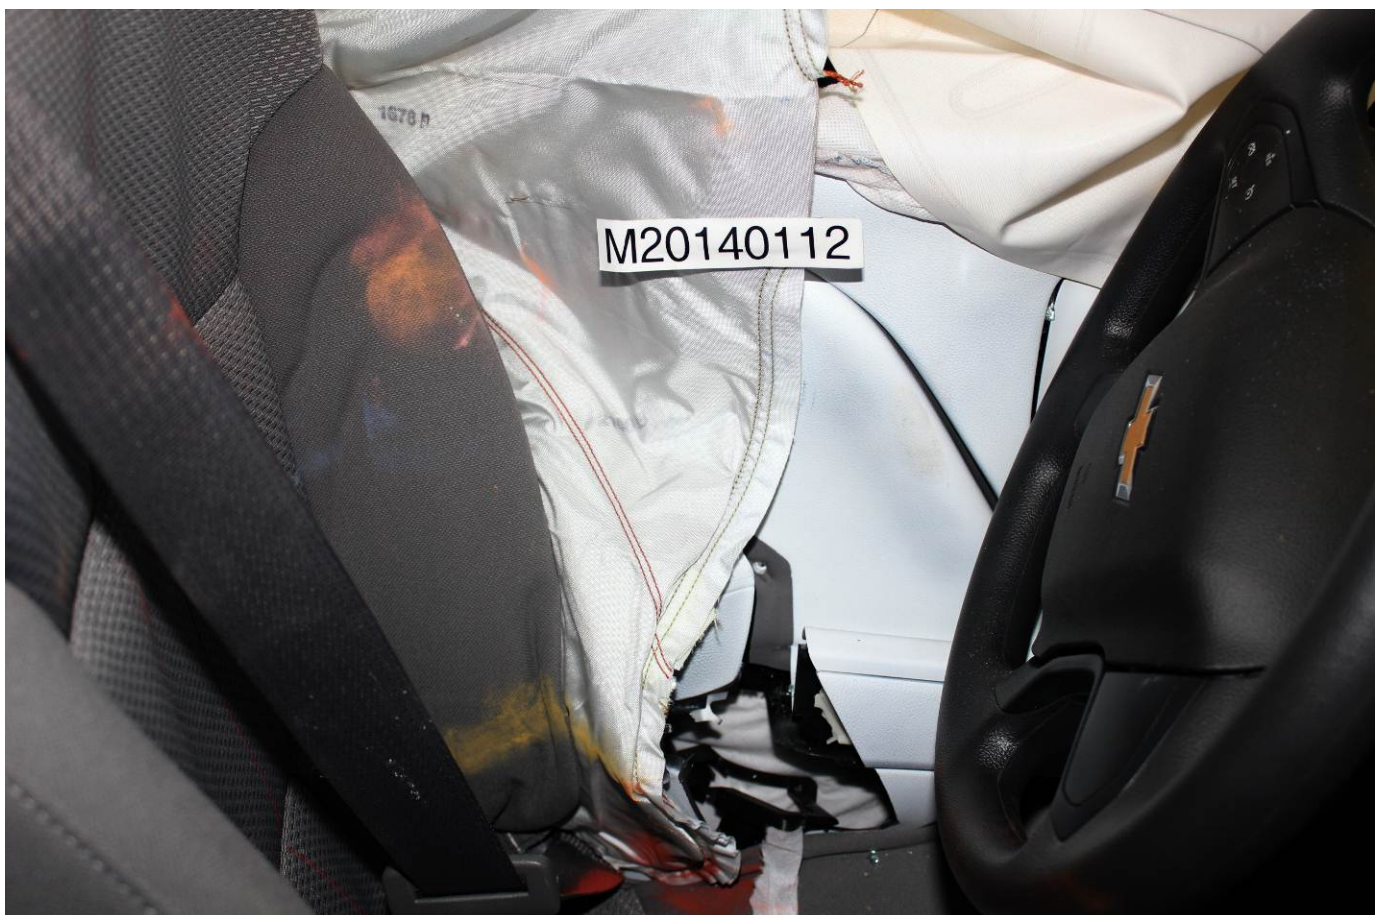
Post-Test Dummy Close-Up Torso Contact with Side Air Bag View

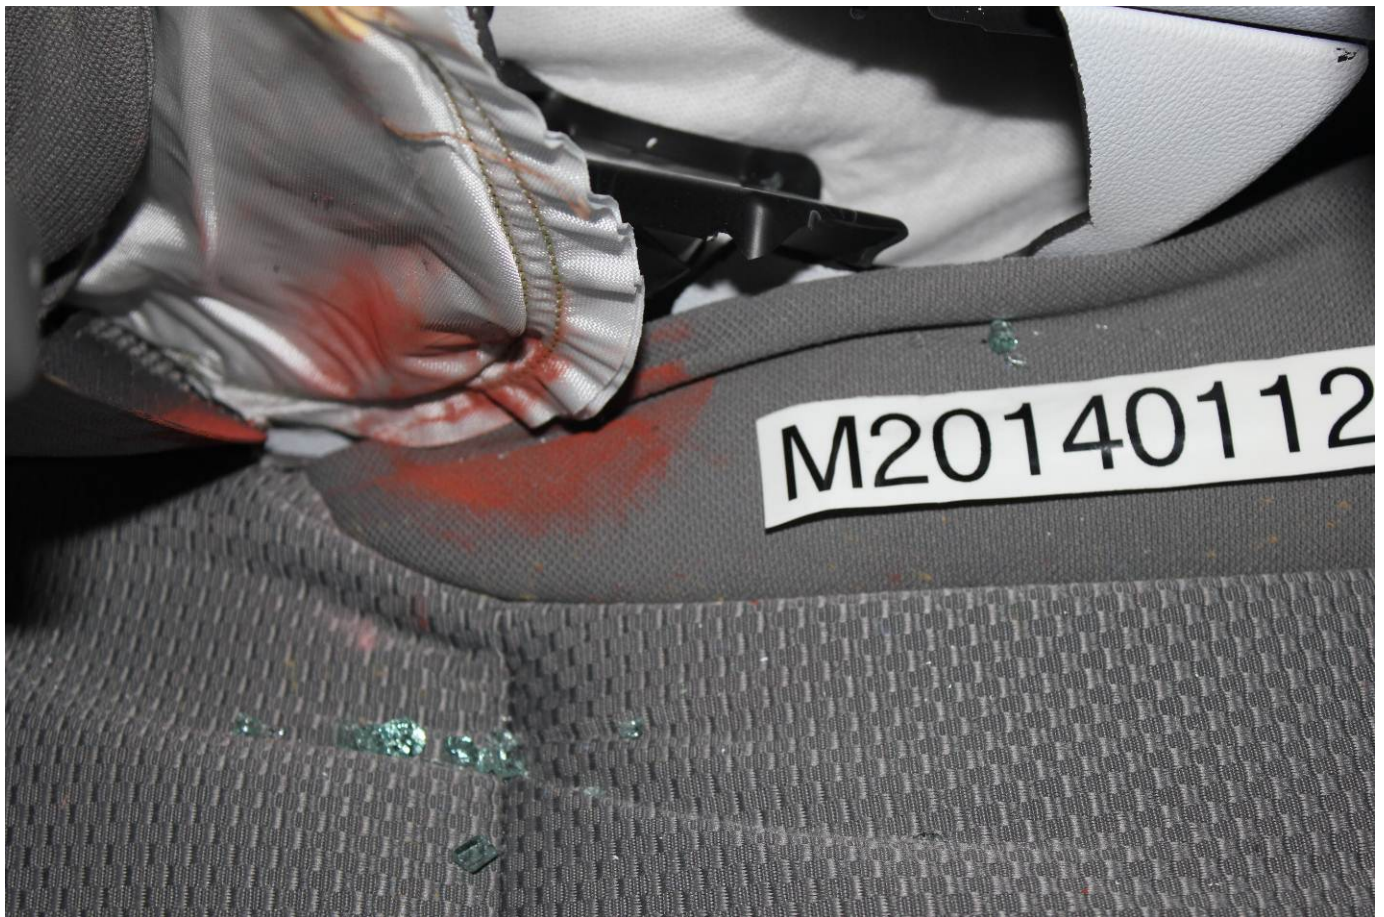
Post-Test Dummy Close-Up Pelvis Contact with Vehicle Interior View

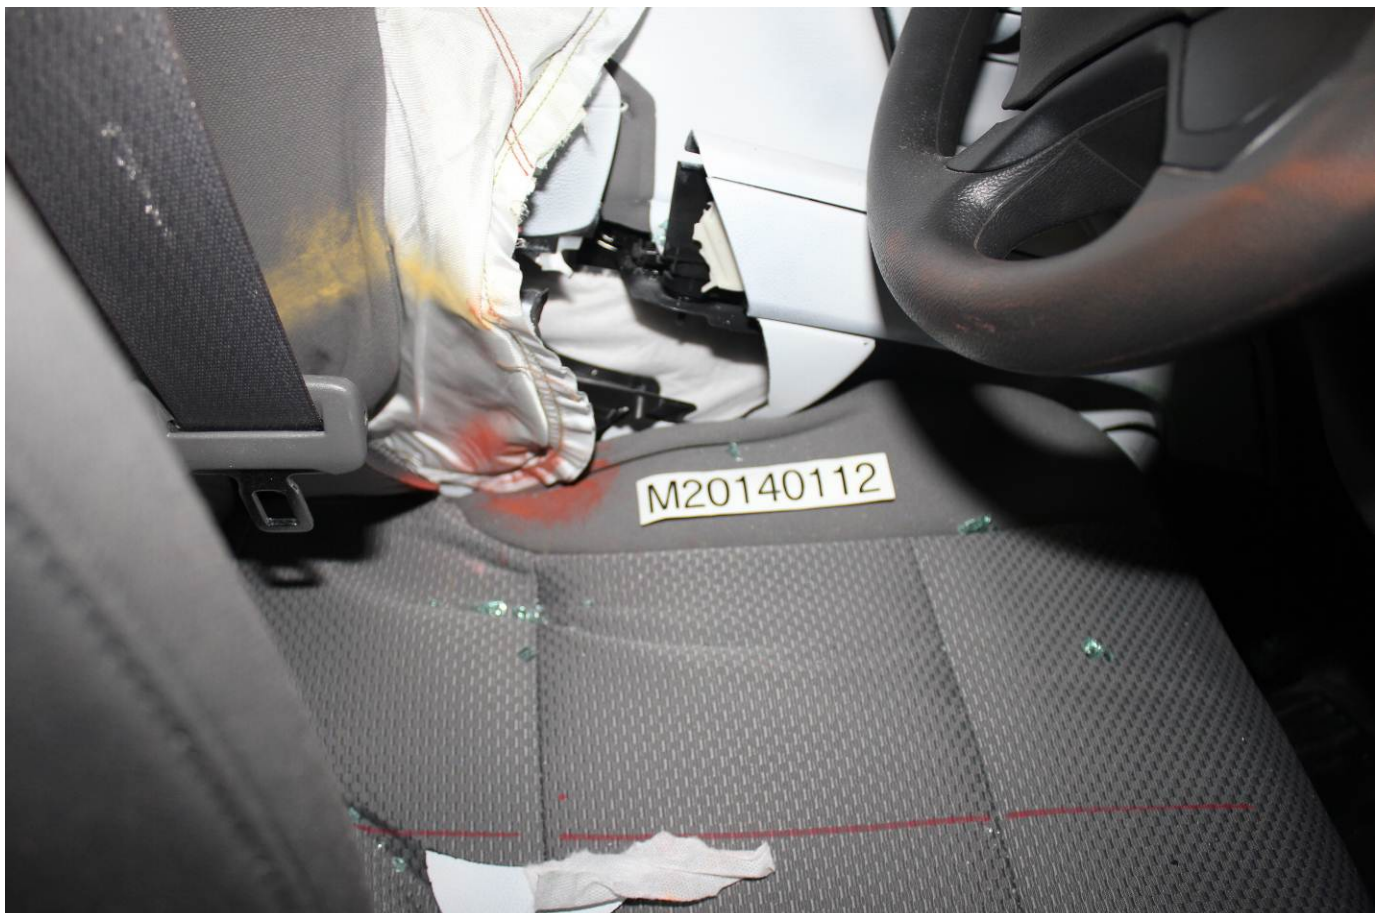
Post-Test Dummy Close-Up Pelvis Contact with Side Air Bag View

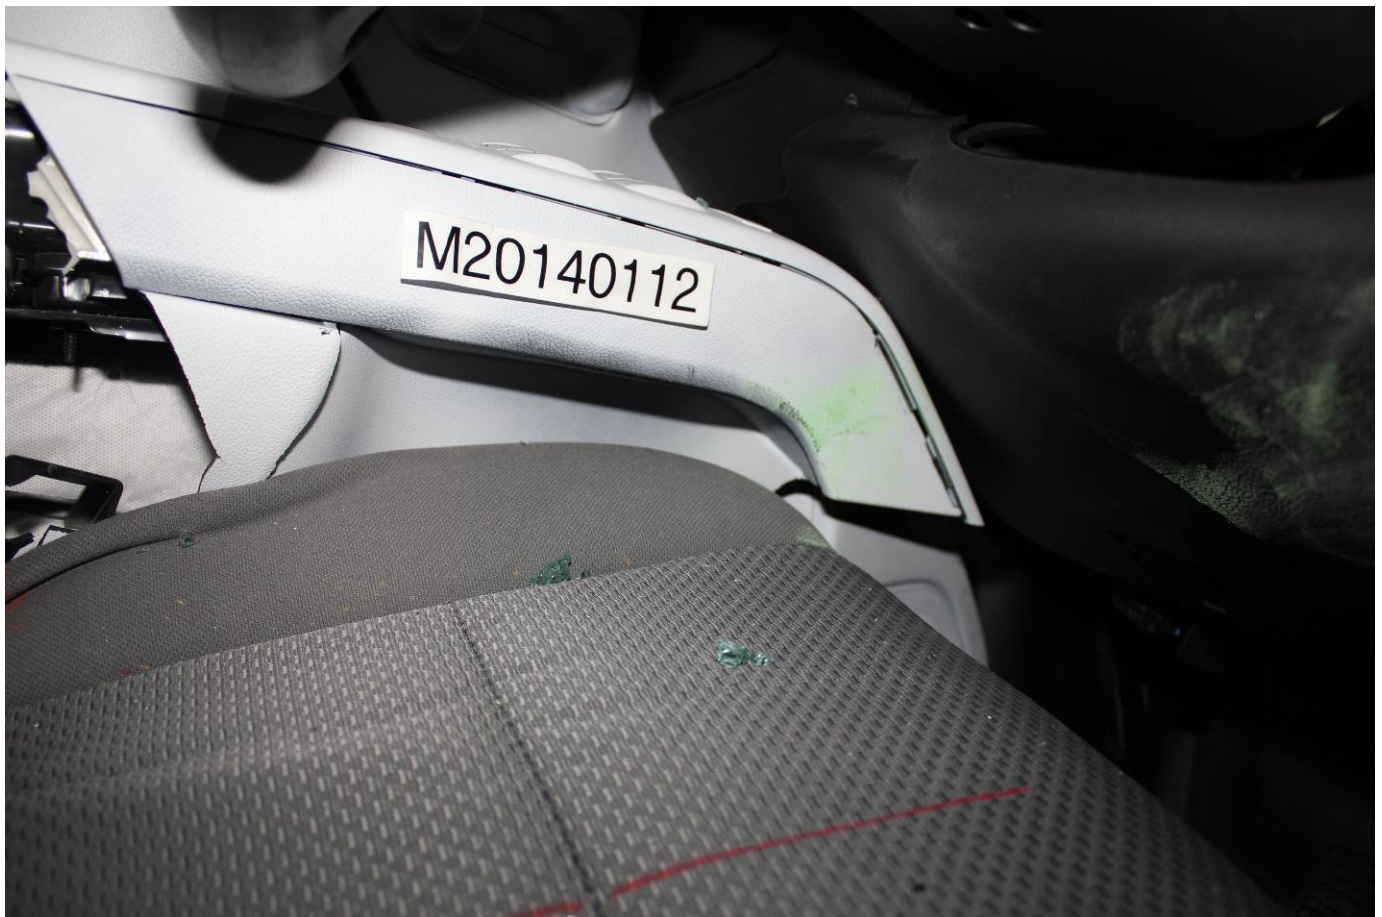
Post-Test Dummy Close-Up Knee Contact with Vehicle Interior View
