REPORT NUMBER: NCAP-CAL-14-002

**NEW CAR ASSESSMENT PROGRAM (NCAP)
FRONTAL BARRIER IMPACT TEST**

**GM Korea Company
2014 Chevrolet Spark
5Dr Hatchback**

**PREPARED BY:
CALSPAN CORPORATION
P.O. BOX 400
BUFFALO, NEW YORK 14225**

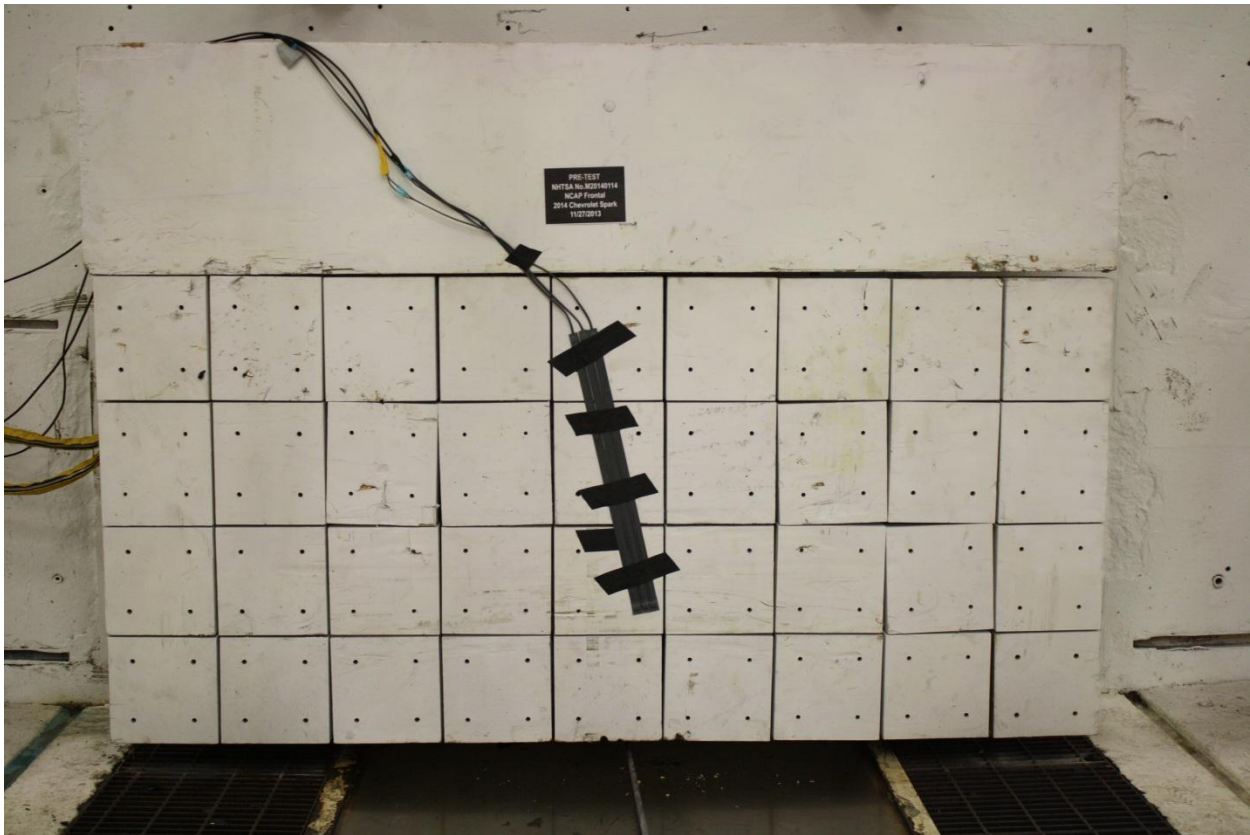
Figure A-2: Load Cell Wall

A load cell barrier consisting of 36 load cells was impacted by a 2014 Chevrolet Spark five door hatchback at a velocity of 56.93 km/h. The test was performed at Calspan Corporation's Transportation Test Operations facility in Buffalo, New York on November 27, 2013. Pre- and post-test photographs of the vehicle and dummies to document the test can be found in Appendix A. One real-time camera and 14 high-speed cameras were used to document the frontal barrier impact event. Camera locations and other pertinent camera information can be found in Data Sheet 6 of this report.

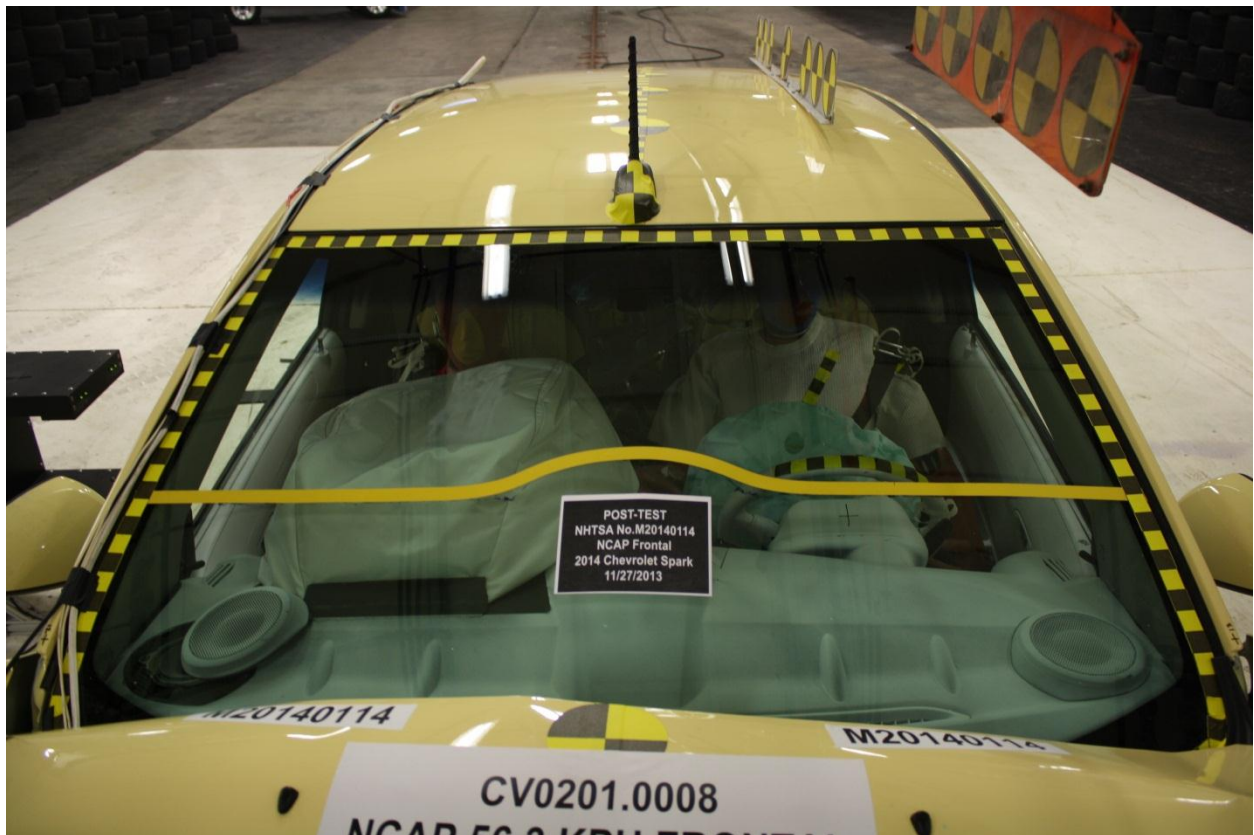
Figure A-18: Post-Test Windshield View

There was 100 percent windshield retention and no intrusion into the protected zone of the windshield during the event. There was a total of 0.0 grams of stoddard solvent leakage after the event and including all phases of the static rollover. The maximum static crush of the test vehicle was 403 mm at the centerline. During and after the impact event, the driver's and passenger's side door were closed and operational.

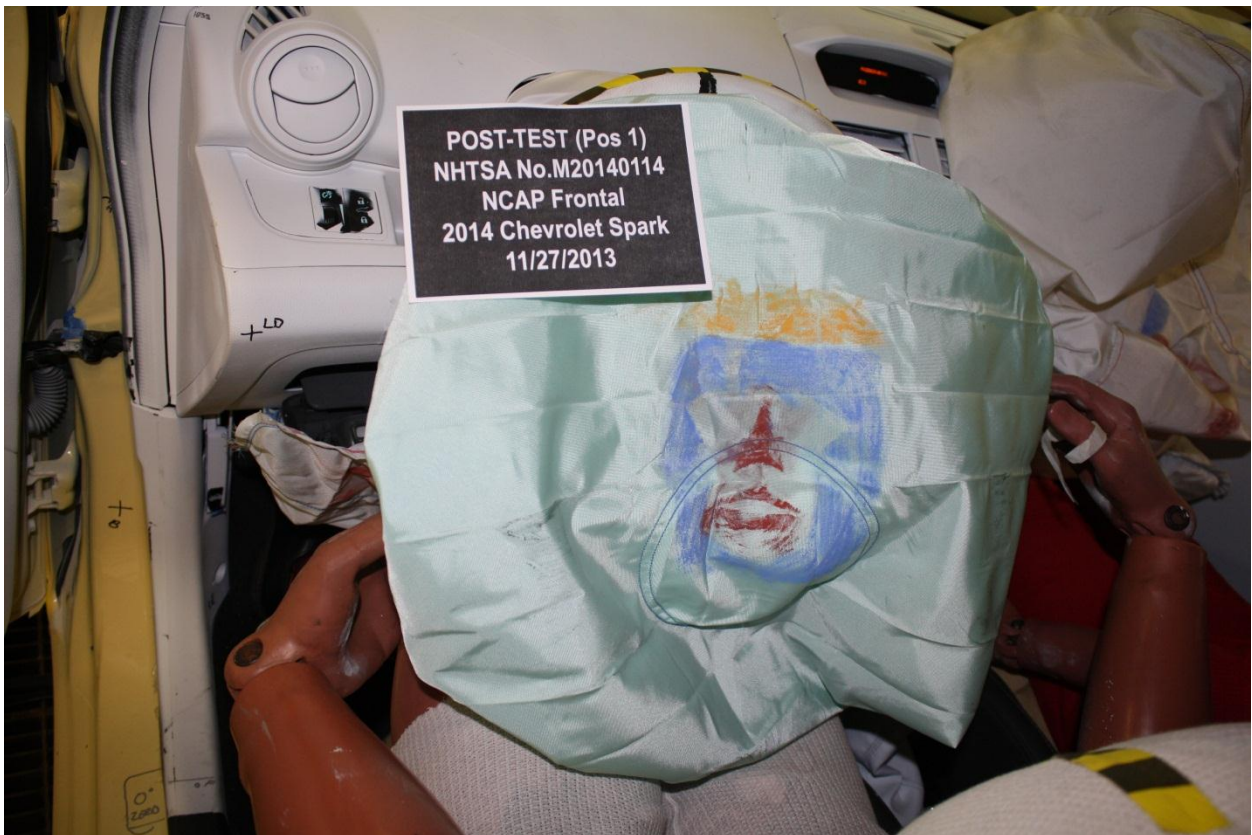
Figure A-46: Post-Test Driver Dummy Contact With Airbag

The driver's visible contact points were as follows: The driver's head contacted the frontal airbag and then the head restraint. The upper torso contacted the frontal airbag. Both knees contacted the knee airbag.

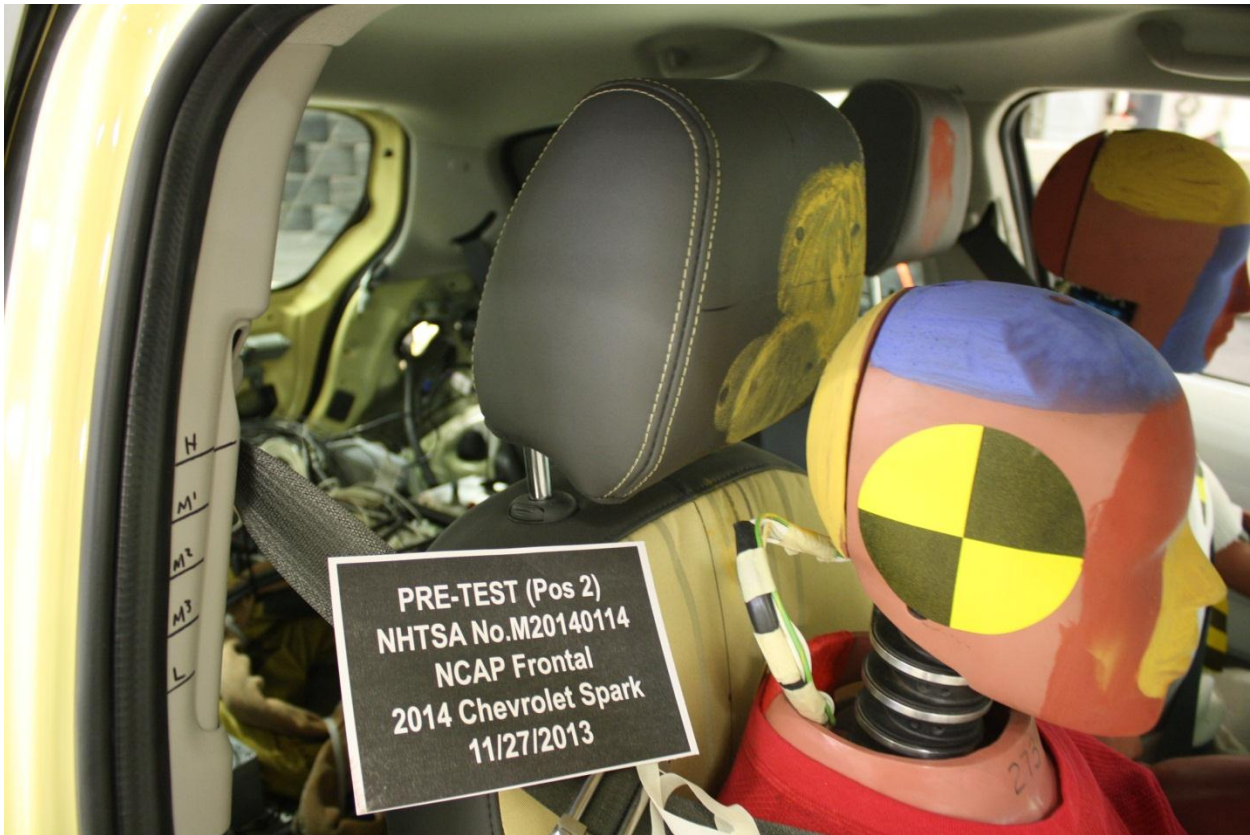
Figure A-68: Post-Test Passenger Dummy Contact With Headrest– **Wrong Placard was used**

The passenger's visible contact points were as follows: The passenger's head contacted the frontal airbag and then the head restraint. The upper torso contacted the frontal airbag. Both knees contacted the knee airbag.
